**Flood Control Project Maintenance
Levee Inspections**

Maintenance Issue Types Only, Levee Inspection Report By Mile - Fall 2021

Madera County FCWCA

Waterway	Bank	Unit Miles	Inspection Start/End	Inspector
Unit No. 01 Ash Slough	Right	2.37	10/14/2021 10/14/2021	Corey Fujitani

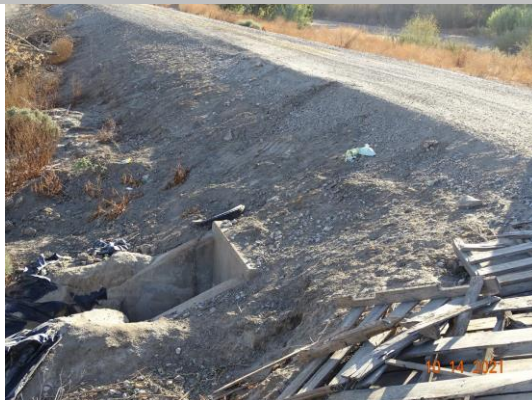
Photo 1 of 1 : FA_2021_NA0011_142_20_20211015_00026.jpg

LM Start	0.04	Rating **	A/W	Issue No.	20
LM End	0.04	Issue Type +	Ma	Location *	LS
Category	Earthen Levee			GPS Latitude/Longitude	
				Start	End
Item	Erosion / Bank Caving			37.046624 °	37.046624 °
				-120.427317 °	-120.427317 °
DWR ID	DWR_NA0011_01_s_2014_20				
Comment Code					
E1 : Note and monitor erosion site.					
Inspector Comment					
Appears to have been repaired. Monitor for settlement.

View of repaired slope damage on landside slope. (Fall 2021)

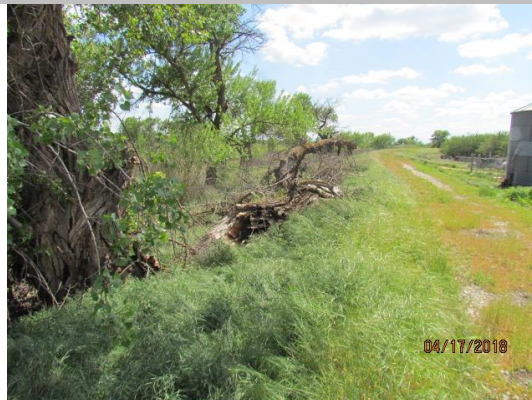
Photo 1 of 1 : FA_2021_NA0011_142_21_20210830_00009.jpg

Looking west at tree limbs and branches on waterward slope. (Spring 2018)

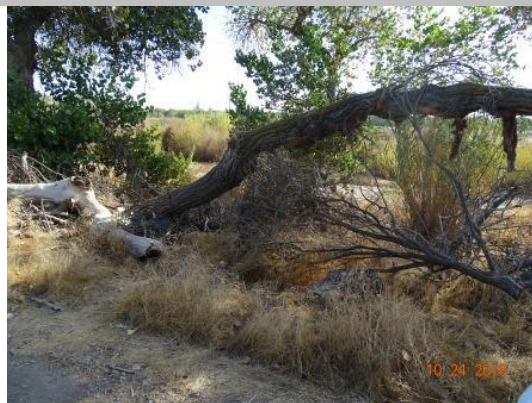
Photo 1 of 1 : FA_2021_NA0011_142_25_20210830_00010.jpg

LM Start	0.79	Rating **	U	Issue No.	25
LM End	0.79	Issue Type +	Ma	Location *	WS
Category	Earthen Levee			GPS Latitude/Longitude	
				Start	End
Item	Encroachments			37.053329 °	37.053329 °
				-120.417448 °	-120.417448 °
DWR ID	DWR_NA0011_01_f_2018_25				
Comment Code					
TR : Tree or limb					
Inspector Comment					
There is a fallen tree blocking the waterside slope.

Tree limbs and trunks are on the waterside shoulder and slope. (Fall 2018)

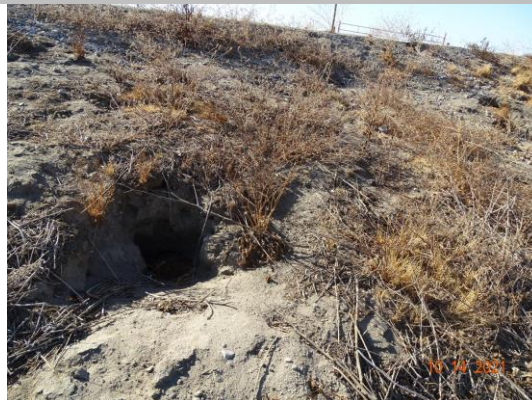
Photo 1 of 1 : FA_2021_NA0011_143_20_20211015_00037.jpg

Representative view of rodent burrows on the waterside slope. (Fall 2021)

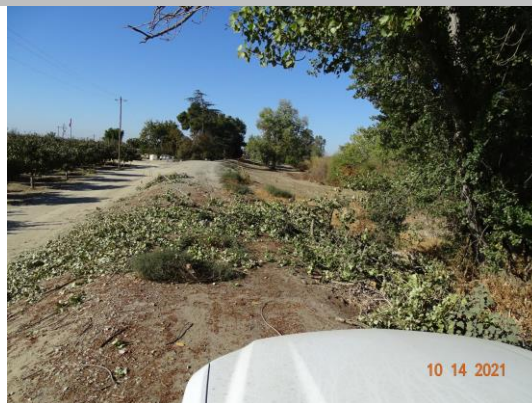
Photo 1 of 1 : FA_2021_NA0011_143_15_20211015_00039.jpg

Tree branches blocking access across the levee crown and waterside slope. (Fall 2021)

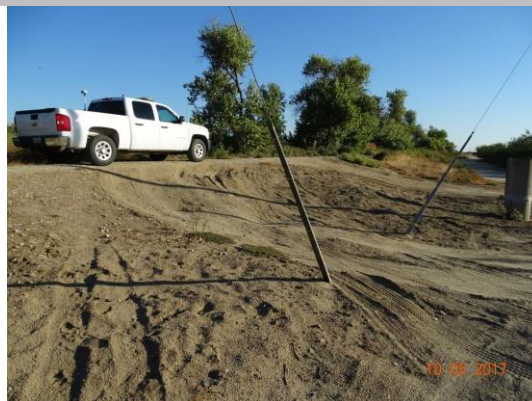
Photo 1 of 1 : FA_2021_NA0011_143_13_20210830_00007.jpg

LM Start	0.31	Rating **	M	Issue No.	13
LM End	0.31	Issue Type +	Ma	Location *	LS
Category	Earthen Levee			GPS Latitude/Longitude	
				Start	End
Item	Slope Stability			37.047266 °	37.047266 °
				-120.422393 °	-120.422393 °
DWR ID	DWR_NA0011_02_f_2017_13				
Comment Code					
S3 : Repair the levee slope damaged by vehicle traffic and prevent access where possible.					
Inspector Comment

Vehicle access to levee slope should be prevented and erosion repaired.

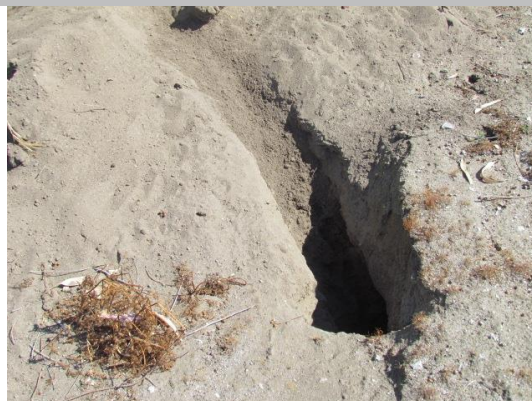
Photo 1 of 1 : FA_2021_NA0011_143_39_20210830_00018.jpg

Previously noted burrows in the area waterside slope levee mile 0.32-1.67.

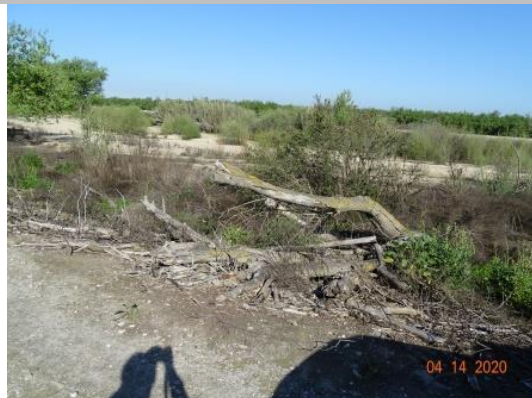
Photo 2 of 2 : FA_2021_NA0011_143_27_20210830_00012.jpg

Branches left along the waterside slope from high flow. (Spring 2020)

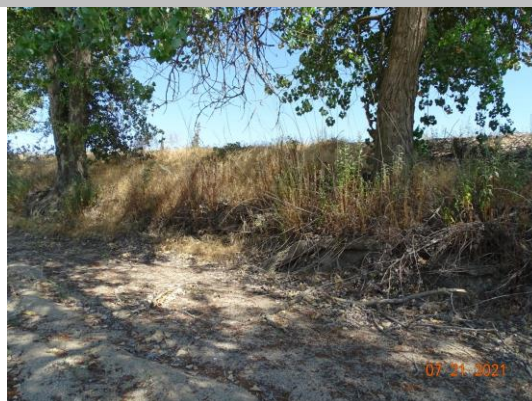
Photo 1 of 2 : SJR2021_NA0011U02RM2.57_1.JPG

LM Start	1.10	Rating **	U	Issue No.	1
LM End	1.19	Issue Type +	Ma	Location *	
Category	Supplemental			GPS Latitude/Longitude	
				Start	End
Item	DWR Erosion Survey			37.055596 °	37.055596 °
				-120.412647 °	-120.412647 °
DWR ID	NA0011U02RM2.57

07/21/2021: From 2013 to present, no significant changes were observed during the annual survey. Vegetation is obscuring the views of the erosion.

2009: Site is recommended as a local maintenance issue, per Critical Levee Repair Office, Critical Erosion Sites Evaluation 2008 Report; site was previously rated "M"

7/21/2021: View of the erosion on the levee toe.

08/05/2010: Recommended for annual assessment and monitoring during flood events, per CLRO.

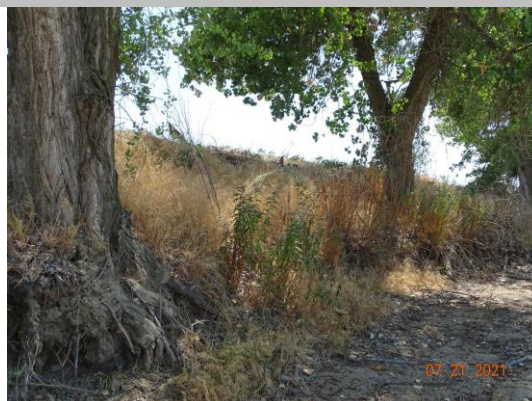
Photo 2 of 2 : SJR2021_NA0011U02RM2.57_2.JPG

7/21/2021: Another view of the erosion.

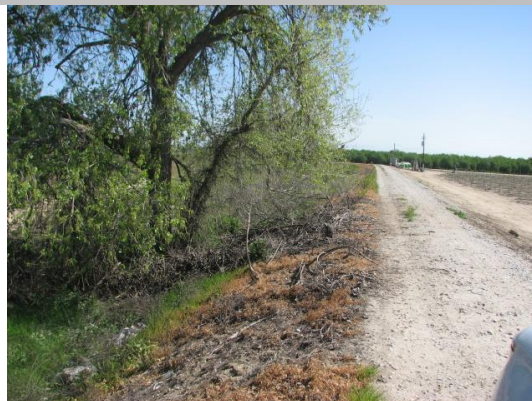
Photo 1 of 1 : FA_2021_NA0011_143_25_20210830_00011.jpg

LM Start	1.10	Rating **	M	Issue No.	17
LM End	1.13	Issue Type +	Ma	Location *	WS
Category	Earthen Levee			GPS Latitude/Longitude	
				Start	End
Item	Trim / Thin Trees			37.055437 °	37.055533 °
				-120.413392 °	-120.412863 °
DWR ID	DWR_NA0011_02_f_2017_17				
Comment Code					
T1 : Trim trees to at least five feet above ground level.					
Inspector Comment					
Trim branches from waterside tree hanging low over the crown inhibiting crown access.

Looking downstream at untrimmed tree on waterward slope. (Spring 2018)

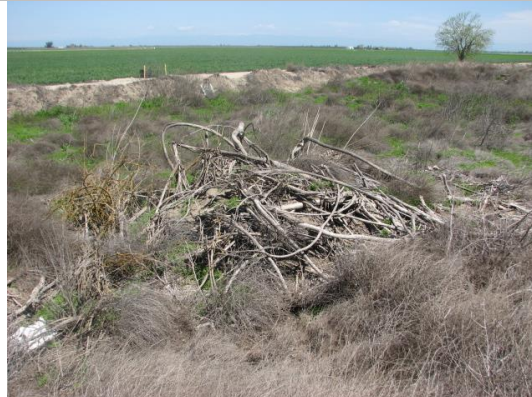
Photo 1 of 1 : FA_2021_NA0011_144_20_20210830_00008.jpg

Looking at prunings on landward slope. (Spring 2018)

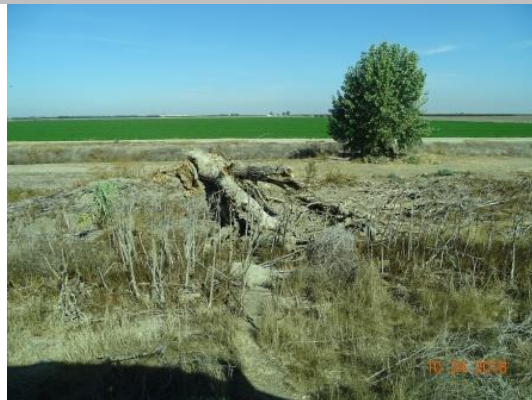
Photo 1 of 1 : FA_2021_NA0011_144_10_20210830_00005.jpg

View of dead tree on the landside slope. (Fall 2018)

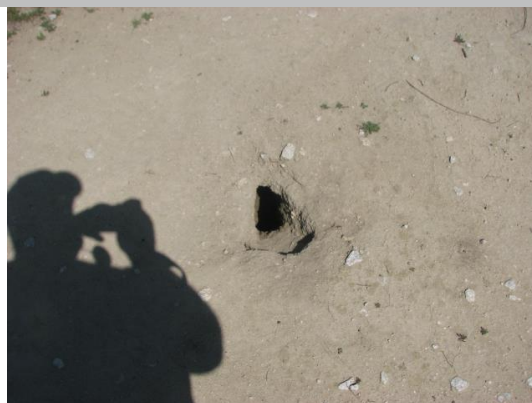
Photo 1 of 1 : FA_2021_NA0011_144_5_20210830_00002.jpg

LM Start	0.46	Rating **	M	Issue No.	5
LM End	0.46	Issue Type +	Ma	Location *	CR
Category	Earthen Levee			GPS Latitude/Longitude	
				Start	End
Item	Animal Control			36.996238 °	36.996238 °
				-120.365563 °	-120.365563 °
DWR ID	DWR_NA0011_03_s_2018_5				
Comment Code					
A3 : No rodents visible, but rodent burrows visible; need to backfill and compact or grout burrows.					
Inspector Comment					
There is a large rodent hole on the crown of the levee.

Looking at rodent hole on levee crown. (Spring 2018)

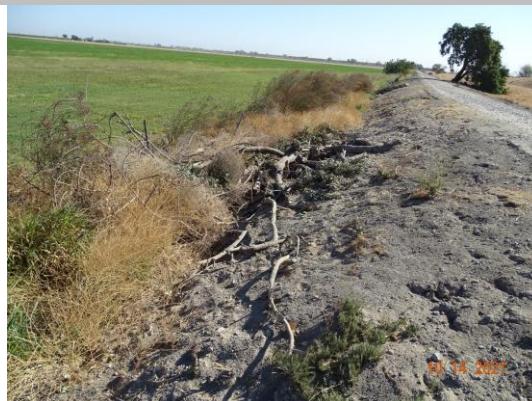
Photo 1 of 1 : FA_2021_NA0011_144_11_20211015_00016.jpg

LM Start	1.04	Rating **	M	Issue No.	11
LM End	1.05	Issue Type +	Ma	Location *	LS
Category	Earthen Levee			GPS Latitude/Longitude	
				Start	End
Item	Encroachments			36.996613 °	36.996610 °
				-120.355055 °	-120.354995 °
DWR ID	DWR_NA0011_03_s_2012_11				
Comment Code					
TR : Tree or limb					
Inspector Comment					
Remove nut tree from the slope.

Tree limbs left on the landside slope. (Fall 2021)

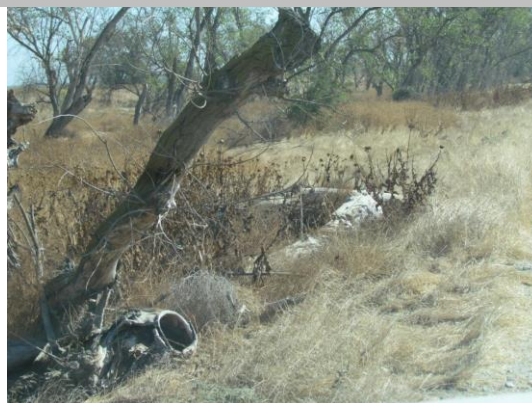
Photo 1 of 1 : FA_2021_NA0011_145_16_20210830_00010.jpg

Tree on WS shoulder.

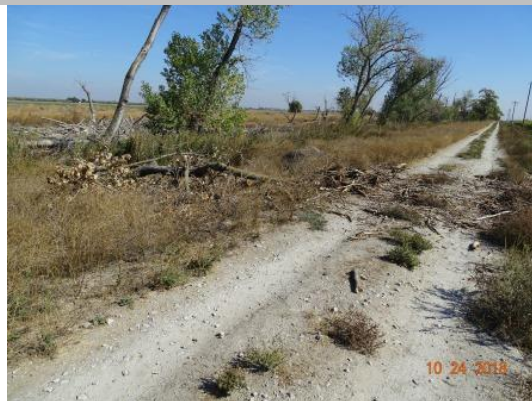
Photo 1 of 1 : FA_2021_NA0011_145_31_20210830_00018.jpg

Tree branches strewn across levee crown and both shoulders. (Fall 2018)

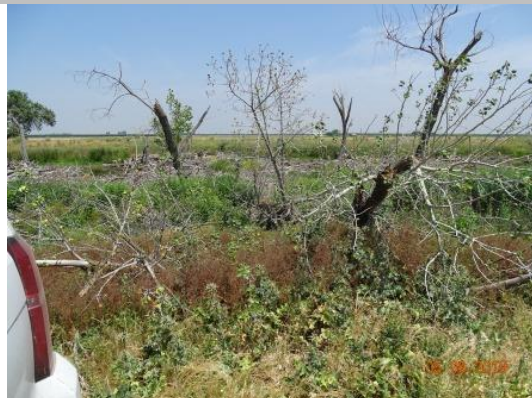
Photo 1 of 1 : FA_2021_NA0011_145_6_20210830_00002.jpg

View of fallen tree on waterside slope. (Spring 2019)

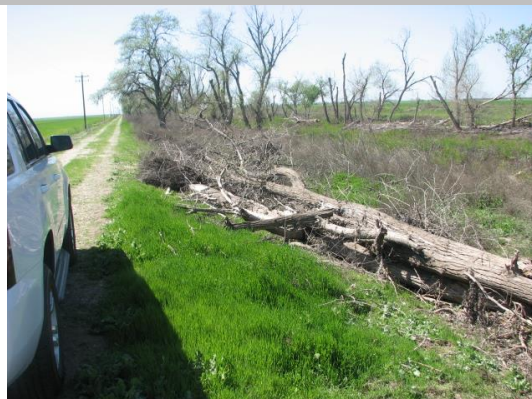
Photo 1 of 1 : FA_2021_NA0011_145_14_20210830_00008.jpg

Looking upstream at fallen tree on waterward slope. (Spring 2018)

LM Start	0.94	Rating **	M	Issue No.	14
LM End	0.94	Issue Type +	Ma	Location *	WS
Category	Earthen Levee			GPS Latitude/Longitude	
				Start	End
Item	Encroachments			36.995573 °	36.995573 °
				-120.356601 °	-120.356601 °
DWR ID	DWR_NA0011_04_f_2017_14				
Comment Code					
TR : Tree or limb					
Inspector Comment					
Remove the downed tree from the waterside slope.

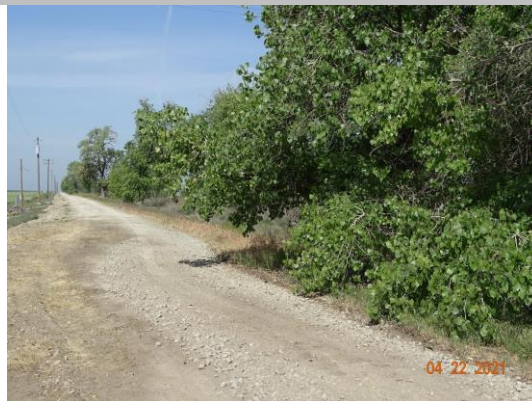
Photo 1 of 1 : FA_2021_NA0011_145_12_20210830_00006.jpg

LM Start	1.01	Rating **	U	Issue No.	12
LM End	1.01	Issue Type +	Ma	Location *	WS
Category	Earthen Levee			GPS Latitude/Longitude	
				Start	End
Item	Trim / Thin Trees			36.995537 °	36.995537 °
				-120.355261 °	-120.355261 °
DWR ID	DWR_NA0011_04_f_2017_12				
Comment Code					
T1 : Trim trees to at least five feet above ground level.					
Inspector Comment					
Branches from waterside tree are blocking visibility of waterside slope and crown. Levee crown is nearly impassible.

Trim trees to at least 5' above levee slope and 12' above levee crown to allow inspection and access. (Spring 2021)

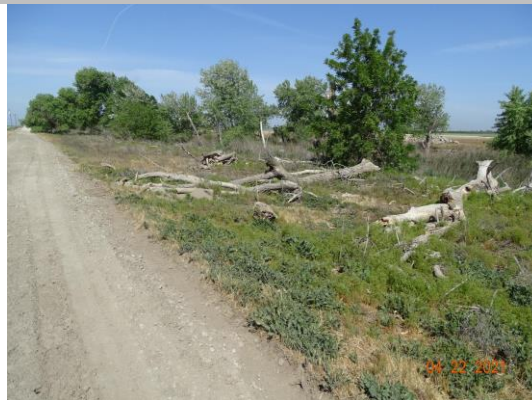
Photo 1 of 1 : FA_2021_NA0011_145_24_20210830_00014.jpg

View of fallen trees on the waterside slope and berm. (Spring 2021)

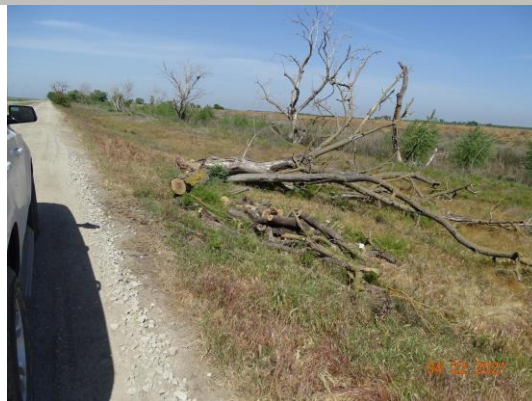
Photo 1 of 1 : FA_2021_NA0011_145_7_20210830_00003.jpg

View of tree limbs on the waterside slope. (Spring 2021)

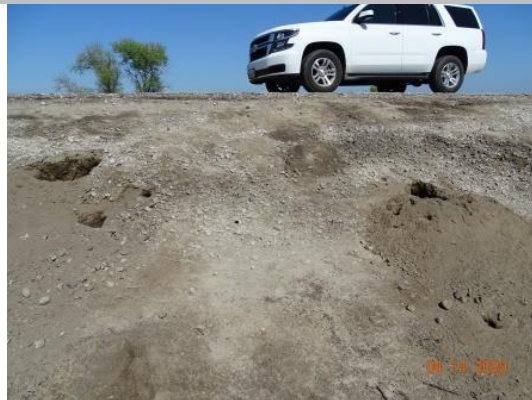
Photo 1 of 1 : FA_2021_NA0011_145_11_20210830_00005.jpg

Representative view of rodent holes observed in this section. (Spring 2020)

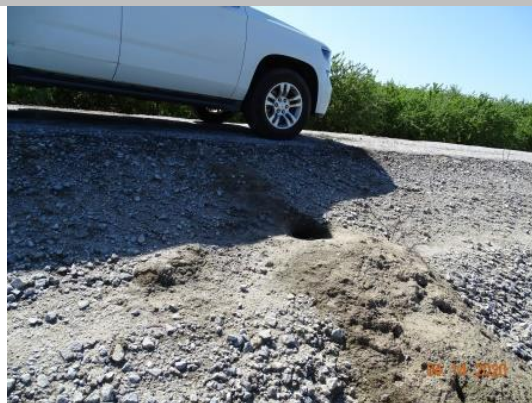
Photo 1 of 1 : FA_2021_NA0011_145_30_20210830_00017.jpg

LM Start	1.50	Rating **	U	Issue No.	30
LM End	2.28	Issue Type +	Ma	Location *	WS
Category	Earthen Levee			GPS Latitude/Longitude	
				Start	End
Item	Animal Control			36.995590 °	37.003740 °
				-120.346406 °	-120.336877 °
DWR ID	DWR_NA0011_04_f_2014_30				
Comment Code					
A1 : Exterminate rodents and backfill and compact or grout burrows.					
Inspector Comment					
Bait stations are needed in the rodent infested area on the waterside slope and toe.

Several large rodent holes on waterside slope. (Spring 2020)

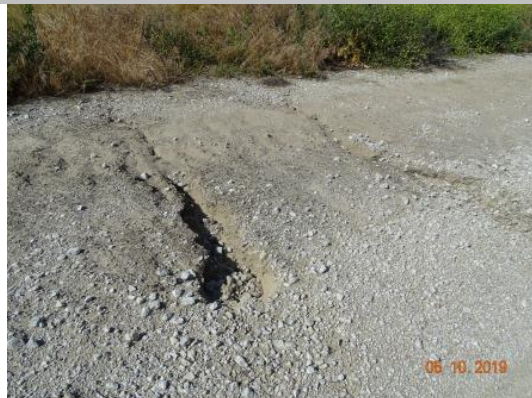
Photo 1 of 1 : FA_2021_NA0011_146_46_20210830_00018.jpg

LM Start	6.30	Rating **	M	Issue No.	46
LM End	6.30	Issue Type +	Ma	Location *	WS
Category	Earthen Levee			GPS Latitude/Longitude	
				Start	End
Item	Erosion / Bank Caving			36.968399 °	36.968399 °
				-120.260433 °	-120.260433 °
DWR ID	DWR_NA0011_05_s_2019_46				
Comment Code					
E2 : Schedule repair of erosion site prior to the next inspection.					
Inspector Comment					
Rills on waterside slope.

Rills observed on waterside slope. (Spring 2019)

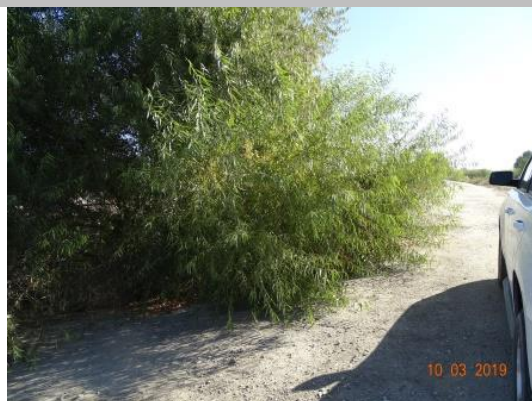
Photo 1 of 1 : FA_2021_NA0011_146_29_20210830_00012.jpg

LM Start	6.57	Rating **	U	Issue No.	29
LM End	6.57	Issue Type +	Ma	Location *	LS
Category	Earthen Levee			GPS Latitude/Longitude	
				Start	End
Item	Trim / Thin Trees			36.968477 °	36.968477 °
				-120.255557 °	-120.255557 °
DWR ID	DWR_NA0011_05_f_2019_29				
Comment Code					
T2 : Thin trees to allow visibility of the ground and room to flood fight.					
Inspector Comment					
Tree should be trimmed above the levee crown and 5 feet above the slope.

View of tree growing on landside slope looking upstream. (Fall 2019)

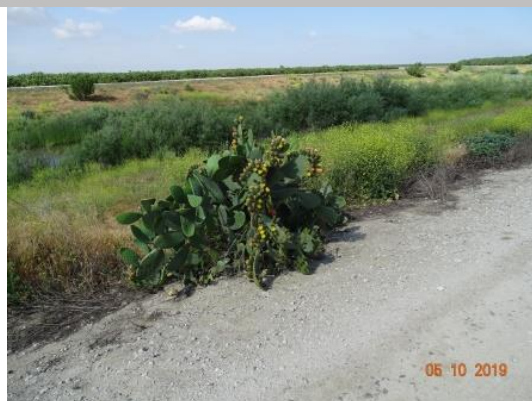
Photo 1 of 1 : FA_2021_NA0011_146_10_20210830_00001.jpg

Cactus growing on waterside shoulder. (Spring 2019)

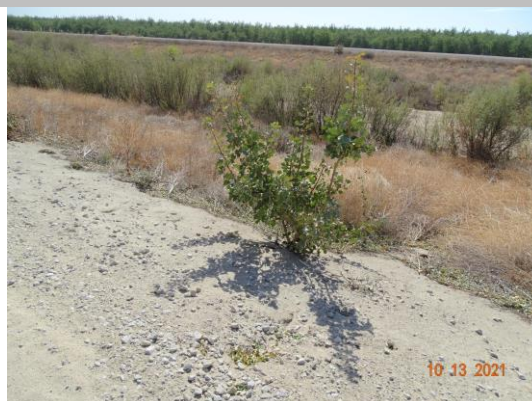
Photo 1 of 1 : FA_2021_NA0011_146_8_20211018_00031.jpg

Sapling growing on the waterside shoulder. (Fall 2021)

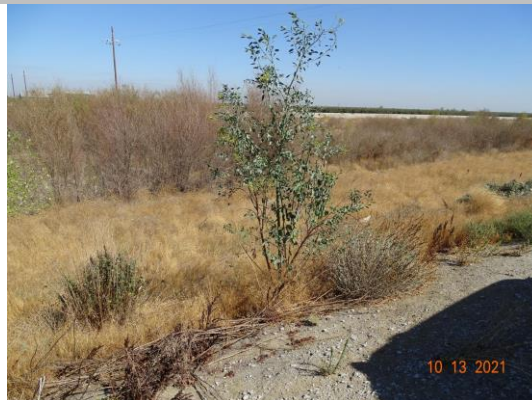
Photo 1 of 1 : FA_2021_NA0011_147_16_20211018_00040.jpg

View of sapling growing in the waterside shoulder. (Fall 2021)

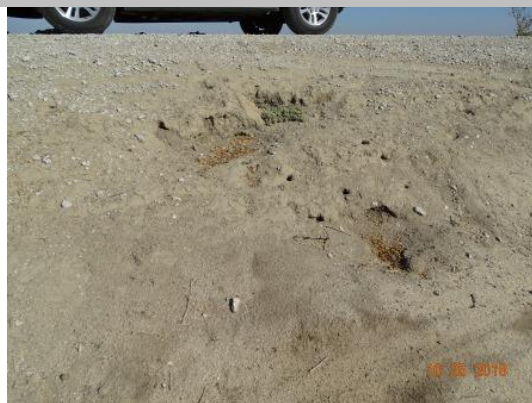
Photo 1 of 1 : FA_2021_NA0011_147_58_20210830_00016.jpg

Minor erosion on landside slope. (Fall 2018)

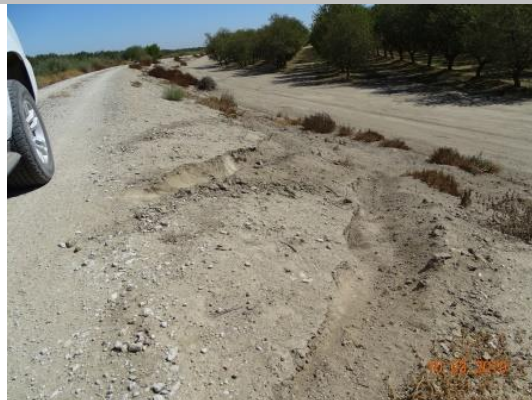
Photo 1 of 1 : FA_2021_NA0011_147_23_20210830_00004.jpg

Damage to landside slope from vehicle traffic. (Fall 2019)
