**Flood Control Project Maintenance  
Levee Inspections**

**Maintenance Issue Types Only, Levee Inspection Report By Mile - Fall 2022**

**Madera County FCWCA**

Waterway	Bank	Unit Miles	Inspection Start/End	Inspector
Unit No. 01 Ash Slough	Right	2.37	10/05/2022 10/05/2022	Corey Fujitani

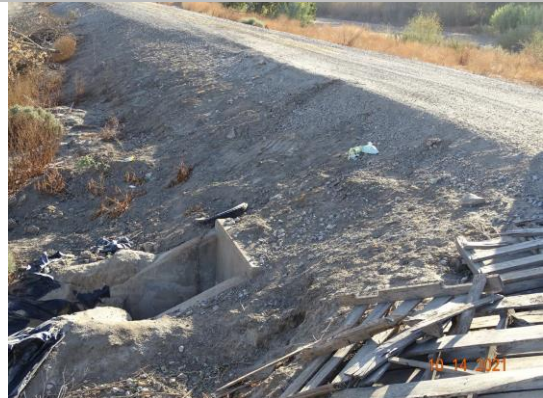
Photo 1 of 1 : FA\_2022\_NA0011\_142\_20\_20220822\_00010.jpg

LM Start	0.04	Rating **	A/W	Issue No.	20
LM End	0.04	Issue Type +	Ma	Location *	LS
Category	Earthen Levee			GPS Latitude/Longitude	
				Start	End
Item	Erosion / Bank Caving			37.046624 °	37.046624 °
				-120.427317 °	-120.427317 °
DWR ID	DWR_NA0011_01_s_2014_20				
Comment Code					
E1 : Note and monitor erosion site.					
Inspector Comment					
The site appears to have been repaired. Monitor for settlement.

View of repaired slope damage on landside slope. (Fall 2021)

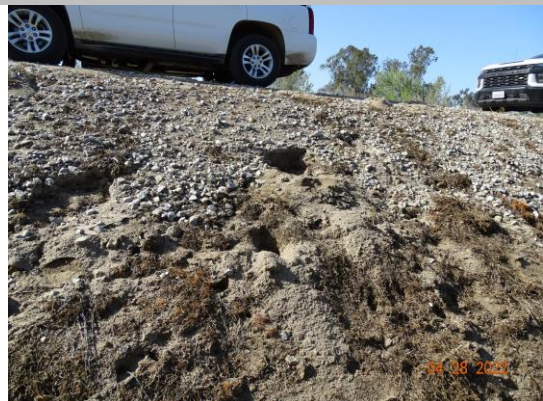
Photo 1 of 1 : FA\_2022\_NA0011\_142\_19\_20220822\_00009.jpg

LM Start	0.16	Rating **	M	Issue No.	19
LM End	0.16	Issue Type +	Ma	Location *	LS
Category	Earthen Levee			GPS Latitude/Longitude	
				Start	End
Item	Animal Control			37.047122 °	37.047122 °
				-120.425237 °	-120.425237 °
DWR ID	DWR_NA0011_01_s_2022_19				
Comment Code					
A3 : No rodents visible, but rodent burrows visible; need to backfill and compact or grout burrows.					
Inspector Comment					
Rodent holes appear to have collapsed or partially been backfilled. Burrows should be completely backfilled and compacted.

Partially collapsed rodent holes in the landside slope. (Spring 2022)

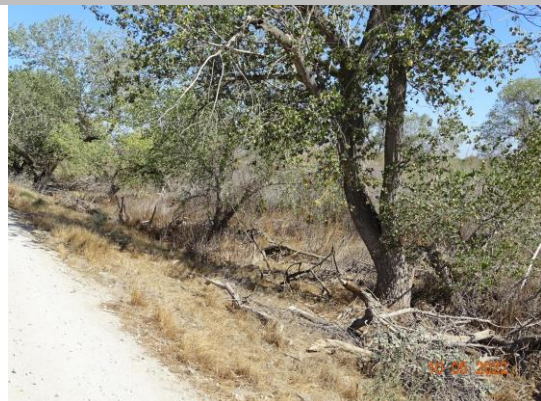
Photo 1 of 1 : FA\_2022\_NA0011\_142\_8\_20221020\_00016.jpg

Tree limbs on the waterside slope and toe should be removed. (Fall 2022)

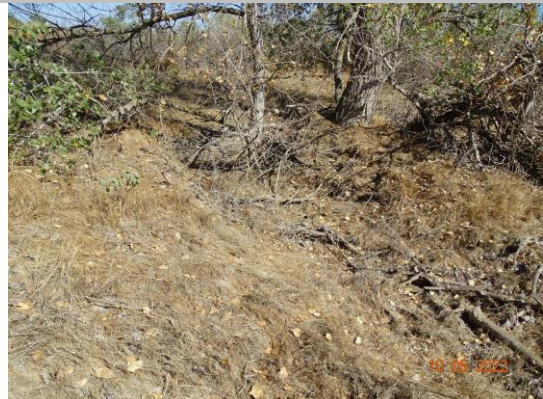
Photo 1 of 1 : FA\_2022\_NA0011\_142\_24\_20221020\_00017.jpg

LM Start	0.56	Rating **	M	Issue No.	24
LM End	0.56	Issue Type +	Ma	Location *	WS
Category	Earthen Levee			GPS Latitude/Longitude	
				Start	End
Item	Erosion / Bank Caving			37.050660 °	37.050660 °
				-120.419583 °	-120.419583 °
DWR ID	DWR_NA0011_01_f_2022_24				
Comment Code					
E2 : Schedule repair of erosion site prior to the next inspection.					
Inspector Comment					
There is an erosion pocket at the waterside toe around tree trunk and downed tree limb.

Erosion on the waterside toe around a fallen tree limb and tree trunk. (Fall 2022)

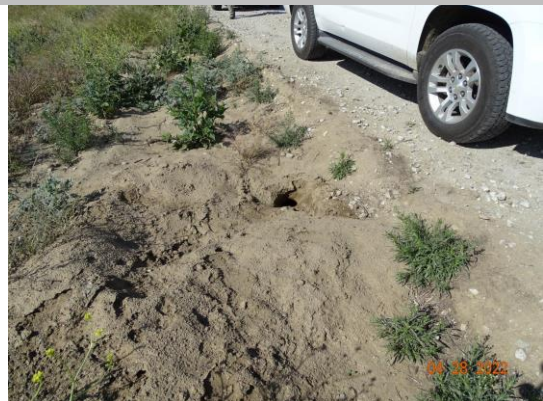
Photo 1 of 1 : FA\_2022\_NA0011\_142\_23\_20220822\_00012.jpg

Rodent burrows observed on the waterside slope. (Spring 2022)

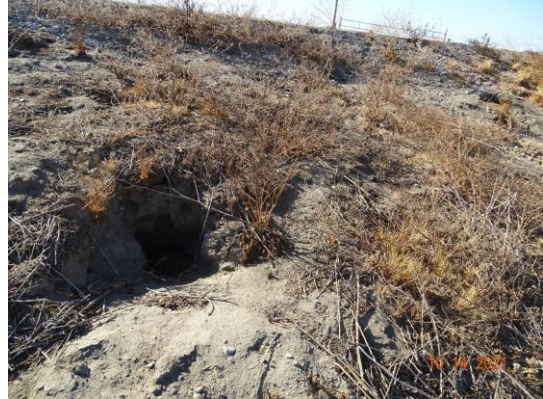
Photo 1 of 1 : FA\_2022\_NA0011\_143\_20\_20220822\_00010.jpg

Representative view of rodent burrows on the waterside slope. (Fall 2021)

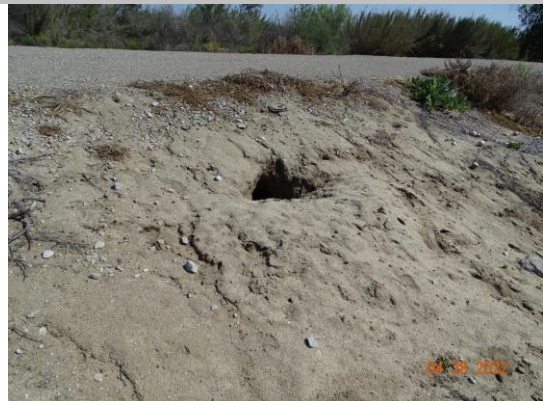
Photo 1 of 1 : FA\_2022\_NA0011\_143\_30\_20220822\_00017.jpg

LM Start	0.01	Rating **	U	Issue No.	30
LM End	0.01	Issue Type +	Ma	Location *	LS
Category	Earthen Levee			GPS Latitude/Longitude	
				Start	End
Item	Animal Control			37.045531 °	37.045531 °
				-120.427244 °	-120.427244 °
DWR ID	DWR_NA0011_02_s_2022_30				
Comment Code					
A3 : No rodents visible, but rodent burrows visible; need to backfill and compact or grout burrows.					
Inspector Comment

View of animal burrow on the landside slope. (Spring 2022)

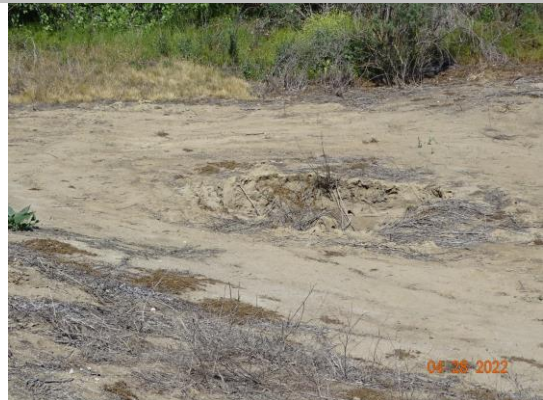
Photo 1 of 1 : FA\_2022\_NA0011\_143\_31\_20220822\_00018.jpg

LM Start	0.01	Rating **	M	Issue No.	31
LM End	0.01	Issue Type +	Ma	Location *	WS
Category	Rivers, Channels & Designated Floodways			GPS Latitude/Longitude	
				Start	End
Item	Erosion / Bank Caving			37.045531 °	37.045531 °
				-120.427244 °	-120.427244 °
DWR ID	DWR_NA0011_02_s_2022_31				
Comment Code					
Inspector Comment					
Large hole within the channel roughly 15 feet off waterside toe. Does not appear to penetrate towards levee. Hole should be backfilled and compacted.

Large hole in the channel approximately 15 feet from the waterside toe. (Spring 2022)

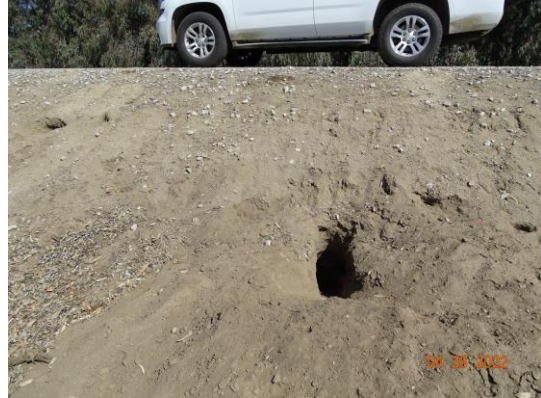
Photo 1 of 1 : FA\_2022\_NA0011\_143\_26\_20220822\_00013.jpg

Large rodent burrow observed on the landside toe. (Spring 2022)

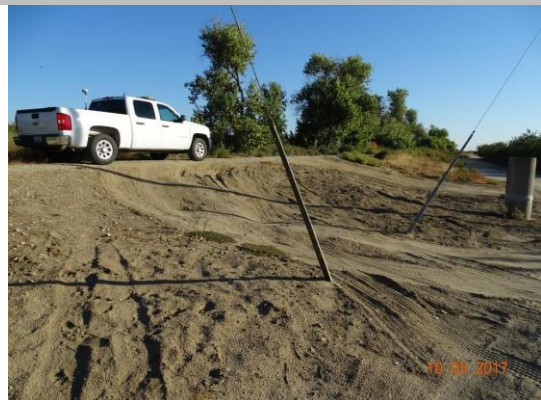
Photo 1 of 1 : FA\_2022\_NA0011\_143\_13\_20220822\_00007.jpg

LM Start	0.31	Rating **	M	Issue No.	13
LM End	0.31	Issue Type +	Ma	Location *	LS
Category	Earthen Levee			GPS Latitude/Longitude	
				Start	End
Item	Erosion / Vehicle Traffic			37.047266 °	37.047266 °
				-120.422393 °	-120.422393 °
DWR ID	DWR_NA0011_02_f_2017_13				
Comment Code					
E6 : Repair the levee slope damaged by vehicle traffic and prevent access where possible.					
Inspector Comment

Vehicle access to levee slope should be prevented and erosion repaired.

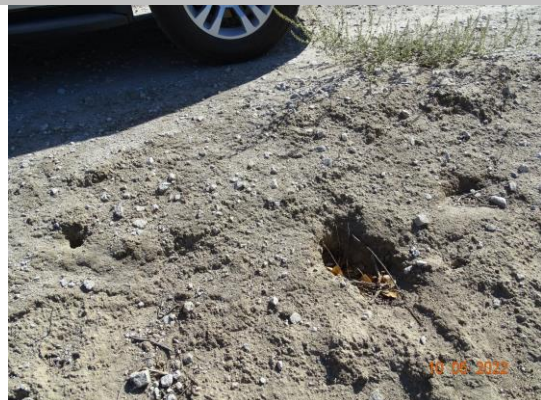
Photo 1 of 1 : FA\_2022\_NA0011\_143\_39\_20221020\_00026.jpg

Representative view of burrows on the waterside slope in this section.  
(Fall 2022)

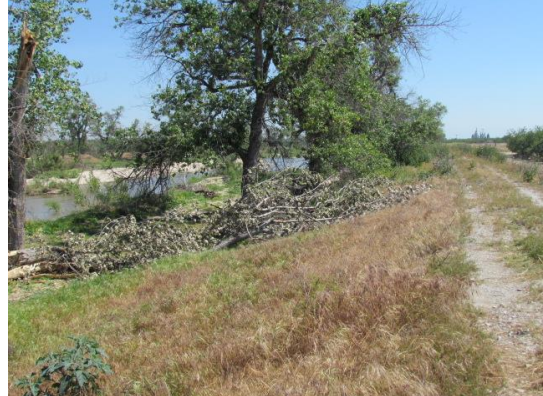
Photo 1 of 1 : FA\_2022\_NA0011\_143\_33\_20220822\_00020.jpg

Dead fallen trees on the waterside levee slope and shoulder.

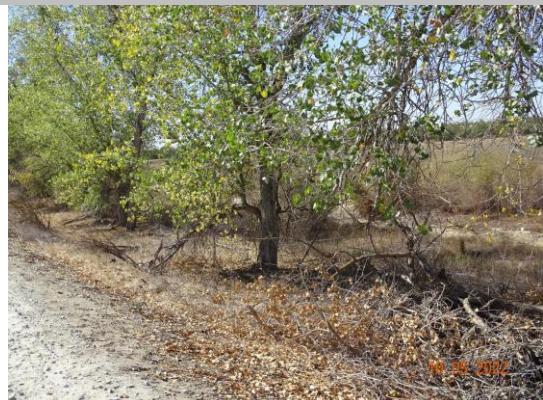
Photo 1 of 1 : FA\_2022\_NA0011\_143\_27\_20221020\_00027.jpg

Branches left along the waterside slope from high flow. (Fall 2022)

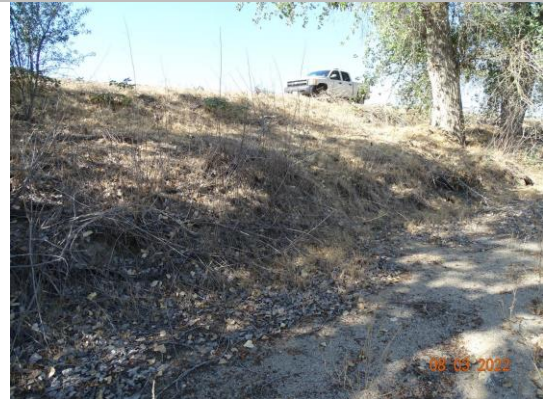
Photo 1 of 2 : SJR2022\_NA0011U02RM2.57\_2.jpg

08/03/2022: From 2013 to present, no significant changes were observed during the annual survey. Vegetation is obscuring the views of the erosion.

8/3/2022: View of the erosion on the levee toe.

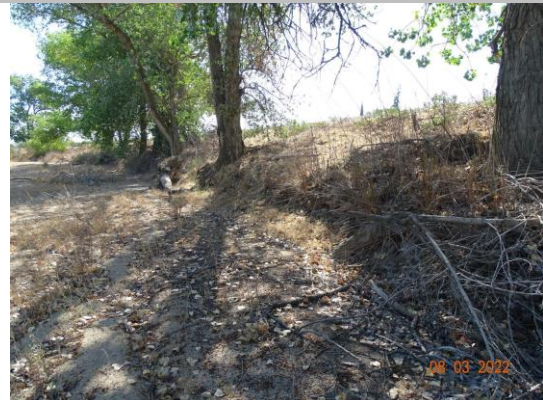
Photo 2 of 2 : SJR2022\_NA0011U02RM2.57\_4.jpg

8/3/2022: Another view of the erosion.

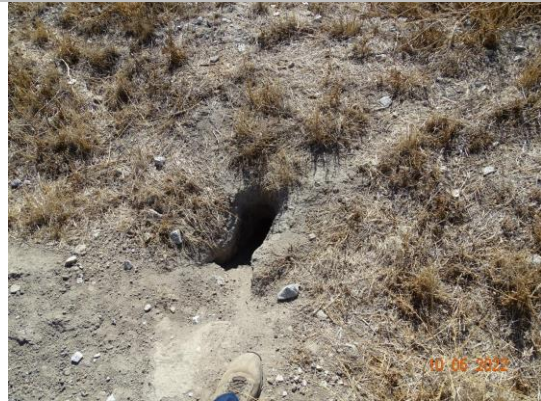
Photo 1 of 1 : FA\_2022\_NA0011\_144\_9\_20221020\_00008.jpg

Representative view of rodent holes on the landside slope. (Fall 2022)

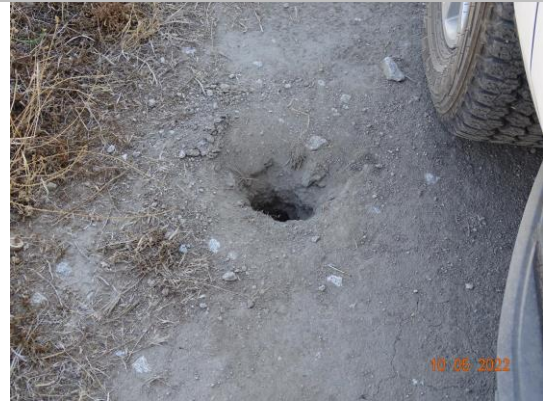
Photo 1 of 1 : FA\_2022\_NA0011\_144\_5\_20221020\_00009.jpg

View of a rodent hole on levee crown. (Fall 2022)

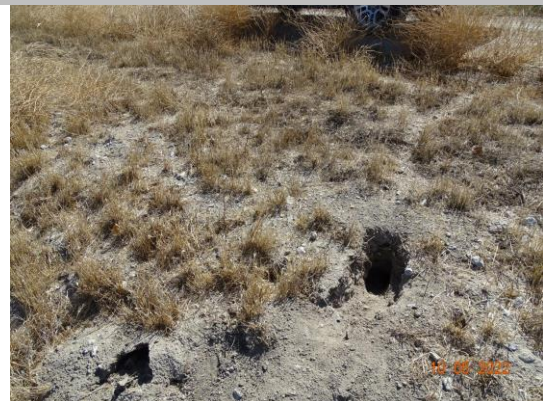
Photo 1 of 1 : FA\_2022\_NA0011\_144\_12\_20221020\_00010.jpg

Several rodent burrows observed on the landside slope. (Fall 2022)

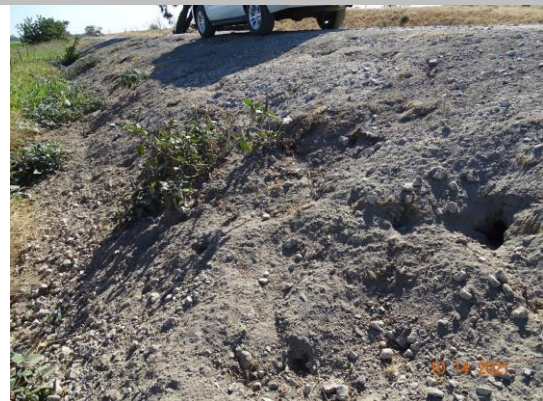
Photo 1 of 1 : FA\_2022\_NA0011\_144\_6\_20220822\_00002.jpg

View of rodent burrows in the landside slope. (Fall 2021)

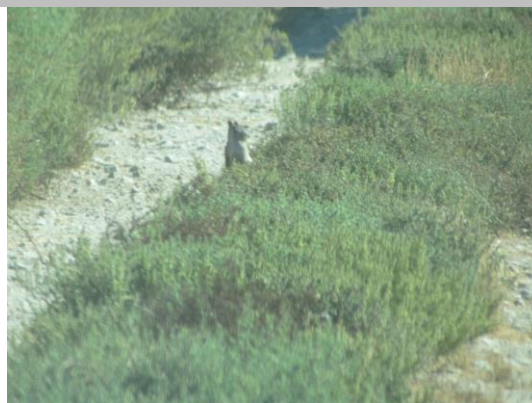
Photo 1 of 1 : FA\_2022\_NA0011\_144\_8\_20220822\_00003.jpg

LM Start	1.14	Rating **	M	Issue No.	8
LM End	1.35	Issue Type +	Ma	Location *	CR
Category	Earthen Levee			GPS Latitude/Longitude	
				Start	End
Item	Animal Control			36.996606 °	36.996618 °
				-120.353292 °	-120.349475 °
DWR ID	DWR_NA0011_03_f_2016_8				
Comment Code					
A1 : Exterminate rodents and backfill and compact or grout burrows.					
Inspector Comment					
Exterminate rodents from the roadway. Active rodents observed during inspection at this site.

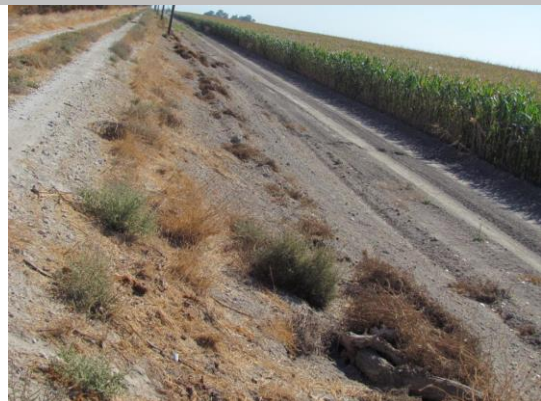
Photo 1 of 1 : FA\_2022\_NA0011\_145\_3\_20220822\_00001.jpg

LM Start	0.02	Rating **	A/W	Issue No.	3
LM End	0.97	Issue Type +	Ma	Location *	LS
Category	Earthen Levee			GPS Latitude/Longitude	
				Start	End
Item	Erosion / Vehicle Traffic			36.995506 °	36.995550 °
				-120.373233 °	-120.355935 °
DWR ID	DWR_NA0011_04_f_2016_3				
Comment Code					
E6 : Repair the levee slope damaged by vehicle traffic and prevent access where possible.					
Inspector Comment					
The slope in this area has been damaged by farm equipment but does not threaten the integrity of the levee. Continue to monitor.

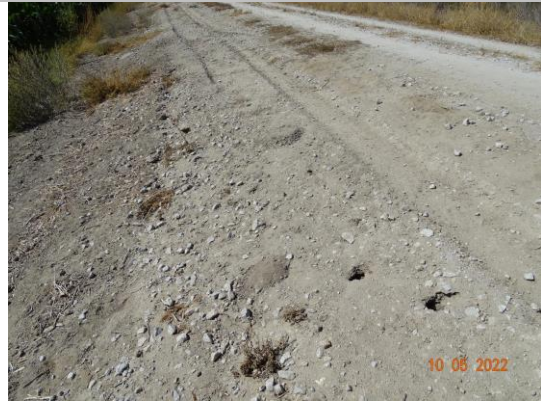
Photo 1 of 1 : FA\_2022\_NA0011\_145\_19\_20221020\_00026.jpg

LM Start	0.12	Rating **	A/W	Issue No.	19
LM End	0.94	Issue Type +	Ma	Location *	LS
Category	Earthen Levee			GPS Latitude/Longitude	
				Start	End
Item	Animal Control			36.995547 °	36.995586 °
				-120.371410 °	-120.356589 °
DWR ID	DWR_NA0011_04_s_2018_19				
Comment Code					
A3 : No rodents visible, but rodent burrows visible; need to backfill and compact or grout burrows.					
Inspector Comment					
Bait stations have been placed. Occasional small burrow observed. Continue to monitor.

View of small rodent burrows observed on the landside slope. (Fall 2022)

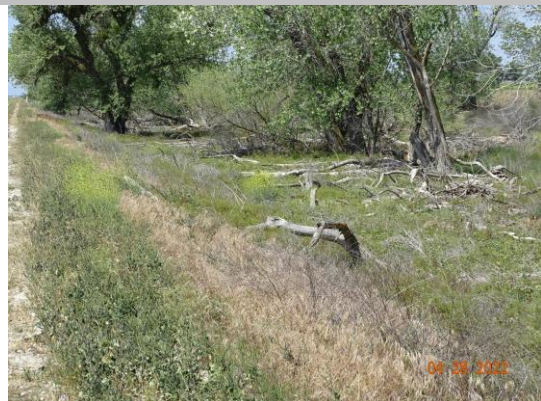
Photo 1 of 1 : FA\_2022\_NA0011\_145\_21\_20220822\_00015.jpg

Broken tree limbs and trunks in the channel should be removed. (Spring 2022)

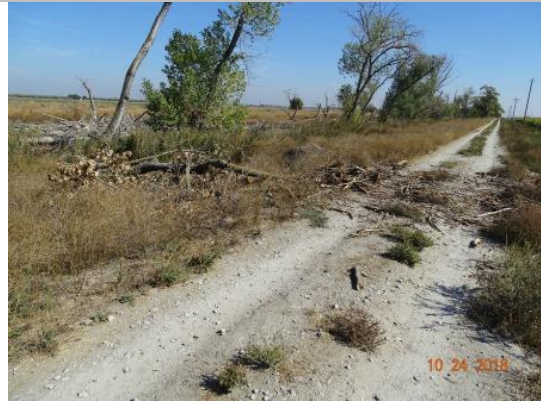
Photo 1 of 1 : FA\_2022\_NA0011\_145\_31\_20220822\_00020.jpg

Tree branches strewn across levee crown and both shoulders. (Fall 2018)

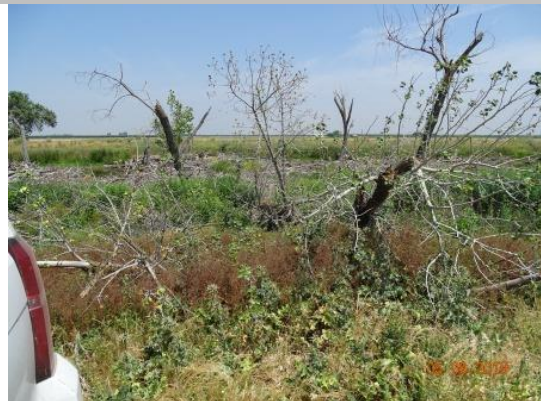
Photo 1 of 1 : FA\_2022\_NA0011\_145\_6\_20220822\_00004.jpg

View of fallen tree on waterside slope. (Spring 2019)

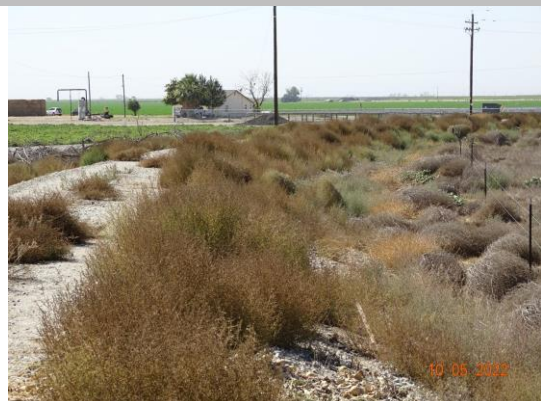
Photo 1 of 1 : FA\_2022\_NA0011\_145\_23\_20221020\_00028.jpg

View of dense vegetation on the waterside slope. (Fall 2022)

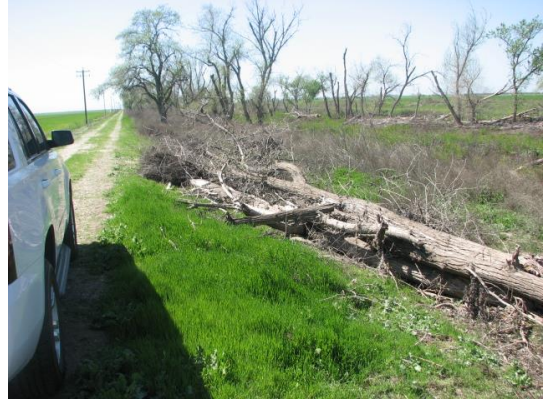
Photo 1 of 1 : FA\_2022\_NA0011\_145\_14\_20220822\_00011.jpg

Looking upstream at fallen tree on waterward slope. (Spring 2018)

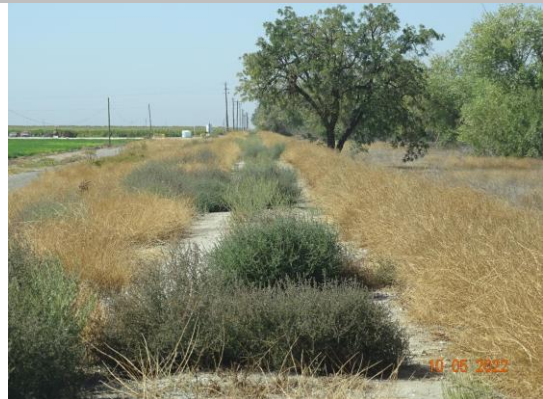
Photo 1 of 1 : FA\_2022\_NA0011\_145\_26\_20221020\_00030.jpg

View of vegetation growing along the levee crown. (Fall 2022)

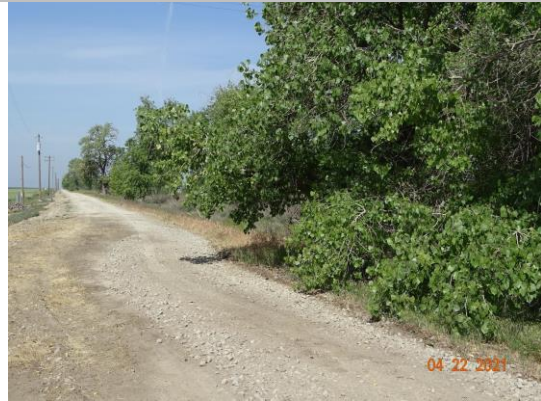
Photo 1 of 1 : FA\_2022\_NA0011\_145\_12\_20220822\_00009.jpg

Trim trees to at least 5' above levee slope and 12' above levee crown to allow inspection and access. (Spring 2021)

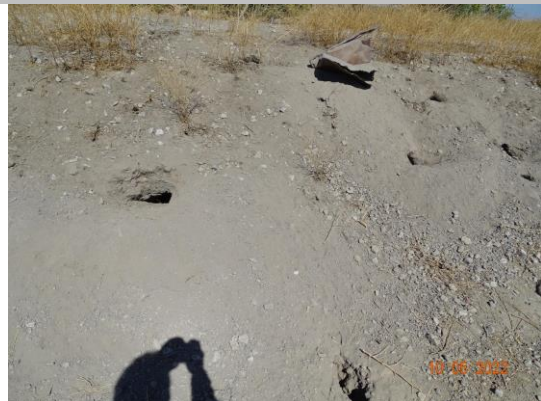
Photo 1 of 1 : FA\_2022\_NA0011\_145\_37\_20221020\_00031.jpg

Multiple burrows observed on the landside slope. (Fall 2022)

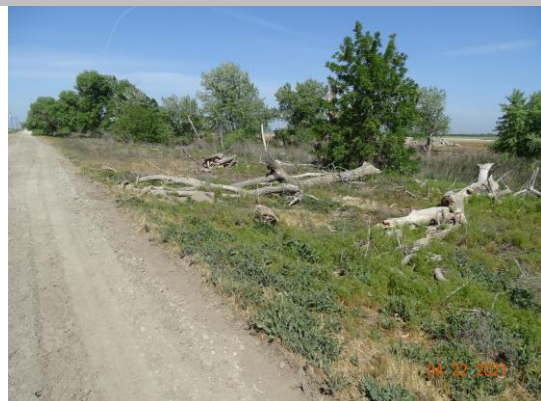
Photo 1 of 1 : FA\_2022\_NA0011\_145\_24\_20220822\_00016.jpg

View of fallen trees on the waterside slope and berm. (Spring 2021)

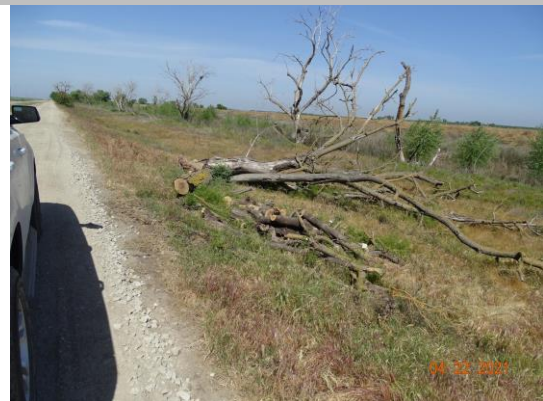
Photo 1 of 1 : FA\_2022\_NA0011\_145\_7\_20220822\_00005.jpg

View of tree limbs on the waterside slope. (Spring 2021)

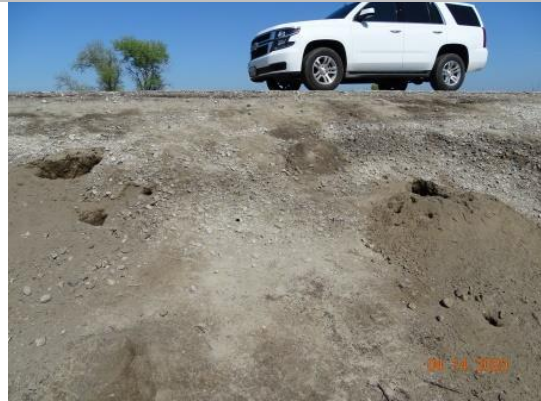
Photo 1 of 1 : FA\_2022\_NA0011\_145\_11\_20220822\_00008.jpg

Representative view of rodent holes observed in this section. (Spring 2020)

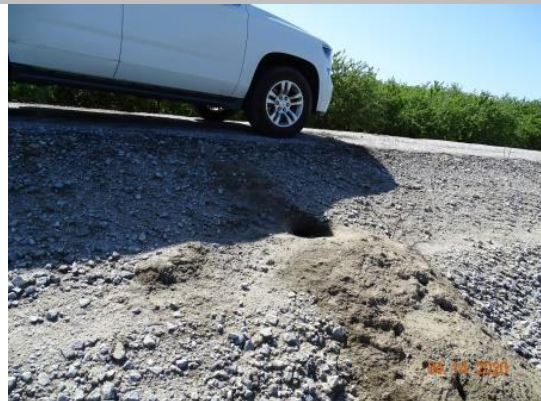
Photo 1 of 1 : FA\_2022\_NA0011\_145\_30\_20220822\_00019.jpg

Several large rodent holes on waterside slope. (Spring 2020)

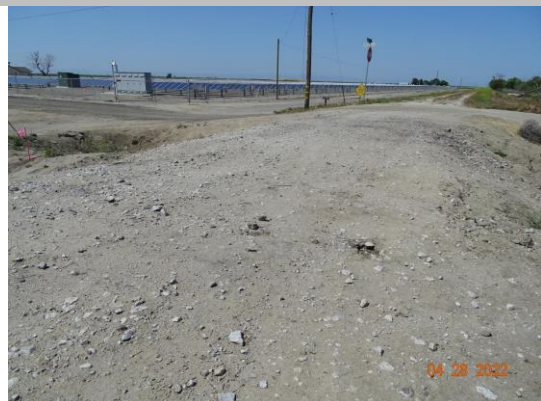
Photo 1 of 1 : FA\_2022\_NA0011\_145\_10\_20220822\_00007.jpg

Depression in the levee crown should be brought to level with appropriate material. (Spring 2022)

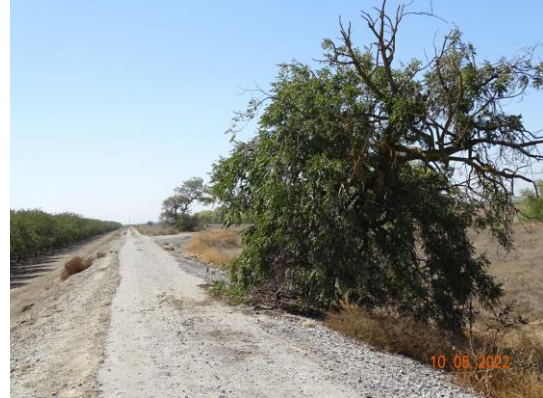
Photo 1 of 1 : FA\_2022\_NA0011\_145\_27\_20221020\_00032.jpg

Trim tree on waterside shoulder. (Fall 2022)

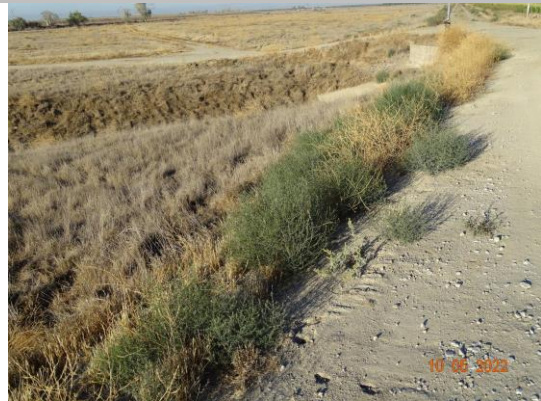
Photo 1 of 1 : FA\_2022\_NA0011\_146\_22\_20221020\_00023.jpg

View of vegetation on the waterside slope. (Fall 2022)

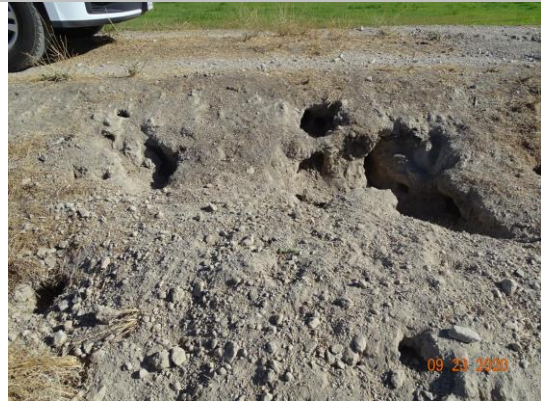
Photo 1 of 1 : FA\_2022\_NA0011\_146\_21\_20220822\_00011.jpg

Rodent burrows in the waterside slope. (Fall 2020)

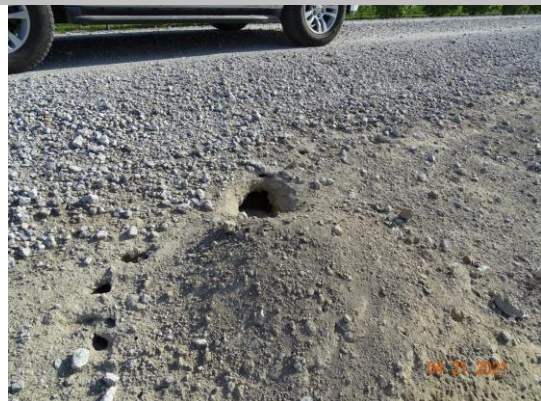
Photo 1 of 1 : FA\_2022\_NA0011\_146\_23\_20220822\_00012.jpg

Large rodent hole observed on the waterside slope. (Spring 2021)

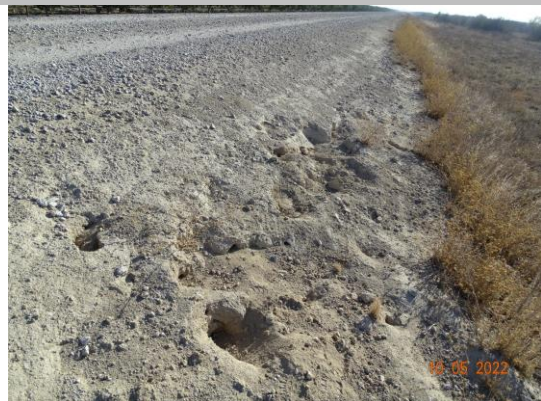
Photo 1 of 1 : FA\_2022\_NA0011\_146\_40\_20221020\_00026.jpg

View of burrows on the waterside slope. (Fall 2022)

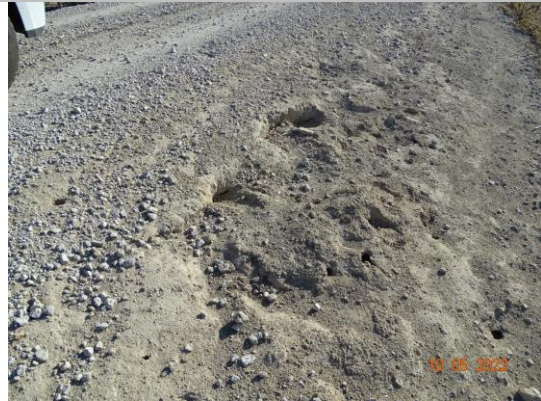
Photo 1 of 1 : FA\_2022\_NA0011\_146\_41\_20221020\_00027.jpg

Partially collapsed rodent holes on the waterside slope. (Fall 2022)

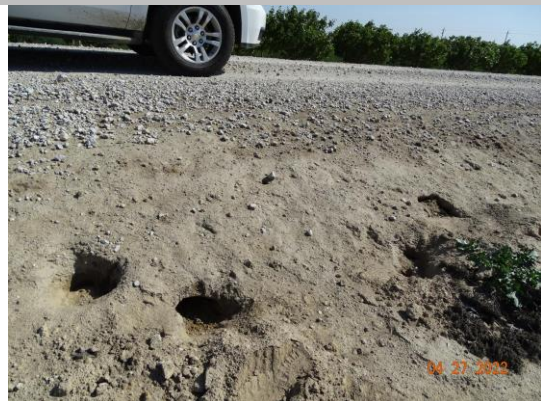
Photo 1 of 1 : FA\_2022\_NA0011\_146\_13\_20220822\_00005.jpg

View of rodent burrows in the waterside slope. (Spring 2022)

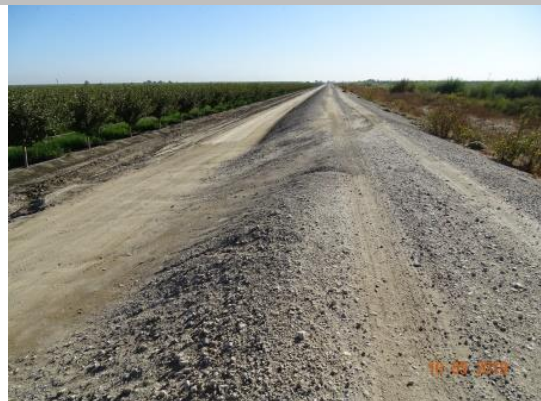
Photo 1 of 1 : FA\_2022\_NA0011\_146\_18\_20220822\_00008.jpg

Damage to landside shoulder and slope looking upstream. (Fall 2019)

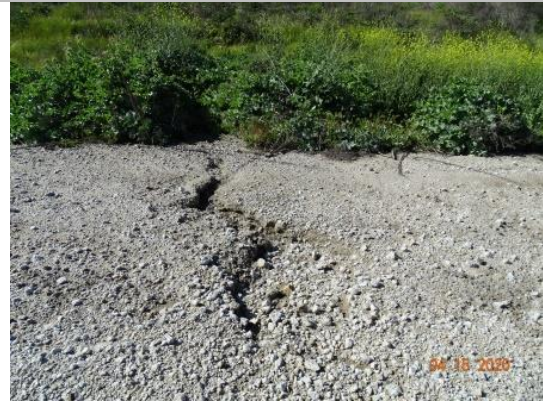
Photo 1 of 1 : FA\_2022\_NA0011\_146\_38\_20220822\_00019.jpg

Finger erosion on the waterside slope. (Spring 2020)

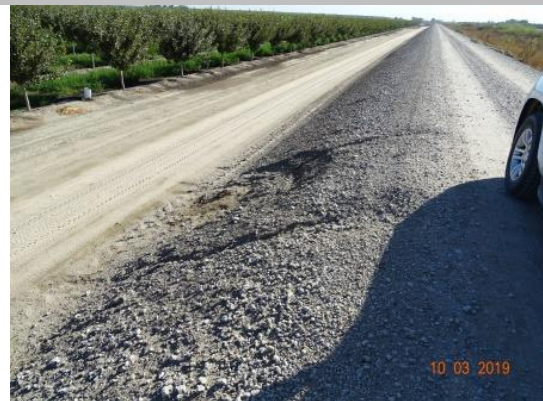
Photo 1 of 1 : FA\_2022\_NA0011\_146\_17\_20220822\_00007.jpg

View of landside slope erosion looking upstream. (Fall 2019)

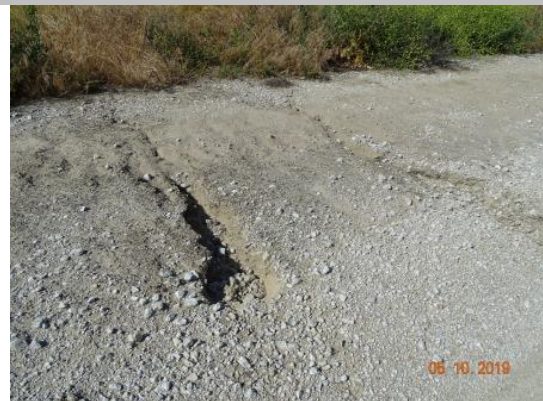
Photo 1 of 1 : FA\_2022\_NA0011\_146\_46\_20220822\_00021.jpg

Rills observed on waterside slope. (Spring 2019)

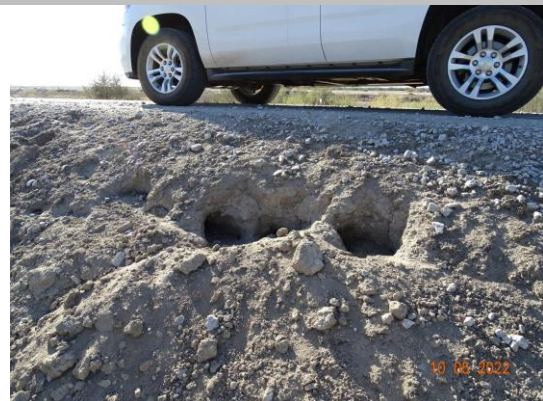
Photo 1 of 1 : FA\_2022\_NA0011\_146\_44\_20221020\_00028.jpg

View of rodent holes on the landside slope. (Fall 2022)

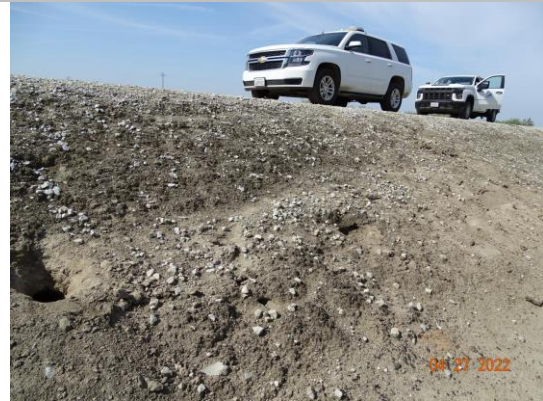
Photo 1 of 1 : FA\_2022\_NA0011\_146\_19\_20220822\_00009.jpg

Several rodent holes were noted at this location. (Spring 2022)

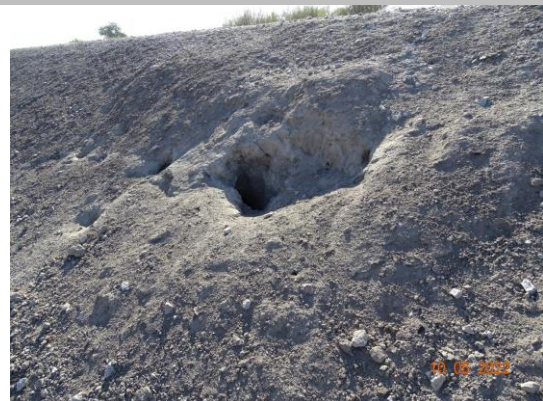
Photo 1 of 1 : FA\_2022\_NA0011\_146\_24\_20221020\_00029.jpg

Representative burrow on the landside slope. (Fall 2022)

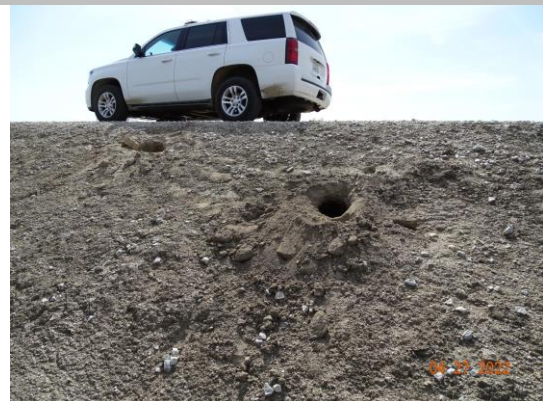
Photo 1 of 1 : FA\_2022\_NA0011\_146\_20\_20220822\_00010.jpg

Representative view of rodent burrow on the landside slope. (Spring 2022)

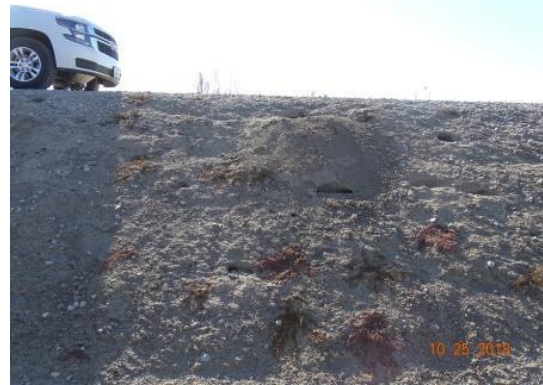
Photo 1 of 1 : FA\_2022\_NA0011\_146\_12\_20220822\_00004.jpg

Rodent activity on landside slope. (Fall 2018)

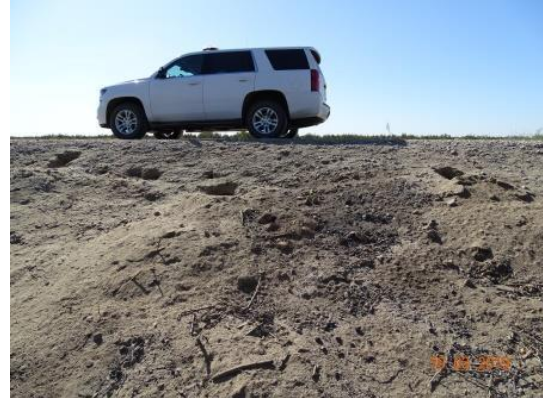
Photo 1 of 1 : FA\_2022\_NA0011\_146\_51\_20220822\_00022.jpg

Several rodent holes observed at this location. (Fall 2019)

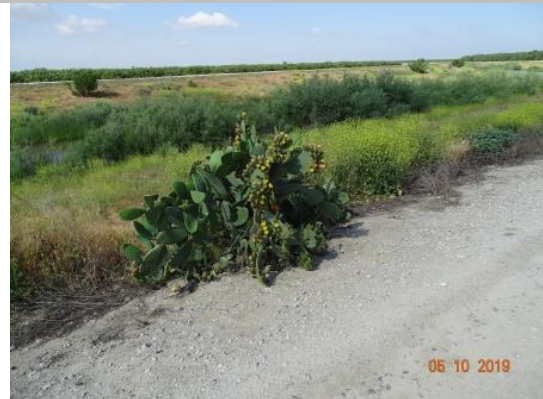
Photo 1 of 1 : FA\_2022\_NA0011\_146\_10\_20220822\_00003.jpg

Cactus growing on waterside shoulder. (Spring 2019)

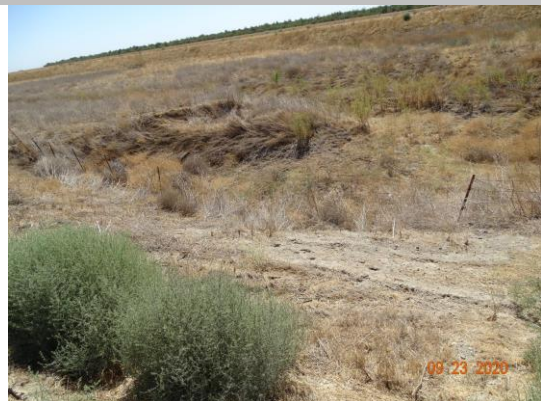
Photo 1 of 1 : FA\_2022\_NA0011\_147\_20\_20220822\_00006.jpg

View of erosion on the landside slope. (Fall 2020)

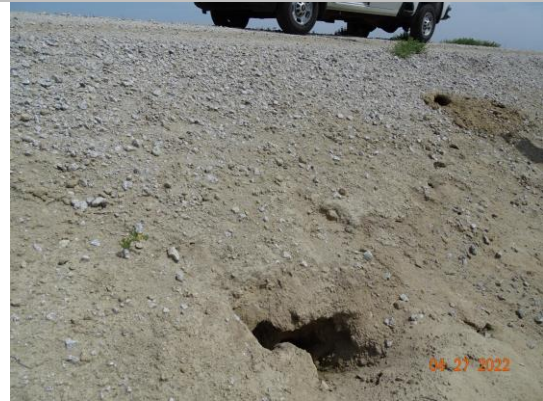
Photo 1 of 1 : FA\_2022\_NA0011\_147\_35\_20220822\_00015.jpg

Multiple rodent holes observed in this section of the levee. (Spring 2022)

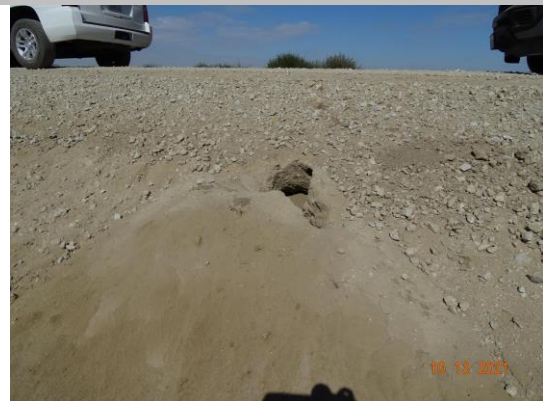
Photo 1 of 1 : FA\_2022\_NA0011\_147\_78\_20220822\_00024.jpg

View of large rodent hole in the landside slope. (Fall 2021)

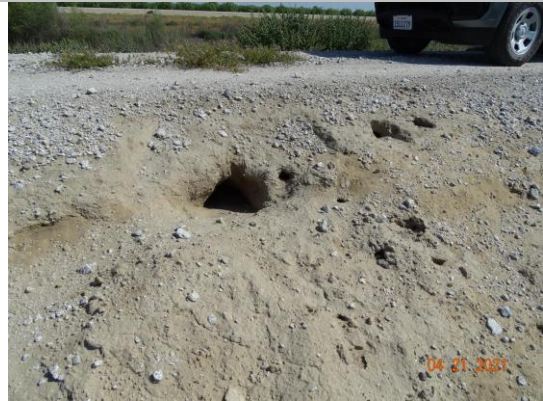
Photo 1 of 1 : FA\_2022\_NA0011\_147\_25\_20220822\_00010.jpg

Rodent activity along the landside shoulder should be repaired. (Spring 2021)

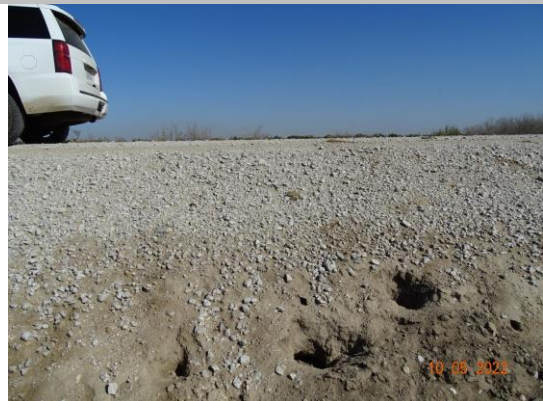
Photo 1 of 1 : FA\_2022\_NA0011\_147\_53\_20221020\_00026.jpg

Looking at typical rodent hole on landward slope. (Fall 2022)

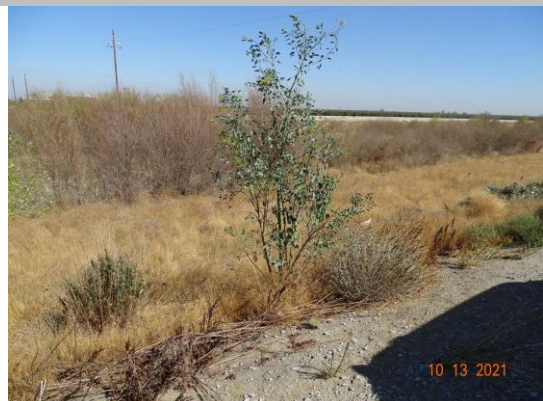
Photo 1 of 1 : FA\_2022\_NA0011\_147\_16\_20220822\_00004.jpg

View of sapling growing in the waterside shoulder. (Fall 2021)

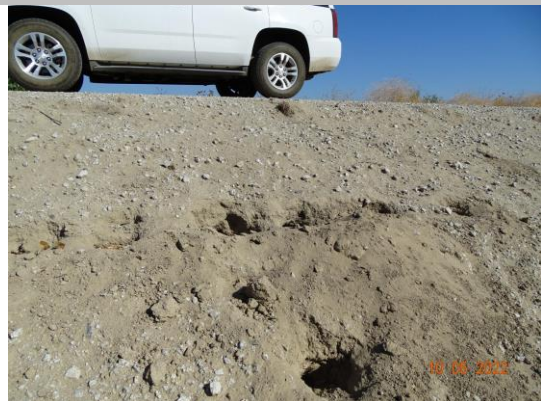
Photo 1 of 1 : FA\_2022\_NA0011\_147\_28\_20221021\_00027.jpg

Multiple rodent holes observed in the landside slope. (Fall 2022)

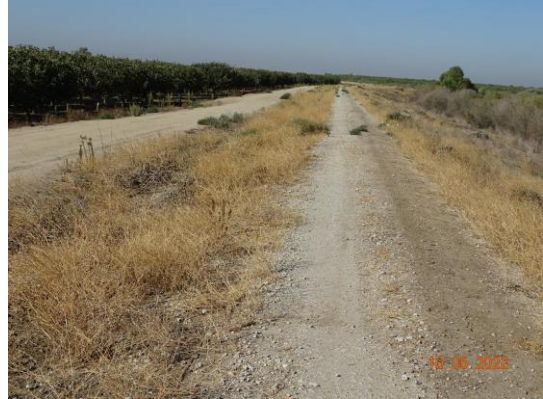
Photo 1 of 1 : FA\_2022\_NA0011\_147\_14\_20221021\_00028.jpg

View of vegetation growing on the waterside slope. (Fall 2022)

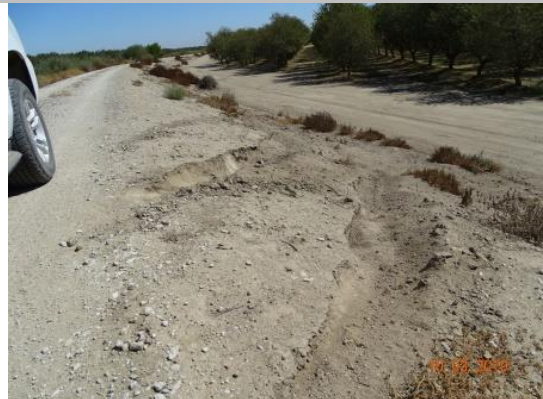
Photo 1 of 1 : FA\_2022\_NA0011\_147\_23\_20220822\_00008.jpg

Damage to landside slope from vehicle traffic. (Fall 2019)
