**Flood Control Project Maintenance  
Levee Inspections**

**Maintenance Issue Types Only, Levee Inspection Report By Mile - Fall 2023**

**Madera County FCWCA**

Waterway	Bank	Unit Miles	Inspection Start/End	Inspector
Unit No. 01 Ash Slough	Right	2.37	10/26/2023 10/26/2023	Corey Fujitani

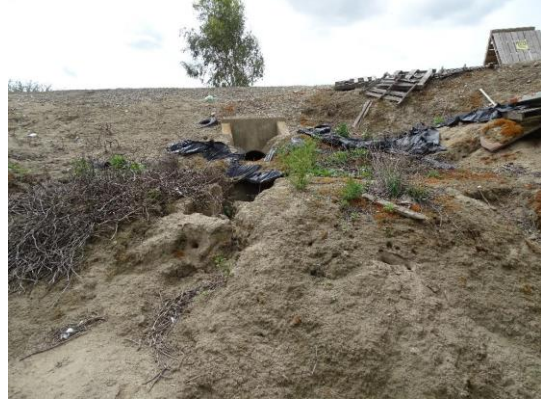
Photo 1 of 2 : UCIP\_FA\_2023\_74905\_112090.jpg

LM Start	0.04	Rating **	U	Issue No.	45
LM End	0.04	Issue Type +	Ma	Location *	
Category	Supplemental			GPS Latitude/Longitude	
				Start	End
Item	DWR UCIP LMA Responsibility			37.046618°	37.046618°
				-120.427350°	-120.427350°
DWR ID	21513

Comment Code					
Inspector Comment					
DS_ID:21513 FS_ID:74905 EP_NO: N/A Repair Type: Urgent EVAL Issue: 2b, Levee Integrity Crossing Status: Found UCIP Comments: 04/19/2022 Record remains Urgent. Erosion present on LS slope in front of concrete headwall. Soil within pipe inlet, mentioned in last inspection, has been removed. WS outlet is at a low point due to sediment buildup at end of spillway; recommend removal of sediment. DMP internal video inspection has not found pipe integrity issues. LOF of crossing is less or equal to 4. Recommend next video inspection in 5 years. (M.Thao - DWR UCIP) 10/31/2018 Erosion present on both the right and the left side of the concrete headwall located on the LS. Pipe inlet is about 50 percent filled with soil. WS outlet is at a low point, water will pond against the levee until it reaches channel elevation. This crossing does not properly drain to the channel. Levee is composed of highly erodible material. Recommend clearing soil from pipe and completing internal pipe inspection to determine pipe integrity through levee. (O. Magana - DWR UCIP) 07/14/2016 No inspection completed--need to inspect October 2016. (DWR UCIP - omagana)05/06/2014 Landward slope has been excavated and a berm built in front of landward headwall. Sediment visible inside pipe from landward side. Dense vegetation limits the inspector's visibility to identify signs of pipe failure (leaks) along the waterward slope. Recommend removing vegetation along pipe alignment and waterward headwall to conduct proper inspection of structure. (DWR UCIP - omagana) FIELD_STRUCT_DESC: 30-inch corrugated metal gravity drainage pipe through the levee, 9.5 feet below the crown. Headwall and wing wall on each end. Flap gate on the waterside (WS) end. [Additional Reference(s): DWR Levee Log, 2005 (HLM 0.04). USACE San Joaquin O&M Manual 605 (Station 2+94), listed as 30-inch pipe]. FS Date: 4/19/2022

LS view: Looking toward levee; erosion in front of concrete headwall.

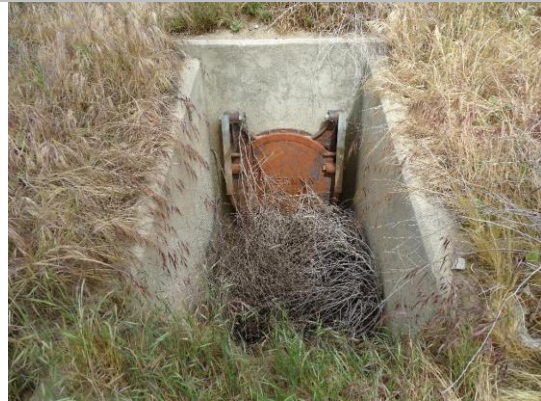
Photo 2 of 2 : UCIP\_FA\_2023\_74905\_112092.jpg

WS view: Concrete headwall, spillway, and flap gate; outlet is at a low point due to sediment buildup at end of spillway.

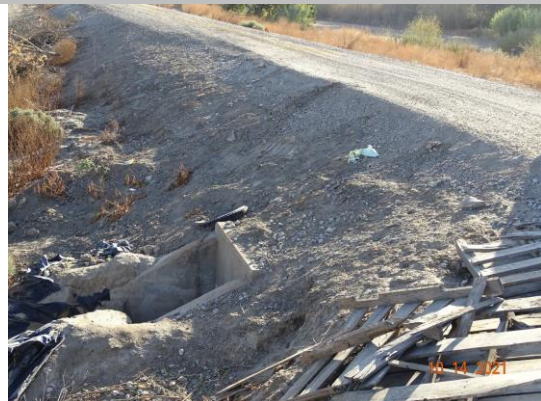
Photo 1 of 1 : FA\_2023\_NA0011\_142\_20\_20230821\_00011.jpg

LM Start	0.04	Rating **	A/W	Issue No.	20
LM End	0.04	Issue Type +	Ma	Location *	LS
Category	Earthen Levee			GPS Latitude/Longitude	
				Start	End
Item	Erosion / Bank Caving			37.046624°	37.046624°
				-120.427317°	-120.427317°
DWR ID	DWR_NA0011_01_s_2014_20				
Comment Code					
E1 : Note and monitor erosion site.					
Inspector Comment					
The site appears to have been repaired. Monitor for settlement.

View of repaired slope damage on landside slope. (Fall 2021)

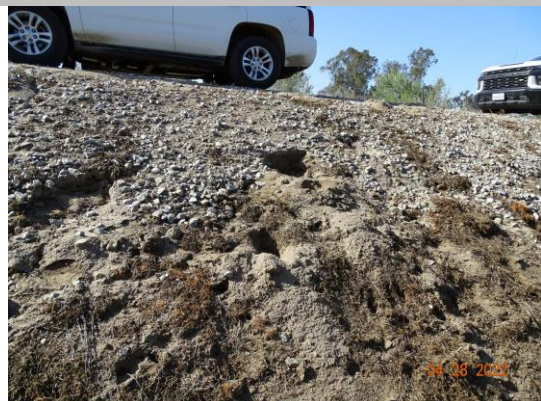
Photo 1 of 1 : FA\_2023\_NA0011\_142\_19\_20230821\_00010.jpg

LM Start	0.16	Rating **	M	Issue No.	19
LM End	0.16	Issue Type +	Ma	Location *	LS
Category	Earthen Levee			GPS Latitude/Longitude	
				Start	End
Item	Animal Control			37.047122°	37.047122°
				-120.425237°	-120.425237°
DWR ID	DWR_NA0011_01_s_2022_19				
Comment Code					
A3 : No rodents visible, but rodent burrows visible; need to backfill and compact or grout burrows.					
Inspector Comment					
Rodent holes appear to have collapsed or partially been backfilled. Burrows should be completely backfilled and compacted.

Partially collapsed rodent holes in the landside slope. (Spring 2022)

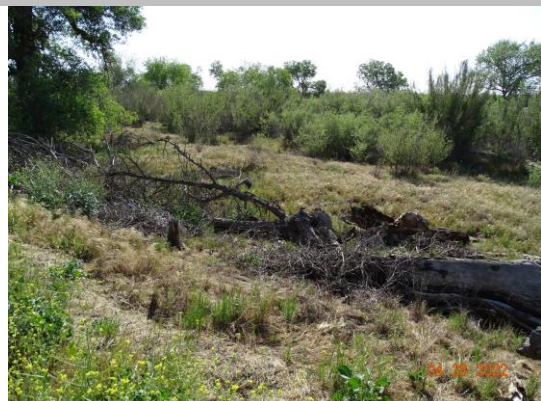
Photo 1 of 1 : FA\_2023\_NA0011\_142\_11\_20230821\_00004.jpg

Remove downed tree from waterside slope. (Spring 2022)

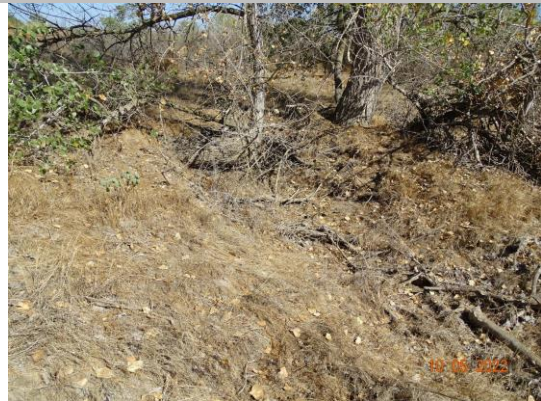
Photo 1 of 1 : FA\_2023\_NA0011\_142\_24\_20230821\_00014.jpg

LM Start	0.56	Rating **	M	Issue No.	24
LM End	0.56	Issue Type +	Ma	Location *	WS
Category	Earthen Levee			GPS Latitude/Longitude	
				Start	End
Item	Erosion / Bank Caving			37.050660°	37.050660°
				-120.419583°	-120.419583°
DWR ID	DWR_NA0011_01_f_2022_24				
Comment Code					
E2 : Schedule repair of erosion site prior to the next inspection.					
Inspector Comment					
There is an erosion pocket at the waterside toe around tree trunk and downed tree limb.

Erosion on the waterside toe around a fallen tree limb and tree trunk.  
(Fall 2022)

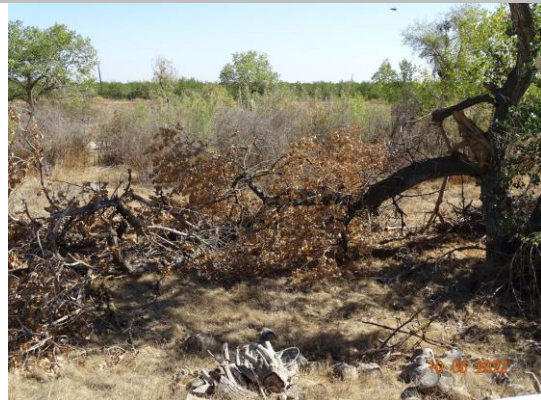
Photo 1 of 1 : FA\_2023\_NA0011\_142\_37\_20230821\_00022.jpg

Downed tree limbs on the waterside berm should be removed. (Fall 2022)

LM Start	0.62	Rating **	A/W	Issue No.	37
LM End	0.62	Issue Type +	Ma	Location *	WS
Category	Earthen Levee			GPS Latitude/Longitude	
				Start	End
Item	Trim / Thin Trees			37.051222°	37.051222°
				-120.418810°	-120.418810°
DWR ID	DWR_NA0011_01_f_2015_37				
Comment Code					
T2 : Tree or limb.					
Inspector Comment					
Remove the tree branches from the waterside slope.

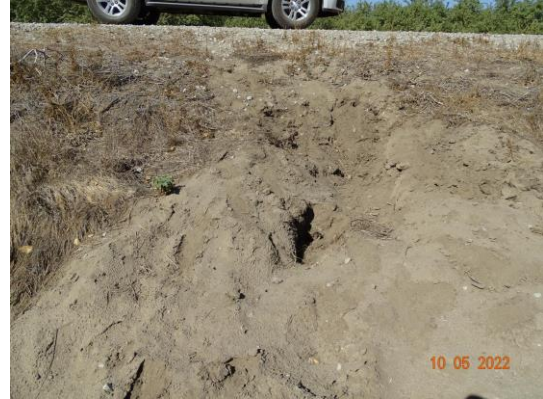
Photo 1 of 1 : FA\_2023\_NA0011\_142\_30\_20230821\_00018.jpg

LM Start	1.00	Rating **	U	Issue No.	30
LM End	1.00	Issue Type +	Ma	Location *	WS
Category	Earthen Levee			GPS Latitude/Longitude	
				Start	End
Item	Erosion / Bank Caving			37.055763°	37.055763°
				-120.415308°	-120.415308°
DWR ID	DWR_NA0011_01_f_2022_30				
Comment Code					
E2 : Schedule repair of erosion site prior to the next inspection.					
Inspector Comment					
Erosion pocket that appears to be caused by rodent activity on the waterside slope.

Erosion pocket on the waterside slope. (Fall 2022)

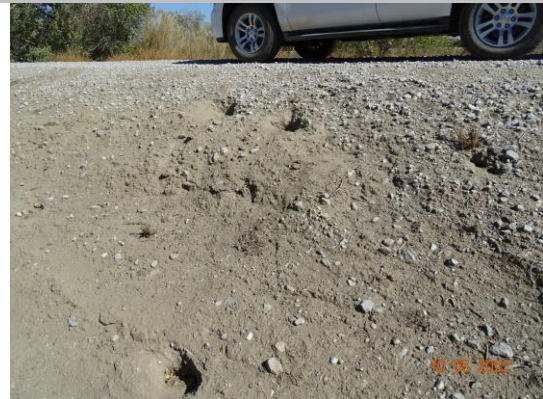
Photo 1 of 1 : FA\_2023\_NA0011\_142\_31\_20230821\_00019.jpg

Multiple rodent holes observed on the landside slope. (Fall 2022)

LM Start	1.26	Rating **	A/W	Issue No.	31
LM End	1.31	Issue Type +	Ma	Location *	LS
Category	Earthen Levee			GPS Latitude/Longitude	
				Start	End
Item	Animal Control			37.057219°	37.057878°
				-120.411317°	-120.410915°
DWR ID	DWR_NA0011_01_f_2022_31				
Comment Code					
A3 : No rodents visible, but rodent burrows visible; need to backfill and compact or grout burrows.					
Inspector Comment

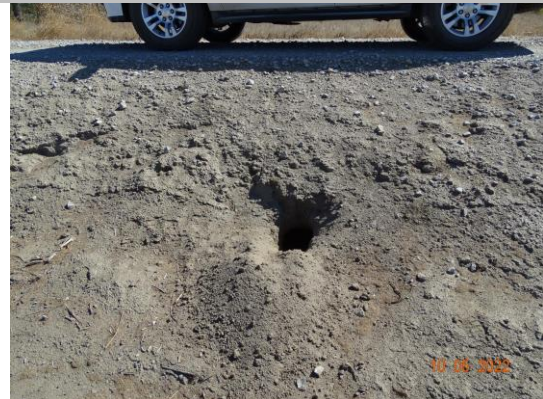
Photo 1 of 1 : FA\_2023\_NA0011\_142\_33\_20230821\_00021.jpg

View of animal burrow on the landside slope. (Fall 2022)

LM Start	1.51	Rating **	A/W	Issue No.	33
LM End	1.51	Issue Type +	Ma	Location *	LS
Category	Earthen Levee			GPS Latitude/Longitude	
				Start	End
Item	Animal Control			37.059440°	37.059440°
				-120.407896°	-120.407896°
DWR ID	DWR_NA0011_01_f_2022_33				
Comment Code					
A3 : No rodents visible, but rodent burrows visible; need to backfill and compact or grout burrows.					
Inspector Comment

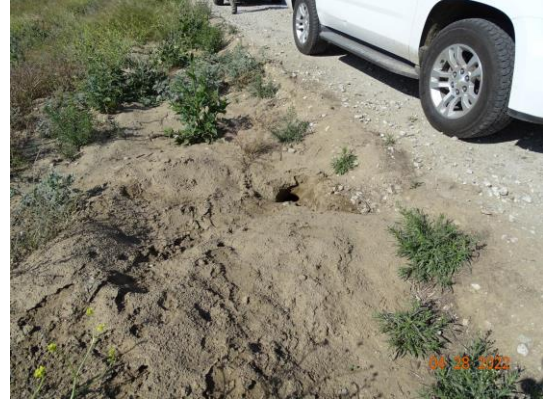
Photo 1 of 1 : FA\_2023\_NA0011\_142\_23\_20230821\_00013.jpg

Rodent burrows observed on the waterside slope. (Spring 2022)

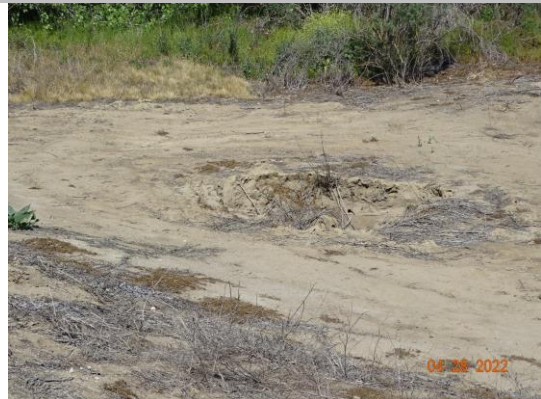
Photo 1 of 1 : FA\_2023\_NA0011\_143\_31\_20230821\_00017.jpg

Large hole in the channel approximately 15 feet from the waterside toe. (Spring 2022)

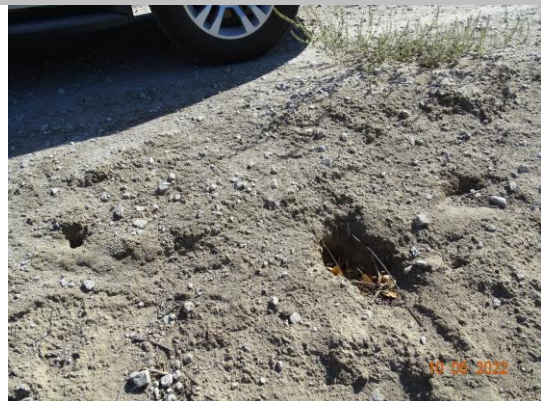
Photo 1 of 1 : FA\_2023\_NA0011\_143\_39\_20230821\_00022.jpg

Representative view of burrows on the waterside slope in this section.  
(Fall 2022)

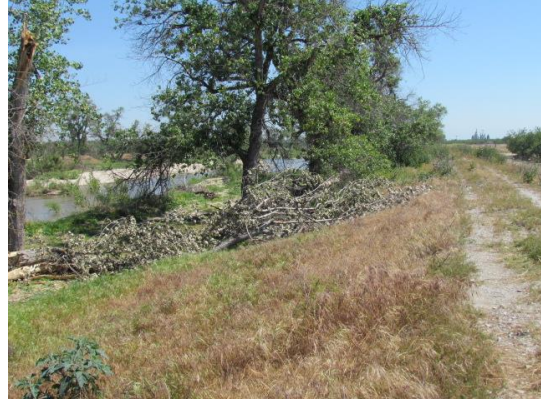
Photo 1 of 1 : FA\_2023\_NA0011\_143\_33\_20230821\_00019.jpg

Dead fallen trees on the waterside levee slope and shoulder.

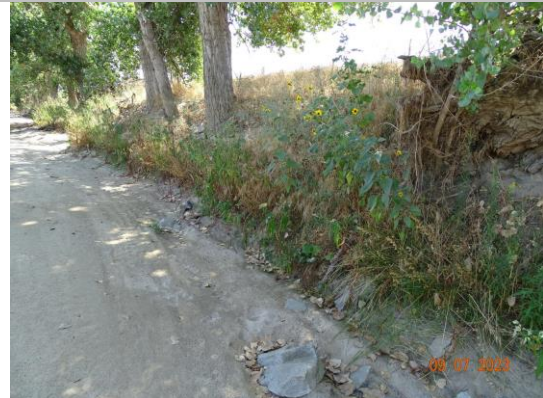
Photo 1 of 2 : SJR2023\_NA0011U02RM2.57\_1.JPG

Comment Code					
Inspector Comment					
Site ID: NA0011U02RM2.57					
9/14/2023: From 2012 to present, no significant changes were observed during the annual survey. Vegetation is obscuring the views of the erosion.					
07/24/2012: Dense vegetation around the site.					
08/09/2011: A fallen tree was seen at the levee toe about 20 feet upstream, and tree root exposed. There has been no report from the district that this site was corrected.					
11/30/2010: Site was not inspected due to time constraints. There have been no reports from the district that the site was corrected. Continue to monitor site during flood events.					
08/05/2010: Recommended for annual assessment and monitoring during flood events, per CLRO.					
2009: Site is recommended as a local maintenance issue, per Critical Levee Repair Office, Critical Erosion Sites Evaluation 2008 Report; site was previously rated "M"					
09/6/2007: Undercutting of the toe; several trees along the WS slope with roots exposed.

9/14/2023: View of the erosion on the levee toe.

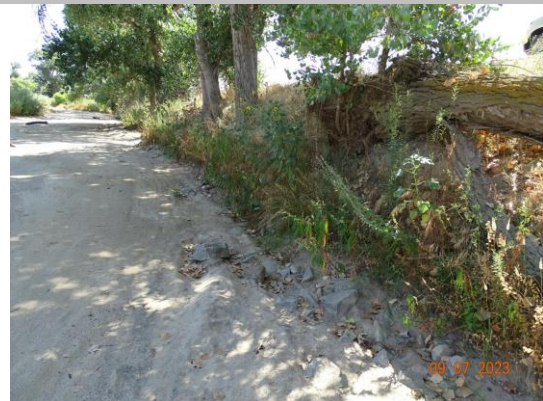
Photo 2 of 2 : SJR2023\_NA0011U02RM2.57\_2.JPG

9/14/2023: Another view of the erosion.

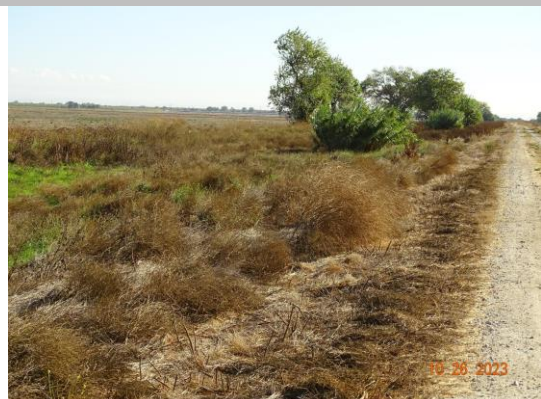
Photo 1 of 1 : FA\_2023\_NA0011\_144\_3\_20231102\_00009.jpg

View of vegetation growing along the landside slope. (Fall 2023)

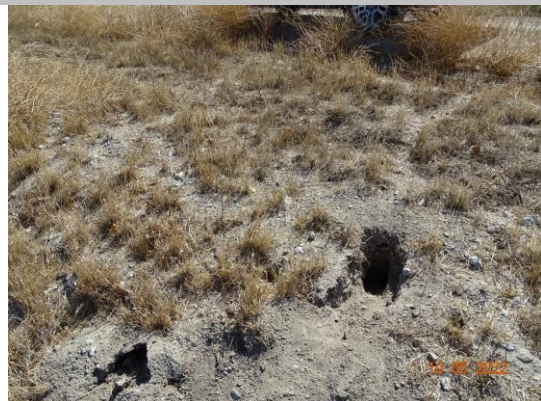
Photo 1 of 1 : FA\_2023\_NA0011\_144\_12\_20230821\_00005.jpg

Several rodent burrows observed on the landside slope. (Fall 2022)

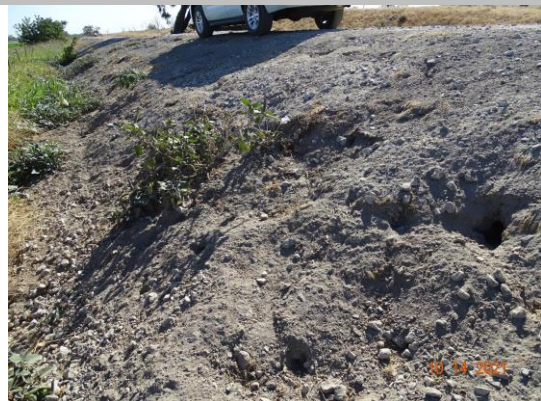
Photo 1 of 1 : FA\_2023\_NA0011\_144\_6\_20230821\_00002.jpg

View of rodent burrows in the landside slope. (Fall 2021)

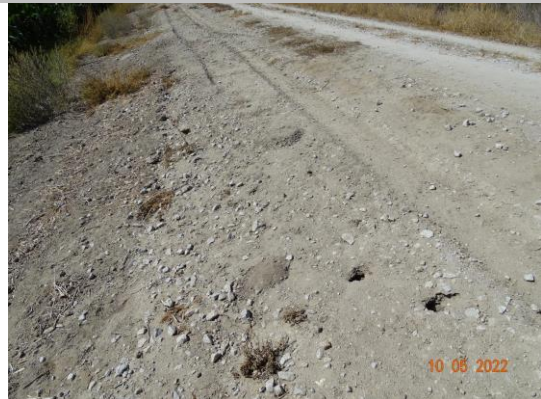
Photo 1 of 1 : FA\_2023\_NA0011\_145\_19\_20230821\_00014.jpg

View of small rodent burrows observed on the landside slope. (Fall 2022)

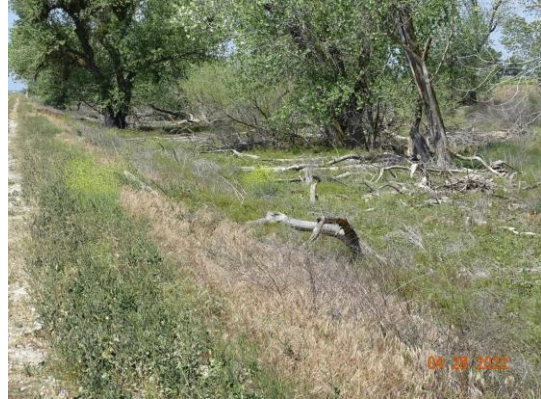
Photo 1 of 1 : FA\_2023\_NA0011\_145\_21\_20230821\_00015.jpg

Broken tree limbs and trunks in the channel should be removed. (Spring 2022)

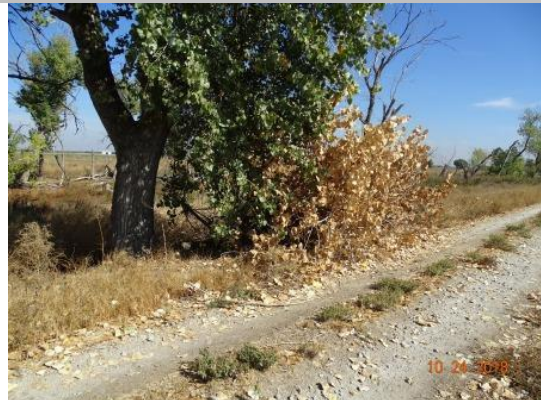
Photo 1 of 1 : FA\_2023\_NA0011\_145\_32\_20230821\_00022.jpg

Trim branches on waterside shoulder. (Fall 2018)

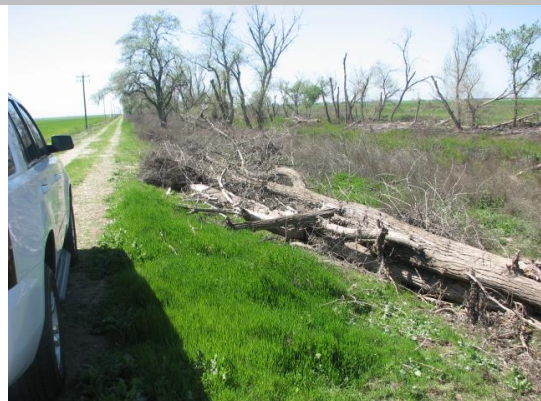
Photo 1 of 1 : FA\_2023\_NA0011\_145\_14\_20230821\_00010.jpg

Looking upstream at fallen tree on waterward slope. (Spring 2018)

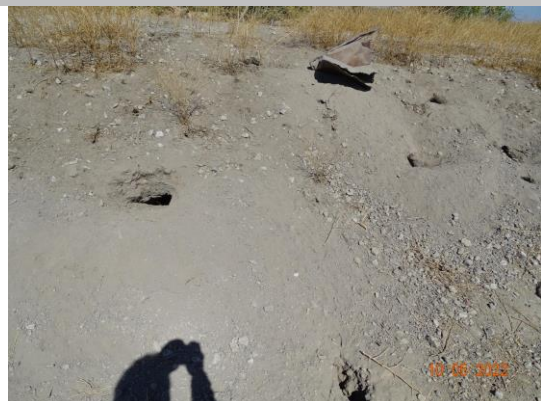
Photo 1 of 1 : FA\_2023\_NA0011\_145\_37\_20230821\_00025.jpg

Multiple burrows observed on the landside slope. (Fall 2022)

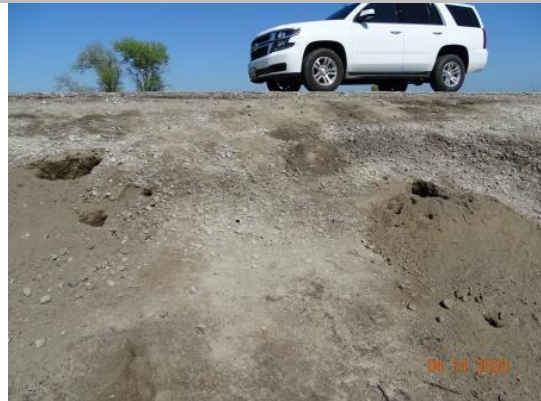
Photo 1 of 1 : FA\_2023\_NA0011\_145\_11\_20230821\_00007.jpg

Representative view of rodent holes observed in this section. (Spring 2020)

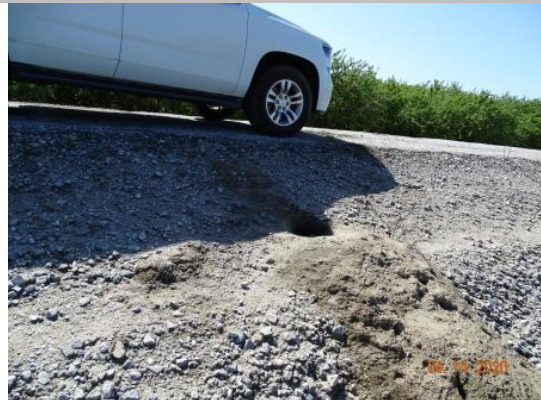
Photo 1 of 1 : FA\_2023\_NA0011\_145\_30\_20230821\_00020.jpg

Several large rodent holes on waterside slope. (Spring 2020)

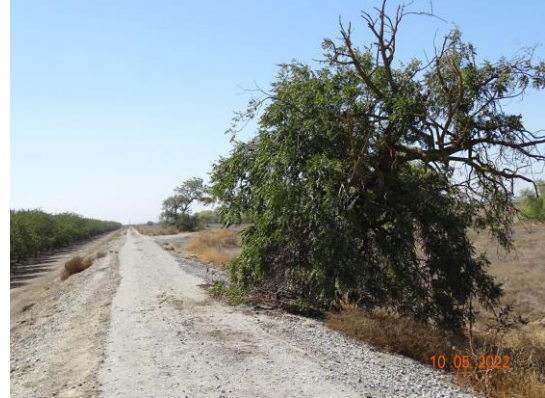
Photo 1 of 1 : FA\_2023\_NA0011\_145\_27\_20230821\_00019.jpg

Trim tree on waterside shoulder. (Fall 2022)

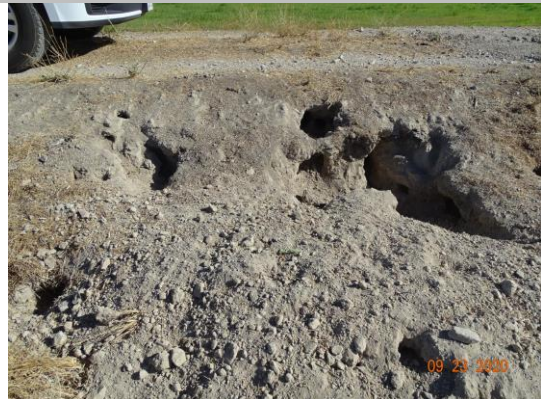
Photo 1 of 1 : FA\_2023\_NA0011\_146\_21\_20230821\_00011.jpg

Rodent burrows in the waterside slope. (Fall 2020)

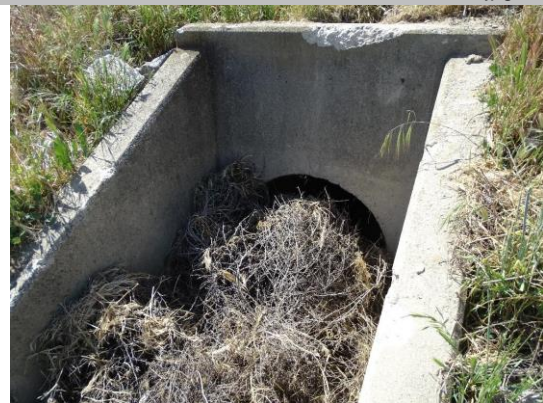
Photo 2 of 3 : UCIP\_FA\_2023\_81023\_112410.jpg

LS view: Concrete headwall and pipe inlet; tumbleweeds in front of inlet.

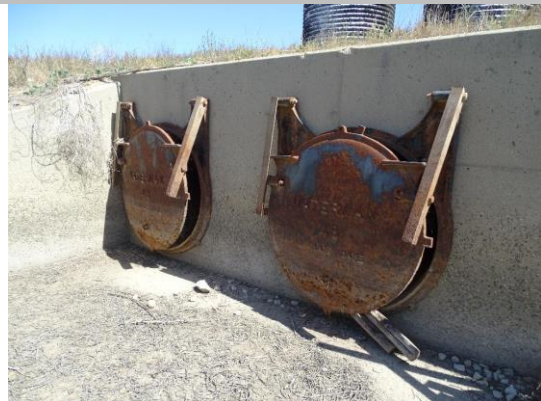
Photo 1 of 2 : UCIP\_FA\_2023\_80592\_112507.jpg

WS view: Flap gate not closed properly and appears not to be propped open. Record associated with flap gate on the left side.

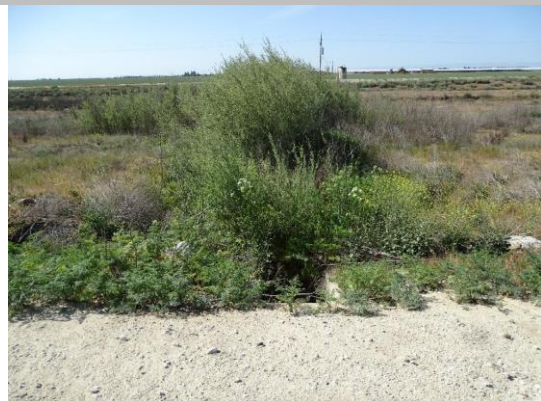
Photo 1 of 1 : UCIP\_FA\_2023\_80586\_112436.jpg

WS view: Looking from crown; concrete headwall at toe. Overgrown vegetation around headwall.

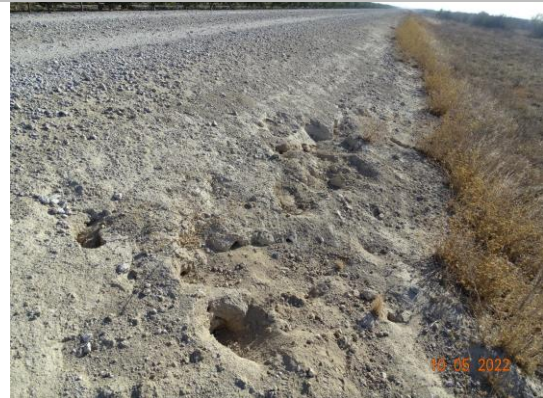
Photo 1 of 1 : FA\_2023\_NA0011\_146\_40\_20230821\_00019.jpg

View of burrows on the waterside slope. (Fall 2022)

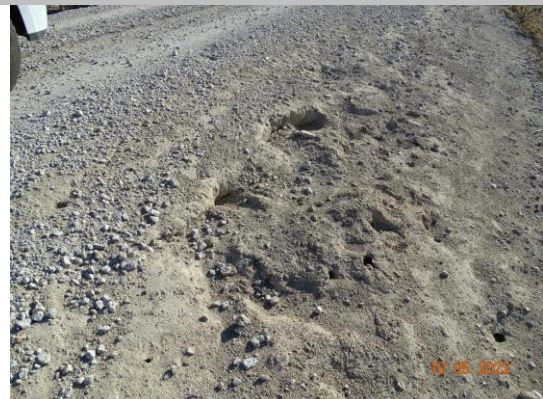
Photo 1 of 1 : FA\_2023\_NA0011\_146\_41\_20230821\_00020.jpg

Partially collapsed rodent holes on the waterside slope. (Fall 2022)

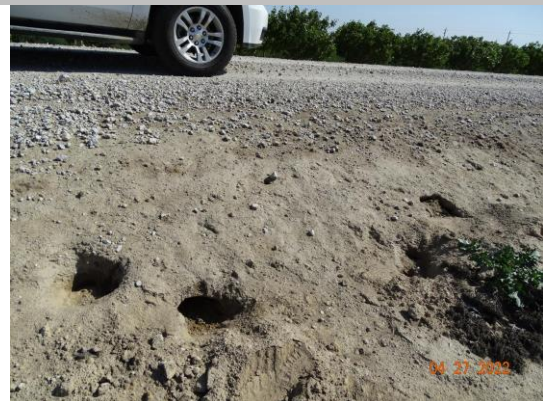
Photo 1 of 1 : FA\_2023\_NA0011\_146\_13\_20230821\_00005.jpg

View of rodent burrows in the waterside slope. (Spring 2022)

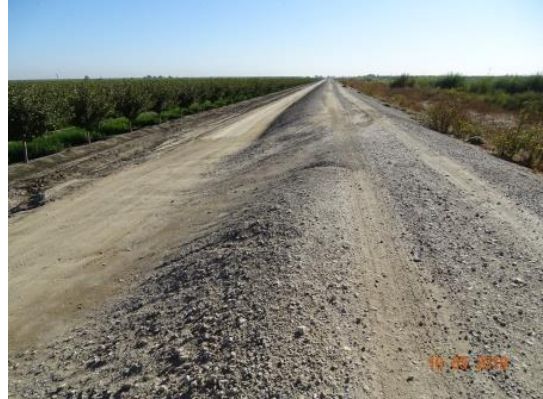
Photo 1 of 1 : FA\_2023\_NA0011\_146\_18\_20230821\_00008.jpg

Damage to landside shoulder and slope looking upstream. (Fall 2019)

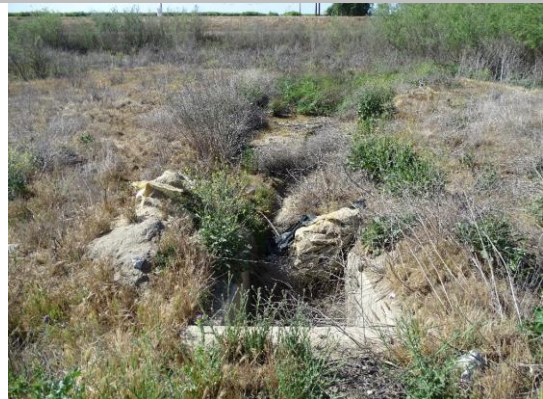
Photo 1 of 2 : UCIP\_FA\_2023\_80585\_112441.jpg

WS view: Concrete headwall on toe; stacked sandbags at end of spillway that would impede drainage.

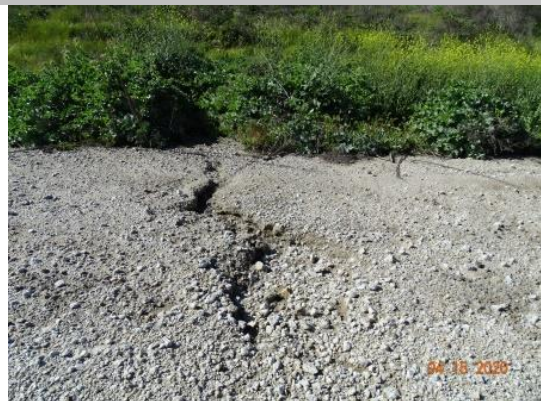
Photo 1 of 1 : FA\_2023\_NA0011\_146\_38\_20230821\_00018.jpg

Finger erosion on the waterside slope. (Spring 2020)

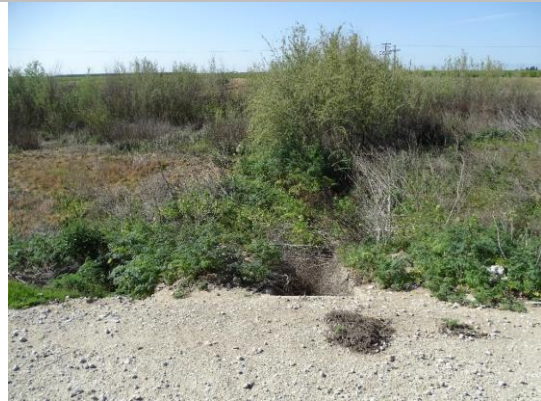
Photo 1 of 1 : UCIP\_FA\_2023\_80584\_112445.jpg

WS view: Concrete headwall on toe; overgrown vegetation around headwall.

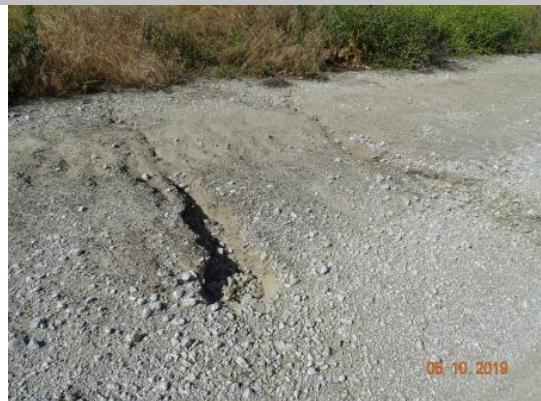
Photo 1 of 1 : FA\_2023\_NA0011\_146\_46\_20230821\_00023.jpg

Rills observed on waterside slope. (Spring 2019)

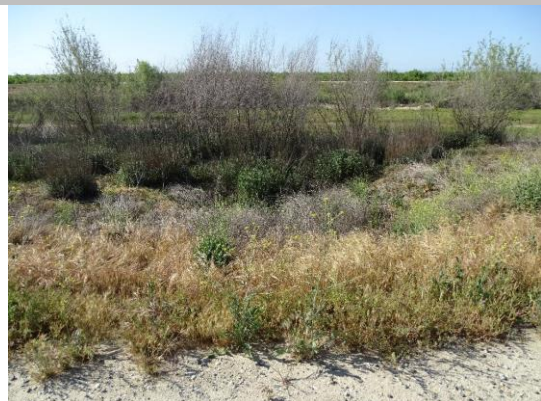
Photo 1 of 1 : UCIP\_FA\_2023\_80580\_112463.jpg

WS view: Looking from crown; dense vegetation on slope and floodway.

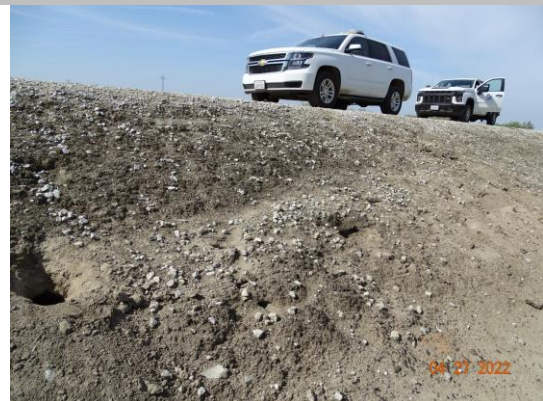
Photo 1 of 1 : FA\_2023\_NA0011\_146\_19\_20230821\_00009.jpg

Several rodent holes were noted at this location. (Spring 2022)

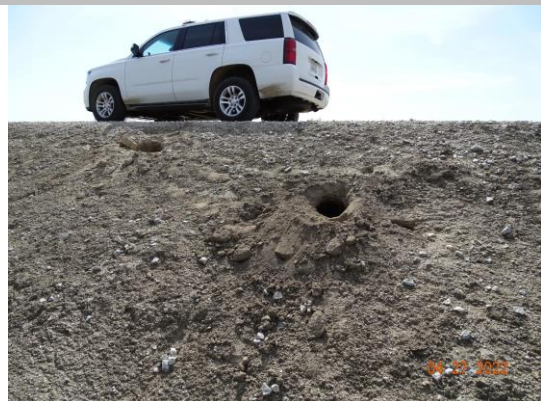
Photo 1 of 1 : FA\_2023\_NA0011\_146\_20\_20230821\_00010.jpg

Representative view of rodent burrow on the landside slope. (Spring 2022)

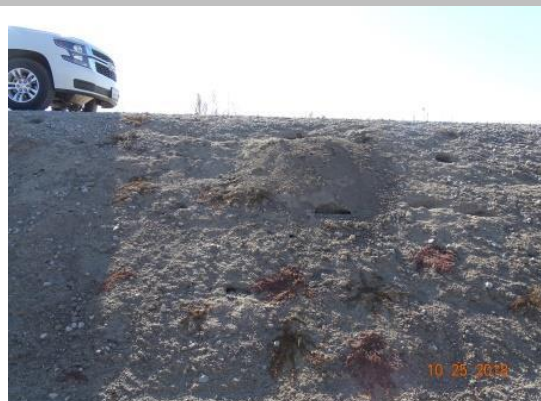
Photo 1 of 1 : FA\_2023\_NA0011\_146\_12\_20230821\_00004.jpg

Rodent activity on landside slope. (Fall 2018)

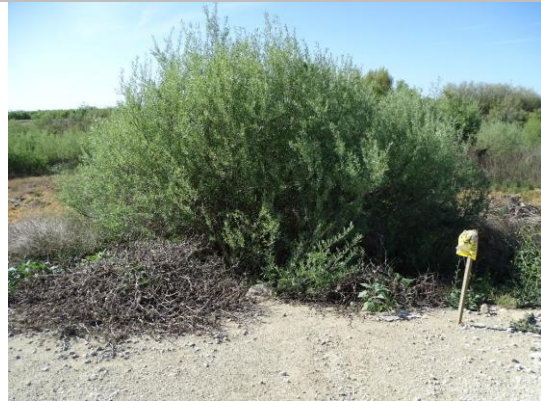
Photo 1 of 1 : UCIP\_FA\_2023\_80578\_112470.jpg

WS view: Looking from levee; dense and overgrown vegetation around headwall.

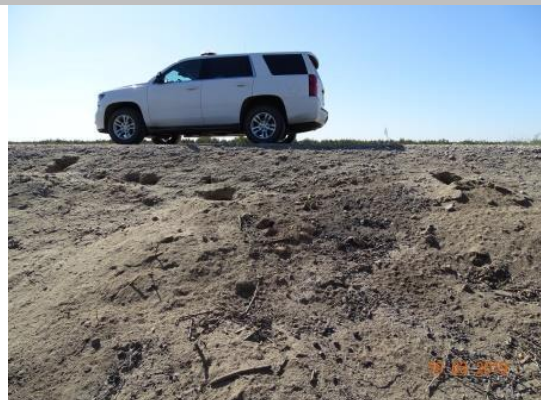
Photo 1 of 1 : FA\_2023\_NA0011\_146\_51\_20230821\_00026.jpg

Several rodent holes observed at this location. (Fall 2019)

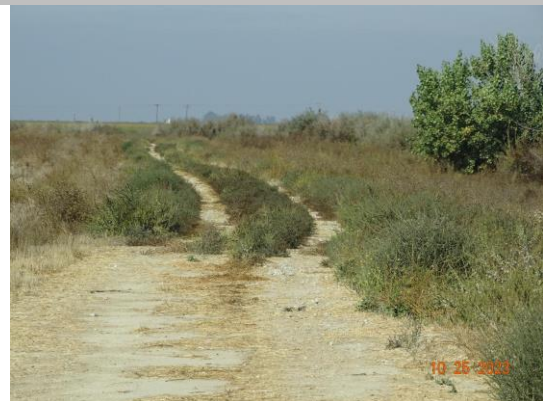
Photo 1 of 1 : FA\_2023\_NA0011\_147\_51\_20231102\_00025.jpg

View of vegetation growing along the levee crown. (Fall 2023)

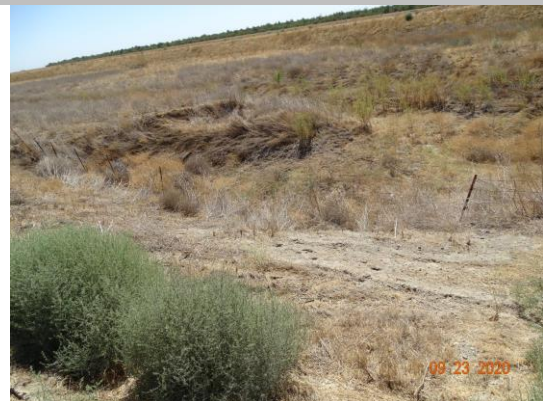
Photo 1 of 1 : FA\_2023\_NA0011\_147\_20\_20230821\_00007.jpg

View of erosion on the landside slope. (Fall 2020)

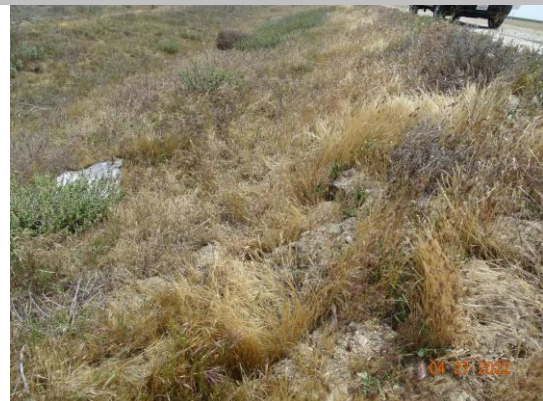
Photo 1 of 1 : FA\_2023\_NA0011\_147\_17\_20230821\_00006.jpg

View of slump possibly the result of rodent activity. (Spring 2022)

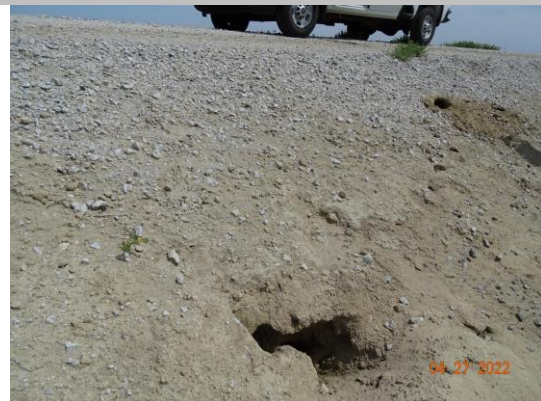
Photo 1 of 1 : FA\_2023\_NA0011\_147\_35\_20230821\_00015.jpg

Multiple rodent holes observed in this section of the levee. (Spring 2022)

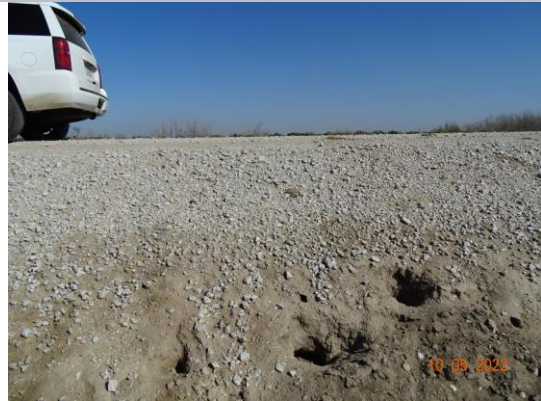
Photo 1 of 1 : FA\_2023\_NA0011\_147\_53\_20230821\_00019.jpg

Looking at typical rodent hole on landward slope. (Fall 2022)

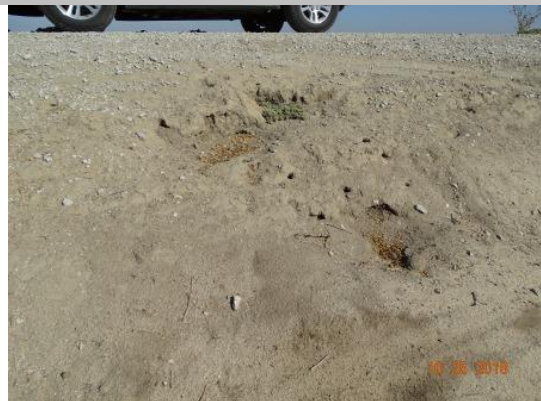
Photo 1 of 1 : FA\_2023\_NA0011\_147\_58\_20230821\_00020.jpg

Minor erosion on landside slope. (Fall 2018)
