**Flood Control Project Maintenance
Levee Inspections****Maintenance Issue Types Only, Levee Inspection Report By Mile - Fall 2024****Madera County FCWCA**

Waterway	Bank	Unit Miles	Inspection Start/End	Inspector
Unit No. 01 Ash Slough	Right	2.37	10/18/2024 10/18/2024	Corey Fujitani

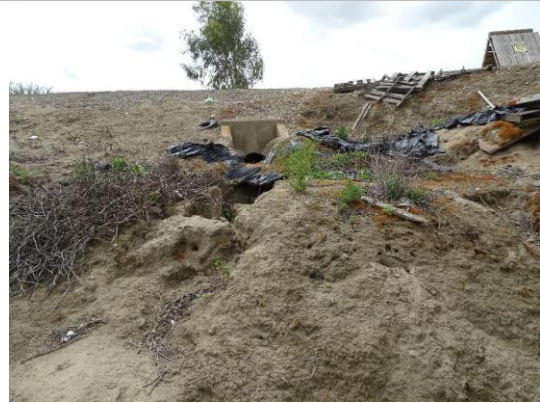
Photo 1 of 2 : UCIP_FA_2024_84784_112090.jpg

LM Start	0.04	Rating **	U	Issue No.	45
LM End	0.04	Issue Type +	Ma	Location *	
Category	Supplemental			GPS Latitude/Longitude	
				Start	End
Item	DWR UCIP LMA Responsibility			37.046618°	37.046618°
				-120.427350°	-120.427350°
DWR ID	21513

Comment Code					
Inspector Comment					
DS_ID:21513 FS_ID:84784 EP_NO: N/A Repair Type: Urgent EVAL Issue: 2b, Levee Integrity Crossing Status: Found UCIP Comments: 04/19/2022 Record remains Urgent. Erosion present on LS slope in front of concrete headwall. Soil within pipe inlet, mentioned in last inspection, has been removed. WS outlet is at a low point due to sediment buildup at end of spillway; recommend removal of sediment. Topography on LS has been altered so pipe does not appear to function as drainage. DMP internal video inspection has not found pipe integrity issues. LOF of crossing is less or equal to 4. Recommend next video inspection in 5 years. (M. Thao - DWR UCIP) 10/31/2018 Erosion present on both the right and the left side of the concrete headwall located on the LS. Pipe inlet is about 50 percent filled with soil. WS outlet is at a low point, water will pond against the levee until it reaches channel elevation. This crossing does not properly drain to the channel. Levee is composed of highly erodible material. Recommend clearing soil from pipe and completing internal pipe inspection to determine pipe integrity through levee. (O. Magana - DWR UCIP) 07/14/2016 No inspection completed--need to inspect October 2016. (DWR UCIP - omagana) 05/06/2014 Landward slope has been excavated and a berm built in front of landward headwall. Sediment visible inside pipe from landward side. Dense vegetation limits the inspector's visibility to identify signs of pipe failure (leaks) along the waterward slope. Recommend removing vegetation along pipe alignment and waterward headwall to conduct proper inspection of structure. (DWR UCIP - omagana) FIELD_STRUCT_DESC: 30-inch corrugated metal gravity drainage pipe through the levee, 9.5 feet below the crown. Headwall and wing wall on each end. Flap gate on the waterside (WS) end. [Additional Reference(s): DWR Levee Log, 2005 (HLM 0.04). USACE San Joaquin O&M Manual 605 (Station 2+94), listed as 30-inch pipe]. FS Date: 4/19/2022

LS view: Looking toward levee; erosion in front of concrete headwall.

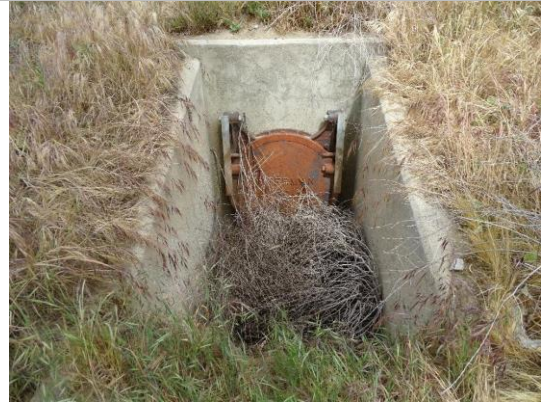
Photo 2 of 2 : UCIP_FA_2024_84784_112092.jpg

WS view: Concrete headwall, spillway, and flap gate; outlet is at a low point due to sediment buildup at end of spillway.

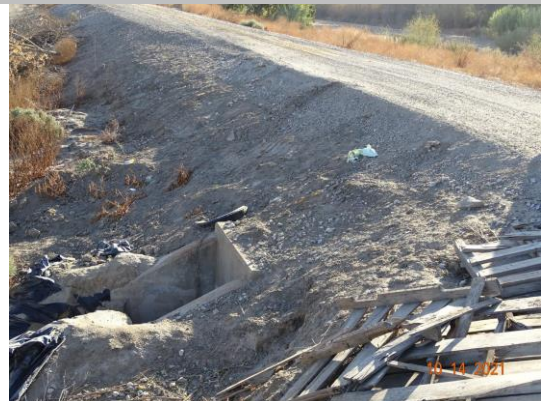
Photo 1 of 1 : FA_2024_NA0011_142_20_20240828_00009.jpg

LM Start	0.04	Rating **	A/W	Issue No.	20
LM End	0.04	Issue Type +	Ma	Location *	LS
Category	Earthen Levee			GPS Latitude/Longitude	
				Start	End
Item	Erosion / Bank Caving			37.046624°	37.046624°
				-120.427317°	-120.427317°
DWR ID	DWR_NA0011_01_s_2014_20				
Comment Code					
E1 : Note and monitor erosion site.					
Inspector Comment					
The site appears to have been repaired. Monitor for settlement.

View of repaired slope damage on landside slope. (Fall 2021)

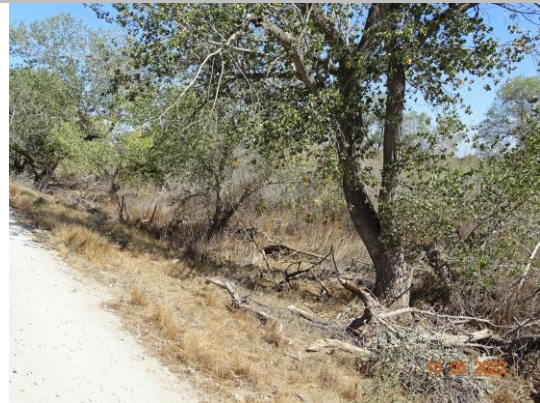
Photo 1 of 1 : FA_2024_NA0011_142_8_20240828_00002.jpg

Tree limbs on the waterside slope and toe should be removed. (Fall 2022)

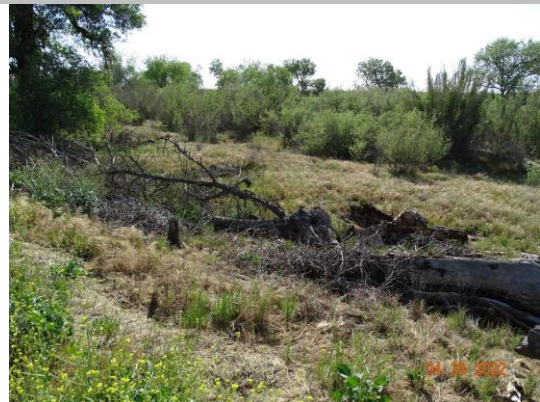
Photo 1 of 1 : FA_2024_NA0011_142_11_20240828_00004.jpg

Remove downed tree from waterside slope. (Spring 2022)

LM Start	0.44	Rating **	M	Issue No.	11
LM End	0.44	Issue Type +	Ma	Location *	WS
Category	Earthen Levee			GPS Latitude/Longitude	
				Start	End
Item	Trim / Thin Trees			37.049455°	37.049455°
				-120.421218°	-120.421218°
DWR ID	DWR_NA0011_01_f_2023_11				
Comment Code					
T2 : Tree or limb.					
Inspector Comment					
Remove the dead tree from the waterside slope.

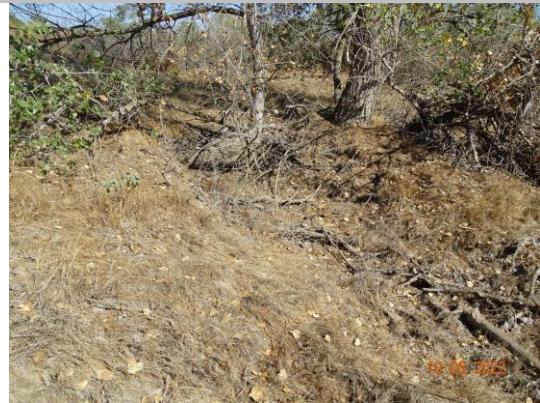
Photo 1 of 1 : FA_2024_NA0011_142_24_20240828_00011.jpg

LM Start	0.56	Rating **	M	Issue No.	24
LM End	0.56	Issue Type +	Ma	Location *	WS
Category	Earthen Levee			GPS Latitude/Longitude	
				Start	End
Item	Erosion / Bank Caving			37.050660°	37.050660°
				-120.419583°	-120.419583°
DWR ID	DWR_NA0011_01_f_2022_24				
Comment Code					
E2 : Schedule repair of erosion site prior to the next inspection.					
Inspector Comment					
There is an erosion pocket at the waterside toe around tree trunk and downed tree limb.

Erosion on the waterside toe around a fallen tree limb and tree trunk.
(Fall 2022)

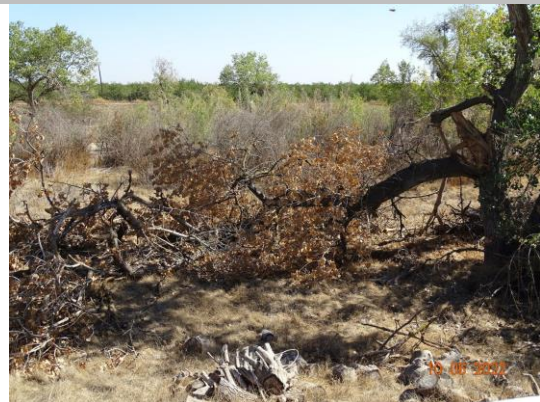
Photo 1 of 1 : FA_2024_NA0011_142_37_20240828_00017.jpg

Downed tree limbs on the waterside berm should be removed. (Fall 2022)

LM Start	0.62	Rating **	M	Issue No.	37
LM End	0.62	Issue Type +	Ma	Location *	WS
Category	Earthen Levee			GPS Latitude/Longitude	
				Start	End
Item	Trim / Thin Trees			37.051222°	37.051222°
				-120.418810°	-120.418810°
DWR ID	DWR_NA0011_01_f_2015_37				
Comment Code					
T2 : Tree or limb.					
Inspector Comment					
Remove the tree branches from the waterside slope.

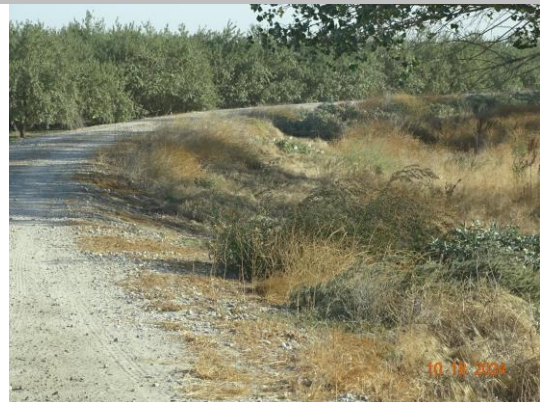
Photo 1 of 1 : FA_2024_NA0011_142_4_20241025_00021.jpg

View of vegetation on the waterside slope looking upstream. (Fall 2024)

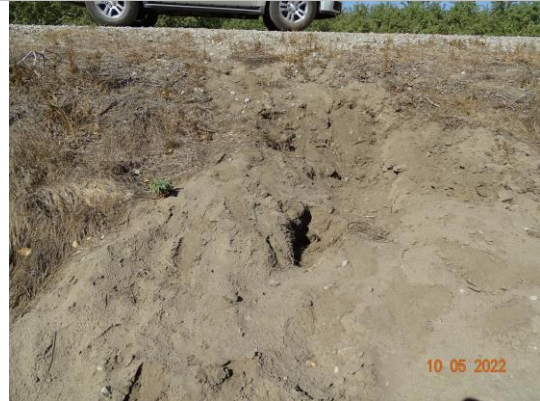
Photo 1 of 1 : FA_2024_NA0011_142_30_20240828_00015.jpg

LM Start	1.00	Rating **	U	Issue No.	30
LM End	1.00	Issue Type +	Ma	Location *	WS
Category	Earthen Levee			GPS Latitude/Longitude	
				Start	End
Item	Erosion / Bank Caving			37.055763°	37.055763°
				-120.415308°	-120.415308°
DWR ID	DWR_NA0011_01_f_2022_30				
Comment Code					
E2 : Schedule repair of erosion site prior to the next inspection.					
Inspector Comment					
Erosion pocket that appears to be caused by rodent activity on the waterside slope.

Erosion pocket on the waterside slope. (Fall 2022)

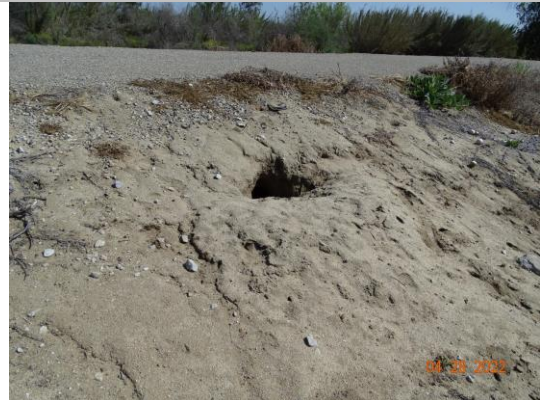
Photo 1 of 1 : FA_2024_NA0011_143_30_20240828_00014.jpg

View of animal burrow on the landside slope. (Spring 2022)

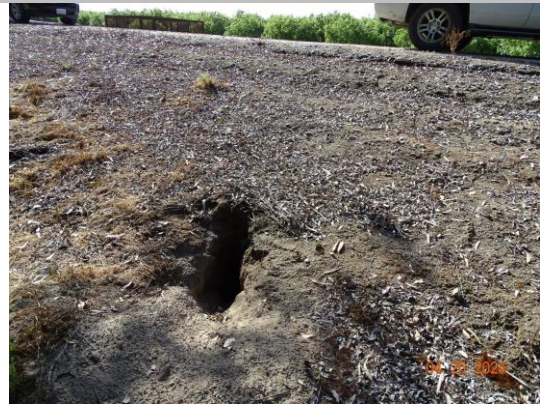
Photo 1 of 1 : FA_2024_NA0011_143_7_20240828_00004.jpg

Large rodent burrow with significant material displaced, observed on the waterside slope. (Spring 2024)

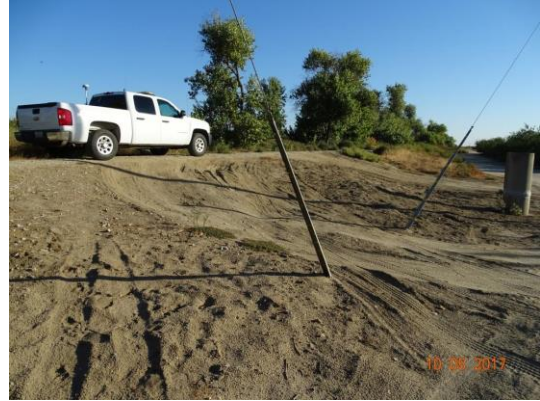
Photo 1 of 1 : FA_2024_NA0011_143_13_20240828_00007.jpg

LM Start	0.31	Rating **	M	Issue No.	13
LM End	0.31	Issue Type +	Ma	Location *	LS
Category	Earthen Levee			GPS Latitude/Longitude	
				Start	End
Item	Erosion / Vehicle Traffic			37.047266°	37.047266°
				-120.422393°	-120.422393°
DWR ID	DWR_NA0011_02_f_2017_13				
Comment Code					
E6 : Repair the levee slope damaged by vehicle traffic and prevent access where possible.					
Inspector Comment

Vehicle access to levee slope should be prevented and erosion repaired.

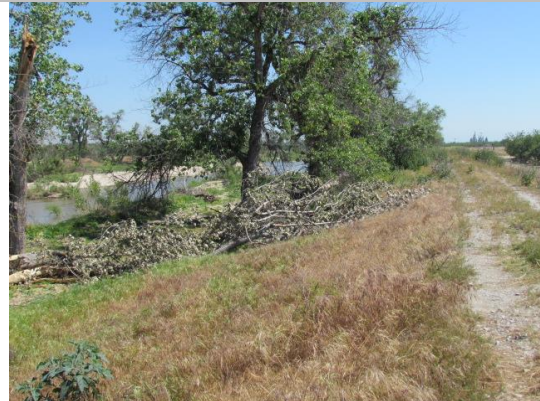
Photo 1 of 1 : FA_2024_NA0011_143_33_20240828_00017.jpg

Dead fallen trees on the waterside levee slope and shoulder.

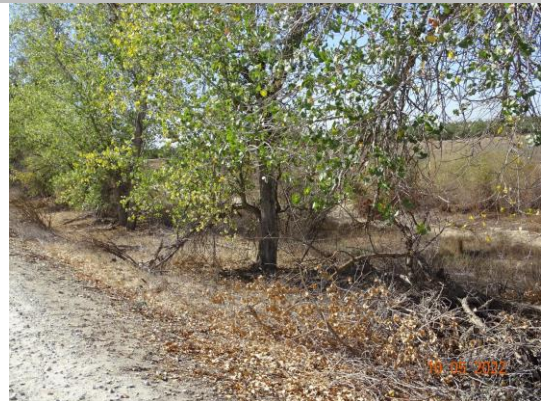
Photo 1 of 1 : FA_2024_NA0011_143_27_20240828_00012.jpg

Branches left along the waterside slope from high flow. (Fall 2022)

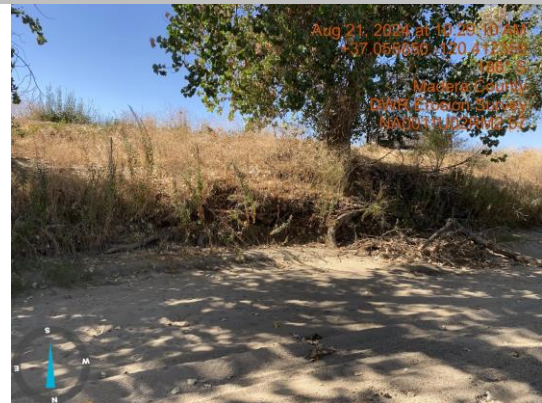
Photo 2 of 2 : SJR2024_NA0011U02RM2.57_2.JPG

Comment Code					
Inspector Comment					
Site ID: NA0011U02RM2.57 8/21/2024: From 2012 to present, no significant changes were observed during the annual survey. Vegetation is obscuring the views of the erosion. 07/24/2012: Dense vegetation around the site. 08/09/2011: A fallen tree was seen at the levee toe about 20 feet upstream, and tree root exposed. There has been no report from the district that this site was corrected. 11/30/2010: Site was not inspected due to time constraints. There have been no reports from the district that the site was corrected. Continue to monitor site during flood events. 08/05/2010: Recommended for annual assessment and monitoring during flood events, per CLRO. 2009: Site is recommended as a local maintenance issue, per Critical Levee Repair Office, Critical Erosion Sites Evaluation 2008 Report; site was previously rated "M" 09/6/2007: Undercutting of the toe; several trees along the WS slope with roots exposed.

8/21/2024: Another view of the erosion on the levee toe.

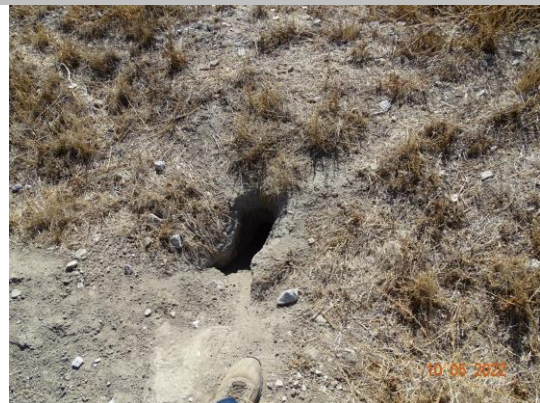
Photo 1 of 1 : FA_2024_NA0011_144_9_20240828_00003.jpg

Representative view of rodent holes on the landside slope. (Fall 2022)

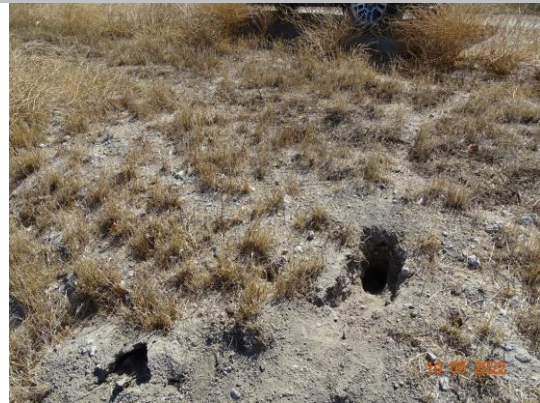
Photo 1 of 1 : FA_2024_NA0011_144_12_20240828_00005.jpg

Several rodent burrows observed on the landside slope. (Fall 2022)

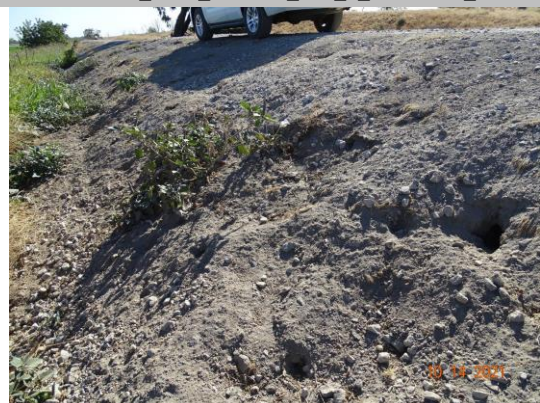
Photo 1 of 1 : FA_2024_NA0011_144_6_20240828_00002.jpg

View of rodent burrows in the landside slope. (Fall 2021)

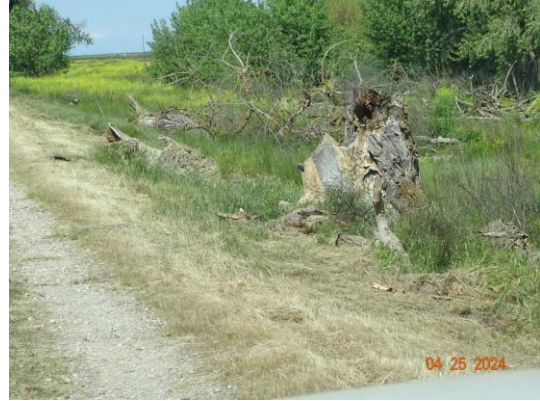
Photo 1 of 1 : FA_2024_NA0011_145_15_20240828_00010.jpg

View of broken tree limbs along the waterside slope and toe. (Spring 2024)

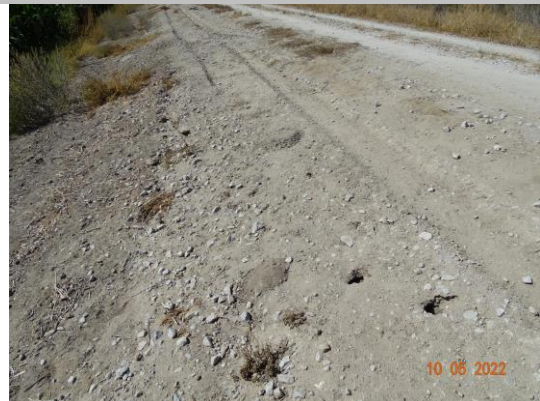
Photo 1 of 1 : FA_2024_NA0011_145_19_20240828_00013.jpg

LM Start	0.12	Rating **	A/W	Issue No.	19
LM End	0.94	Issue Type +	Ma	Location *	LS
Category	Earthen Levee			GPS Latitude/Longitude	
				Start	End
Item	Animal Control			36.995547°	36.995586°
				-120.371410°	-120.356589°
DWR ID	DWR_NA0011_04_s_2018_19				
Comment Code					
A3 : No rodents visible, but rodent burrows visible; need to backfill and compact or grout burrows.					
Inspector Comment					
Bait stations have been placed. Occasional small burrow observed. Continue to monitor.

View of small rodent burrows observed on the landside slope. (Fall 2022)

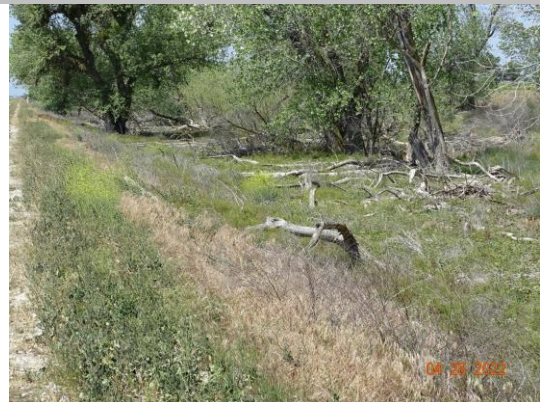
Photo 1 of 1 : FA_2024_NA0011_145_21_20240828_00014.jpg

Broken tree limbs and trunks in the channel should be removed. (Spring 2022)

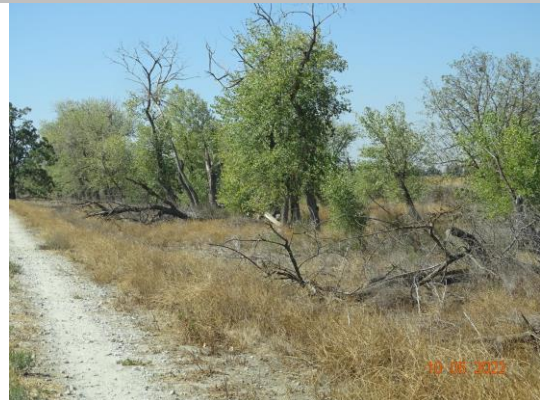
Photo 1 of 1 : FA_2024_NA0011_145_39_20240828_00024.jpg

Fallen trees washed up on the waterside slope and berm from high water. (Fall 2022)

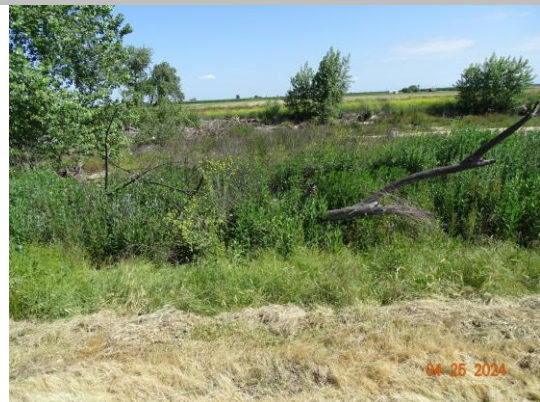
Photo 1 of 1 : FA_2024_NA0011_145_6_20240828_00002.jpg

View of fallen tree on waterside slope. (Spring 2024)

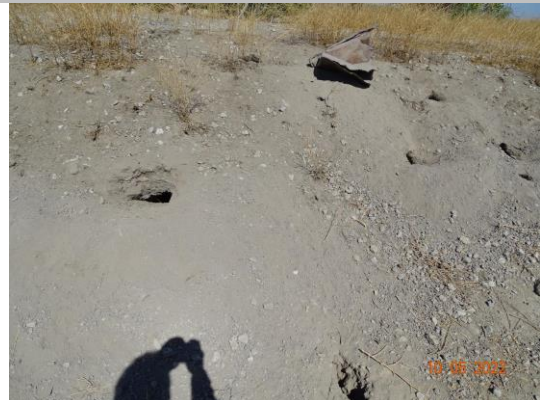
Photo 1 of 1 : FA_2024_NA0011_145_37_20240828_00023.jpg

Multiple burrows observed on the landside slope. (Fall 2022)

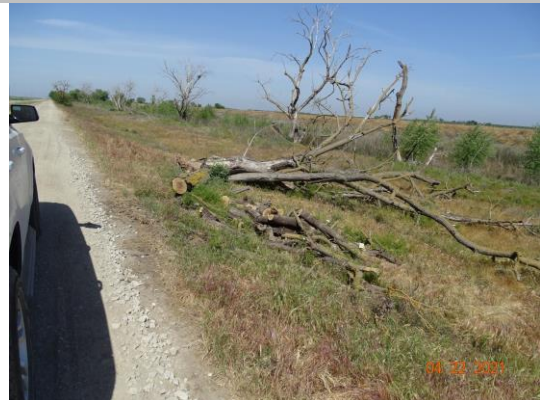
Photo 1 of 1 : FA_2024_NA0011_145_7_20240828_00003.jpg

View of tree limbs on the waterside slope. (Spring 2021)

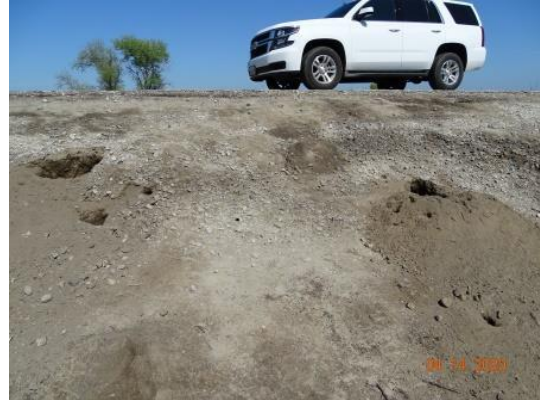
Photo 1 of 1 : FA_2024_NA0011_145_11_20240828_00006.jpg

Representative view of rodent holes observed in this section. (Spring 2020)

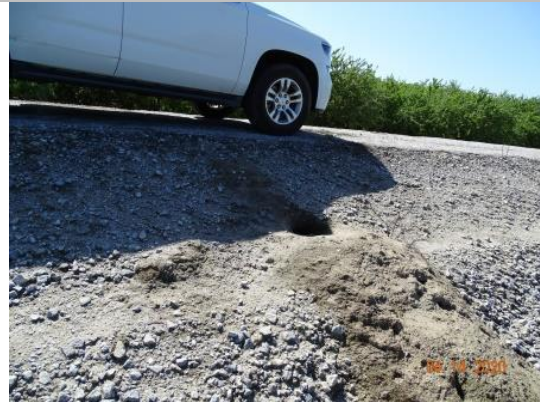
Photo 1 of 1 : FA_2024_NA0011_145_30_20240828_00019.jpg

Several large rodent holes on waterside slope. (Spring 2020)

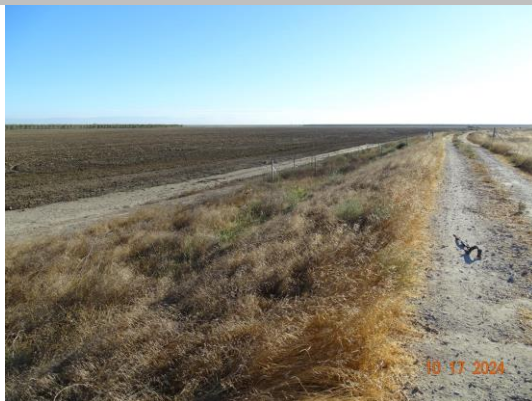
Photo 1 of 1 : FA_2024_NA0011_146_45_20241025_00060.jpg

View of vegetation along the landside slope. (Fall 2024)

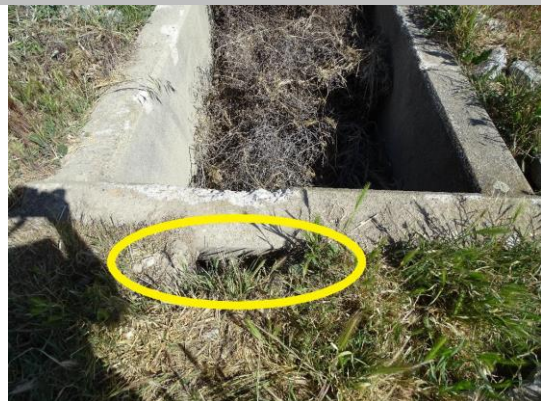
Photo 1 of 3 : UCIP_FA_2024_81023_112417.jpg

LS view: Rodent activity behind headwall on slope.

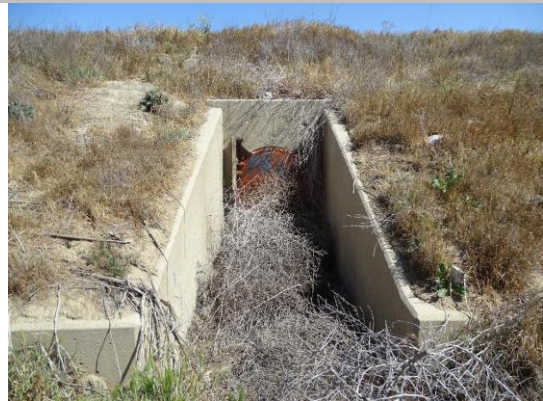
Photo 3 of 3 : UCIP_FA_2024_81023_112412.jpg

WS view: Concrete headwall and flap gate on toe; tumbleweeds at pipe outlet.

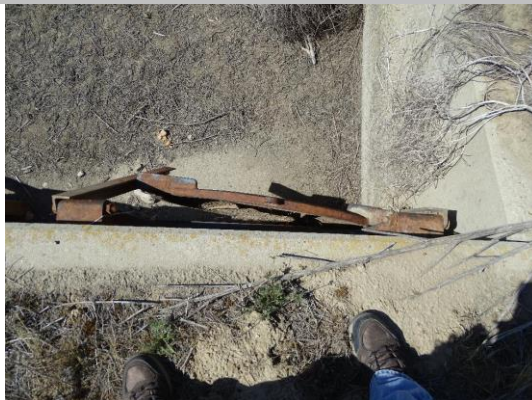
Photo 2 of 2 : UCIP_FA_2024_82670_112480.jpg

WS view: View from above; flap gate does not close properly and appears not to be propped open with anything.

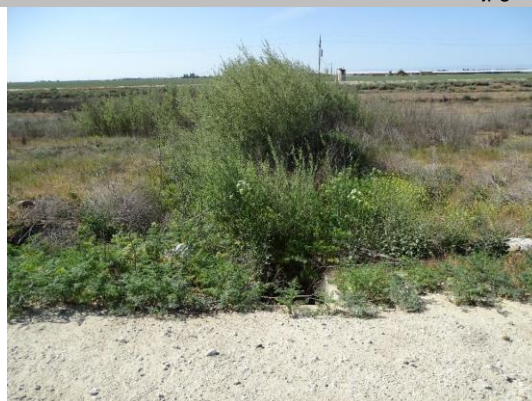
Photo 1 of 1 : UCIP_FA_2024_80586_112436.jpg

WS view: Looking from crown; concrete headwall at toe. Overgrown vegetation around headwall.

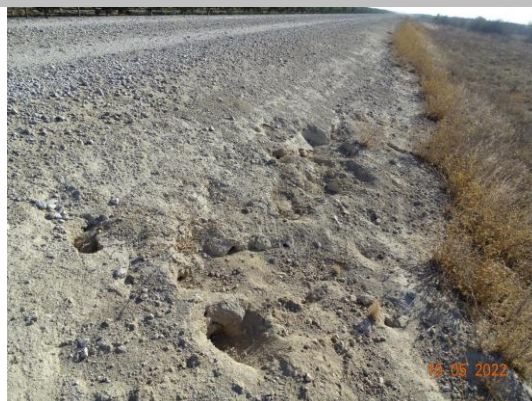
Photo 1 of 1 : FA_2024_NA0011_146_40_20240828_00015.jpg

View of burrows on the waterside slope. (Fall 2022)

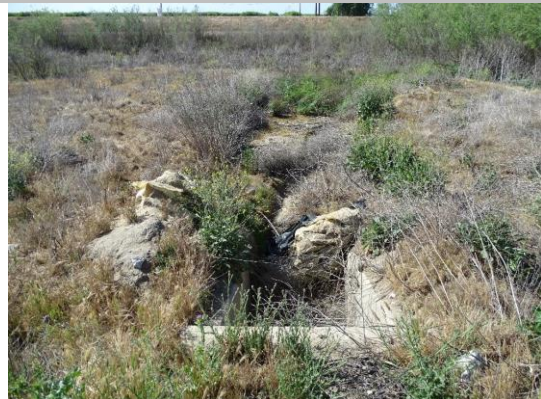
Photo 1 of 2 : UCIP_FA_2024_80585_112441.jpg

WS view: Concrete headwall on toe; stacked sandbags at end of spillway that would impede drainage.

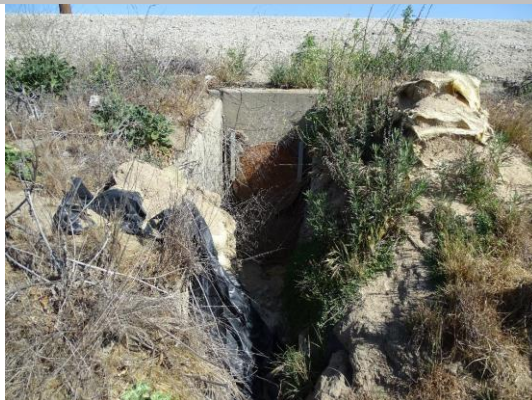
Photo 2 of 2 : UCIP_FA_2024_80585_112442.jpg

WS view: Sandbags at end of spillway that would impede drainage.

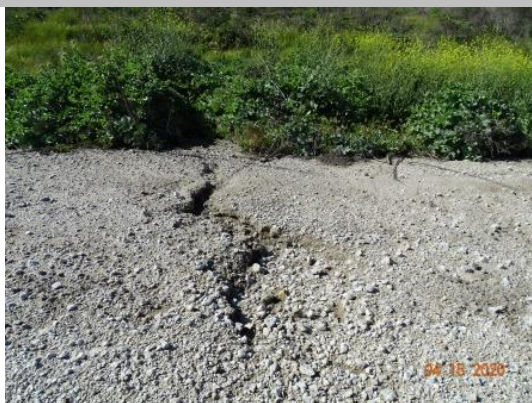
Photo 1 of 1 : FA_2024_NA0011_146_38_20240828_00014.jpg

Finger erosion on the waterside slope. (Spring 2020)

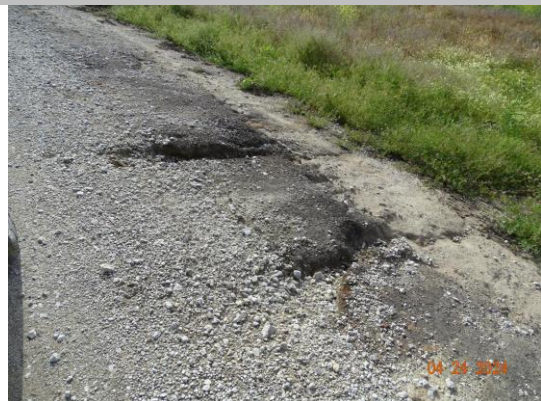
Photo 1 of 1 : FA_2024_NA0011_146_46_20240828_00018.jpg

Rills observed on waterside slope. (Spring 2024)

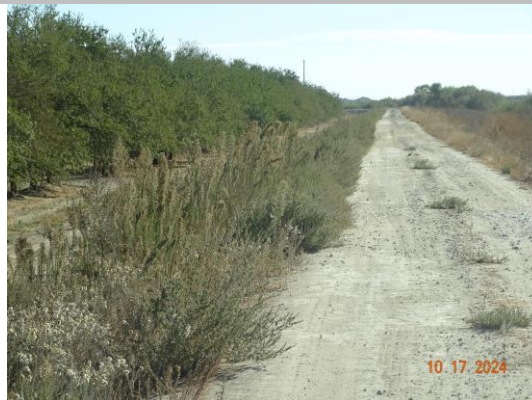
Photo 1 of 1 : FA_2024_NA0011_146_53_20241025_00062.jpg

Vegetation growing on the landside shoulder and slope. (Fall 2024)

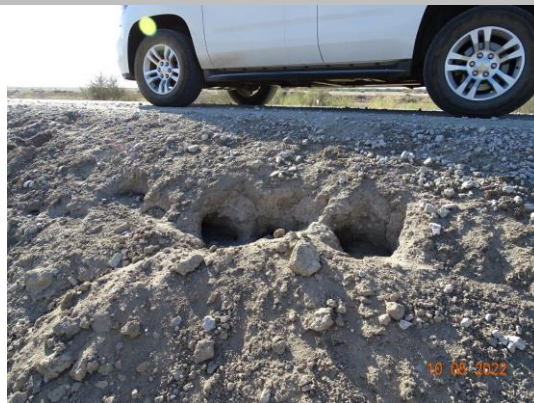
Photo 1 of 1 : FA_2024_NA0011_146_44_20240828_00017.jpg

View of rodent holes on the landside slope. (Fall 2022)

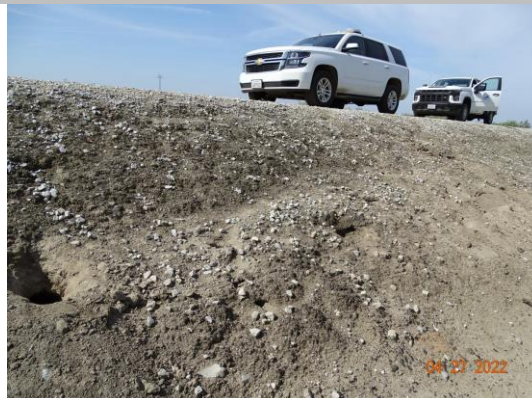
Photo 1 of 1 : FA_2024_NA0011_146_19_20240828_00006.jpg

Several rodent holes were noted at this location. (Spring 2022)

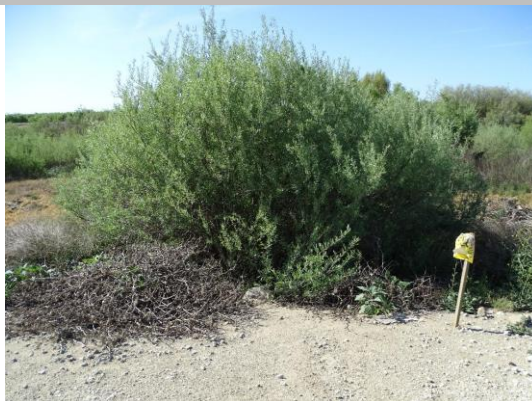
Photo 1 of 1 : UCIP_FA_2024_80578_112470.jpg

WS view: Looking from levee; dense and overgrown vegetation around headwall.

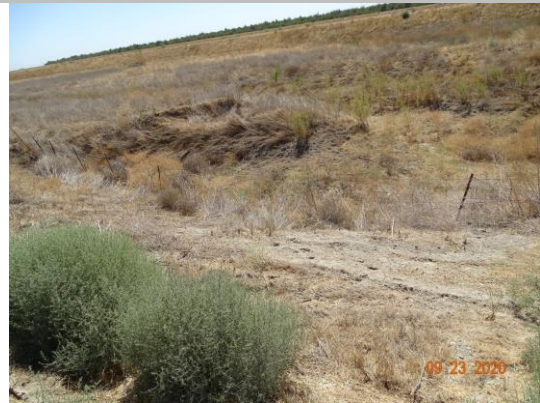
Photo 1 of 1 : FA_2024_NA0011_147_20_20240828_00007.jpg

View of erosion on the landside slope. (Fall 2020)

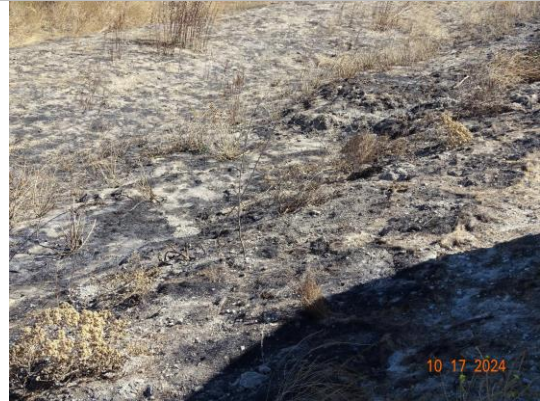
Photo 1 of 1 : FA_2024_NA0011_147_17_20241025_00038.jpg

View of slump possibly the result of rodent activity. (Fall 2024)

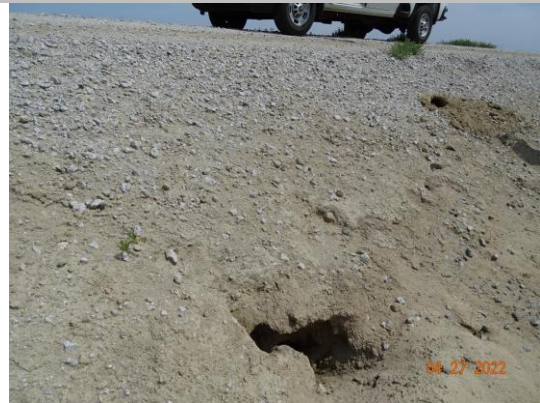
Photo 1 of 1 : FA_2024_NA0011_147_35_20240828_00014.jpg

Multiple rodent holes observed in this section of the levee. (Spring 2022)

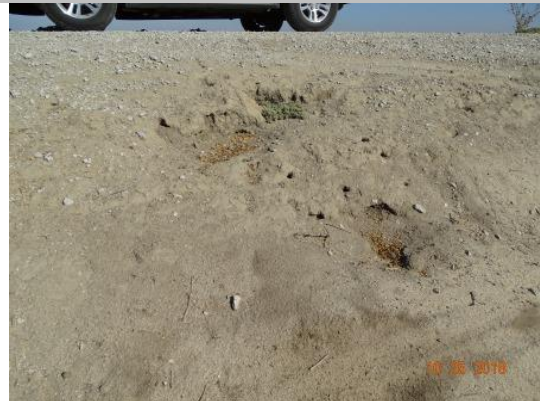
Photo 1 of 1 : FA_2024_NA0011_147_58_20240828_00020.jpg

Minor erosion on landside slope. (Fall 2018)

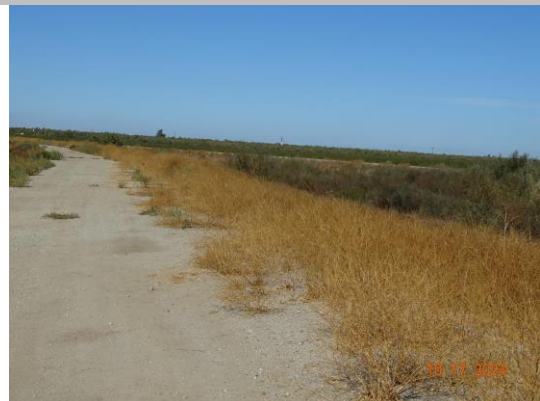
Photo 1 of 1 : FA_2024_NA0011_147_14_20241025_00039.jpg

View of vegetation on the waterside shoulder and slope. (Fall 2024)

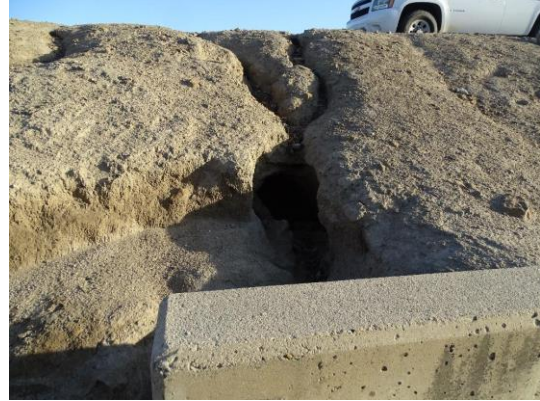
Photo 1 of 1 : UCIP_FA_2024_80594_113279.jpg

LS view: Surface erosion on slope; deep hole located behind concrete headwall.
