**Flood Control Project Maintenance
Levee Inspections**

Maintenance Issue Types Only, Levee Inspection Report By Mile - Spring 2015

Madera County FCWCA

Waterway	Bank	Unit Miles	Inspection Start/End	Inspector
Unit No. 01 Ash Slough	Right	2.37	05/06/2015 05/05/2015	Herman Phillips

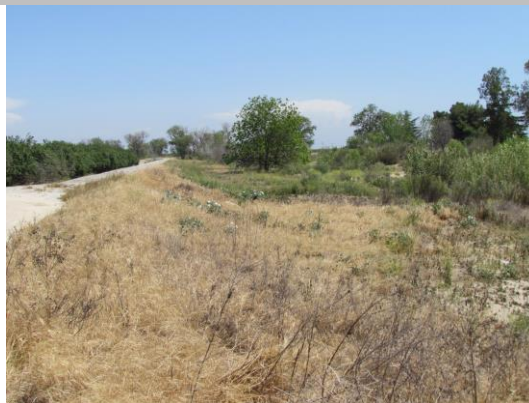
Photo 1 of 1 : SP_2015_NA0011_142_34_20150508_00072.jpg

LM Start	0.01	Rating **	U	Issue No.	34
LM End	2.15	Issue Type +	Ma	Location *	WS
Category	Earthen Levee			GPS Latitude/Longitude	
				Start	End
Item	Vegetation			37.046507 °	37.066035 °
				-120.427762 °	-120.399910 °
DWR ID	DWR_NA0011_01_f_2014_34				
Action/Comments					
Remove the wild growth other than native grasses from the levee slopes. Inspector Comments: Control the wild growth on the waterside of the levee slope.

Looking downstream from levee mile 0.01 waterside slope
unsatisfactory tall weeds present on the levee section.

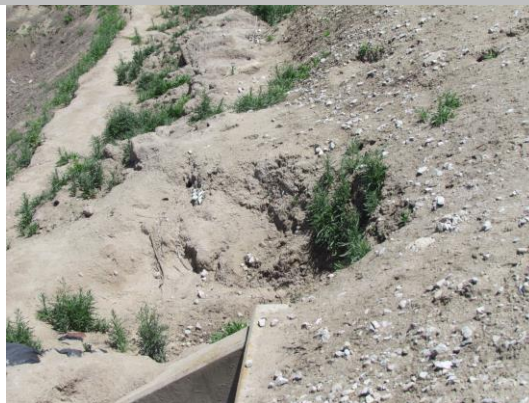
Photo 1 of 1 : SP_2015_NA0011_142_20_20150508_00077.jpg

LM Start	0.04	Rating **	U	Issue No.	20
LM End	0.05	Issue Type +	Ma	Location *	LS
Category	Earthen Levee			GPS Latitude/Longitude	
				Start	End
Item	Slope Stability			37.046624 °	37.046682 °
				-120.427317 °	-120.427108 °
DWR ID	DWR_NA0011_01_s _ 2014_20				
Action/Comments					
Repair slope instability. Inspector Comments: This is not a new erosion site, it should be repaired before the condition get any worse.

The landside levee slope and toe has been damaged and this was reported in the last inspection.

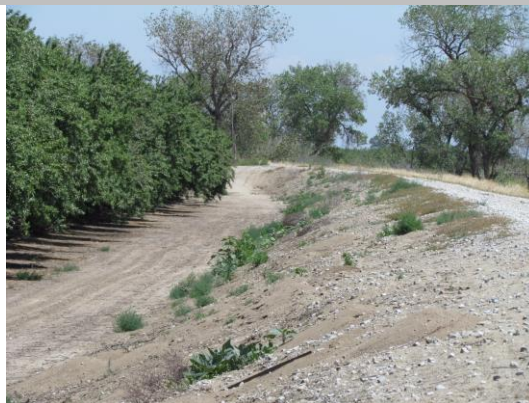
Photo 1 of 1 : SP_2015_NA0011_142_185_20150508_00078.jpg

The rodents are very active in this area.

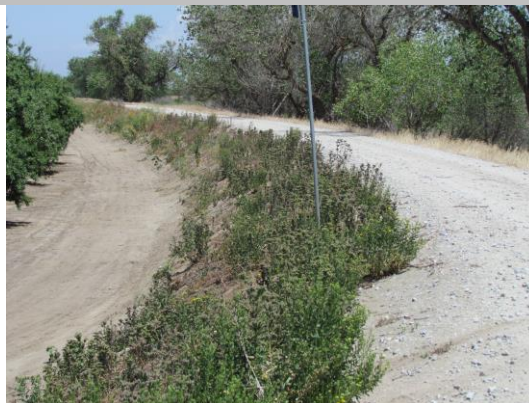
Photo 1 of 1 : SP_2015_NA0011_142_37_20150508_00079.jpg

LM Start	0.13	Rating **	M	Issue No.	23
LM End	0.73	Issue Type +	Ma	Location *	LS
Category	Earthen Levee			GPS Latitude/Longitude	
				Start	End
Item	Vegetation			37.046994 °	37.052529 °
				-120.425776 °	-120.417800 °
DWR ID	DWR_NA0011_01_s _ 2014_23				
Action/Comments					
Remove the wild growth other than native grasses from the levee slopes.

Unsatisfactory tall weeds on the landside slope.

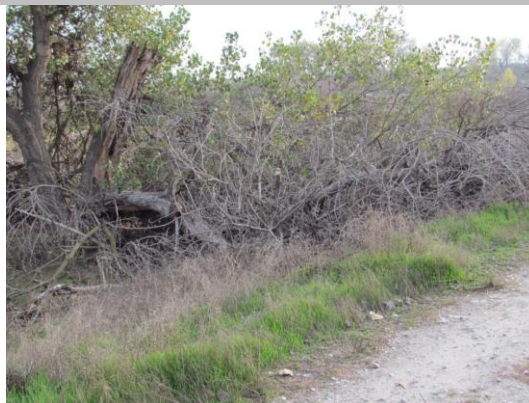
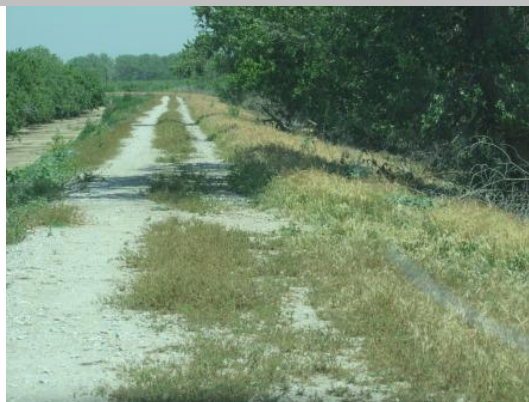
The levee crown roadway is overgrown with weeds. Photo taken 4-29-2014.

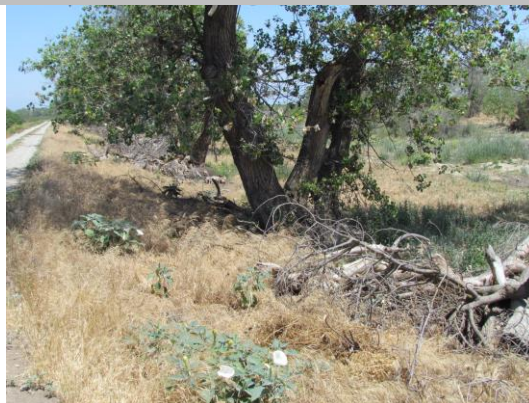
Photo 1 of 1 : SP_2015_NA0011_142_11_20150508_00081.jpg

Dead trees on the waterside slope that should have been removed already.

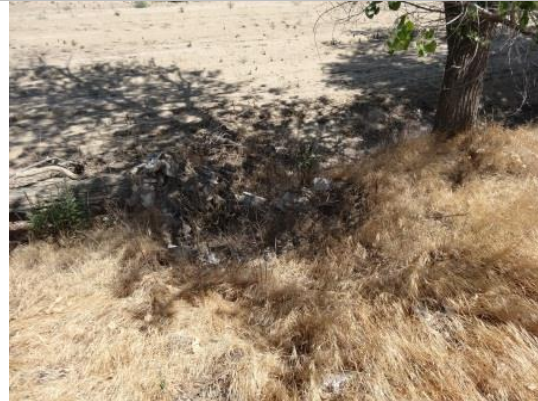
Photo 1 of 1 : SP_2015_NA0011_142_1_20150312_00001.jpg

LM Start	1.11	Rating **	U	Issue No.	1
LM End	1.20	Issue Type +	Ma	Location *	WS
Category	Supplemental			GPS Latitude/Longitude	
				Start	End
Item	DWR Erosion Survey			37.055596 °	37.055596 °
				-120.412647 °	-120.412647 °
DWR ID	DWR_NA0011_01_s _ 2015_1				
Action/Comments					
Inspector Comments: 07/22/2014: No significant change observed. 08/30/2013: No significant change observed. 07/31/2012: Site was visited on 07/24/2012. No significant change observed. Dense vegetation around the site 08/09/2011: Site was inspected. No visible change was observed from the previous condition. A fallen tree was seen at the levee toe about 20 feet upstream, and tree root exposed. There has been no report from the district that this site was corrected. 11/30/2010: Site was not inspected due to time constraints. There have been no reports from the district that the site was corrected. Continue to monitor site during flood events. 08/05/2010: Recommended for annual assessment and monitoring during flood events, per CLRO. 2009: Site is recommended as a local maintenance issue, per Critical Levee Repair Office, Critical Erosion Sites Evaluation 2008 Report; site was previously rated "M" 9/6/2007: Undercutting of the toe; several trees along the WS slope with roots exposed. [2014 Site ID:NA0011U01RM2.57]

View of the erosion site from the levee crest.

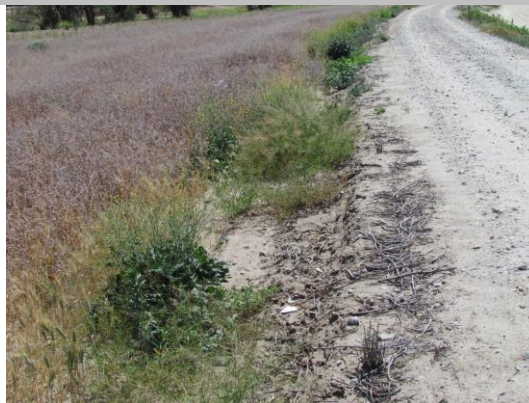
Photo 1 of 1 : SP_2015_NA0011_142_32_20150508_00073.jpg

LM Start	1.36	Rating **	U	Issue No.	32
LM End	1.81	Issue Type +	Ma	Location *	WS
Category	Earthen Levee			GPS Latitude/Longitude	
				Start	End
Item	Slope Stability			37.058460 °	37.062580 °
				-120.410390 °	-120.404180 °
DWR ID	DWR_NA0011_01_f_2014_32				
Action/Comments					
Repair slope instability. Inspector Comments: The toe has been damaged by disking too close to the levee toe waterward. 1.50-2.50 foot cut in toe

View looking downstream at the waterside toe damage.

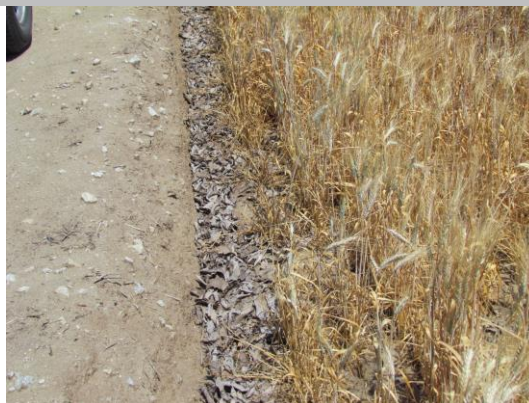
Photo 1 of 1 : SP_2015_NA0011_142_190_20150508_00075.jpg

LM Start	1.42	Rating **	U	Issue No.	190
LM End	2.07	Issue Type +	Ma	Location *	WS
Category	Earthen Levee			GPS Latitude/Longitude	
				Start	End
Item	Slope Stability			37.058925 °	37.065360 °
				-120.409392 °	-120.401108 °
DWR ID	DWR_NA0011_01_s_2015_190				
Action/Comments					
Repair the levee slope damaged by vehicle traffic and prevent access where possible.					
Inspector Comments: The hinge point has been cut 1.5 inches deep.

The hinge point has been disced from levee mile 1.42 -2.07.

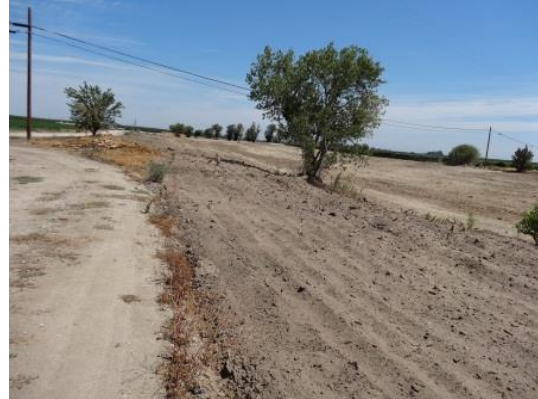
Photo 1 of 1 : SP_2015_NA0011_142_15_20150312_00002.jpg

Inspector Comments: 07/22/2014: No significant change observed.
08/30/2013: No significant change observed
07/31/2012: Site was visited on 07/26/2012. No significant change observed
08/09/2011: Site was inspected. No visible change was observed from the previous condition. There have been no reports from the district that this site was corrected.
11/30/2010: Site was not inspected this year due to time constraints. There have been no reports from the district that this site was corrected. Continue monitor during flood events.
08/05/2010: Recommended for annual assessment and monitoring during flood events, per CLRO.
2009: Site is recommended as a local maintenance issue, per CLRO CES Evaluation 2008 Report; it was previously rated "M".
8/26/2008: Undulating waterside slope surface; vehicular damage along the waterside slope possibly caused by farming equipment; levee crown is composed of sandy material; there is a collection of concrete rubble on the waterside crown hinge; vehicular damage extends from levee toe to crown surface.

9/6/2007: Farmer degraded levee on water-ward slope and crown.
[2014 Site ID:NA0011U01RM3.8]

Close view of the site. The site has been plowed by the farm vehicle and the erosion is not visible any longer.

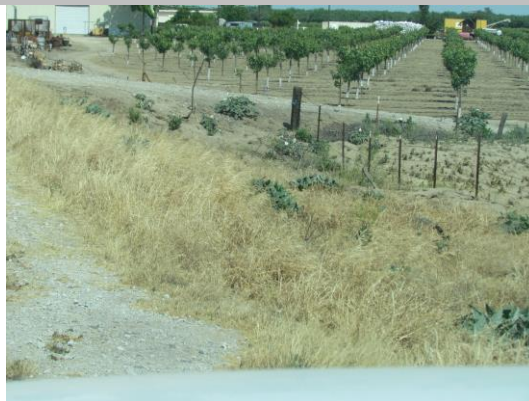
Photo 1 of 1 : SP_2015_NA0011_143_177_20150511_00039.jpg

Tall weeds present on the landside shoulder and slope.

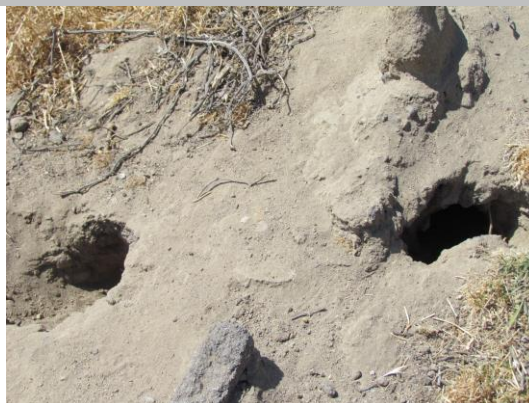
Photo 1 of 1 : SP_2015_NA0011_143_178_20150511_00040.jpg

LM Start	0.00	Rating **	U	Issue No.	178
LM End	0.14	Issue Type +	Ma	Location *	LS
Category	Earthen Levee			GPS Latitude/Longitude	
				Start	End
Item	Animal Control			37.045493 °	37.046112 °
				-120.427455 °	-120.425045 °
DWR ID	DWR_NA0011_02_s _ 2015_178				
Action/Comments					
Exterminate rodents and backfill and compact or grout burrows. Inspector Comments: There need to be bait stations in place to control the rodent population.

There are many rodent holes present on the shoulder and slope of the landside section.

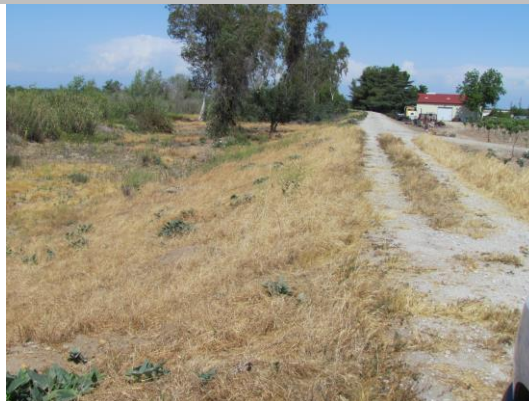
Photo 1 of 1 : SP_2015_NA0011_143_176_20150511_00041.jpg

LM Start	0.00	Rating **	U	Issue No.	176
LM End	2.03	Issue Type +	Ma	Location *	WS
Category	Earthen Levee			GPS Latitude/Longitude	
				Start	End
Item	Vegetation			37.045493 °	37.064097 °
				-120.427455 °	-120.401053 °
DWR ID	DWR_NA0011_02_s _ 2015_176				
Action/Comments					
Remove the wild growth other than native grasses from the levee slopes.					
Inspector Comments: Remove the tall weeds from the levee slope waterside.

Ash Slough looking upstream from the waterside at unsatisfactory tall weeds on the levee slope.

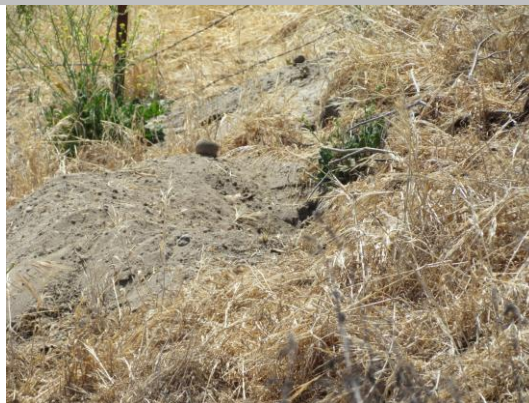
Photo 1 of 1 : SP_2015_NA0011_143_179_20150511_00042.jpg

From levee mile 0.03 through levee mile 2.03 rodent's are active and there are no bait stations in place.

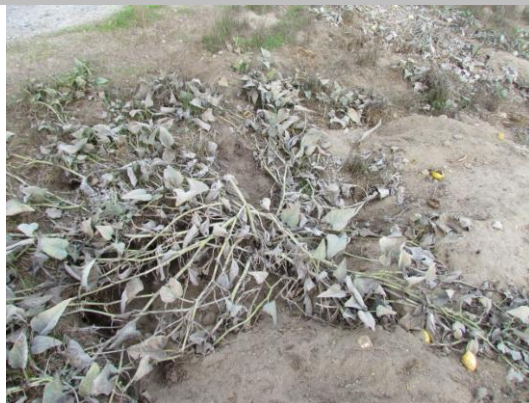
Photo 1 of 1 : SP_2015_NA0011_143_19_20150312_00003.jpg

LM Start	0.06	Rating **	U	Issue No.	19
LM End	1.67	Issue Type +	Ma	Location *	LS
Category	Earthen Levee			GPS Latitude/Longitude	
				Start	End
Item	Animal Control			37.045806 °	37.060091 °
				-120.426405 °	-120.405342 °
DWR ID	DWR_NA0011_02_f_2012_19				
Action/Comments					
Exterminate rodents and backfill and compact or grout burrows. Inspector Comments: The rodents here on the landside need to be controlled. Bait stations are needed. No new photo was taken.

Large rodent mounds underneath vine growth on the landside slope.

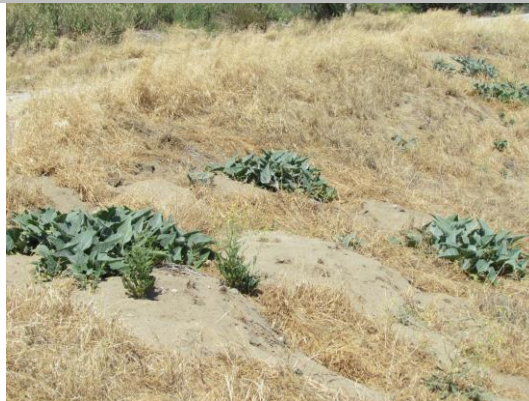
Photo 1 of 1 : SP_2015_NA0011_143_39_20150511_00043.jpg

Looking upstream from landside levee mile 0.32 wild weeds and broadleaf on levee slope. Rodent are active here also.

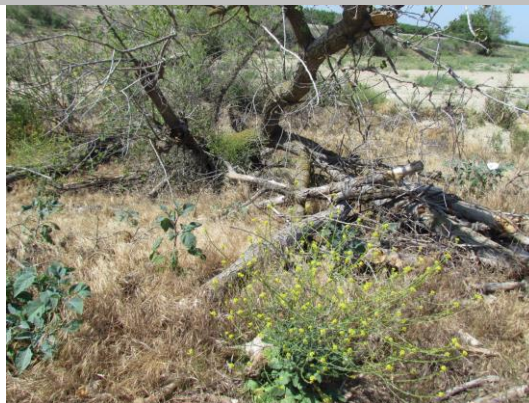
Photo 1 of 1 : SP_2015_NA0011_143_28_20150511_00044.jpg

This dead tree has not been removed since last inspection.

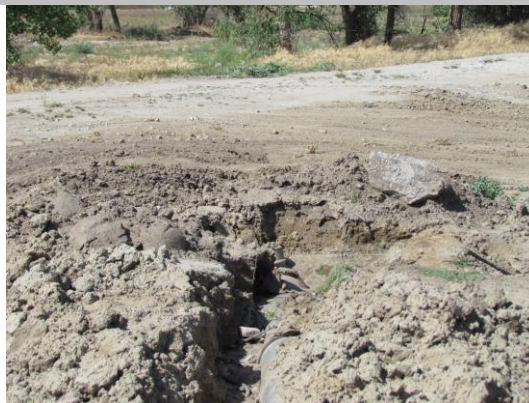
Photo 1 of 2 : SP_2015_NA0011_143_14_20150511_00045.jpg

This pipe goes all the way over to Unit 1 across the channel. No permit on file for this encroachment.

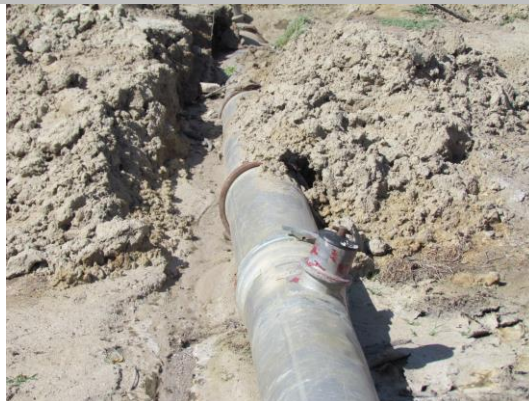
Photo 2 of 2 : SP_2015_NA0011_143_14_20150511_00046.jpg

Another view of the pipe; there is evidence of leakage at the joints.

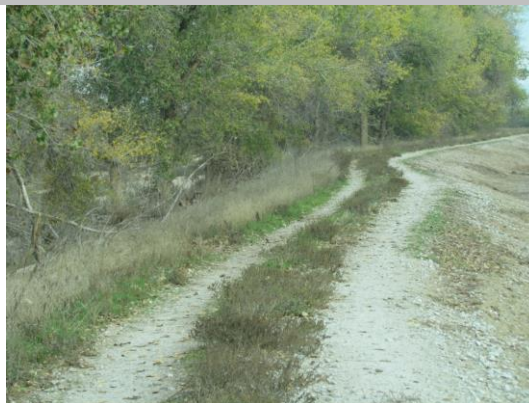
Photo 1 of 1 : SP_2015_NA0011_143_44_20150312_00010.jpg

View of the crown roadway with tall grasses present. No new picture.

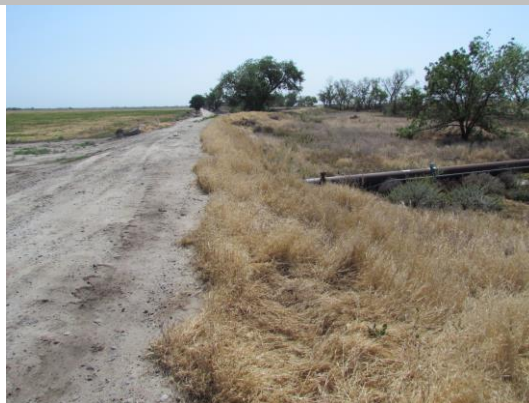
Photo 1 of 1 : SP_2015_NA0011_144_1_20150511_00025.jpg

Berenda Slough looking upstream from the waterside at unwanted tall weeds on the shoulder and slope.

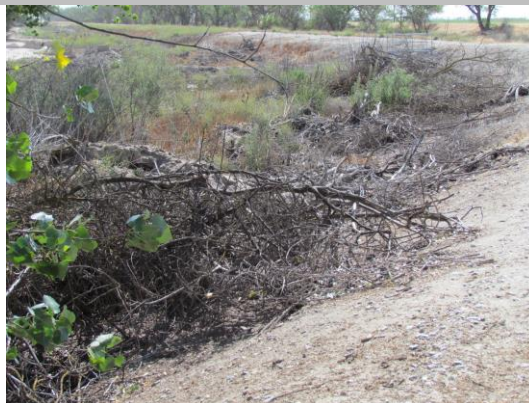
Photo 1 of 1 : SP_2015_NA0011_144_35_20150511_00026.jpg

Levee mile 0.03 landside dead trees still remain on the levee slope from last inspection.

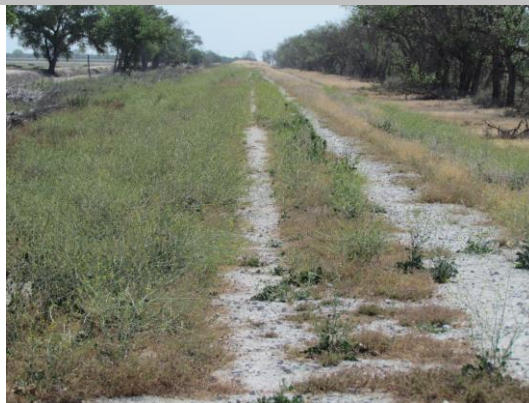
Photo 1 of 1 : SP_2015_NA0011_144_121_20150513_00028.jpg

Crown roadway need to be free of vegetation.

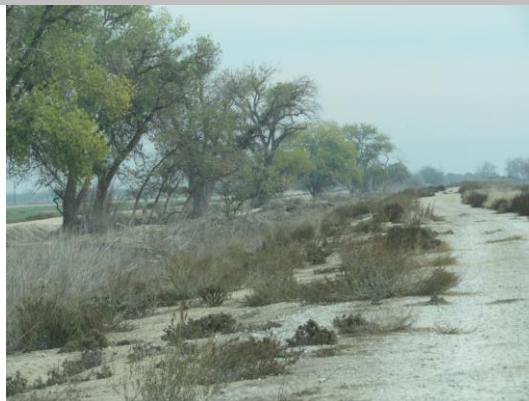
Photo 1 of 1 : SP_2015_NA0011_144_36_20150312_00005.jpg

Looking upstream at levee mile 0.36 wild growth covering the landward levee section to the levee mile 1.52. No new photo taken 5-6-2015.

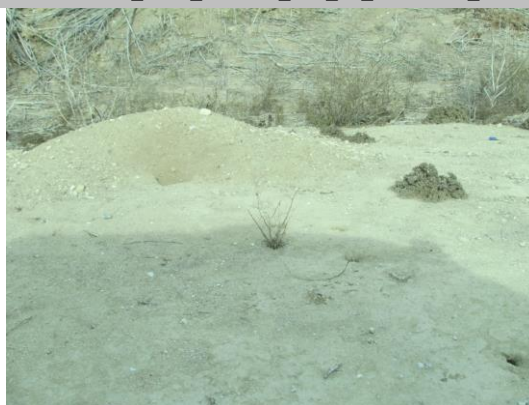
Photo 1 of 1 : SP_2015_NA0011_144_41_20150312_00007.jpg

LM Start	0.71	Rating **	U	Issue No.	41
LM End	1.52	Issue Type +	Ma	Location *	LS
Category	Earthen Levee			GPS Latitude/Longitude	
				Start	End
Item	Animal Control			36.996240 °	36.996611 °
				-120.361028 °	-120.346460 °
DWR ID	DWR_NA0011_03_f_2014_41				
Action/Comments					
Repair the levee slope damaged by livestock and prevent large animal access.					
Inspector Comments: Need bait stations present where rodents are active.

Large rodent mounds on the landward levee slope. No new photo taken 5-2015, no change.

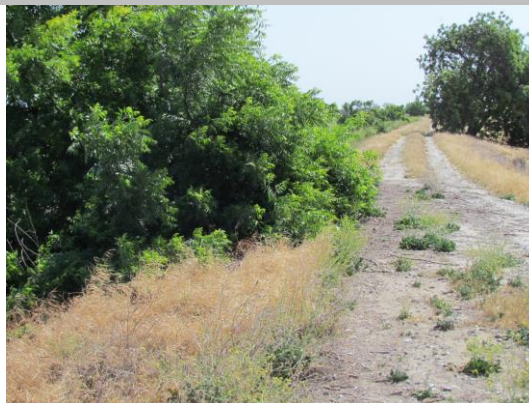
Photo 1 of 1 : SP_2015_NA0011_144_47_20150513_00029.jpg

Woody tree growth completely blocking the levee slope and shoulder on the landside.

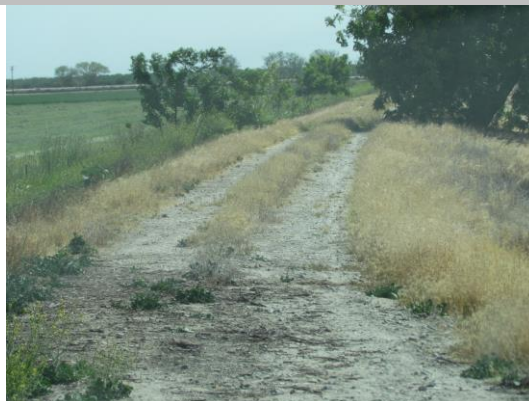
Photo 1 of 1 : SP_2015_NA0011_144_44_20150513_00030.jpg

Looking upstream from levee mile 1.04 to levee mile 1.52 crown roadway overgrown with tall weeds.

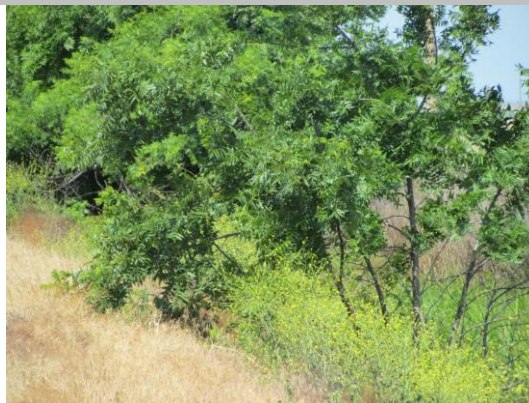
Photo 1 of 1 : SP_2015_NA0011_144_15_20150513_00032.jpg

Unacceptable nut trees on the landside levee slope.

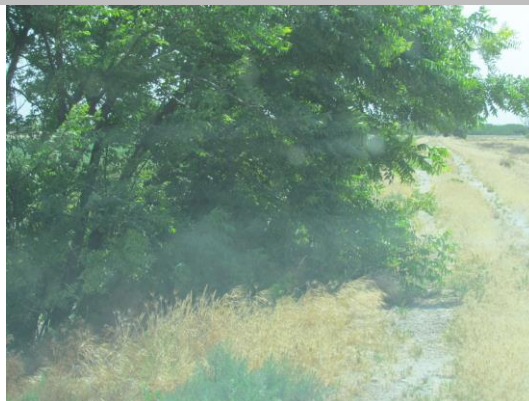
Photo 1 of 1 : SP_2015_NA0011_144_17_20150513_00033.jpg

Looking upstream from landward levee mile 1.24 tree growth blocks slope shoulder and portion of the crown roadway.

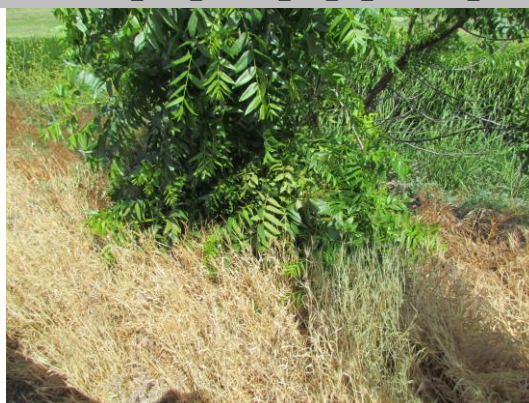
Photo 1 of 1 : SP_2015_NA0011_144_30_20150513_00034.jpg

Young nut tree on the landside levee slope.

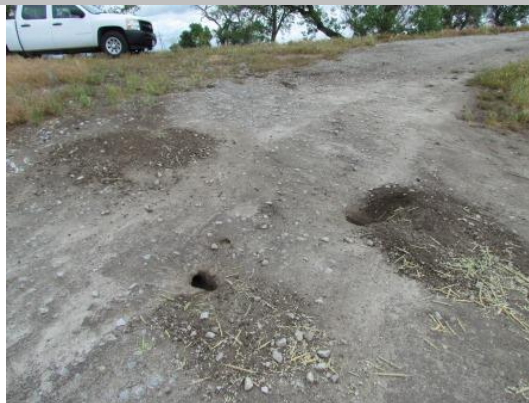
Photo 1 of 2 : SP_2015_NA0011_145_2_20150312_00002.jpg

Listed last year inspection 2014. The area has not changed. The slopes look the same.

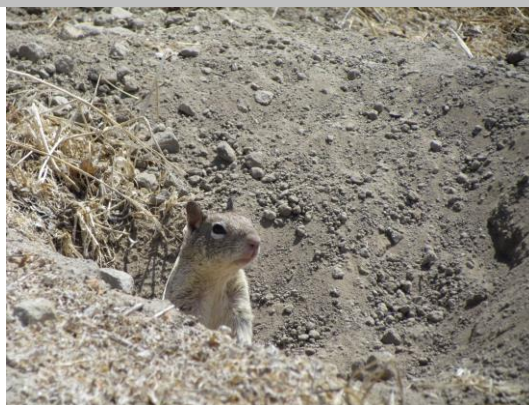
Photo 2 of 2 : SP_2015_NA0011_145_2_20150513_00089.jpg

Rodents are active in the area as listed during the last inspection. No bait stations on site.

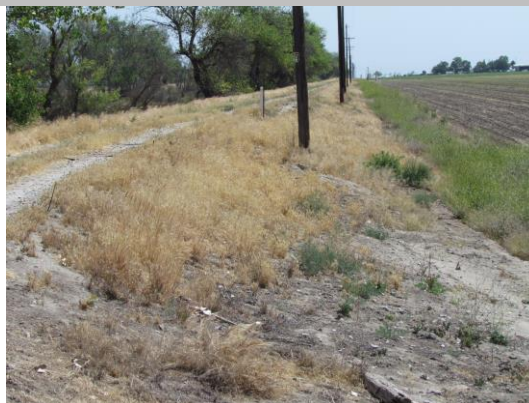
Photo 1 of 1 : SP_2015_NA0011_145_1_20150513_00088.jpg

Berenda Slough looking upstream from levee mile 0.01 to levee mile 1.50, tall weeds present on the landward levee slope.

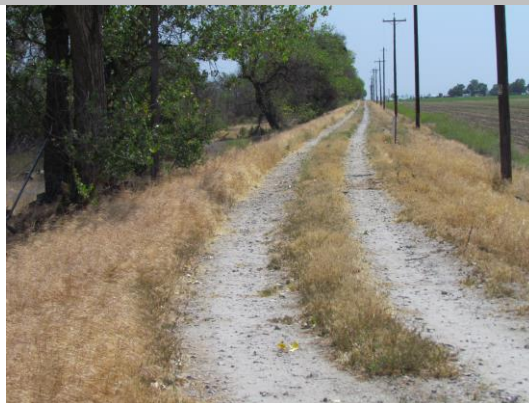
Photo 1 of 1 : SP_2015_NA0011_145_4_20150513_00090.jpg

Unacceptable wild growth on the waterside slope and shoulder.

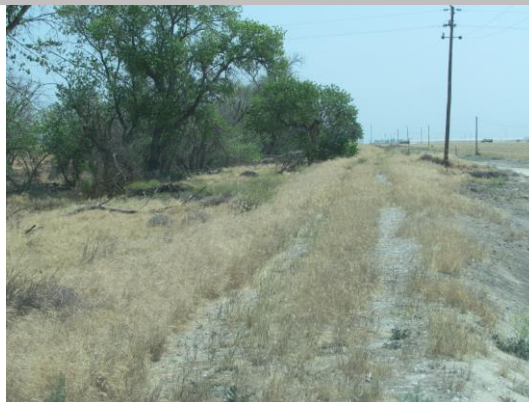
Photo 1 of 1 : SP_2015_NA0011_145_22_20150513_00093.jpg

Looking upstream where no maintenance has been done. Weeds are 3.0 foot tall on crown and both slopes.

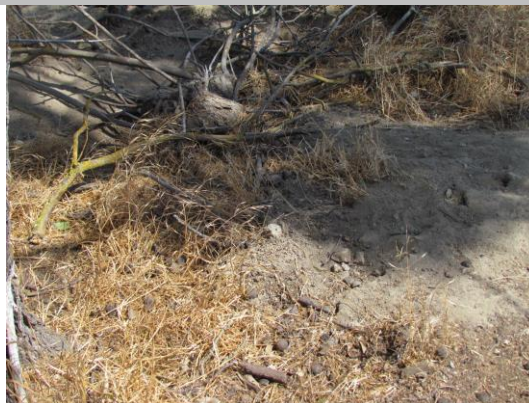
Photo 1 of 2 : SP_2015_NA0011_145_205_20150513_00091.jpg

Rodents are active at this location.

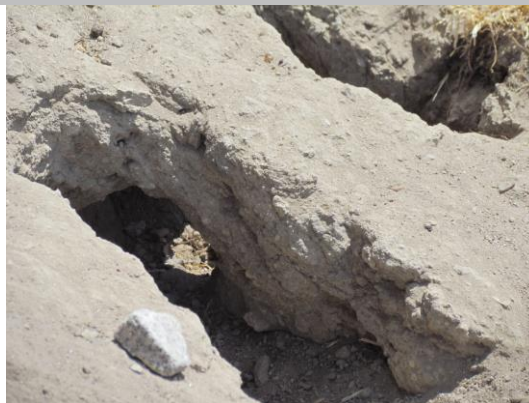
Photo 2 of 2 : SP_2015_NA0011_145_205_20150513_00092.jpg

Another view of the activity in area.

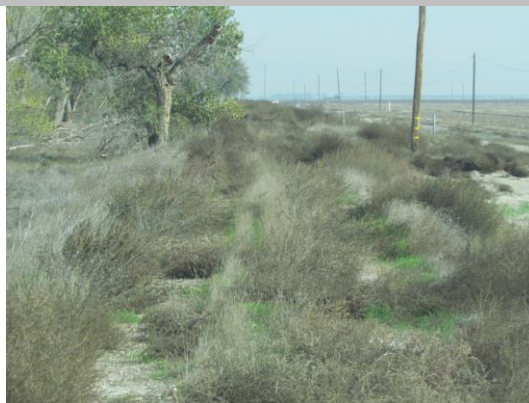
Photo 1 of 1 : SP_2015_NA0011_145_7_20150312_00004.jpg

Unwanted tall weeds completely covering the levee crown roadway. No new photo.

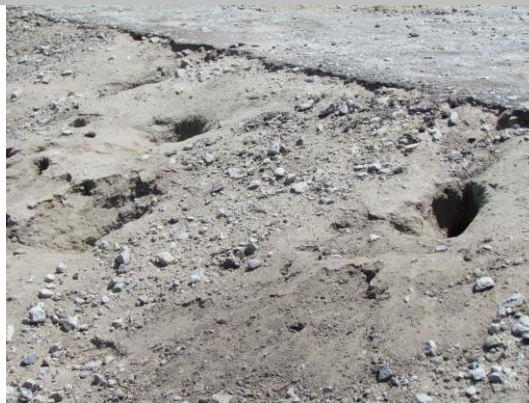
Photo 1 of 1 : SP_2015_NA0011_145_23_20150513_00094.jpg

Rodent mounds and holes covers the slope. The levee is like this through to the end of the unit.

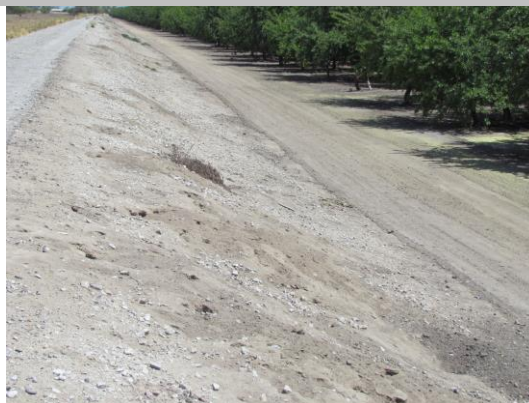
Photo 1 of 2 : SP_2015_NA0011_145_24_20150513_00095.jpg

Rodent are very active here from levee mile 1.50 to 1.87 slope and crown roadway.

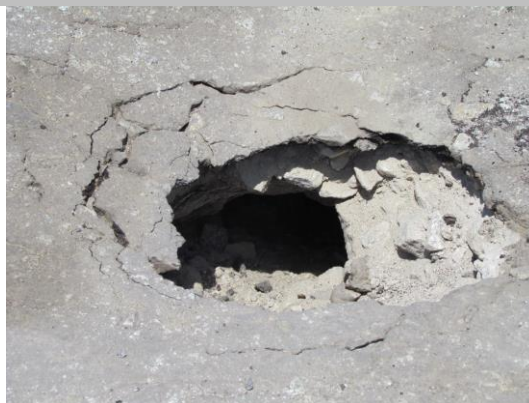
Photo 2 of 2 : SP_2015_NA0011_145_24_20150513_00096.jpg

Here in the crown roadway the rodent has burrowed through the blacktop.

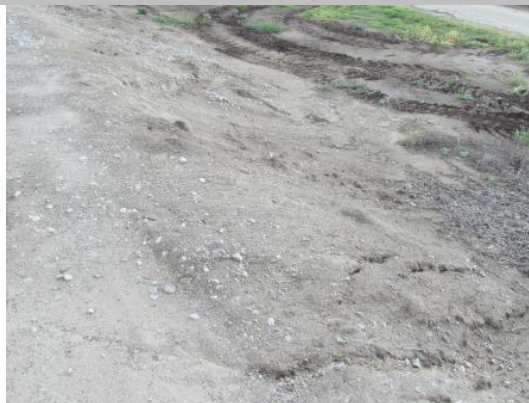
Photo 1 of 3 : SP_2015_NA0011_145_9_20150312_00005.jpg

Levee mile 1.51 levee damaged by the landowner. Photo taken 4-24-2014.

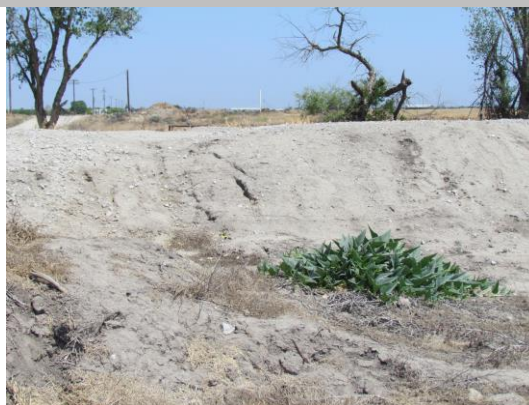
Photo 2 of 3 : SP_2015_NA0011_145_9_20150513_00097.jpg

No repairs to the levee observed on 5-6-2015.

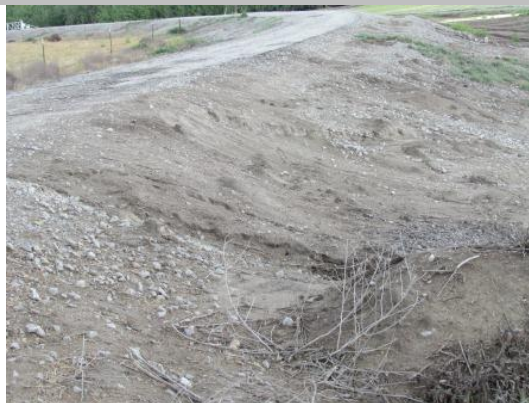
Photo 3 of 3 : SP_2015_NA0011_145_9_20150312_00006.jpg

Levee mile 1.51 landward slope remains unrepaired by the landowner. Photo taken 4-24-2014. No new photo taken Fall 2014. no change.

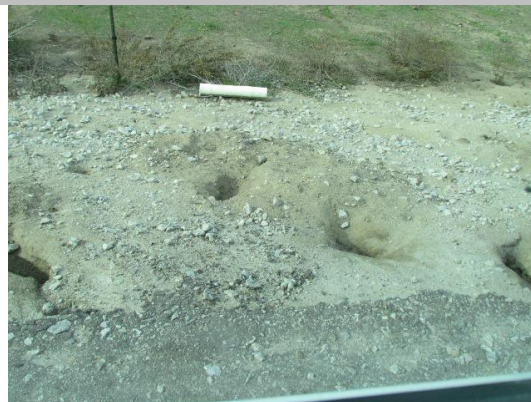
Photo 1 of 1 : SP_2015_NA0011_145_30_20150312_00011.jpg

Berenda Slough looking downstream along the waterside slope at large rodent holes on slope. No new photo.

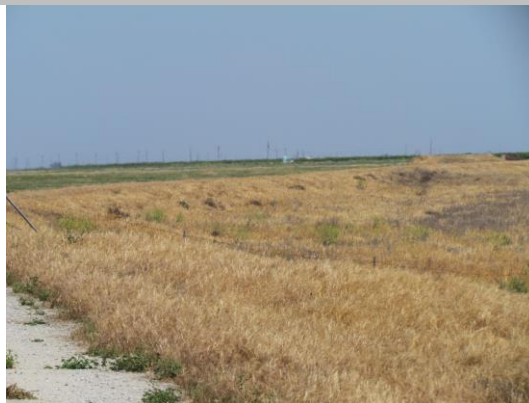
Photo 1 of 1 : SP_2015_NA0011_146_40_20150513_00157.jpg

Looking downstream from levee mile 0.03 tall weeds on the waterside slope.

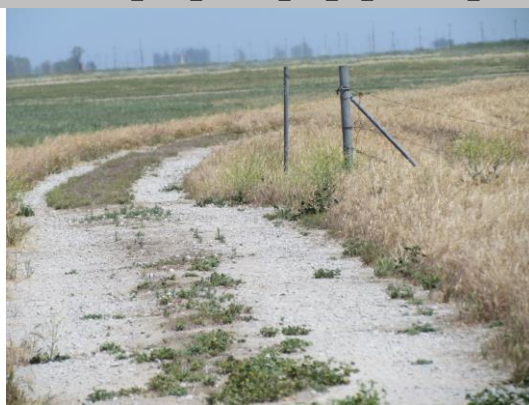
Photo 1 of 1 : SP_2015_NA0011_146_15_20150513_00156.jpg

Looking downstream at the crown roadway. It should be free of vegetation.

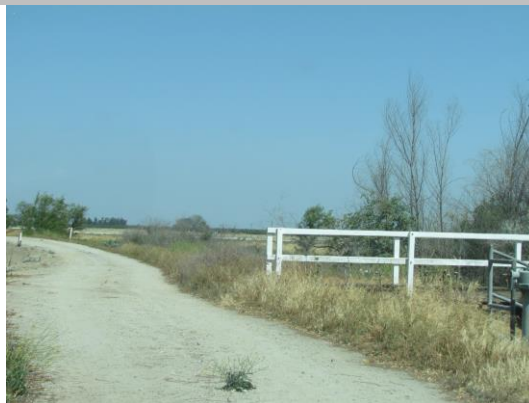
Photo 1 of 1 : SP_2015_NA0011_146_34_20150527_00159.jpg

Looking upstream at the waterside with tall weeds on the levee slope.

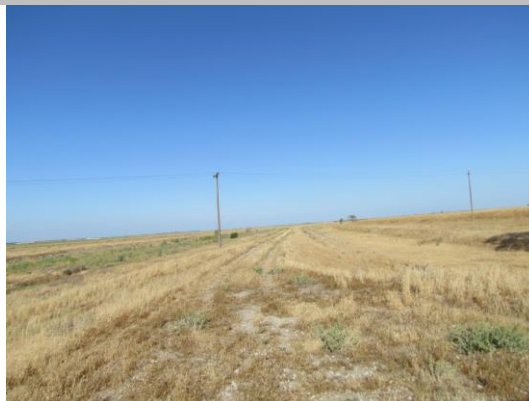
Photo 1 of 1 : SP_2015_NA0011_147_21_20150528_00137.jpg

View of weeds on both slopes and crown roadway.

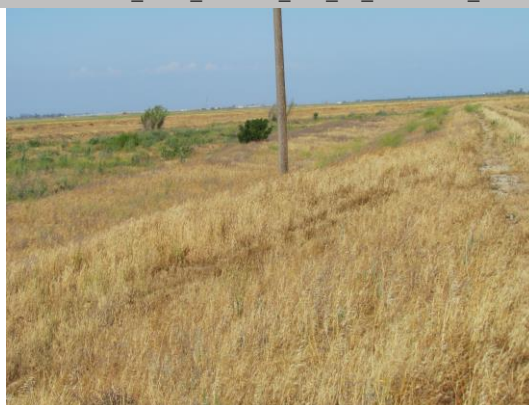
Photo 1 of 1 : SP_2015_NA0011_147_23_20150528_00138.jpg

Fresno River looking upstream at tall weeds on the waterside slope.

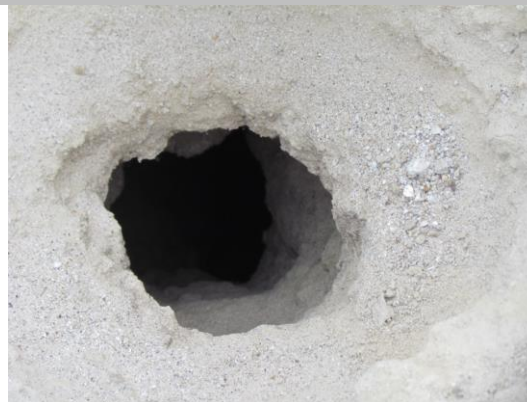
Photo 1 of 1 : SP_2015_NA0011_147_48_20150312_00013.jpg

Huge rodent hole in crown roadway.

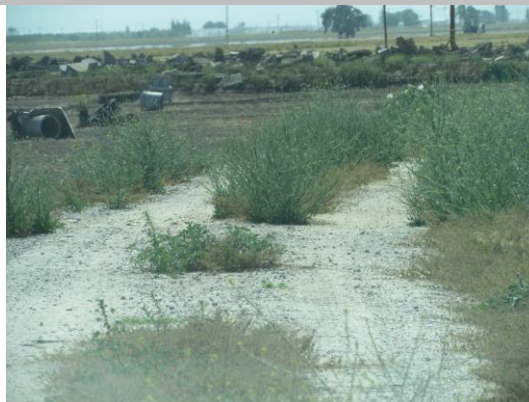
Photo 1 of 1 : SP_2015_NA0011_147_422_20150528_00144.jpg

View of unacceptable tall weeds growing on crown roadway.

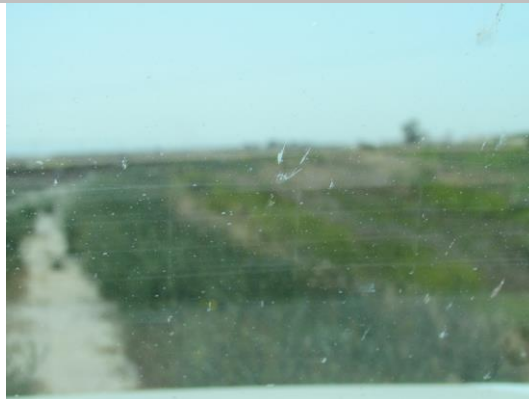
Photo 1 of 1 : SP_2015_NA0011_147_423_20150528_00142.jpg

View of unacceptable tall weeds on the waterside slope.

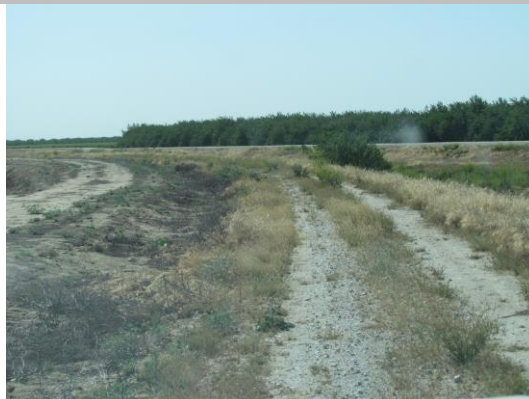
Photo 1 of 1 : SP_2015_NA0011_147_420_20150528_00141.jpg

Fresno River Unit 6 from levee mile 7.90-8.39 weeds are growing on crown roadway.
