**Flood Control Project Maintenance
Levee Inspections**

Maintenance Issue Types Only, Levee Inspection Report By Mile - Spring 2016

Madera County FCWCA

Waterway	Bank	Unit Miles	Inspection Start/End	Inspector
Unit No. 01 Ash Slough	Right	2.37	04/14/2016 04/14/2016	Herman Phillips

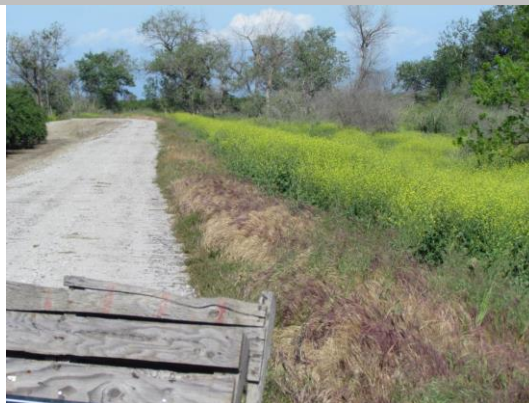
Photo 1 of 1 : SP_2016_NA0011_142_26_20160426_00021.jpg

LM Start	0.01	Rating **	U	Issue No.	26
LM End	2.37	Issue Type +	Ma	Location *	WS
Category	Earthen Levee			GPS Latitude/Longitude	
				Start	End
Item	Vegetation			37.046495 °	37.068713 °
				-120.427787 °	-120.398490 °
DWR ID	DWR_NA0011_01_f_2015_26				
Comment Code					
V1 : Control annual grass and weeds on the levee slopes and easements.					
Inspector Comment					
Remove the unwanted tall weeds from the wateside slope and shoulder.

Unit 1 Ash Slough looking upstream waterside slope. Tall Mustard grass and other unwanted tall weeds covering the slope and shoulder.

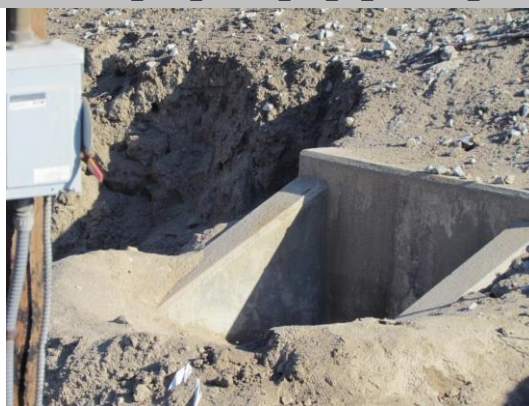
Photo 1 of 1 : SP_2016_NA0011_142_20_20160223_00004.jpg

LM Start	0.04	Rating **	U	Issue No.	20
LM End	0.05	Issue Type +	Ma	Location *	LS
Category	Earthen Levee			GPS Latitude/Longitude	
				Start	End
Item	Slope Stability			37.046624 °	37.046682 °
				-120.427317 °	-120.427108 °
DWR ID	DWR_NA0011_01_s_2014_20				
Comment Code					
S1 : Repair slope instability.					
Inspector Comment					
This is not a new erosion site, it should be repaired before the condition get any worse.

There is damage to the landside slope near the concrete wing wall.

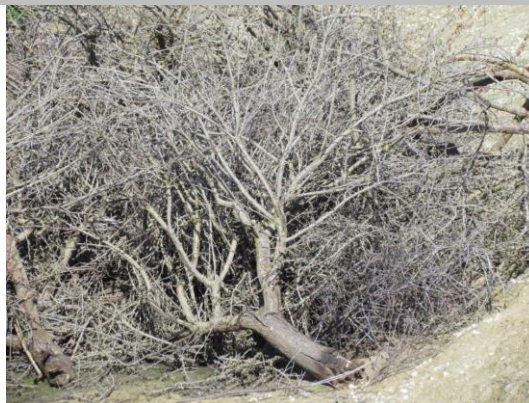
Photo 1 of 1 : SP_2016_NA0011_142_19_20160426_00022.jpg

Looking upstream from the landward toe Tree trimmings covering the slope and toe

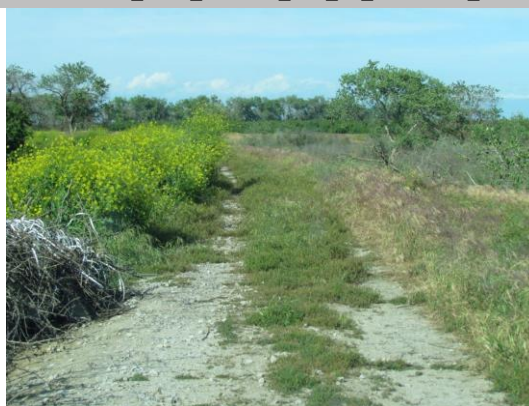
Photo 1 of 1 : SP_2016_NA0011_142_21_20160426_00023.jpg

LM Start	0.59	Rating **	U	Issue No.	21
LM End	2.35	Issue Type +	Ma	Location *	CR
Category	Earthen Levee			GPS Latitude/Longitude	
				Start	End
Item	Vegetation			37.050968 °	37.068513 °
				-120.419167 °	-120.398665 °
DWR ID	DWR_NA0011_01_s _ 2016_21				
Comment Code					
V9 : Keep the crown roadway free of vegetation.					
Inspector Comment					
Keep the crown free of vegetation.

Looking upstream from the levee mile 0.59 to 2.35 tall weeds growing on the crown roadway.

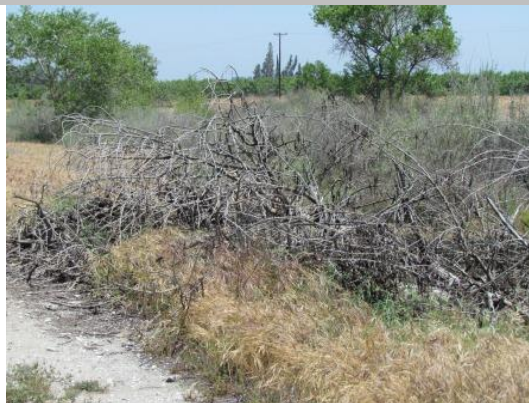
Photo 1 of 1 : SP_2016_NA0011_142_16_20160223_00001.jpg

This dead tree has not been removed from the levee section, the shoulder, slope and toe is blocked. Photo taken 4-29-2014. There is no new picture for this issue. No change has been made prior to Fall inspection 2014.

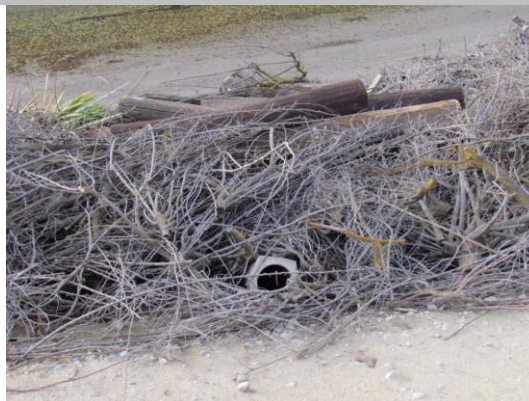
Photo 1 of 1 : SP_2016_NA0011_142_28_20160223_00007.jpg

Unwanted brush pile on the landside toe and slope.

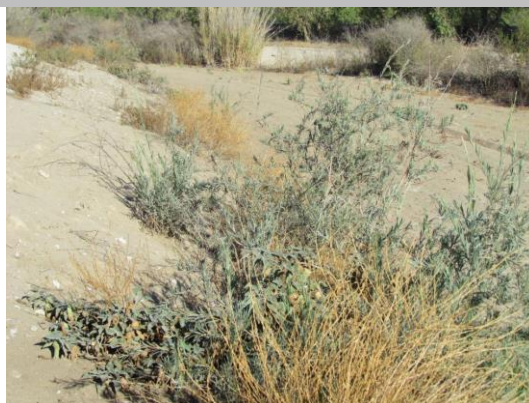
Photo 1 of 3 : SP_2016_NA0011_142_38_20160223_00008.jpg

LM Start	1.17	Rating **	U	Issue No.	38
LM End	1.37	Issue Type +	Ma	Location *	WS
Category	Earthen Levee			GPS Latitude/Longitude	
				Start	End
Item	Slope Stability			37.056380 °	37.058520 °
				-120.412483 °	-120.410257 °
DWR ID	DWR_NA0011_01_f_2015_38				
Comment Code					
S3 : Repair the levee slope damaged by vehicle traffic and prevent access where possible.					
Inspector Comment					
The slope will have to be put back in place damaged by equipment.

The levee slope has been damaged by equipment, the farmer has cut the toe away while working too close to the levee.

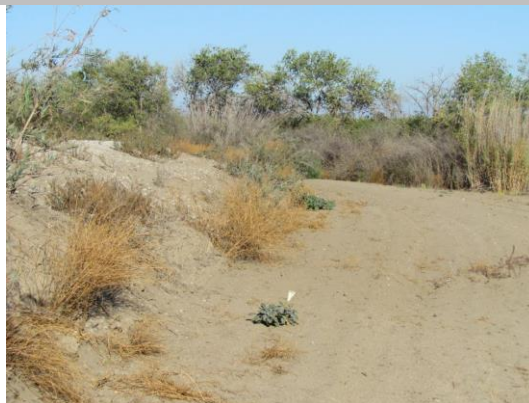
Photo 2 of 3 : SP_2016_NA0011_142_38_20160223_00009.jpg

Another view of the damaged toe.

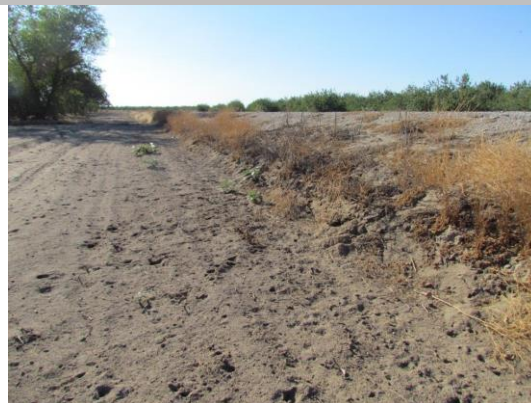
Photo 3 of 3 : SP_2016_NA0011_142_38_20160223_00010.jpg

LM Start	1.17	Rating **	U	Issue No.	38 (cont)	
LM End	1.37	Issue Type +	Ma	Location *	WS	
Category	Earthen Levee			GPS Latitude/Longitude		
				Start		End
Item	Slope Stability			37.056380 °		37.058520 °
				-120.412483 °		-120.410257 °
DWR ID	DWR_NA0011_01_f_2015_38					
Comment Code						
S3 : Repair the levee slope damaged by vehicle traffic and prevent access where possible.						
Inspector Comment						
The slope will have to be put back in place damaged by equipment.

Slope damage at toe of the water side levee section.

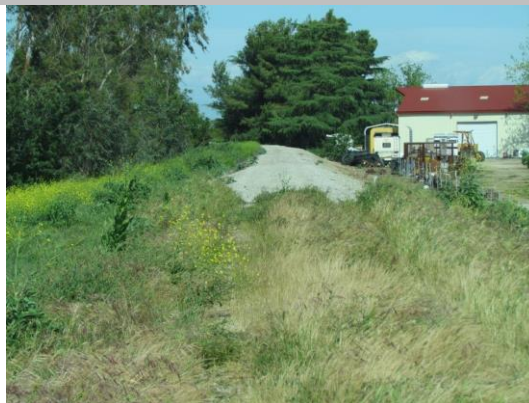
Photo 1 of 1 : SP_2016_NA0011_143_15_20160425_00027.jpg

Unsatisfactory tall weeds on the landside slope and crown.

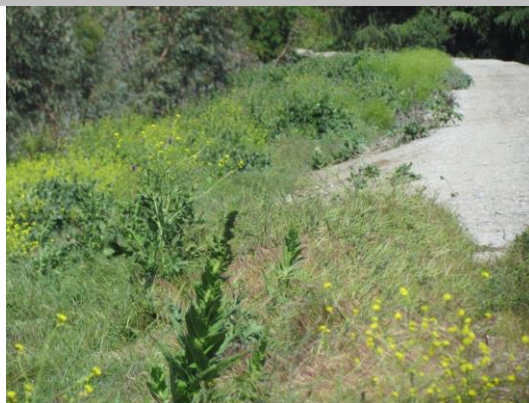
Photo 1 of 1 : SP_2016_NA0011_143_34_20160425_00030.jpg

levee mile 0.00 to 2.03 unsatisfactory tall weeds present on the levee slope and toe.

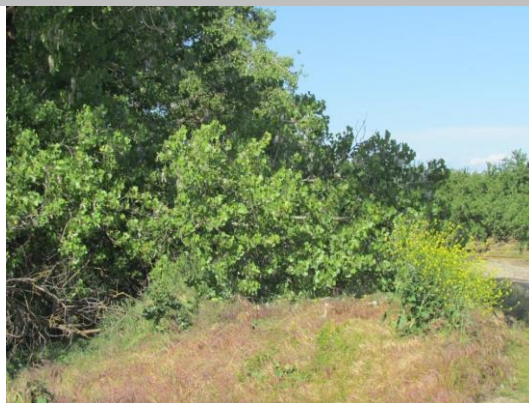
Photo 1 of 1 : SP_2016_NA0011_143_17_20160426_00043.jpg

Looking upstream from levee mile 0.14 fallen tree blocking access along the crown roadway.

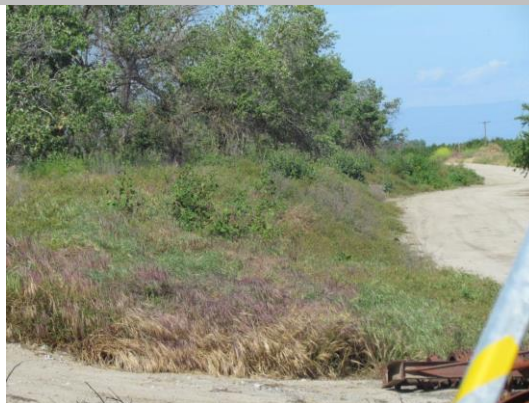
Photo 1 of 1 : SP_2016_NA0011_143_24_20160425_00031.jpg

Looking upstream from levee mile 0.31 to 1.62 landside slope.

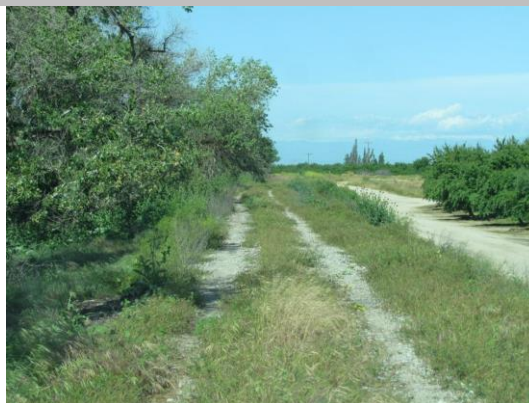
Photo 1 of 1 : SP_2016_NA0011_143_26_20160425_00032.jpg

Looking downstream crown roadway from levee mile 0.33-0.96.

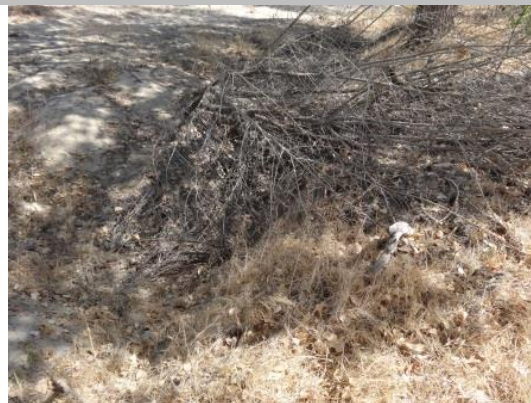
Photo 1 of 2 : SP_2016_NA0011_143_1_20160223_00001.jpg

09/08/2015: No significant change observed.
 07/22/2014: No significant change observed.
 08/30/2013: No significant change observed.
 07/31/2012: Site was visited on 07/24/2012. No significant change observed. Dense vegetation around the site
 08/09/2011: Site was inspected. No visible change was observed from the previous condition. A fallen tree was seen at the levee toe about 20 feet upstream, and tree root exposed. There has been no report from the district that this site was corrected.
 11/30/2010: Site was not inspected due to time constraints. There have been no reports from the district that the site was corrected. Continue to monitor site during flood events.
 08/05/2010: Recommended for annual assessment and monitoring during flood events, per CLRO.
 2009: Site is recommended as a local maintenance issue, per Critical Levee Repair Office, Critical Erosion Sites Evaluation 2008 Report; site was previously rated "M"

Debris at the site.

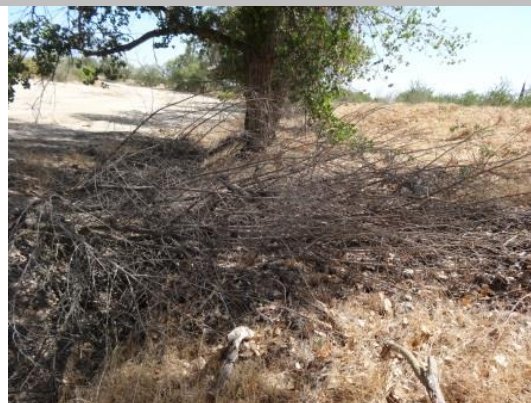
Photo 2 of 2 : SP_2016_NA0011_143_1_20160223_00002.jpg

Close view of the site with the dead tree.

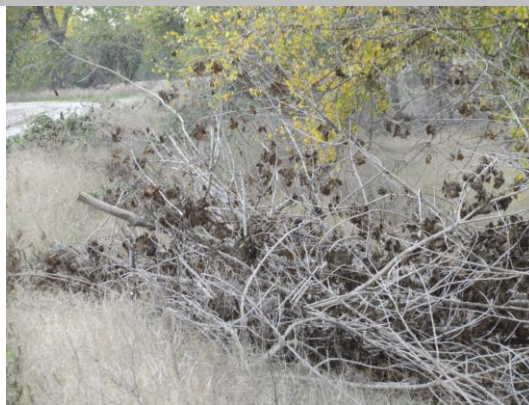
Photo 1 of 1 : SP_2016_NA0011_143_43_20160223_00010.jpg

Dead fallen tree not removed from levee section, reported in Spring inspection. Dead tree reported last spring not removed.

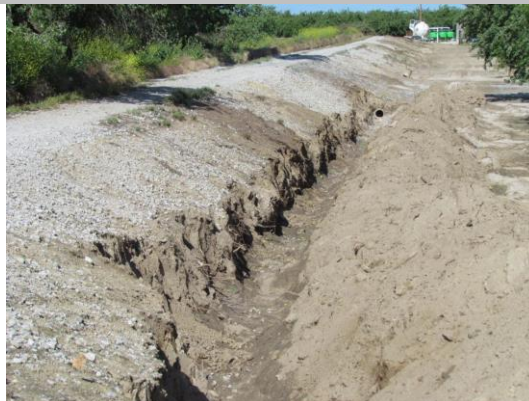
Photo 1 of 4 : SP_2016_NA0011_143_31_20160425_00033.jpg

LM Start	1.49	Rating **	U	Issue No.	31
LM End	1.52	Issue Type +	Ma	Location *	LS
Category	Earthen Levee			GPS Latitude/Longitude	
				Start	End
Item	Slope Stability			37.058462 °	37.058705 °
				-120.407907 °	-120.407390 °
DWR ID	DWR_NA0011_02_s_2016_31				
Comment Code					
S1 : Repair slope instability.					
Inspector Comment					
Major work need to be done to make the repairs this location. This levee was cut prior to my inspection 4-14-2016.

Looking upstream from the landside slope pipe work being performed.

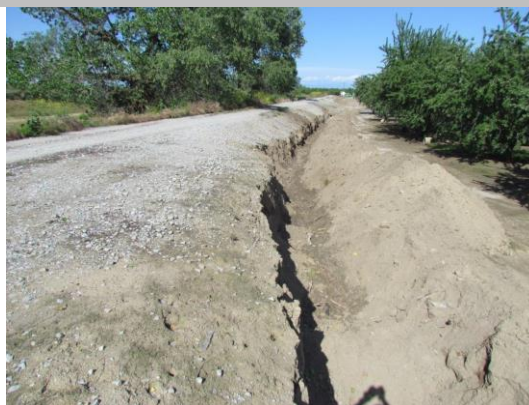
Photo 2 of 4 : SP_2016_NA0011_143_31_20160425_00035.jpg

Standing at levee mile 1.49 looking towards levee mile 1.52

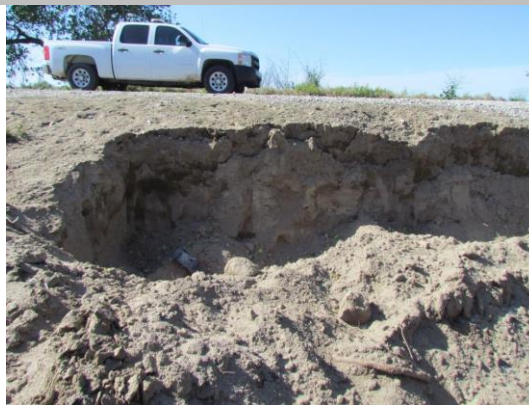
Photo 3 of 4 : SP_2016_NA0011_143_31_20160425_00038.jpg

Standing at the downstream end of cut landward levee toe mile 1.49.

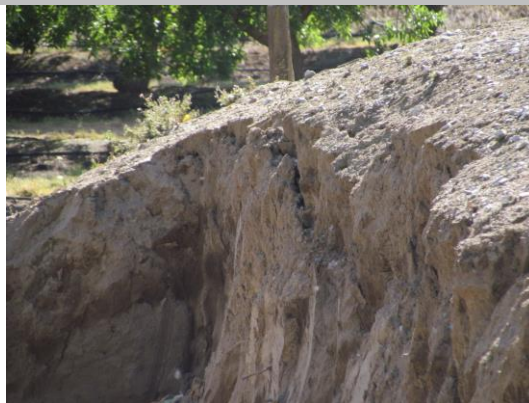
Photo 4 of 4 : SP_2016_NA0011_143_31_20160425_00042.jpg

LM Start	1.49	Rating **	U	Issue No.	31 (cont)	
LM End	1.52	Issue Type +	Ma	Location *	LS	
Category	Earthen Levee			GPS Latitude/Longitude		
				Start		End
Item	Slope Stability			37.058462 °		37.058705 °
				-120.407907 °		-120.407390 °
DWR ID	DWR_NA0011_02_s _ 2016_31					
Comment Code						
S1 : Repair slope instability.						
Inspector Comment						
Major work need to be done to make the repairs this location. This levee was cut prior to my inspection 4-14-2016.

Looking downstream from the landside slope.

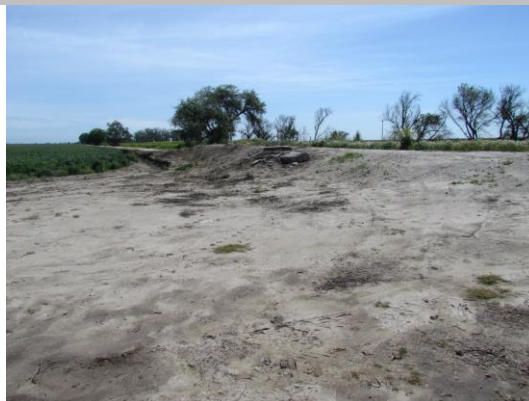
Photo 1 of 1 : SP_2016_NA0011_144_6_20160426_00015.jpg

Looking upstream Unit 3 landside levee mile 0.00 - 0.06.

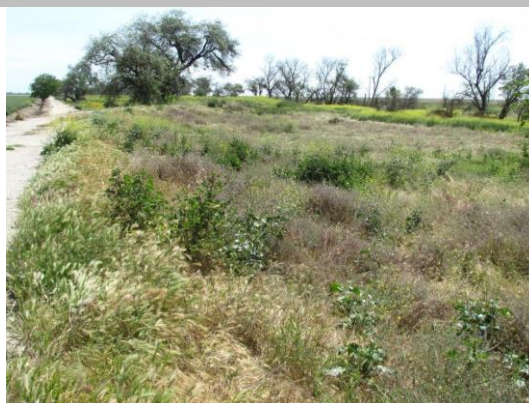
Photo 1 of 1 : SP_2016_NA0011_144_5_20160426_00017.jpg

Looking upstream levee mile 0.00-1.51 tall weeds on the shoulder and slope water ward.

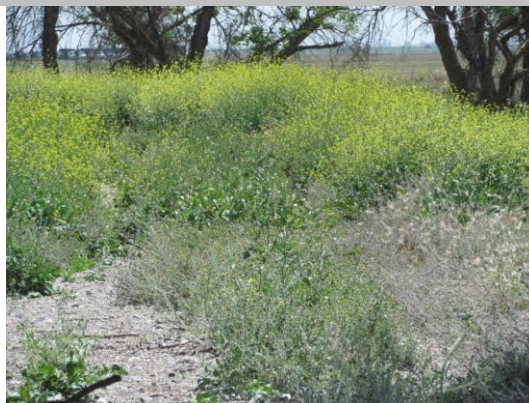
Photo 1 of 1 : SP_2016_NA0011_144_8_20160426_00019.jpg

Looking upstream from levee mile 0.04-1.51 crown roadway, these mustards are from 2.5-3.0-foot tall.

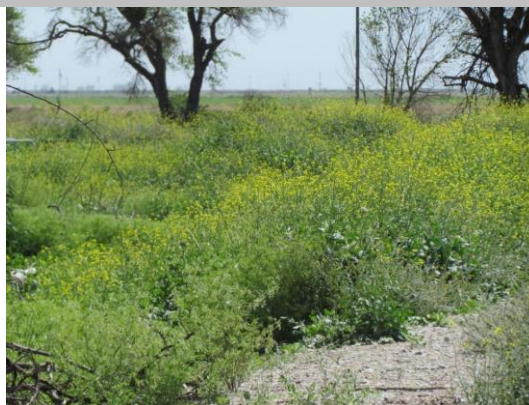
Photo 1 of 1 : SP_2016_NA0011_144_7_20160426_00018.jpg

Looking up stream from levee mile 0.06 - 1.51 wild mustards 4.0-foot tall.

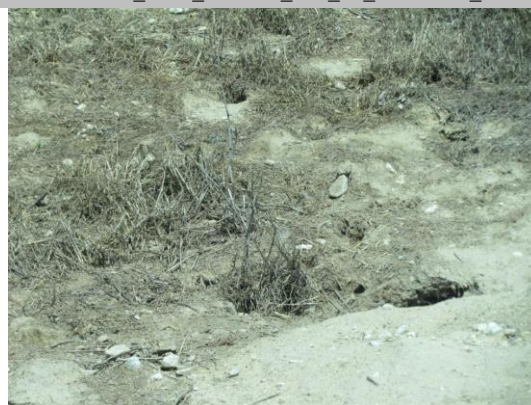
Photo 1 of 3 : SP_2016_NA0011_144_41_20160426_00020.jpg

LM Start	0.71	Rating **	U	Issue No.	41
LM End	1.51	Issue Type +	Ma	Location *	LS
Category	Earthen Levee			GPS Latitude/Longitude	
				Start	End
Item	Animal Control			36.996240 °	36.996583 °
				-120.361028 °	-120.346680 °
DWR ID	DWR_NA0011_03_s _ 2016_41				
Comment Code					
A2 : Repair the levee slope damaged by livestock and prevent large animal access.					
Inspector Comment					
The District need to do a much better job of removing the rodents from the levee section. GOOD PLACE FOR BAIT STATIONS.

Looking along the landward slope levee mile 0.71-1.51 an active infestation of rodents present.

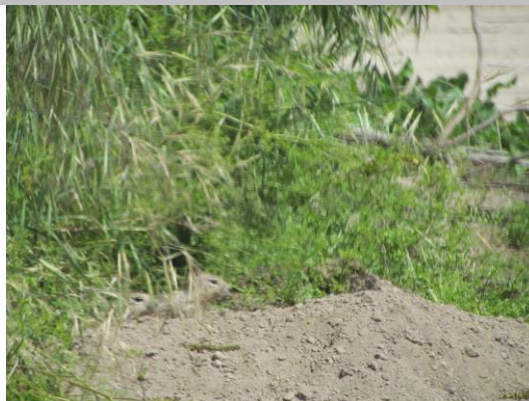
Photo 2 of 3 : SP_2016_NA0011_144_41_20160426_00022.jpg

Active colony of rodents in process of borrowing in the levee section.

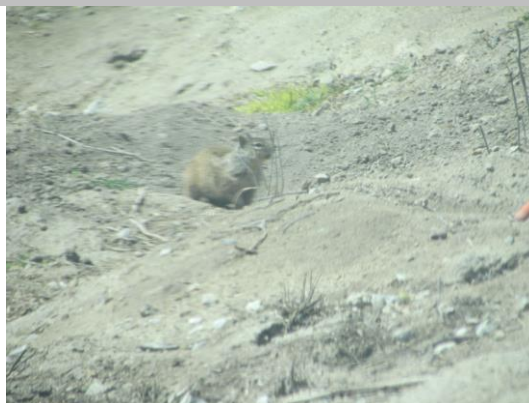
Photo 3 of 3 : SP_2016_NA0011_144_41_20160426_00025.jpg

One of many active rodent captured in this photo.

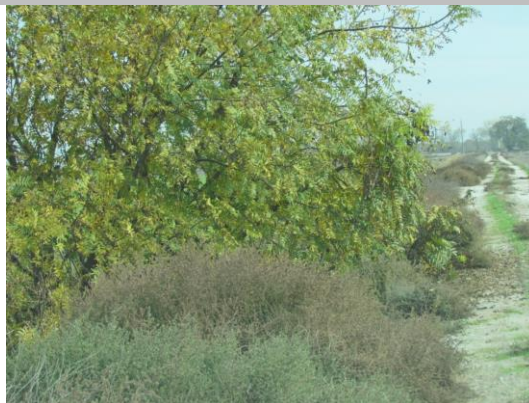
Photo 1 of 1 : SP_2016_NA0011_144_17_20160223_00004.jpg

Looking upstream landward levee mile 1.24 tree growth blocks slope, shoulder and portion on the crown roadway.

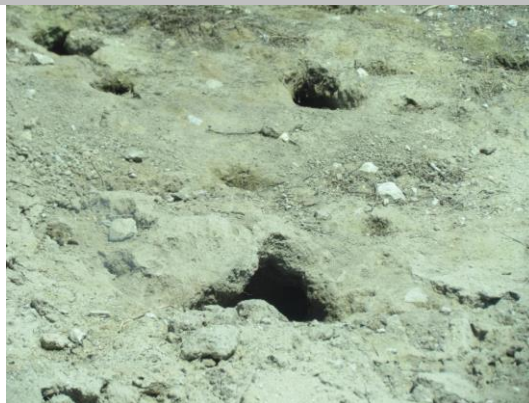
Photo 1 of 2 : SP_2016_NA0011_145_2_20160428_00020.jpg

From levee miles 0.01-0.45 landside slope rodents are very active here.

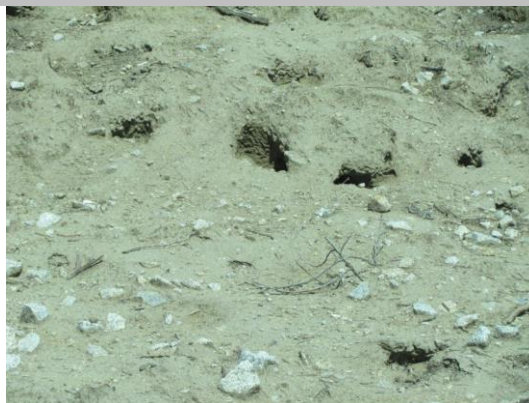
Photo 2 of 2 : SP_2016_NA0011_145_2_20160428_00021.jpg

Another view of the infestation..

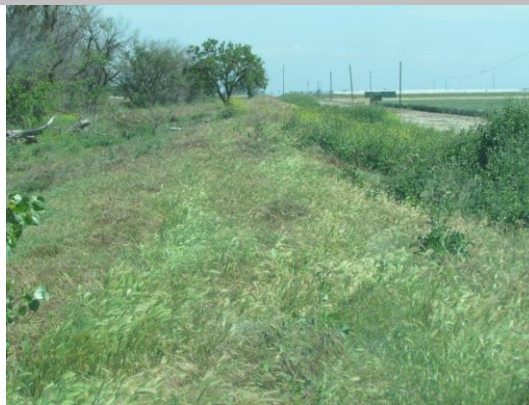
Photo 1 of 1 : SP_2016_NA0011_145_5_20160428_00018.jpg

Looking at the crown roadway from levee mile 0.01- 1.49 the tall weeds has covered the levee section.

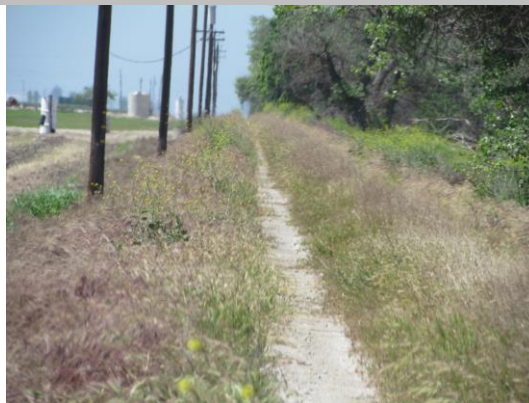
Photo 1 of 1 : SP_2016_NA0011_145_1_20160428_00019.jpg

Levee mile 0.01 -1.50 the tall weeds covering the entire landside levee section.

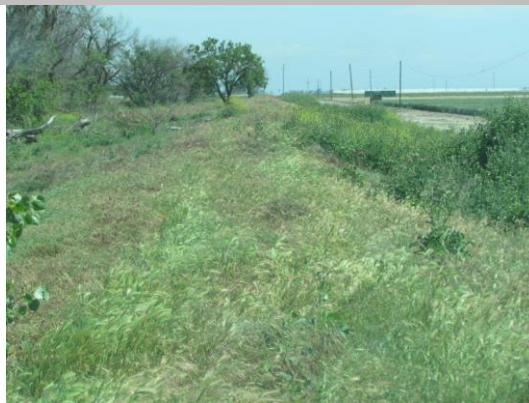
Photo 1 of 1 : SP_2016_NA0011_145_4_20160502_00022.jpg

Berenda Slough waterside wild weeds has blocked view of the slope from 0.01 to 1.60. This photo shows entire levee covered with wild weeds.

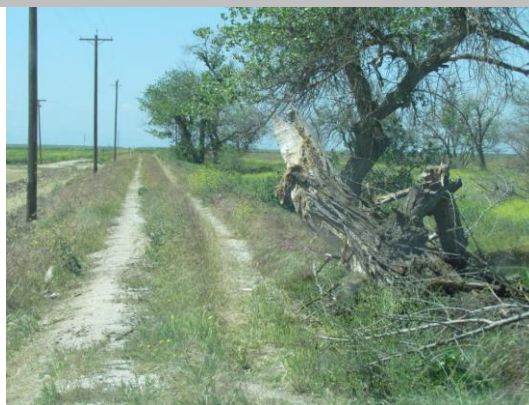
Photo 1 of 1 : SP_2016_NA0011_145_16_20160428_00017.jpg

Levee mile 0.47 dead tree partially blocking the levee section along the waterside.

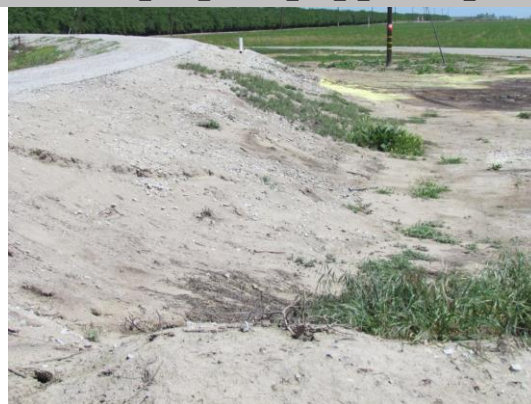
Photo 1 of 2 : SP_2016_NA0011_145_9_20160428_00015.jpg

Levee mile 1.51 landside slope damaged by the landowner.

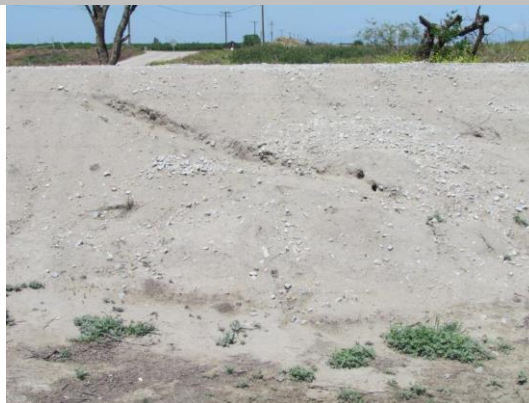
Photo 2 of 2 : SP_2016_NA0011_145_9_20160428_00013.jpg

Another view of the slope damage.

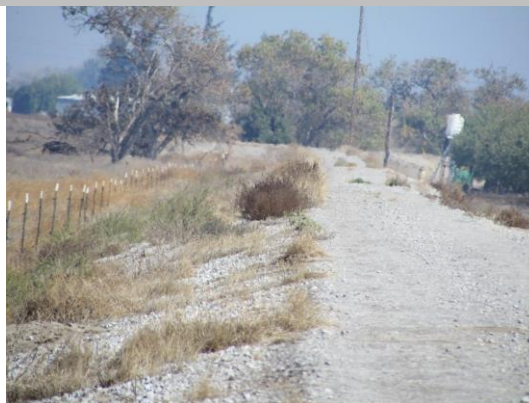
Photo 1 of 2 : SP_2016_NA0011_145_30_20160223_00009.jpg

Berenda Slough looking upstream water side levee slope covered with rodent holes.

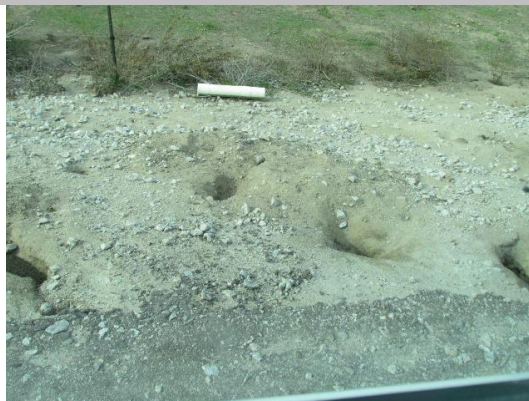
Photo 2 of 2 : SP_2016_NA0011_145_30_20160223_00010.jpg

Berenda Slough looking downstream from levee mile 1.65 waterside large rodent holes on slope.

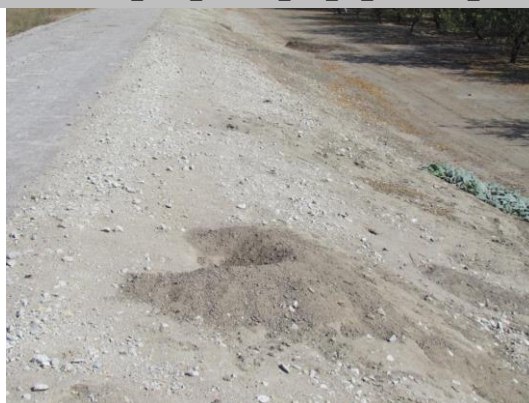
Photo 1 of 2 : SP_2016_NA0011_145_57_20160223_00012.jpg

Berenda Slough looking downstream from the landside slope at large rodent holes on the slope shoulder and crown roadway.

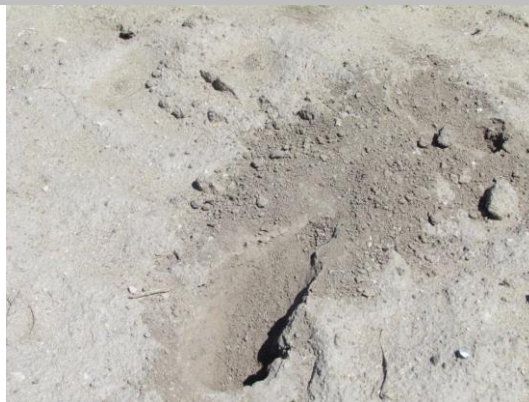
Photo 2 of 2 : SP_2016_NA0011_145_57_20160502_00024.jpg

There are fresh rodent holes but so view of rodent.

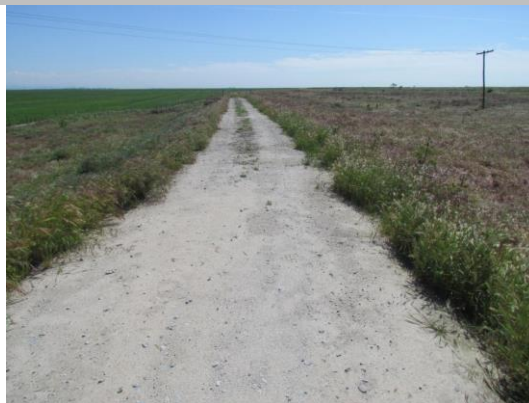
Photo 1 of 1 : SP_2016_NA0011_146_8_20160502_00027.jpg

Levee mile 0.00 crown roadway.

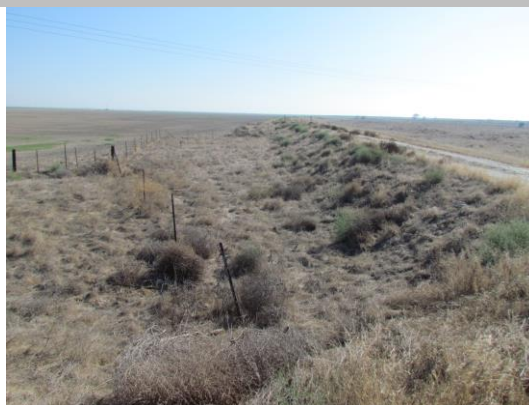
Photo 1 of 1 : SP_2016_NA0011_146_7_20160502_00020.jpg

Fresno River levee mile 0.00 looking upstream landside levee slope and toe covered with tall weeds.

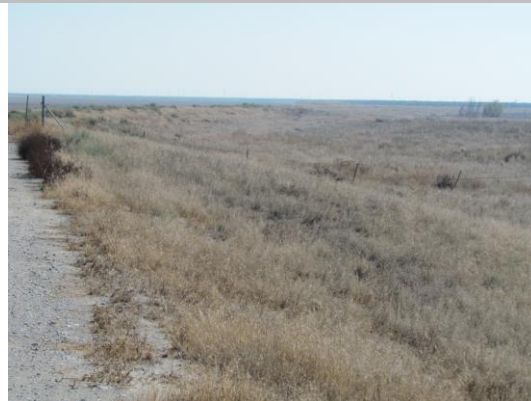
Photo 1 of 1 : SP_2016_NA0011_146_9_20160502_00022.jpg

Fresno River levee mile 0.00 looking upstream to levee mile 4.06
waterside slope and toe is covered with wild growth.

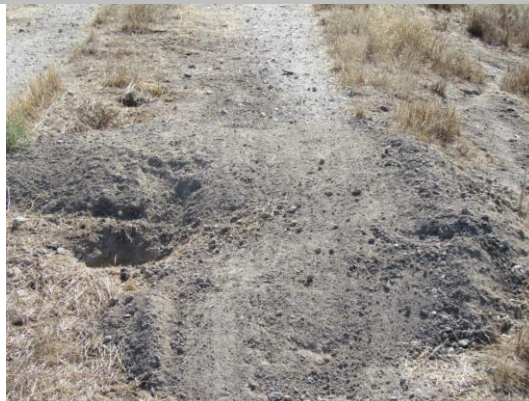
Photo 1 of 1 : SP_2016_NA0011_146_10_20160223_00004.jpg

Huge rodent holes in the crown road way levee mile 0.39 to 0.43.

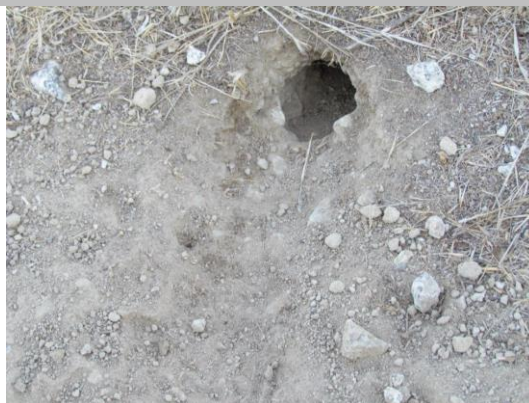
Photo 1 of 2 : SP_2016_NA0011_146_24_20160223_00005.jpg

Rodent holes in the crown roadway(fresh).

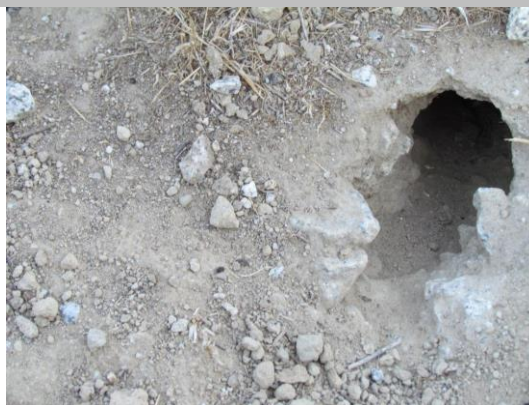
Photo 2 of 2 : SP_2016_NA0011_146_24_20160223_00006.jpg

Crown road way levee mile 2.80 to 3.23 covered with active rodent holes.

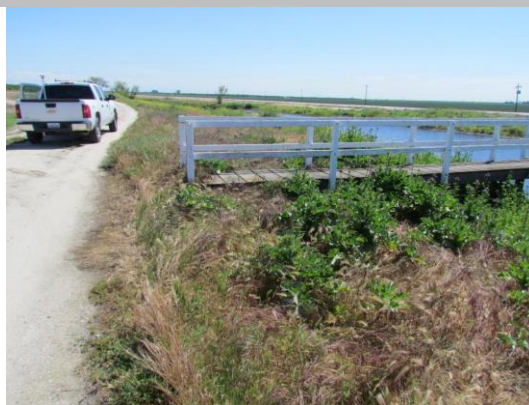
Photo 1 of 1 : SP_2016_NA0011_146_28_20160502_00029.jpg

Looking upstream from levee mile 6.59- 9.08 waterside slope covered with tall weeds.

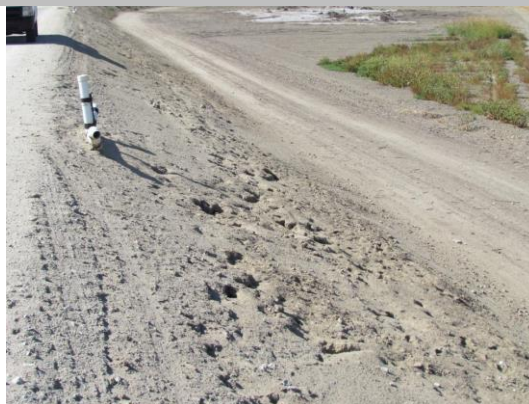
Photo 1 of 1 : SP_2016_NA0011_146_44_20160223_00010.jpg

This area has an active rodent presence from levee mile 6.63 to 6.82.

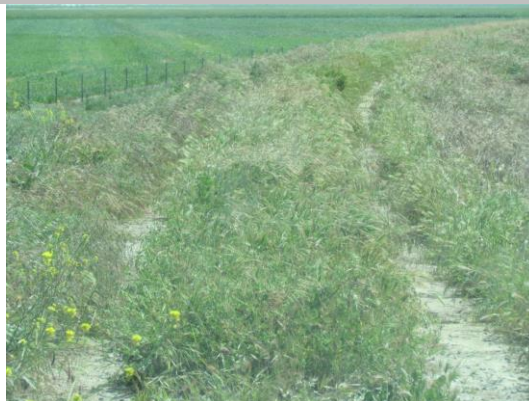
Photo 1 of 1 : SP_2016_NA0011_146_45_20160502_00028.jpg

Looking upstream of crown roadway from levee mile 7.11- 7.52.

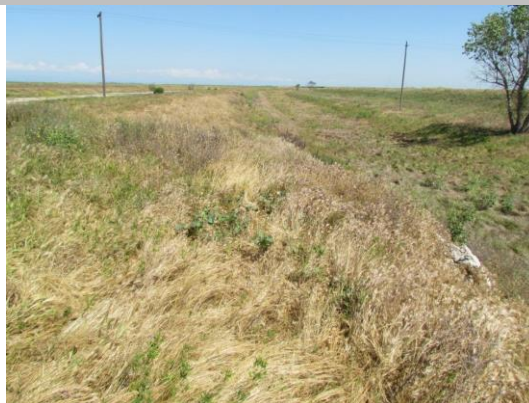
Photo 1 of 1 : SP_2016_NA0011_147_11_20160502_00032.jpg

Looking upstream from levee mile 0.00 to 0.96 tall weeds covering slope and toe landside levee section.

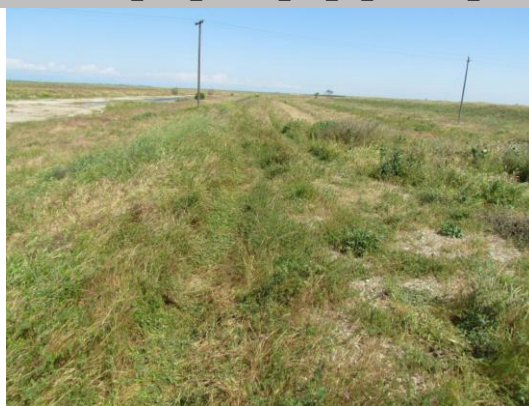
Photo 1 of 1 : SP_2016_NA0011_147_15_20160502_00031.jpg

Looking upstream from levee mile 0.00 unit 6 Fresno River to 0.96.

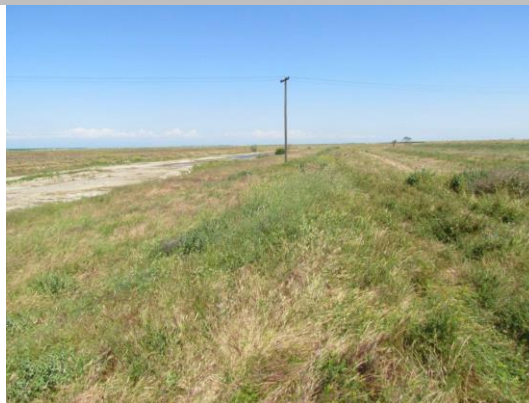
Photo 1 of 1 : SP_2016_NA0011_147_14_20160502_00033.jpg

Looking upstream from levee mile 0.00 -3.63 unwanted tall weeds covering the water side levee section.

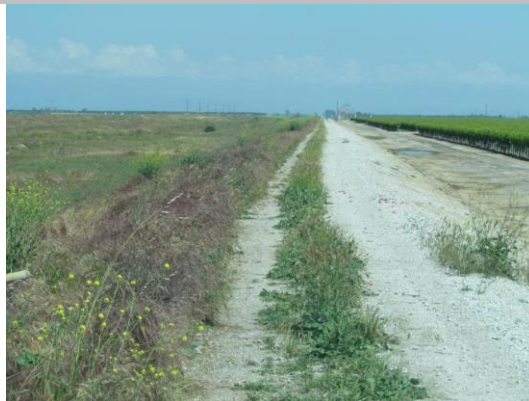
Photo 1 of 1 : SP_2016_NA0011_147_17_20160502_00035.jpg

Looking upstream from levee mile 2.49-3.68 weeds present on the crown roadway.

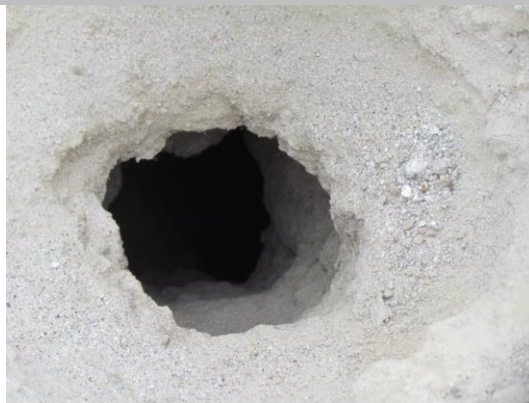
Photo 1 of 1 : SP_2016_NA0011_147_48_20160223_00011.jpg

Huge Rodent hole in crown roadway and many other holes at this location on the slope and toe.

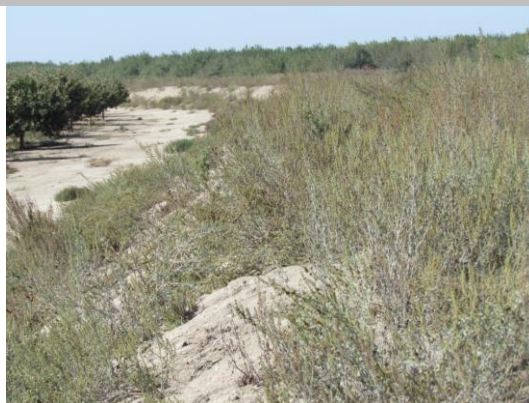
Photo 1 of 1 : SP_2016_NA0011_147_27_20160223_00004.jpg

Fresno River Looking at the landside levee slope unsatisfactory tall weeds has covered the slope, shoulder and crown.

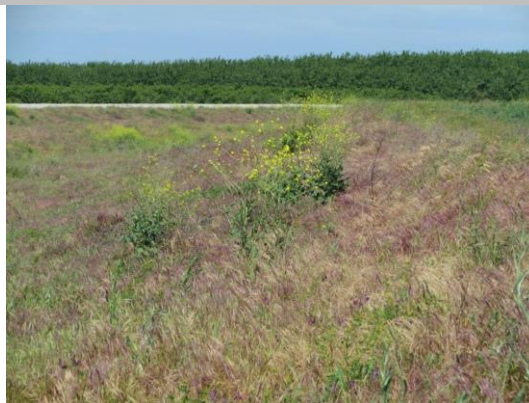
Photo 1 of 1 : SP_2016_NA0011_147_21_20160502_00037.jpg

Looking upstream from levee mile 7.70 -8.53 weeds taller than 3.0 foot covering the slope and toe.

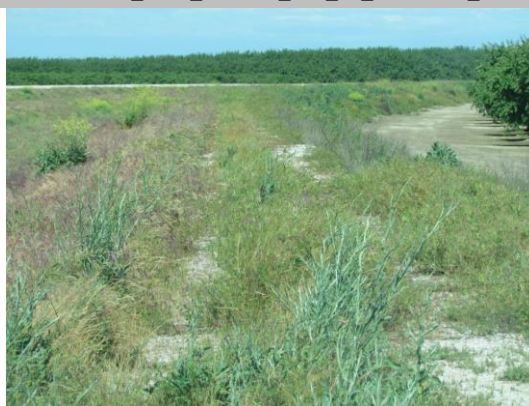
Photo 1 of 1 : SP_2016_NA0011_147_22_20160502_00036.jpg

Looking upstream from levee mile 7.70-8.53, tall weeds 3.0-4.0 foot tall on the crown.
