**Flood Control Project Maintenance
Levee Inspections**

Maintenance Issue Types Only, Levee Inspection Report By Mile - Spring 2017

Madera County FCWCA

Waterway	Bank	Unit Miles	Inspection Start/End	Inspector
Unit No. 01 Ash Slough	Right	2.37	05/04/2017 05/04/2017	Herman Phillips

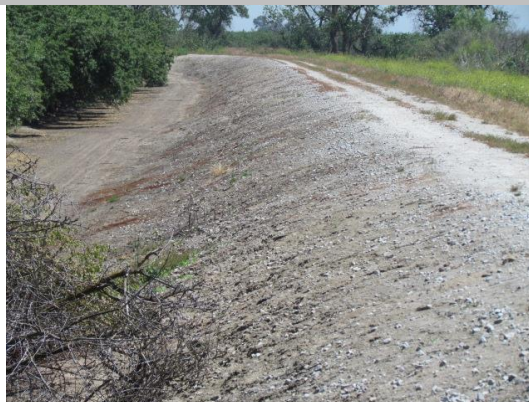
Photo 1 of 1 : SP_2017_NA0011_142_9_20170508_00021.jpg

LM Start	0.03	Rating **	A	Issue No.	9
LM End	0.25	Issue Type +	Ma	Location *	LS
Category	Earthen Levee			GPS Latitude/Longitude	
				Start	End
Item	Vegetation			37.046608 °	37.047553 °
				-120.427455 °	-120.423673 °
DWR ID	DWR_NA0011_01_s _ 2017_9				
Comment Code					
V1 : Control annual grass and weeds on the levee slopes and easements.					
Inspector Comment					
There is no unwanted vegetation at the levee miles listed along the landside slope.

Looking upstream from levee mile 0.03-0.25 there is no unwanted vegetation.

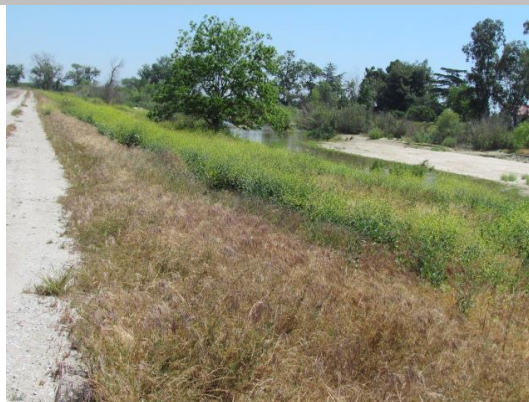
Photo 1 of 1 : SP_2017_NA0011_142_15_20170508_00022.jpg

Looking upstream from the levee mile 0.03-2.31 tall unwanted weeds present on the waterside slope.

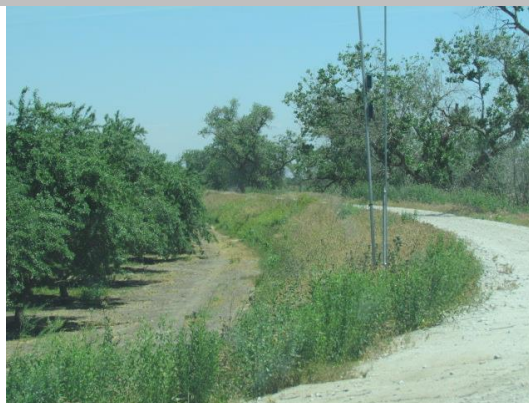
Photo 1 of 1 : SP_2017_NA0011_142_22_20170508_00026.jpg

Looking upstream from the landside slope there is landscaping planted at this location but its very weedy.

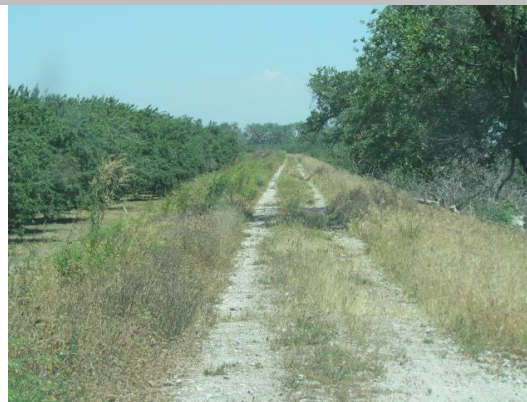
Photo 1 of 1 : SP_2017_NA0011_142_25_20170508_00025.jpg

Unwanted vegetation on the crown roadway.

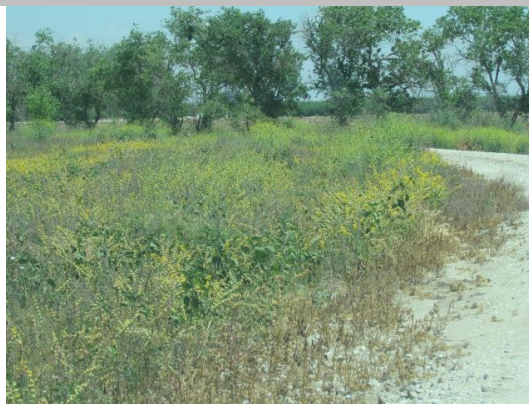
Photo 1 of 1 : SP_2017_NA0011_142_31_20170508_00030.jpg

Unwanted tall weed growth on the landside shoulder and slope.

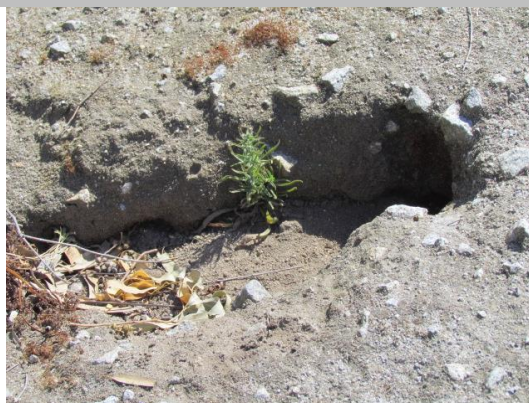
Photo 2 of 2 : SP_2017_NA0011_143_39_20170508_00039.jpg

Other rodent holes noted in the slope waterside levee section.

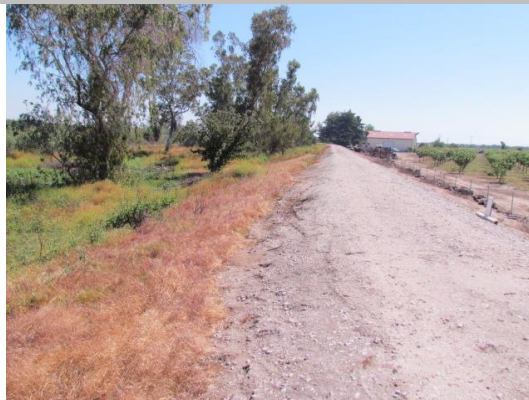
Photo 1 of 1 : SP_2017_NA0011_143_13_20170508_00037.jpg

Looking upstream from the waterside slope levee mile 0.03.

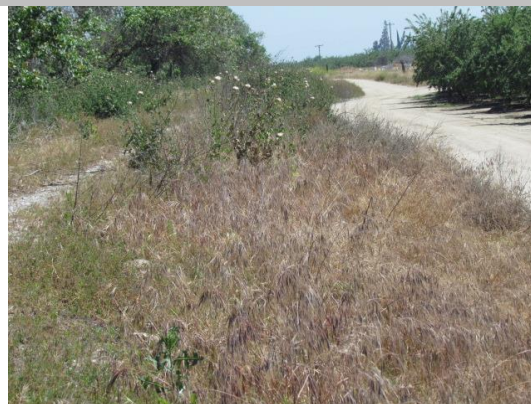
Photo 1 of 1 : SP_2017_NA0011_143_30_20170508_00041.jpg

Unwanted vegetation on the waterside levee slope.

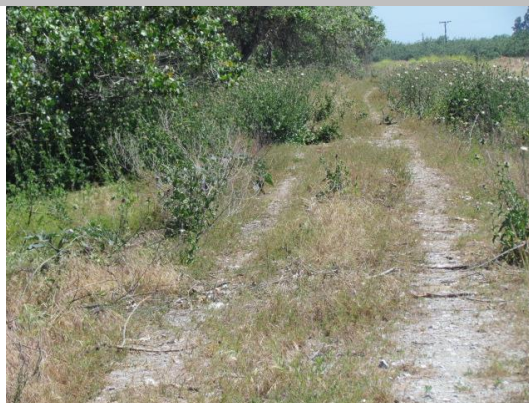
Photo 1 of 1 : SP_2017_NA0011_143_31_20170508_00042.jpg

Looking upstream levee mile 0.32-0.97 wild growth present on the crown roadway.

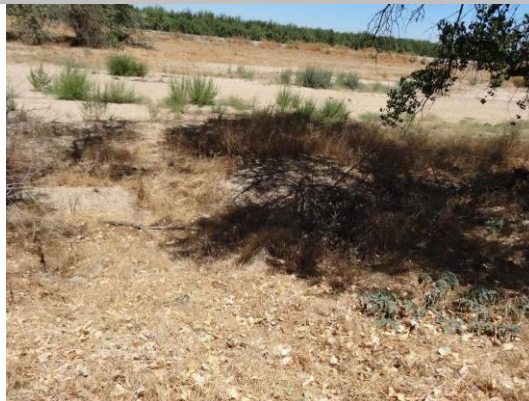
Photo 1 of 3 : SP_2017_NA0011_143_1_20170404_00001.jpg

07/22/2016: No significant change observed.
 09/08/2015: No significant change observed.
 07/22/2014: No significant change observed.
 08/30/2013: No significant change observed.
 07/31/2012: Site was visited on 07/24/2012. No significant change observed. Dense vegetation around the site
 08/09/2011: Site was inspected. No visible change was observed from the previous condition. A fallen tree was seen at the levee toe about 20 feet upstream, and tree root exposed. There has been no report from the district that this site was corrected.
 11/30/2010: Site was not inspected due to time constraints. There have been no reports from the district that the site was corrected. Continue to monitor site during flood events.
 08/05/2010: Recommended for annual assessment and monitoring during flood events, per CLRO.
 2009: Site is recommended as a local maintenance issue, per Critical Levee Repair Office, Critical Erosion Sites Evaluation 2008 Report; site was previously rated "M"

View of the erosion site from the levee crest.

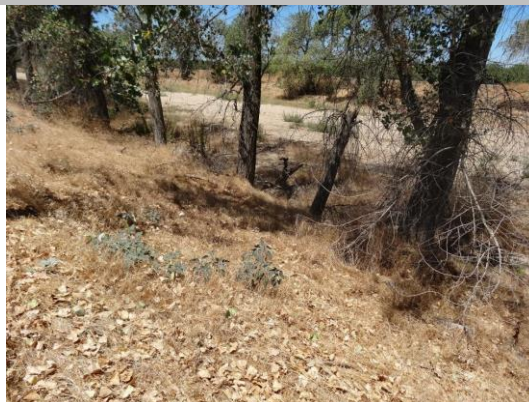
Photo 2 of 3 : SP_2017_NA0011_143_1_20170404_00002.jpg

Close view of the site.

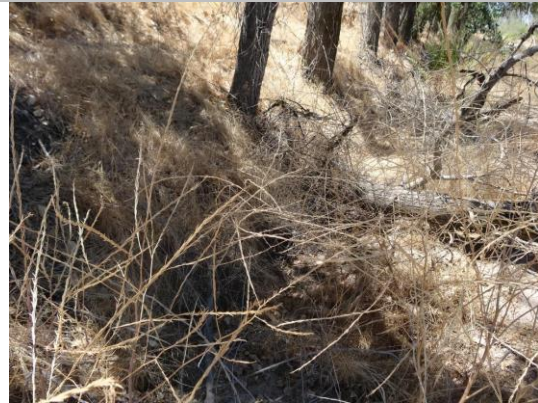
Photo 3 of 3 : SP_2017_NA0011_143_1_20170404_00003.jpg

Comment Code						
Inspector Comment						
07/22/2016: No significant change observed.						
09/08/2015: No significant change observed.						
07/22/2014: No significant change observed.						
08/30/2013: No significant change observed.						
07/31/2012: Site was visited on 07/24/2012. No significant change observed. Dense vegetation around the site						
08/09/2011: Site was inspected. No visible change was observed from the previous condition. A fallen tree was seen at the levee toe about 20 feet upstream, and tree root exposed. There has been no report from the district that this site was corrected.						
11/30/2010: Site was not inspected due to time constraints. There have been no reports from the district that the site was corrected. Continue to monitor site during flood events.						
08/05/2010: Recommended for annual assessment and monitoring during flood events, per CLRO.						
2009: Site is recommended as a local maintenance issue, per Critical Levee Repair Office, Critical Erosion Sites Evaluation 2008 Report; site was previously rated "M"

Close view of the site.

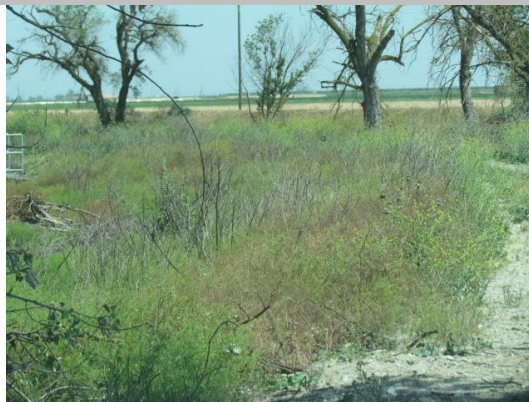
Photo 1 of 1 : SP_2017_NA0011_144_10_20170509_00018.jpg

Looking upstream from the landside shoulder from levee mile 0.05 unwanted tall weeds completely blocks view of the landward levee section.

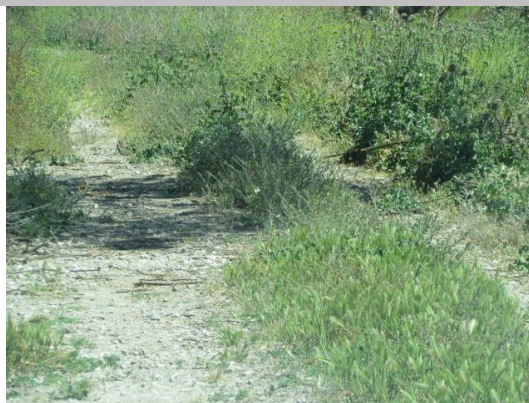
Photo 1 of 1 : SP_2017_NA0011_144_12_20170509_00017.jpg

Looking upstream at the crown roadway that's covered with wild vegetation.

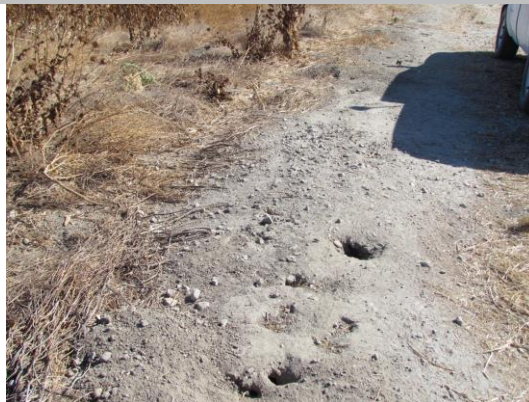
Photo 1 of 2 : SP_2017_NA0011_144_6_20170404_00004.jpg

LM Start	0.40	Rating **	U	Issue No.	6
LM End	1.51	Issue Type +	Ma	Location *	LS
Category	Earthen Levee			GPS Latitude/Longitude	
				Start	End
Item	Animal Control			36.996208 °	36.996607 °
				-120.366550 °	-120.346568 °
DWR ID	DWR_NA0011_03_f_2016_6				
Comment Code					
A1 : Exterminate rodents and backfill and compact or grout burrows.					
Inspector Comment					
There need to be rodent bait stations placed along the landside slope and or shoulder at levee miles listed. No new photo was taken. Unable to see the ground, observed rodents running across the roadway.

Berenda Slough Unit 3 levee miles 0.40-1.51 landside shoulder and slope.

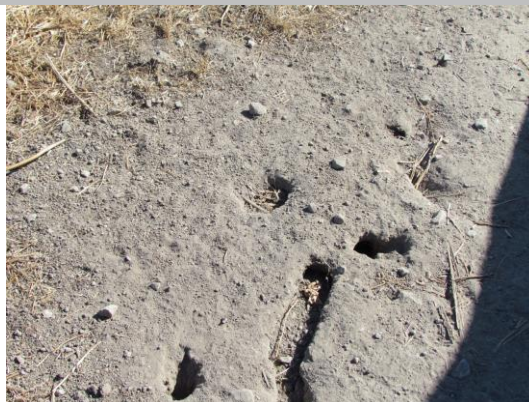
Photo 2 of 2 : SP_2017_NA0011_144_6_20170404_00005.jpg

More active rodents holes and foot traffic seen around holes though no rodents observed.

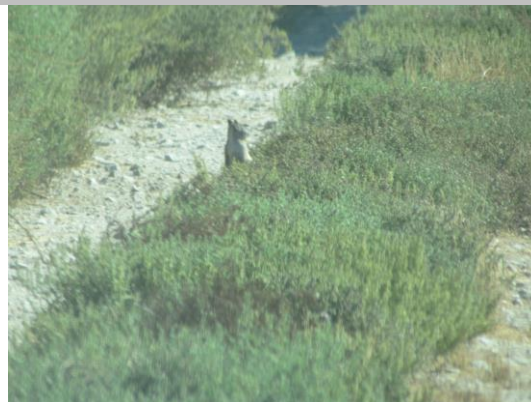
Photo 1 of 1 : SP_2017_NA0011_144_8_20170404_00006.jpg

LM Start	0.71	Rating **	M	Issue No.	8
LM End	1.51	Issue Type +	Ma	Location *	CR
Category	Earthen Levee			GPS Latitude/Longitude	
				Start	End
Item	Animal Control			36.996257 °	36.996607 °
				-120.361025 °	-120.346568 °
DWR ID	DWR_NA0011_03_f_2016_8				
Comment Code					
A1 : Exterminate rodents and backfill and compact or grout burrows.					
Inspector Comment					
Exterminate rodents from the crown roadway in the area listed. Active rodents observed during inspection at this site.

Berenda Slough Unit 3 looking upstream from levee miles 0.71 - to 1.51.

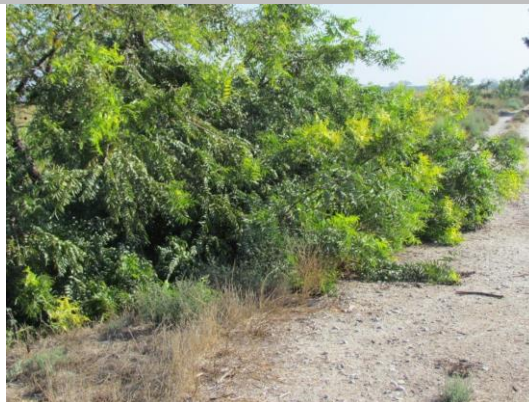
Photo 1 of 2 : SP_2017_NA0011_144_11_20170404_00007.jpg

Berenda Slough Unit 3 looking upstream from levee mile 1.04-1.05 walnut trees blocking the view of the landside levee section.

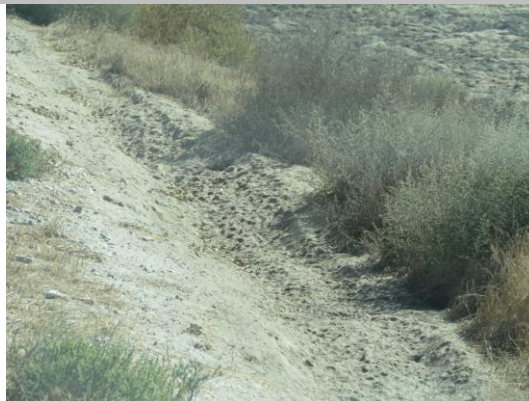
Photo 1 of 1 : SP_2017_NA0011_144_4_20170404_00002.jpg

Berenda Slough looking back upstream waterside at the shoulder and slope levee miles 1.24-1.25.

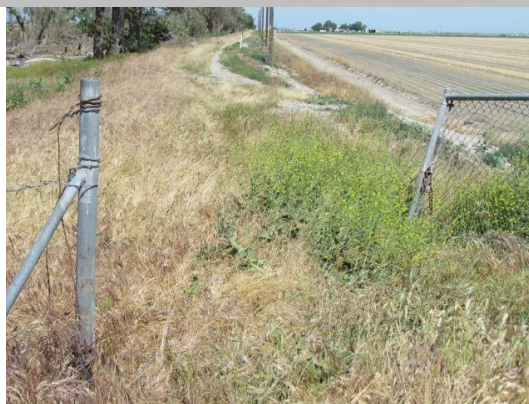
Photo 1 of 1 : SP_2017_NA0011_145_7_20170510_00018.jpg

LM Start	0.01	Rating **	U	Issue No.	7
LM End	1.50	Issue Type +	Ma	Location *	WS
Category	Earthen Levee			GPS Latitude/Longitude	
				Start	End
Item	Vegetation			36.995503 °	36.995583 °
				-120.373417 °	-120.346448 °
DWR ID	DWR_NA0011_04_s_2017_7				
Comment Code					
V1 : Control annual grass and weeds on the levee slopes and easements.					
Inspector Comment					
No maintenance has been done to this levee section in several years now. The tall weeds makes it hard to inspect.

Looking upstream from levee mile 0.01 at waterside slope tall unwanted vegetation on the levee section.

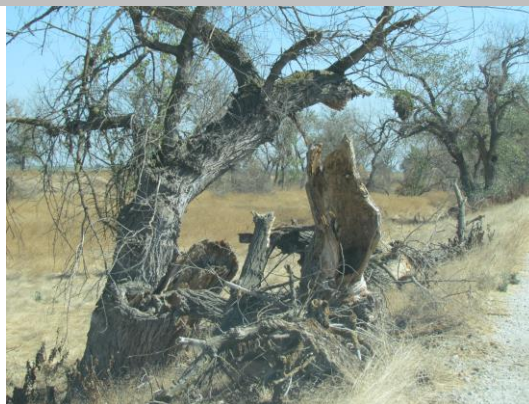
Photo 1 of 1 : SP_2017_NA0011_145_15_20170404_00008.jpg

Berenda Slough looking upstream from the levee mile 0.14.

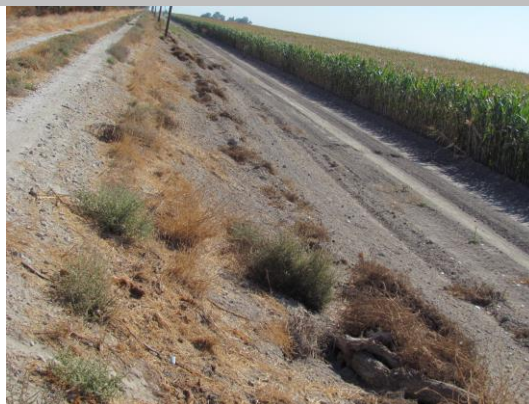
Photo 1 of 1 : SP_2017_NA0011_145_3_20170404_00002.jpg

Berenda Slough Unit 4 Looking upstream from levee mile 0.14-0.97.

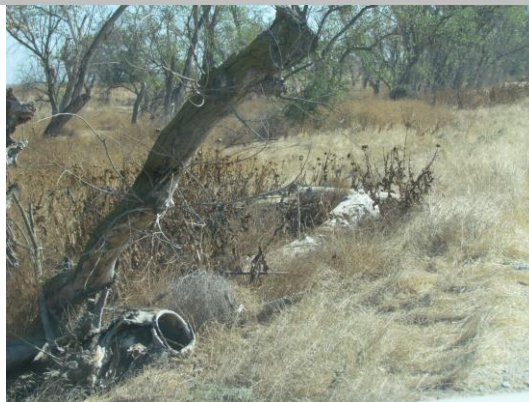
Photo 1 of 1 : SP_2017_NA0011_145_16_20170404_00009.jpg

Berenda Slough Unit 4 levee mile 0.47 looking back upstream.

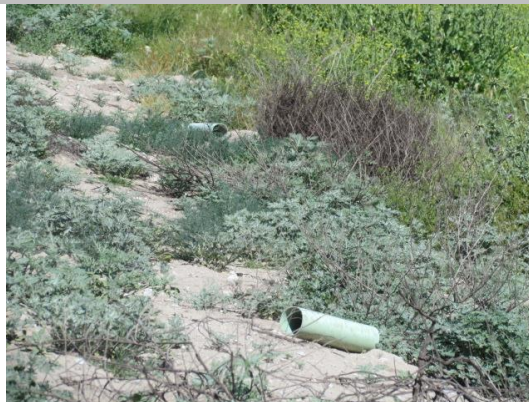
Photo 1 of 3 : SP_2017_NA0011_145_11_20170511_00021.jpg

Berenda Slough looking upstream levee mile 0.62 landward.

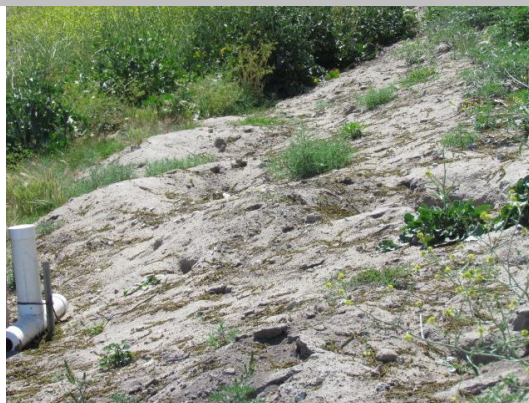
Photo 2 of 3 : SP_2017_NA0011_145_11_20170511_00022.jpg

Berenda Slough looking downstream levee 0.62 landside slope covered with rodent holes to levee mile 2.09.

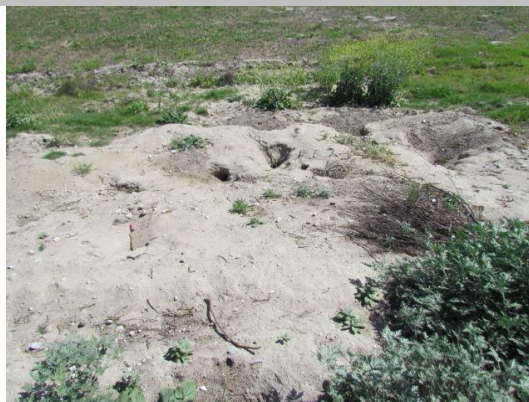
Photo 3 of 3 : SP_2017_NA0011_145_11_20170511_00023.jpg

Looking upstream at rodent activity on landward slope and toe.

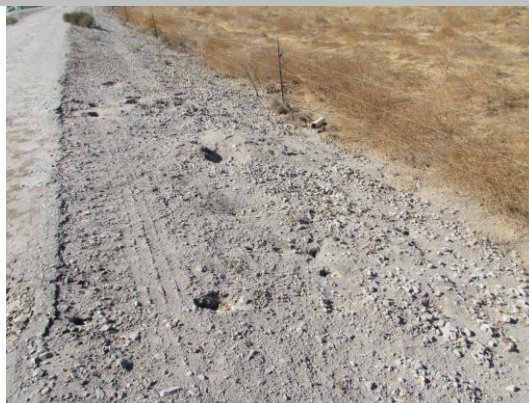
Photo 1 of 1 : SP_2017_NA0011_145_30_20170404_00010.jpg

Berenda Slough levee mile 1.63-2.23 looking upstream at waterside slope.

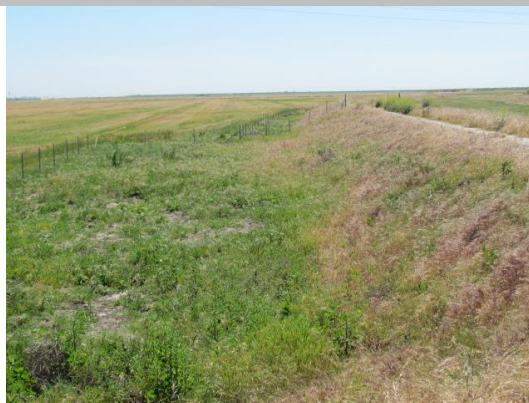
Photo 1 of 1 : SP_2017_NA0011_146_7_20170518_00020.jpg

Looking upstream from levee mile 0.00 landside slope unwanted tall weeds block view of levee slope.

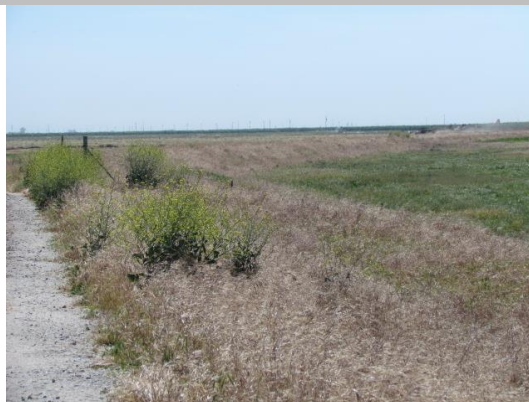
Photo 1 of 1 : SP_2017_NA0011_146_9_20170518_00021.jpg

Fresno River looking upstream waterside levee mile 0.00.

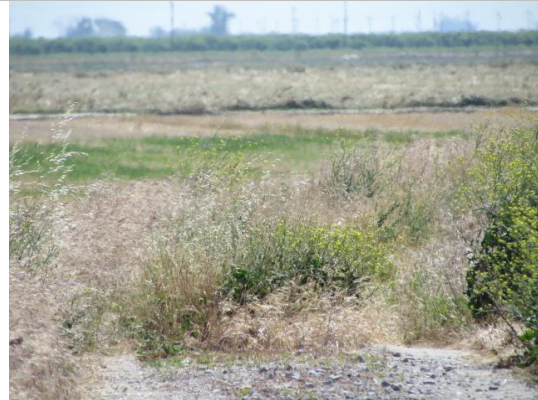
Photo 1 of 1 : SP_2017_NA0011_146_8_20170518_00022.jpg

Fresno River looking upstream levee mile 0.00.

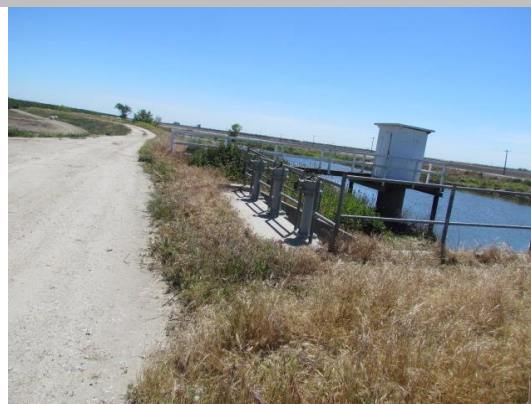
Photo 1 of 1 : SP_2017_NA0011_146_17_20170518_00023.jpg

Fresno River waterside looking upstream from levee mile 6.57, wild weed growth present on slope and shoulder.

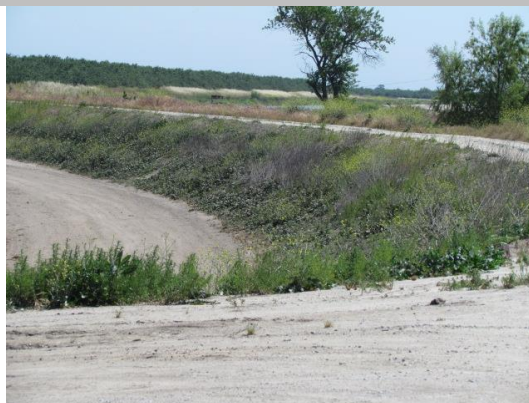
Photo 1 of 1 : SP_2017_NA0011_146_20_20170518_00024.jpg

Fresno River Unit 5 levee mile 6.58 looking upstream to 7.04 unsatisfactory weed growth covering levee slope.

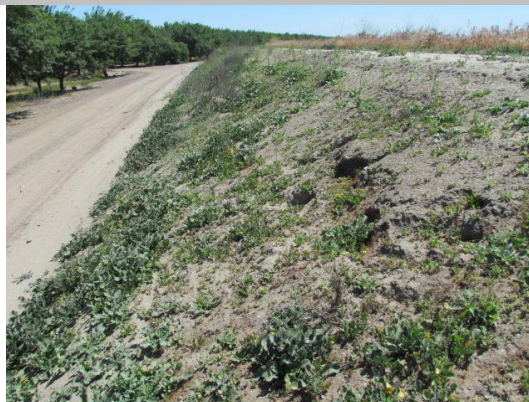
Photo 1 of 1 : SP_2017_NA0011_146_28_20170518_00026.jpg

Fresno River landside levee slope levee mile 6.75-6.95.

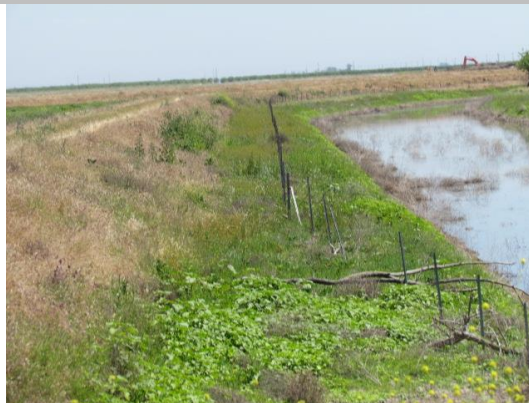
Photo 1 of 1 : SP_2017_NA0011_147_23_20170518_00033.jpg

Fresno River levee mile 0.00 landside slope.

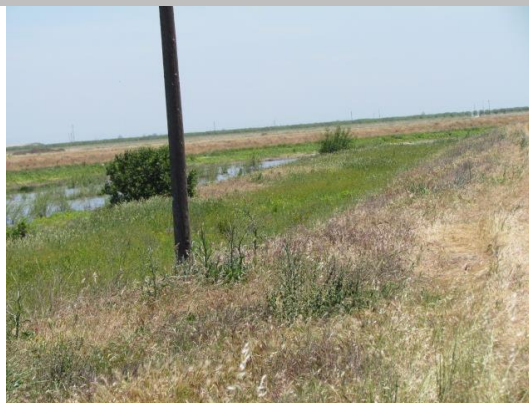
Photo 1 of 1 : SP_2017_NA0011_147_11_20170518_00034.jpg

Fresno River levee mile 0.01 looking upstream wild weed growth present on the slope and shoulder.

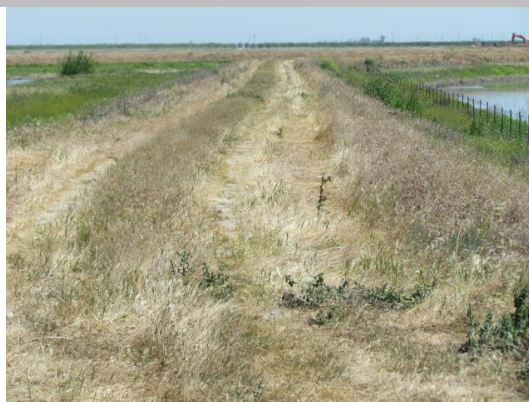
Photo 1 of 1 : SP_2017_NA0011_147_12_20170518_00035.jpg

Fresno River looking upstream from levee mile 0.01 to 0.95.

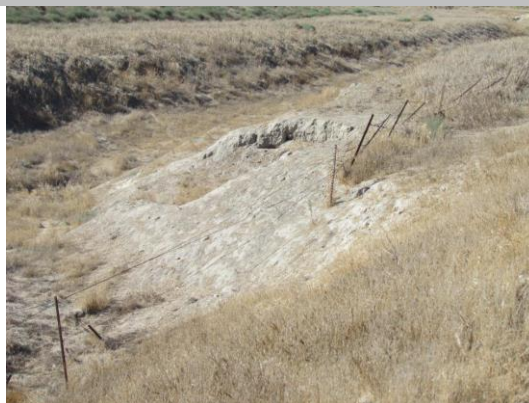
Photo 1 of 1 : SP_2017_NA0011_147_20_20170404_00005.jpg

Looking upstream at the old erosion site landside slope.

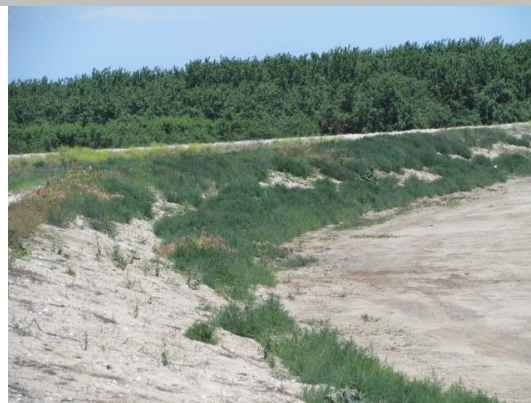
Photo 1 of 1 : SP_2017_NA0011_147_29_20170518_00038.jpg

Fresno River landside levee mile 7.71-8.59.

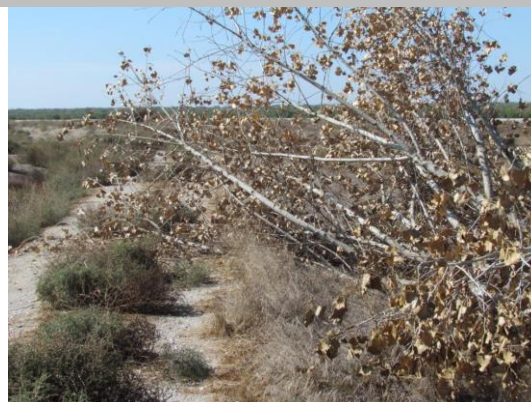
Photo 1 of 2 : SP_2017_NA0011_147_36_20170404_00010.jpg

Dead tree pushed upon the waterside slope and blocking the crown.

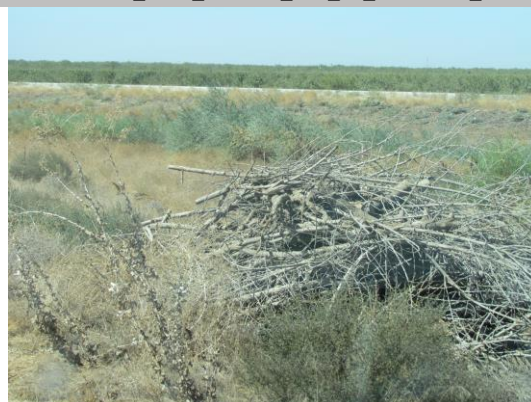
Photo 2 of 2 : SP_2017_NA0011_147_36_20170404_00011.jpg

Fresno River levee mile 8.03 waterside slope and shoulder.

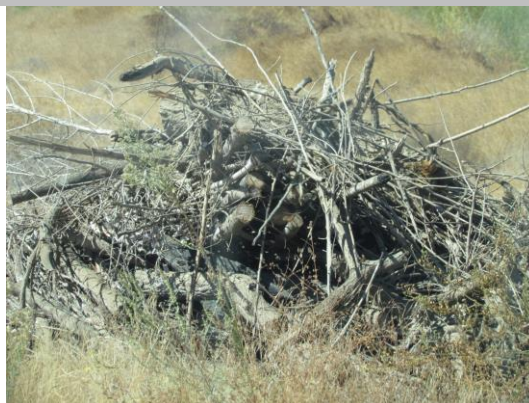
Photo 1 of 1 : SP_2017_NA0011_147_31_20170404_00009.jpg

Fresno River levee mile 8.09.
