**Flood Control Project Maintenance
Levee Inspections**

Maintenance Issue Types Only, Levee Inspection Report By Mile - Spring 2018

Madera County FCWCA

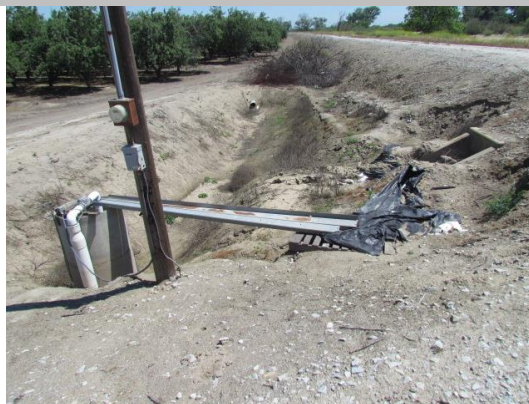
Photo 1 of 1 : SP_2018_NA0011_142_20_20180411_00010.jpg

LM Start	0.04	Rating **	U	Issue No.	20
LM End	0.05	Issue Type +	Ma	Location *	LS
Category	Earthen Levee			GPS Latitude/Longitude	
				Start	End
Item	Slope Stability			37.046624 °	37.046682 °
				-120.427317 °	-120.427108 °
DWR ID	DWR_NA0011_01_s _ 2014_20				
Comment Code					
S1 : Repair slope instability.					
Inspector Comment					
This is not a new erosion site, it should be repaired before the condition get any worse.

There is damage to the landside levee slope next to the concrete inlet structure.

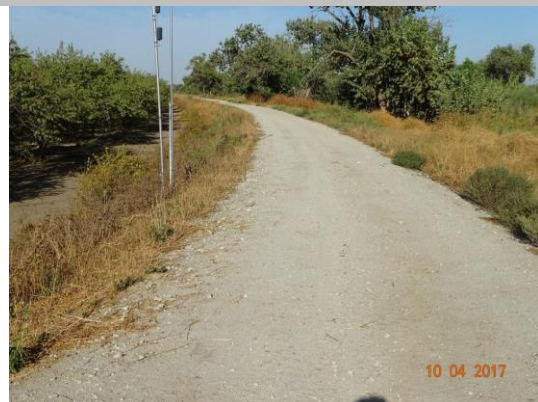
Photo 1 of 1 : SP_2018_NA0011_142_9_20180411_00001.jpg

Tall weeds should be removed from landside slope.

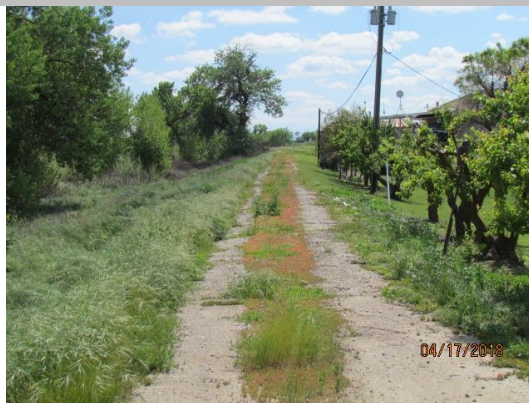
Photo 1 of 1 : SP_2018_NA0011_142_22_20180420_00029.jpg

Looking west at veg on levee crown within the section. (Spring 2018)

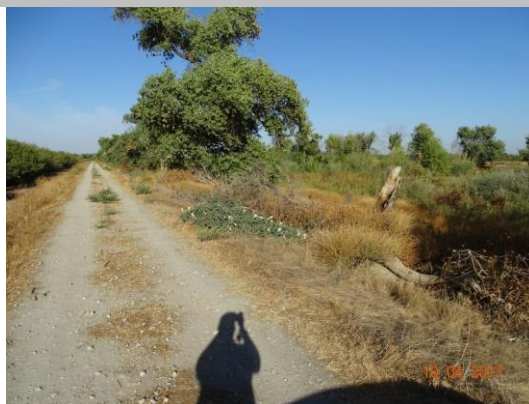
Photo 1 of 1 : SP_2018_NA0011_142_11_20180411_00002.jpg

LM Start	0.44	Rating **	M	Issue No.	11
LM End	0.44	Issue Type +	Ma	Location *	WS
Category	Earthen Levee			GPS Latitude/Longitude	
				Start	End
Item	Encroachments			37.049455 °	37.049455 °
				-120.421218 °	-120.421218 °
DWR ID	DWR_NA0011_01_s_2012_11				
Comment Code					
TR : Tree or limb					
Inspector Comment					
Remove the dead tree from the waterside slope.

Remove downed tree from waterside slope.

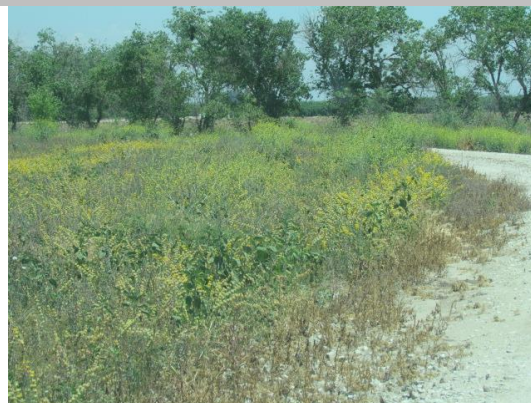
Photo 1 of 1 : SP_2018_NA0011_142_31_20180411_00014.jpg

Unwanted tall weed growth on the landside shoulder and slope.

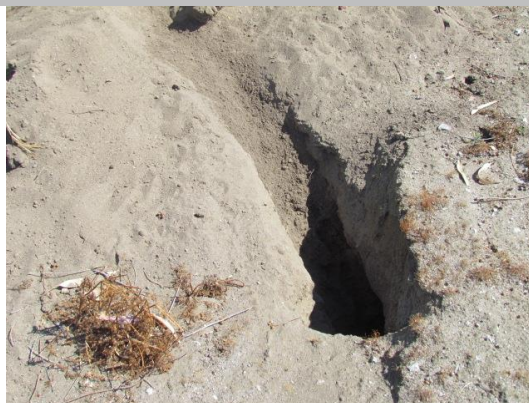
Photo 1 of 2 : SP_2018_NA0011_143_39_20180307_00018.jpg

Active rodents spotted in the area waterside slope levee mile 0.00- 1.67.

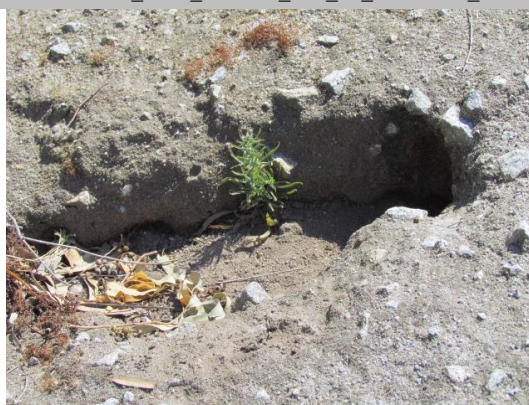
Photo 2 of 2 : SP_2018_NA0011_143_39_20180307_00019.jpg

Other rodent holes noted in the slope waterside levee section.

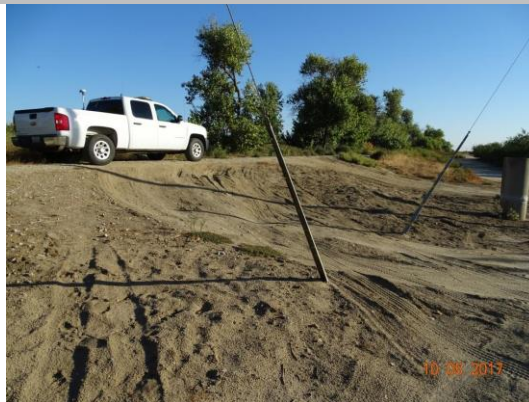
Photo 1 of 1 : SP_2018_NA0011_143_13_20180307_00009.jpg

LM Start	0.31	Rating **	M	Issue No.	13
LM End	0.31	Issue Type +	Ma	Location *	LS
Category	Earthen Levee			GPS Latitude/Longitude	
				Start	End
Item	Slope Stability			37.047266 °	37.047266 °
				-120.422393 °	-120.422393 °
DWR ID	DWR_NA0011_02_f_2017_13				
Comment Code					
S3 : Repair the levee slope damaged by vehicle traffic and prevent access where possible.					
Inspector Comment

Vehicle access to levee slope should be prevented and erosion repaired.

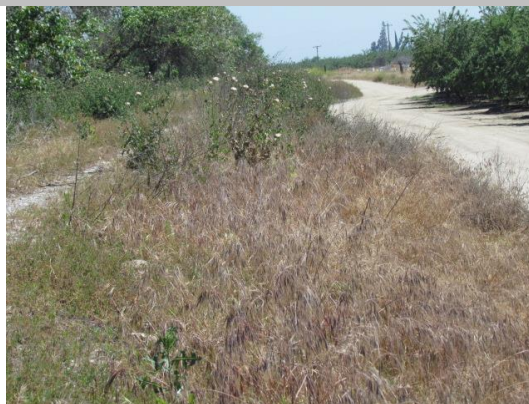
Photo 1 of 1 : SP_2018_NA0011_143_30_20180307_00014.jpg

Unwanted vegetation on the waterside levee slope.

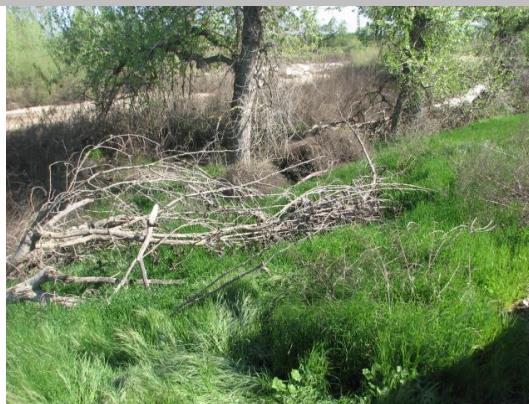
Photo 1 of 1 : SP_2018_NA0011_143_28_20180411_00039.jpg

Looking downstream at tree limbs on waterward slope and toe. (Spring 2018)

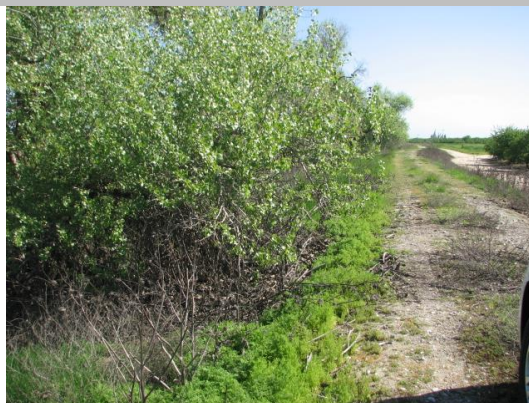
Photo 1 of 1 : SP_2018_NA0011_143_14_20180411_00040.jpg

Looking downstream at untrimmed tree on waterward shoulder and slope. (Spring 2018)

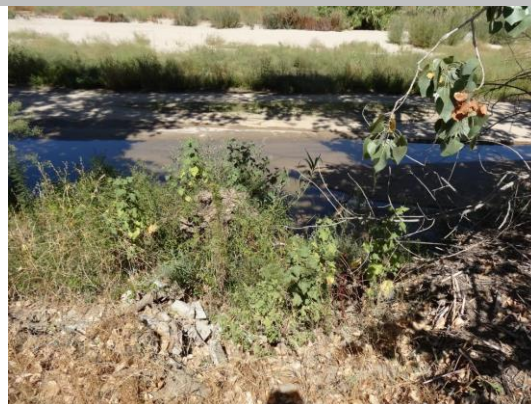
Photo 1 of 4 : SP_2018_NA0011_143_1_20180307_00001.jpg

Comment Code					
Inspector Comment					
09/20/2017: No significant change observed.					
07/22/2016: No significant change observed.					
09/08/2015: No significant change observed.					
07/22/2014: No significant change observed.					
08/30/2013: No significant change observed.					
07/31/2012: Site was visited on 07/24/2012. No significant change observed. Dense vegetation around the site					
08/09/2011: Site was inspected. No visible change was observed from the previous condition. A fallen tree was seen at the levee toe about 20 feet upstream, and tree root exposed. There has been no report from the district that this site was corrected.					
11/30/2010: Site was not inspected due to time constraints. There have been no reports from the district that the site was corrected. Continue to monitor site during flood events.					
08/05/2010: Recommended for annual assessment and monitoring during flood events, per CLRO.

2009: Site is recommended as a local maintenance issue, per Critical Levee Repair Office, Critical Erosion Sites Evaluation 2008 Report; site was previously rated "M"					
9/6/2007: Undercutting of the toe; several trees along the WS slope with roots exposed. [2017 Site ID:NA0011U02RM2.57]

View of the erosion site from the levee crest.

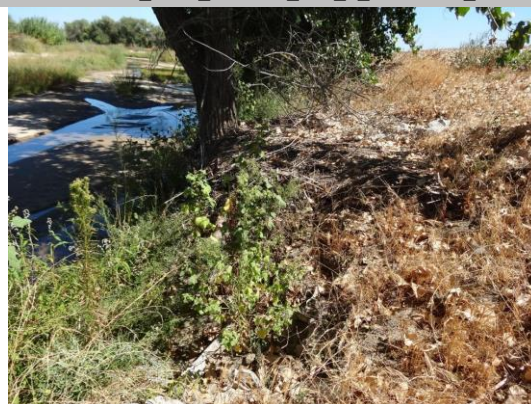
Photo 2 of 4 : SP_2018_NA0011_143_1_20180307_00002.jpg

Close view of the site.

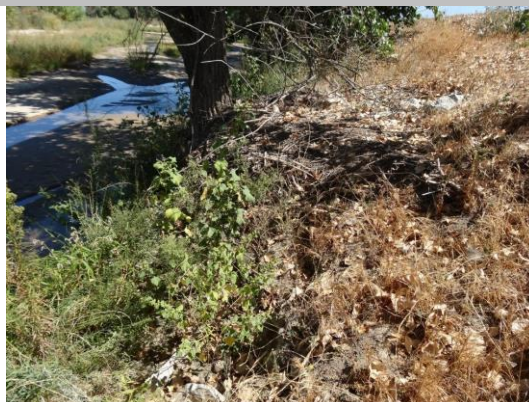
Photo 4 of 4 : SP_2018_NA0011_143_1_20180307_00004.jpg

Close view of the site.

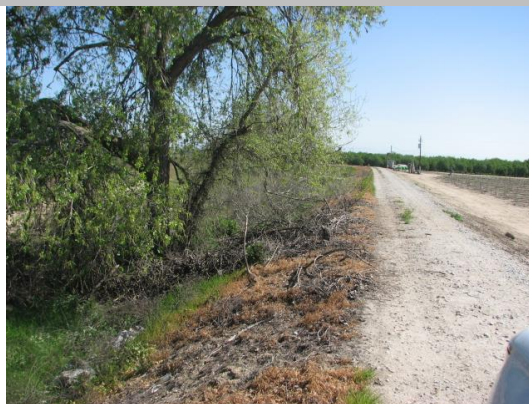
Photo 1 of 1 : SP_2018_NA0011_143_25_20180411_00044.jpg

Look downstream at untrimmed tree on waterward slope. (Spring 2018)

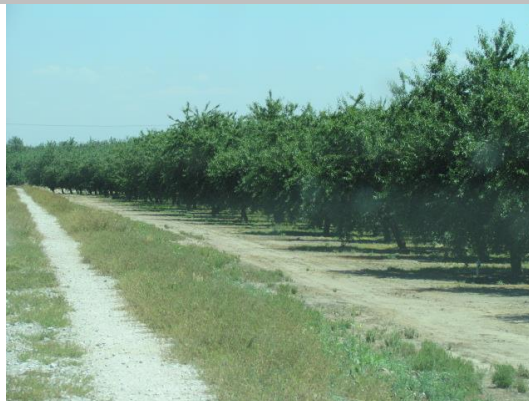
Photo 1 of 1 : SP_2018_NA0011_143_38_20180307_00017.jpg

Looking upstream from levee mile 1.66-2.00 tall weeds present on the landside slope.

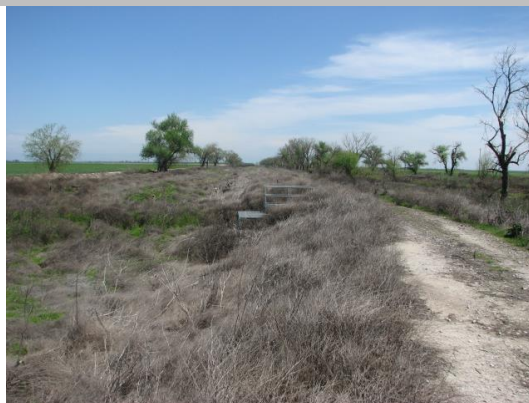
Photo 1 of 2 : SP_2018_NA0011_144_3_20180411_00018.jpg

Looking downstream at landward slope. (Spring 2018)

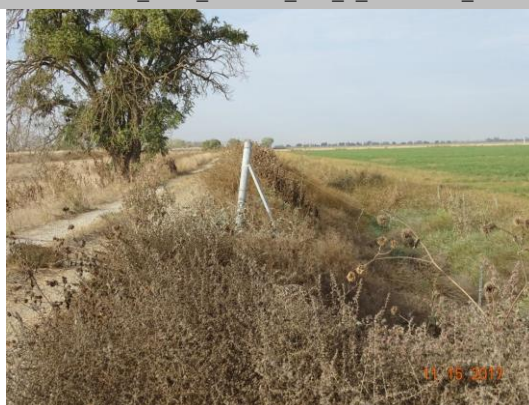
Photo 2 of 2 : SP_2018_NA0011_144_3_20180307_00001.jpg

Manage landside vegetation to allow inspection and access to levee slope and toe.

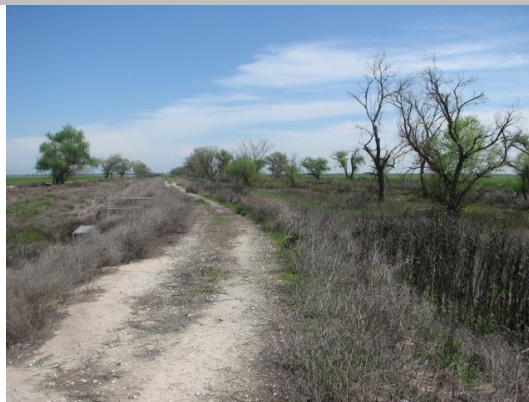
Photo 1 of 2 : SP_2018_NA0011_144_9_20180411_00019.jpg

Looking downstream at wild growth on waterward slope. (Spring 2018)

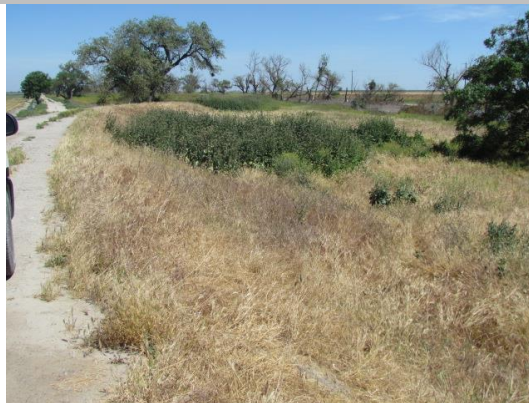
Photo 2 of 2 : SP_2018_NA0011_144_9_20180307_00007.jpg

Looking upstream from the waterside shoulder wild growth covering slope and toe.

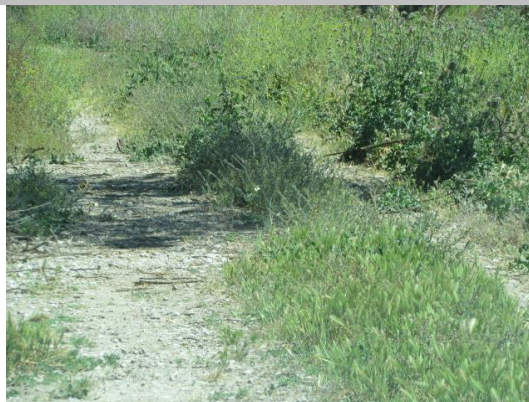
Photo 1 of 1 : SP_2018_NA0011_144_12_20180307_00010.jpg

Looking upstream at the crown roadway that's covered with wild vegetation.

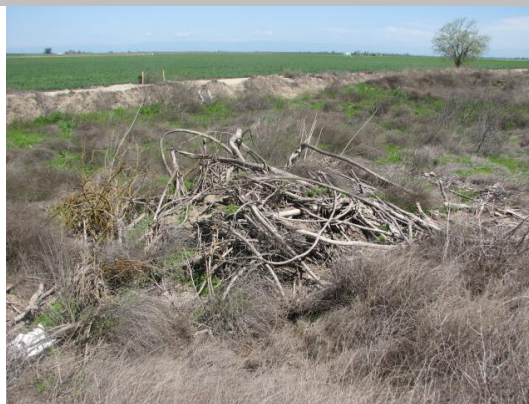
Photo 1 of 1 : SP_2018_NA0011_144_20_20180411_00021.jpg

Looking at prunings on landward slope. (Spring 2018)

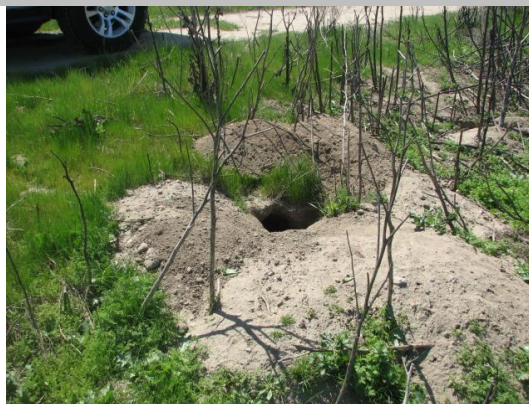
Photo 1 of 6 : SP_2018_NA0011_144_6_20180411_00023.jpg

Looking at rodent hole with erosion on landward slope. (Spring 2018)

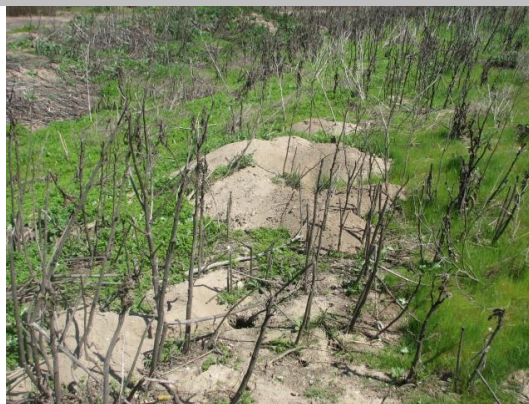
Photo 2 of 6 : SP_2018_NA0011_144_6_20180411_00022.jpg

Looking at typical rodent holes within this section (Spring 2018)

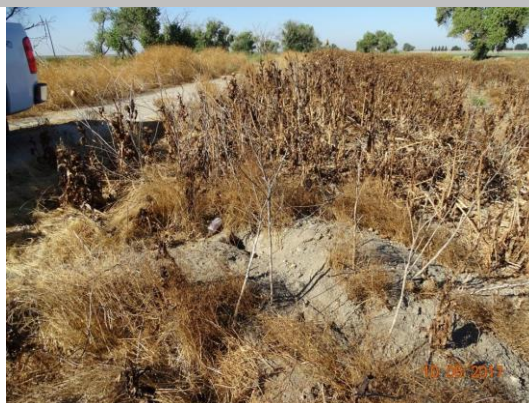
Photo 4 of 6 : SP_2018_NA0011_144_6_20180307_00005.jpg

Continued rodent activity.

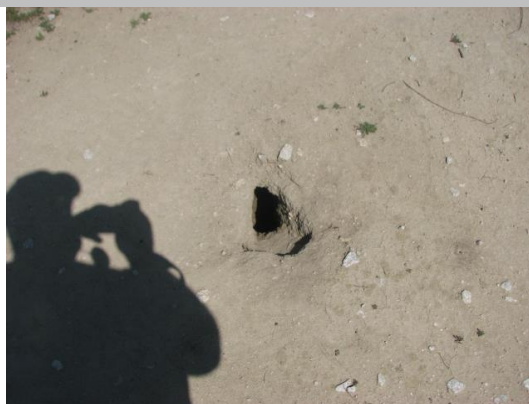
Photo 1 of 1 : SP_2018_NA0011_144_5_20180411_00025.jpg

Looking at rodent hole on levee crown. (Spring 2018)

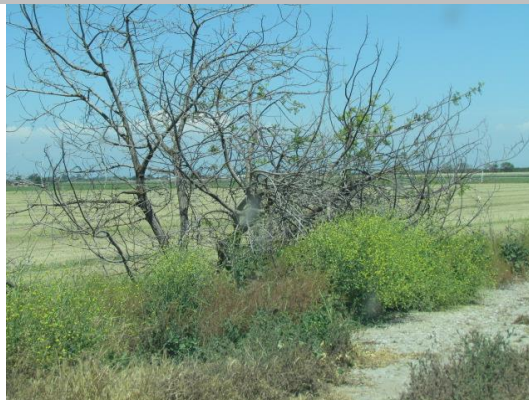
Photo 2 of 2 : SP_2018_NA0011_144_11_20180307_00009.jpg

levee mile 1.04-1.05 landside slope and shoulder wild walnut tree growth was covered with leaves that blocked the view of the levee section.

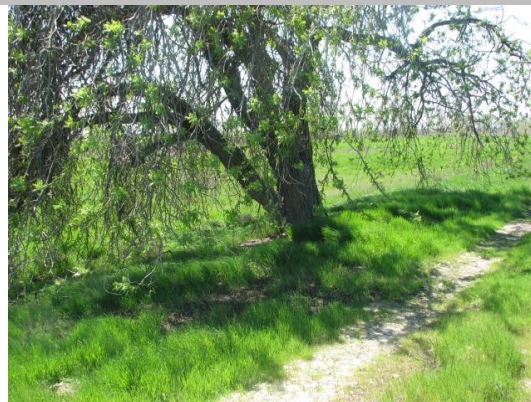
Photo 1 of 1 : SP_2018_NA0011_144_14_20180411_00026.jpg

Looking at untrimmed tree on waterward shoulder. (Spring 2018)

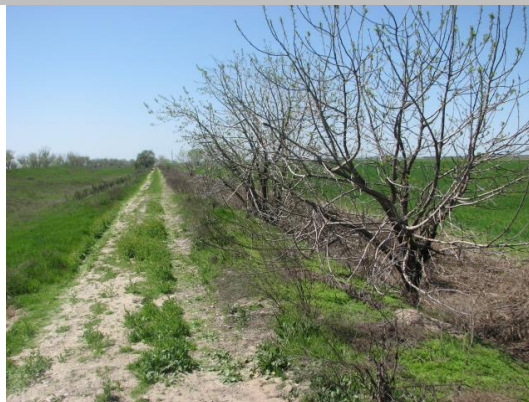
Photo 1 of 2 : SP_2018_NA0011_144_17_20180411_00027.jpg

Looking at cluster of walnut trees on landward slope. (Spring 2018)

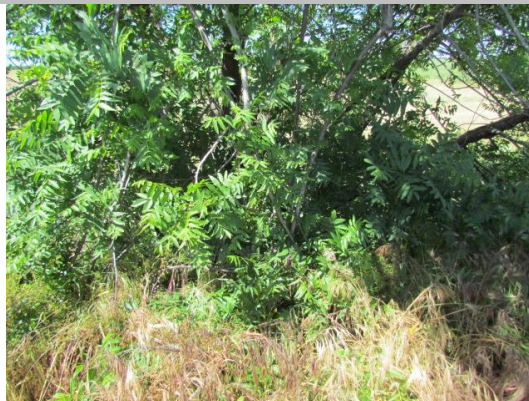
Photo 2 of 2 : SP_2018_NA0011_144_17_20180307_00011.jpg

Looking upstream from landside slope tree has blocked view of the slope and shoulder.

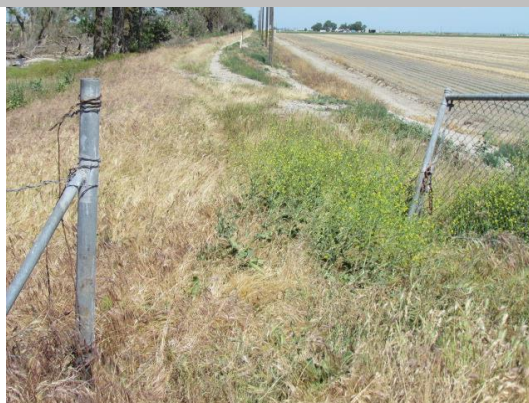
Photo 2 of 2 : SP_2018_NA0011_145_8_20180307_00003.jpg

Looking upstream from levee mile 0.01 at the wild vegetation growing on the grown roadway.

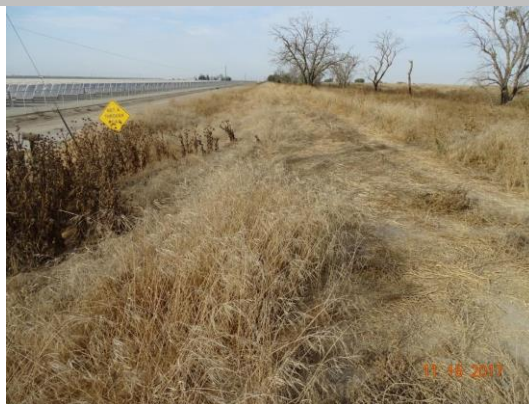
Photo 1 of 1 : SP_2018_NA0011_145_5_20180307_00002.jpg

Manage landside vegetation to allow inspection and access to levee slope and toe.

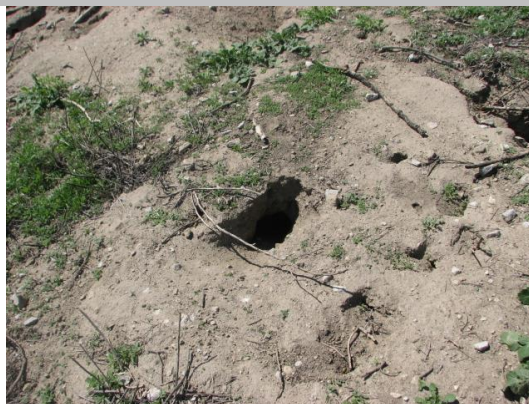
Photo 1 of 1 : SP_2018_NA0011_145_19_20180411_00020.jpg

Looking at large rodent hole on landward slope. (Spring 2018)

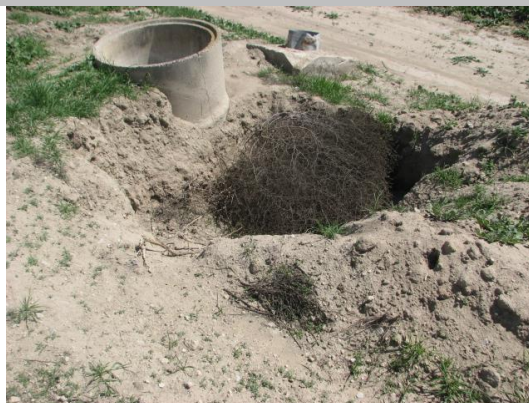
Photo 1 of 3 : SP_2018_NA0011_145_22_20180411_00022.jpg

Looking west at large hole next concrete riser (no pipe) on landward slope. (Spring 2018)

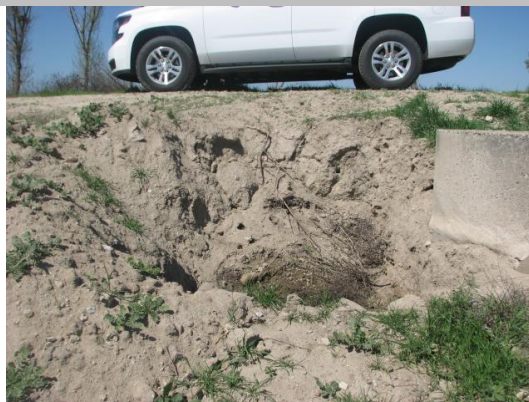
Photo 3 of 3 : SP_2018_NA0011_145_22_20180411_00024.jpg

Looking east at large hole next to riser (no pipe) on landward slope. (Spring 2018)

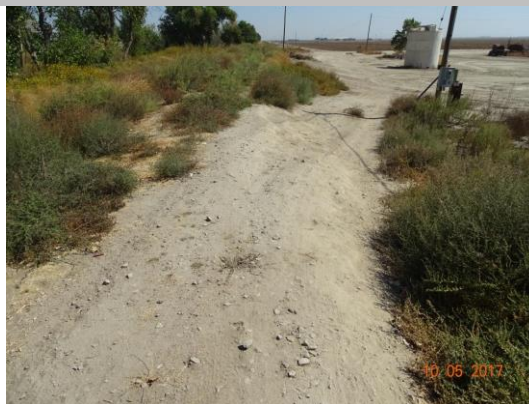
Photo 1 of 2 : SP_2018_NA0011_145_13_20180307_00010.jpg

A proper ramp should be permitted and created to replace vehicle erosion site on landside levee slope. Slope should be repaired.

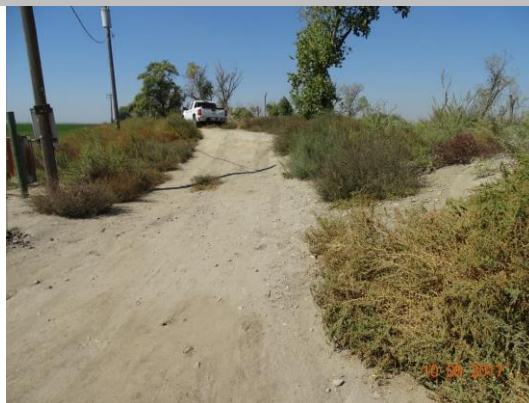
Photo 2 of 2 : SP_2018_NA0011_145_13_20180307_00011.jpg

A proper ramp should be permitted and created to replace vehicle erosion site on landside levee slope. Slope should be repaired.

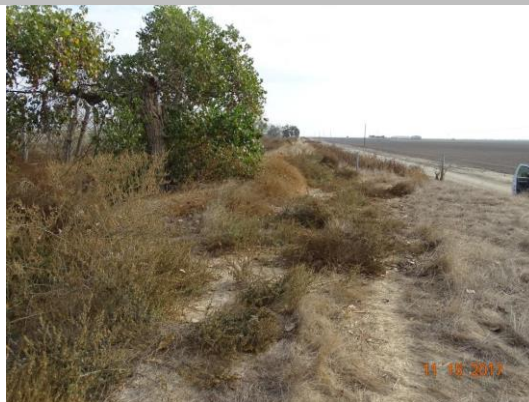
Photo 1 of 1 : SP_2018_NA0011_145_12_20180307_00009.jpg

Trim trees to at least 5' above levee slope and 12' above levee crown to allow inspection and access.

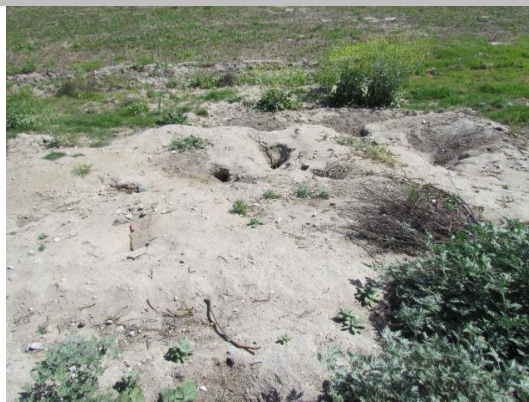
Photo 2 of 5 : SP_2018_NA0011_145_11_20180307_00005.jpg

Looking upstream at rodent activity on landward slope and toe.

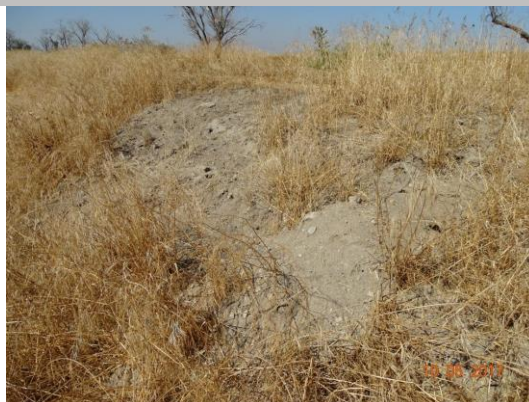
Photo 5 of 5 : SP_2018_NA0011_145_11_20180307_00008.jpg

Rodent activity at LM 1.44.

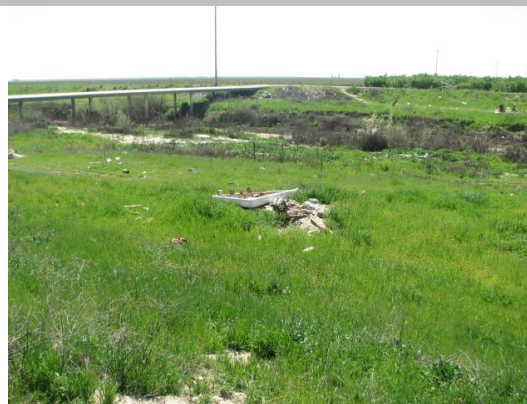
Photo 1 of 1 : SP_2018_NA0011_146_19_20180411_00021.jpg

Looking west at garage in channel. (Spring 2018)

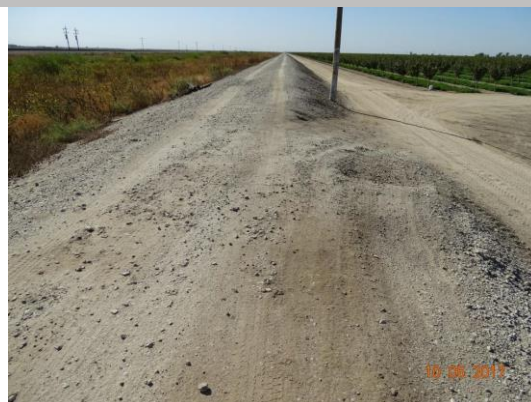
Photo 1 of 1 : SP_2018_NA0011_146_18_20180307_00005.jpg

Repair damage from vehicle traffic on slope and shoulder.

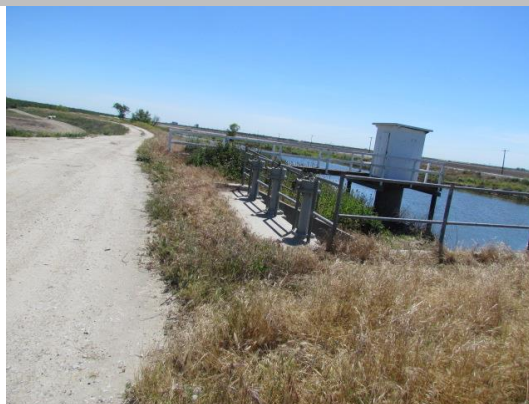
Photo 1 of 1 : SP_2018_NA0011_146_17_20180307_00004.jpg

Fresno River waterside looking upstream from levee mile 6.57, wild weed growth present on slope and shoulder.

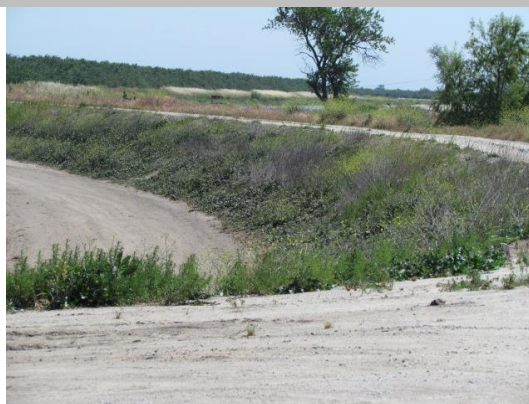
Photo 1 of 1 : SP_2018_NA0011_146_20_20180307_00006.jpg

Fresno River Unit 5 levee mile 6.58 looking upstream to 7.04 unsatisfactory weed growth covering levee slope.

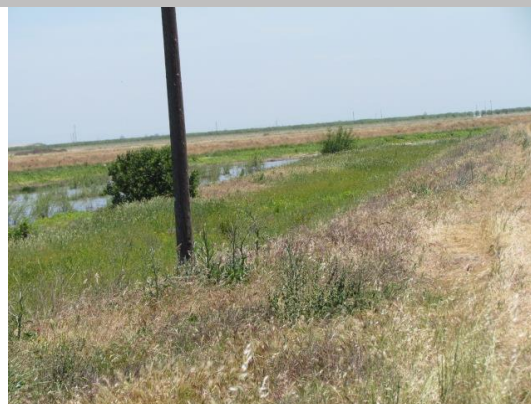
Photo 1 of 1 : SP_2018_NA0011_147_11_20180307_00002.jpg

Fresno River levee mile 0.01 looking upstream wild weed growth present on the slope and shoulder.

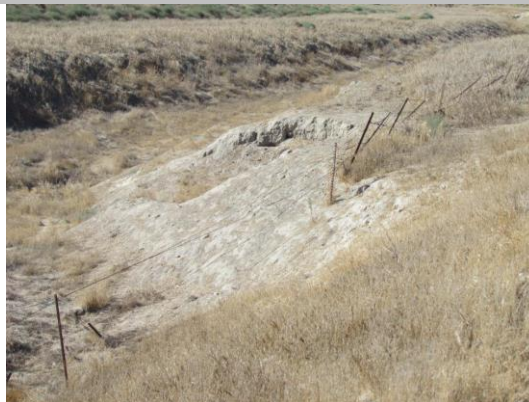
Photo 1 of 1 : SP_2018_NA0011_147_20_20180307_00007.jpg

Looking downstream at the old erosion site landside slope.

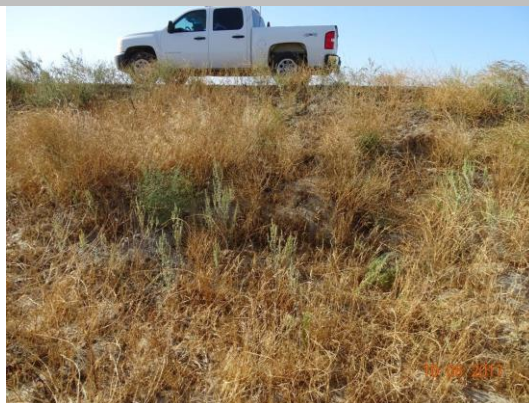
Photo 1 of 2 : SP_2018_NA0011_147_17_20180307_00005.jpg

Observed slump possibly exacerbated by rodent activity. 20' long x 8' high x 18" deep into levee slope.

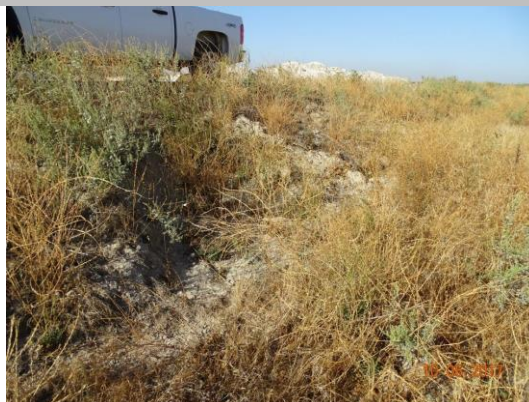
Photo 2 of 2 : SP_2018_NA0011_147_17_20180307_00006.jpg

Observed slump possibly exacerbated by rodent activity. 20' long x 8' high x 18" deep into levee slope.

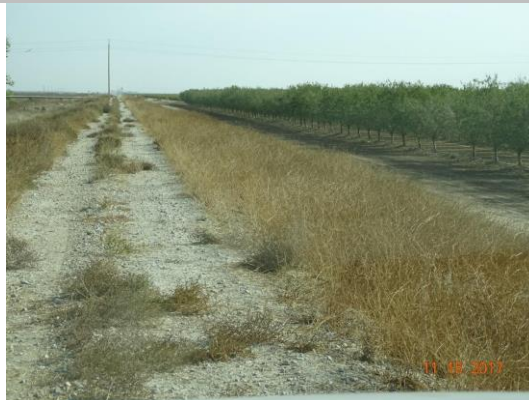
Photo 1 of 1 : SP_2018_NA0011_147_21_20180307_00008.jpg

Landside vegetation should be managed to allow inspection and access to slope and toe.

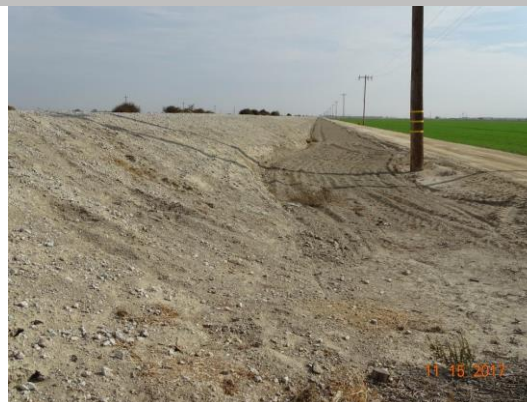
Photo 1 of 1 : SP_2018_NA0011_147_27_20180307_00009.jpg

Ag activity has cut into landside toe. Activity should be stopped and levee slope repaired.

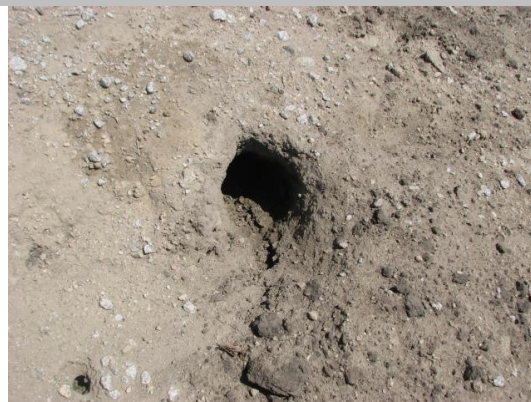
Photo 1 of 1 : SP_2018_NA0011_147_53_20180411_00040.jpg

Looking at typical rodent hole on landward slope. (Spring 2018)

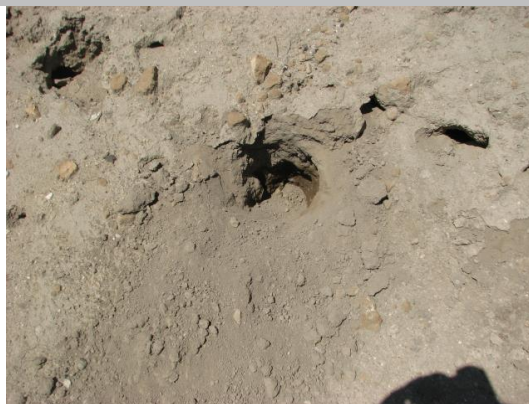
Photo 1 of 1 : SP_2018_NA0011_147_51_20180411_00045.jpg

Looking at typical rodent holes on landward slope. (Spring 2018)

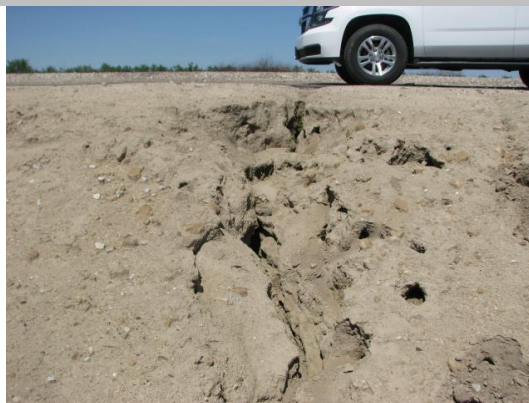
Photo 1 of 1 : SP_2018_NA0011_147_22_20180411_00046.jpg

Looking at finger erosion on landward slope. (Spring 2018)
