**Flood Control Project Maintenance
Levee Inspections**

Maintenance Issue Types Only, Levee Inspection Report By Mile - Spring 2019

Madera County FCWCA

Waterway	Bank	Unit Miles	Inspection Start/End	Inspector
Unit No. 01 Ash Slough	Right	2.37	05/09/2019 05/09/2019	Corey Fujitani

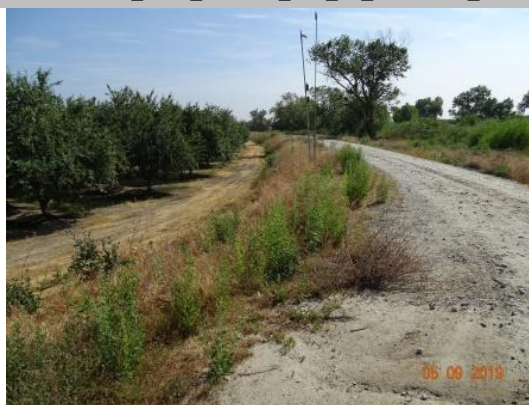
Photo 1 of 1 : SP_2019_NA0011_142_28_20190513_00033.jpg

View of landside slope looking upstream. (Spring 2019)

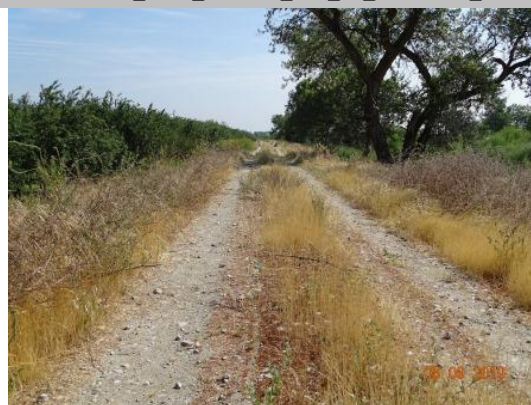
Photo 1 of 1 : SP_2019_NA0011_142_32_20190513_00034.jpg

View of vegetation along levee crown looking upstream. (Spring 2019)

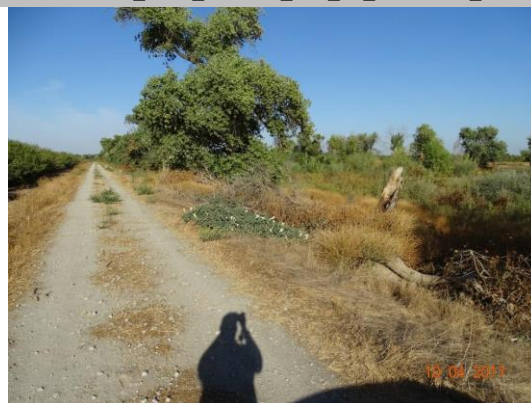
Photo 1 of 1 : SP_2019_NA0011_142_11_20190307_00002.jpg

LM Start	0.44	Rating **	M	Issue No.	11
LM End	0.44	Issue Type +	Ma	Location *	WS
Category	Earthen Levee			GPS Latitude/Longitude	
				Start	End
Item	Encroachments			37.049455 °	37.049455 °
				-120.421218 °	-120.421218 °
DWR ID	DWR_NA0011_01_s_2012_11				
Comment Code					
TR : Tree or limb					
Inspector Comment					
Remove the dead tree from the waterside slope.

Remove downed tree from waterside slope.

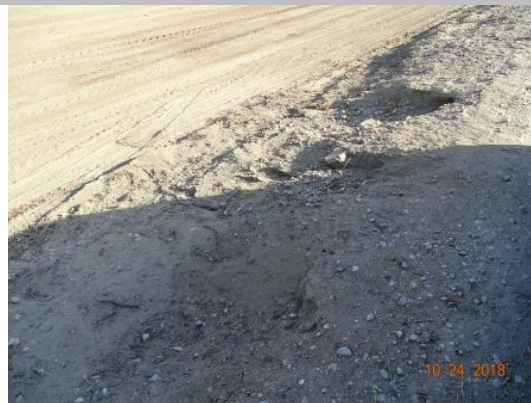
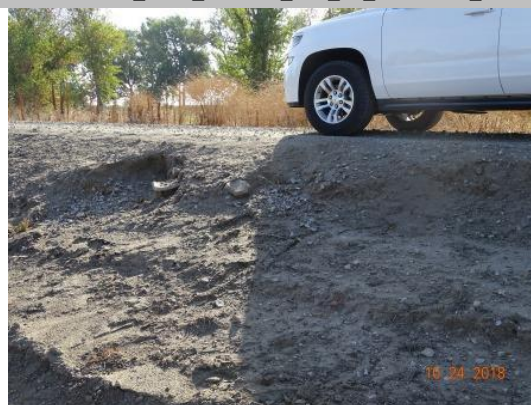
Photo 1 of 2 : SP_2019_NA0011_142_29_20190307_00015.jpg

LM Start	1.04	Rating **	M	Issue No.	29
LM End	1.04	Issue Type +	Ma	Location *	LS
Category	Earthen Levee			GPS Latitude/Longitude	
				Start	End
Item	Erosion / Bank Caving			37.055880 °	37.055880 °
				-120.414628 °	-120.414628 °
DWR ID	DWR_NA0011_01_f_2018_29				
Comment Code					
E2 : Schedule repair of erosion site prior to the next inspection.					
Inspector Comment

Erosion on landside slope. (Fall 2018)

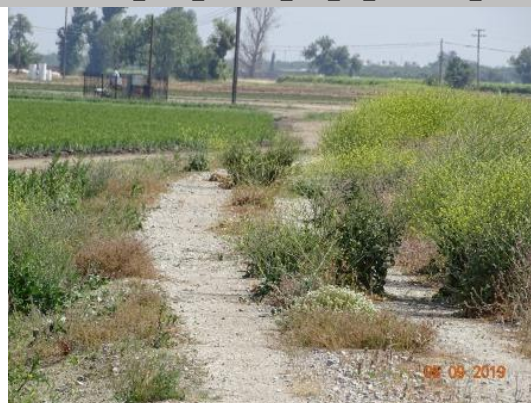
Photo 1 of 1 : SP_2019_NA0011_142_35_20190513_00037.jpg

View of vegetation along levee crown looking upstream. (Spring 2019)

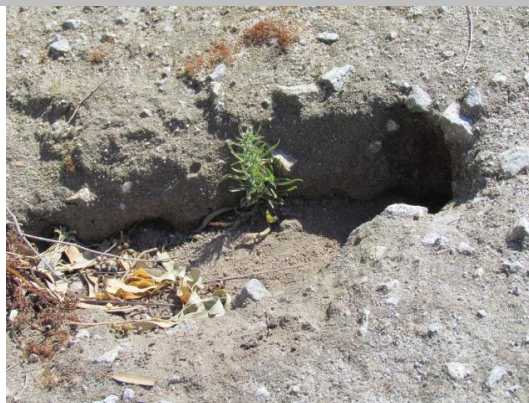
Photo 2 of 2 : SP_2019_NA0011_143_39_20190307_00031.jpg

Other rodent holes noted in the slope waterside levee section.

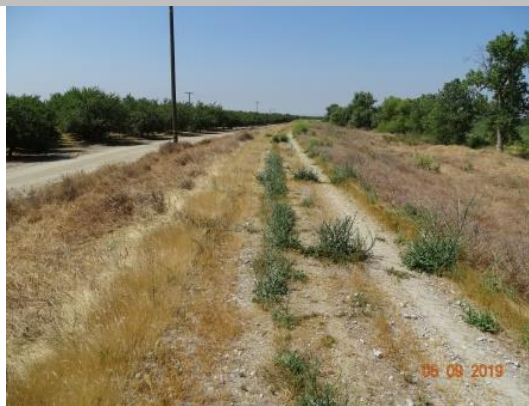
Photo 1 of 1 : SP_2019_NA0011_143_43_20190513_00052.jpg

View of vegetation on levee crown looking downstream. (Spring 2019)

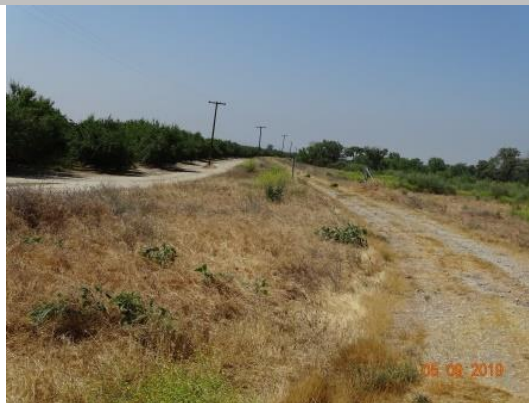
Photo 1 of 1 : SP_2019_NA0011_143_42_20190513_00053.jpg

LM Start	0.23	Rating **	U	Issue No.	42
LM End	0.94	Issue Type +	Ma	Location *	LS
Category	Earthen Levee			GPS Latitude/Longitude	
				Start	End
Item	Vegetation			37.046624 °	37.054441 °
				-120.423496 °	-120.415898 °
DWR ID	DWR_NA0011_02_s_2019_42				
Comment Code					
V1 : Control annual grass and weeds on the levee slopes and easements.					
Inspector Comment

View along landside slope looking downstream. (Spring 2019)

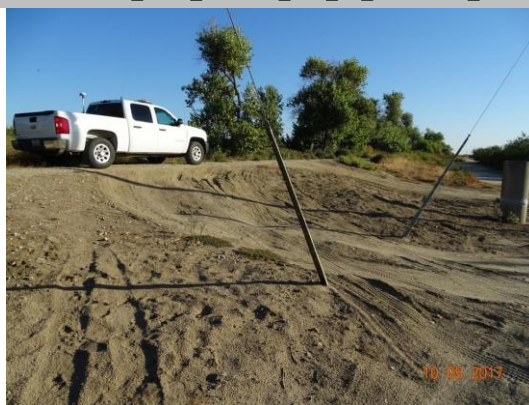
Photo 1 of 1 : SP_2019_NA0011_143_13_20190307_00010.jpg

LM Start	0.31	Rating **	M	Issue No.	13
LM End	0.31	Issue Type +	Ma	Location *	LS
Category	Earthen Levee			GPS Latitude/Longitude	
				Start	End
Item	Slope Stability			37.047266 °	37.047266 °
				-120.422393 °	-120.422393 °
DWR ID	DWR_NA0011_02_f_2017_13				
Comment Code					
S3 : Repair the levee slope damaged by vehicle traffic and prevent access where possible.					
Inspector Comment

Vehicle access to levee slope should be prevented and erosion repaired.

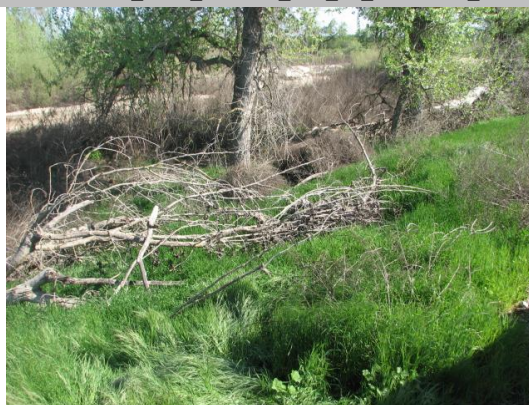
Photo 1 of 1 : SP_2019_NA0011_143_28_20190307_00022.jpg

Looking downstream at tree limbs on waterward slope and toe. (Spring 2018)

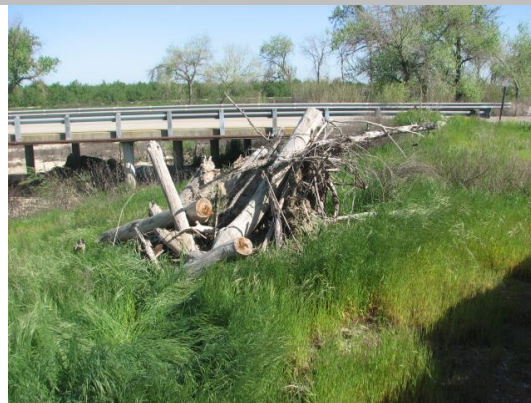
Photo 1 of 1 : SP_2019_NA0011_143_34_20190307_00027.jpg

Looking downstream at bush pile on waterward slope. (Spring 2018)

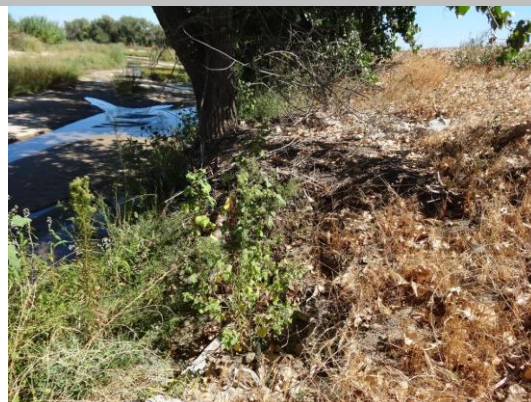
Photo 2 of 4 : SP_2019_NA0011_143_1_20190307_00002.jpg

Comment Code					
Inspector Comment					
09/20/2017: No significant change observed.					
07/22/2016: No significant change observed.					
09/08/2015: No significant change observed.					
07/22/2014: No significant change observed.					
08/30/2013: No significant change observed.					
07/31/2012: Site was visited on 07/24/2012. No significant change observed. Dense vegetation around the site					
08/09/2011: Site was inspected. No visible change was observed from the previous condition. A fallen tree was seen at the levee toe about 20 feet upstream, and tree root exposed. There has been no report from the district that this site was corrected.					
11/30/2010: Site was not inspected due to time constraints. There have been no reports from the district that the site was corrected. Continue to monitor site during flood events.					
08/05/2010: Recommended for annual assessment and monitoring during flood events, per CLRO.

2009: Site is recommended as a local maintenance issue, per Critical Levee Repair Office, Critical Erosion Sites Evaluation 2008 Report; site was previously rated "M"					
9/6/2007: Undercutting of the toe; several trees along the WS slope with roots exposed. [2017 Site ID:NA0011U02RM2.57]

Close view of the site.

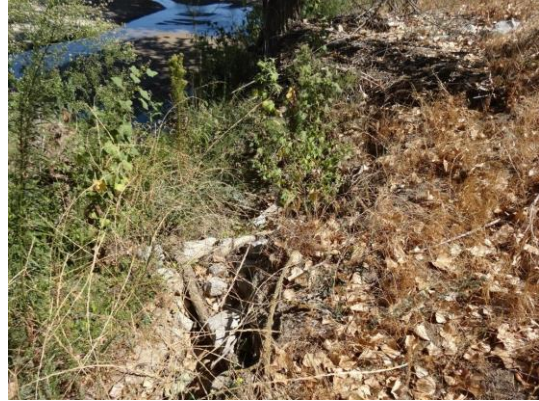
Photo 3 of 4 : SP_2019_NA0011_143_1_20190307_00003.jpg

Comment Code						
Inspector Comment						
09/20/2017: No significant change observed.						
07/22/2016: No significant change observed.						
09/08/2015: No significant change observed.						
07/22/2014: No significant change observed.						
08/30/2013: No significant change observed.						
07/31/2012: Site was visited on 07/24/2012. No significant change observed. Dense vegetation around the site						
08/09/2011: Site was inspected. No visible change was observed from the previous condition. A fallen tree was seen at the levee toe about 20 feet upstream, and tree root exposed. There has been no report from the district that this site was corrected.						
11/30/2010: Site was not inspected due to time constraints. There have been no reports from the district that the site was corrected. Continue to monitor site during flood events.						
08/05/2010: Recommended for annual assessment and monitoring during flood events, per CLRO.

2009: Site is recommended as a local maintenance issue, per Critical Levee Repair Office, Critical Erosion Sites Evaluation 2008 Report; site was previously rated "M"						
9/6/2007: Undercutting of the toe; several trees along the WS slope with roots exposed. [2017 Site ID:NA0011U02RM2.57]

Vegetation debris at the site.

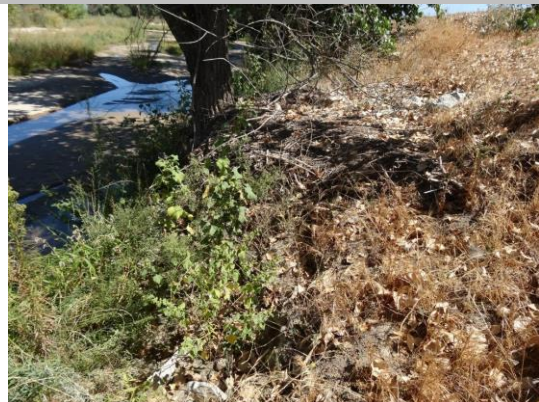
Photo 4 of 4 : SP_2019_NA0011_143_1_20190307_00004.jpg

Close view of the site.

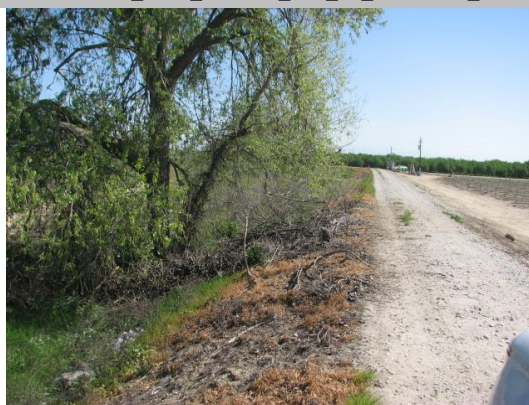
Photo 1 of 1 : SP_2019_NA0011_143_25_20190307_00019.jpg

Look downstream at untrimmed tree on waterward slope. (Spring 2018)

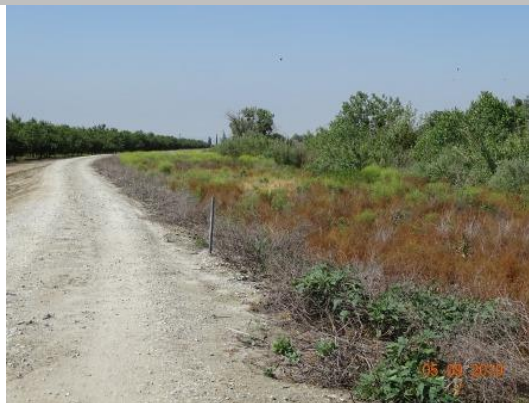
Photo 1 of 1 : SP_2019_NA0011_143_9_20190513_00058.jpg

View of vegetation on waterside slope looking downstream. (Spring 2019)

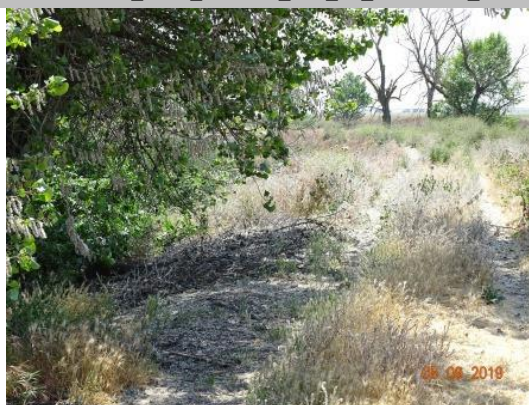
Photo 1 of 1 : SP_2019_NA0011_144_16_20190514_00031.jpg

View of vegetation on the landside slope looking upstream. (Spring 2019)

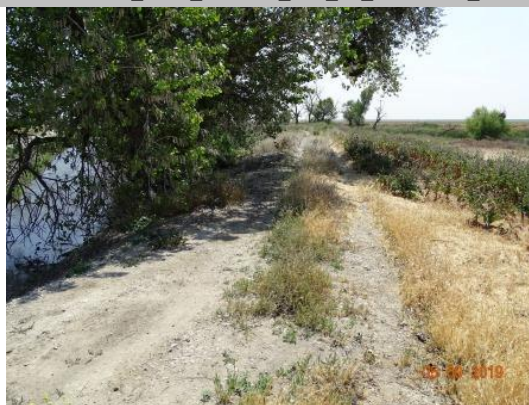
Photo 1 of 1 : SP_2019_NA0011_144_19_20190514_00030.jpg

View of vegetation on levee crown looking upstream. (Spring 2019)

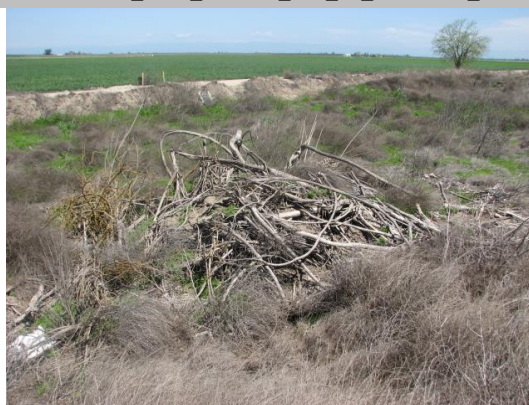
Photo 1 of 1 : SP_2019_NA0011_144_20_20190307_00020.jpg

Looking at prunings on landward slope. (Spring 2018)

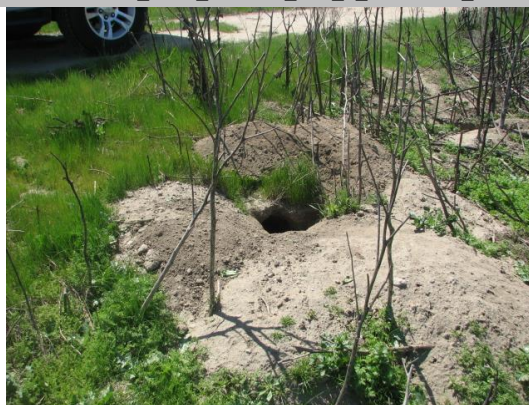
Photo 1 of 6 : SP_2019_NA0011_144_6_20190307_00005.jpg

Looking at rodent hole on landward slope. (Spring 2018)

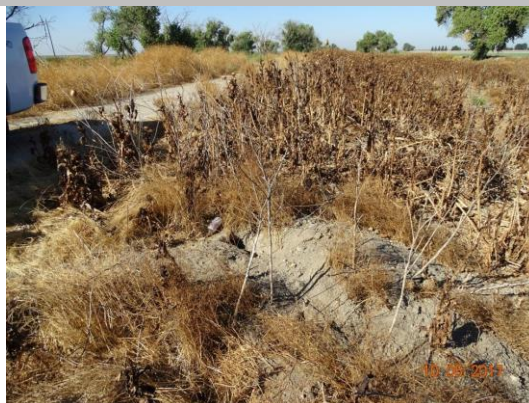
Photo 4 of 6 : SP_2019_NA0011_144_6_20190307_00008.jpg

Continued rodent activity.

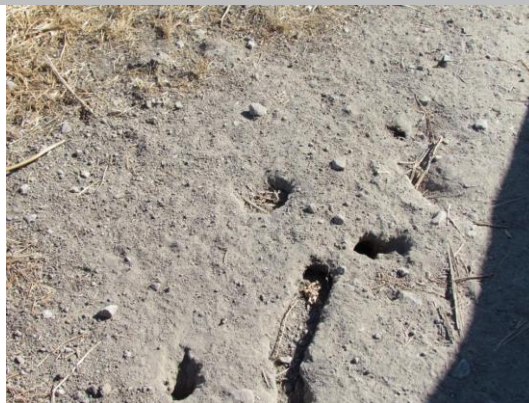
Photo 5 of 6 : SP_2019_NA0011_144_6_20190307_00009.jpg

More active rodent holes but no rodents observed at this specific location.

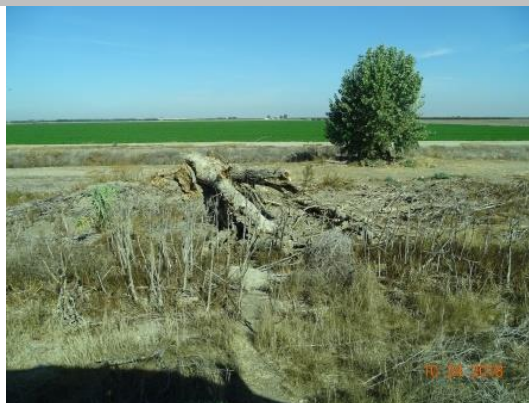
Photo 1 of 1 : SP_2019_NA0011_144_10_20190307_00014.jpg

View of dead tree on the landside slope. (Fall 2018)

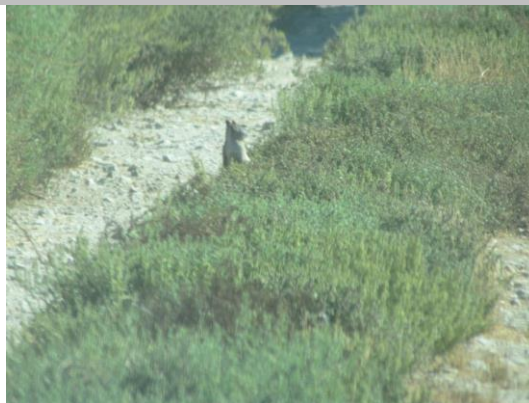
Photo 1 of 1 : SP_2019_NA0011_144_8_20190307_00011.jpg

LM Start	0.71	Rating **	M	Issue No.	8
LM End	1.51	Issue Type +	Ma	Location *	CR
Category	Earthen Levee			GPS Latitude/Longitude	
				Start	End
Item	Animal Control			36.996257 °	36.996607 °
				-120.361025 °	-120.346568 °
DWR ID	DWR_NA0011_03_f_2016_8				
Comment Code					
A1 : Exterminate rodents and backfill and compact or grout burrows.					
Inspector Comment					
Exterminate rodents from the roadway. Active rodents observed during inspection at this site.

Berenda Slough Unit 3 looking upstream from levee miles 0.71 - to 1.51.

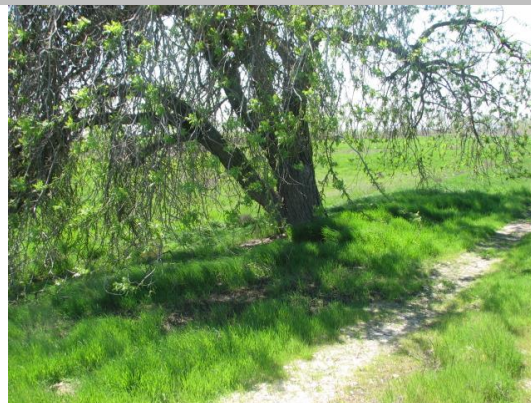
Photo 1 of 1 : SP_2019_NA0011_144_14_20190307_00017.jpg

Looking at untrimmed tree on waterward shoulder. (Spring 2018)

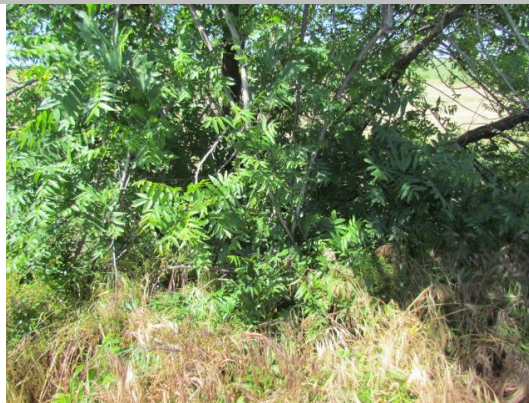
Photo 2 of 2 : SP_2019_NA0011_144_17_20190307_00019.jpg

Looking upstream from landside slope tree has blocked view of the slope and shoulder.

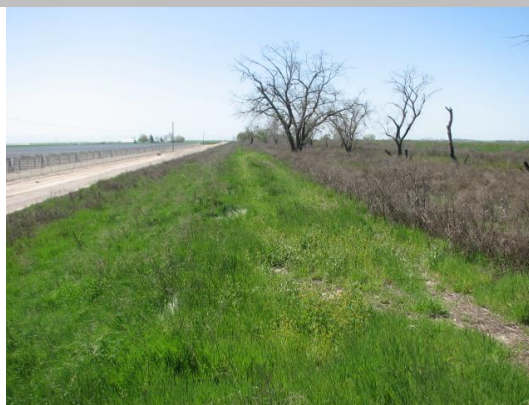
Photo 2 of 2 : SP_2019_NA0011_145_8_20190307_00006.jpg

Looking downstream from 1.49 at wild growth on levee crown. (Spring 2018)

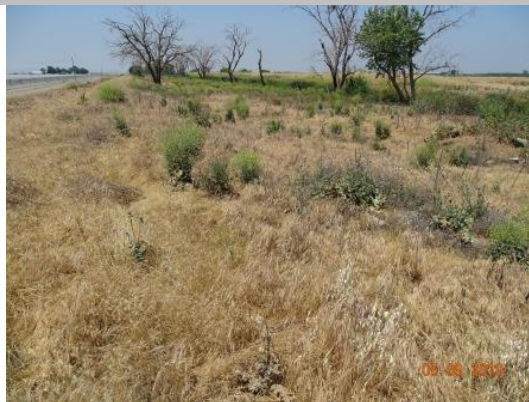
Photo 1 of 2 : SP_2019_NA0011_145_4_20190514_00031.jpg

View of waterside slope looking downstream. (Spring 2019)

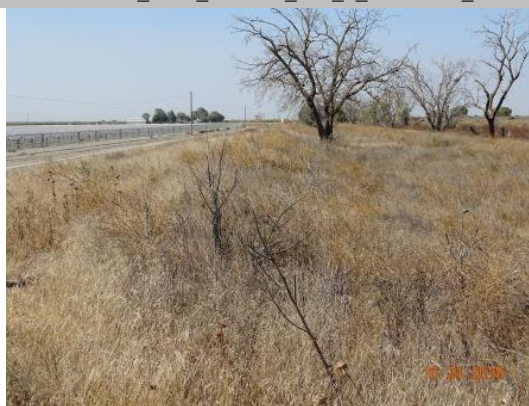
Photo 2 of 2 : SP_2019_NA0011_145_4_20190307_00002.jpg

View of wild growth on waterside slope and shoulder. (Fall 2018)

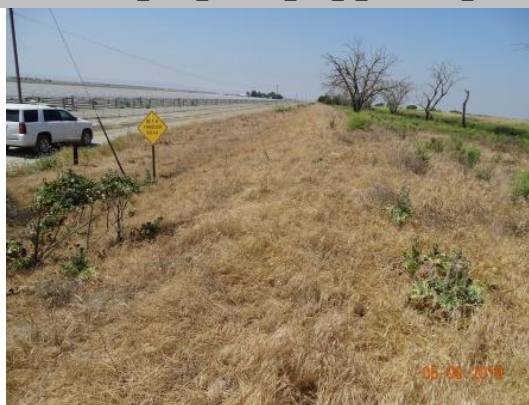
Photo 1 of 2 : SP_2019_NA0011_145_5_20190514_00032.jpg

View of vegetation along landside slope looking downstream. (Spring 2019)

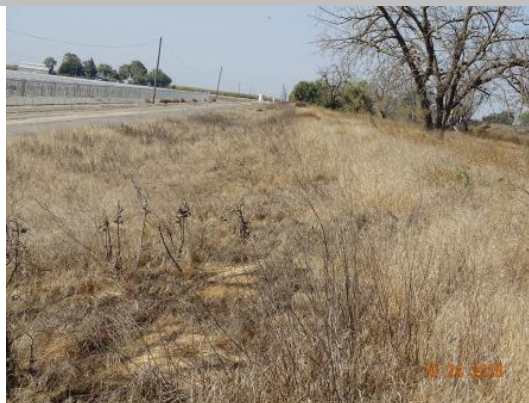
Photo 2 of 2 : SP_2019_NA0011_145_5_20190307_00003.jpg

View of wild growth on landside slope and shoulder. (Fall 2018)

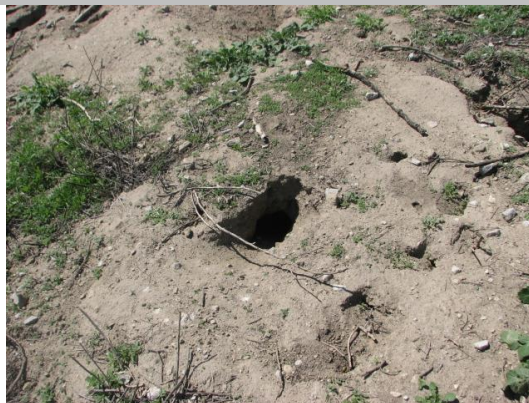
Photo 1 of 1 : SP_2019_NA0011_145_19_20190307_00017.jpg

Looking at large rodent hole on landward slope. (Spring 2018)

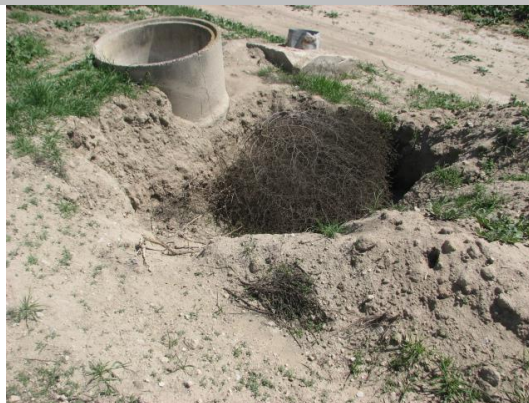
Photo 1 of 3 : SP_2019_NA0011_145_22_20190307_00018.jpg

Looking west at large hole next concrete riser (no pipe) on landward slope. (Spring 2018)

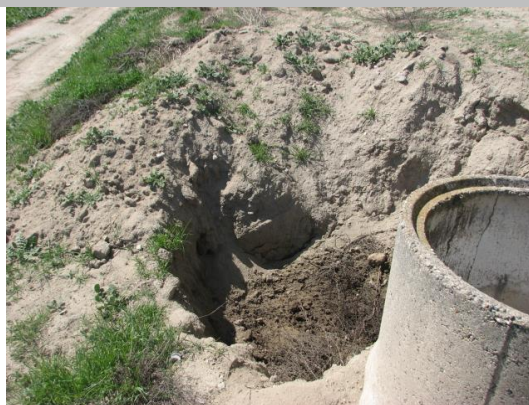
Photo 2 of 3 : SP_2019_NA0011_145_22_20190307_00019.jpg

Looking upstream at large hole on landward slope. (Spring 2018)

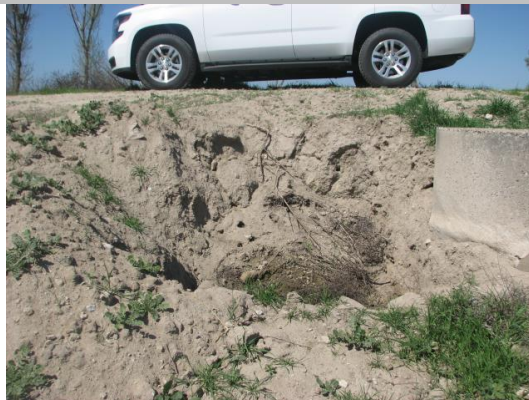
Photo 3 of 3 : SP_2019_NA0011_145_22_20190307_00020.jpg

Looking east at large hole next to riser (no pipe) on landward slope. (Spring 2018)

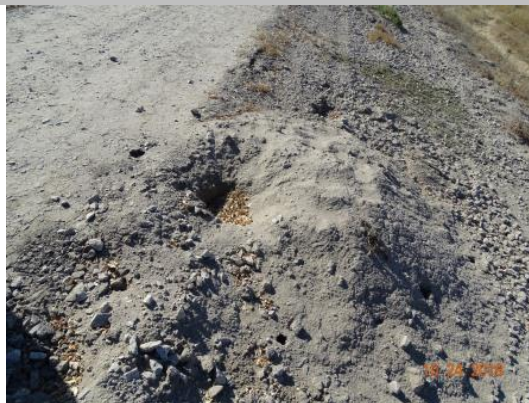
Photo 1 of 2 : SP_2019_NA0011_145_30_20190307_00022.jpg

Several large rodent holes on waterside slope. (Fall 2018)

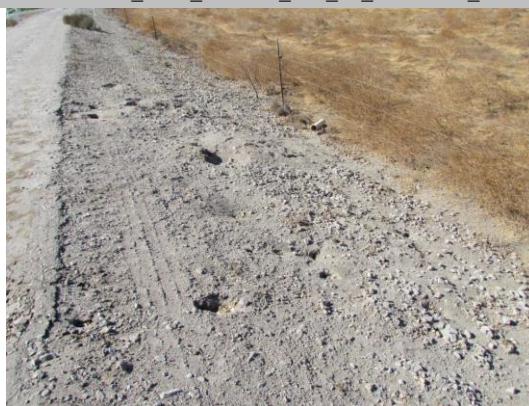
Photo 2 of 2 : SP_2019_NA0011_145_30_20190307_00023.jpg

View of rodent holes on the waterside slope.

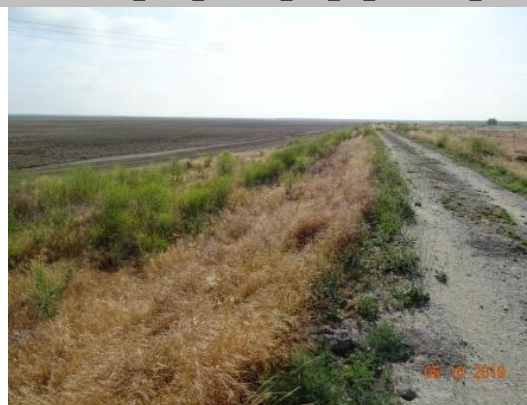
Photo 1 of 1 : SP_2019_NA0011_146_20_20190514_00034.jpg

View of landside slope looking upstream. (Spring 2019)

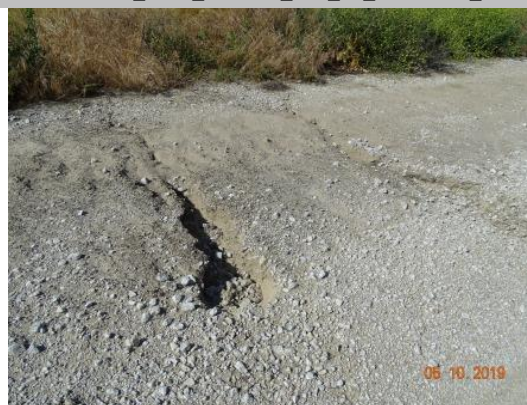
Photo 1 of 1 : SP_2019_NA0011_146_46_20190514_00038.jpg

Rills observed on waterside slope. (Spring 2019)

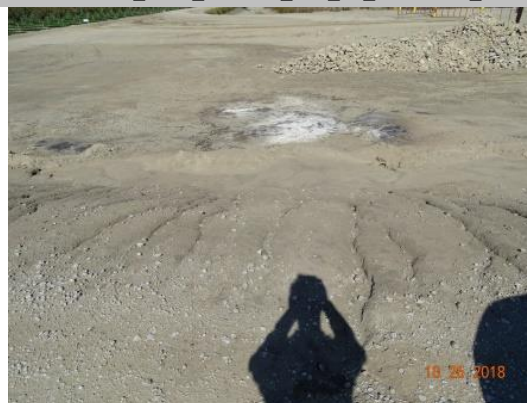
Photo 1 of 1 : SP_2019_NA0011_146_37_20190307_00021.jpg

Rill erosion on landside slope. (Fall 2018)

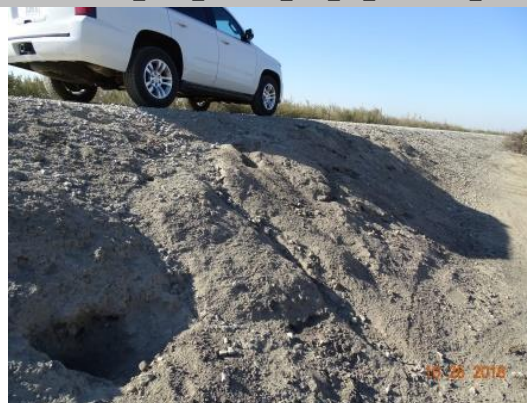
Photo 1 of 1 : SP_2019_NA0011_146_24_20190307_00012.jpg

Rodent activity on landside slope. (Fall 2018)

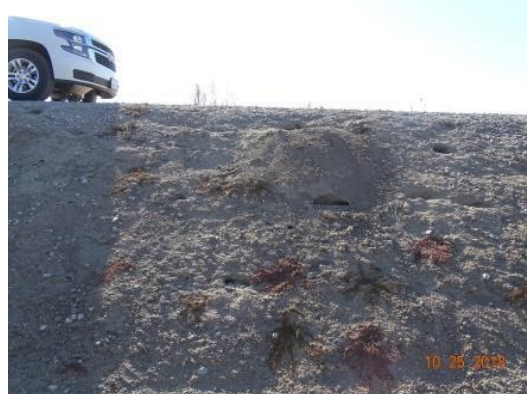
Photo 1 of 1 : SP_2019_NA0011_146_12_20190307_00005.jpg

Rodent activity on landside slope. (Fall 2018)

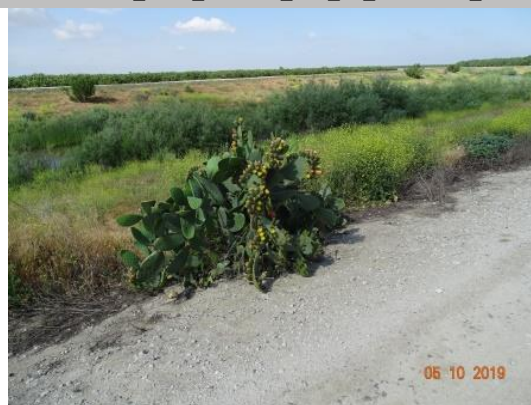
Photo 1 of 2 : SP_2019_NA0011_146_10_20190514_00041.jpg

Cactus growing on waterside shoulder. (Spring 2019)

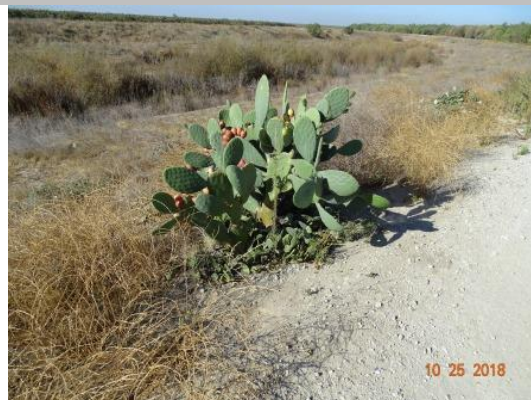
Photo 2 of 2 : SP_2019_NA0011_146_10_20190307_00003.jpg

Cactus on waterside slope. (Fall 2018)

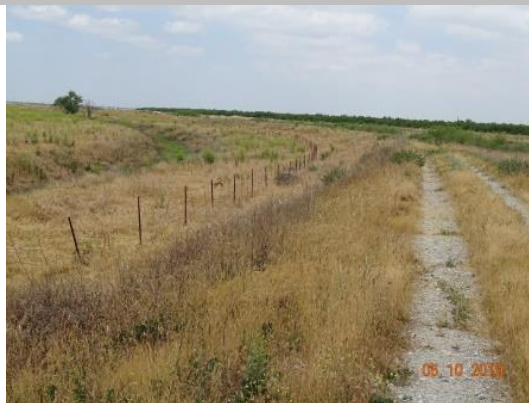
Photo 1 of 1 : SP_2019_NA0011_147_84_20190514_00056.jpg

View of landside slope looking downstream. (Spring 2019)

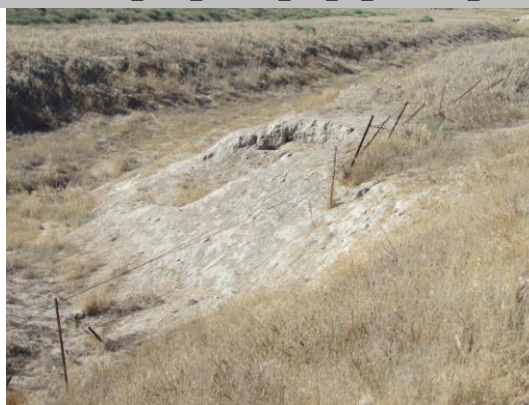
Photo 1 of 1 : SP_2019_NA0011_147_20_20190307_00008.jpg

Looking downstream at the old erosion site landside slope.

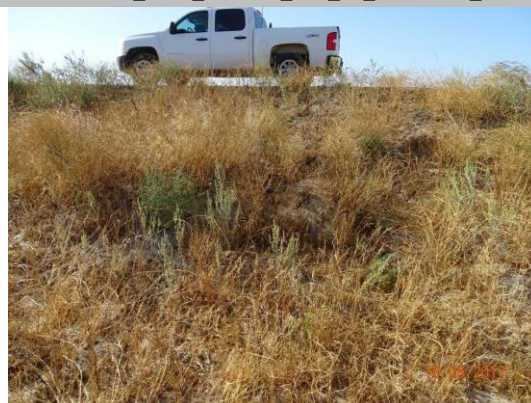
Photo 1 of 2 : SP_2019_NA0011_147_17_20190307_00006.jpg

Observed slump possibly exacerbated by rodent activity. 20' long x 8' high x 18" deep into levee slope.

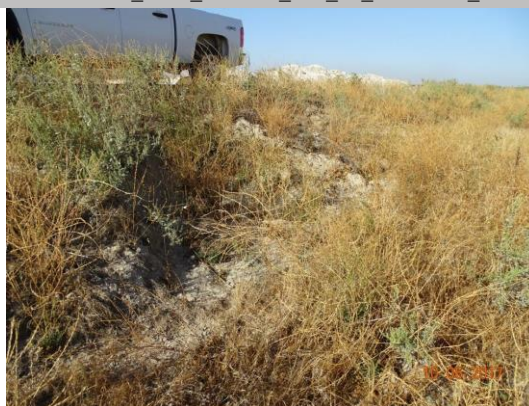
Photo 2 of 2 : SP_2019_NA0011_147_17_20190307_00007.jpg

Observed slump possibly exacerbated by rodent activity. 20' long x 8' high x 18" deep into levee slope.

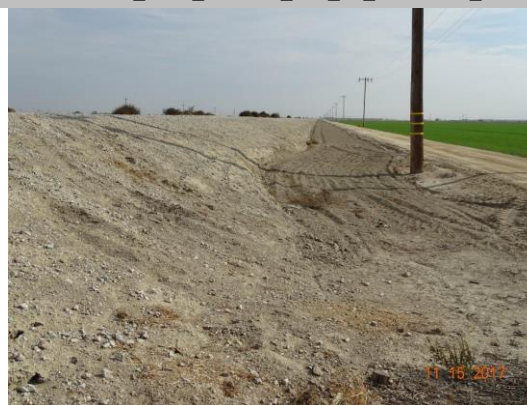
Photo 1 of 1 : SP_2019_NA0011_147_27_20190307_00013.jpg

Ag activity has cut into landside toe. Activity should be stopped and levee slope repaired.

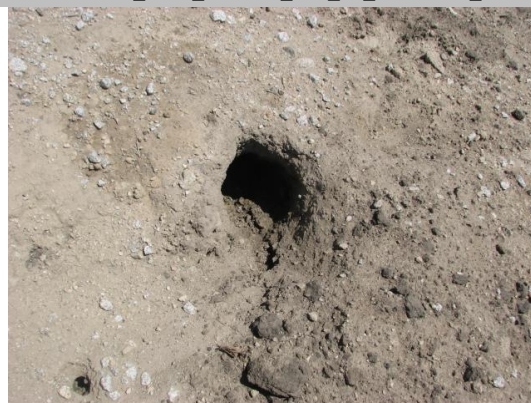
Photo 1 of 1 : SP_2019_NA0011_147_53_20190307_00029.jpg

Looking at typical rodent hole on landward slope. (Spring 2018)

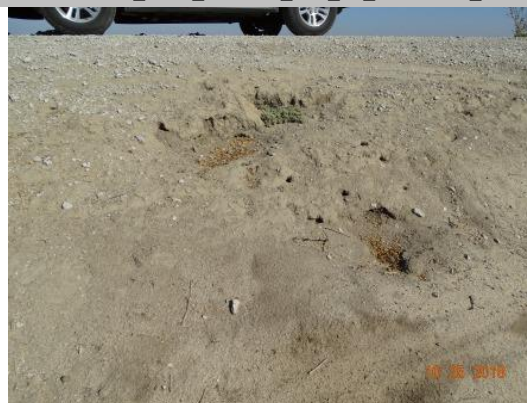
Photo 1 of 1 : SP_2019_NA0011_147_58_20190307_00032.jpg

minor erosion in landside slope. (Fall 2018)

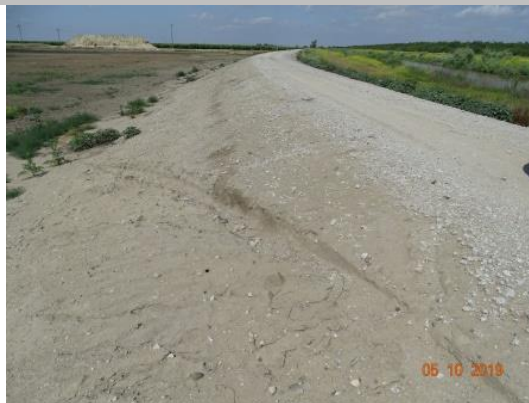
Photo 1 of 1 : SP_2019_NA0011_147_59_20190514_00064.jpg

View of vehicle tracks on landside slope. (Spring 2019)

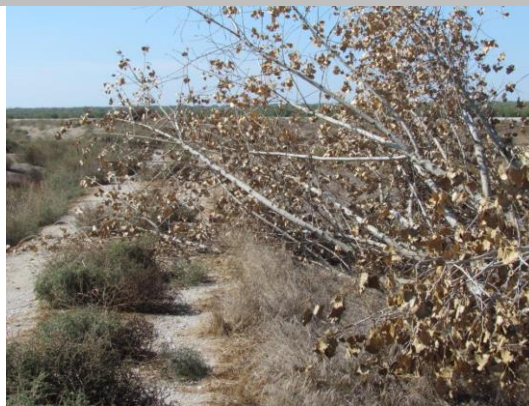
Photo 1 of 2 : SP_2019_NA0011_147_36_20190307_00018.jpg

Dead tree pushed upon the waterside slope and blocking the crown.

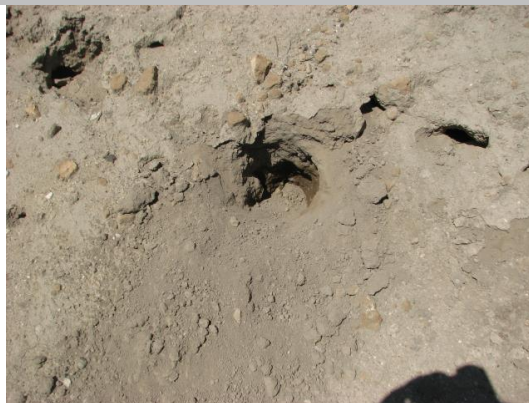
Photo 1 of 1 : SP_2019_NA0011_147_51_20190307_00026.jpg

Looking at typical rodent holes on landward slope. (Spring 2018)

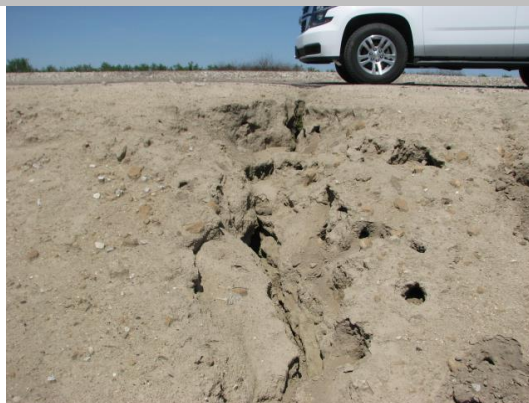
Photo 1 of 1 : SP_2019_NA0011_147_22_20190307_00010.jpg

Looking at finger erosion on landward slope. (Spring 2018)
