**Flood Control Project Maintenance  
Levee Inspections**

**Maintenance Issue Types Only, Levee Inspection Report By Mile - Spring 2020**

**Madera County FCWCA**

Waterway	Bank	Unit Miles	Inspection Start/End	Inspector
Unit No. 01 Ash Slough	Right	2.37	04/14/2020 04/14/2020	Corey Fujitani

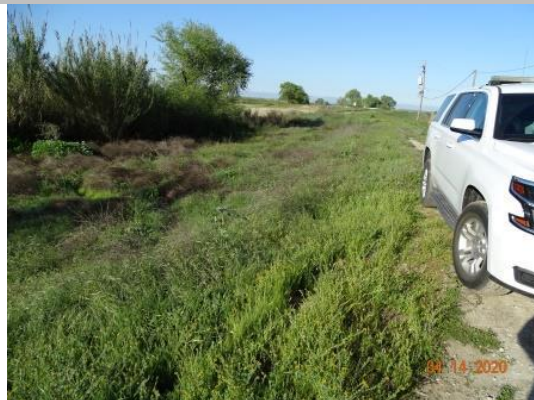
Photo 1 of 1 : SP\_2020\_NA0011\_142\_7\_20200417\_00035.jpg

LM Start	0.03	Rating **	U	Issue No.	7
LM End	0.90	Issue Type +	Ma	Location *	WS
Category	Earthen Levee			GPS Latitude/Longitude	
				Start	End
Item	Vegetation			37.046600 °	37.054865 °
				-120.427453 °	-120.416844 °
DWR ID	DWR_NA0011_01_s_2020_7				
Comment Code					
V1 : Control annual grass and weeds on the levee slopes and easements.					
Inspector Comment

View of vegetation on the waterside slope looking downstream. (Spring 2020)

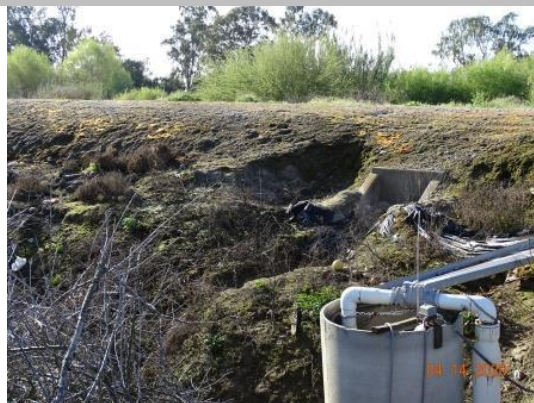
Photo 1 of 2 : SP\_2020\_NA0011\_142\_20\_20200417\_00036.jpg

LM Start	0.04	Rating **	U	Issue No.	20
LM End	0.04	Issue Type +	Ma	Location *	LS
Category	Earthen Levee			GPS Latitude/Longitude	
				Start	End
Item	Slope Stability			37.046624 °	37.046624 °
				-120.427317 °	-120.427317 °
DWR ID	DWR_NA0011_01_s_2014_20				
Comment Code					
S1 : Repair slope instability.					
Inspector Comment					
This is not a new erosion site, it should be repaired before the condition gets any worse.

View of slope damage next to pipe headwall structure. (Spring 2020)

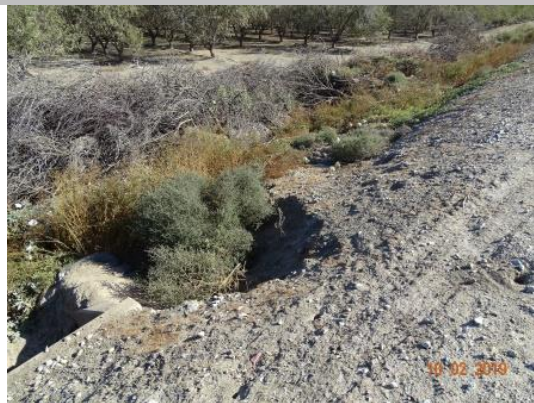
Photo 2 of 2 : SP\_2020\_NA0011\_142\_20\_20200225\_00010.jpg

View of damage to landside slope. (Fall 2019)

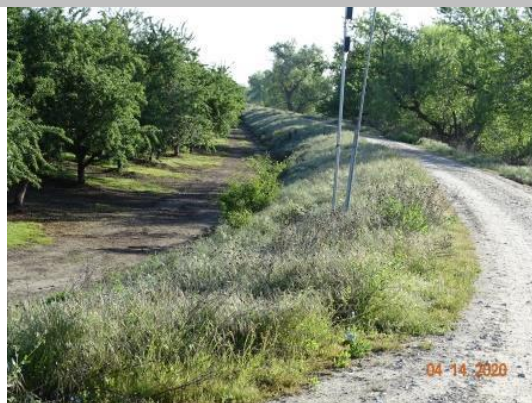
Photo 1 of 1 : SP\_2020\_NA0011\_142\_12\_20200417\_00038.jpg

View of the landside slope looking upstream. (Spring 2020)

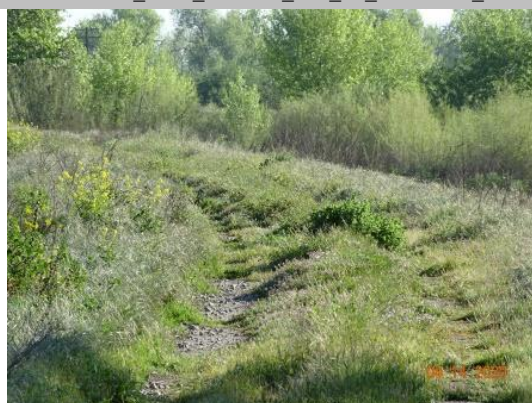
Photo 1 of 1 : SP\_2020\_NA0011\_142\_30\_20200417\_00042.jpg

View of vegetation along the levee crown. (Spring 2020)

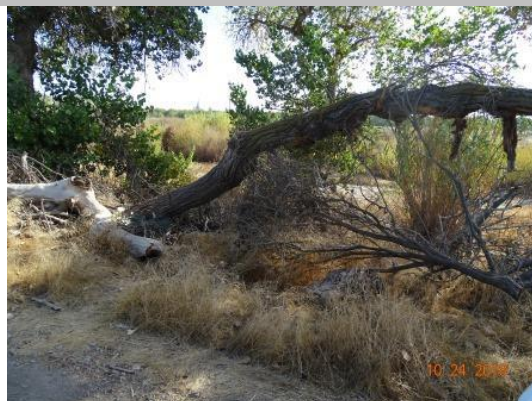
Photo 1 of 1 : SP\_2020\_NA0011\_142\_25\_20200225\_00015.jpg

LM Start	0.79	Rating **	U	Issue No.	25
LM End	0.79	Issue Type +	Ma	Location *	WS
Category	Earthen Levee			GPS Latitude/Longitude	
				Start	End
Item	Encroachments			37.053329 °	37.053329 °
				-120.417448 °	-120.417448 °
DWR ID	DWR_NA0011_01_f_2018_25				
Comment Code					
TR : Tree or limb					
Inspector Comment					
There is a fallen tree blocking the waterside slope.

tree limbs and trunks on waterside shoulder and slope. (Fall 2018)

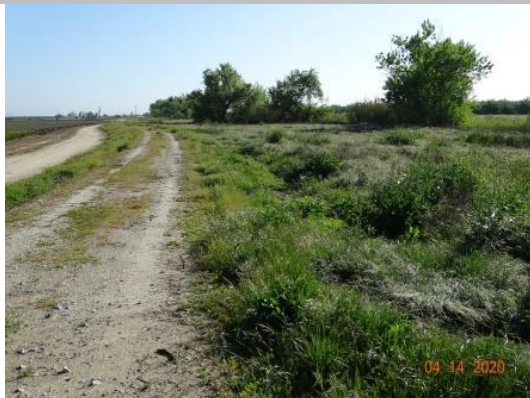
Photo 1 of 1 : SP\_2020\_NA0011\_142\_35\_20200417\_00046.jpg

View of vegetation growing along the waterside slope looking upstream.  
(Spring 2020)

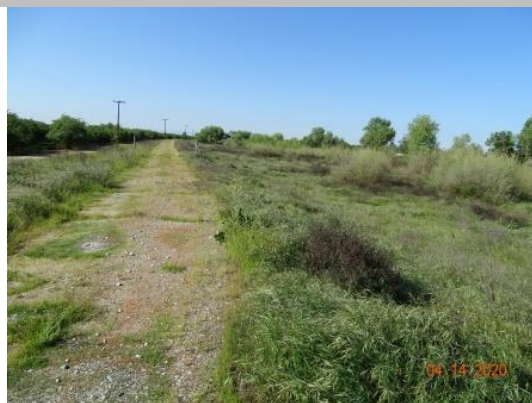
Photo 1 of 1 : SP\_2020\_NA0011\_143\_37\_20200417\_00050.jpg

View of the vegetation on the waterside slope looking downstream.  
(Spring 2020)

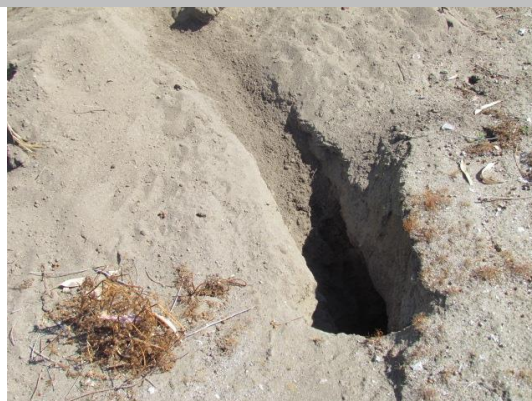
Photo 1 of 2 : SP\_2020\_NA0011\_143\_39\_20200225\_00028.jpg

Active rodents spotted in the area waterside slope levee mile 0.00- 1.67.

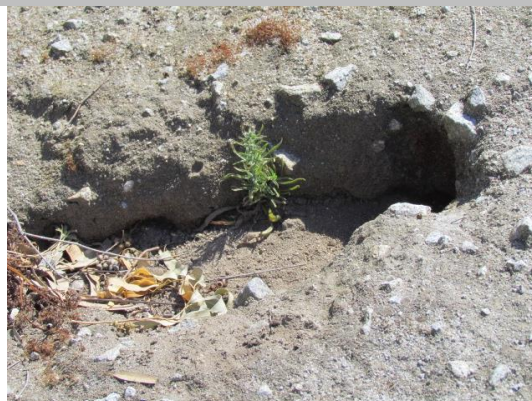
Photo 2 of 2 : SP\_2020\_NA0011\_143\_39\_20200225\_00029.jpg

Other rodent holes noted in the slope waterside levee section.

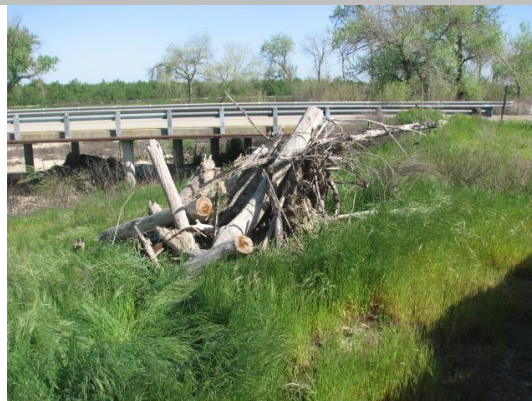
Photo 1 of 1 : SP\_2020\_NA0011\_143\_34\_20200225\_00027.jpg

Looking downstream at bush pile on waterward slope. (Spring 2018)

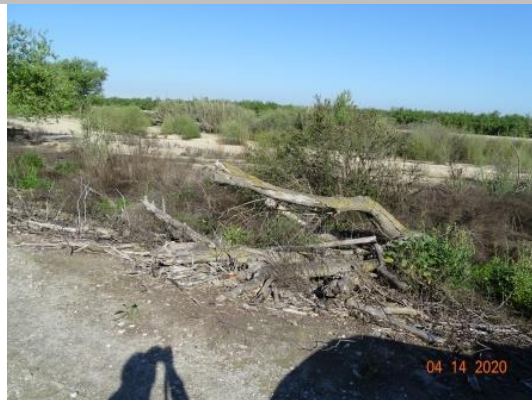
Photo 1 of 1 : SP\_2020\_NA0011\_143\_27\_20200417\_00053.jpg

Branches left along the waterside slope from high flow. (Spring 2020)

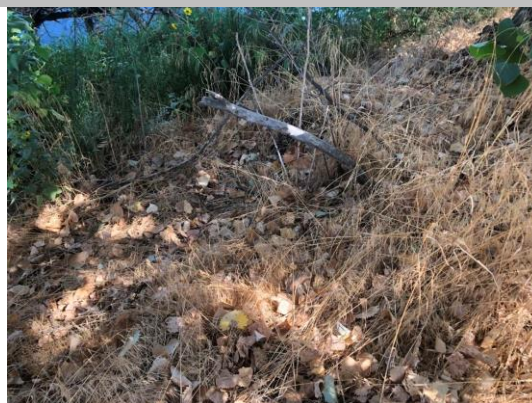
Photo 1 of 1 : SP\_2020\_NA0011\_143\_1\_20200225\_00001.jpg

LM Start	1.10	Rating **	U	Issue No.	1	
LM End	1.19	Issue Type +	Ma	Location *		
Category	Supplemental			GPS Latitude/Longitude		
				Start	End	
Item	DWR Erosion Survey			37.055596 °	37.055596 °	
				-120.412647 °	-120.412647 °	
DWR ID	NA0011U02RM2.57

Comment Code						
Inspector Comment						
Site ID: NA0011U02RM2.57 09/10/2019: No significant change observed. 09/20/2017: No significant change observed. 07/22/2016: No significant change observed. 09/08/2015: No significant change observed. 07/22/2014: No significant change observed. 08/30/2013: No significant change observed. 07/31/2012: Site was visited on 07/24/2012. No significant change observed. Dense vegetation around the site 08/09/2011: Site was inspected. No visible change was observed from the previous condition. A fallen tree was seen at the levee toe about 20 feet upstream, and tree root exposed. There has been no report from the district that this site was corrected. 11/30/2010: Site was not inspected due to time constraints. There have been no reports from the district that the site was corrected. Continue to monitor site during flood events. 08/05/2010: Recommended for annual assessment and monitoring during flood events, per CLRO. 2009: Site is recommended as a local maintenance issue, per Critical Levee Repair Office, Critical Erosion Sites Evaluation 2008 Report; site was previously rated "M" 9/6/2007: Undercutting of the toe; several trees along the WS slope with roots exposed.

View of the erosion site from the levee crest.

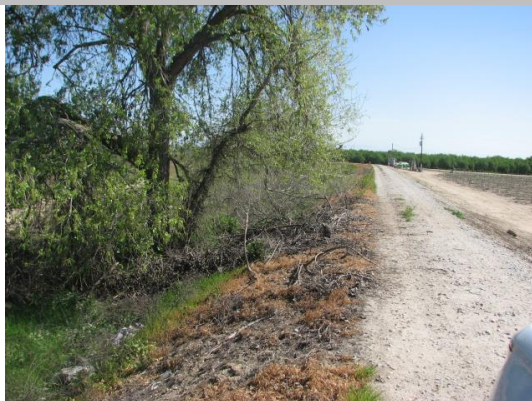
Photo 1 of 1 : SP\_2020\_NA0011\_143\_25\_20200225\_00019.jpg

Looking downstream at untrimmed tree on waterward slope. (Spring 2018)

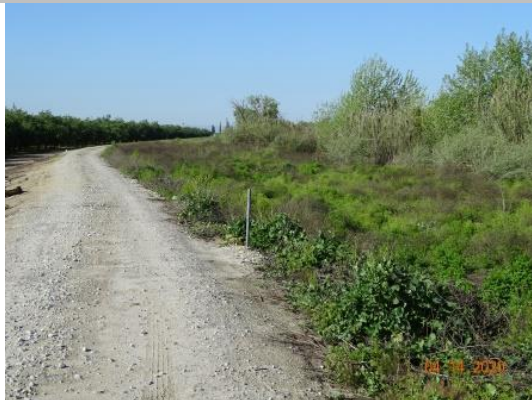
Photo 1 of 1 : SP\_2020\_NA0011\_143\_30\_20200417\_00054.jpg

Vegetation growing on the waterside slope. (Spring 2020)

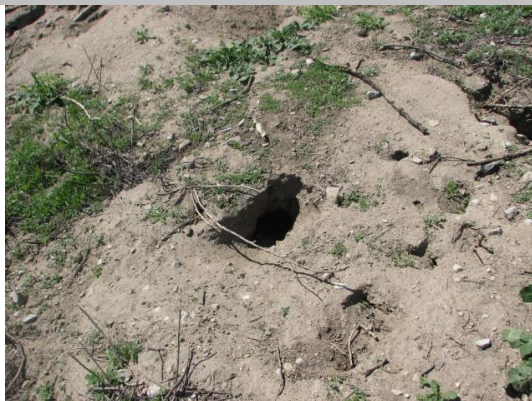
Photo 1 of 1 : SP\_2020\_NA0011\_145\_19\_20200225\_00017.jpg

Looking at large rodent hole on landward slope. (Spring 2018)

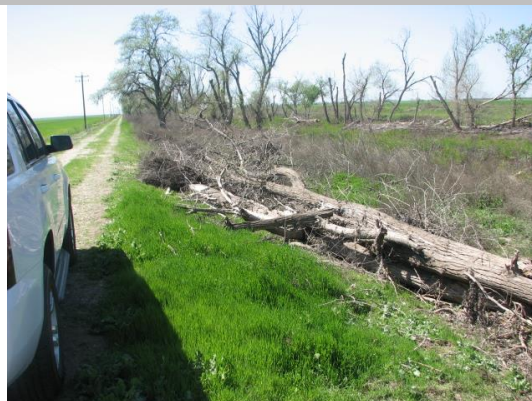
Photo 1 of 1 : SP\_2020\_NA0011\_145\_14\_20200225\_00013.jpg

Looking upstream at fallen tree on waterward slope. (Spring 2018)

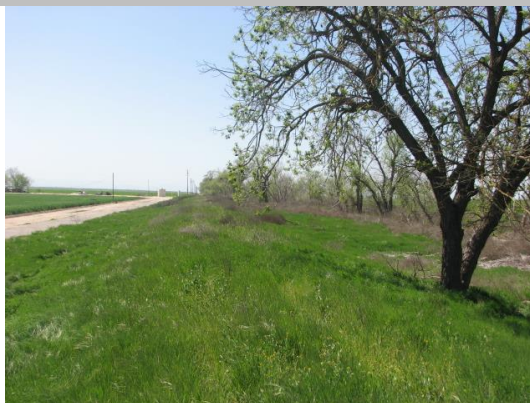
Photo 1 of 1 : SP\_2020\_NA0011\_145\_10\_20200225\_00007.jpg

Looking upstream at tree on waterward slope. (Spring 2018)

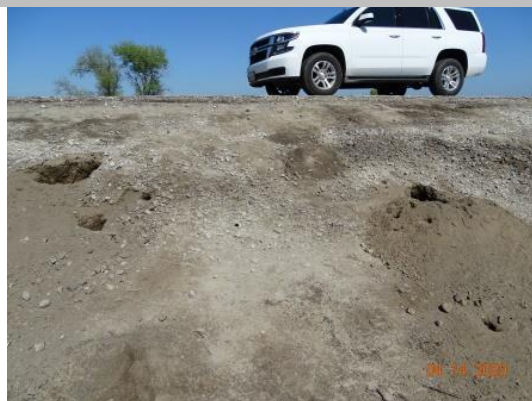
Photo 1 of 1 : SP\_2020\_NA0011\_145\_11\_20200420\_00035.jpg

Representative view of rodent holes observed in this section. (Spring 2020)

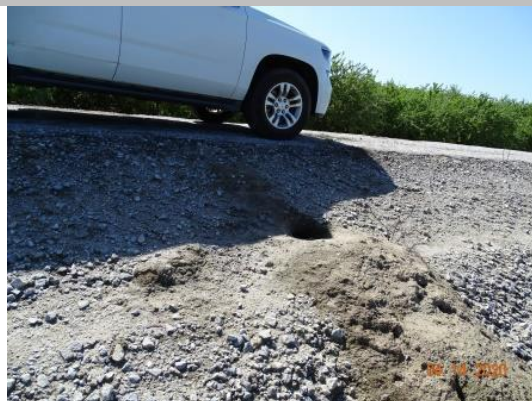
Photo 1 of 1 : SP\_2020\_NA0011\_145\_30\_20200420\_00036.jpg

Several large rodent holes on waterside slope. (Spring 2020)

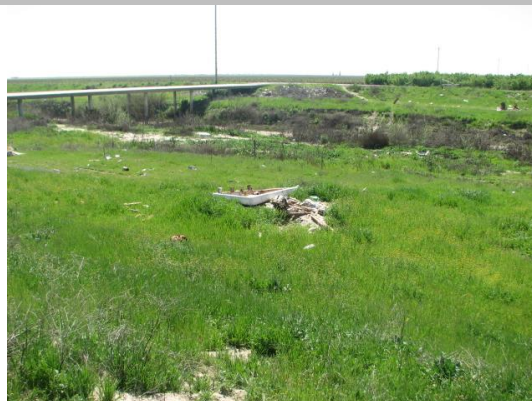
Photo 1 of 1 : SP\_2020\_NA0011\_146\_19\_20200225\_00015.jpg

Looking west at garbage in channel. (Spring 2018)

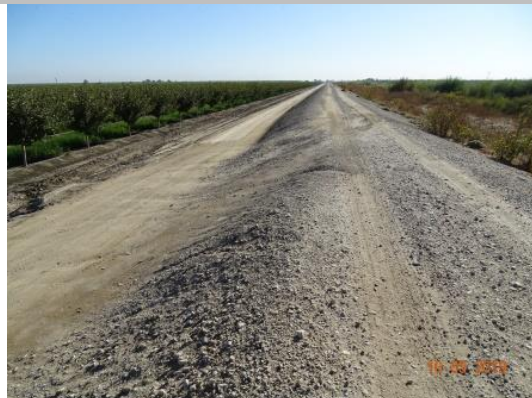
Photo 1 of 1 : SP\_2020\_NA0011\_146\_18\_20200225\_00013.jpg

LM Start	5.56	Rating **	M	Issue No.	18
LM End	5.56	Issue Type +	Ma	Location *	LS
Category	Earthen Levee			GPS Latitude/Longitude	
				Start	End
Item	Slope Stability			36.968210 °	36.968210 °
				-120.273729 °	-120.273729 °
DWR ID	DWR_NA0011_05_f_2017_18				
Comment Code					
S3 : Repair the levee slope damaged by vehicle traffic and prevent access where possible.					
Inspector Comment					
Repair damage from vehicle traffic on slope and shoulder.

Damage to landside shoulder and slope looking upstream. (Fall 2019)

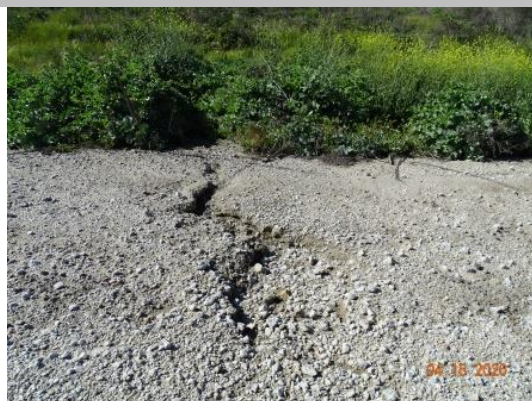
Photo 1 of 1 : SP\_2020\_NA0011\_146\_38\_20200504\_00057.jpg

LM Start	5.67	Rating **	M	Issue No.	38
LM End	5.67	Issue Type +	Ma	Location *	WS
Category	Earthen Levee			GPS Latitude/Longitude	
				Start	End
Item	Erosion / Bank Caving			36.968204 °	36.968204 °
				-120.271707 °	-120.271707 °
DWR ID	DWR_NA0011_05_f_2018_38				
Comment Code					
E2 : Schedule repair of erosion site prior to the next inspection.					
Inspector Comment

Finger erosion on the waterside slope. (Spring 2020)

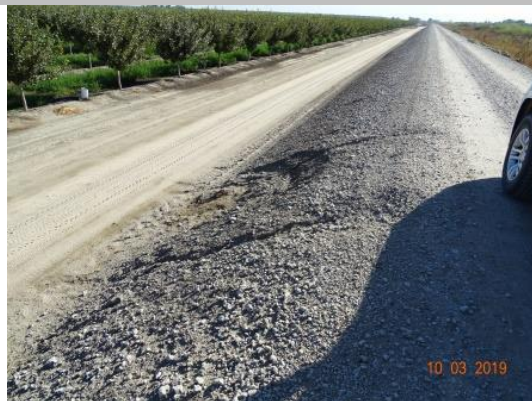
Photo 1 of 1 : SP\_2020\_NA0011\_146\_17\_20200225\_00011.jpg

View of landside slope erosion looking upstream. (Fall 2019)

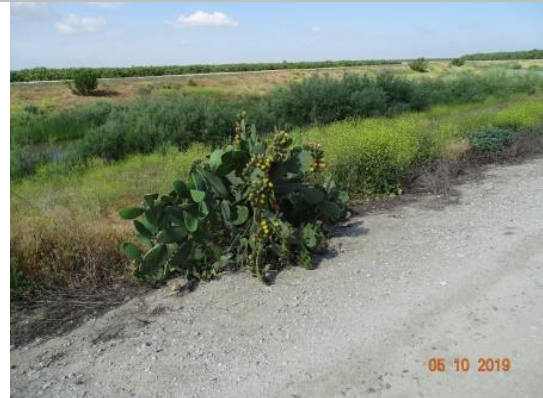
Photo 1 of 1 : SP\_2020\_NA0011\_146\_10\_20200225\_00005.jpg

Cactus growing on waterside shoulder. (Spring 2019)

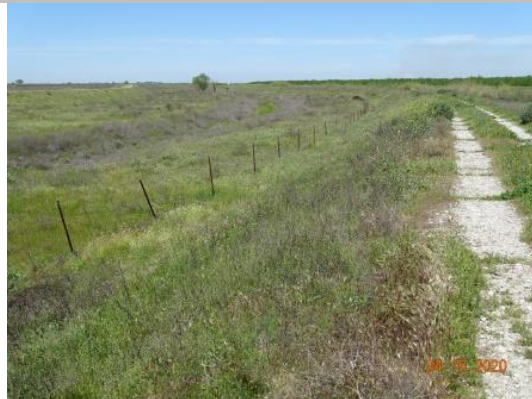
Photo 1 of 1 : SP\_2020\_NA0011\_147\_72\_20200519\_00067.jpg

View of vegetation along the landside slope looking downstream. (Spring 2020)

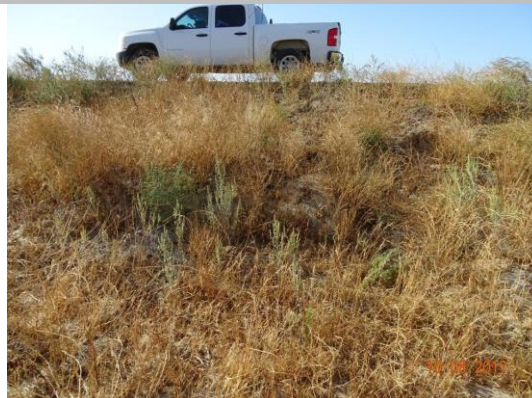
Photo 1 of 1 : SP\_2020\_NA0011\_147\_17\_20200225\_00006.jpg

Observed slump possibly exacerbated by rodent activity. 20' long x 8' high x 18" deep into levee slope.

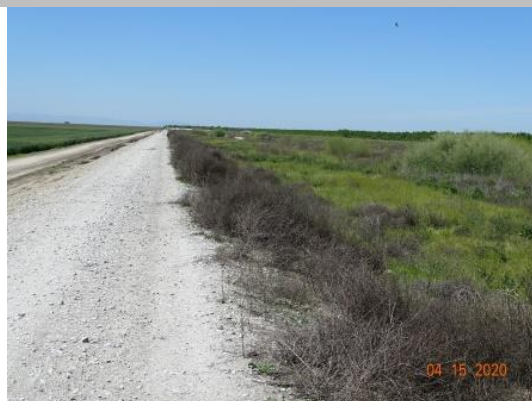
Photo 1 of 1 : SP\_2020\_NA0011\_147\_70\_20200504\_00058.jpg

View of vegetation along the waterside slope. (Spring 2020)

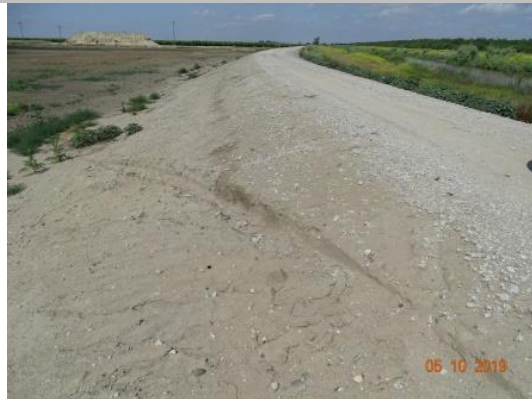
Photo 1 of 1 : SP\_2020\_NA0011\_147\_59\_20200225\_00032.jpg

View of vehicle tracks on landside slope. (Spring 2019)

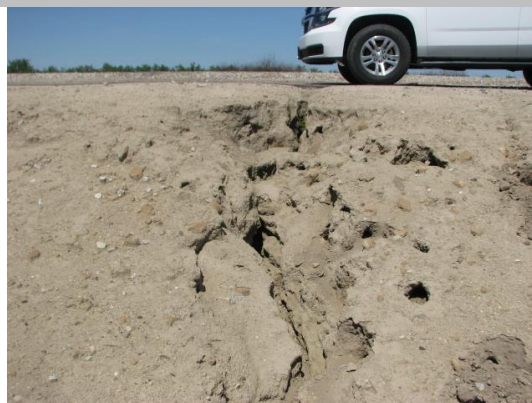
Photo 1 of 1 : SP\_2020\_NA0011\_147\_22\_20200225\_00009.jpg

Looking at finger erosion on landward slope. (Spring 2018)
