**Flood Control Project Maintenance
Levee Inspections**

Maintenance Issue Types Only, Levee Inspection Report By Mile - Spring 2021

Madera County FCWCA

Waterway	Bank	Unit Miles	Inspection Start/End	Inspector
Unit No. 01 Ash Slough	Right	2.37	04/22/2021 04/22/2021	Corey Fujitani

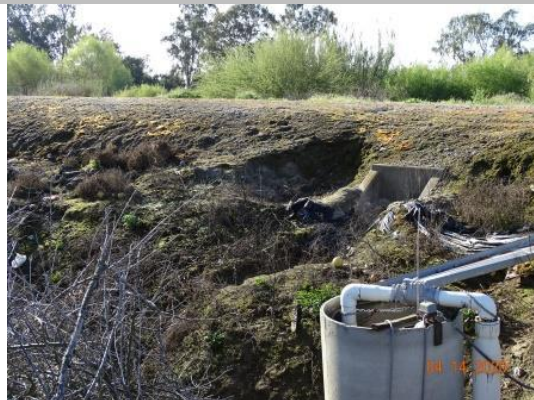
Photo 1 of 1 : SP_2021_NA0011_142_20_20210308_00007.jpg

LM Start	0.04	Rating **	U	Issue No.	20
LM End	0.04	Issue Type +	Ma	Location *	LS
Category	Earthen Levee			GPS Latitude/Longitude	
				Start	End
Item	Erosion / Bank Caving			37.046624 °	37.046624 °
				-120.427317 °	-120.427317 °
DWR ID	DWR_NA0011_01_s _ 2014_20				
Comment Code					
E2 : Schedule repair of erosion site prior to the next inspection.					
Inspector Comment					
This is not a new erosion site, it should be repaired before the condition gets any worse.

View of slope damage next to pipe headwall structure. (Spring 2020)

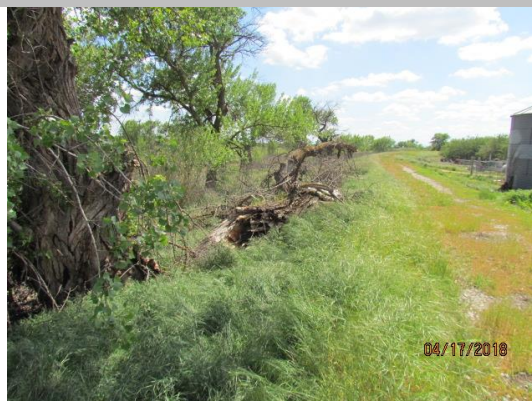
Photo 1 of 1 : SP_2021_NA0011_142_21_20210308_00009.jpg

Looking west at tree limbs and branches on waterward slope. (Spring 2018)

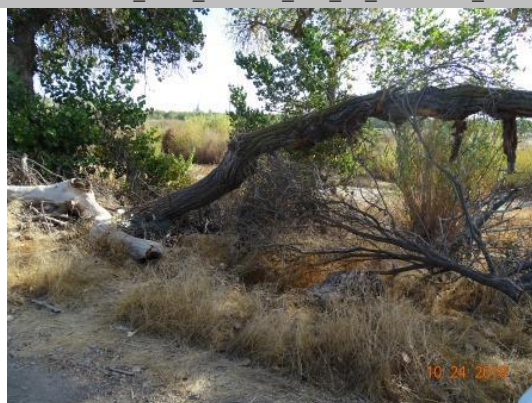
Photo 1 of 1 : SP_2021_NA0011_142_25_20210308_00010.jpg

LM Start	0.79	Rating **	U	Issue No.	25	
LM End	0.79	Issue Type +	Ma	Location *	WS	
Category	Earthen Levee			GPS Latitude/Longitude		
				Start		End
Item	Encroachments			37.053329 °		37.053329 °
				-120.417448 °		-120.417448 °
DWR ID	DWR_NA0011_01_f_2018_25					
Comment Code						
TR : Tree or limb						
Inspector Comment						
There is a fallen tree blocking the waterside slope.

Tree limbs and trunks are on the waterside shoulder and slope. (Fall 2018)

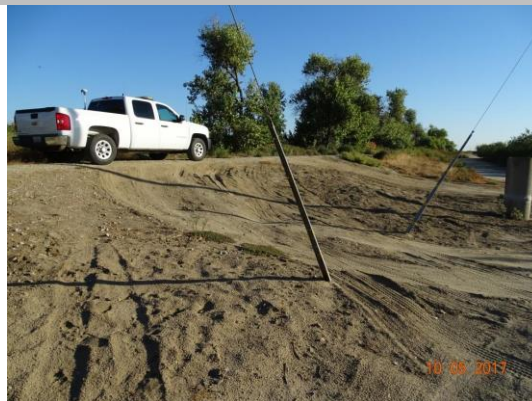
Photo 1 of 1 : SP_2021_NA0011_143_13_20210308_00008.jpg

LM Start	0.31	Rating **	M	Issue No.	13
LM End	0.31	Issue Type +	Ma	Location *	LS
Category	Earthen Levee			GPS Latitude/Longitude	
				Start	End
Item	Slope Stability			37.047266 °	37.047266 °
				-120.422393 °	-120.422393 °
DWR ID	DWR_NA0011_02_f_2017_13				
Comment Code					
S3 : Repair the levee slope damaged by vehicle traffic and prevent access where possible.					
Inspector Comment

Vehicle access to levee slope should be prevented and erosion repaired.

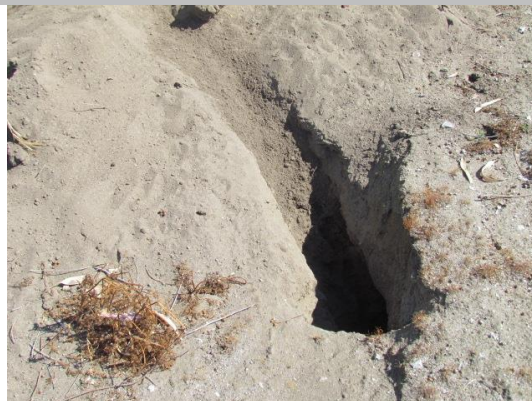
Photo 1 of 1 : SP_2021_NA0011_143_39_20210308_00021.jpg

Active rodents spotted in the area waterside slope levee mile 0.32- 1.67.

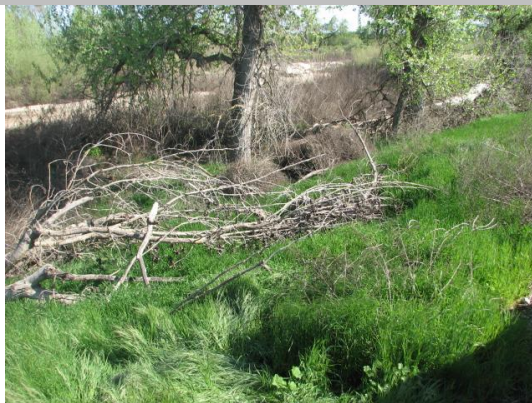
Photo 1 of 1 : SP_2021_NA0011_143_28_20210308_00015.jpg

Looking downstream at tree limbs on waterward slope and toe. (Spring 2018)

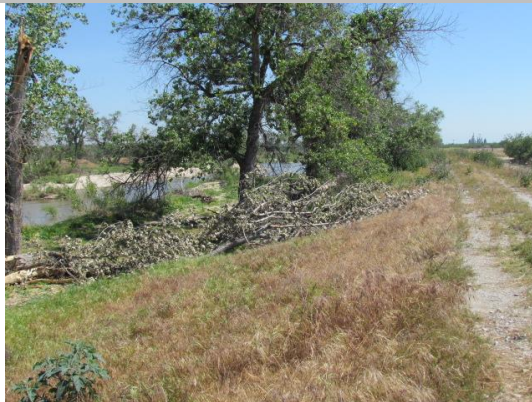
Photo 1 of 1 : SP_2021_NA0011_143_33_20210308_00019.jpg

Dead fallen trees on the waterside levee slope and shoulder.

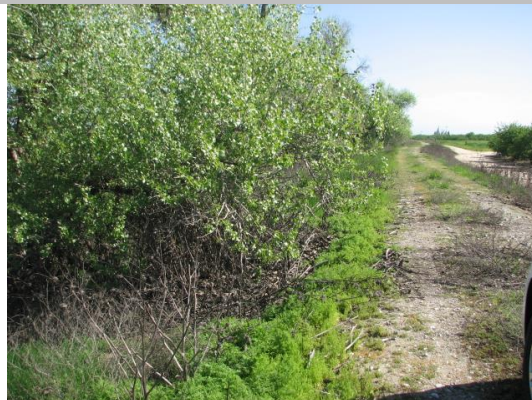
Photo 1 of 1 : SP_2021_NA0011_143_14_20210308_00009.jpg

Looking downstream at untrimmed trees on waterward shoulder and slope. (Spring 2018)

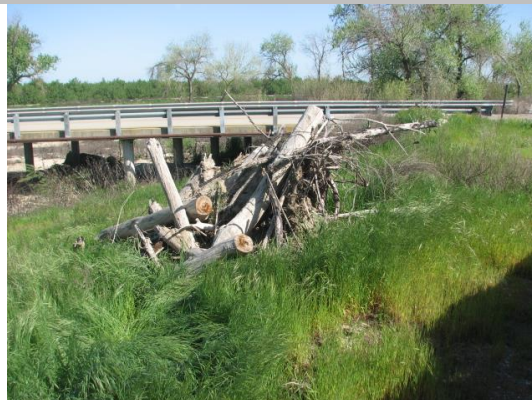
Photo 1 of 1 : SP_2021_NA0011_143_34_20210308_00020.jpg

Looking downstream at bush pile on waterward slope. (Spring 2018)

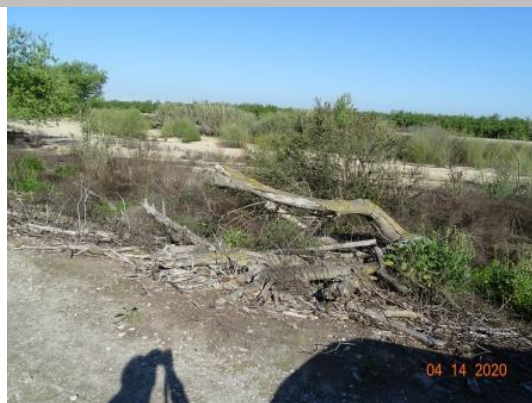
Photo 1 of 1 : SP_2021_NA0011_143_27_20210308_00014.jpg

LM Start	0.98	Rating **	U	Issue No.	27
LM End	1.52	Issue Type +	Ma	Location *	WS
Category	Earthen Levee			GPS Latitude/Longitude	
				Start	End
Item	Encroachments			37.054928 °	37.058752 °
				-120.415482 °	-120.407323 °
DWR ID	DWR_NA0011_02_s_2017_27				
Comment Code					
TR : Tree or limb					
Inspector Comment					
Remove the dead trees from the waterside slope and shoulder.

Branches left along the waterside slope from high flow. (Spring 2020)

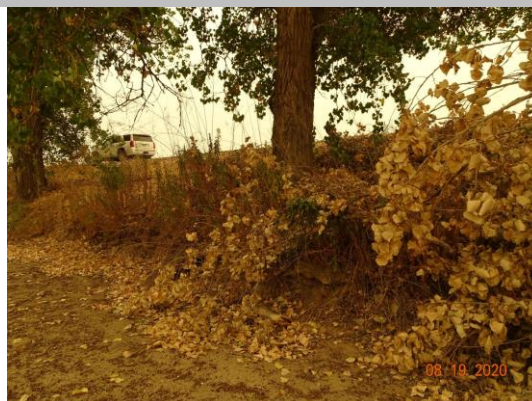
Photo 1 of 3 : SP_2021_NA0011_143_1_20210308_00001.jpg

Site ID: NA0011U02RM2.57
 08/19/2020: From 2013 to present, no significant changes were observed during the annual survey.
 07/24/2012: Dense vegetation around the site.
 08/09/2011: A fallen tree was seen at the levee toe about 20 feet upstream, and tree root exposed. There has been no report from the district that this site was corrected.
 11/30/2010: Site was not inspected due to time constraints. There have been no reports from the district that the site was corrected. Continue to monitor site during flood events.
 08/05/2010: Recommended for annual assessment and monitoring during flood events, per CLRO.
 2009: Site is recommended as a local maintenance issue, per Critical Levee Repair Office, Critical Erosion Sites Evaluation 2008 Report; site was previously rated "M"
 9/6/2007: Undercutting of the toe; several trees along the WS slope with roots exposed.

8/19/2020: Close-up view of erosion beneath a tree on the levee slope.

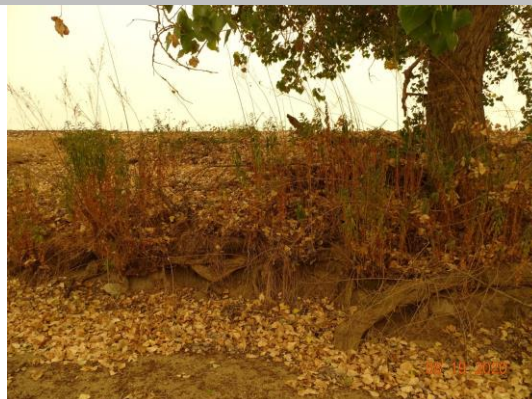
Photo 2 of 3 : SP_2021_NA0011_143_1_20210308_00002.jpg

8/19/2020: Eorsion visible on the levee toe.

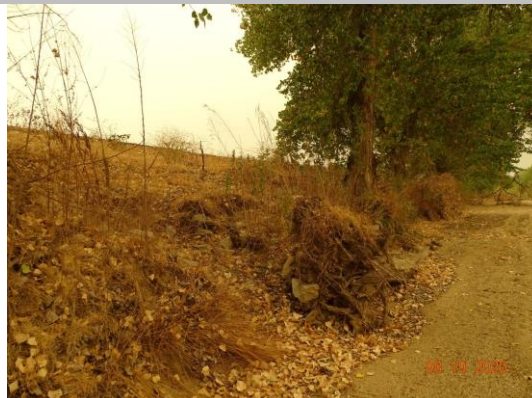
Photo 3 of 3 : SP_2021_NA0011_143_1_20210308_00003.jpg

8/19/2020: View of the levee slope looking downstream with erosion around a fallen tree root in the foreground.

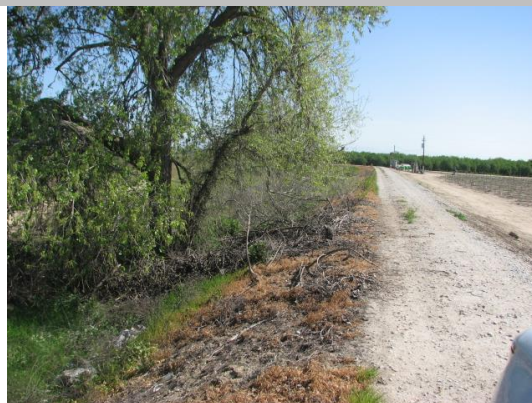
Photo 1 of 1 : SP_2021_NA0011_143_25_20210308_00013.jpg

Looking downstream at untrimmed tree on waterward slope. (Spring 2018)

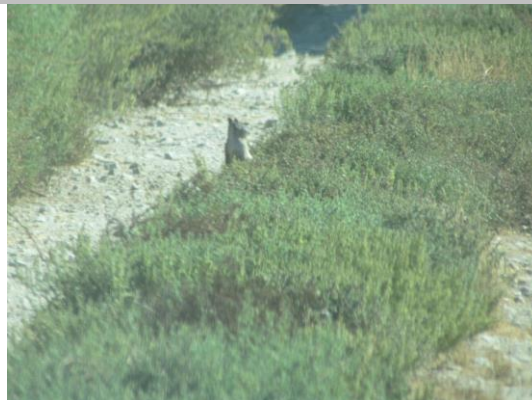
Photo 1 of 1 : SP_2021_NA0011_144_8_20210308_00004.jpg

LM Start	1.06	Rating **	M	Issue No.	8
LM End	1.51	Issue Type +	Ma	Location *	CR
Category	Earthen Levee			GPS Latitude/Longitude	
				Start	End
Item	Animal Control			36.996627 °	36.996607 °
				-120.354812 °	-120.346568 °
DWR ID	DWR_NA0011_03_f_2016_8				
Comment Code					
A1 : Exterminate rodents and backfill and compact or grout burrows.					
Inspector Comment					
Exterminate rodents from the roadway. Active rodents observed during inspection at this site.

Berenda Slough Unit 3 looking upstream.

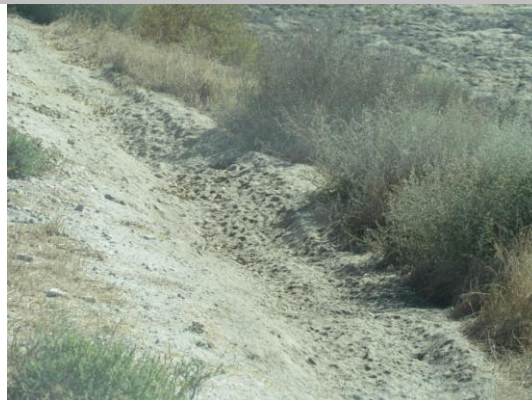
Photo 1 of 1 : SP_2021_NA0011_144_4_20210308_00001.jpg

LM Start	1.24	Rating **	M	Issue No.	4
LM End	1.25	Issue Type +	Ma	Location *	CR
Category	Earthen Levee			GPS Latitude/Longitude	
				Start	End
Item	Slope Stability			36.996582 °	36.996582 °
				-120.351482 °	-120.351258 °
DWR ID	DWR_NA0011_03_f_2016_4				
Comment Code					
S1 : Repair slope instability.					
Inspector Comment					
Repair the slope instability and damaged shoulder at this location.

Berenda Slough looking back upstream waterside at the shoulder and slope.

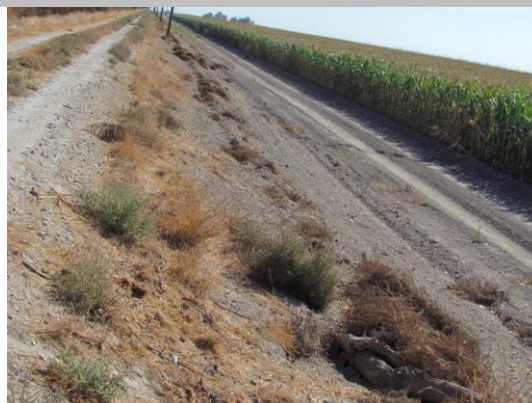
Photo 1 of 1 : SP_2021_NA0011_145_3_20210308_00001.jpg

LM Start	0.02	Rating **	M	Issue No.	3
LM End	0.97	Issue Type +	Ma	Location *	LS
Category	Earthen Levee			GPS Latitude/Longitude	
				Start	End
Item	Slope Stability			36.995506 °	36.995550 °
				-120.373233 °	-120.355935 °
DWR ID	DWR_NA0011_04_f_2016_3				
Comment Code					
S1 : Repair slope instability.					
Inspector Comment					
The slope in this area has been damaged by farm equipment.

Berenda Slough Unit 4 Looking upstream landside.

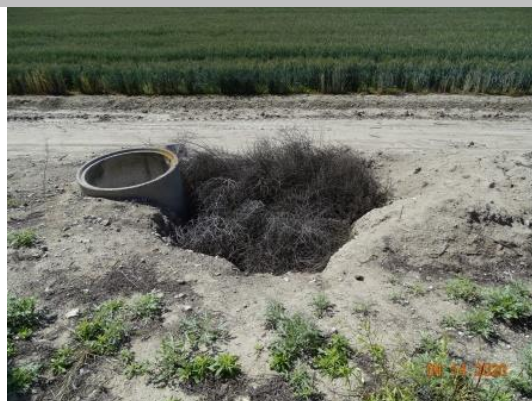
Photo 1 of 1 : SP_2021_NA0011_145_22_20210308_00016.jpg

LM Start	0.44	Rating **	U	Issue No.	22
LM End	0.44	Issue Type +	Ma	Location *	LS
Category	Earthen Levee			GPS Latitude/Longitude	
				Start	End
Item	Erosion / Bank Caving			36.995560 °	36.995560 °
				-120.365614 °	-120.365614 °
DWR ID	DWR_NA0011_04_s_2018_22				
Comment Code					
E2 : Schedule repair of erosion site prior to the next inspection.					
Inspector Comment					
A large hole was dug on the landward slope next to the concrete riser. There is no visible pipe at the site.

Looking west at large hole next concrete riser (no pipe) on landward slope. (Spring 2020)

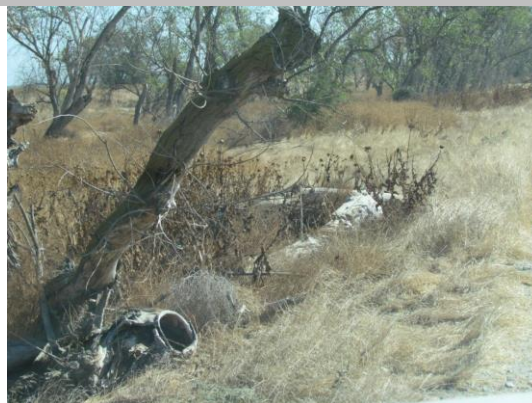
Photo 1 of 1 : SP_2021_NA0011_145_16_20210308_00013.jpg

LM Start	0.47	Rating **	M	Issue No.	16
LM End	0.47	Issue Type +	Ma	Location *	WS
Category	Earthen Levee			GPS Latitude/Longitude	
				Start	End
Item	Encroachments			36.995603 °	36.995603 °
				-120.364978 °	-120.364978 °
DWR ID	DWR_NA0011_04_s_2014_16				
Comment Code					
TR : Tree or limb					
Inspector Comment					
This dead tree on the waterward slope should be removed from the levee section.

Tree on WS shoulder.

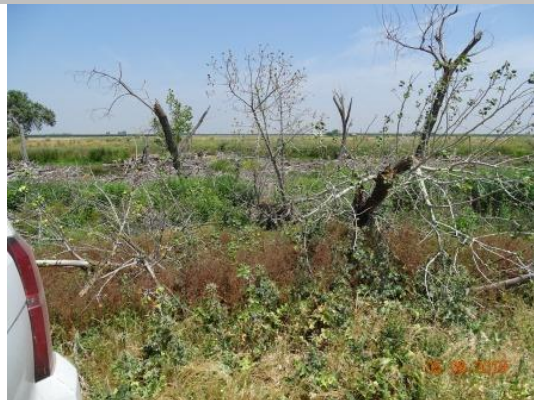
Photo 1 of 1 : SP_2021_NA0011_145_6_20210308_00004.jpg

View of fallen tree on waterside slope. (Spring 2019)

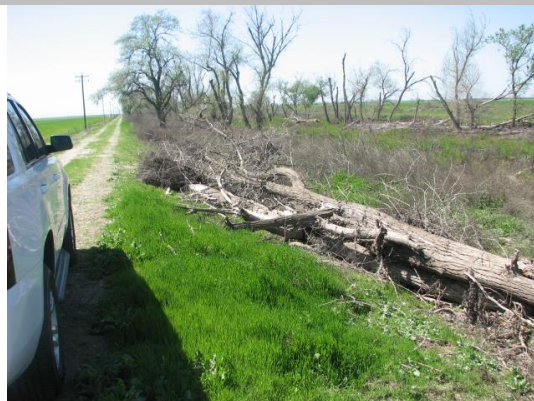
Photo 1 of 1 : SP_2021_NA0011_145_14_20210308_00011.jpg

Looking upstream at fallen tree on waterward slope. (Spring 2018)

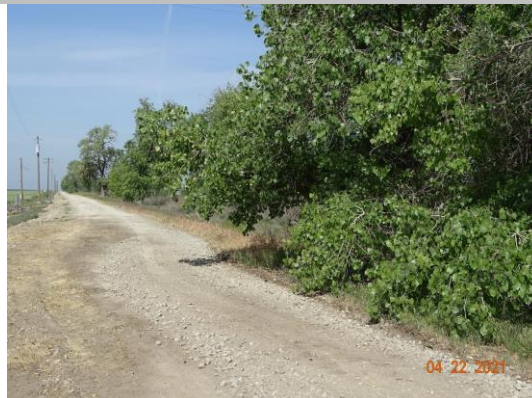
Photo 1 of 1 : SP_2021_NA0011_145_12_20210427_00027.jpg

Trim trees to at least 5' above levee slope and 12' above levee crown to allow inspection and access. (Spring 2021)

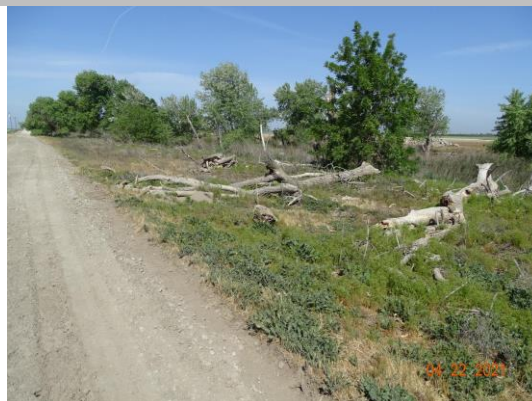
Photo 1 of 1 : SP_2021_NA0011_145_24_20210427_00028.jpg

LM Start	1.07	Rating **	U	Issue No.	24
LM End	1.07	Issue Type +	Ma	Location *	WS
Category	Earthen Levee			GPS Latitude/Longitude	
				Start	End
Item	Encroachments			36.995587 °	36.995587 °
				-120.354128 °	-120.354128 °
DWR ID	DWR_NA0011_04_s_2021_24				
Comment Code					
TR : Tree or limb					
Inspector Comment

View of fallen trees on the waterside slope and berm. (Spring 2021)

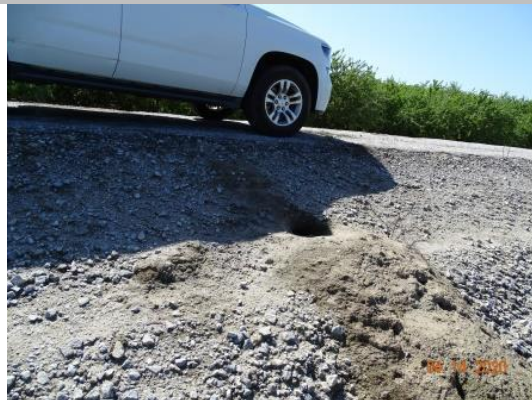
Photo 1 of 1 : SP_2021_NA0011_145_30_20210308_00019.jpg

Several large rodent holes on waterside slope. (Spring 2020)

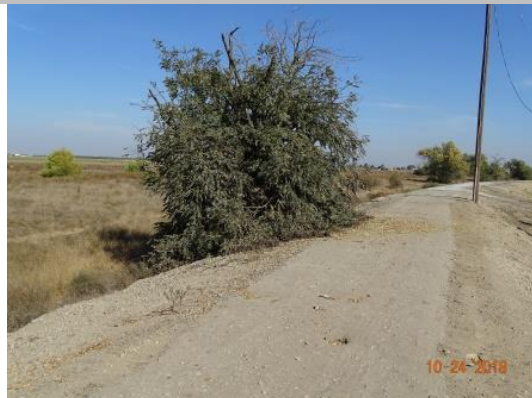
Photo 1 of 1 : SP_2021_NA0011_145_27_20210308_00018.jpg

Trim tree on waterside shoulder. (Fall 2018)

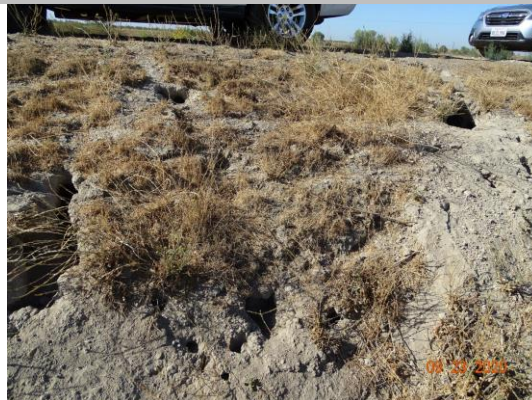
Photo 1 of 1 : SP_2021_NA0011_146_14_20210419_00007.jpg

Rodent activity on the landside slope. (Fall 2020)

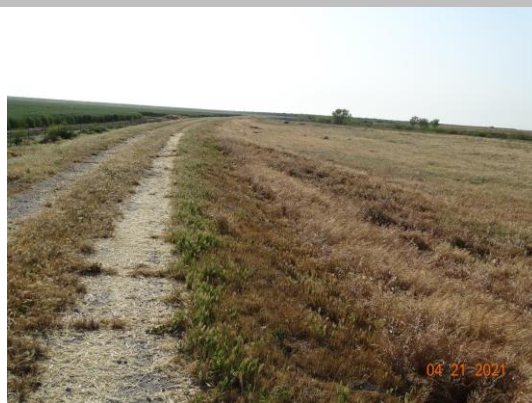
Photo 1 of 1 : SP_2021_NA0011_146_8_20210427_00037.jpg

View of vegetation along the waterside slope. (Spring 2021)

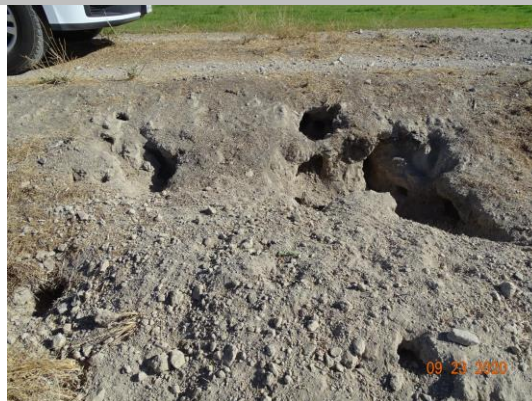
Photo 1 of 1 : SP_2021_NA0011_146_21_20210419_00011.jpg

LM Start	0.12	Rating **	U	Issue No.	21
LM End	0.12	Issue Type +	Ma	Location *	WS
Category	Earthen Levee			GPS Latitude/Longitude	
				Start	End
Item	Animal Control			36.978327 °	36.978327 °
				-120.366440 °	-120.366440 °
DWR ID	DWR_NA0011_05_f_2020_21				
Comment Code					
A1 : Exterminate rodents and backfill and compact or grout burrows.					
Inspector Comment

Rodent burrows in the waterside slope. (Fall 2020)

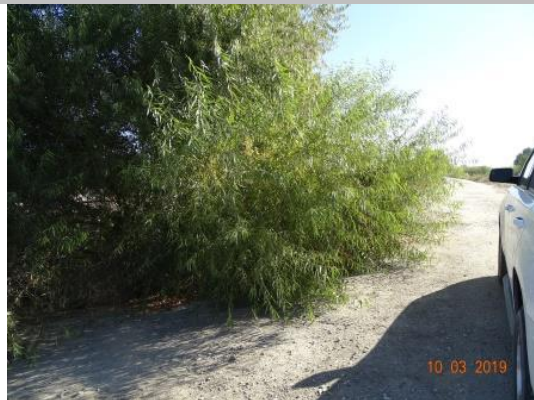
Photo 1 of 1 : SP_2021_NA0011_146_29_20210419_00016.jpg

View of tree growing on landside slope looking upstream. (Fall 2019)

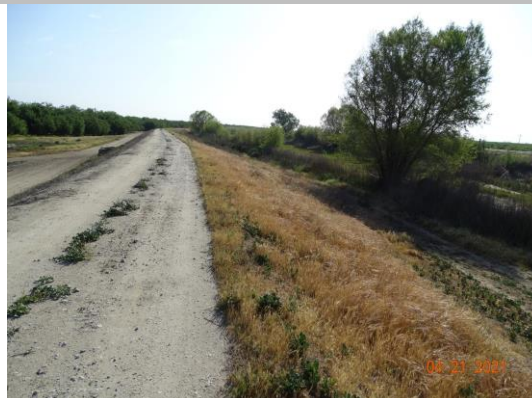
Photo 1 of 1 : SP_2021_NA0011_146_30_20210427_00039.jpg

Looking upstream along the waterside slope. (Spring 2021)

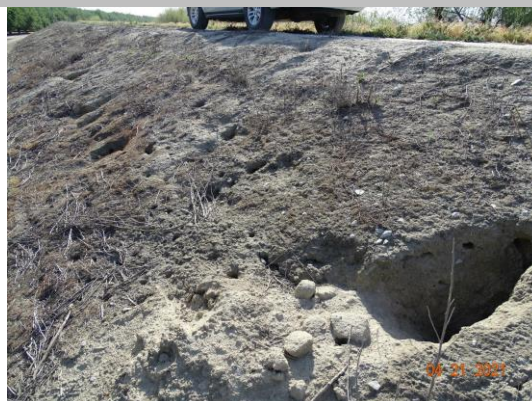
Photo 1 of 1 : SP_2021_NA0011_146_28_20210427_00040.jpg

LM Start	6.75	Rating **	A/W	Issue No.	28
LM End	6.95	Issue Type +	Ma	Location *	LS
Category	Earthen Levee			GPS Latitude/Longitude	
				Start	End
Item	Animal Control			36.969200 °	36.969507 °
				-120.252462 °	-120.248893 °
DWR ID	DWR_NA0011_05_f_2016_28				
Comment Code					
A1 : Exterminate rodents and backfill and compact or grout burrows.					
Inspector Comment					
LMA has repair rodent damage.

View of large rodent burrow and smaller burrows along the landside slope. (Spring 2021)

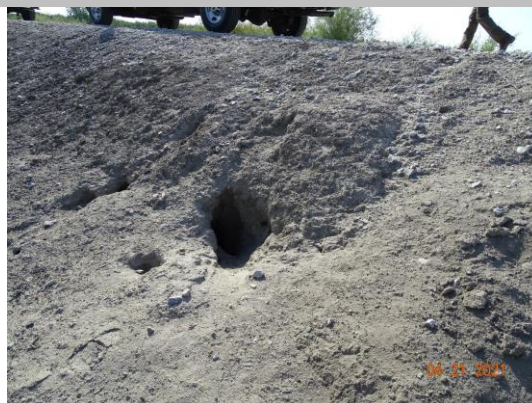
Photo 1 of 1 : SP_2021_NA0011_146_24_20210427_00041.jpg

LM Start	7.66	Rating **	A/W	Issue No.	24
LM End	7.66	Issue Type +	Ma	Location *	LS
Category	Earthen Levee			GPS Latitude/Longitude	
				Start	End
Item	Animal Control			36.969606 °	36.969606 °
				-120.236091 °	-120.236091 °
DWR ID	DWR_NA0011_05_f_2018_24				
Comment Code					
A3 : No rodents visible, but rodent burrows visible; need to backfill and compact or grout burrows.					
Inspector Comment					
LMA has repaired the rodent burrows in the landside slope.

A large rodent burrow on the landside slope. (Spring 2021)

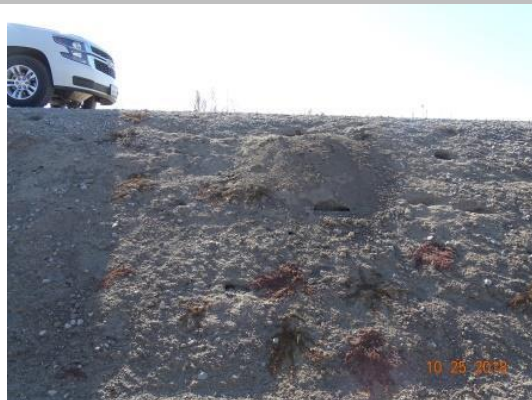
Photo 1 of 1 : SP_2021_NA0011_146_12_20210419_00005.jpg

Rodent activity on landside slope. (Fall 2018)

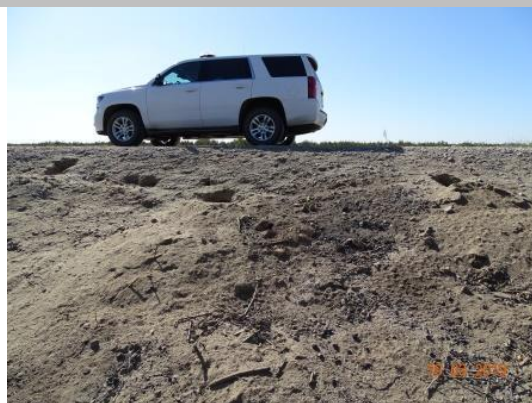
Photo 1 of 1 : SP_2021_NA0011_146_51_20210419_00026.jpg

Several rodent holes observed at this location. (Fall 2019)

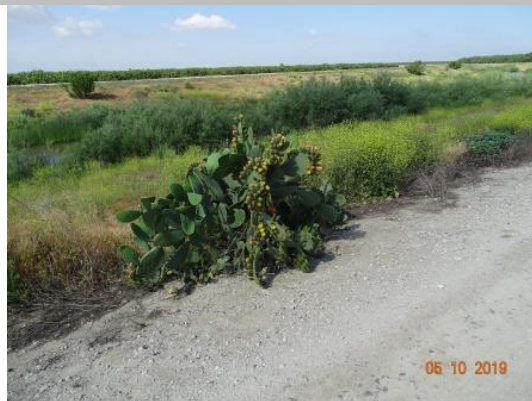
Photo 1 of 1 : SP_2021_NA0011_146_10_20210419_00003.jpg

Cactus growing on waterside shoulder. (Spring 2019)

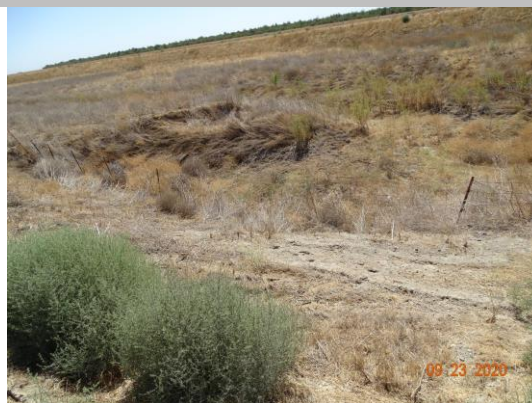
Photo 1 of 1 : SP_2021_NA0011_147_20_20210308_00006.jpg

View of erosion on the landside slope. (Fall 2020)

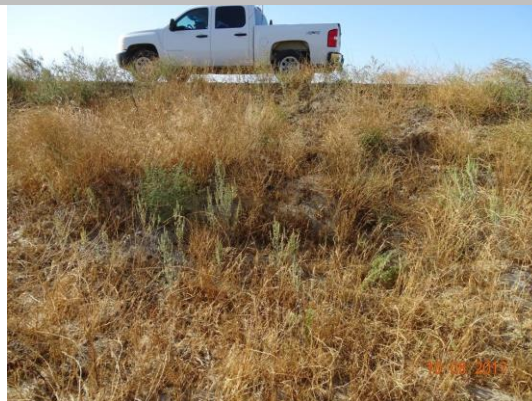
Photo 1 of 1 : SP_2021_NA0011_147_17_20210308_00005.jpg

View of slump possibly the result of rodent activity.

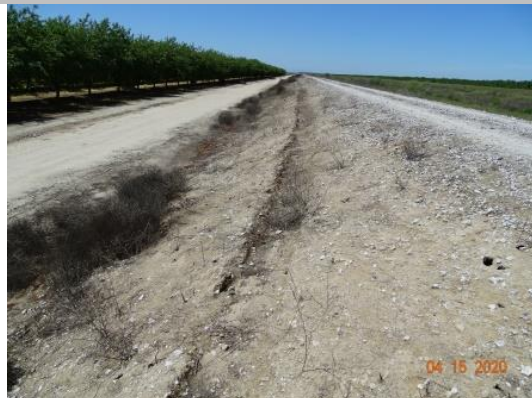
Photo 1 of 1 : SP_2021_NA0011_147_69_20210308_00025.jpg

Vehicle tracks in the landside slope. (Spring 2020)

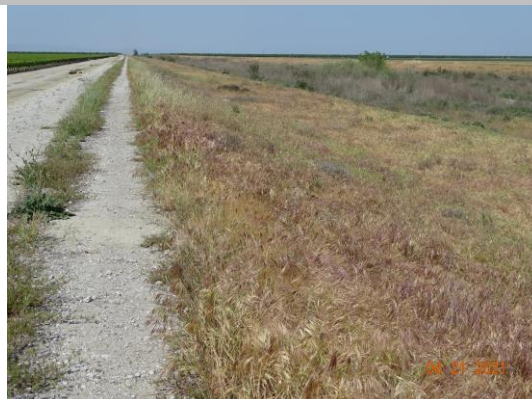
Photo 1 of 1 : SP_2021_NA0011_147_28_20210427_00046.jpg

View of the waterside slope looking downstream. (Spring 2021)

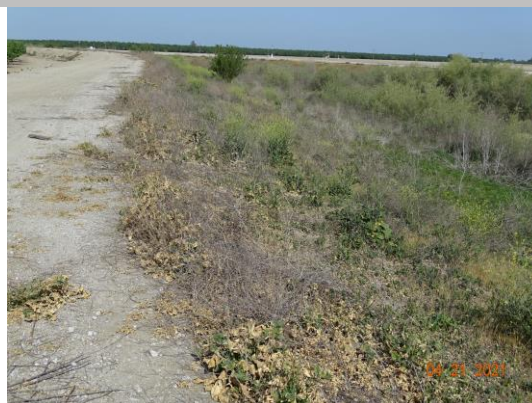
Photo 1 of 1 : SP_2021_NA0011_147_12_20210427_00051.jpg

Looking at vegetation along the waterside slope. (Spring 2021)

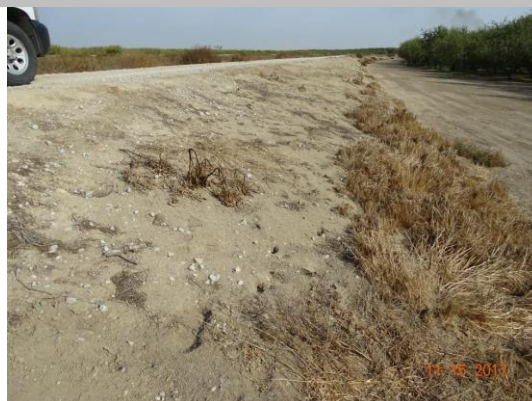
Photo 1 of 1 : SP_2021_NA0011_147_47_20210308_00018.jpg

Bait traps should be maintained and rodent holes should be backfilled.

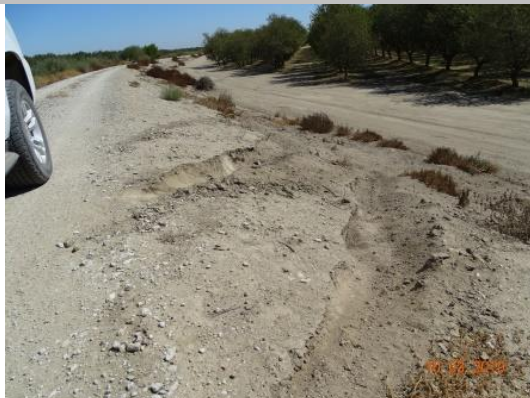
Photo 1 of 1 : SP_2021_NA0011_147_23_20210308_00007.jpg

Damage to landside slope from vehicle traffic. (Fall 2019)

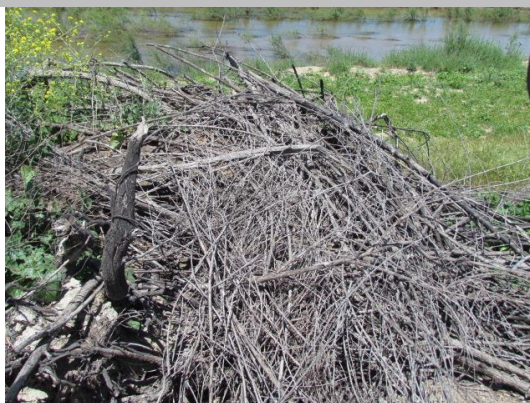
Photo 1 of 1 : SP_2021_NA0011_147_32_20210308_00012.jpg

Fresno River waterside levee mile 7.96.

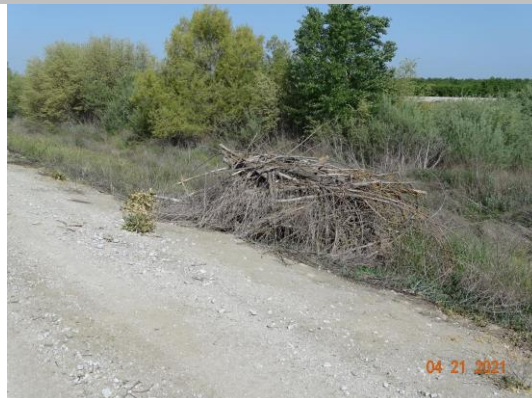
Photo 1 of 1 : SP_2021_NA0011_147_36_20210427_00052.jpg

Burn pile left on the waterside shoulder and slope. (Spring 2021)

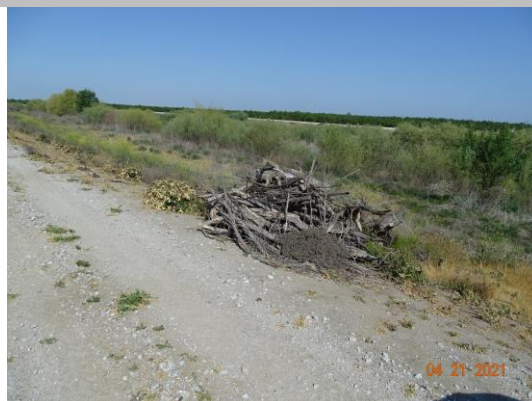
Photo 1 of 1 : SP_2021_NA0011_147_31_20210427_00053.jpg

Burn pile left on the waterside shoulder. (Spring 2021)
