**Flood Control Project Maintenance
Levee Inspections**

Maintenance Issue Types Only, Levee Inspection Report By Mile - Spring 2022

Madera County FCWCA

Waterway	Bank	Unit Miles	Inspection Start/End	Inspector
Unit No. 01 Ash Slough	Right	2.37	04/28/2022 04/28/2022	Corey Fujitani

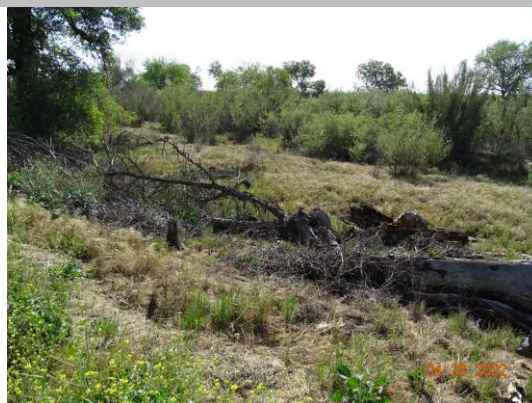
Photo 1 of 1 : SP_2022_NA0011_142_11_20220503_00029.jpg

Remove downed tree from waterside slope. (Spring 2022)

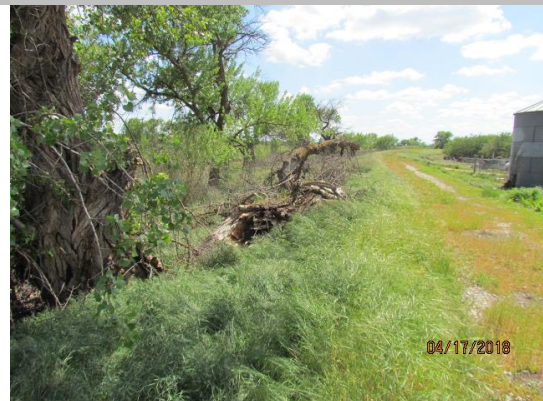
Photo 1 of 1 : SP_2022_NA0011_142_21_20220308_00011.jpg

Looking west at tree limbs and branches on waterward slope. (Spring 2018)

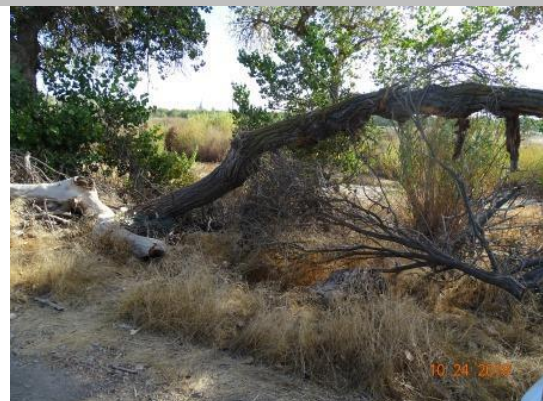
Photo 1 of 1 : SP_2022_NA0011_142_25_20220308_00012.jpg

LM Start	0.79	Rating **	U	Issue No.	25
LM End	0.79	Issue Type +	Ma	Location *	WS
Category	Earthen Levee			GPS Latitude/Longitude	
				Start	End
Item	Encroachments			37.053329 °	37.053329 °
				-120.417448 °	-120.417448 °
DWR ID	DWR_NA0011_01_f_2018_25				
Comment Code					
TR : Tree or limb					
Inspector Comment					
There is a fallen tree blocking the waterside slope.

Tree limbs and trunks are on the waterside shoulder and slope. (Fall 2018)

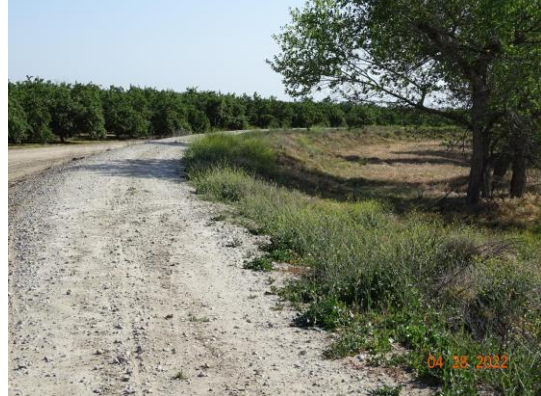
Photo 1 of 1 : SP_2022_NA0011_142_22_20220503_00030.jpg

Looking upstream along the waterside slope. (Spring 2022)

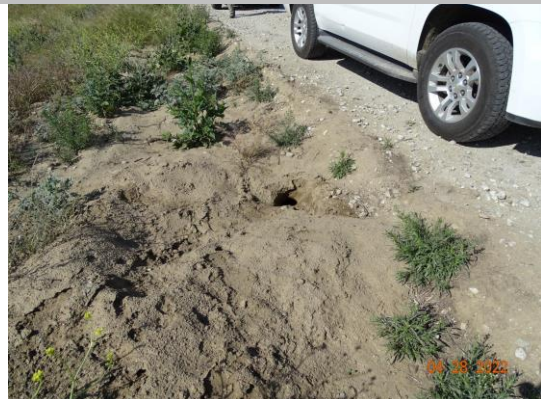
Photo 1 of 1 : SP_2022_NA0011_142_23_20220503_00031.jpg

LM Start	1.58	Rating **	M	Issue No.	23
LM End	1.58	Issue Type +	Ma	Location *	WS
Category	Earthen Levee			GPS Latitude/Longitude	
				Start	End
Item	Animal Control			37.060115 °	37.060115 °
				-120.406932 °	-120.406932 °
DWR ID	DWR_NA0011_01_s_2022_23				
Comment Code					
A3 : No rodents visible, but rodent burrows visible; need to backfill and compact or grout burrows.					
Inspector Comment					
Single rodent hole with large quantity of material displaced.

Rodent burrows observed on the waterside slope. (Spring 2022)

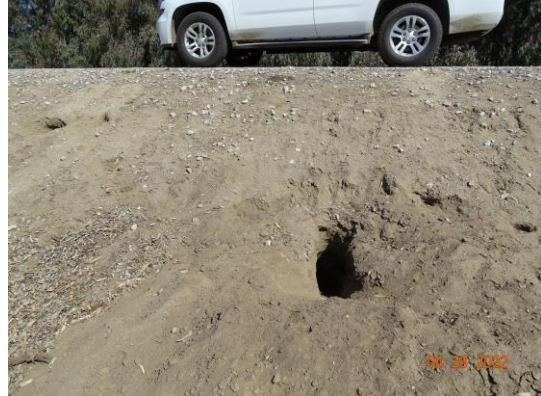
Photo 1 of 1 : SP_2022_NA0011_143_26_20220504_00043.jpg

Large rodent burrow observed on the landside toe. (Spring 2022)

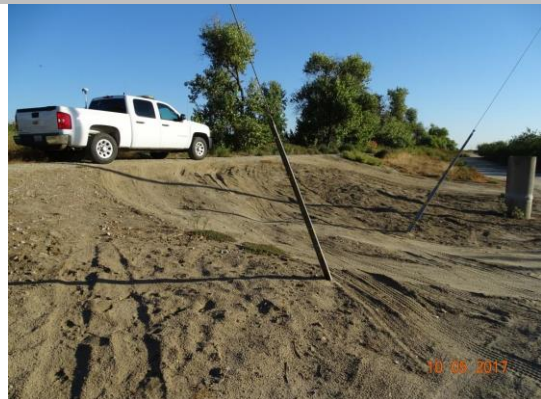
Photo 1 of 1 : SP_2022_NA0011_143_13_20220308_00007.jpg

LM Start	0.31	Rating **	M	Issue No.	13
LM End	0.31	Issue Type +	Ma	Location *	LS
Category	Earthen Levee			GPS Latitude/Longitude	
				Start	End
Item	Erosion / Vehicle Traffic			37.047266 °	37.047266 °
				-120.422393 °	-120.422393 °
DWR ID	DWR_NA0011_02_f_2017_13				
Comment Code					
E6 : Repair the levee slope damaged by vehicle traffic and prevent access where possible.					
Inspector Comment

Vehicle access to levee slope should be prevented and erosion repaired.

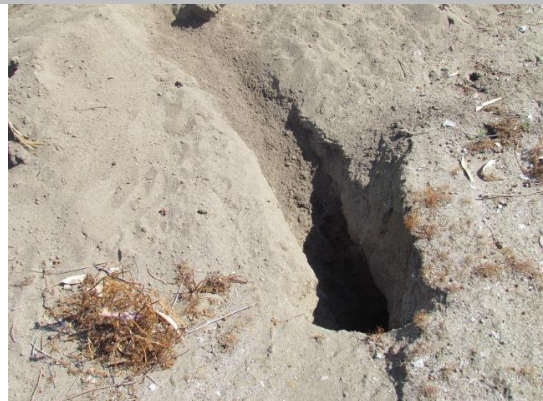
Photo 1 of 1 : SP_2022_NA0011_143_39_20220308_00022.jpg

Previously noted burrows in the area waterside slope levee mile 0.32-1.67.

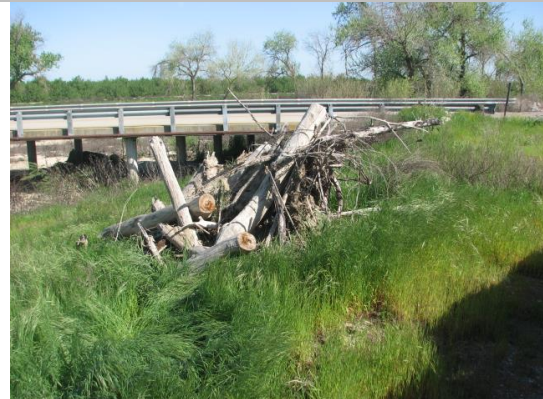
Photo 1 of 1 : SP_2022_NA0011_143_34_20220308_00021.jpg

Looking downstream at pile of limbs on waterward slope. (Spring 2018)

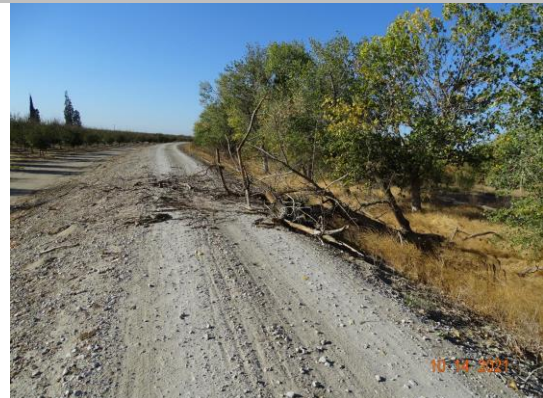
Photo 1 of 2 : SP_2022_NA0011_143_27_20220308_00015.jpg

View of downed tree on the shoulder and crown. (Fall 2021)

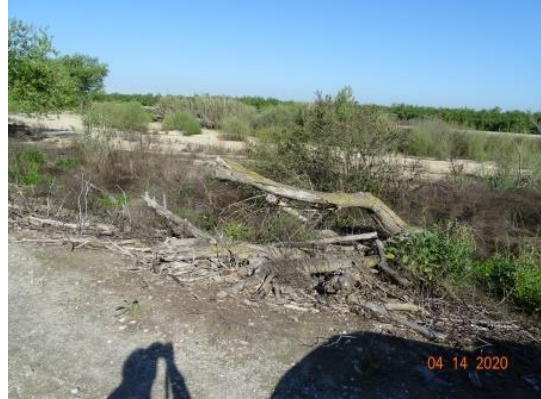
Photo 2 of 2 : SP_2022_NA0011_143_27_20220308_00016.jpg

Branches left along the waterside slope from high flow. (Spring 2020)

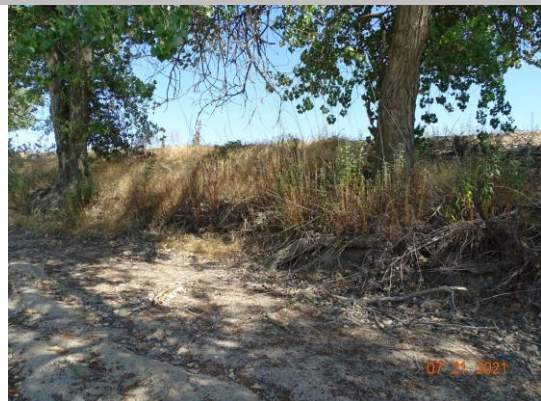
Photo 1 of 2 : SP_2022_NA0011_143_1_20220308_00001.jpg

07/21/2021: From 2013 to present, no significant changes were observed during the annual survey. Vegetation is obscuring the views of the erosion.

08/05/2010: Recommended for annual assessment and monitoring during flood events, per CLRO.

2009: Site is recommended as a local maintenance issue, per Critical Levee Repair Office, Critical Erosion Sites Evaluation 2008 Report; site was previously rated "M"

7/21/2021: View of the erosion on the levee toe.

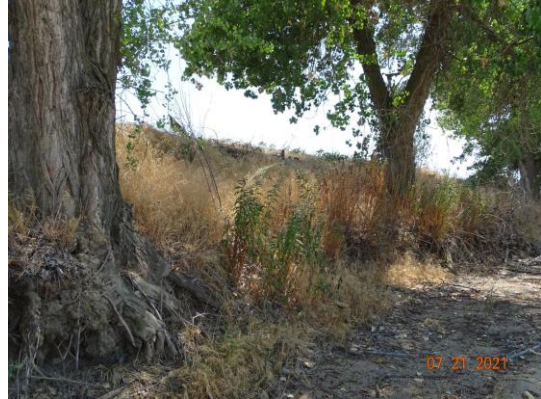
Photo 2 of 2 : SP_2022_NA0011_143_1_20220308_00002.jpg

7/21/2021: Another view of the erosion.

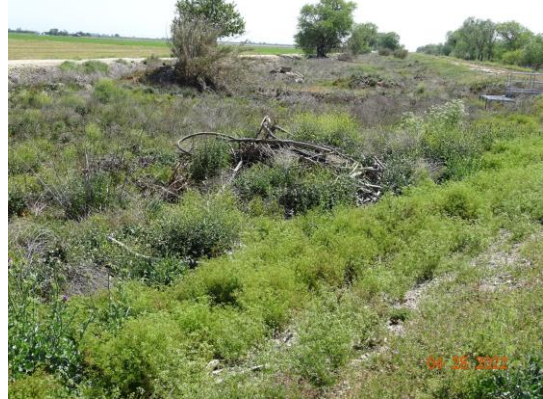
Photo 1 of 1 : SP_2022_NA0011_144_20_20220504_00015.jpg

Looking at prunings on landward slope. (Spring 2022)

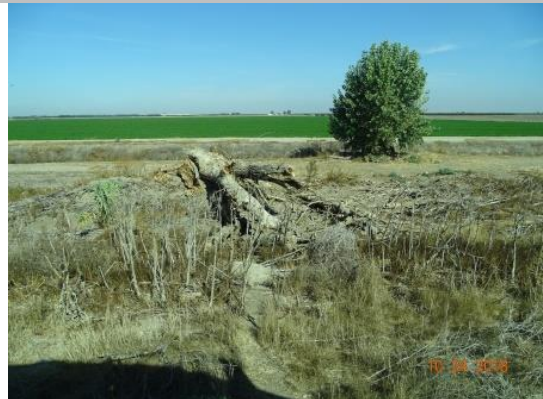
Photo 1 of 1 : SP_2022_NA0011_144_10_20220308_00005.jpg

View of dead tree on the landside slope. (Fall 2018)

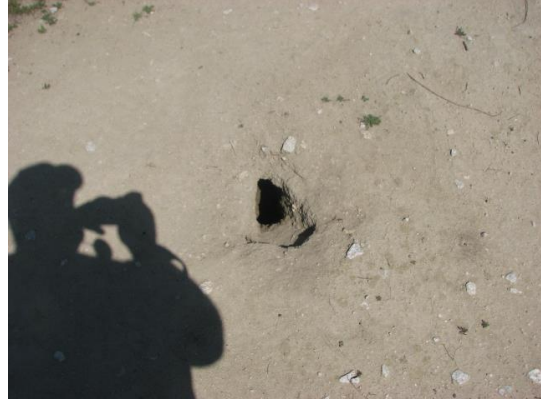
Photo 1 of 1 : SP_2022_NA0011_144_5_20220308_00002.jpg

Looking at rodent hole on levee crown. (Spring 2018)

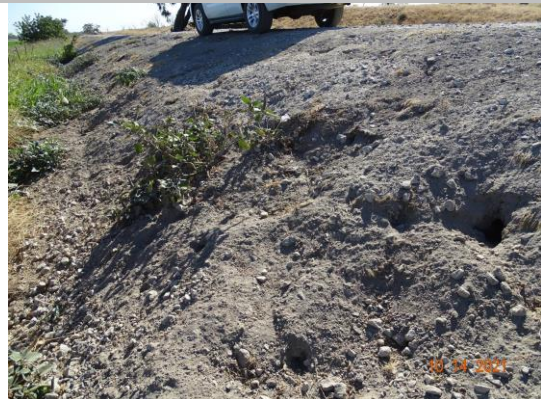
Photo 1 of 1 : SP_2022_NA0011_144_6_20220308_00003.jpg

View of rodent burrows in the landside slope. (Fall 2021)

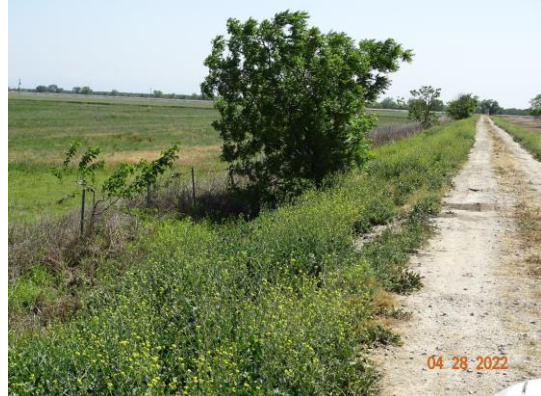
Photo 1 of 1 : SP_2022_NA0011_144_9_20220504_00017.jpg

View of vegetation growing on the landside slope. (Spring 2022)

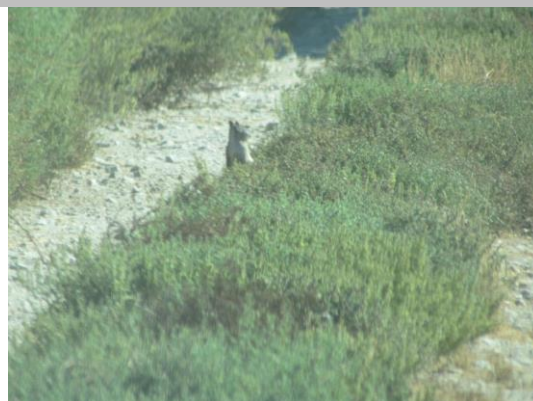
Photo 1 of 1 : SP_2022_NA0011_144_8_20220308_00004.jpg

LM Start	1.14	Rating **	M	Issue No.	8
LM End	1.35	Issue Type +	Ma	Location *	CR
Category	Earthen Levee			GPS Latitude/Longitude	
				Start	End
Item	Animal Control			36.996606 °	36.996618 °
				-120.353292 °	-120.349475 °
DWR ID	DWR_NA0011_03_f_2016_8				
Comment Code					
A1 : Exterminate rodents and backfill and compact or grout burrows.					
Inspector Comment					
Exterminate rodents from the roadway. Active rodents observed during inspection at this site.

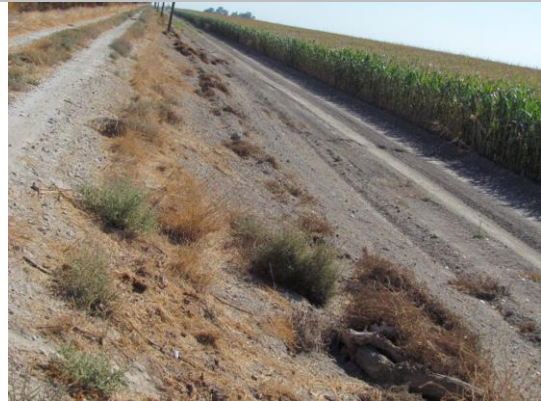
Photo 1 of 1 : SP_2022_NA0011_145_3_20220308_00001.jpg

LM Start	0.02	Rating **	A/W	Issue No.	3
LM End	0.97	Issue Type +	Ma	Location *	LS
Category	Earthen Levee			GPS Latitude/Longitude	
				Start	End
Item	Erosion / Vehicle Traffic			36.995506 °	36.995550 °
				-120.373233 °	-120.355935 °
DWR ID	DWR_NA0011_04_f _ 2016_3				
Comment Code					
E6 : Repair the levee slope damaged by vehicle traffic and prevent access where possible.					
Inspector Comment					
The slope in this area has been damaged by farm equipment.

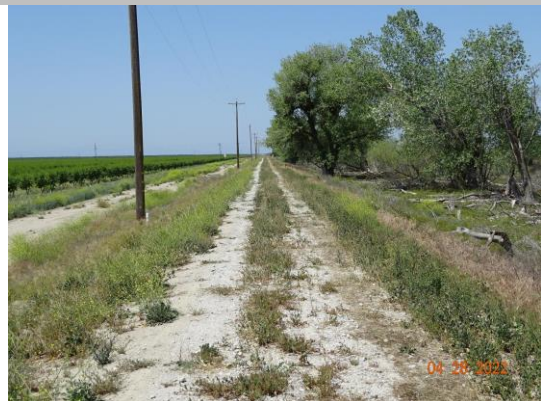
Photo 1 of 1 : SP_2022_NA0011_145_35_20220504_00024.jpg

View of vegetation growing along the levee crown. (Spring 2022)

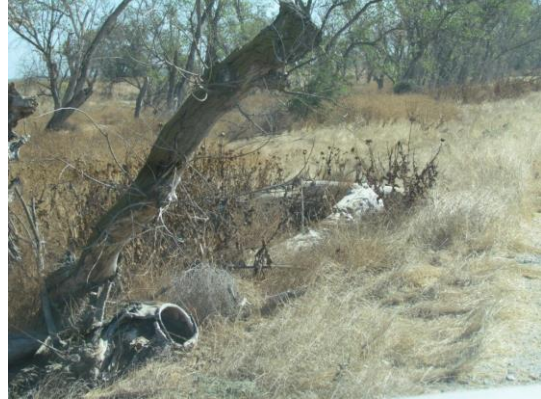
Photo 1 of 1 : SP_2022_NA0011_145_16_20220308_00011.jpg

Tree on WS shoulder.

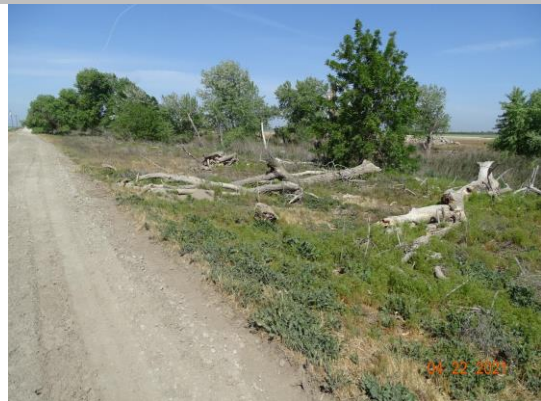
Photo 1 of 1 : SP_2022_NA0011_145_24_20220308_00013.jpg

View of fallen trees on the waterside slope and berm. (Spring 2021)

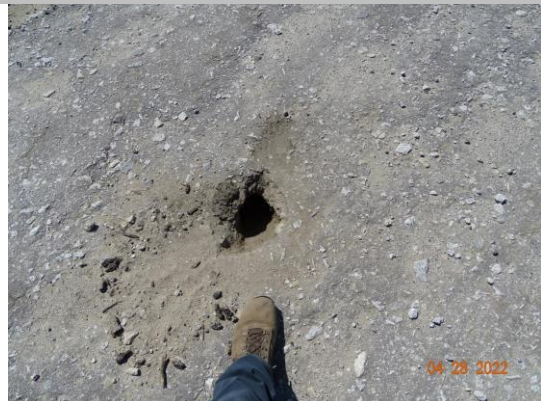
Photo 1 of 1 : SP_2022_NA0011_145_59_20220504_00028.jpg

Representative rodent hole in the levee crown along this section. (Spring 2022)

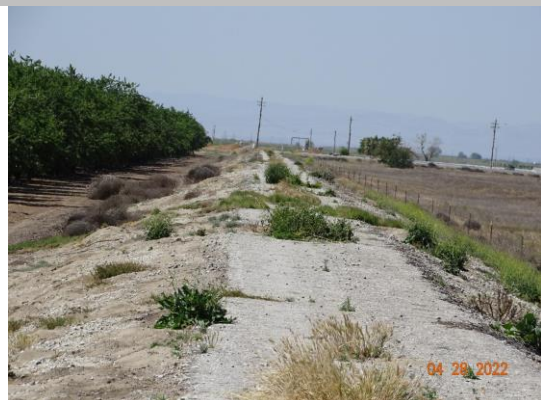
Photo 1 of 1 : SP_2022_NA0011_145_5_20220504_00029.jpg

View of vegetation growing on the levee crown. (Spring 2022)

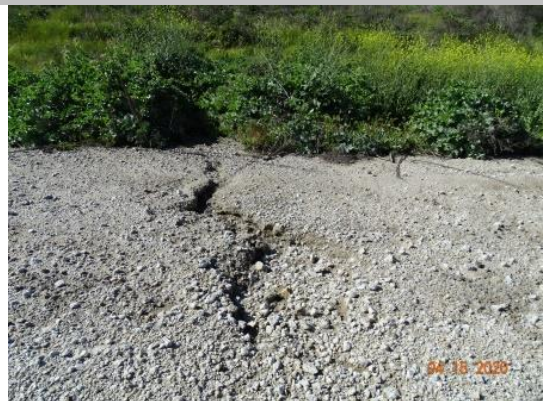
Photo 1 of 1 : SP_2022_NA0011_146_38_20220308_00015.jpg

Finger erosion on the waterside slope. (Spring 2020)

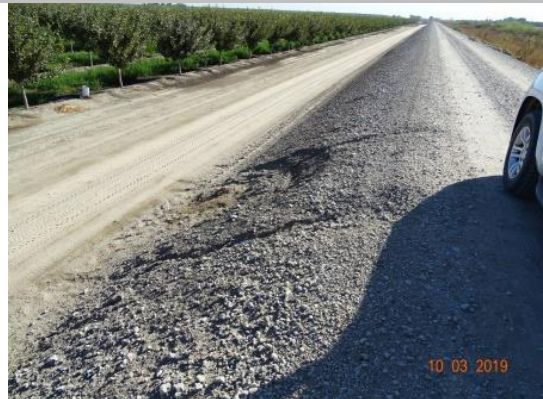
Photo 1 of 1 : SP_2022_NA0011_146_17_20220308_00005.jpg

View of landside slope erosion looking upstream. (Fall 2019)

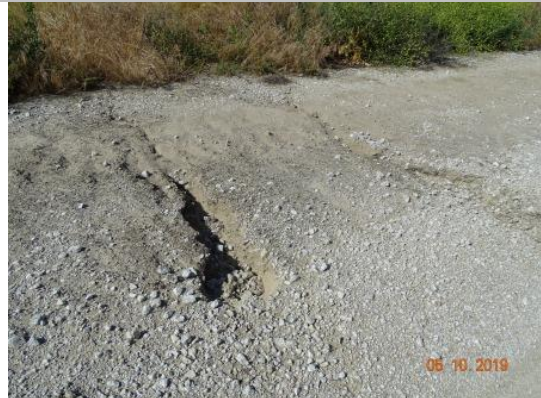
Photo 1 of 1 : SP_2022_NA0011_146_46_20220308_00017.jpg

Rills observed on waterside slope. (Spring 2019)

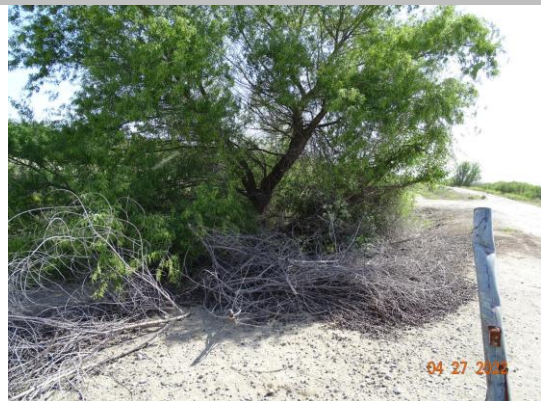
Photo 1 of 1 : SP_2022_NA0011_146_29_20220505_00031.jpg

View of tree growing on the landside slope. (Spring 2022)

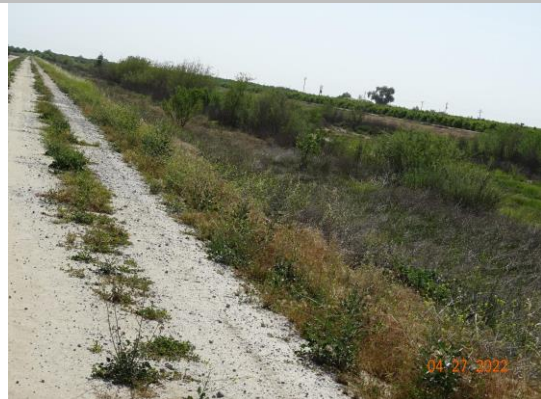
Photo 1 of 1 : SP_2022_NA0011_146_16_20220505_00032.jpg

Looking upstream at vegetation along the waterside slope. (Spring 2022)

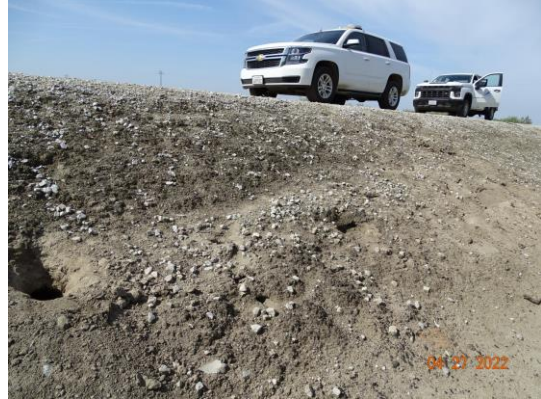
Photo 1 of 1 : SP_2022_NA0011_146_19_20220505_00033.jpg

Several rodent holes were noted at this location. (Spring 2022)

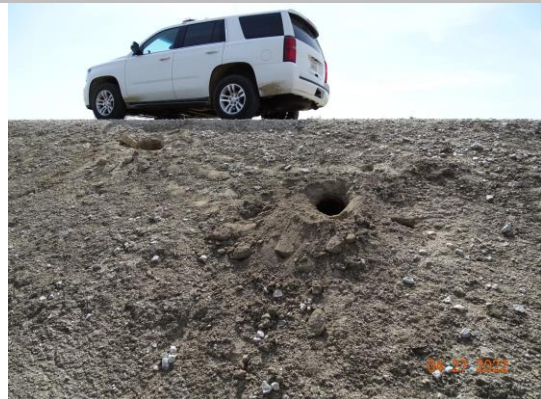
Photo 1 of 1 : SP_2022_NA0011_146_20_20220505_00034.jpg

Representative view of rodent burrow on the landside slope. (Spring 2022)

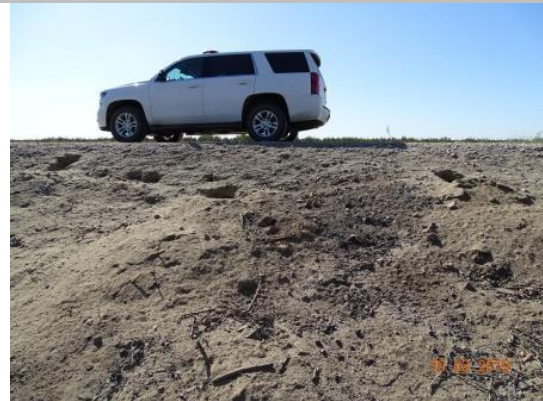
Photo 1 of 1 : SP_2022_NA0011_146_51_20220308_00018.jpg

Several rodent holes observed at this location. (Fall 2019)

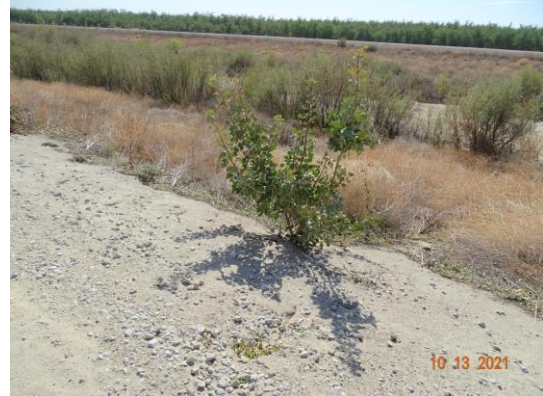
Photo 1 of 1 : SP_2022_NA0011_146_8_20220308_00001.jpg

Sapling growing on the waterside shoulder. (Fall 2021)

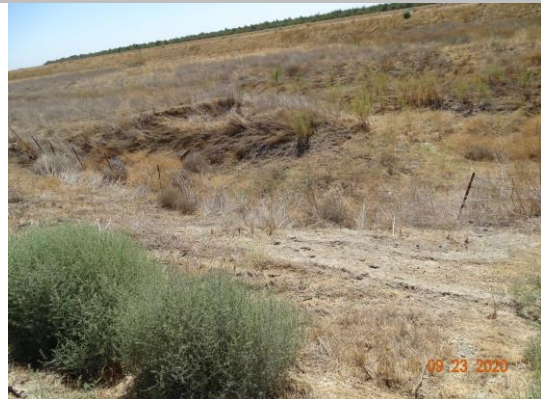
Photo 1 of 1 : SP_2022_NA0011_147_20_20220308_00006.jpg

View of erosion on the landside slope. (Fall 2020)

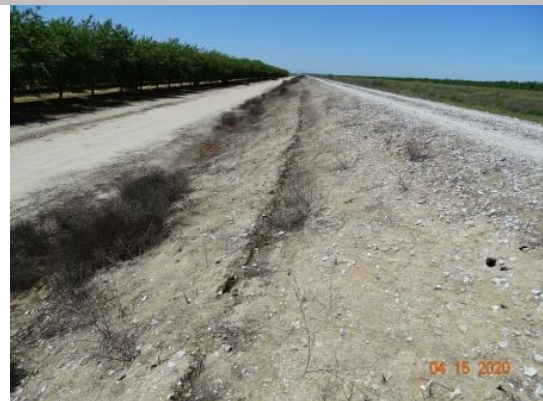
Photo 1 of 1 : SP_2022_NA0011_147_69_20220308_00020.jpg

Vehicle tracks in the landside slope. (Spring 2020)

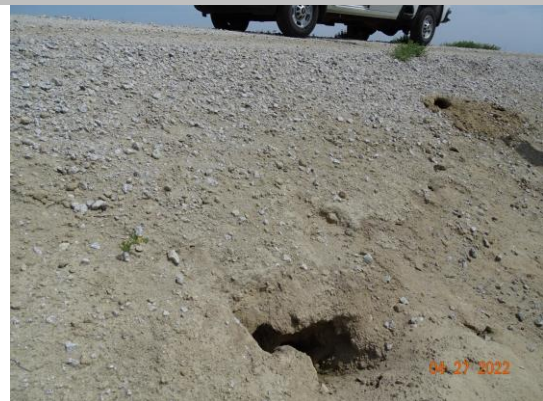
Photo 1 of 1 : SP_2022_NA0011_147_35_20220505_00043.jpg

Multiple rodent holes observed in this section of the levee. (Spring 2022)

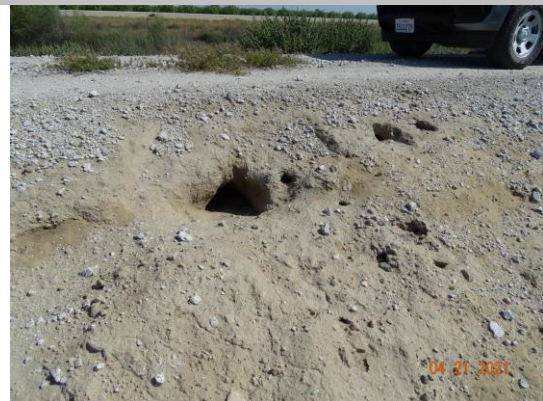
Photo 1 of 1 : SP_2022_NA0011_147_25_20220308_00009.jpg

Rodent activity along the landside shoulder should be repaired. (Spring 2021)

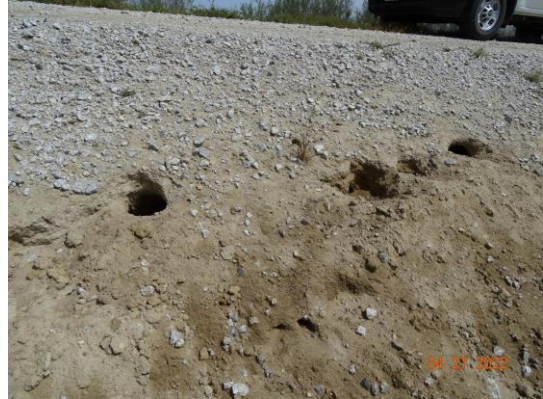
Photo 1 of 1 : SP_2022_NA0011_147_29_20220505_00044.jpg

View of rodent holes in the landside slope. (Spring 2022)

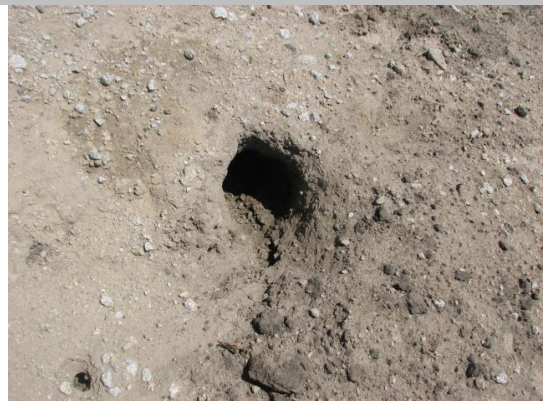
Photo 1 of 1 : SP_2022_NA0011_147_53_20220308_00017.jpg

Looking at typical rodent hole on landward slope. (Spring 2018)

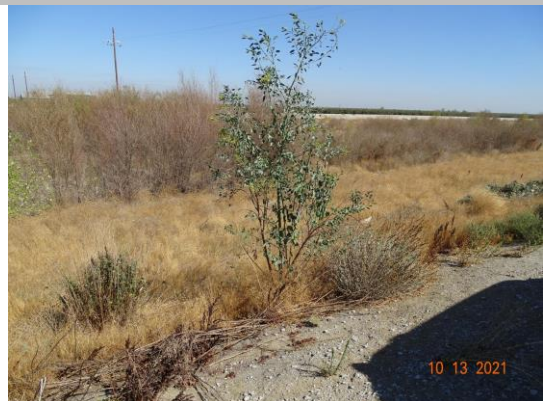
Photo 1 of 1 : SP_2022_NA0011_147_16_20220308_00004.jpg

View of sapling growing in the waterside shoulder. (Fall 2021)

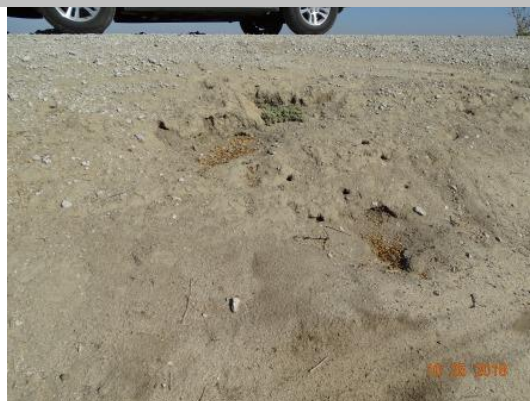
Photo 1 of 1 : SP_2022_NA0011_147_58_20220308_00018.jpg

Minor erosion on landside slope. (Fall 2018)

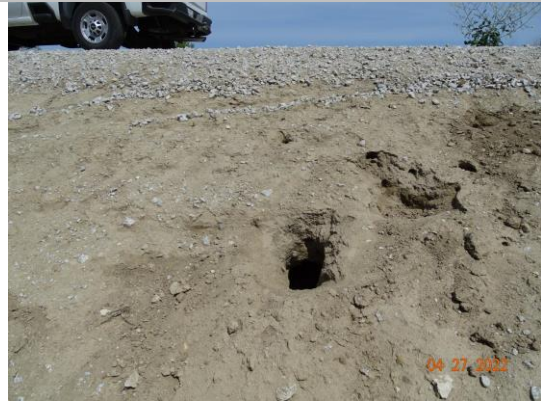
Photo 1 of 1 : SP_2022_NA0011_147_22_20220505_00046.jpg

Representative view of rodent burrow on the landside slope. (Spring 2022)

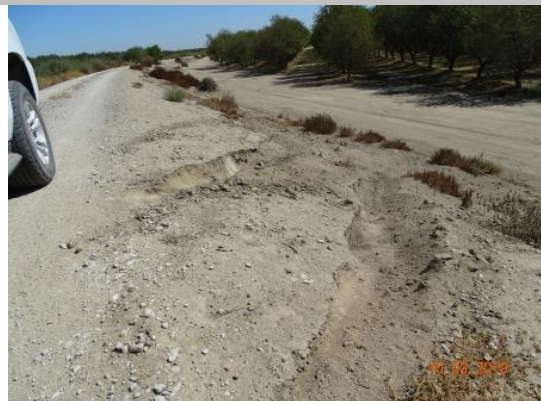
Photo 1 of 1 : SP_2022_NA0011_147_23_20220308_00007.jpg

Damage to landside slope from vehicle traffic. (Fall 2019)

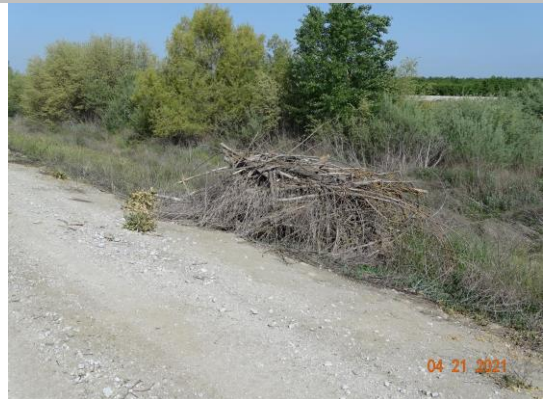
Photo 1 of 1 : SP_2022_NA0011_147_36_20220308_00012.jpg

Burn pile left on the waterside shoulder and slope. (Spring 2021)

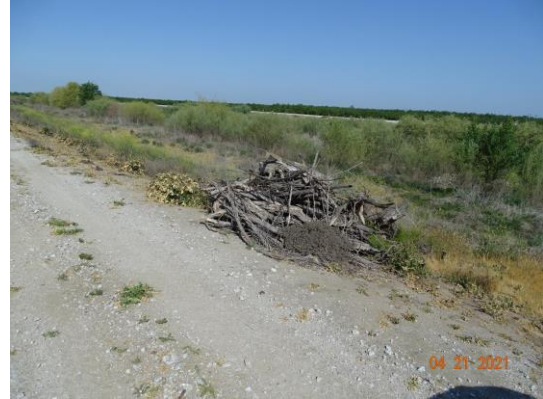
Photo 1 of 1 : SP_2022_NA0011_147_31_20220308_00010.jpg

Burn pile left on the waterside shoulder. (Spring 2021)
