**Flood Control Project Maintenance  
Levee Inspections**

**Maintenance Issue Types Only, Levee Inspection Report By Mile - Spring 2024**

**Madera County FCWCA**

Waterway	Bank	Unit Miles	Inspection Start/End	Inspector
Unit No. 01 Ash Slough	Right	2.37	04/25/2024 04/25/2024	Corey Fujitani

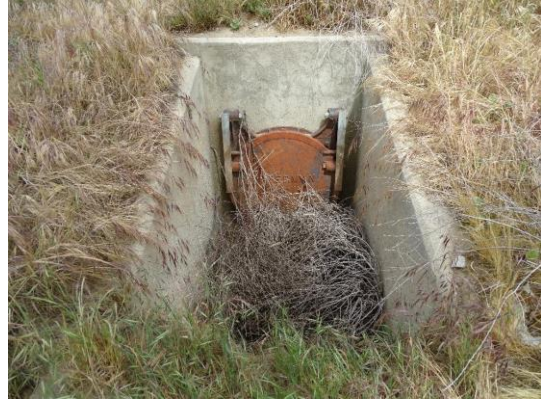
Photo 2 of 2 : UCIP\_SP\_2024\_74905\_112092.jpg

WS view: Concrete headwall, spillway, and flap gate; outlet is at a low point due to sediment buildup at end of spillway.

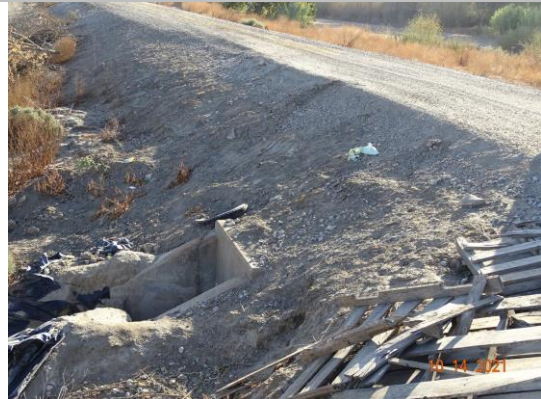
Photo 1 of 1 : SP\_2024\_NA0011\_142\_20\_20240212\_00010.jpg

LM Start	0.04	Rating **	A/W	Issue No.	20
LM End	0.04	Issue Type +	Ma	Location *	LS
Category	Earthen Levee			GPS Latitude/Longitude	
				Start	End
Item	Erosion / Bank Caving			37.046624°	37.046624°
				-120.427317°	-120.427317°
DWR ID	DWR_NA0011_01_s_ 2014_20				
Comment Code					
E1 : Note and monitor erosion site.					
Inspector Comment					
The site appears to have been repaired. Monitor for settlement.

View of repaired slope damage on landside slope. (Fall 2021)

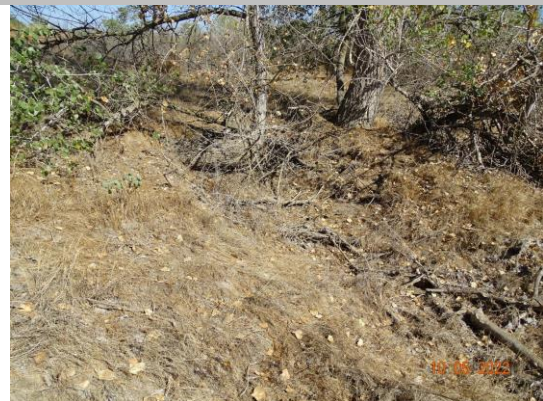
Photo 1 of 1 : SP\_2024\_NA0011\_142\_24\_20240212\_00013.jpg

LM Start	0.56	Rating **	M	Issue No.	24
LM End	0.56	Issue Type +	Ma	Location *	WS
Category	Earthen Levee			GPS Latitude/Longitude	
				Start	End
Item	Erosion / Bank Caving			37.050660°	37.050660°
				-120.419583°	-120.419583°
DWR ID	DWR_NA0011_01_f_2022_24				
Comment Code					
E2 : Schedule repair of erosion site prior to the next inspection.					
Inspector Comment					
There is an erosion pocket at the waterside toe around tree trunk and downed tree limb.

Erosion on the waterside toe around a fallen tree limb and tree trunk.  
(Fall 2022)

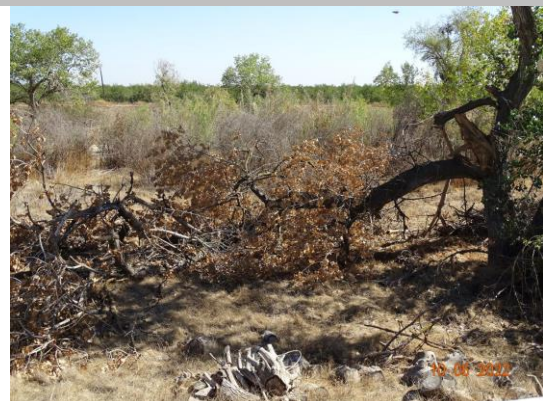
Photo 1 of 1 : SP\_2024\_NA0011\_142\_37\_20240212\_00021.jpg

LM Start	0.62	Rating **	M	Issue No.	37
LM End	0.62	Issue Type +	Ma	Location *	WS
Category	Earthen Levee			GPS Latitude/Longitude	
				Start	End
Item	Trim / Thin Trees			37.051222°	37.051222°
				-120.418810°	-120.418810°
DWR ID	DWR_NA0011_01_f_2015_37				
Comment Code					
T2 : Tree or limb.					
Inspector Comment					
Remove the tree branches from the waterside slope.

Downed tree limbs on the waterside berm should be removed. (Fall 2022)

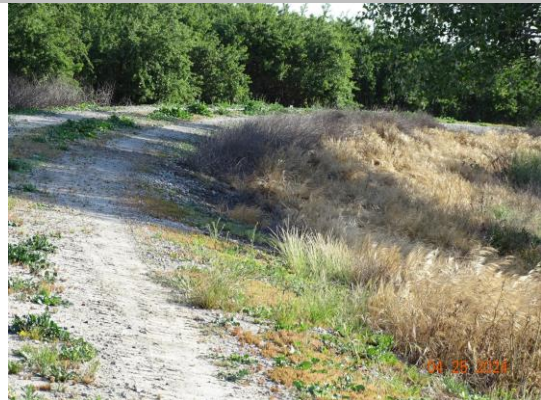
Photo 1 of 1 : SP\_2024\_NA0011\_142\_3\_20240426\_00025.jpg

View of vegetation on the waterside slope. (Spring 2024)

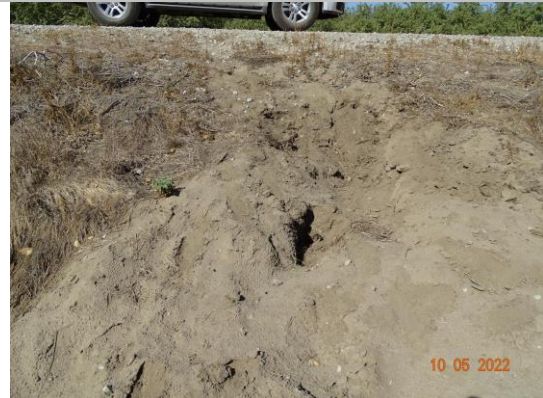
Photo 1 of 1 : SP\_2024\_NA0011\_142\_30\_20240212\_00017.jpg

LM Start	1.00	Rating **	U	Issue No.	30
LM End	1.00	Issue Type +	Ma	Location *	WS
Category	Earthen Levee			GPS Latitude/Longitude	
				Start	End
Item	Erosion / Bank Caving			37.055763°	37.055763°
				-120.415308°	-120.415308°
DWR ID	DWR_NA0011_01_f_2022_30				
Comment Code					
E2 : Schedule repair of erosion site prior to the next inspection.					
Inspector Comment					
Erosion pocket that appears to be caused by rodent activity on the waterside slope.

Erosion pocket on the waterside slope. (Fall 2022)

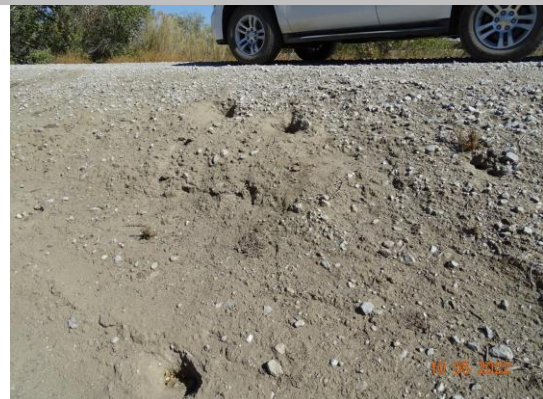
Photo 1 of 1 : SP\_2024\_NA0011\_142\_31\_20240212\_00018.jpg

LM Start	1.26	Rating **	A/W	Issue No.	31
LM End	1.31	Issue Type +	Ma	Location *	LS
Category	Earthen Levee			GPS Latitude/Longitude	
				Start	End
Item	Animal Control			37.057219°	37.057878°
				-120.411317°	-120.410915°
DWR ID	DWR_NA0011_01_f_2022_31				
Comment Code					
A3 : No rodents visible, but rodent burrows visible; need to backfill and compact or grout burrows.					
Inspector Comment

Multiple rodent holes observed on the landside slope. (Fall 2022)

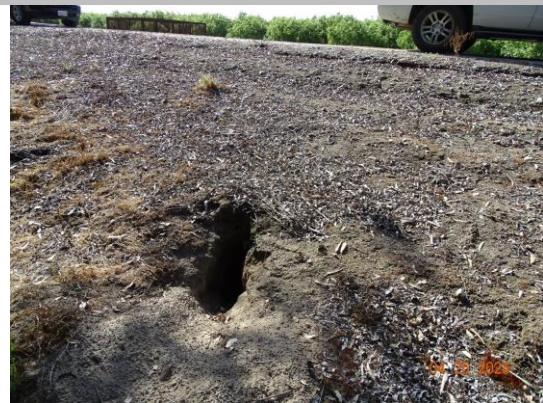
Photo 1 of 1 : SP\_2024\_NA0011\_143\_7\_20240426\_00032.jpg

Large rodent burrow with significant material displaced, observed on the waterside slope. (Spring 2024)

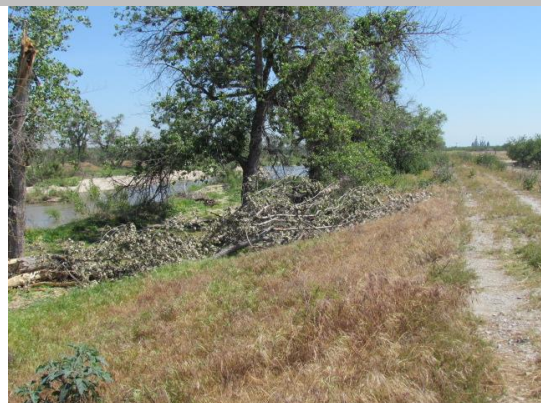
Photo 1 of 1 : SP\_2024\_NA0011\_143\_33\_20240212\_00021.jpg

Dead fallen trees on the waterside levee slope and shoulder.

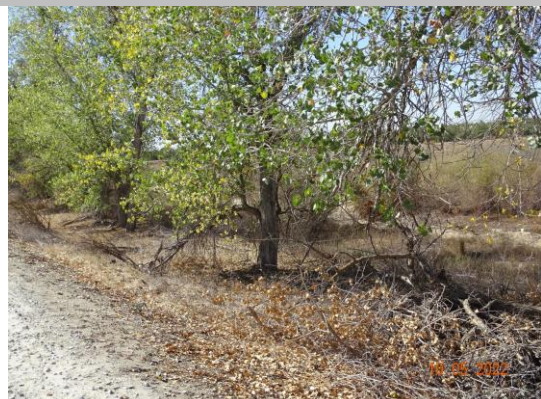
Photo 1 of 1 : SP\_2024\_NA0011\_143\_27\_20240212\_00016.jpg

Branches left along the waterside slope from high flow. (Fall 2022)

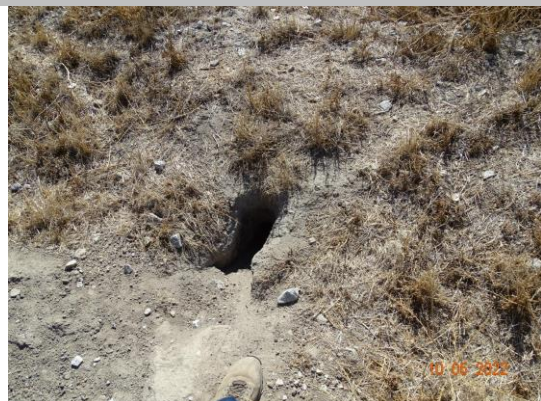
Photo 1 of 1 : SP\_2024\_NA0011\_144\_9\_20240212\_00006.jpg

Representative view of rodent holes on the landside slope. (Fall 2022)

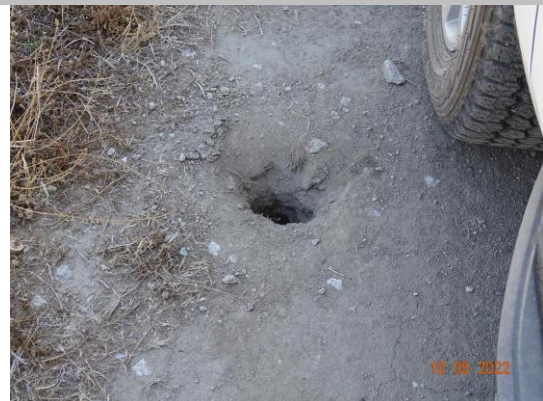
Photo 1 of 1 : SP\_2024\_NA0011\_144\_5\_20240212\_00003.jpg

View of a rodent hole on levee crown. (Fall 2022)

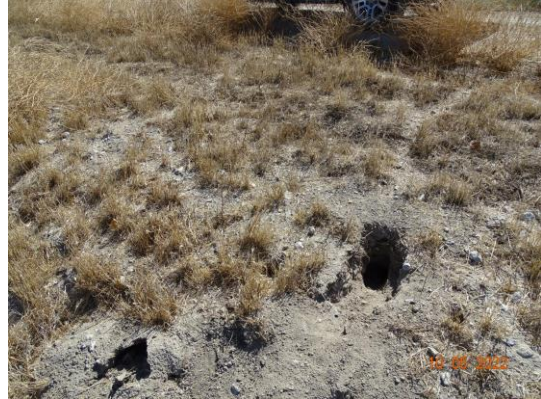
Photo 1 of 1 : SP\_2024\_NA0011\_144\_12\_20240212\_00007.jpg

Several rodent burrows observed on the landside slope. (Fall 2022)

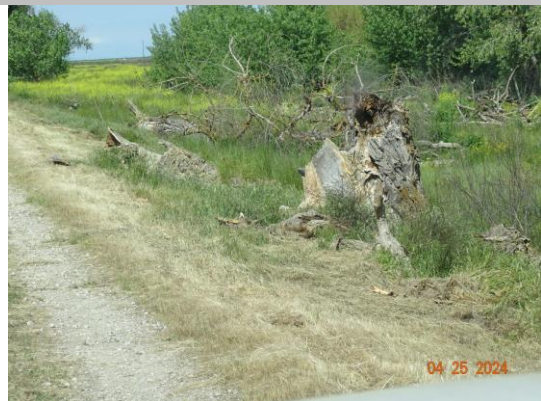
Photo 1 of 1 : SP\_2024\_NA0011\_145\_15\_20240429\_00035.jpg

View of broken tree limbs along the waterside slope and toe. (Spring 2024)

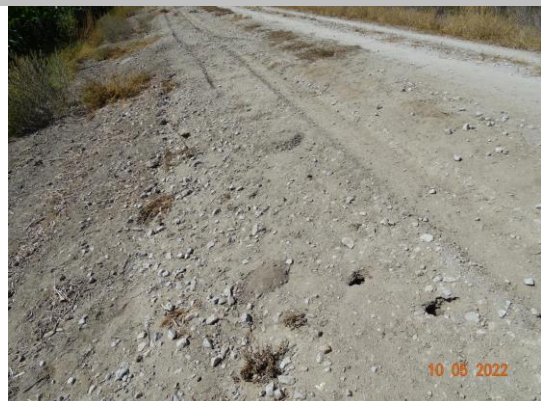
Photo 1 of 1 : SP\_2024\_NA0011\_145\_19\_20240212\_00014.jpg

View of small rodent burrows observed on the landside slope. (Fall 2022)

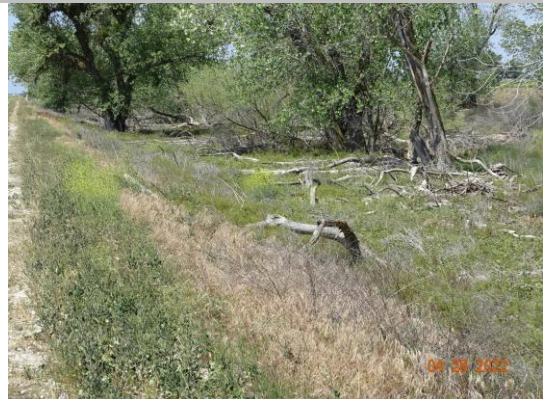
Photo 1 of 1 : SP\_2024\_NA0011\_145\_21\_20240212\_00015.jpg

Broken tree limbs and trunks in the channel should be removed. (Spring 2022)

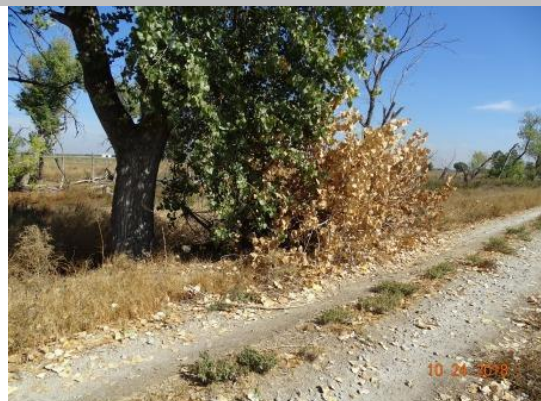
Photo 1 of 1 : SP\_2024\_NA0011\_145\_32\_20240212\_00023.jpg

Trim branches on waterside shoulder. (Fall 2018)

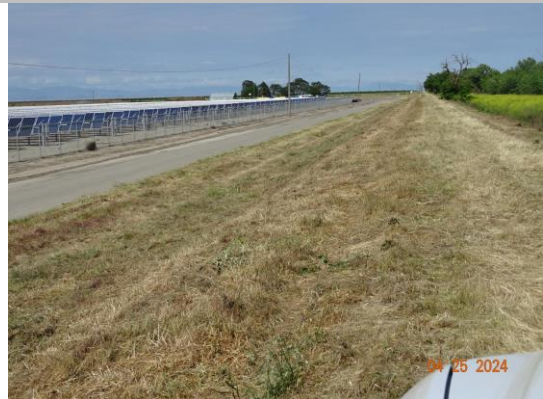
Photo 1 of 1 : SP\_2024\_NA0011\_145\_23\_20240429\_00039.jpg

View of vegetation management on the landside slope. (Spring 2024)

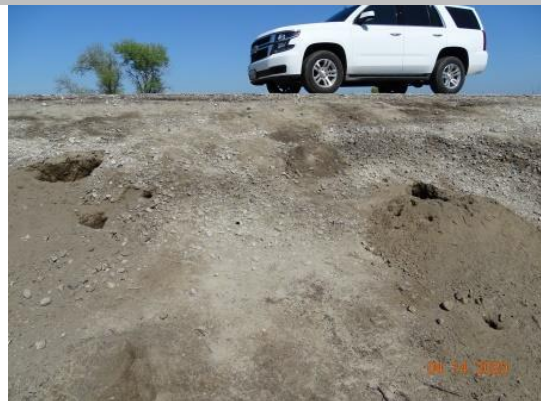
Photo 1 of 1 : SP\_2024\_NA0011\_145\_11\_20240212\_00007.jpg

Representative view of rodent holes observed in this section. (Spring 2020)

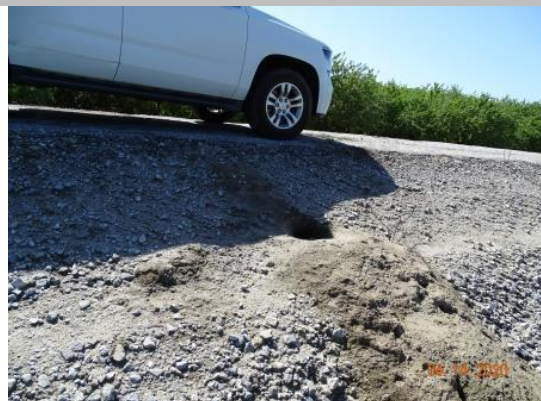
Photo 1 of 1 : SP\_2024\_NA0011\_145\_30\_20240212\_00021.jpg

Several large rodent holes on waterside slope. (Spring 2020)

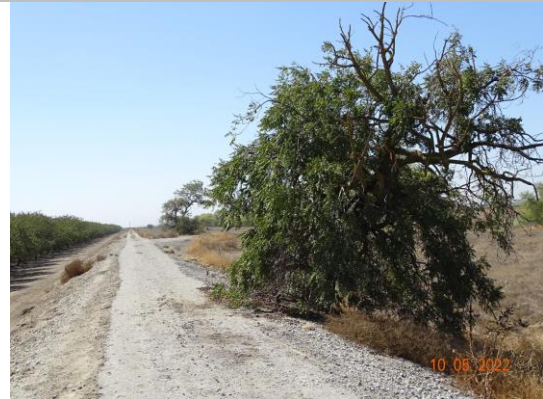
Photo 1 of 1 : SP\_2024\_NA0011\_145\_27\_20240212\_00020.jpg

Trim tree on waterside shoulder. (Fall 2022)

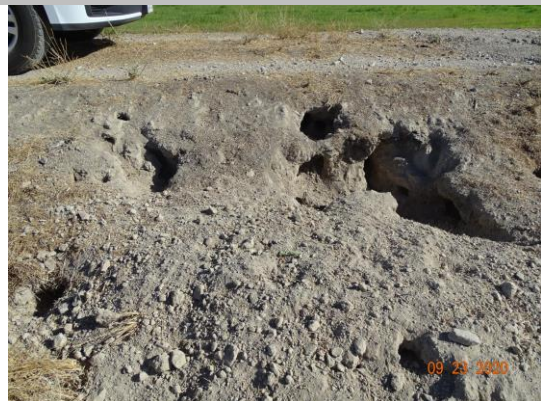
Photo 1 of 1 : SP\_2024\_NA0011\_146\_21\_20240212\_00011.jpg

Rodent burrows in the waterside slope. (Fall 2020)

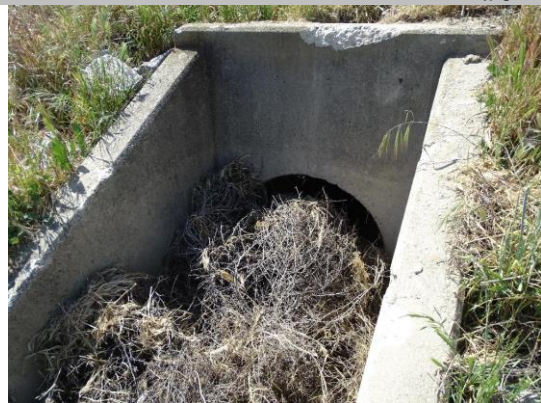
Photo 2 of 3 : UCIP\_SP\_2024\_81023\_112410.jpg

LS view: Concrete headwall and pipe inlet; tumbleweeds in front of inlet.

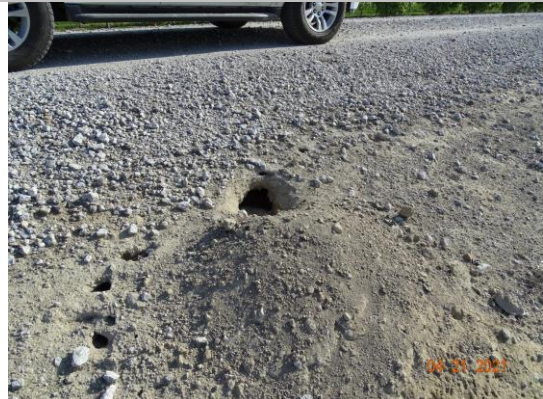
Photo 1 of 1 : SP\_2024\_NA0011\_146\_23\_20240212\_00012.jpg

Large rodent hole observed on the waterside slope. (Spring 2021)

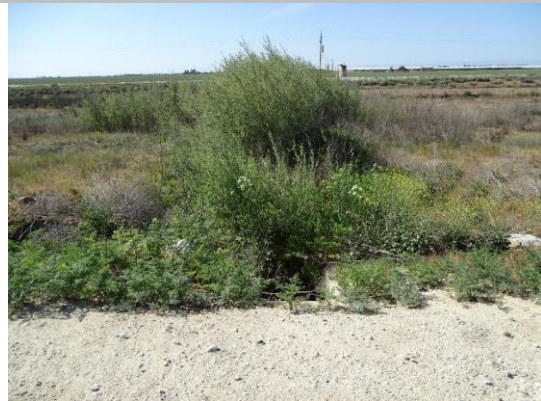
Photo 1 of 1 : UCIP\_SP\_2024\_80586\_112436.jpg

WS view: Looking from crown; concrete headwall at toe. Overgrown vegetation around headwall.

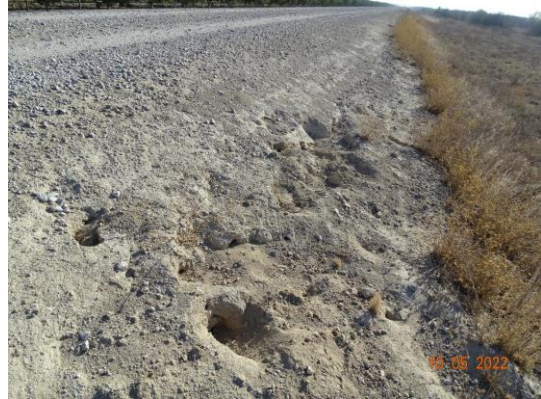
Photo 1 of 1 : SP\_2024\_NA0011\_146\_40\_20240212\_00019.jpg

View of burrows on the waterside slope. (Fall 2022)

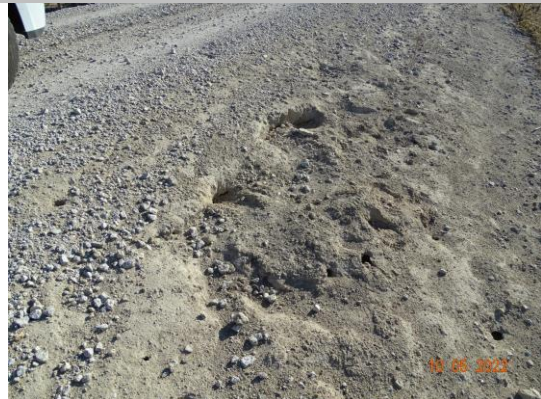
Photo 1 of 1 : SP\_2024\_NA0011\_146\_41\_20240212\_00020.jpg

Partially collapsed rodent holes on the waterside slope. (Fall 2022)

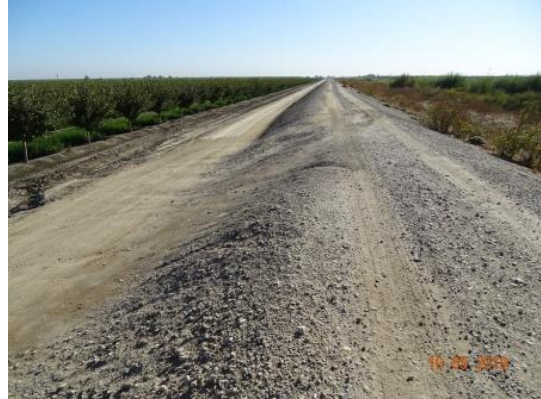
Photo 1 of 1 : SP\_2024\_NA0011\_146\_18\_20240212\_00008.jpg

Damage to landside shoulder and slope looking upstream. (Fall 2019)

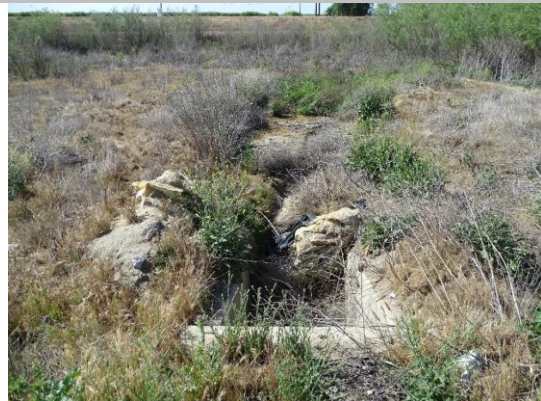
Photo 1 of 2 : UCIP\_SP\_2024\_80585\_112441.jpg

WS view: Concrete headwall on toe; stacked sandbags at end of spillway that would impede drainage.

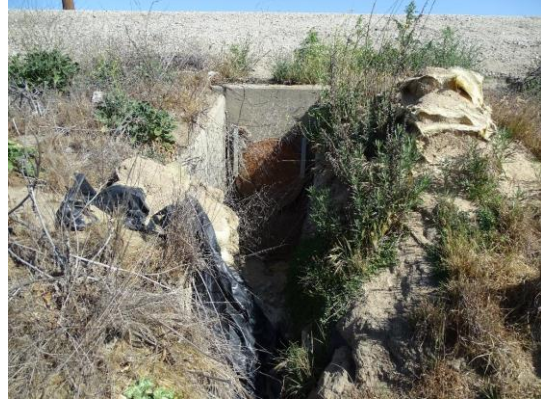
Photo 2 of 2 : UCIP\_SP\_2024\_80585\_112442.jpg

WS view: Sandbags at end of spillway that would impede drainage.

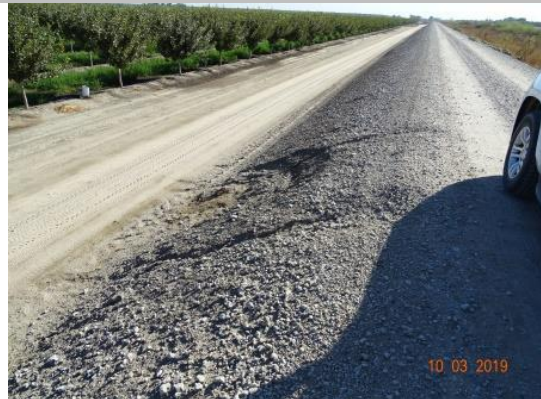
Photo 1 of 1 : SP\_2024\_NA0011\_146\_17\_20240212\_00007.jpg

View of landside slope erosion looking upstream. (Fall 2019)

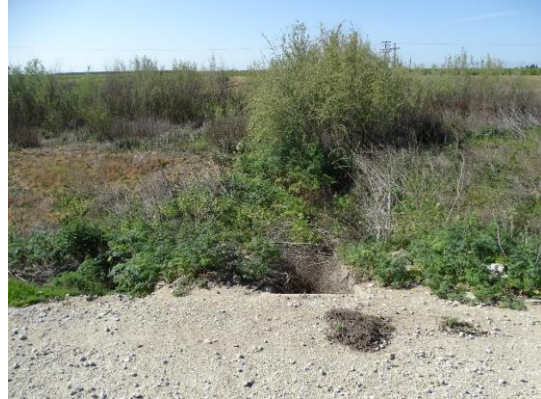
Photo 1 of 1 : UCIP\_SP\_2024\_80584\_112445.jpg

WS view: Concrete headwall on toe; overgrown vegetation around headwall.

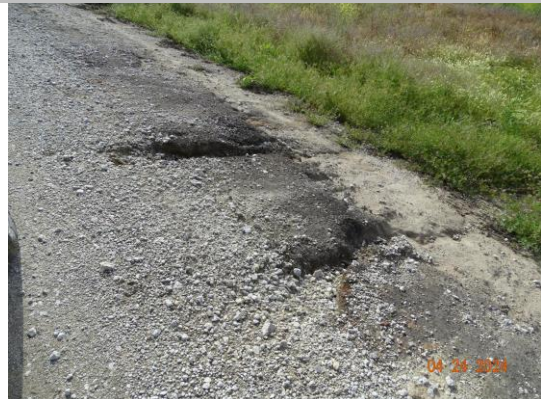
Photo 1 of 1 : SP\_2024\_NA0011\_146\_46\_20240429\_00065.jpg

Rills observed on waterside slope. (Spring 2024)

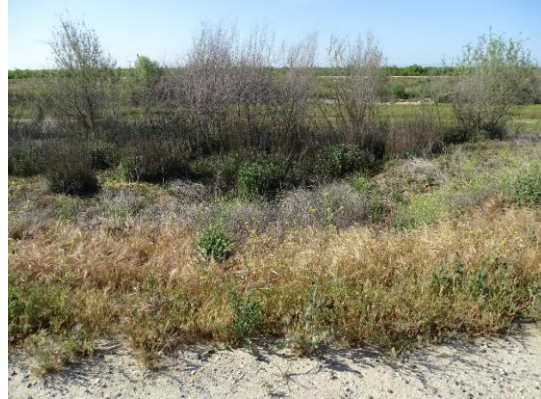
Photo 1 of 1 : UCIP\_SP\_2024\_80580\_112463.jpg

WS view: Looking from crown; dense vegetation on slope and floodway.

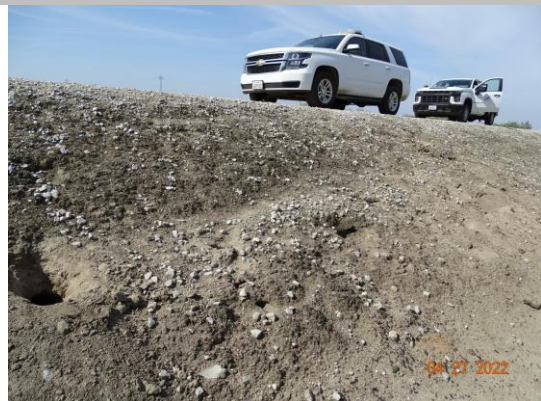
Photo 1 of 1 : SP\_2024\_NA0011\_146\_19\_20240212\_00009.jpg

Several rodent holes were noted at this location. (Spring 2022)

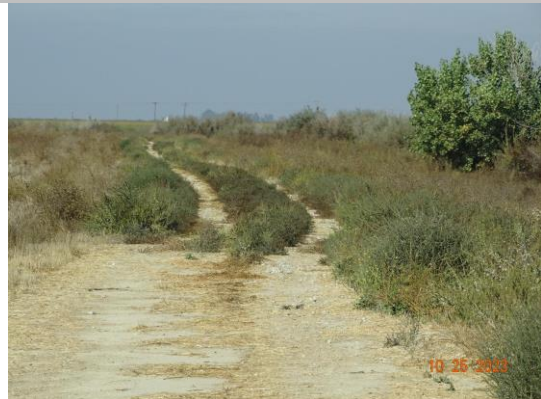
Photo 1 of 1 : SP\_2024\_NA0011\_147\_51\_20240212\_00019.jpg

View of vegetation growing along the levee crown. (Fall 2023)

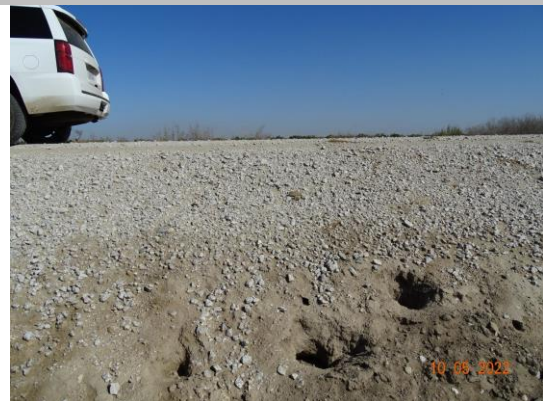
Photo 1 of 1 : SP\_2024\_NA0011\_147\_53\_20240212\_00020.jpg

Looking at typical rodent hole on landward slope. (Fall 2022)

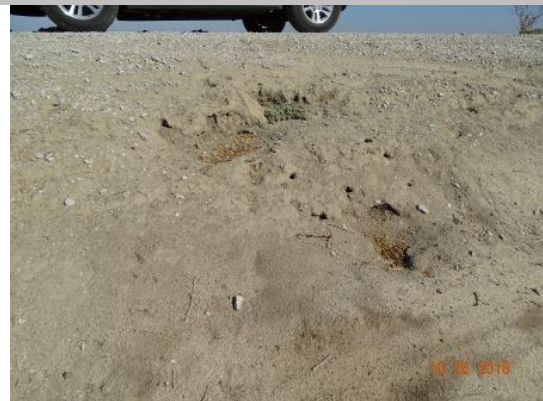
Photo 1 of 1 : SP\_2024\_NA0011\_147\_58\_20240212\_00021.jpg

Minor erosion on landside slope. (Fall 2018)

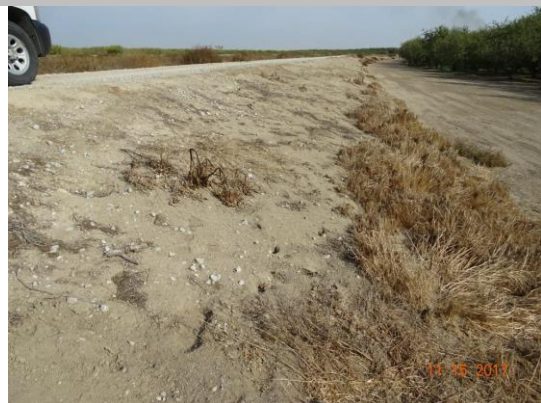
Photo 1 of 1 : SP\_2024\_NA0011\_147\_47\_20240212\_00018.jpg

Bait traps should be maintained and rodent holes should be backfilled.
