**Flood Control Project Maintenance  
Levee Inspections**  
**LMA District Cover Sheet**  
**Spring 2009 Levee Inspection Results**  
**Madera County FCWCA**

**Flood Control Project Maintenance  
Levee Inspections  
Levee Inspection Report By Mile - Spring 2009**

**Madera County FCWCA**

Waterway	Bank	Unit Miles	Inspection Start/End	Inspector
Unit No. 01 Ash Slough	Right	2.40	04/08/2009 04/08/2009	Herman Phillips

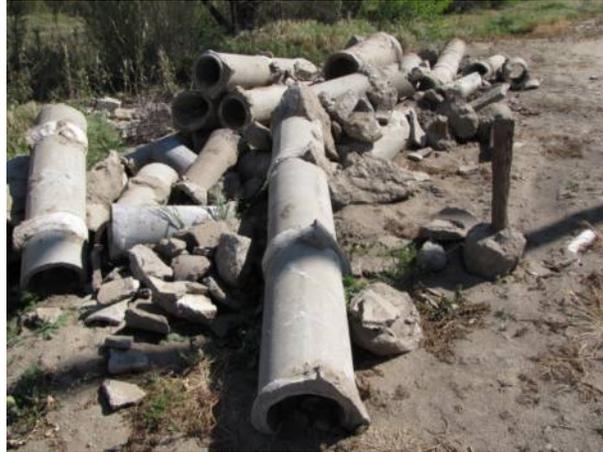
Levee Mile Report Line	23
Start Levee Mile	2.41
End Levee Mile	2.41
Location	Crown
Category	Earthen Levee
Item	Encroachments
Looking at pipe on waterward slope and toe of levee in unit 1 Ash Slough l/m 2.41

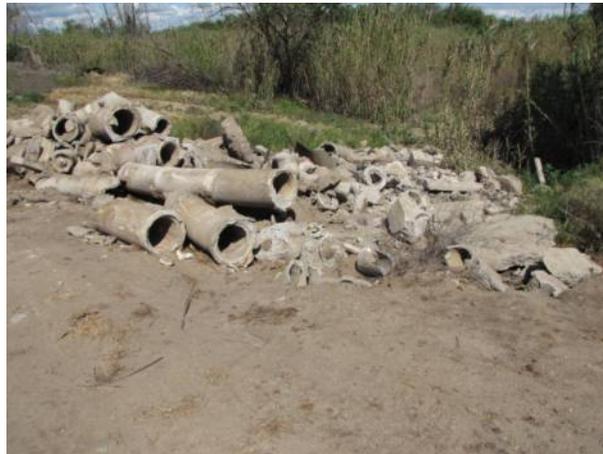
Levee Mile Report Line	23
Start Levee Mile	2.41
End Levee Mile	2.41
Location	Crown
Category	Earthen Levee
Item	Encroachments
This photo taken downstream of L/M 2.41 Ash Slough. Lots of broken concrete from hinge point to toe of levee.
