Flood Control Project Maintenance
2015 Structure Summary Report
Overall Unit and Item Ratings

Madera County FCWCA

Ash And Berenda Slough Control Structures

Levee Inspection Report By Mile - Structure 2015

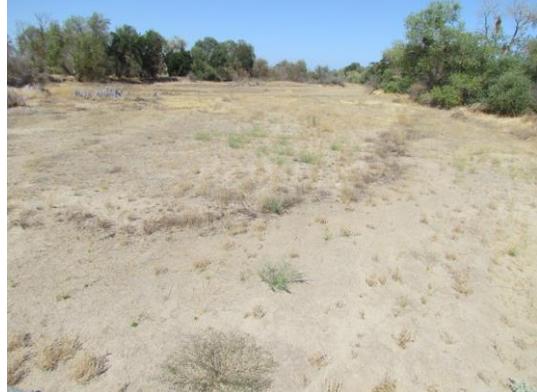
Photo 1 of 2 : ST_2015_NA0011_46_1_20150810_00001.jpg

LM Start	0.00	Rating **		Issue No.	1
LM End	0.00	Issue Type +	Ma	Location *	
Category	Structures & Concrete Lined Channels		GPS Latitude/Longitude		
			Start	End	
Item	Photo Documentation		37.157904 °	37.143520 °	
			-120.124165 °	-120.162171 °	
DWR ID	DWR_NA0011_46_t_2015_1				
Action/Comments					
Inspector Comments: Looking upstream from the Berenda Slough Control Structure, no

Looking upstream from the Berenda Slough Control Structure.

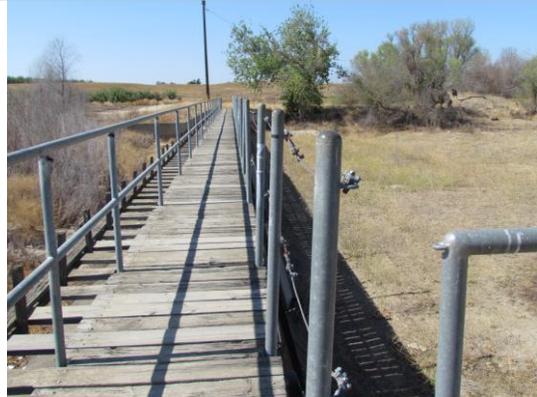
Photo 2 of 2 : ST_2015_NA0011_46_1_20150810_00004.jpg

This photo is the Ash Slough upstream side of the walkway.

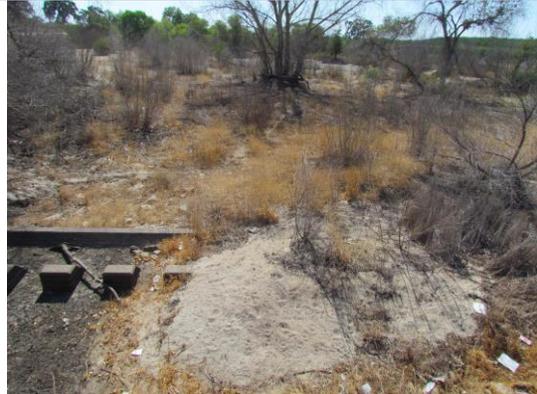
Photo 1 of 1 : ST_2015_NA0011_46_2_20150810_00002.jpg

LM Start	0.00	Rating **	M	Issue No.	2
LM End	0.00	Issue Type +	Ma	Location *	
Category	Structures & Concrete Lined Channels		GPS Latitude/Longitude		
			Start	End	
Item	Vegetation & Obstructions		37.157904 °	37.143520 °	
			-120.124165 °	-120.162171 °	
DWR ID	DWR_NA0011_46_t_2015_2				
Action/Comments					
Inspector Comments: Dead trees and other brush present downstream of Berenda Slough Structure.

Dead trees and other brush present downstream side of Berenda Slough Control Structure.

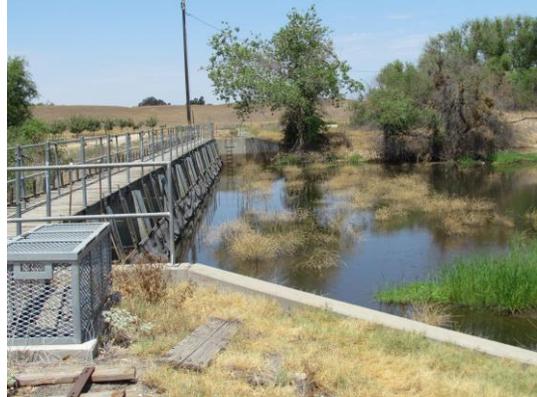
Photo 1 of 1 : ST_2015_NA0011_46_12_20150827_00005.jpg

LM Start	0.00	Rating **	A	Issue No.	12
LM End	0.00	Issue Type +	Ma	Location *	
Category	Structures & Concrete Lined Channels		GPS Latitude/Longitude		
			Start	End	
Item	Sluice/Slide Gates		37.157904 °	37.143520 °	
			-120.124165 °	-120.162171 °	
DWR ID	DWR_NA0011_46_t_2015_12				
Action/Comments					
Inspector Comments: There are no Sluice/Slide Gates, flash boards are used to restrict the flow. They are manually put in place.

This photo shows the flash boards used to close off the inlets at this structure.

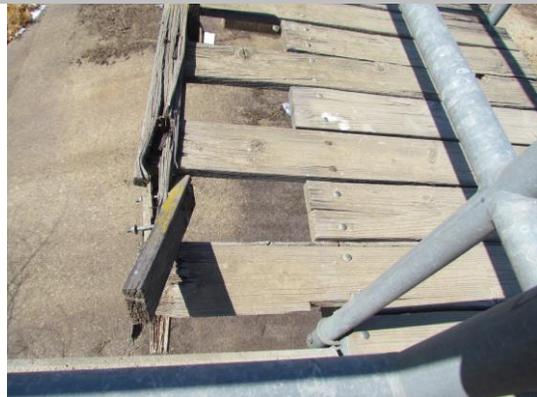
Photo 1 of 1 : ST_2015_NA0011_46_23_20150810_00003.jpg

LM Start	0.00	Rating **	M	Issue No.	23
LM End	0.00	Issue Type +	Ma	Location *	
Category	Structures & Concrete Lined Channels		GPS Latitude/Longitude		
			Start	End	
Item	Safety		37.157904 °	37.143520 °	
			-120.124165 °	-120.162171 °	
DWR ID	DWR_NA0011_46_t_2015_23				
Action/Comments					
Inspector Comments: Minor safety hazards are present, but do not pose an immediate threat to the structure or personnel at the structure. Corrections should be made prior to the next annual inspection.

There are damaged boards on the walkway that should be replaced on the downstream side of Ash Slough Control Structure.

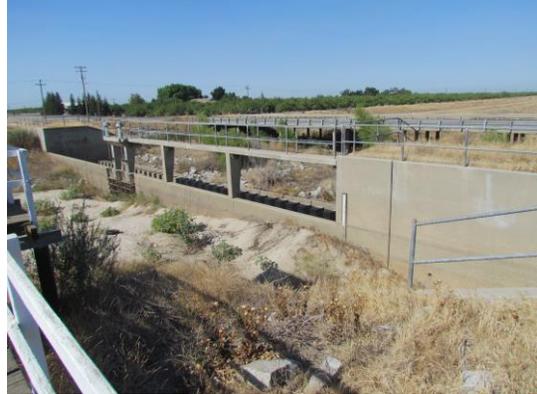
Photo 1 of 1 : ST_2015_NA0011_6_1_20150810_00001.jpg

LM Start	0.00	Rating **		Issue No.	1
LM End	0.00	Issue Type +	--	Location *	
Category	Structures & Concrete Lined Channels		GPS Latitude/Longitude		
			Start	End	
Item	Photo Documentation		36.967930 °	36.967930 °	
			-120.255680 °	-120.255680 °	
DWR ID	DWR_NA0011_6_t_2015_1				
Action/Comments					
Inspector Comments: View of weir from upstream right bank side of structure looking downstream.

Upstream side of the Fresno River Diversion Weir.

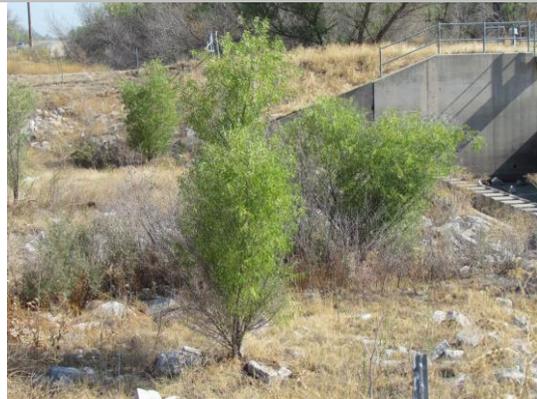
Photo 1 of 2 : ST_2015_NA0011_6_2_20150812_00002.jpg

LM Start	0.00	Rating **	M	Issue No.	2
LM End	0.00	Issue Type +	Ma	Location *	
Category	Structures & Concrete Lined Channels		GPS Latitude/Longitude		
			Start	End	
Item	Vegetation & Obstructions		36.967930 °	36.967930 °	
			-120.255680 °	-120.255680 °	
DWR ID	DWR_NA0011_6_t_2015_2				
Action/Comments					
Inspector Comments: Remove these small willow trees that have grown in the channel downstream of weir.

Small willow trees presently growing on the downstream side of the deflectors within the channel of the Fresno River and on the left bank Unit 6 there is buildup of small brush upstream of structure.

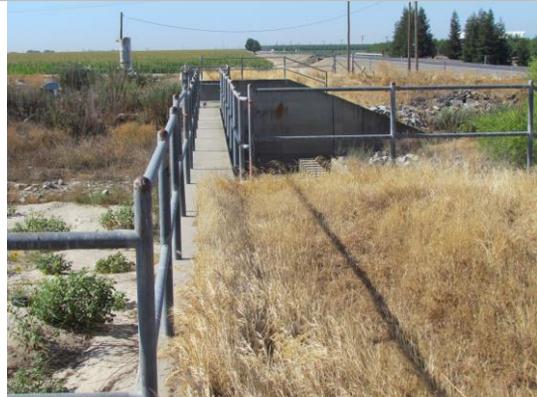
Photo 2 of 2 : ST_2015_NA0011_6_2_20150812_00005.jpg

Vegetation present in channel up stream side of structure looking over to unit 6.

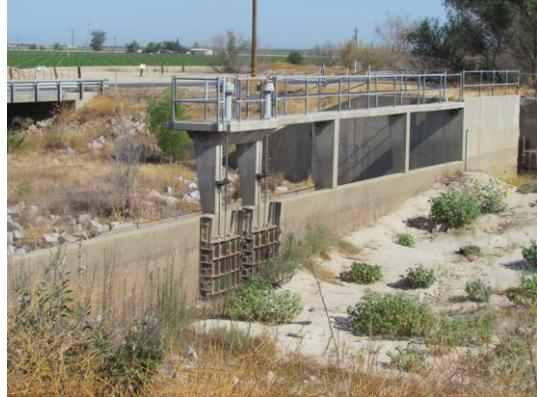
Photo 1 of 1 : ST_2015_NA0011_6_3_20150812_00004.jpg

LM Start	0.00	Rating **	M	Issue No.	3
LM End	0.00	Issue Type +	Ma	Location *	
Category	Structures & Concrete Lined Channels		GPS Latitude/Longitude		
			Start	End	
Item	Shoaling / Sedimentation		36.967930 °	36.967930 °	
			-120.255680 °	-120.255680 °	
DWR ID	DWR_NA0011_6_t_2015_3				
Action/Comments					
Inspector Comments: Monitor the buildup of sedimentation along the inside wall upstream of structure.

Sedimentation building up on the upstream side of structure against the concrete wall. The slide gates aren't blocked.

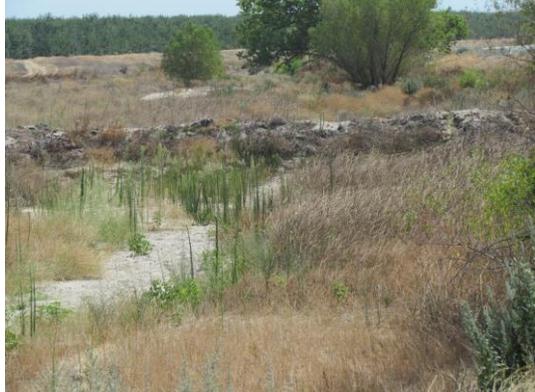
Photo 1 of 1 : ST_2015_NA0011_6_6_20150826_00007.jpg

LM Start	0.00	Rating **	U	Issue No.	6
LM End	0.00	Issue Type +	Ma	Location *	
Category	Structures & Concrete Lined Channels		GPS Latitude/Longitude		
			Start	End	
Item	Encroachments		36.967930 °	36.967930 °	
			-120.255680 °	-120.255680 °	
DWR ID	DWR_NA0011_6_t_2015_6				
Action/Comments					
Inspector Comments: There is a earthen dam upstream of the structure that was placed across the Fresno River channel by Chowchilla Water District.

This earthen dam remains across the Fresno River channel.

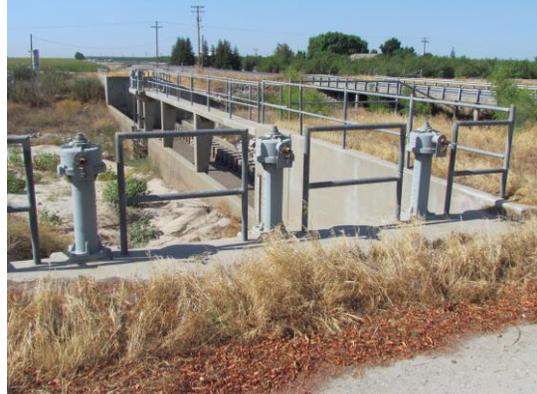
Photo 1 of 1 : ST_2015_NA0011_6_14_20150812_00006.jpg

LM Start	0.00	Rating **	A	Issue No.	14
LM End	0.00	Issue Type +	Ma	Location *	
Category	Structures & Concrete Lined Channels		GPS Latitude/Longitude		
			Start	End	
Item	Manual Gate Operators		36.967930 °	36.967930 °	
			-120.255680 °	-120.255680 °	
DWR ID	DWR_NA0011_6_t_2015_14				
Action/Comments					
Inspector Comments: All manual gate operators are in good working condition and are capable of opening and closing the gate properly. Preventative maintenance is being performed and the system is tested periodically.

Manual gates are in good working order.
