Flood Control Project Maintenance
2016 Structure Summary Report
Overall Unit and Item Ratings

Madera County FCWCA

Ash And Berenda Slough Control Structures

Flood Control Project Maintenance
Unit Cover Sheet
2016 Structure Inspection Results

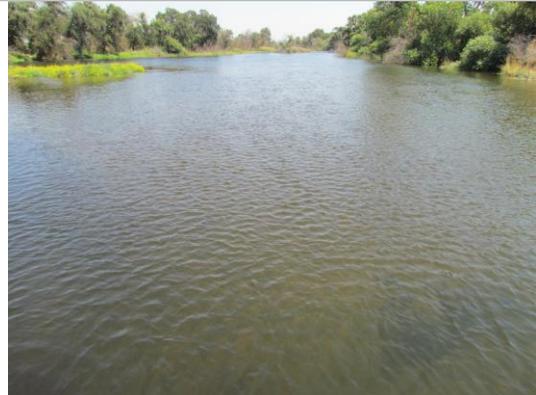
Photo 1 of 10 : ST_2016_NA0011_46_1_20160808_00001.jpg

Looking upstream from the Berenda Slough structure.

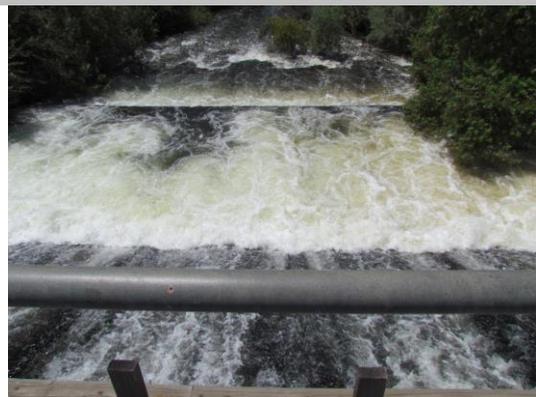
Photo 2 of 10 : ST_2016_NA0011_46_1_20160808_00002.jpg

Looking at the downstream side of Berenda Slough Control Structure.

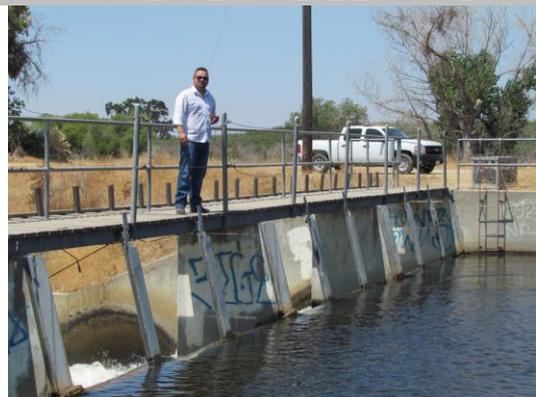
Photo 3 of 10 : ST_2016_NA0011_46_1_20160808_00004.jpg

Looking at the platform across the top of the Berenda Slough Control Structure.

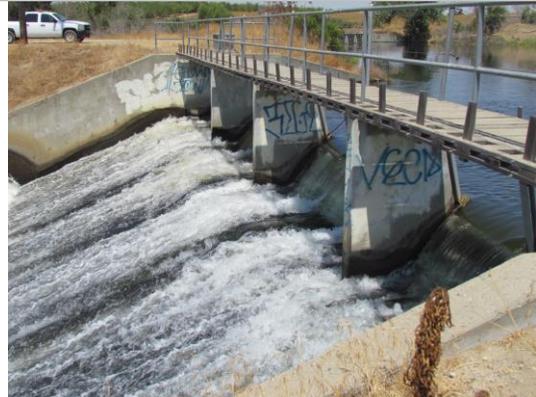
Photo 4 of 10 : ST_2016_NA0011_46_1_20160808_00005.jpg

Looking at Berenda Slough from the outlet downstream side of structure.

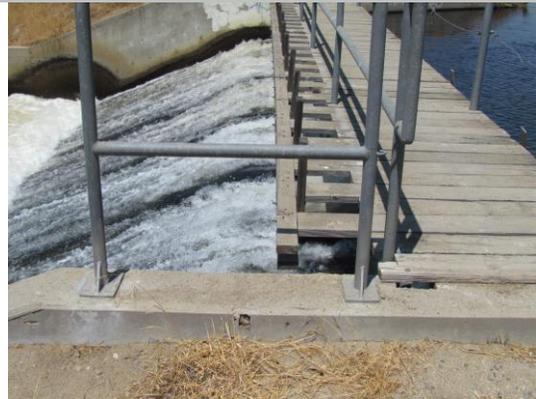
Photo 5 of 10 : ST_2016_NA0011_46_1_20160808_00006.jpg

Looking at the walkway crossing the top of Berenda slough control structure. The wood is in good shape.

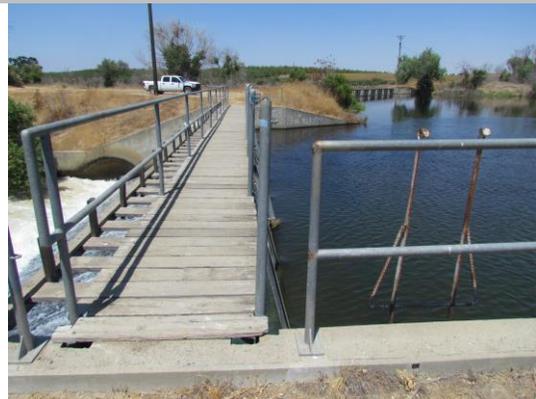
Photo 6 of 10 : ST_2016_NA0011_46_1_20160808_00007.jpg

Another view of the walk way and safety railing crossing the Berenda slough control structure

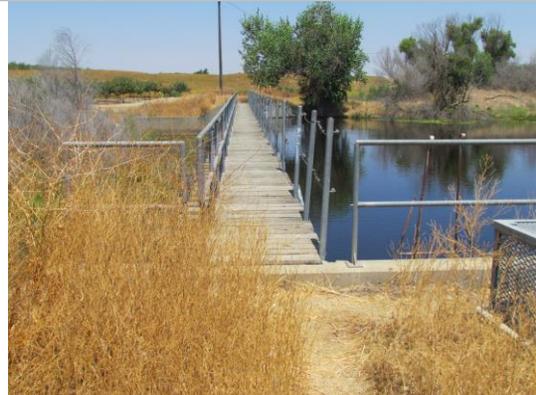
Photo 7 of 10 : ST_2016_NA0011_46_1_20160808_00008.jpg

Looking at the crossing of the Ash Slough Structure.

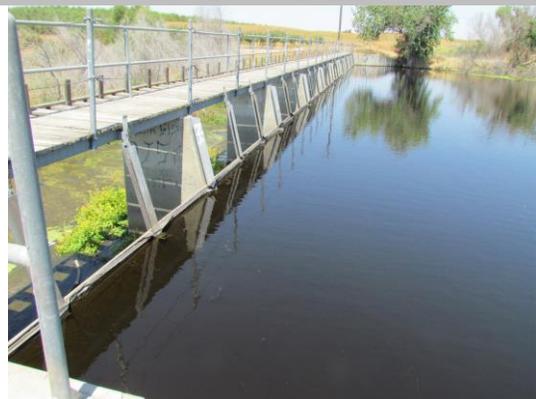
Photo 8 of 10 : ST_2016_NA0011_46_1_20160808_00009.jpg

Looking at the upstream side of the Ash Slough, flash boards in place and view of the pedestrian crossing.

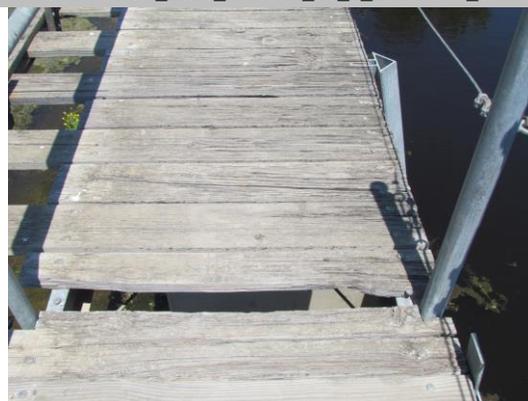
Photo 10 of 10 : ST_2016_NA0011_46_1_20160808_00011.jpg

Missing board on the walkway.

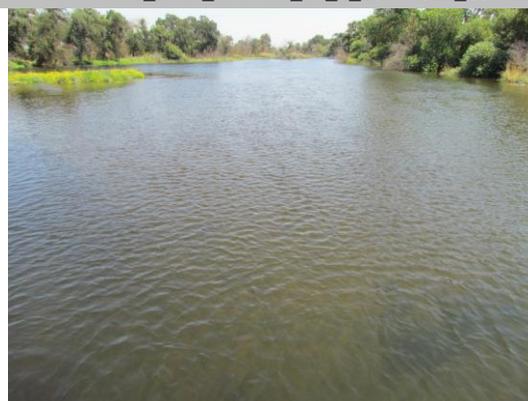
Photo 1 of 1 : ST_2016_NA0011_46_2_20160822_00012.jpg

| Inspector Comments: Channel clear of vegetation. | | | | | |

Looking upstream of structure, there is no vegetation present that would impede the flow coming downstream.

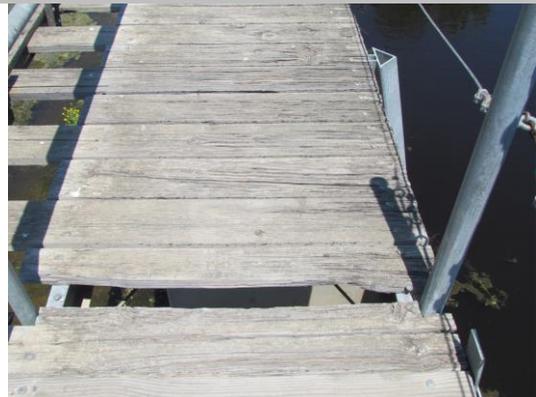
Photo 1 of 3 : ST_2016_NA0011_46_23_20160822_00016.jpg

| Inspector Comments: There are no safety hazards present at the Berenda Slough Structure. The Ash Slough Structure has minor safety hazards present. Missing boards, boards that could be replaced, and boards that have failed which were reported in my last report. | | | | | |

The photo shown here is the Ash Slough Structure, missing boards.

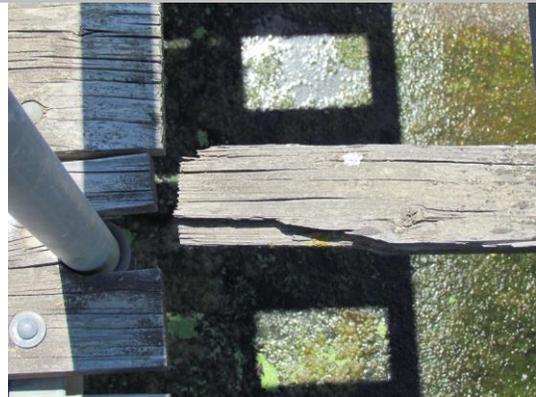
Photo 2 of 3 : ST_2016_NA0011_46_23_20160822_00017.jpg

This photo of the same crossing shows broken boards.

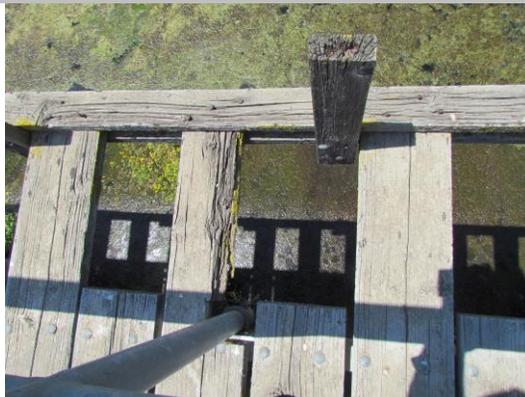
Photo 3 of 3 : ST_2016_NA0011_46_23_20160822_00018.jpg

| Inspector Comments: There are no safety hazards present at the Berenda Slough Structure. The Ash Slough Structure has minor safety hazards present. Missing boboards, boards that could be replaced, and boards that have failed which were reported in my last report. | | | | | |

This photo shows rotten boards that should be replaced. Ash Slough Control Structure.

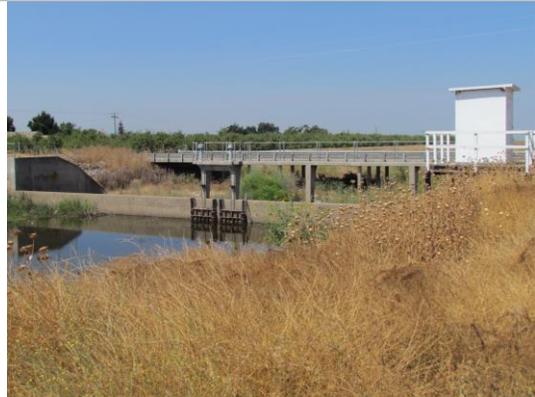
Photo 1 of 2 : ST_2016_NA0011_6_1_20160821_00001.jpg

Standing upstream of weir looking back across channel.

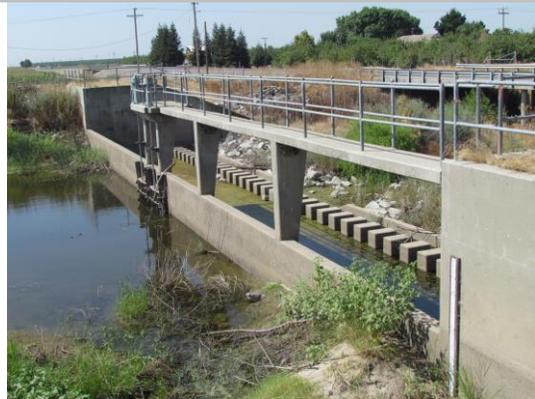
Photo 2 of 2 : ST_2016_NA0011_6_1_20160821_00002.jpg

View from upstream of structure standing on Unit 5 looking back across to Unit 6.

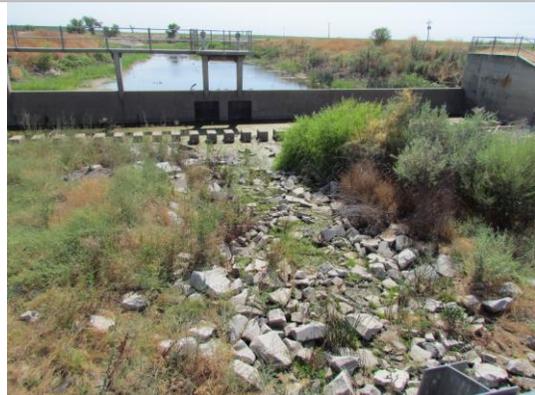
Photo 1 of 2 : ST_2016_NA0011_6_2_20160901_00008.jpg

| Inspector Comments: Clear vegetation growth from upstream side of structure. Wild growth of trees present on the downstream side of structure looking back upstream. | | | | | |

Trees on downstream side of structure may impede flow and should be removed.

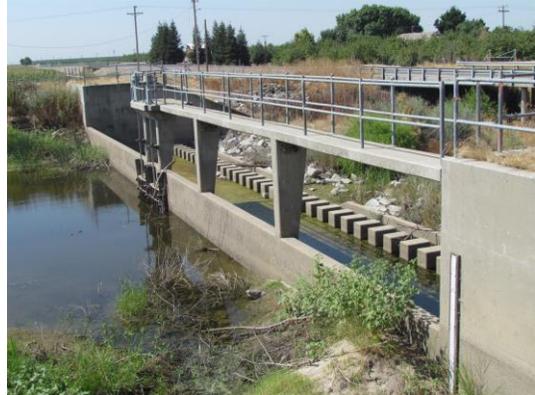
Photo 2 of 2 : ST_2016_NA0011_6_2_20160821_00003.jpg

Very little vegetation present in channel upstream of structure of the Fresno River.

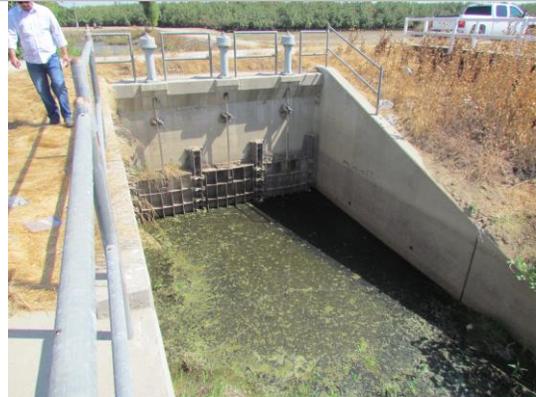
Photo 1 of 1 : ST_2016_NA0011_6_14_20160821_00005.jpg

| Inspector Comments: The manual control gates here are in good working order. | | | | | |

The photo here shows the manual control gates in the background.

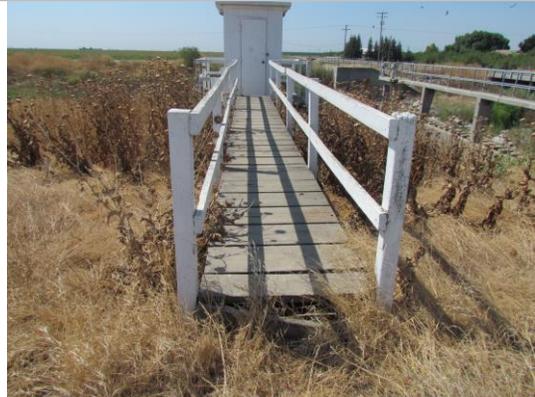
Photo 1 of 2 : ST_2016_NA0011_6_23_20160901_00009.jpg

| Inspector Comments: No safety issues present at this location. | | | | | |

Safety handrails on structure.

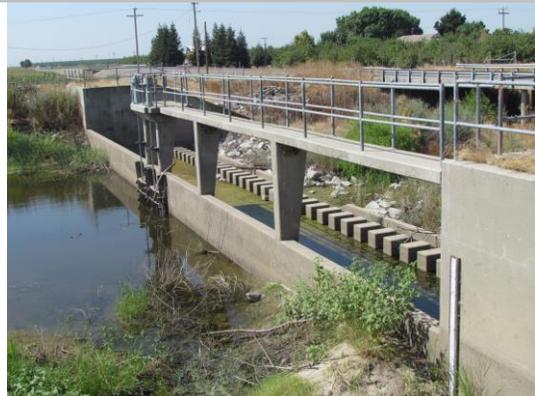
Photo 2 of 2 : ST_2016_NA0011_6_23_20160901_00010.jpg

Safety handrails on structure.
