**Flood Control Project Maintenance
Levee Inspections**
LMA District Cover Sheet
Spring 2014 Levee Inspection Results

Solano County Public Works Mellin Levee

Levee Inspection Report By Mile - Spring 2014

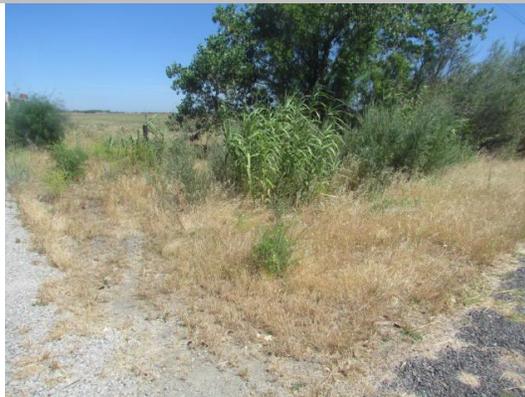
Photo 1 of 1 : richard_s_20140529_849.jpg

LM Start	0.00	Rating **	M	Issue No.	1
LM End	0.00	Issue Type +	Ma	Location *	WS
Category	Earthen Levee		GPS Latitude/Longitude		
			Start	End	
Item	Vegetation		38.174051 °	38.174051 °	
			-121.674220 °	-121.674221 °	
DWR ID	DWR_NA0012_01_s_2012_1				
Action/Comments					
Remove the wild growth other than native grasses from the levee slopes. Inspector Comments: Control Arundo on waterside slope at the entrance to the levee.

Looking west at arundo on waterside slope at entrance to unit.

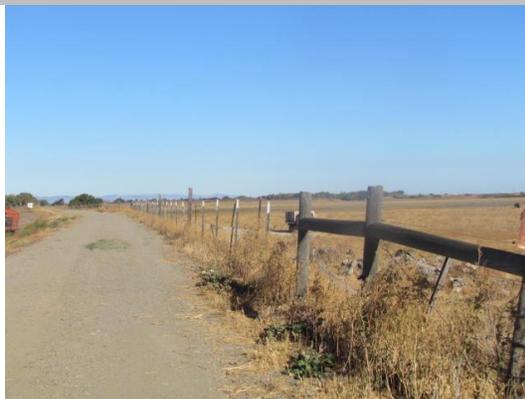
Photo 1 of 1 : richard_s_20140320_458.jpg

LM Start	0.00	Rating **	M	Issue No.	3
LM End	0.59	Issue Type +	En	Location *	WS
Category	Earthen Levee		GPS Latitude/Longitude		
			Start	End	
Item	Encroachments		38.174167 °	38.178960 °	
			-121.674312 °	-121.680600 °	
DWR ID	DWR_NA0012_01_s_2012_3				
Action/Comments					
Fence

Looking west at fence on waterside shoulder.

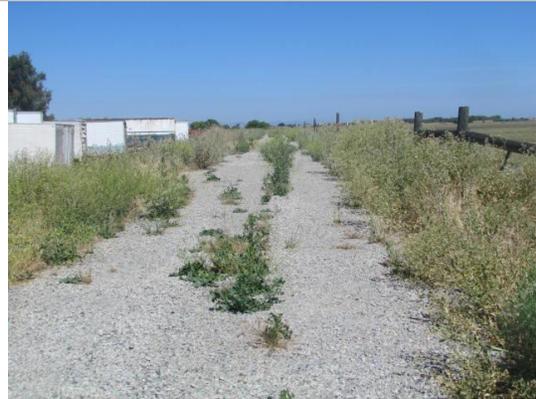
Photo 1 of 1 : richard_s_20140529_850.jpg

LM Start	0.00	Rating **	M	Issue No.	10
LM End	0.59	Issue Type +	Ma	Location *	LS
Category	Earthen Levee		GPS Latitude/Longitude		
			Start	End	
Item	Vegetation		38.174063 °	38.180023 °	
			-121.674253 °	-121.681937 °	
DWR ID	DWR_NA0012_01_s_2014_10				
Action/Comments					
Remove the wild growth other than native grasses from the levee slopes.

Looking west at wild growth on waterward and landward slopes.

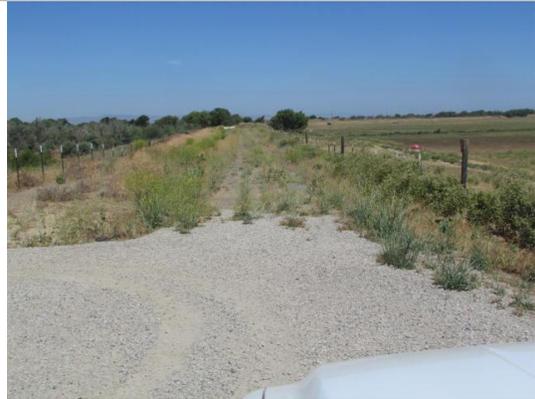
Photo 1 of 1 : richard_s_20140529_852.jpg

LM Start	0.15	Rating **	M	Issue No.	2
LM End	0.59	Issue Type +	Ma	Location *	CR
Category	Earthen Levee		GPS Latitude/Longitude		
			Start	End	
Item	Crown Surface / Depressions / Rutting		38.175618 °	38.178960 °	
			-121.676190 °	-121.680600 °	
DWR ID	DWR_NA0012_01_s_2012_2				
Action/Comments					
Add appropriate material and re-grade the levee to bring the crown above the design elevation.

Looking west at wild growth on levee crown.

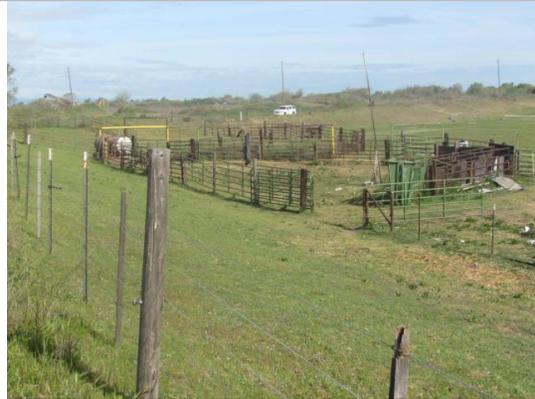
Photo 1 of 2 : richard_s_20140320_459.jpg

LM Start	0.59	Rating **	M	Issue No.	5
LM End	0.59	Issue Type +	En	Location *	WS
Category	Earthen Levee		GPS Latitude/Longitude		
			Start	End	
Item	Encroachments		38.180012 °	38.180012 °	
			-121.681943 °	-121.681943 °	
DWR ID	DWR_NA0012_01_s_2012_5				
Action/Comments					
Fence Inspector Comments: Animal corral.

Looking west at animal corral on waterside toe.

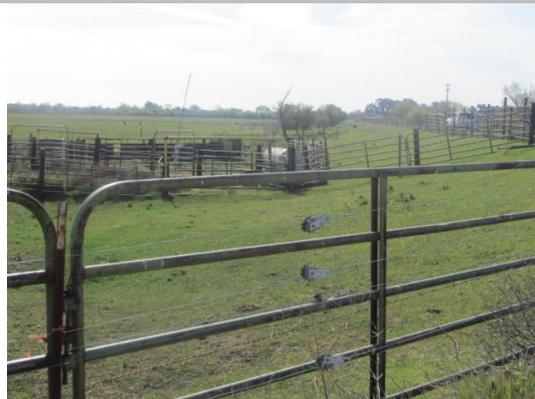
Photo 2 of 2 : richard_s_20140320_460.jpg

LM Start	0.59	Rating **	M	Issue No.	5 (cont)
LM End	0.59	Issue Type +	En	Location *	WS

Looking east at animal corral on waterside toe.
