**Flood Control Project Maintenance  
Levee Inspections**

**Maintenance Issue Types Only, Levee Inspection Report By Mile - Fall 2014**

**Solano County Public Works Mellin Levee**

Waterway	Bank	Unit Miles	Inspection Start/End	Inspector
Unit No. 01 Mellin Levee	Right	0.59	10/16/2014 10/16/2014	Richard Willoughby

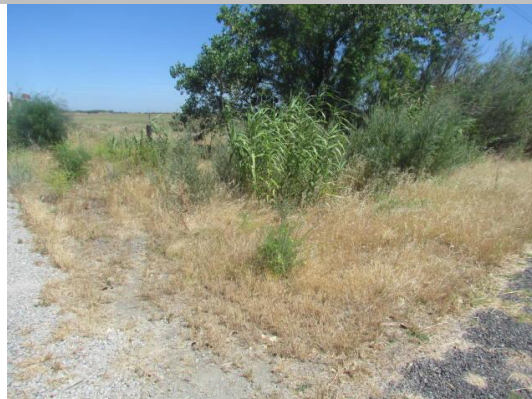
Photo 1 of 1 : FA\_2014\_NA0012\_258\_1\_20141010\_00001.jpg

LM Start	0.00	Rating **	M	Issue No.	1
LM End	0.00	Issue Type +	Ma	Location *	WS
Category	Earthen Levee			GPS Latitude/Longitude	
				Start	End
Item	Vegetation			38.174051 °	38.174051 °
				-121.674220 °	-121.674221 °
DWR ID	DWR_NA0012_01_s_2012_1				
Action/Comments					
Remove the wild growth other than native grasses from the levee slopes.					
Inspector Comments: Control Arundo on waterside slope at the entrance to the levee.

Looking west at arundo on waterside slope at entrance to unit.

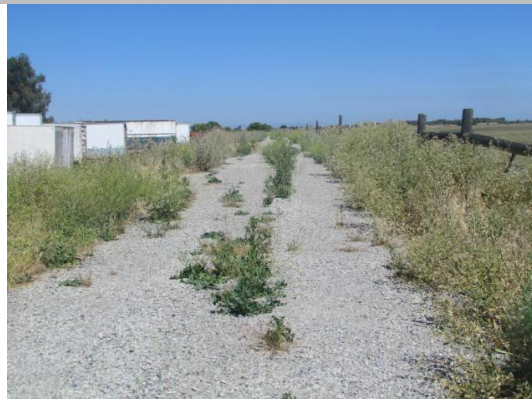
Photo 1 of 1 : FA\_2014\_NA0012\_258\_10\_20141010\_00006.jpg

LM Start	0.00	Rating **	A	Issue No.	10
LM End	0.59	Issue Type +	Ma	Location *	LS
Category	Earthen Levee			GPS Latitude/Longitude	
				Start	End
Item	Vegetation			38.174063 °	38.180023 °
				-121.674253 °	-121.681937 °
DWR ID	DWR_NA0012_01_s_2014_10				
Action/Comments					
Remove the wild growth other than native grasses from the levee slopes.

Looking west at wild growth on waterward and landward slopes.

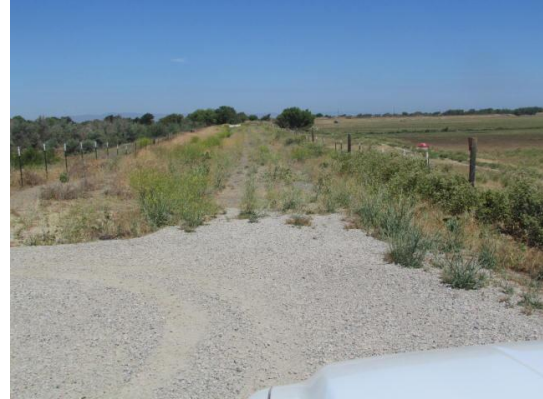
Photo 1 of 1 : FA\_2014\_NA0012\_258\_2\_20141010\_00002.jpg

LM Start	0.15	Rating **	A	Issue No.	2
LM End	0.59	Issue Type +	Ma	Location *	CR
Category	Earthen Levee			GPS Latitude/Longitude	
				Start	End
Item	Crown Surface / Depressions / Rutting			38.175618 °	38.178960 °
				-121.676190 °	-121.680600 °
DWR ID	DWR_NA0012_01_s_2012_2				
Action/Comments					
Add appropriate material and re-grade the levee to bring the crown above the design elevation.

Looking west at wild growth on levee crown.
