**Flood Control Project Maintenance  
Levee Inspections**

**Maintenance Issue Types Only, Levee Inspection Report By Mile - Fall 2015**

**Solano County Public Works Mellin Levee**

Waterway	Bank	Unit Miles	Inspection Start/End	Inspector
Unit No. 01 Mellin Levee	Right	0.59	11/03/2015 11/03/2015	Richard Willoughby

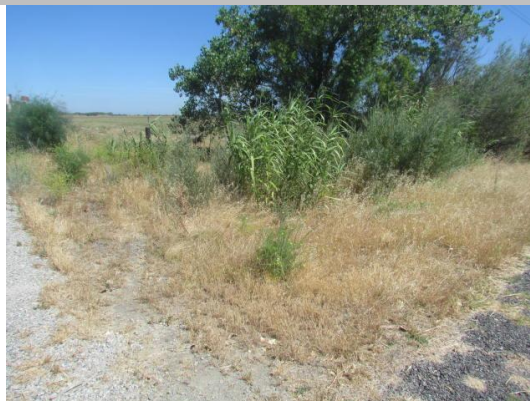
Photo 1 of 1 : FA\_2015\_NA0012\_258\_1\_20150914\_00001.jpg

LM Start	0.00	Rating **	M	Issue No.	1
LM End	0.00	Issue Type +	Ma	Location *	WS
Category	Earthen Levee			GPS Latitude/Longitude	
				Start	End
Item	Vegetation			38.174051 °	38.174051 °
				-121.674220 °	-121.674221 °
DWR ID	DWR_NA0012_01_s_2012_1				
Action/Comments					
Remove the wild growth other than native grasses from the levee slopes.					
Inspector Comments: Control Arundo on waterside slope at the entrance to the levee.

Looking west at arundo on waterside slope at entrance to unit.

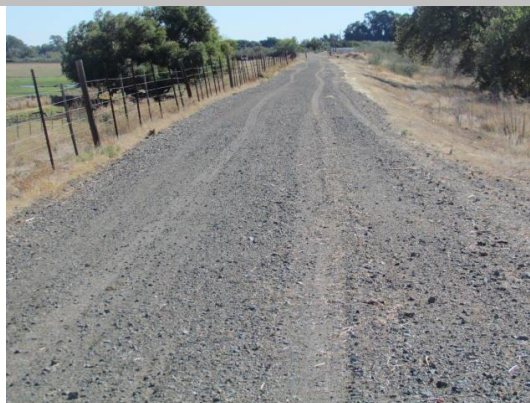
Photo 1 of 3 : FA\_2015\_NA0012\_258\_10\_20151106\_00009.jpg

LM Start	0.15	Rating **	A/W	Issue No.	10
LM End	0.59	Issue Type +	Ma	Location *	CR
Category	Earthen Levee			GPS Latitude/Longitude	
				Start	End
Item	Vegetation			38.175627 °	38.180044 °
				-121.676185 °	-121.681978 °
DWR ID	DWR_NA0012_01_s_2015_10				
Action/Comments					
Remove the wild growth other than native grasses from the levee slopes.					
Inspector Comments: Add appropriate gravel or road base.

Looking east at levee crown fall 2015.

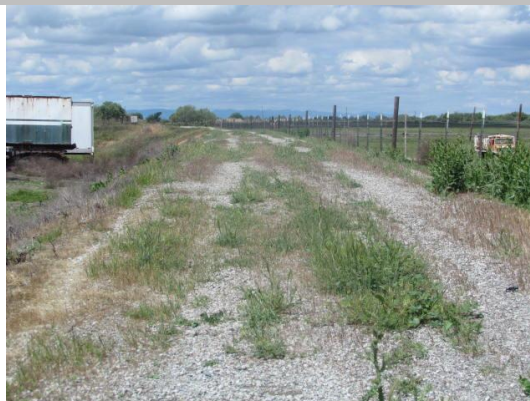
Photo 2 of 3 : FA\_2015\_NA0012\_258\_10\_20150914\_00006.jpg

Looking west at vegetation on levee crown at LM 0.00 to 0.10

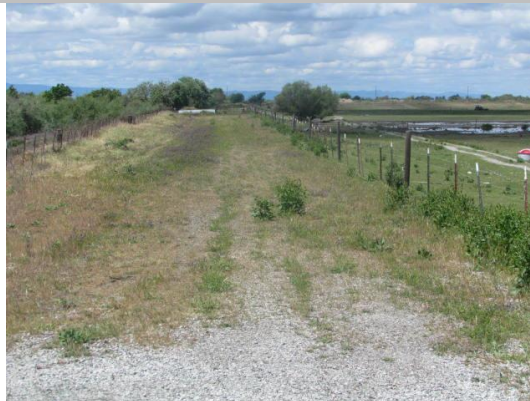
Photo 3 of 3 : FA\_2015\_NA0012\_258\_10\_20150914\_00007.jpg

LM Start	0.15	Rating **	A/W	Issue No.	10 (cont)	
LM End	0.59	Issue Type +	Ma	Location *	CR	
Category	Earthen Levee			GPS Latitude/Longitude		
				Start		End
Item	Vegetation			38.175627 °		38.180044 °
				-121.676185 °		-121.681978 °
DWR ID	DWR_NA0012_01_s_2015_10					
Action/Comments						
Remove the wild growth other than native grasses from the levee slopes.						
Inspector Comments: Add appropriate gravel or road base.

Looking west at vegetation on levee crown at LM 0.28 to 0.59

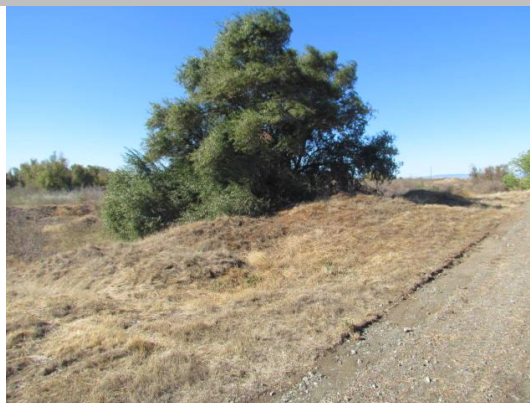
Photo 1 of 2 : FA\_2015\_NA0012\_258\_12\_20151106\_00011.jpg

LM Start	0.58	Rating **	U	Issue No.	12
LM End	0.58	Issue Type +	Ma	Location *	LS
Category	Earthen Levee			GPS Latitude/Longitude	
				Start	End
Item	Trim / Thin Trees			38.179966 °	38.179966 °
				-121.681872 °	-121.681872 °
DWR ID	DWR_NA0012_01_s_2015_12				
Action/Comments					
Trim trees to at least five feet above ground level.

Looking at untrimmed tree on landward slope fall 2015.

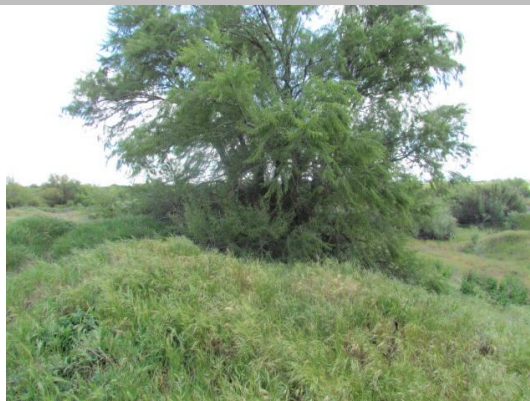
Photo 2 of 2 : FA\_2015\_NA0012\_258\_12\_20150914\_00008.jpg

Looking east at untrimmed tree on landward slope spring 2015
