**Flood Control Project Maintenance  
Levee Inspections**

## Maintenance Issue Types Only, Levee Inspection Report By Mile - Fall 2017

### Solano County Public Works Mellin Levee

Waterway	Bank	Unit Miles	Inspection Start/End	Inspector
Unit No. 01 Mellin Levee	Right	0.59	09/06/2017 09/06/2017	Dave Torres

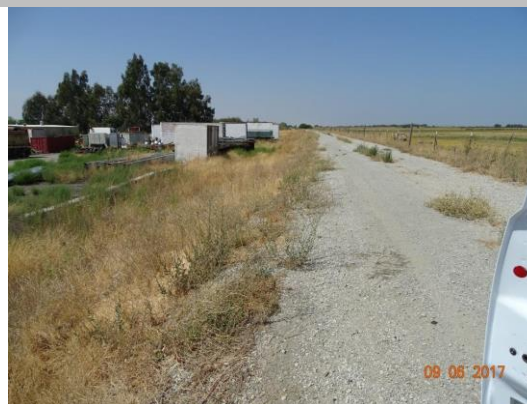
Photo 1 of 1 : FA\_2017\_NA0012\_258\_1\_20170907\_00010.jpg

LM Start	0.00	Rating **	M	Issue No.	1
LM End	0.34	Issue Type +	Ma	Location *	LS
Category	Earthen Levee			GPS Latitude/Longitude	
				Start	End
Item	Vegetation			38.174070 °	38.177475 °
				-121.674285 °	-121.678649 °
DWR ID	DWR_NA0012_01_f_2017_1				
Comment Code					
V1 : Control annual grass and weeds on the levee slopes and easements.					
Inspector Comment					
Unable to adequately see landside due to vegetation.

Looking northwest at the landside vegetation.
