**Flood Control Project Maintenance
Levee Inspections**

Maintenance Issue Types Only, Levee Inspection Report By Mile - Fall 2018

Solano County Public Works Mellin Levee

Waterway	Bank	Unit Miles	Inspection Start/End	Inspector
Unit No. 01 Mellin Levee	Right	0.59	10/10/2018 10/10/2018	David Julian

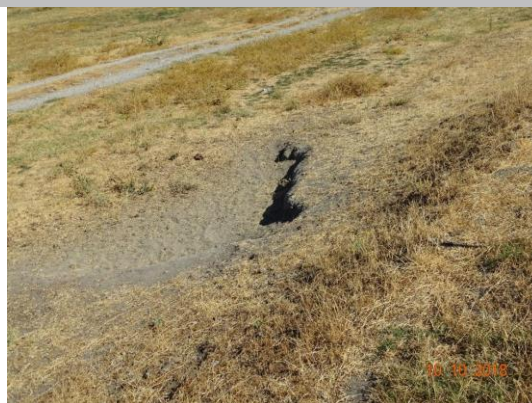
Photo 1 of 1 : FA_2018_NA0012_258_11_20181011_00007.jpg

LM Start	0.12	Rating **	M	Issue No.	11
LM End	0.12	Issue Type +	Ma	Location *	WS
Category	Earthen Levee			GPS Latitude/Longitude	
				Start	End
Item	Erosion / Bank Caving			38.175333°	38.175333°
				-121.675780°	-121.675780°
DWR ID	DWR_NA0012_01_f_2018_11				
Comment Code					
E1 : Note and monitor erosion site.					
Inspector Comment					
Erosion at land side toe.

View of erosion into water side toe (October 2018).

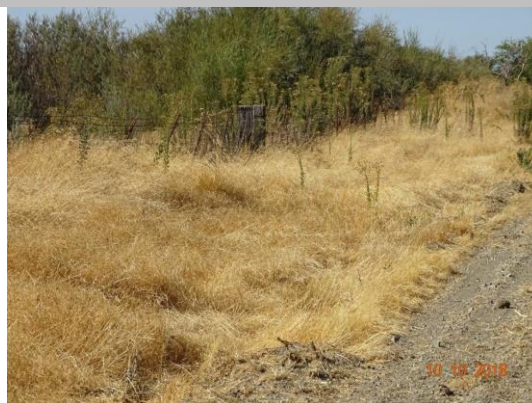
Photo 1 of 1 : FA_2018_NA0012_258_5_20181011_00006.jpg

LM Start	0.18	Rating **	M	Issue No.	5
LM End	0.25	Issue Type +	Ma	Location *	LS
Category	Earthen Levee			GPS Latitude/Longitude	
				Start	End
Item	Vegetation			38.175925 °	38.176615 °
				-121.676618 °	-121.677528 °
DWR ID	DWR_NA0012_01_f_2018_5				
Comment Code					
V1 : Control annual grass and weeds on the levee slopes and easements.					
Inspector Comment					
Remove vegetation up to fence

View of vegetation on the land side slope that should be remove to the fence (October 2018).

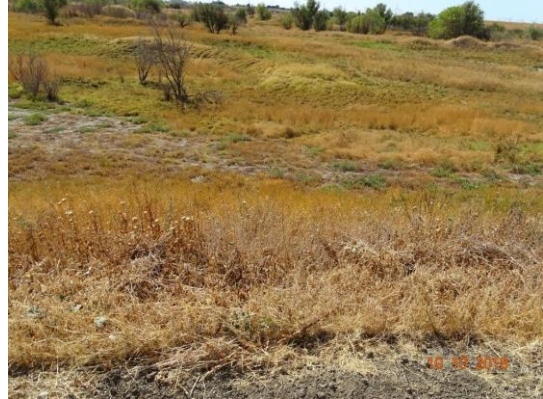
Photo 1 of 1 : FA_2018_NA0012_258_1_20181011_00005.jpg

LM Start	0.50	Rating **	M	Issue No.	1
LM End	0.55	Issue Type +	Ma	Location *	LS
Category	Earthen Levee			GPS Latitude/Longitude	
				Start	End
Item	Vegetation			38.179138 °	38.179638 °
				-121.680727 °	-121.681370 °
DWR ID	DWR_NA0012_01_f _ 2018_1				
Comment Code					
V1 : Control annual grass and weeds on the levee slopes and easements.					
Inspector Comment					
Remove vegetation to bottom of land side slope.

View of vegetation on land side slope that should be removed (October 2018).
