**Flood Control Project Maintenance
Levee Inspections**

Maintenance Issue Types Only, Levee Inspection Report By Mile - Fall 2019

Solano County Public Works Mellin Levee

Waterway	Bank	Unit Miles	Inspection Start/End	Inspector
Unit No. 01 Mellin Levee	Right	0.59	10/24/2019 10/24/2019	David Julian

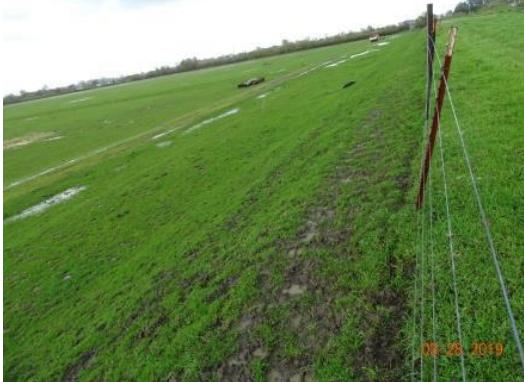
Photo 1 of 1 : FA_2019_NA0012_258_10_20190826_00003.jpg

View of slope instabilities caused by cows on the waterside slope (Spring 2019).

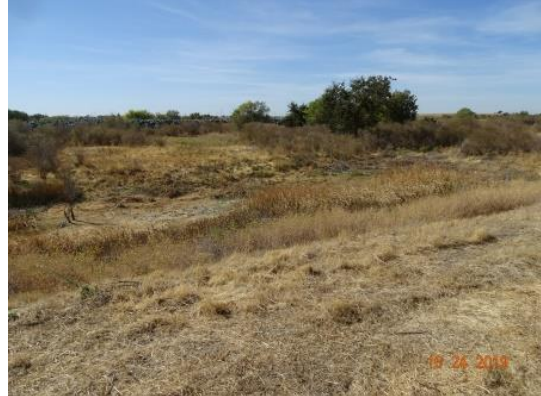
Photo 1 of 1 : FA_2019_NA0012_258_1_20191025_00006.jpg

LM Start	0.30	Rating **	M	Issue No.	1
LM End	0.35	Issue Type +	Ma	Location *	LS
Category	Earthen Levee			GPS Latitude/Longitude	
				Start	End
Item	Vegetation			38.177067°	38.177632°
				-121.678112°	-121.678840°
DWR ID	DWR_NA0012_01_f_2019_1				
Comment Code					
V1 : Control annual grass and weeds on the levee slopes and easements.					
Inspector Comment

View looking downslope at vegetation on the landside slope (Fall 2019).
