**Flood Control Project Maintenance
Levee Inspections**

Maintenance Issue Types Only, Levee Inspection Report By Mile - Fall 2020

Solano County Public Works Mellin Levee

| Waterway | Bank | Unit Miles | Inspection Start/End | Inspector |
|---|---|---|---|---|
| Unit No. 01 Mellin Levee | Right | 0.59 | 11/04/2020 11/04/2020 | David Julian |

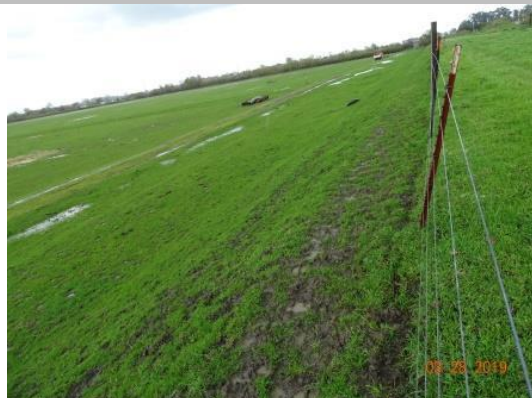
Photo 1 of 1 : FA_2020_NA0012_258_10_20201009_00004.jpg

| LM Start | 0.00 | Rating ** | M | Issue No. | 10 |
| Item | Slope Stability | | | 38.174067 ° | 38.177508 ° |
| Repair instabilities caused by cattle walking on the waterside slope. | | | | | |

View of slope instabilities caused by cows on the waterside slope (Spring 2019).

| S2 : Repair the levee slope damaged by foot traffic and prevent access where possible. | | | | | |

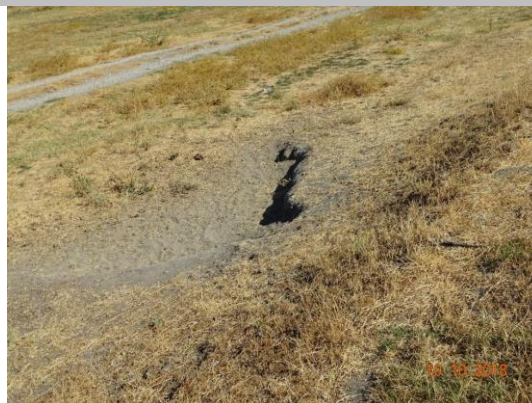
Photo 1 of 1 : FA_2020_NA0012_258_11_20201009_00005.jpg

| LM Start | 0.13 | Rating ** | U | Issue No. | 11 |
| Cows are digging into the waterside toe. | | | | | |

View of erosion into waterside toe (October 2018).

| S2 : Repair the levee slope damaged by foot traffic and prevent access where possible. | | | | | |
