**Flood Control Project Maintenance
Levee Inspections**

Maintenance Issue Types Only, Levee Inspection Report By Mile - Fall 2021

Solano County Public Works Mellin Levee

Waterway	Bank	Unit Miles	Inspection Start/End	Inspector
Unit No. 01 Mellin Levee	Right	0.59	09/27/2021 09/27/2021	David Julian

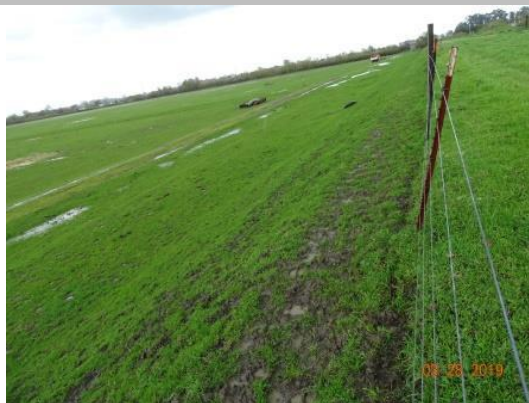
Photo 1 of 1 : FA_2021_NA0012_258_10_20210830_00004.jpg

LM Start	0.00	Rating **	M	Issue No.	10
LM End	0.34	Issue Type +	Ma	Location *	WS
Category	Earthen Levee			GPS Latitude/Longitude	
				Start	End
Item	Slope Stability			38.174067 °	38.177508 °
				-121.674271 °	-121.678675 °
DWR ID	DWR_NA0012_01_s_2019_10				
Comment Code					
S2 : Repair the levee slope damaged by foot traffic and prevent access where possible.					
Inspector Comment					
Repair instabilities caused by cattle walking on the waterside slope.

View of slope instabilities caused by cows on the waterside slope (Spring 2019).

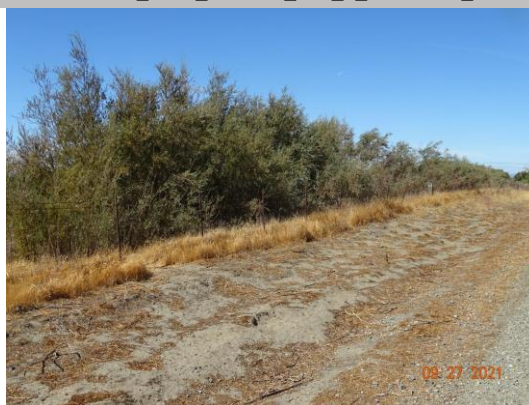
Photo 1 of 1 : FA_2021_NA0012_258_1_20210928_00009.jpg

LM Start	0.10	Rating **	U	Issue No.	1
LM End	0.12	Issue Type +	Ma	Location *	LS
Category	Earthen Levee			GPS Latitude/Longitude	
				Start	End
Item	Vegetation			38.175069 °	38.175293 °
				-121.675454 °	-121.675767 °
DWR ID	DWR_NA0012_01_f_2021_1				
Comment Code					
V2 : Remove the wild growth other than native grasses from the levee slopes.					
Inspector Comment					
There are willows on the landside slope.

View of thick willows on the landside slope (Fall 2021).

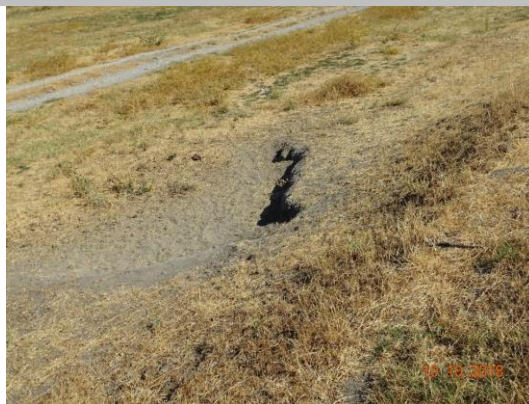
Photo 1 of 1 : FA_2021_NA0012_258_11_20210830_00005.jpg

LM Start	0.13	Rating **	M	Issue No.	11
LM End	0.13	Issue Type +	Ma	Location *	WS
Category	Earthen Levee			GPS Latitude/Longitude	
				Start	End
Item	Erosion / Bank Caving			38.175355 °	38.175355 °
				-121.675833 °	-121.675833 °
DWR ID	DWR_NA0012_01_f_2018_11				
Comment Code					
E2 : Schedule repair of erosion site prior to the next inspection.					
Inspector Comment					
Repair erosion caused by cattle digging into the waterside toe.

View of erosion into waterside toe (October 2018).

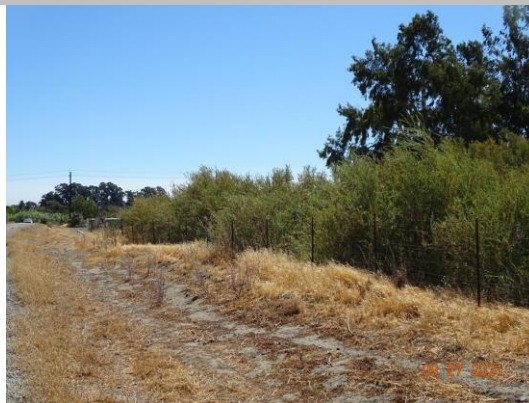
Photo 1 of 1 : FA_2021_NA0012_258_5_20210928_00010.jpg

LM Start	0.23	Rating **	U	Issue No.	5
LM End	0.27	Issue Type +	Ma	Location *	LS
Category	Earthen Levee			GPS Latitude/Longitude	
				Start	End
Item	Vegetation			38.176413 °	38.176737 °
				-121.677250 °	-121.677681 °
DWR ID	DWR_NA0012_01_f_2021_5				
Comment Code					
V2 : Remove the wild growth other than native grasses from the levee slopes.					
Inspector Comment					
There are willows on the landside slope.

View of thick willows on the landside slope (Fall 2021).

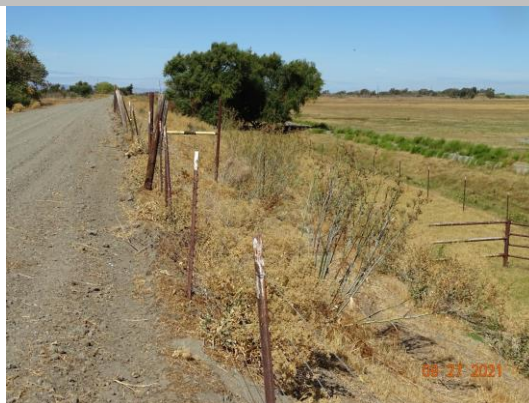
Photo 1 of 1 : FA_2021_NA0012_258_8_20210928_00011.jpg

LM Start	0.28	Rating **	M	Issue No.	8
LM End	0.37	Issue Type +	Ma	Location *	WS
Category	Earthen Levee			GPS Latitude/Longitude	
				Start	End
Item	Vegetation			38.176885 °	38.177813 °
				-121.677895 °	-121.679086 °
DWR ID	DWR_NA0012_01_f_2021_8				
Comment Code					
V1 : Control annual grass and weeds on the levee slopes and easements.					
Inspector Comment

View looking upstream at vegetation on the waterside slope (Fall 2021).
