**Flood Control Project Maintenance
Levee Inspections**

Maintenance Issue Types Only, Levee Inspection Report By Mile - Fall 2022

Solano County Public Works Mellin Levee

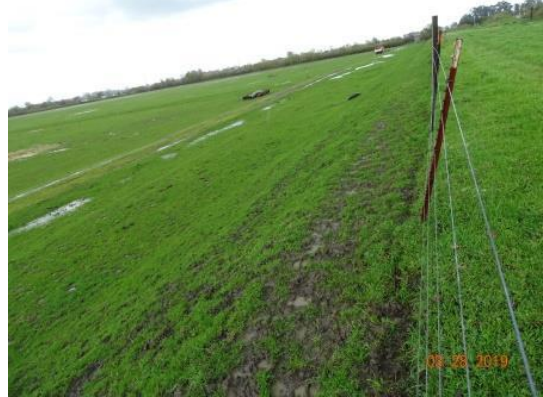
Photo 1 of 1 : FA_2022_NA0012_258_10_20220831_00005.jpg

| Item | Erosion / Livestock | | | 38.174067 ° | 38.177508 ° |
| Repair instabilities caused by cattle walking on the waterside slope. | | | | | |

View of slope instabilities caused by cows on the waterside slope (Spring 2019).

| E4 : Repair the levee slope damaged by livestock and prevent large animal access. | | | | | |
