**Flood Control Project Maintenance
Levee Inspections**

Maintenance Issue Types Only, Levee Inspection Report By Mile - Fall 2023

Solano County Public Works Mellin Levee

Waterway	Bank	Unit Miles	Inspection Start/End	Inspector
Unit No. 01 Mellin Levee	Right	0.59	10/31/2023 10/31/2023	Zach Jojola

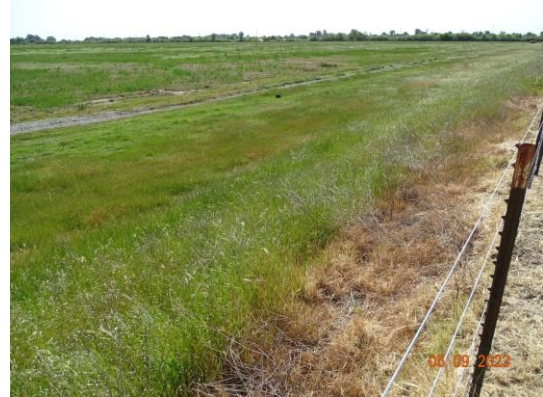
Photo 1 of 1 : FA_2023_NA0012_258_10_20231019_00005.jpg

LM Start	0.00	Rating **	A/W	Issue No.	10
LM End	0.31	Issue Type +	Ma	Location *	WS
Category	Earthen Levee			GPS Latitude/Longitude	
				Start	End
Item	Erosion / Livestock			38.174067°	38.177193°
				-121.674271°	-121.678229°
DWR ID	DWR_NA0012_01_s_2019_10				
Comment Code					
E4 : Repair the levee slope damaged by livestock and prevent large animal access.					
Inspector Comment					
Repair instabilities caused by cattle walking on the waterside slope.

View of the erosion on the WS slope (Spring 2023).

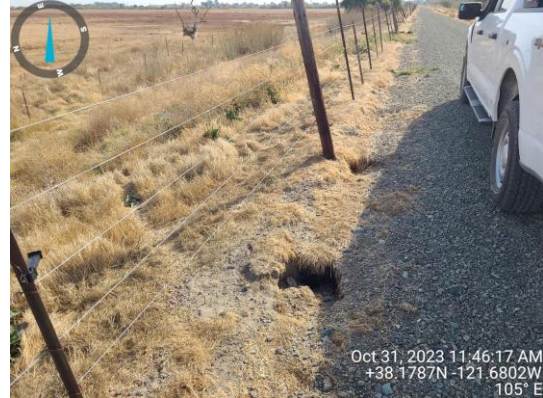
Photo 1 of 1 : FA_2023_NA0012_258_2_20231031_00006.jpg

LM Start	0.45	Rating **	M	Issue No.	2
LM End	0.45	Issue Type +	Ma	Location *	WS
Category	Earthen Levee			GPS Latitude/Longitude	
				Start	End
Item	Animal Control			38.178641°	38.178641°
				-121.680106°	-121.680106°
DWR ID	DWR_NA0012_01_f_2023_2				
Comment Code					
A3 : No rodents visible, but rodent burrows visible; need to backfill and compact or grout burrows.					
Inspector Comment					
Rodent holes on the waterside shoulder.

View of rodent holes on the waterside shoulder. Fall 2023.
