**Flood Control Project Maintenance
Levee Inspections**
LMA District Cover Sheet
Spring 2010 Levee Inspection Results

Solano County Public Works Mellin Levee

Levee Inspection Report By Mile - Spring 2010

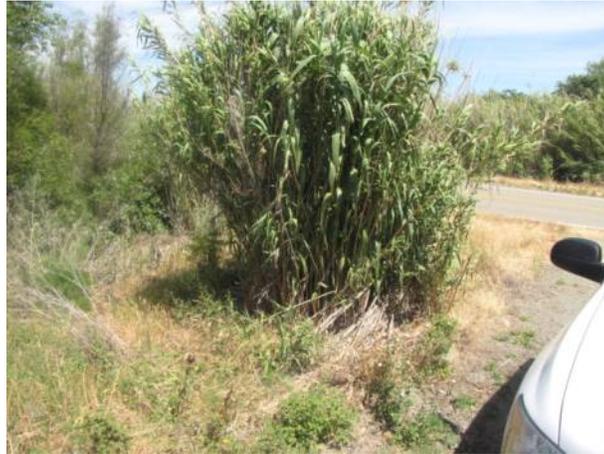
Levee Mile Report Line	1
Start Levee Mile	0.00
End Levee Mile	0.00
Location	Water Side
Category	Earthen Levee
Item	Vegetation
Looking northeast at bamboo on waterside at the entrance to levee.	
jhirabay_s_20100608_001.jpg

LMIR No	Levee Mile		Category	Item	Location *	Rating **	Action/Comment	GPS Latitude/Longitude		Issue No. Photo
	Start	End						Start	End	
1	0.00	0.00	Earthen Levee	Vegetation	WS	M	Remove the wild growth other than native grasses from the levee slopes. Inspector Comments: Bamboo on waterside slope	38.174051 ° -121.674221 °	38.174051 ° -121.674221 °	1 Y
2	0.00	0.59	Earthen Levee	Vegetation	LS	M	Control annual grass and weeds on the levee slopes and easements.	38.174051 ° -121.674221 °	38.180046 ° -121.681975 °	2
3	0.00	0.59	Earthen Levee	Encroachments	WS	PO	Fences	38.174167 ° -121.674312 °	38.178960 ° -121.680600 °	3 Y
4	0.00	0.59	Earthen Levee	Vegetation	WS	M	Control annual grass and weeds on the levee slopes and easements.	38.174051 ° -121.674221 °	38.180046 ° -121.681975 °	5
5	0.04	0.04	Earthen Levee	Encroachments	LS	M	Abandoned vehicles	38.174470 ° -121.674730 °	38.174470 ° -121.674730 °	8 Y
6	0.10	0.28	Earthen Levee	Encroachments	LS	PO	Fences	38.175115 ° -121.675463 °	38.176805 ° -121.677893 °	4

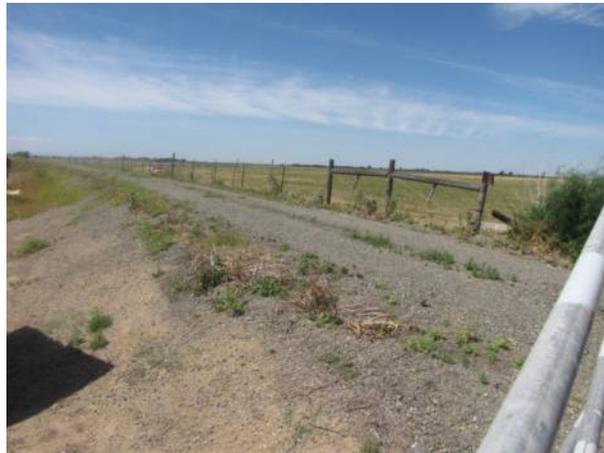
Levee Mile Report Line	3
Start Levee Mile	0.00
End Levee Mile	0.59
Location	Water Side
Category	Earthen Levee
Item	Encroachments
Fence along the waterside shoulder.	
jhirabay_s_20100610_003.jpg

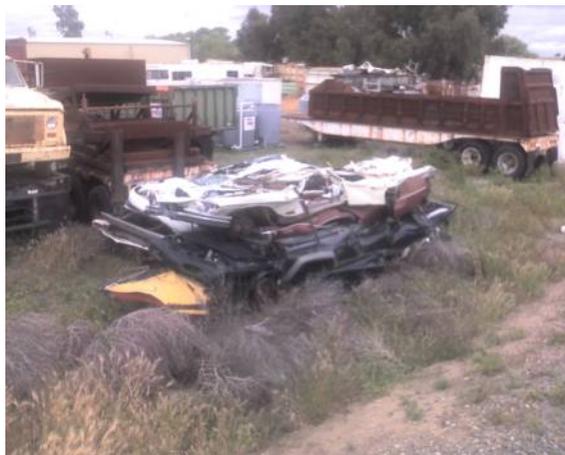
Levee Mile Report Line	5
Start Levee Mile	0.04
End Levee Mile	0.04
Location	Land Side
Category	Earthen Levee
Item	Encroachments
Looking southwest at dilapidated vehicles on landside toe.	
jhirabay_s_20100610_002.jpg
