**Flood Control Project Maintenance  
Levee Inspections**  
**LMA District Cover Sheet**  
**Spring 2011 Levee Inspection Results**

**Solano County Public Works Mellin Levee**

**Levee Inspection Report By Mile - Spring 2011**

Waterway	Bank	Unit Miles	Inspection Start/End	Inspector
Unit No. 01 Mellin Levee	Right	0.59	04/18/2011 04/18/2011	Richard Willoughby

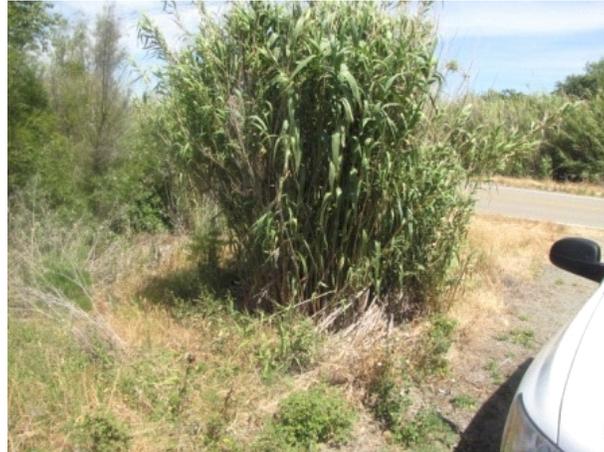
Levee Mile Report Line	1
Start Levee Mile	0.00
End Levee Mile	0.00
Location	Water Side
Category	Earthen Levee
Item	Vegetation
Looking northeast at bamboo on waterside at the entrance to levee.	
richard_s_20110215_099.jpg

LMR No.	Levee Mile		Category	Item	* Location	** Rating	Action/Comment	GPS Latitude/Longitude		Issue No. Photo
	Start	End						Start	End	
1	0.00	0.00	Earthen Levee	Vegetation	WS	W	Remove the wild growth other than native grasses from the levee slopes. Inspector Comments: Bamboo on waterside slope	38.174051 ° -121.674220 °	38.174051 ° -121.674221 °	1 Y
2	0.00	0.59	Earthen Levee	Encroachments	WS	CO	Fences	38.174167 ° -121.674312 °	38.178960 ° -121.680600 °	3 Y
3	0.00	0.59	Earthen Levee	Vegetation	LS	M	Control annual grass and weeds on the levee slopes and easements.	38.174083 ° -121.674265 °	38.180032 ° -121.681958 °	5 Y
4	0.00	0.59	Earthen Levee	Vegetation	LS	M	Control annual grass and weeds on the levee slopes and easements.	38.174087 ° -121.674262 °	38.180032 ° -121.681962 °	11
5	0.02	0.59	Earthen Levee	Crown Surface / Depressions / Rutting	CR	M	Keep the crown roadway free of vegetation.	° °	38.180033 ° -121.681957 °	12

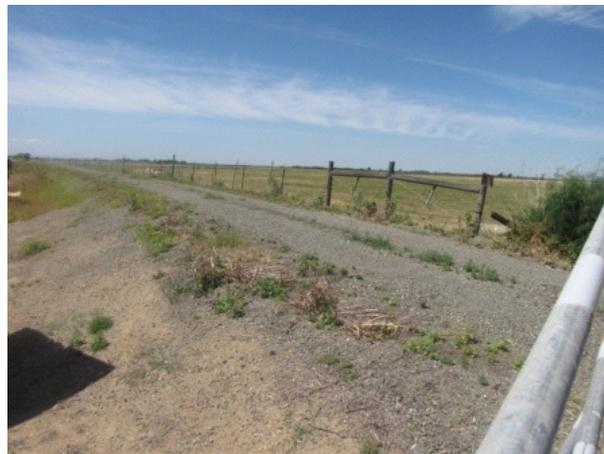
Levee Mile Report Line	2
Start Levee Mile	0.00
End Levee Mile	0.59
Location	Water Side
Category	Earthen Levee
Item	Encroachments
Fence along the waterside shoulder.	
richard_s_20110215_103.jpg

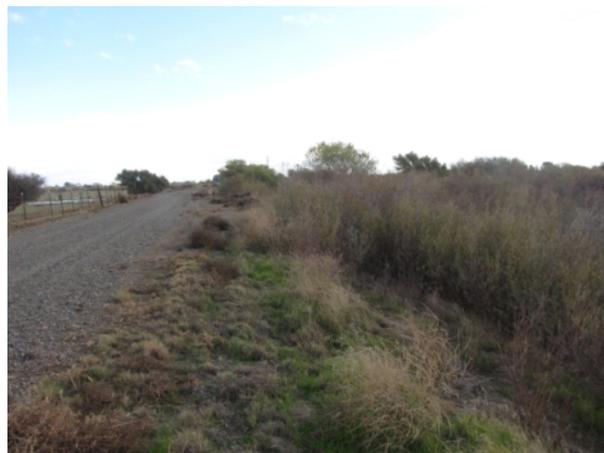
Levee Mile Report Line	3
Start Levee Mile	0.00
End Levee Mile	0.59
Location	Land Side
Category	Earthen Levee
Item	Vegetation
Looking at typical view of levee.	
richard_s_20110606_107.jpg

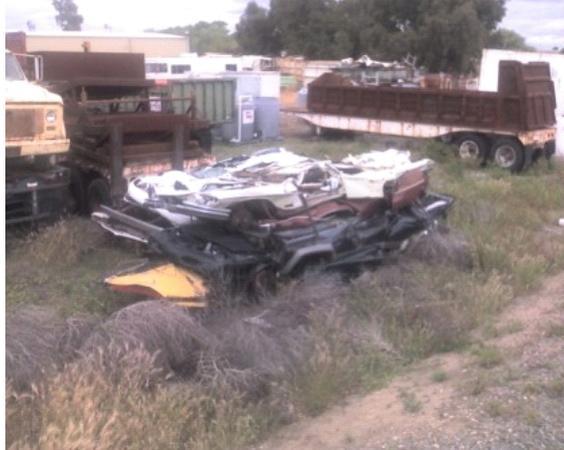
Levee Mile Report Line	6
Start Levee Mile	0.04
End Levee Mile	0.04
Location	Land Side
Category	Earthen Levee
Item	Encroachments
Looking southwest at dilapidated vehicles on landside toe.	
richard_s_20110215_106.jpg

6	0.04	0.04	Earthen Levee	Encroachments	LS	M	Abandoned vehicles	38.174470 ° -121.674730 °	38.174470 ° -121.674730 °	8 Y
7	0.08	0.08	Earthen Levee	Slope Stability	WS	M	Repair the levee slope damaged by foot traffic and prevent access where possible.	38.174948 ° -121.675263 °	38.174948 ° -121.675263 °	2 Y
8	0.10	0.28	Earthen Levee	Encroachments	LS	PO	Fences	38.175115 ° -121.675463 °	38.176805 ° -121.677893 °	4
9	0.36	0.51	Earthen Levee	Crown Surface / Depressions / Rutting	CR	M	Regrade the crown roadway for proper drainage.	38.177743 ° -121.678998 °	38.179212 ° -121.680873 °	6

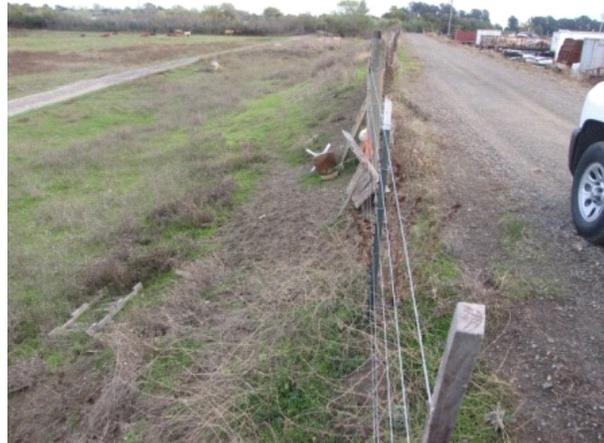
Levee Mile Report Line	7
Start Levee Mile	0.08
End Levee Mile	0.08
Location	Water Side
Category	Earthen Levee
Item	Slope Stability
Looking downstream (east) at slope damage on waterside slope and shoulder.	
richard_s_20110215_100.jpg

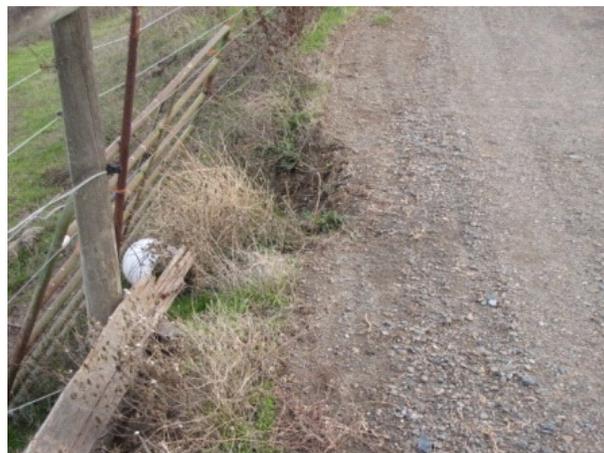
Levee Mile Report Line	7
Start Levee Mile	0.08
End Levee Mile	0.08
Location	Water Side
Category	Earthen Levee
Item	Slope Stability
Looking east at slope damage on waterside shoulder.	
richard_s_20110215_101.jpg

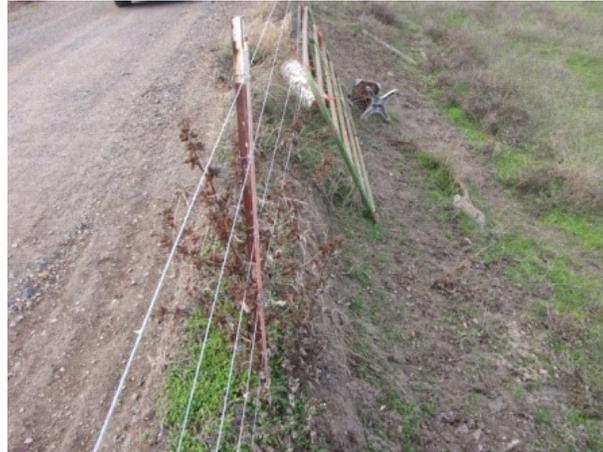
Levee Mile Report Line	7
Start Levee Mile	0.08
End Levee Mile	0.08
Location	Water Side
Category	Earthen Levee
Item	Slope Stability

Looking upstream (west) at slope damage on waterside slope and shoulder.
