**Flood Control Project Maintenance
Levee Inspections**

2012 Channel Summary Report

Merced Streams Group

2012 Channel Inspection Results

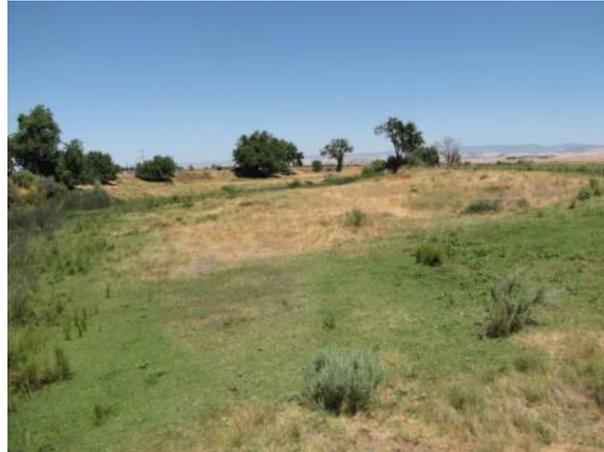
Levee Mile Report Line	6
Start Levee Mile	0.00
End Levee Mile	0.00
Location	
Category	Channels
Item	Vegetation & Obstructions
<p>Bear Creek looking downstream from Bonner Road crossing. Photo taken 7-30-2012. Berries and other growth on left bank of the channel.</p> <p>phillips_c_20120828_166.jpg</p>

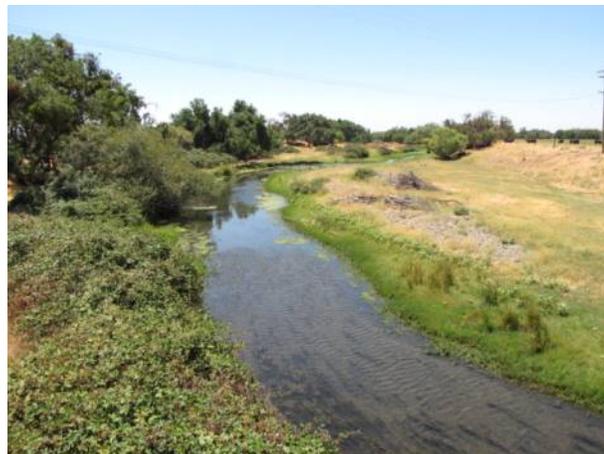
Levee Mile Report Line	11
Start Levee Mile	0.00
End Levee Mile	0.00
Location	
Category	Channels
Item	Vegetation & Obstructions
<p>Bear Creek looking upstream from Arboleda Drive, very wide flood control channel. Brush build up on right bank, flow not impeded. Photo taken 7-30-2012.</p> <p>phillips_c_20120828_167.jpg</p>

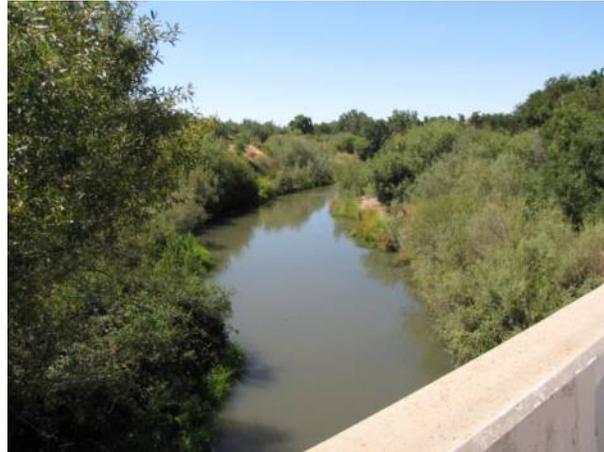
Levee Mile Report Line	21
Start Levee Mile	0.00
End Levee Mile	0.00
Location	
Category	Channels
Item	Vegetation & Obstructions
<p>Bear Creek looking upstream of Kibby Road, wild growth covers both banks. Photo taken 7-30-2012.</p>	
<p>phillips_c_20120828_169.jpg</p>

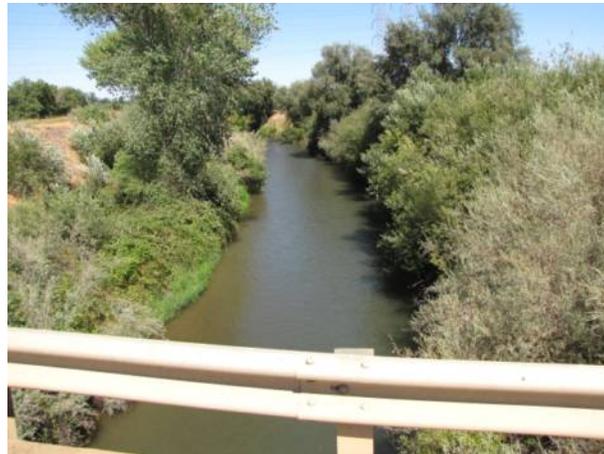
Levee Mile Report Line	26
Start Levee Mile	0.00
End Levee Mile	0.00
Location	
Category	Channels
Item	Vegetation & Obstructions
<p>Bear Creek looking downstream from Kibby Rd crossing. Bambo covers right bank. Photo taken 7-30-2012.</p>	
<p>phillips_c_20120828_170.jpg</p>

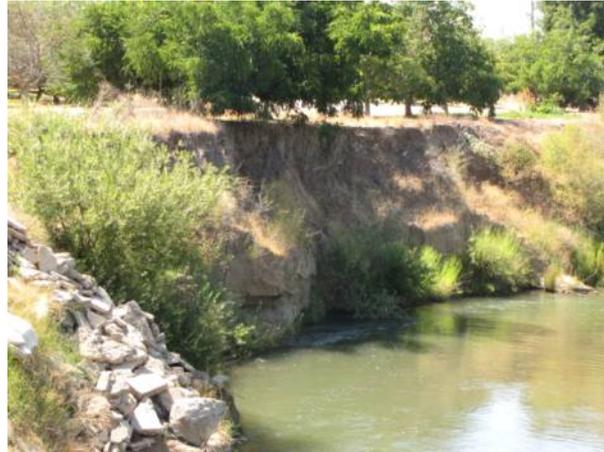
Levee Mile Report Line	31
Start Levee Mile	0.00
End Levee Mile	0.00
Location	
Category	Channels
Item	Vegetation & Obstructions
<p>Bear Creek looking upstream from McKee Rd. crossing. Brush covers both banks, flow not impeded. Photo taken 7-30-2012.</p>	
<p>phillips_c_20120828_172.jpg</p>

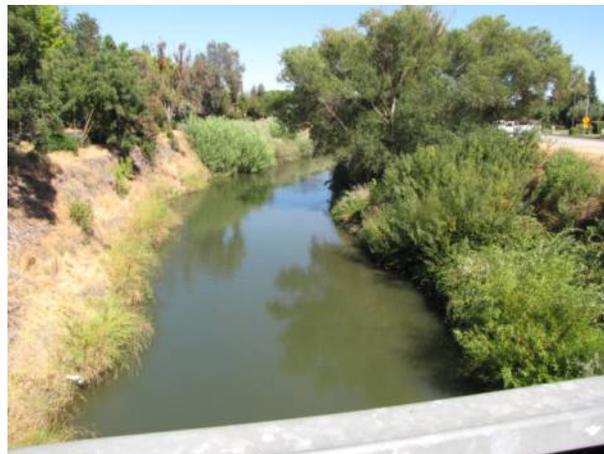
33		Up	Erosion / Bank Caving		U	Inspector Comments: Apparent head cutting and horizontal deviation of more than 1 foot from designed grade or cross section. Corrective actions required to stop or slow erosion.	37.309600 ° -120.444500 °	Y	43
34		Up	Revetments		N	Inspector Comments: This item does not apply to this inspection.	37.309600 ° -120.444500 °		44
35		Up	Encroachments		A	Inspector Comments: No Encroachments at this location.	37.309600 ° -120.444500 °		45
36		Down	Vegetation & Obstructions		A	Inspector Comments: Minimal, scattered obstructions or vegetation. The flow is not impeded.	37.309600 ° -120.444500 °	Y	46
37		Down	Shoaling / Sedimentation		A	Inspector Comments: No shoaling or sedimentation present.	37.309600 ° -120.444500 °		47
38		Down	Erosion / Bank Caving		U	Inspector Comments: Apparent head cutting and horizontal deviation of more than 1 foot from designed grade or cross section. Corrective actions required to stop or slow erosion.	37.309600 ° -120.444500 °	Y	48

Levee Mile Report Line	33
Start Levee Mile	0.00
End Levee Mile	0.00
Location	
Category	Channels
Item	Erosion / Bank Caving
<p>Erosion upstream from bridge right bank levee slope. This erosion was noted in the inspection 2011 Report. No change. 2012.</p>	
<p>phillips_c_20120830_175.jpg</p>

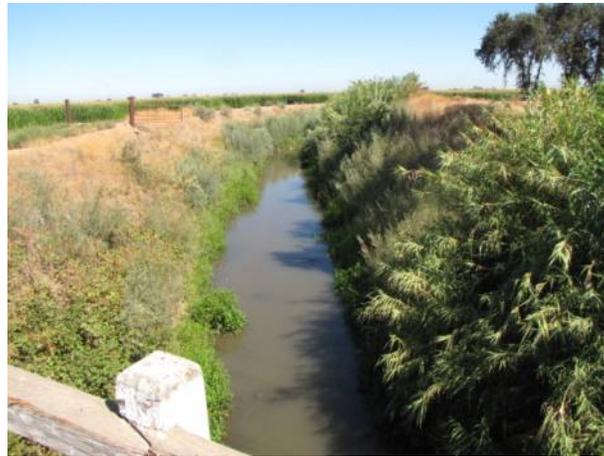
Levee Mile Report Line	86
Start Levee Mile	0.00
End Levee Mile	0.00
Location	
Category	Channels
Item	Vegetation & Obstructions
<p>Bear Creek looking downstream from Dickerson Ferry Rd. Photo taken 7-30-2012. Vegetation on both banks and in channel.</p>	
<p>phillips_c_20120830_187.jpg</p>

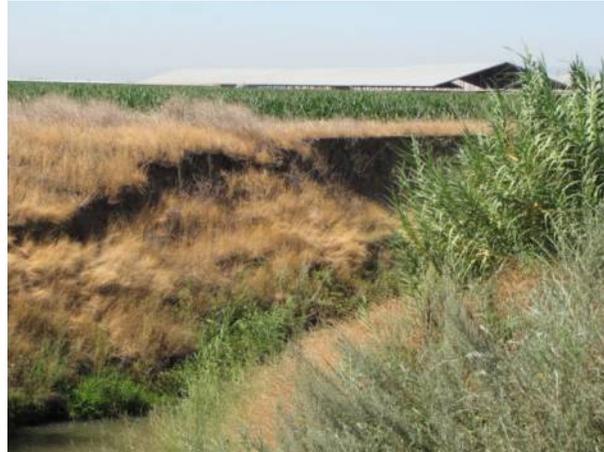
Levee Mile Report Line	91
Start Levee Mile	0.00
End Levee Mile	0.00
Location	
Category	Channels
Item	Vegetation & Obstructions
Bert Crane Rd. crossing the Bear Creek looking upstream at channel. Photo taken 7-30-2012	
phillips_c_20120611_064.jpg

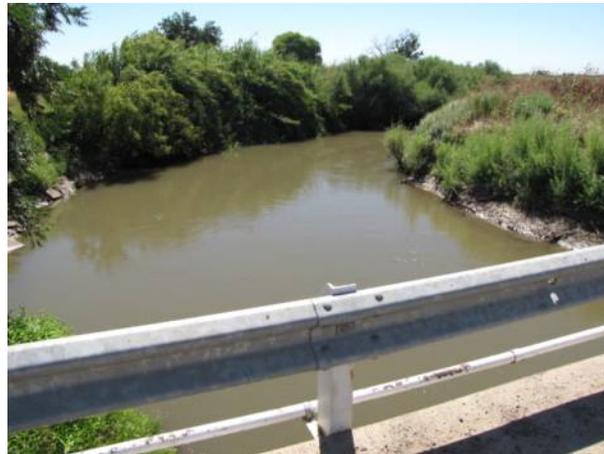
Levee Mile Report Line	96
Start Levee Mile	0.00
End Levee Mile	0.00
Location	
Category	Channels
Item	Vegetation & Obstructions
Bert Crane Rd. Crossing the Bear Creek looking downstream. Photo taken 7-30-2012	
phillips_c_20120611_065.jpg

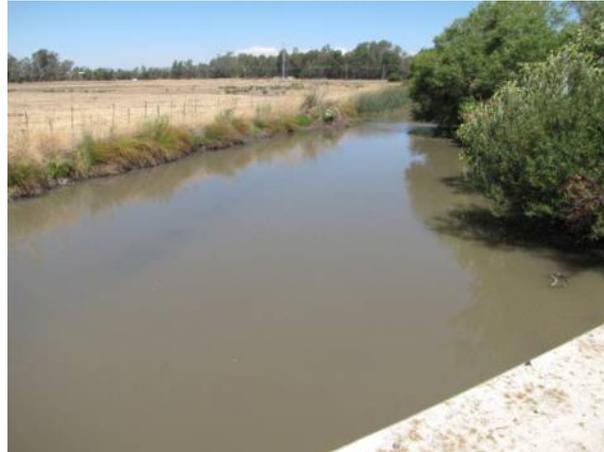
Levee Mile Report Line	6
Start Levee Mile	0.00
End Levee Mile	0.00
Location	
Category	Channels
Item	Vegetation & Obstructions
Black Rascal Creek from Santa Fe Drive looking downstream. Photo taken 8-1-2012.	
phillips_c_20120816_129.jpg

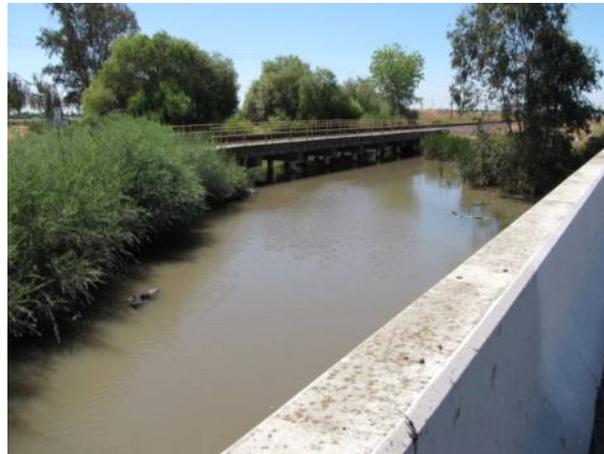
Levee Mile Report Line	11
Start Levee Mile	0.00
End Levee Mile	0.00
Location	
Category	Channels
Item	Vegetation & Obstructions
Black Rascal from structure crossing looking upstream. Photo taken 8-1-2012.	
phillips_c_20120816_130.jpg

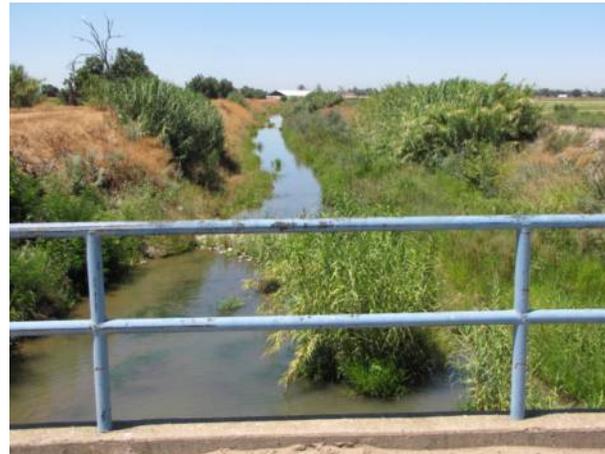
Levee Mile Report Line	21
Start Levee Mile	0.00
End Levee Mile	0.00
Location	
Category	Channels
Item	Vegetation & Obstructions
<p>Black Rascal Creek looking upstream from Franklin Rd. crossing. Photo taken 8-1-2012.</p>	
<p>phillips_c_20120816_132.jpg</p>

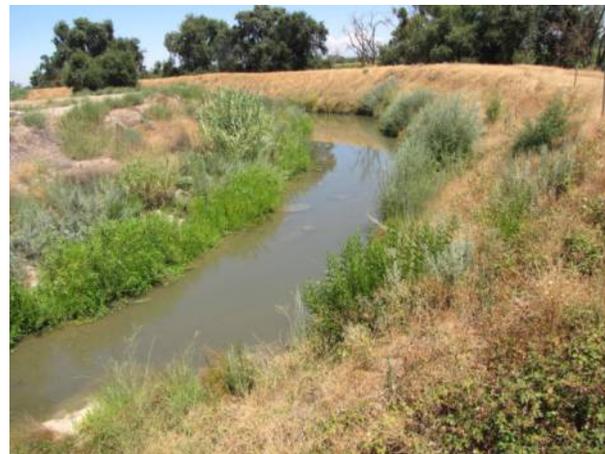
Levee Mile Report Line	26
Start Levee Mile	0.00
End Levee Mile	0.00
Location	
Category	Channels
Item	Vegetation & Obstructions
<p>Black Rascal Creek from Franklin Road crossing. Photo taken 8-1-2012.</p>	
<p>phillips_c_20120817_133.jpg</p>

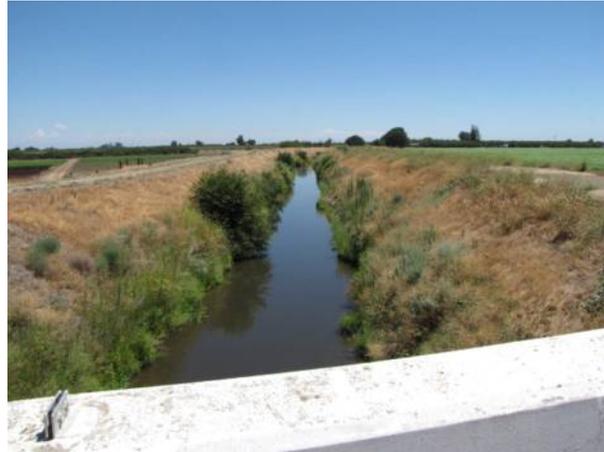
Levee Mile Report Line	35
Start Levee Mile	0.00
End Levee Mile	0.00
Location	
Category	Channels
Item	Vegetation & Obstructions
Black Rascal Creek from Gurr Road looking downstream. Photo taken 8-1-2012.	
phillips_c_20120817_135.jpg

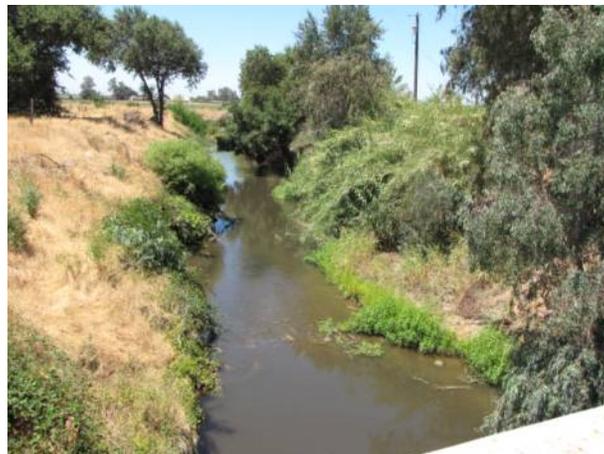
Levee Mile Report Line	41
Start Levee Mile	0.00
End Levee Mile	0.00
Location	
Category	Channels
Item	Vegetation & Obstructions
Black Rascal Creek from Hwy. 140 looking upstream. Photo taken 8-1-2012.	
phillips_c_20120817_136.jpg

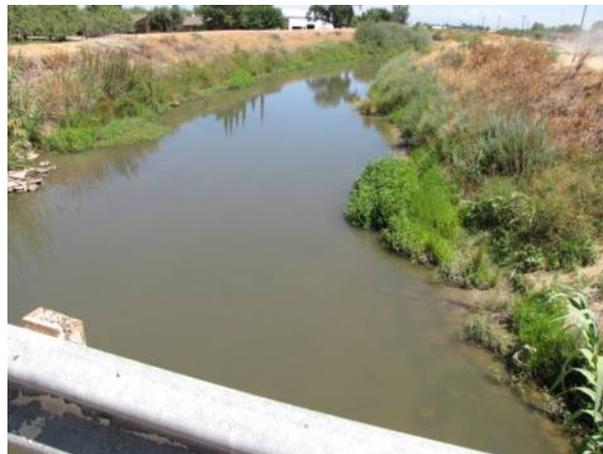
Levee Mile Report Line	55
Start Levee Mile	0.00
End Levee Mile	0.00
Location	
Category	Channels
Item	Vegetation & Obstructions
Black Rascal Creek looking downstream from Quinley Rd. Right on left banks there is a ramp creating a earthen dam. Photo taken 8-1-2012.	
phillips_c_20120817_139.jpg

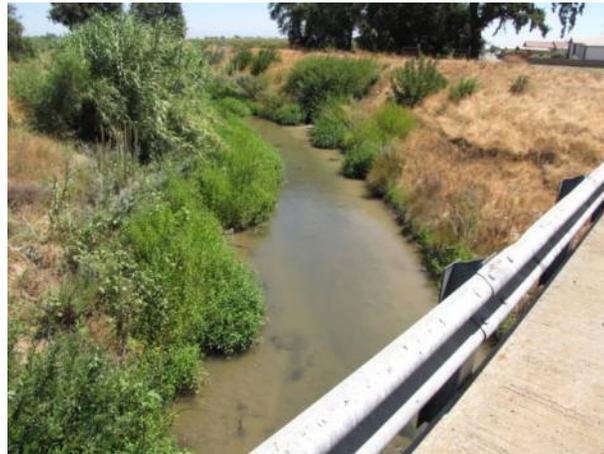
Levee Mile Report Line	66
Start Levee Mile	0.00
End Levee Mile	0.00
Location	
Category	Channels
Item	Vegetation & Obstructions
<p>Black Rascal Creek looking downstream from Oak Ave. bridge. Vegetation present on right bank flow is not impeded. Photo taken 8-1-2012.</p>	
<p>phillips_c_20120821_141.jpg</p>

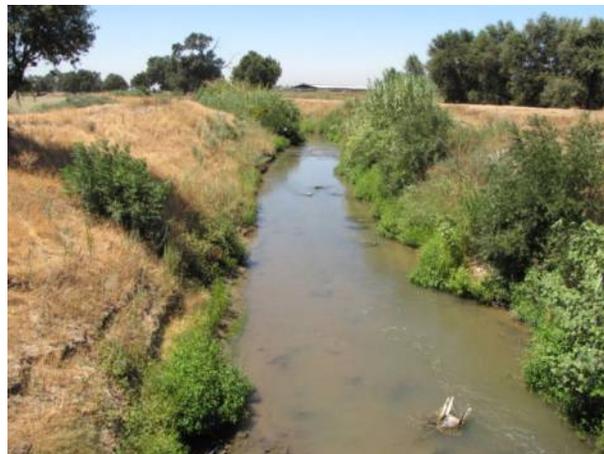
Levee Mile Report Line	70
Start Levee Mile	0.00
End Levee Mile	0.00
Location	
Category	Channels
Item	Encroachments
<p>Black Rascal Creek looking downstream from Oak Ave. bridge crossing fire wood dumped in channel along with material causing the channel to divert. Photo taken 8-1-2012.</p>	
<p>phillips_c_20120830_177.jpg</p>

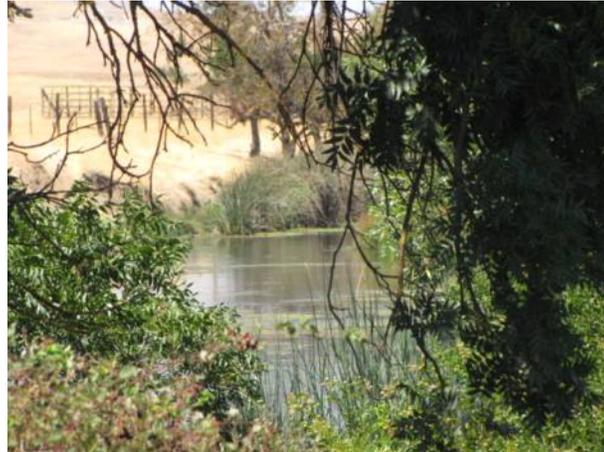
Levee Mile Report Line	1
Start Levee Mile	0.00
End Levee Mile	0.00
Location	
Category	Channels
Item	Vegetation & Obstructions
Burns Creek looking upstream. Photo taken 7-30-2012.	
phillips_c_20120828_173.jpg

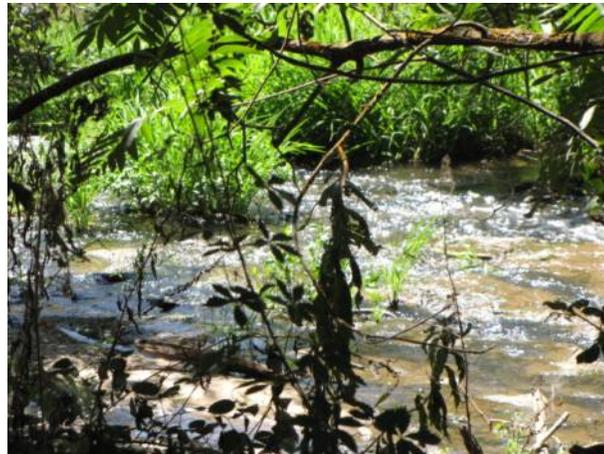
Levee Mile Report Line	6
Start Levee Mile	0.00
End Levee Mile	0.00
Location	
Category	Channels
Item	Vegetation & Obstructions
Burns Creek looking downstream just above the confluence of Bear Creek. Photo taken 7-30-2012.	
phillips_c_20120828_174.jpg

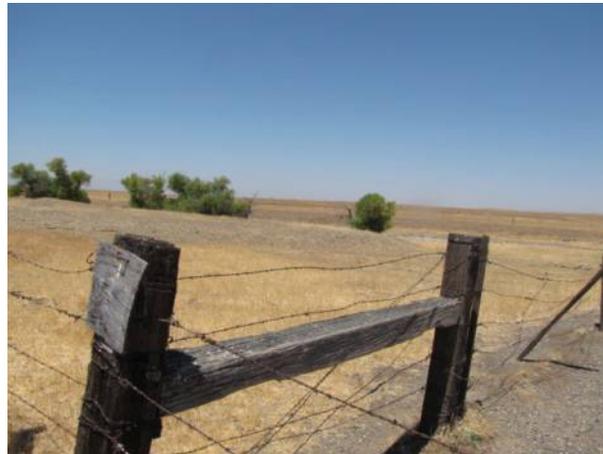
Levee Mile Report Line	11
Start Levee Mile	0.00
End Levee Mile	0.00
Location	
Category	Channels
Item	Vegetation & Obstructions
Mariposa Creek looking upstream from Fresno Road, channel overgrown with vegetation. Photo taken 7-26-2012.	
phillips_c_20120904_191.jpg

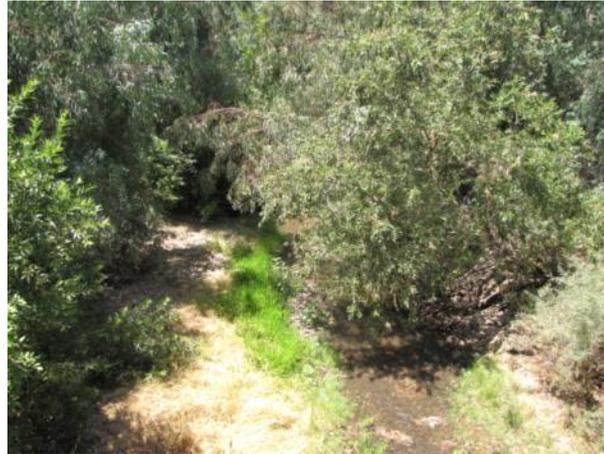
Levee Mile Report Line	21
Start Levee Mile	0.00
End Levee Mile	0.00
Location	
Category	Channels
Item	Vegetation & Obstructions
<p>Mariposa Creek looking upstream from Cunningham Road. Photo taken 7-26-2012.</p>	
<p>phillips_c_20120904_193.jpg</p>

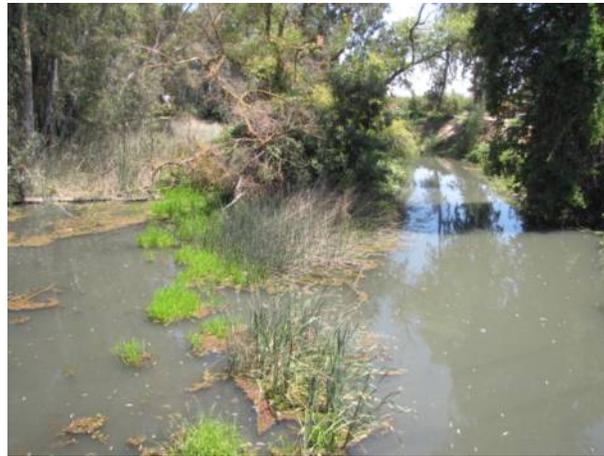
Levee Mile Report Line	26
Start Levee Mile	0.00
End Levee Mile	0.00
Location	
Category	Channels
Item	Vegetation & Obstructions
<p>Mariposa Creek looking downstream from Cunningham Road. Photo taken 7-26-2012.</p>	
<p>phillips_c_20120904_194.jpg</p>

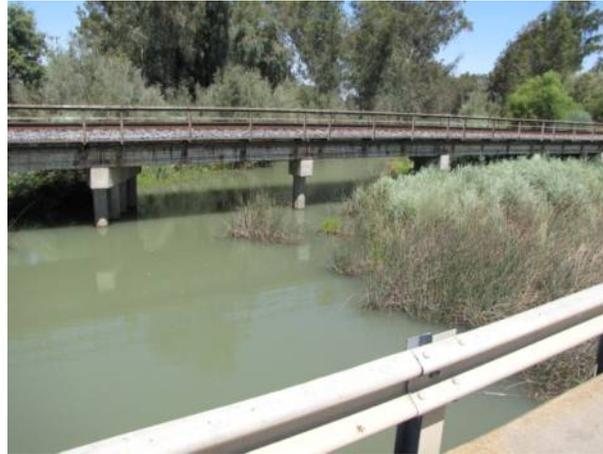
Levee Mile Report Line	36
Start Levee Mile	0.00
End Levee Mile	0.00
Location	
Category	Channels
Item	Vegetation & Obstructions
<p>Mariposa Creek looking dowastream from Santa Fe. Road. Photo taken 7-26-2012.</p> <p>phillips_c_20120904_196.jpg</p>

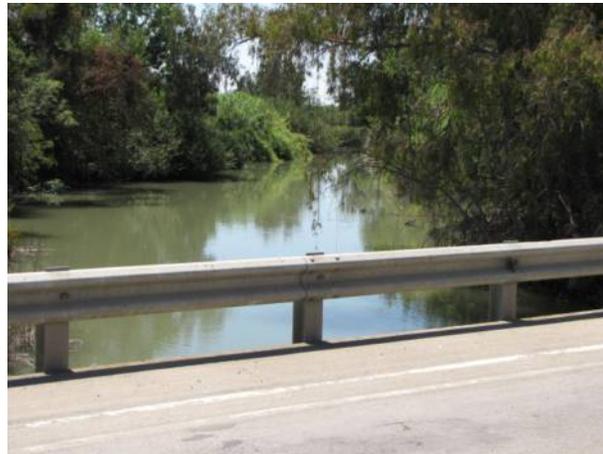
Levee Mile Report Line	41
Start Levee Mile	0.00
End Levee Mile	0.00
Location	
Category	Channels
Item	Vegetation & Obstructions
<p>Mariposa Creek looking upstream from Brucell Rd. crossing. Right off to the left bottom view is the Black Rascal Creek entering Mariposa Creek. Photo taken 7-26-2012.</p> <p>phillips_c_20120904_197.jpg</p>

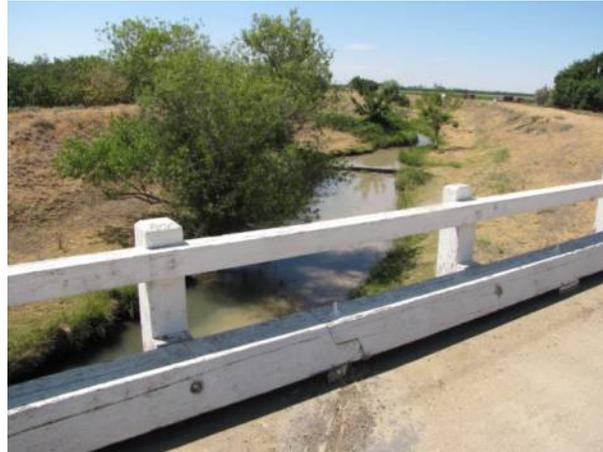
Levee Mile Report Line	48
Start Levee Mile	0.00
End Levee Mile	0.00
Location	
Category	Channels
Item	Erosion / Bank Caving
Mariposa Creek looking downstream from Bruchell Road, there is erosion on left bank down from bridge. Photo taken 7-26-2012.	
phillips_c_20120904_199.jpg

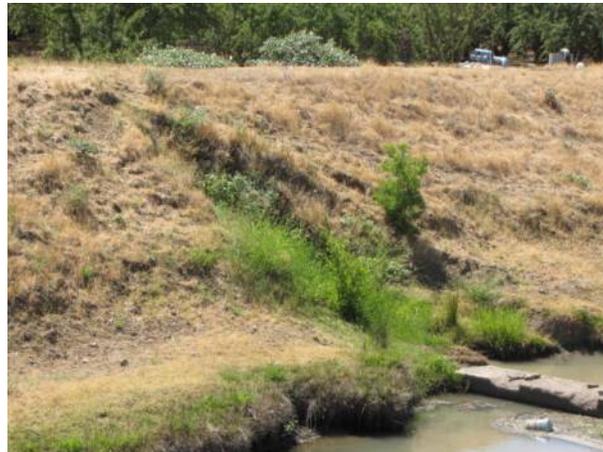
Levee Mile Report Line	51
Start Levee Mile	0.00
End Levee Mile	0.00
Location	
Category	Channels
Item	Vegetation & Obstructions
Mariposa Creek looking upstream from Plainsburg Rd. Photo taken 7-26-2012.	
phillips_c_20120904_200.jpg

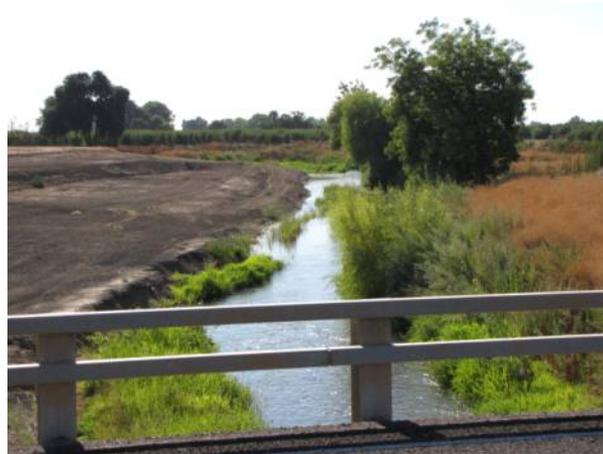
Levee Mile Report Line	61
Start Levee Mile	0.00
End Levee Mile	0.00
Location	
Category	Channels
Item	Vegetation & Obstructions
Mariposa Creek looking upstream from Whealan Rd. Channel is overgrown with wild growth. Photo taken 7-26-2012.	
phillips_c_20120904_202.jpg

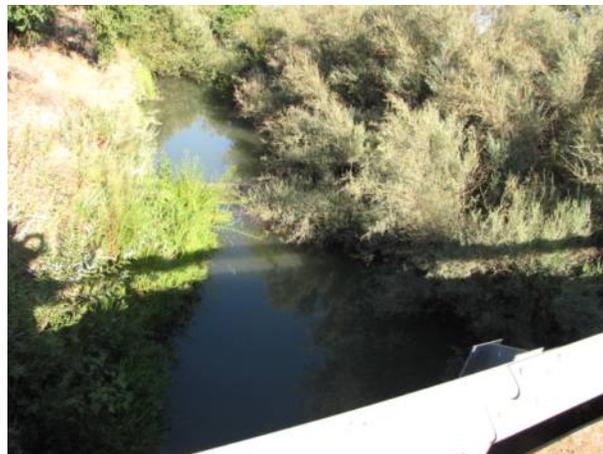
Levee Mile Report Line	66
Start Levee Mile	0.00
End Levee Mile	0.00
Location	
Category	Channels
Item	Vegetation & Obstructions
Mariposa Creek looking downstream from Whealan Rd. Right bank and left bank overgrown channel being choked with growth. Photo taken 7-26-2012.	
phillips_c_20120904_203.jpg

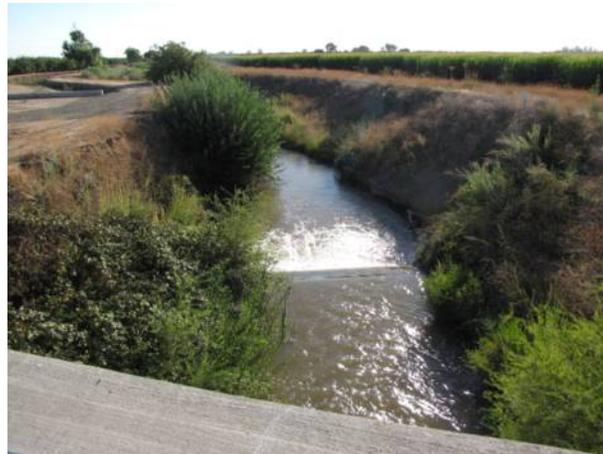
Levee Mile Report Line	78
Start Levee Mile	0.00
End Levee Mile	0.00
Location	
Category	Channels
Item	Erosion / Bank Caving
Mariposa Creek erosion on left bank, this erosion was noted in the last Channel Inspection 2011. This photo was taken 7-26-2012.	
phillips_c_20120904_206.jpg
