**Flood Control Project Maintenance
Levee Inspections**

2014 Channel Summary Report

Merced Streams Group

Levee Inspection Report By Mile - Channel 2014

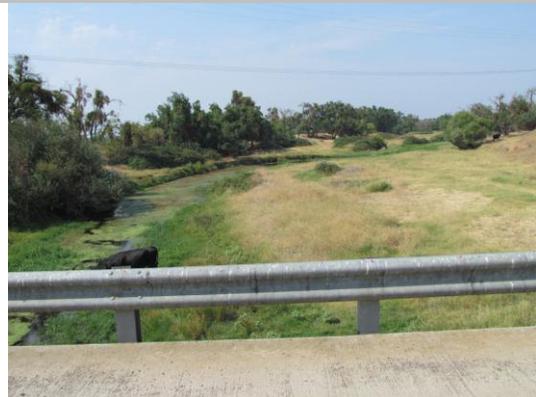
Photo 1 of 1 : CH_2014_NA0013_32_6_20140826_00027.jpg

Bonner Road crossing the Bear Creek looking downstream.

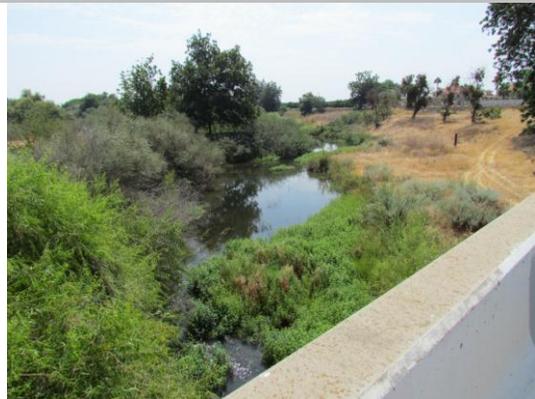
Photo 1 of 1 : CH_2014_NA0013_32_21_20140826_00028.jpg

Arboleda Drive crossing Bear Creek looking upstream. Main channel has vegetation growth.

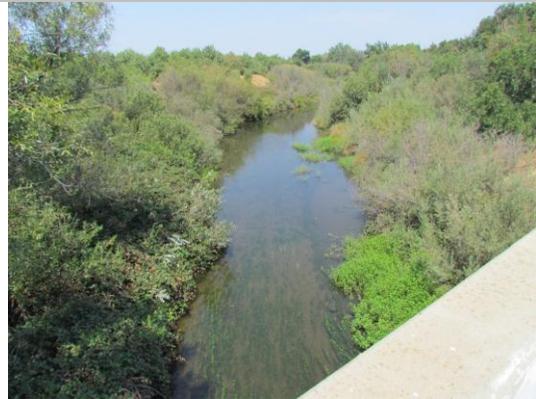
Photo 1 of 1 : CH_2014_NA0013_32_26_20140826_00029.jpg

Arboleda Drive bridge crossing the Bear Creek looking downstream.

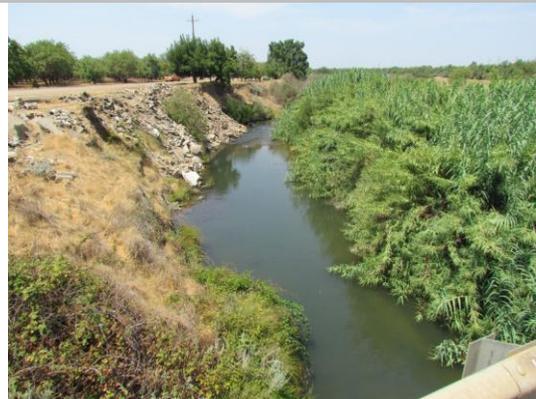
Photo 1 of 1 : CH_2014_NA0013_32_36_20140826_00031.jpg

Kibby Road crossing the Bear Creek looking downstream.

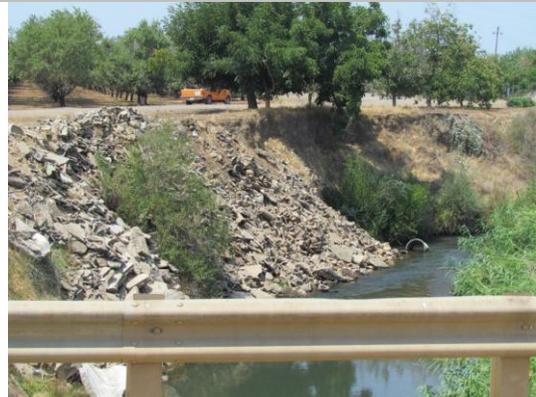
Photo 1 of 1 : CH_2014_NA0013_32_38_20140826_00032.jpg

Check Point / View			
Kibby Rd / Down (cont)			
Rating **	U	Issue No. 38	GPS Lat/Long
Issue Type +	Ob	Location *	37.312200 °
Category	Rivers, Channels & Designated Flood		-120.415000 °
Item	Erosion / Bank Caving		
DWR ID	DWR_NA0013_32_c_2012_38		
Action/Comments			
Inspector Comments: During this inspection some method of repair has been done on the erosion although some of the material may not be acceptable because there is rebar, asphalt and other materials The Department of Fish and Game may have problems with.

Downstream from Kibby Road bridge crossing erosion is present on the left bank.

Rating **	U	Issue No. 39	GPS Lat/Long
Issue Type +	En	Location *	37.312200 °
Category	Rivers, Channels & Designated Flood		-120.415000 °
Item	Revetments		
DWR ID	DWR_NA0013_32_c_2012_39		
Action/Comments			
Inspector Comments: In the area of erosion there was not enough revetment protecting the banks. Very little is shown in photo upstream of the damaged area.

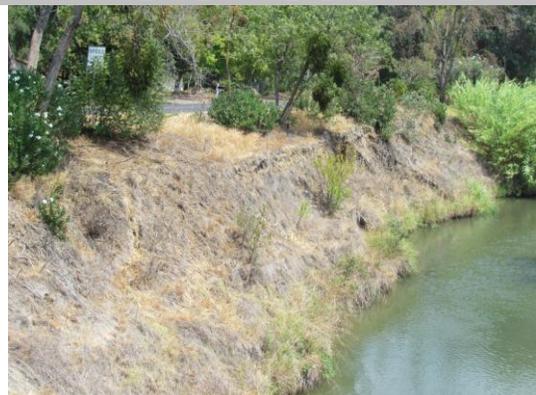
Photo 1 of 1 : CH_2014_NA0013_32_43_20140826_00036.jpg

Looking upstream right bank of Bear Creek from McKee bridge crossing.

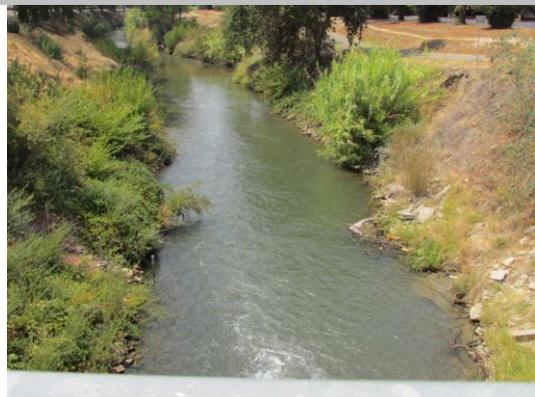
Photo 1 of 1 : CH_2014_NA0013_32_46_20140826_00037.jpg

McKee Road crossing the Bear Creek looking downstream from bridge.

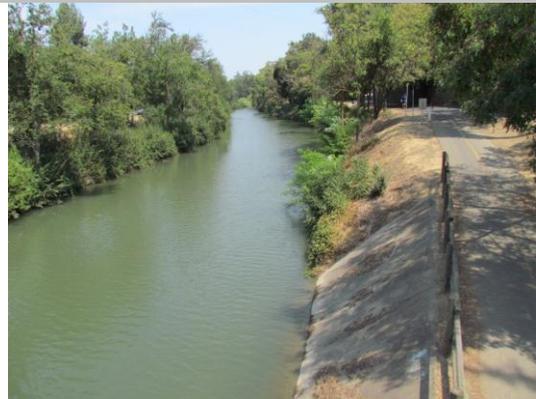
Photo 1 of 1 : CH_2014_NA0013_32_51_20140826_00038.jpg

Bear Creek looking upstream from R Street crossing standing above the bike trail left bank.

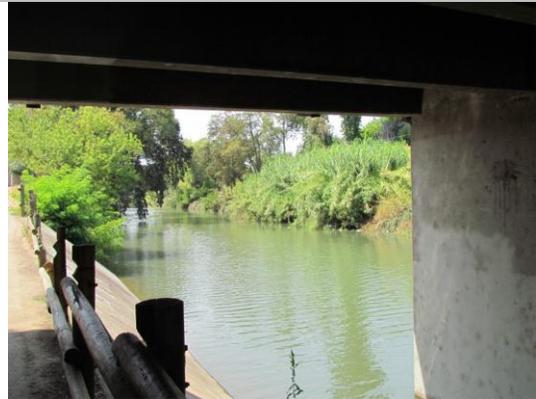
Photo 1 of 1 : CH_2014_NA0013_32_56_20140826_00039.jpg

Standing under R Street bridge crossing the left bank looking downstream from the Bike Trail.

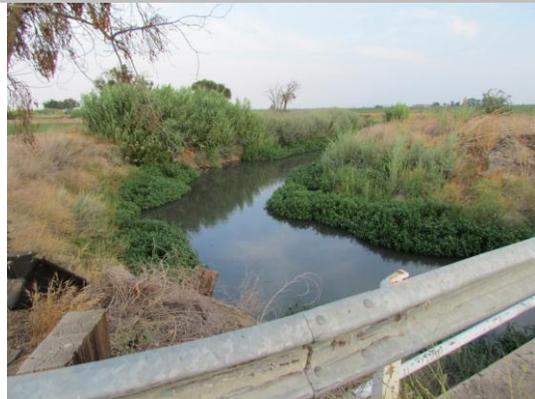
Photo 1 of 1 : CH_2014_NA0013_32_101_20140826_00047.jpg

Bert Crane Road crossing the Bear Creek looking upstream at channel.

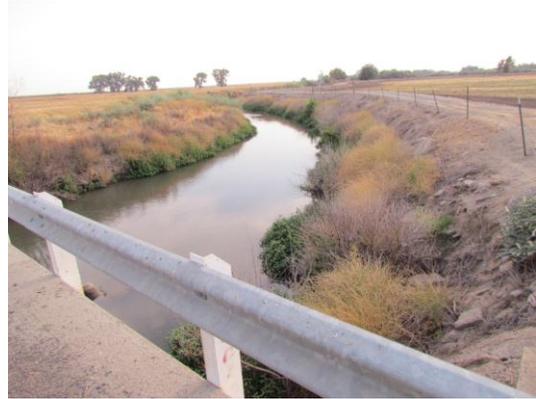
Photo 1 of 1 : CH_2014_NA0013_32_106_20140826_00046.jpg

Bert Crane Road Crossing the Bear Creek looking downstream .

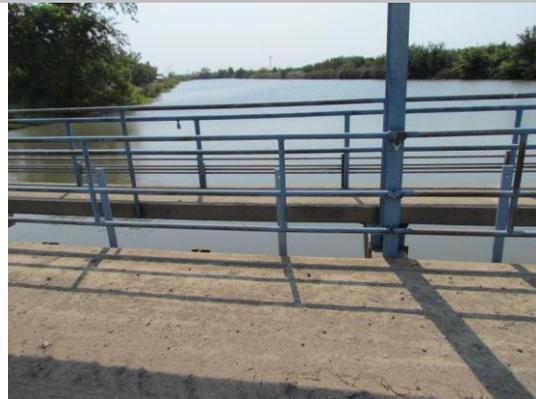
Photo 1 of 1 : CH_2014_NA0013_33_11_20140805_00022.jpg

Looking upstream from Crocker Dam crossing the Black Rascal Creek.

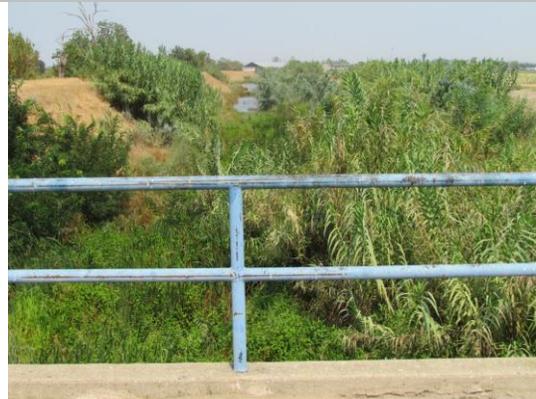
Photo 1 of 1 : CH_2014_NA0013_33_16_20140805_00023.jpg

Looking downstream from the Crocker Dam. Vegetation in channel and both banks.

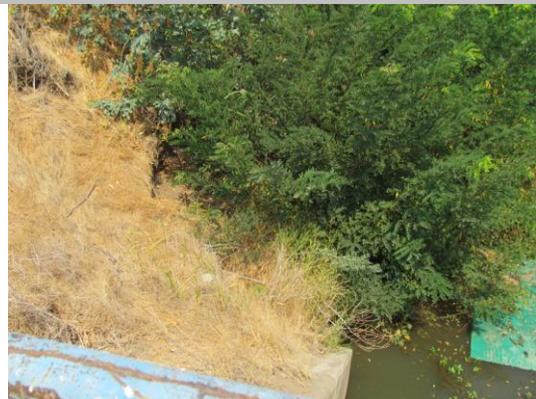
Photo 1 of 1 : CH_2014_NA0013_33_18_20140805_00024.jpg

Erosion present under tree limbs at the end of the concrete headwall left bank downstream.

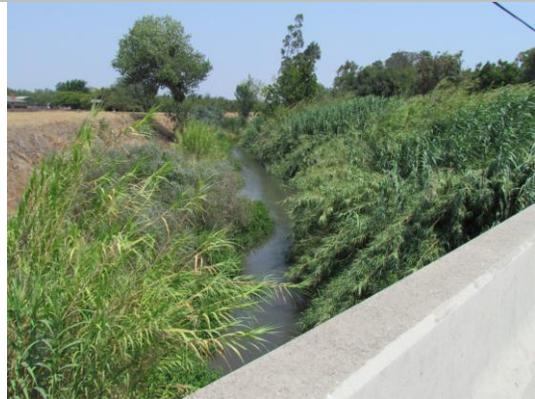
Photo 1 of 1 : CH_2014_NA0013_33_41_20140820_00030.jpg

Black Rascal Creeek from the Hwy 140 crossing the channel. Wild growth of bambo covering the left bank, other wild growth present in channel on the right bank.

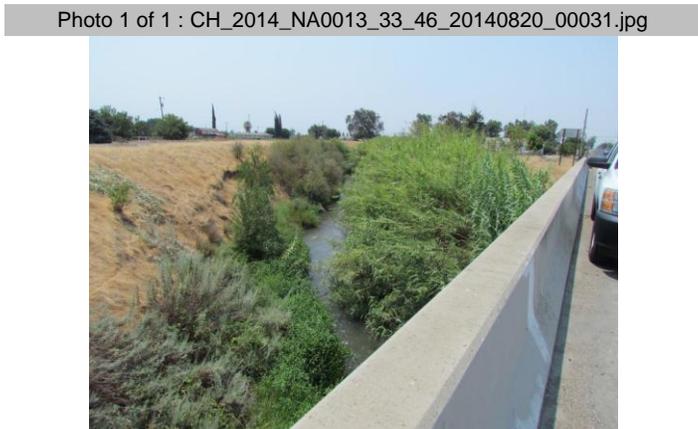
Check Point / View				
Hwy 140 / Down				
Rating **	M	Issue No.	46	GPS Lat/Long
Issue Type +	Ma	Location *		37.302400 °
Category	Rivers, Channels & Designated Flood			-120.575460 °
Item	Vegetation & Obstructions			
DWR ID	DWR_NA0013_33_c_2012_46			
Action/Comments				
Inspector Comments: Vegetation in the channel along both banks. The flow is not impeded.

Black Rascal Creek looking downstream from from Hwy 140 crossing. Right bank covered with bambo and young willow trees covering the left bank levee toe.

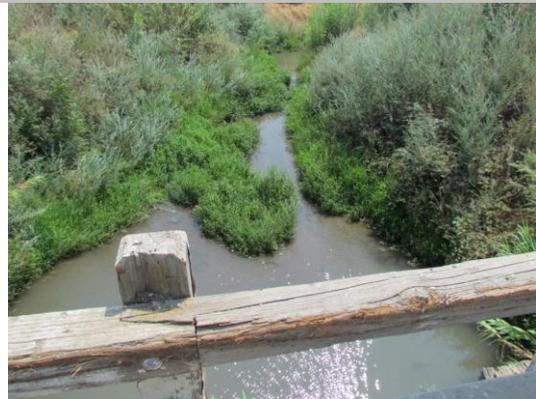
Photo 1 of 1 : CH_2014_NA0013_33_56_20140820_00034.jpg

Black Rascal Creek looking downstream from bridge crossing. Channel has vegetation growth present and along both banks.

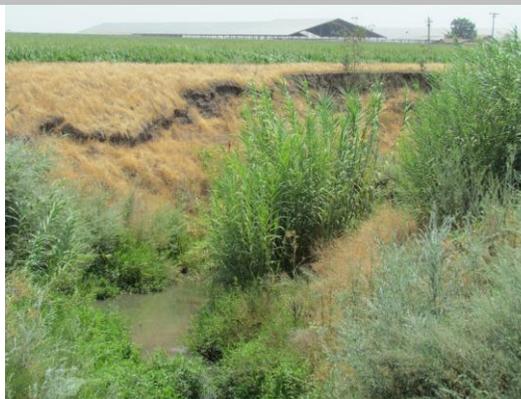
Photo 1 of 1 : CH_2014_NA0013_33_58_20140820_00035.jpg

Erosion (bank caving) noted downstream left bank.

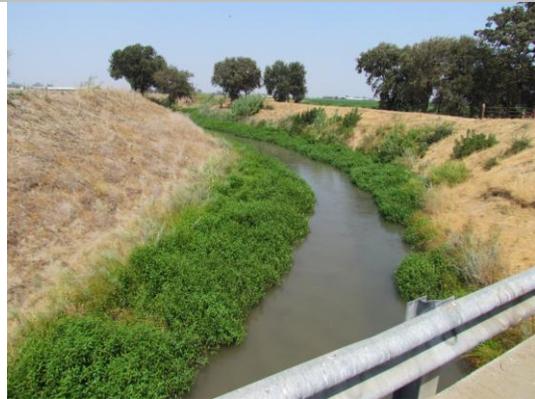
Photo 1 of 1 : CH_2014_NA0013_33_61_20140820_00036.jpg

Black Rascal Creek from Oak Avenue crossing the channel.

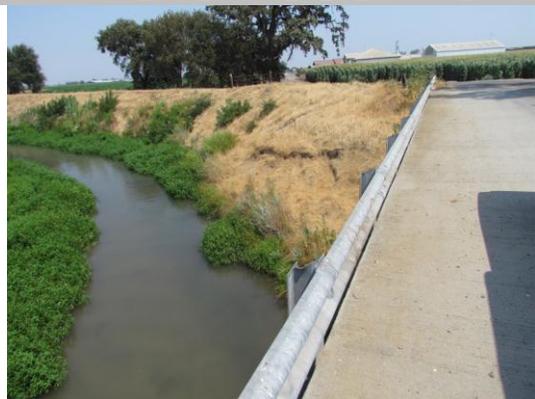
Photo 1 of 1 : CH_2014_NA0013_33_63_20140821_00037.jpg

Black Rascal Creek Oak Avenue bridge crossing there is little erosion present on the left bank.

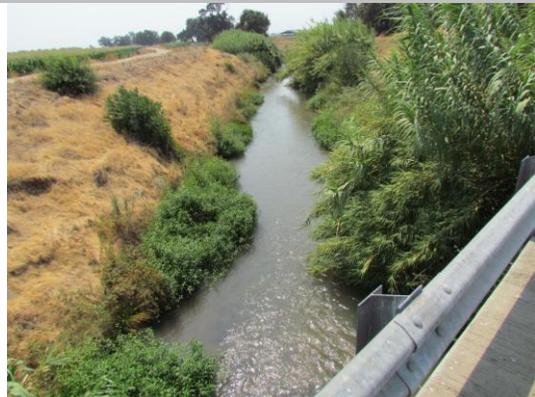
Photo 1 of 1 : CH_2014_NA0013_33_66_20140821_00038.jpg

Looking downstream from Oak Avenue Arundo present on right bank. Flow is not impeded.

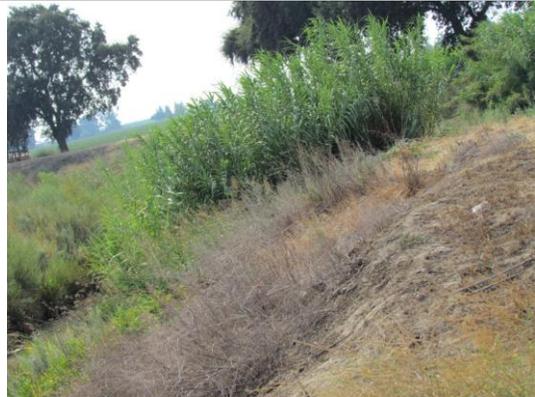
Photo 1 of 1 : CH_2014_NA0013_33_71_20140821_00040.jpg

The Black Rascal Creek and the Bear Creek confluence is at the base of the arundo growth looking downstream from the left bank of the Bear Creek.

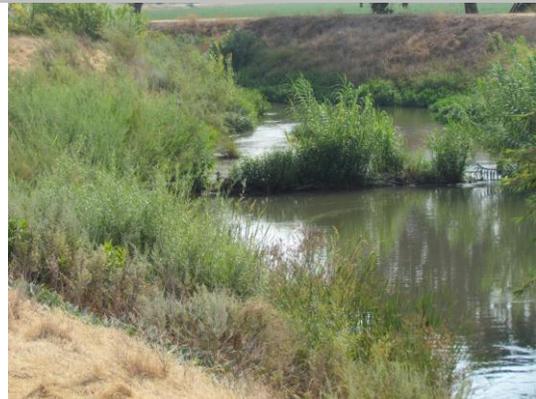
Photo 1 of 1 : CH_2014_NA0013_33_76_20140821_00041.jpg

Looking at the confluence of the Black Rascal and the Bear Creek young willow trees and other vegetation growth present in channel.

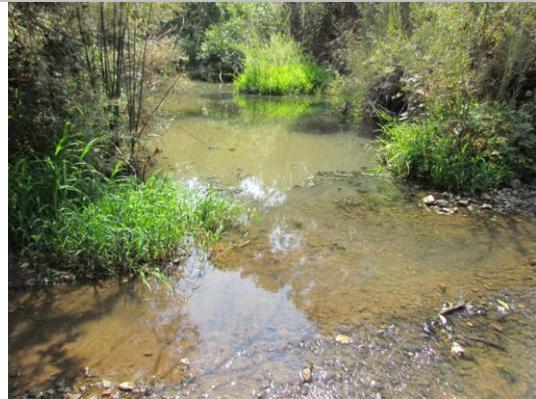
Photo 1 of 1 : CH_2014_NA0013_34_11_20140821_00003.jpg

Burns Creek Low water crossing downstream from here is the confluence with Bear Creek.

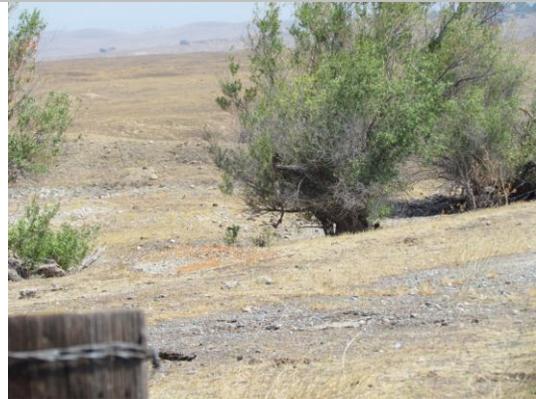
Photo 1 of 1 : CH_2014_NA0013_35_1_20140824_00024.jpg

Mariposa Creek looking upstream from White Rock Road. Dry channel.

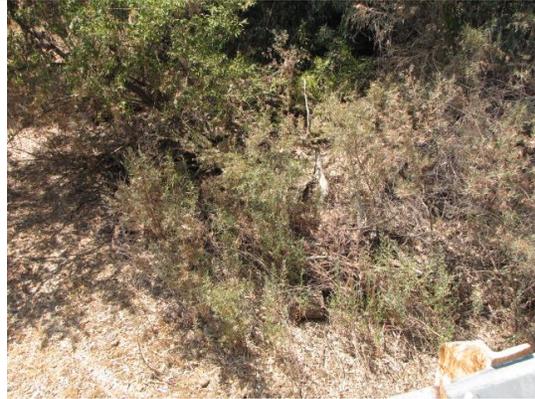
Photo 1 of 1 : CH_2014_NA0013_35_20_20140707_00005.jpg

Wild growth in channel along with firewood piled up in channel downstream from bridge crossing. No new photo taken 2014.

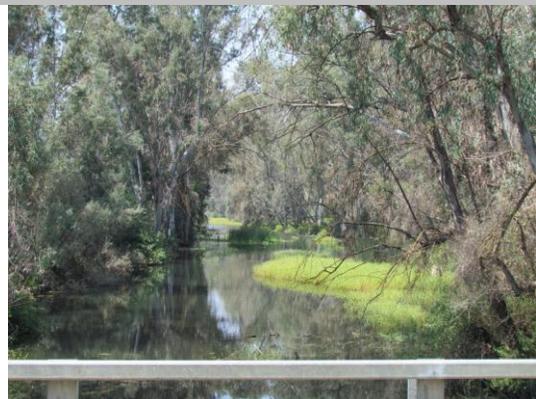
Photo 1 of 1 : CH_2014_NA0013_35_26_20140824_00029.jpg

Mariposa Creek looking downstream from Cunningham bridge crossing.

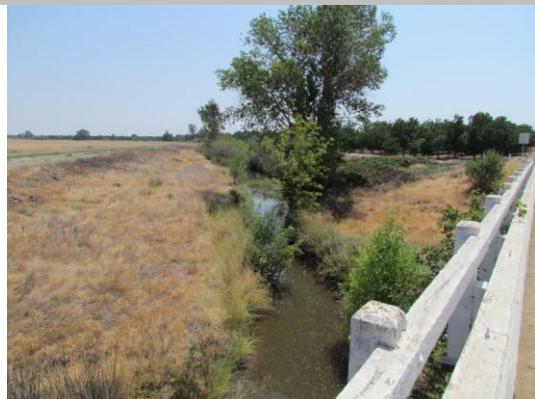
Photo 1 of 1 : CH_2014_NA0013_35_41_20140824_00032.jpg

Mariposa Creek looking upstream from the Burchell Road crossing.

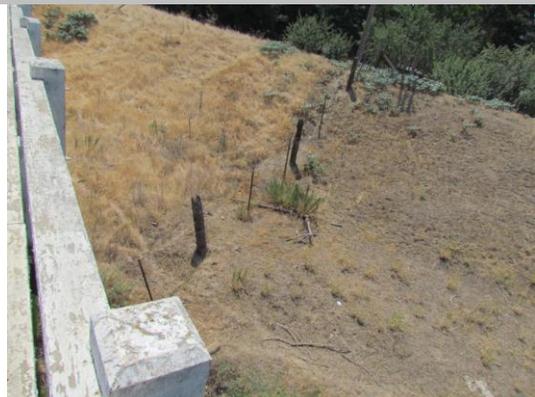
Photo 1 of 2 : CH_2014_NA0013_35_50_20140825_00035.jpg

Fence present under bridge left bank crossing channel.

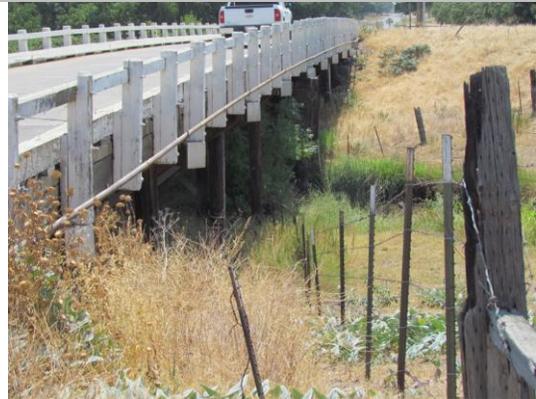
Photo 2 of 2 : CH_2014_NA0013_35_50_20140825_00036.jpg

Fence continues up the slope of the right bank.

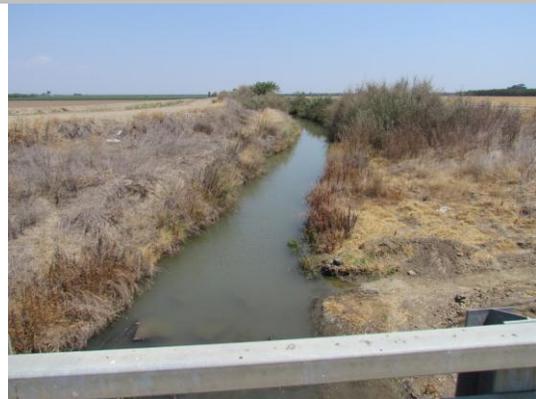
Photo 1 of 1 : CH_2014_NA0013_35_51_20140825_00034.jpg

Mariposa Creek looking upstream from Plainsburg Road Crossing.

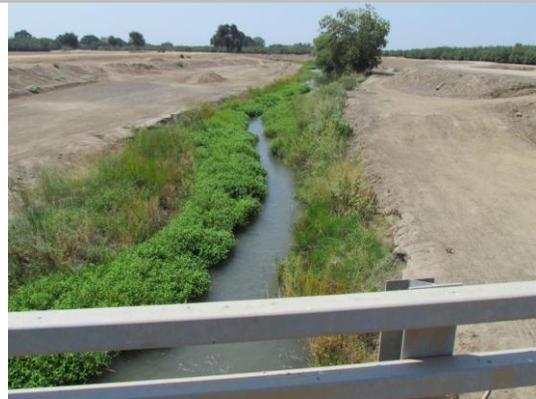
Photo 1 of 1 : CH_2014_NA0013_35_56_20140825_00037.jpg

Mariposa Creek looking downstream from Plainsburg Road Crossing.

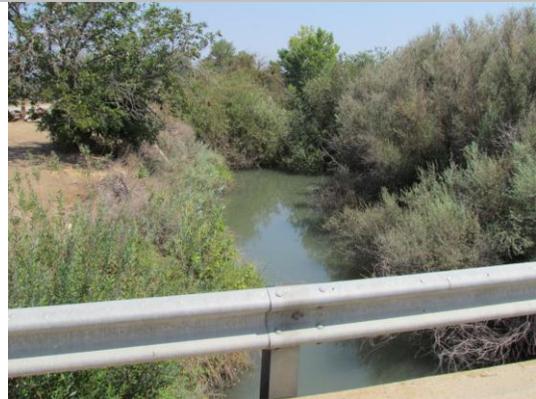
Photo 1 of 1 : CH_2014_NA0013_35_61_20140825_00038.jpg

Mariposa Creek looking upstream from Whealan Road crossing.

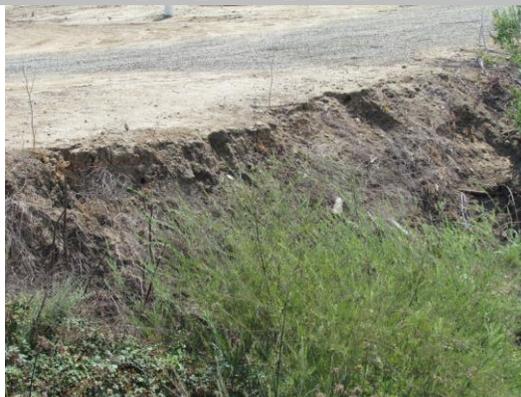
Photo 1 of 1 : CH_2014_NA0013_35_78_20140825_00043.jpg

Mariposa Creek erosion on the left bank, this erosion was noted on previous channel inspections.

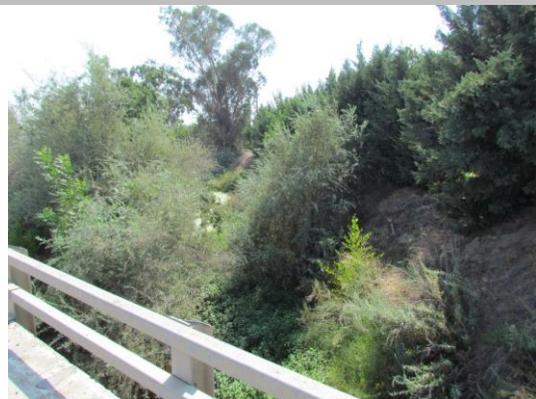
Photo 1 of 1 : CH_2014_NA0013_35_81_20140825_00044.jpg

Mariposa Creek looking upstream from Healy Road crossing.

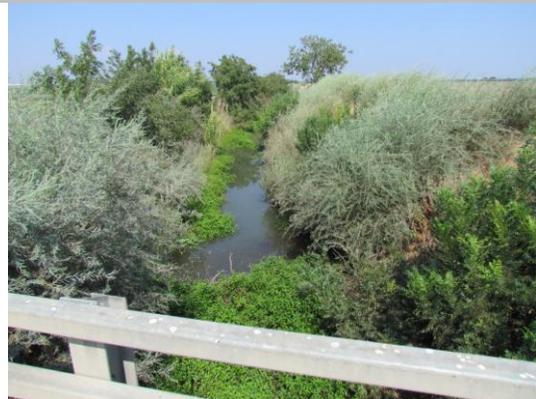
Photo 1 of 1 : CH_2014_NA0013_35_86_20140825_00045.jpg

Mariposa Creek looking downstream from Healy Road crossing.

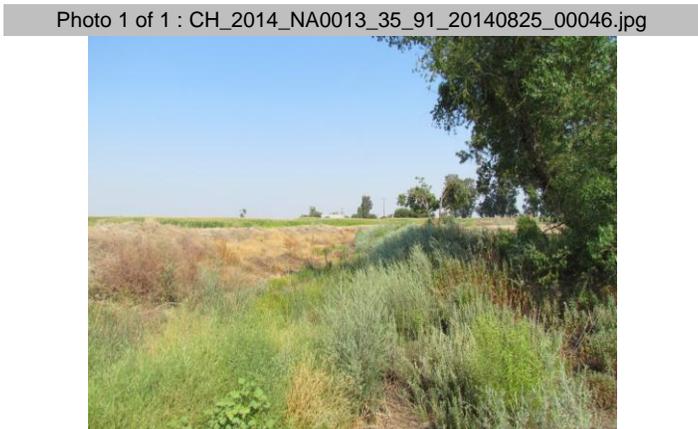
Check Point / View				
Hwy 59 / Up				
Rating **	M	Issue No.	91	GPS Lat/Long
Issue Type +	Ma	Location *		37.233961 °
Category	Rivers, Channels & Designated Flood			-120.487872 °
Item	Vegetation & Obstructions			
DWR ID	DWR_NA0013_35_c_2012_91			
Action/Comments				
Inspector Comments: Log jams, snags, vegetation growth (such as cat tails, bull rushes, bushes or saplings) or other obstructions block approximately 25% of the capacity.

Mariposa Creek looking upstream from Hwy 59.

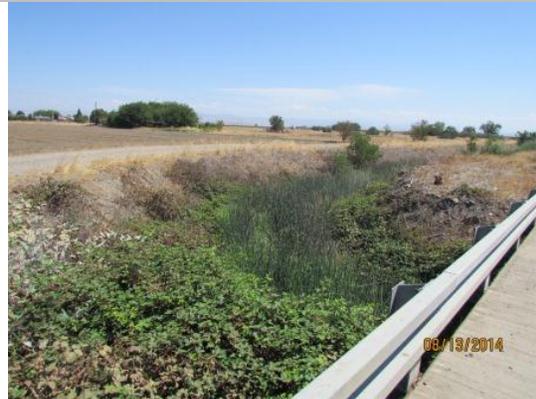
Photo 1 of 1 : CH_2014_NA0013_36_1_20140818_00029.jpg

Upstream view from the Childs Ave. crossing.

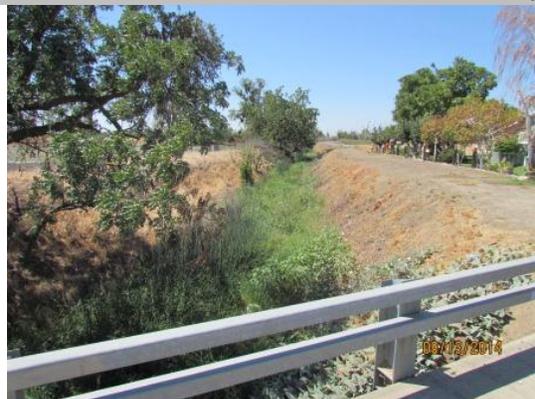
Photo 1 of 1 : CH_2014_NA0013_36_6_20140818_00030.jpg

Downstream view from the Childs Ave. crossing.

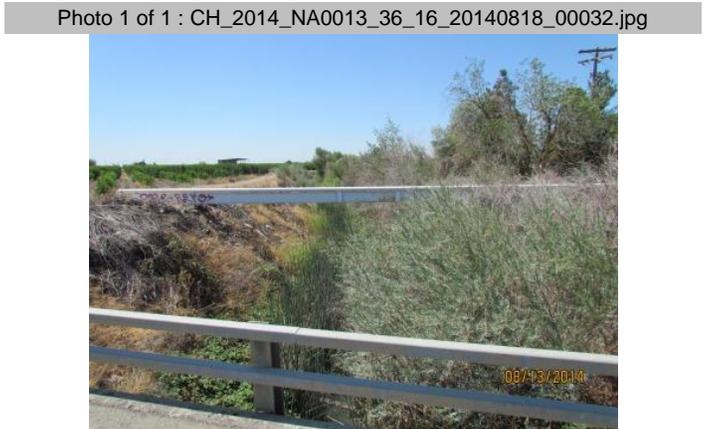
Check Point / View				
Santa Fe Dr / Down				
Rating **	M	Issue No.	16	GPS Lat/Long
Issue Type +	Ma	Location *		37.284393 °
Category	Rivers, Channels & Designated Flood			-120.315460 °
Item	Vegetation & Obstructions			
DWR ID	DWR_NA0013_36_c_2012_16			
Action/Comments				
Inspector Comments: Channel is beginning to be overgrown, some of the vegetation appears to be woody vegetation and should be removed.

Santa Fe Dr. crossing downstream view, note woody vegetation on right side of channel.

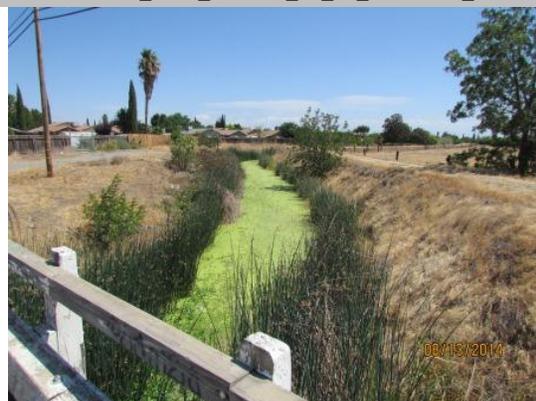
Photo 1 of 1 : CH_2014_NA0013_36_21_20140818_00033.jpg

Plainsburg Road crossing upstream view.

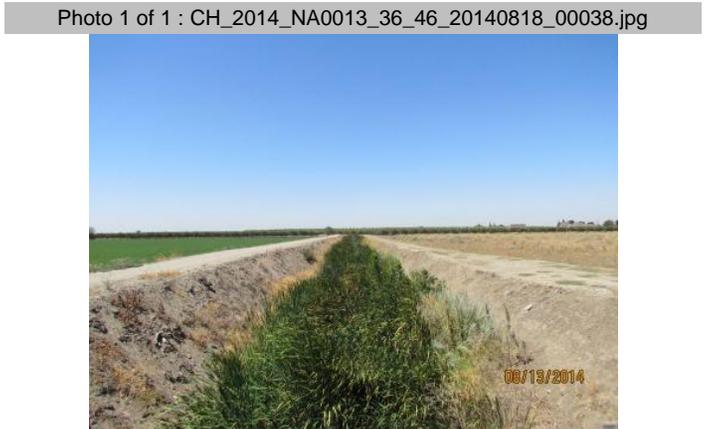
Check Point / View			
Whealan Rd / Down			
Rating **	A	Issue No. 46	GPS Lat/Long
Issue Type +	Ma	Location *	37.278696 °
Category	Rivers, Channels & Designated Flood		-120.343030 °
Item	Vegetation & Obstructions		
DWR ID	DWR_NA0013_36_c_2012_46		
Action/Comments			
Inspector Comments: Very minor vegetation, does not appear as though it would impede flow.

Downstream view from Whealan Rd. crossing.

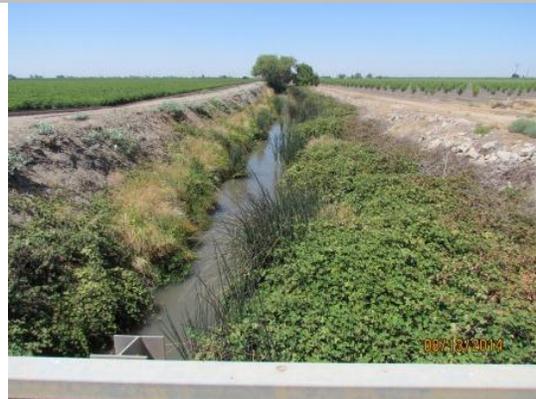
Photo 1 of 1 : CH_2014_NA0013_36_56_20140818_00040.jpg

Downstream view from Arboleda Dr. crossing

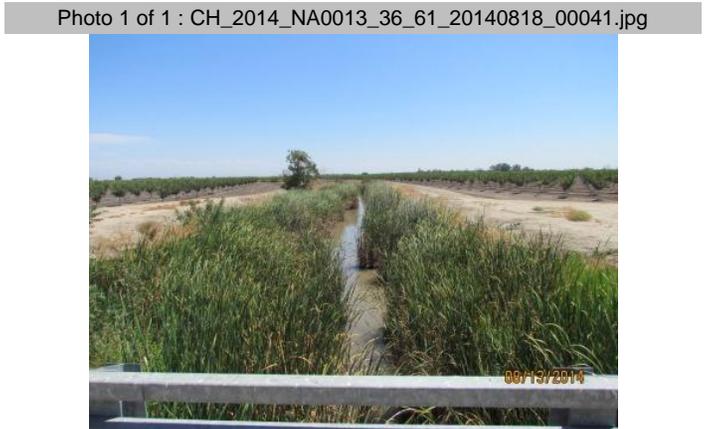
Check Point / View			
Orchard Rd / Up			
Rating **	A	Issue No.	61
Issue Type +	Ma	Location *	GPS Lat/Long
Category	Rivers, Channels & Designated Flood		37.269474 °
Item	Vegetation & Obstructions		-120.397391 °
DWR ID	DWR_NA0013_36_c_2014_61		
Action/Comments			
Inspector Comments: Minor vegetation, but does not appear to be enough to impede flow.

Upstream view from Orchard Rd. crossing.

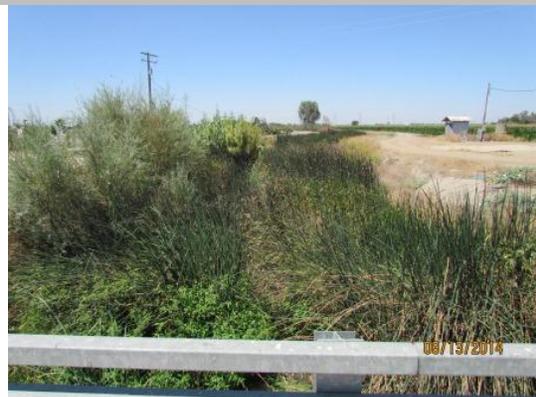
Photo 1 of 1 : CH_2014_NA0013_36_66_20140818_00042.jpg

Downstream view from Orchard Rd. crossing.

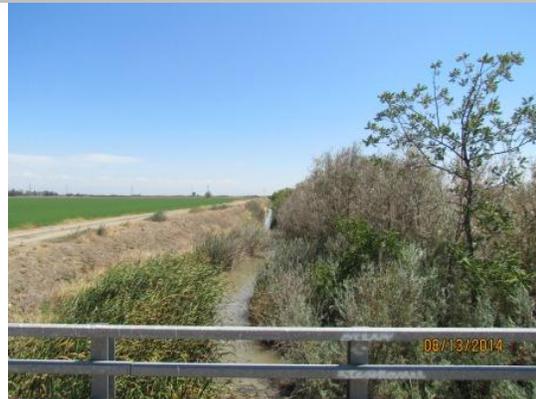
Photo 1 of 1 : CH_2014_NA0013_36_111_20140825_00043.jpg

Upstream view of Miles Creek from Miles Road.

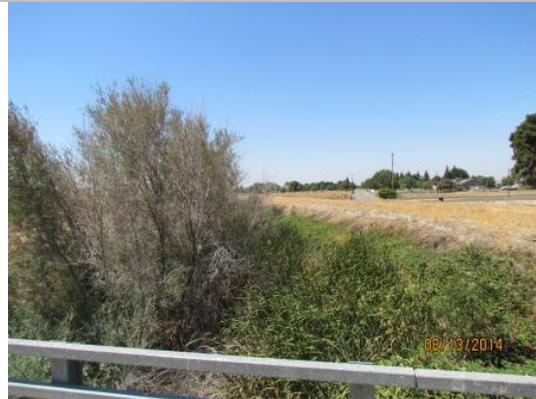
Photo 1 of 1 : CH_2014_NA0013_36_116_20140825_00044.jpg

Downstream view of Miles Creek from Miles Road.

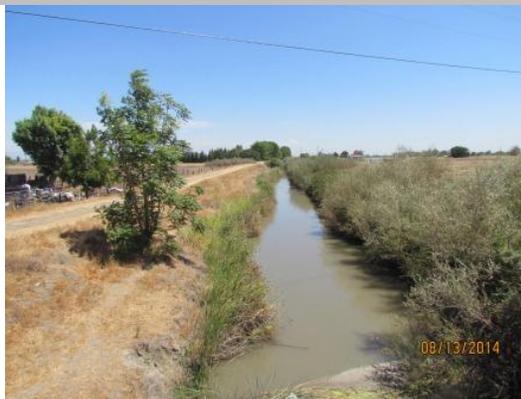
Photo 1 of 1 : CH_2014_NA0013_36_121_20140825_00045.jpg

Upstream view of Miles Creek from Coffee St.

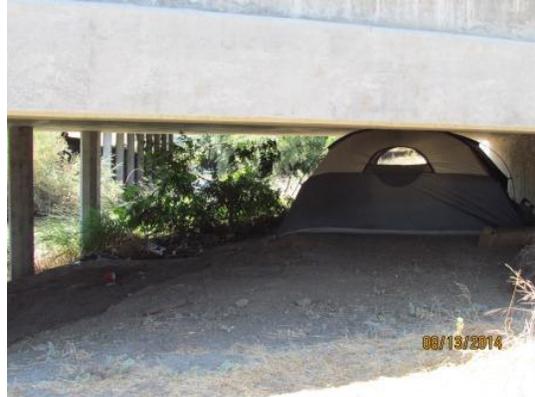
Photo 1 of 1 : CH_2014_NA0013_36_125_20140825_00046.jpg

View of a tent under the bridge on the channel bank.

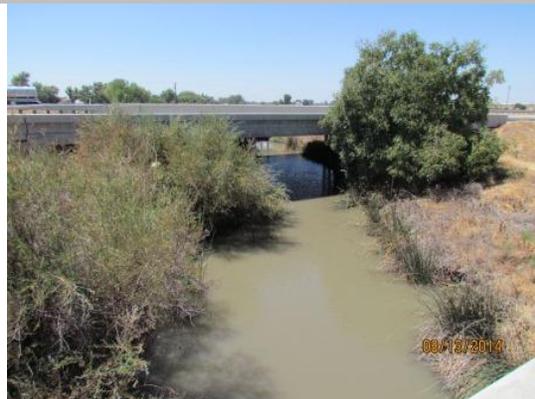
Photo 1 of 1 : CH_2014_NA0013_36_126_20140825_00047.jpg

Downstream view of Miles Creek from Coffee St.

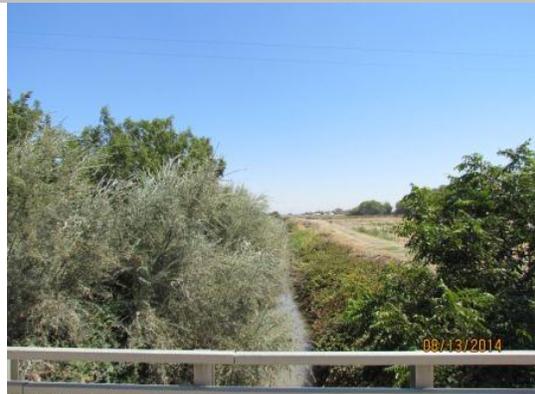
Photo 1 of 1 : CH_2014_NA0013_36_71_20140825_00048.jpg

Upstream view of Miles Creek from Healy Rd. crossing.

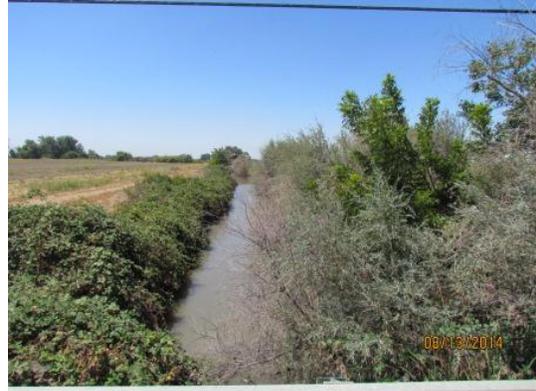
Photo 1 of 1 : CH_2014_NA0013_36_76_20140825_00049.jpg

Downstream view of Miles Creek from Healy Rd. crossing.

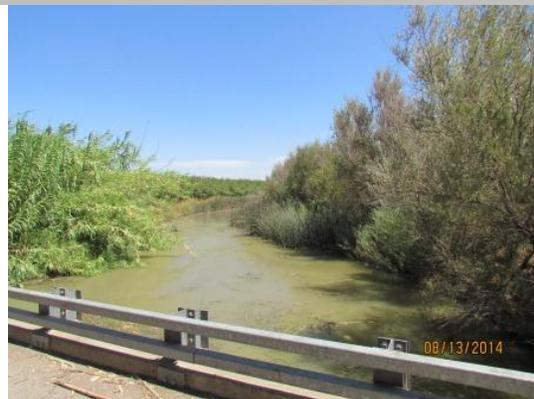
Photo 1 of 1 : CH_2014_NA0013_36_81_20140825_00050.jpg

Upstream view of Miles Creek from Tyler Rd. crossing.

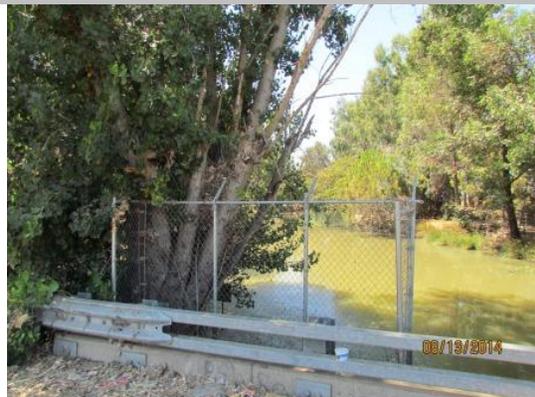
Photo 1 of 2 : CH_2014_NA0013_36_90_20140825_00052.jpg

View of the chain link fence encroaching into the channel on the left bank.

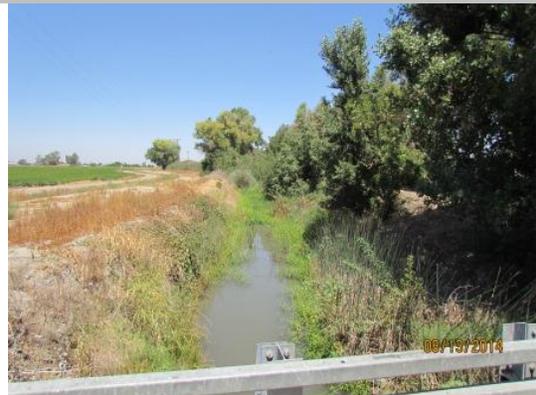
Photo 1 of 1 : CH_2014_NA0013_36_91_20140825_00054.jpg

Upstream view of Miles Creek from Reilly Rd. crossing.

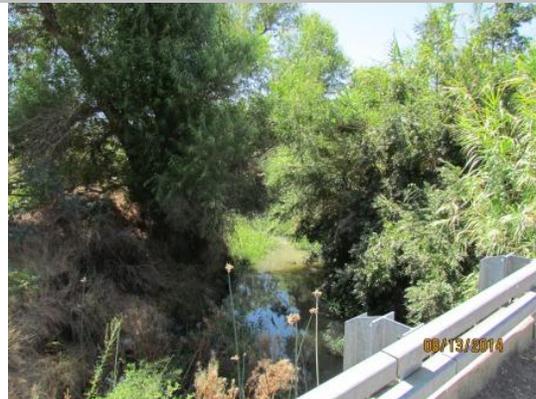
Photo 1 of 1 : CH_2014_NA0013_36_96_20140825_00055.jpg

Downstream view Miles Creek from Reilly Rd. crossing.

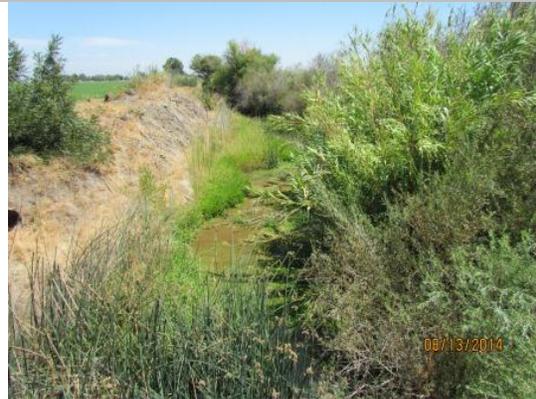
Photo 1 of 1 : CH_2014_NA0013_36_101_20140825_00056.jpg

Upstream view of Miles Creek from Highway 59 crossing.

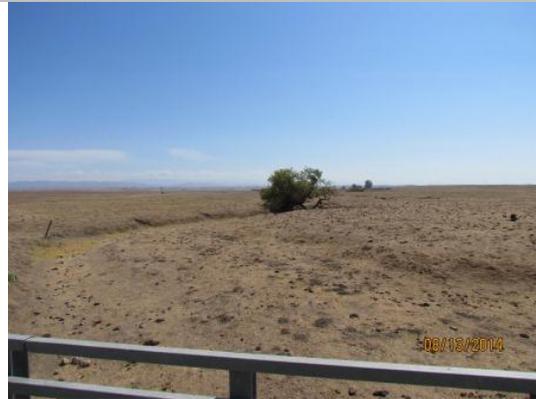
Photo 1 of 1 : CH_2014_NA0013_37_1_20140814_00016.jpg

Upstream view from Cunningham Road crossing.

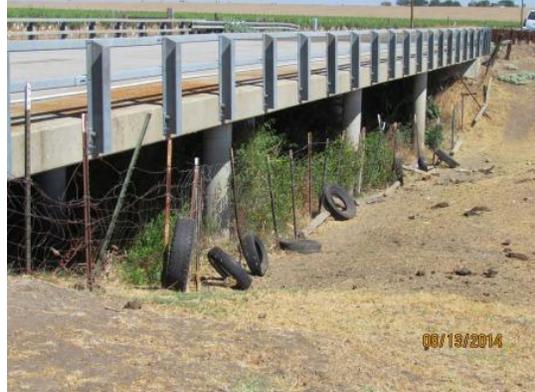
Photo 1 of 1 : CH_2014_NA0013_37_5_20140814_00017.jpg

Wire fence on upstream side of Cunningham crossing.

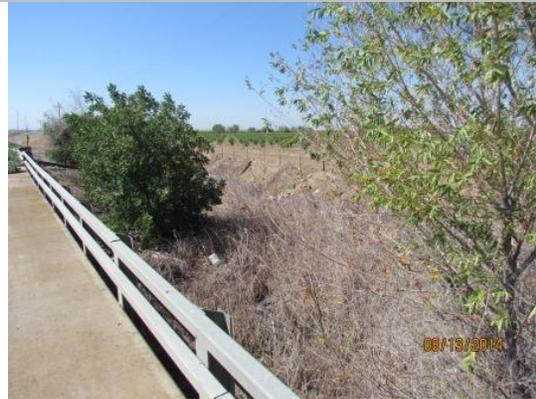
Photo 1 of 1 : CH_2014_NA0013_37_6_20140814_00018.jpg

Cunningham crossing downstream view.

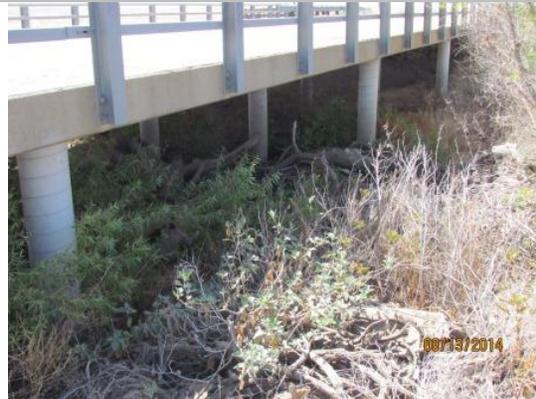
Photo 1 of 1 : CH_2014_NA0013_37_10_20140814_00019.jpg

Debris and vegetation accumulated under bridge.

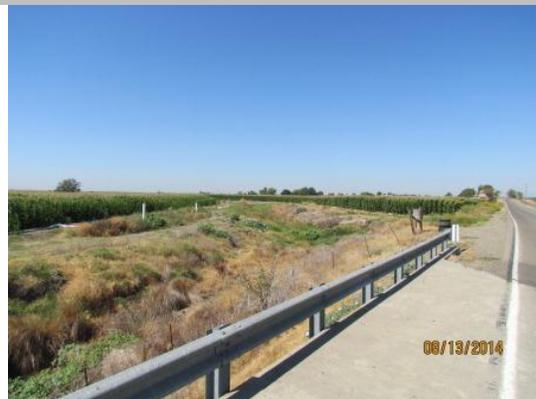
Photo 1 of 1 : CH_2014_NA0013_37_16_20140814_00022.jpg

View of downstream channel at Childs Ave.

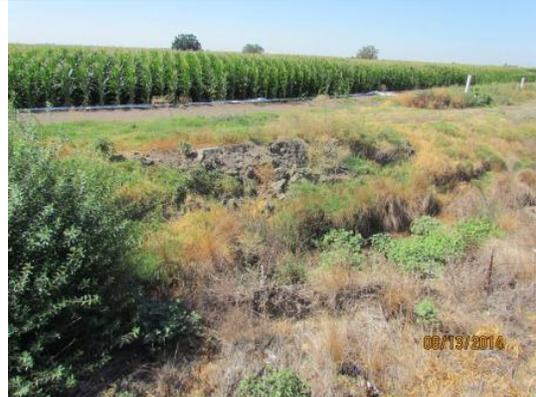
Photo 1 of 1 : CH_2014_NA0013_37_18_20140814_00021.jpg

View of the repaired erosion site.

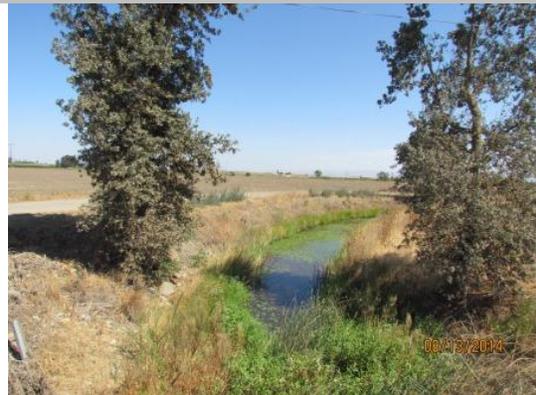
Photo 1 of 1 : CH_2014_NA0013_37_21_20140814_00024.jpg

Upstream view of Owens Creek from Mission Ave. crossing.

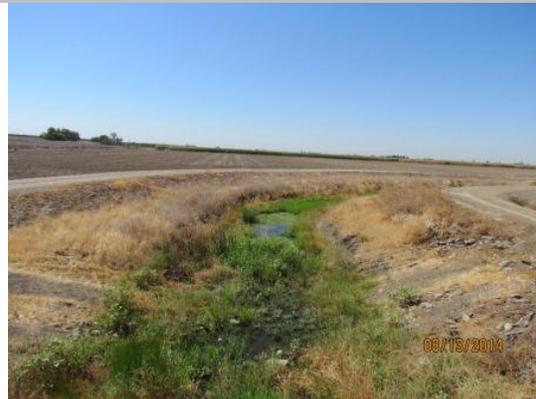
Photo 1 of 1 : CH_2014_NA0013_37_26_20140814_00025.jpg

Downstream view of Owens Creek from Mission Ave. crossing.

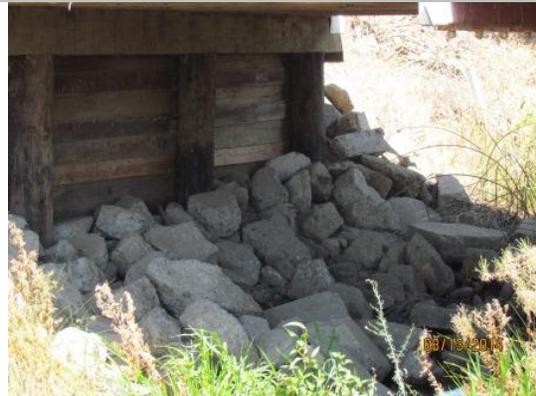
Photo 1 of 1 : CH_2014_NA0013_37_29_20140814_00026.jpg

View of the riprap in the channel at Mission Ave crossing.

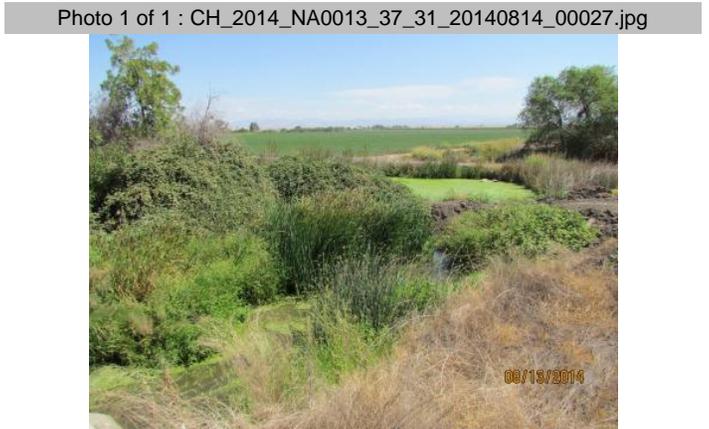
Check Point / View			
Diversion at Le Grand Canal, D/S Limit / Up			
Rating **	M	Issue No. 31	GPS Lat/Long
Issue Type +	Ma	Location *	37.273393 °
Category	Rivers, Channels & Designated Flood		-120.277410 °
Item	Vegetation & Obstructions		
DWR ID	DWR_NA0013_37_c_2012_31		
Action/Comments			
Inspector Comments: Vegetation is thick and obstructing flow.

Upstream view of Owens Creek at diversion.

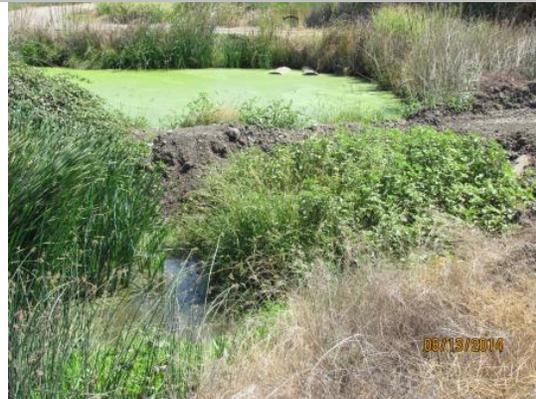
Photo 1 of 1 : CH_2014_NA0013_37_35_20140814_00028.jpg

Photo shows what appears to be material placed in the channel, material is overgrown with vegetation.

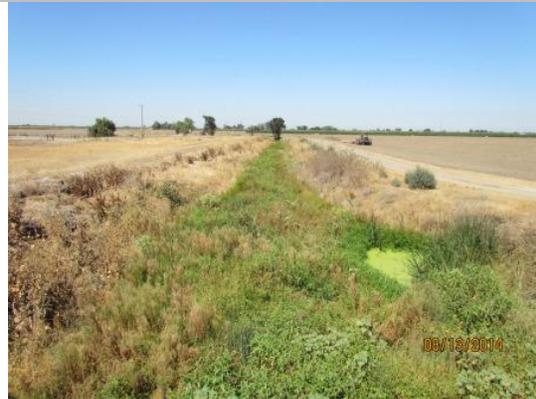
Photo 1 of 1 : CH_2014_NA0013_37_36_20140814_00029.jpg

Downstream view of Owens Creek from the diversion.
