**Flood Control Project Maintenance  
Levee Inspections**

**Fall 2010 Levee Maintenance Deficiency Summary Report**

**Levee Inspection Report By Mile - Fall 2010**

**Merced Streams Group**

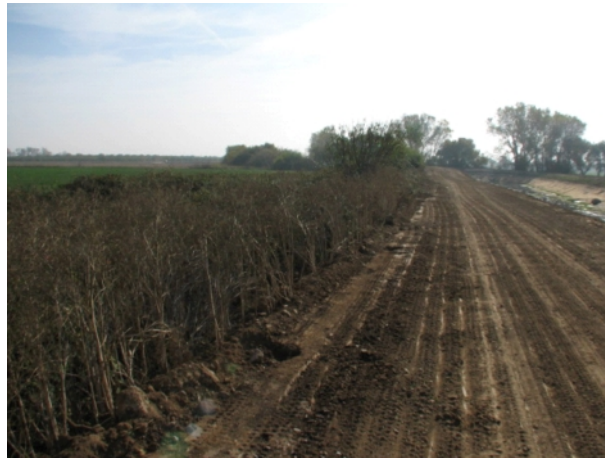
Levee Mile Report Line	1
Start Levee Mile	1.31
End Levee Mile	1.63
Location	Water Side
Category	Earthen Levee
Item	Vegetation

Blackberries and dense brush obstruct access and visibility of top 20' of waterside slope. Photo looking downstream. MID canal on right.

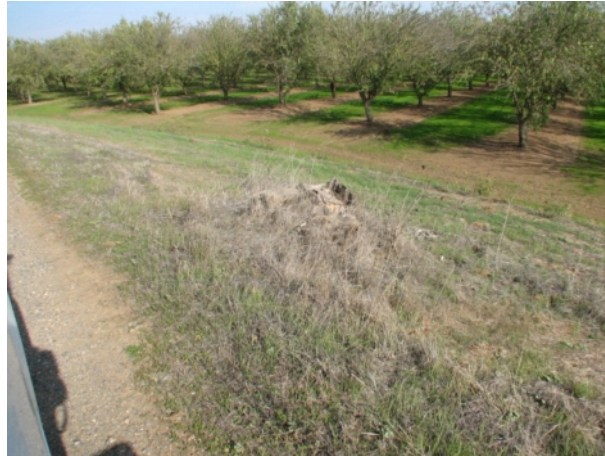
Levee Mile Report Line	2
Start Levee Mile	0.44
End Levee Mile	0.44
Location	Land Side
Category	Earthen Levee
Item	Trim / Thin Trees

Large tree stump on levee slope.

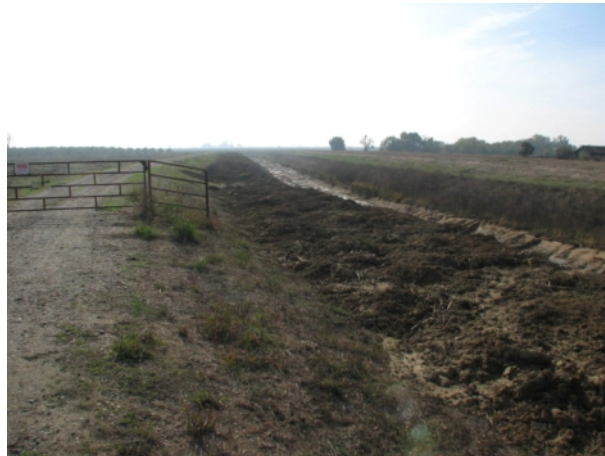
Levee Mile Report Line	3
Start Levee Mile	0.53
End Levee Mile	1.67
Location	Water Side
Category	Channels
Item	Encroachments

Dredge material placed on berm of diversion channel.

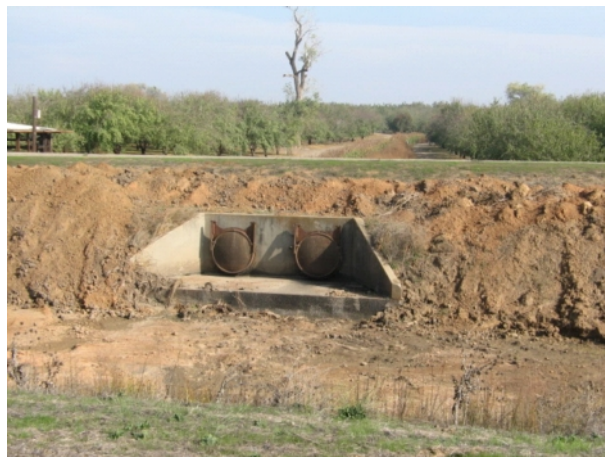
Levee Mile Report Line	11
Start Levee Mile	0.91
End Levee Mile	0.91
Location	Water Side
Category	Interior Drainage & Piping Systems
Item	Culverts: Inlets / Outlets

Drainage discharge outlet to diversion channel.

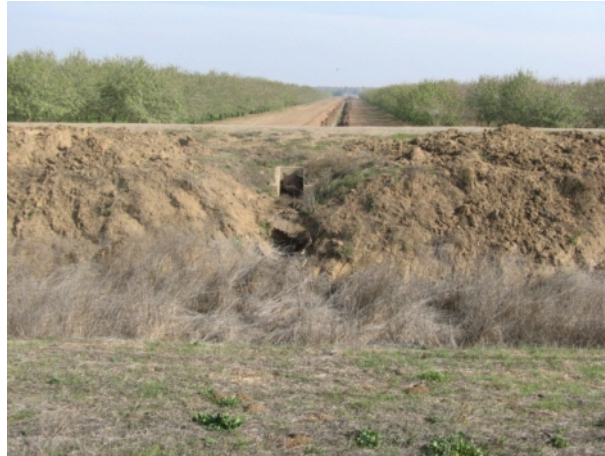
Levee Mile Report Line	12
Start Levee Mile	1.32
End Levee Mile	1.32
Location	Water Side
Category	Interior Drainage & Piping Systems
Item	Culverts: Inlets / Outlets
Drainage discharge outlet to diversion channel.	
jpaasch_f_20101118_593.jpg

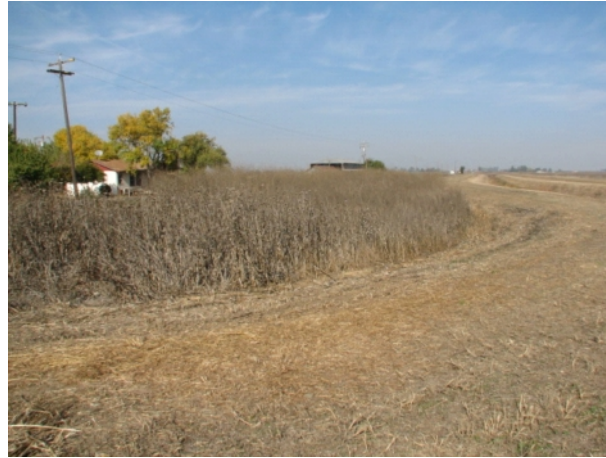
Levee Mile Report Line	1
Start Levee Mile	0.01
End Levee Mile	0.01
Location	Land Side
Category	Earthen Levee
Item	Vegetation

Tall thistle within 10' of landside toe obstructs access and visibility.

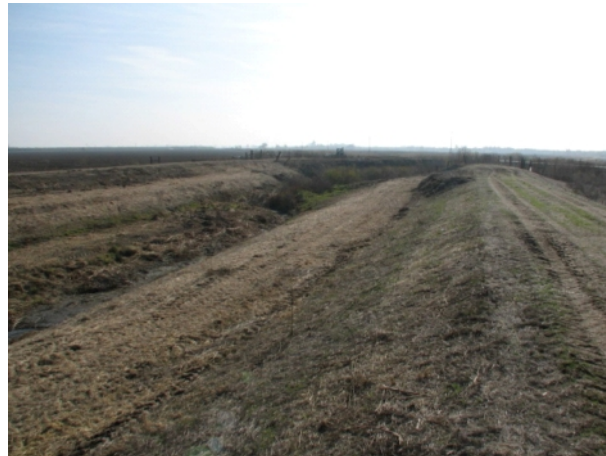
Levee Mile Report Line	2
Start Levee Mile	0.02
End Levee Mile	0.33
Location	Water Side
Category	Earthen Levee
Item	Vegetation

Well maintained vegetation on levee slopes and crown provide access and visibility during inspection.

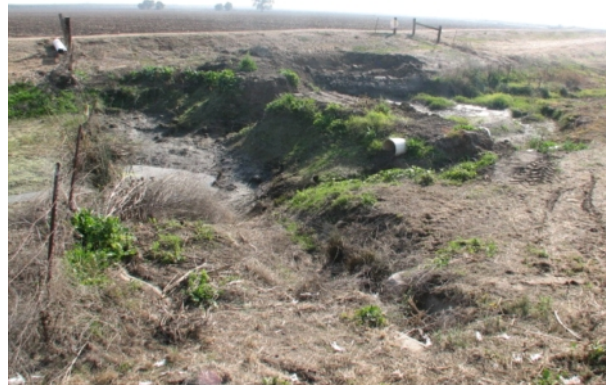
Levee Mile Report Line	8
Start Levee Mile	0.59
End Levee Mile	0.59
Location	Water Side
Category	Channels
Item	Vegetation & Obstructions

Slopes of project channel have been damaged by removing levee material and placing it in the channel to back up water during low flow.

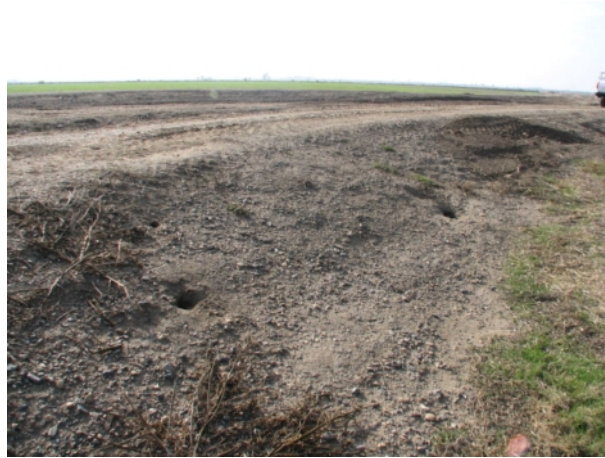
Levee Mile Report Line	20
Start Levee Mile	1.25
End Levee Mile	1.25
Location	Land Side
Category	Earthen Levee
Item	Animal Control

Active animal burrows on levee slope and toe.

20	1.25	1.25	Earthen Levee	Animal Control	LS	M	Exterminate rodents and backfill and compact or grout burrows.	37.272707 ° -120.280334 °	37.272707 ° -120.280334 °	7 Y
21	1.25	1.25	Supplemental	DWR Erosion Survey	WS	M	Inspector Comments: 11/30/2010: Site was not inspected this year due to time constraint. There have been no reports from the district that the site. Continue to monitor during flood events. [2010 SiteID: NA0013U03RM1.25]	37.272630 ° -120.280390 °	37.272630 ° -120.280390 °	1 Y
22	1.27	1.27	Earthen Levee	Trim / Thin Trees	LS	M	Trim trees to at least five feet above ground level.	37.272866 ° -120.280295 °	37.272866 ° -120.280295 °	13
23	1.28	1.28	Interior Drainage & Piping Systems	Culverts: Inlets / Outlets	WS	A	Inspector Comments: Gravity drainage outlet.	37.273081 ° -120.280291 °	37.273081 ° -120.280291 °	5
24	1.28	1.43	Earthen Levee	Vegetation	WS	A	Remove the wild growth other than native grasses from the levee slopes.	37.273050 ° -120.280280 °	37.273580 ° -120.277876 °	3 Y

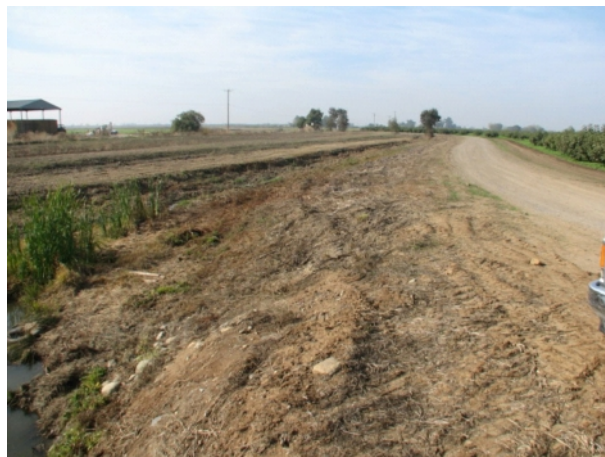
Levee Mile Report Line	24
Start Levee Mile	1.28
End Levee Mile	1.43
Location	Water Side
Category	Earthen Levee
Item	Vegetation

Well maintained vegetation on slopes of diversion channel.

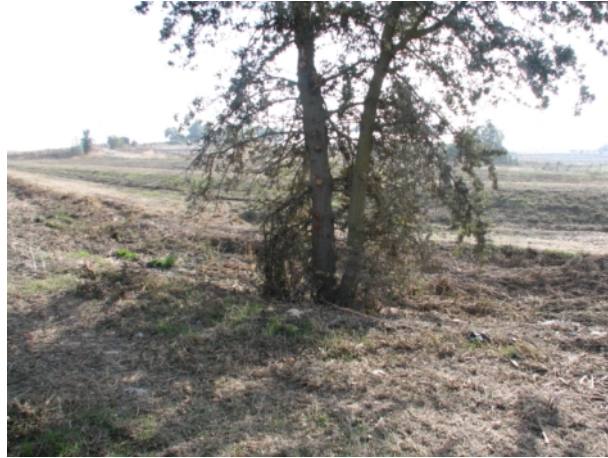
Levee Mile Report Line	26
Start Levee Mile	1.32
End Levee Mile	1.32
Location	Water Side
Category	Earthen Levee
Item	Trim / Thin Trees
Tree on levee slope should be trimmed up 5' to improve vsibility.	
jpaasch_f_20101122_598.jpg

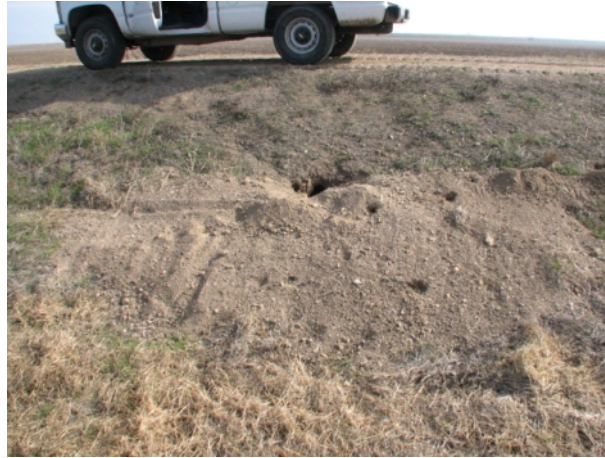
Active animal burrows on levee slope.

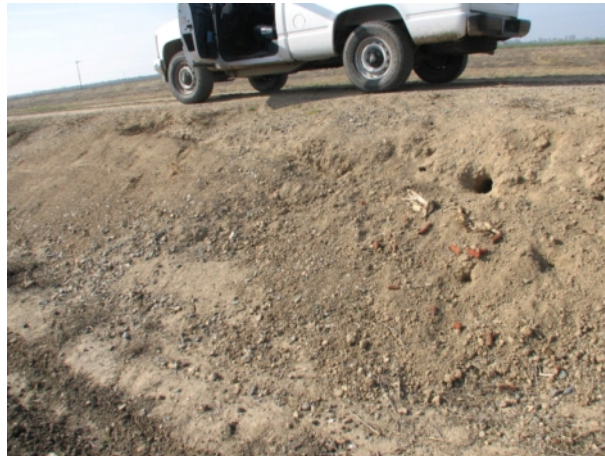
Levee Mile Report Line	20
Start Levee Mile	0.72
End Levee Mile	0.72
Location	Land Side
Category	Earthen Levee
Item	Animal Control

Active animal burrows on levee slope.

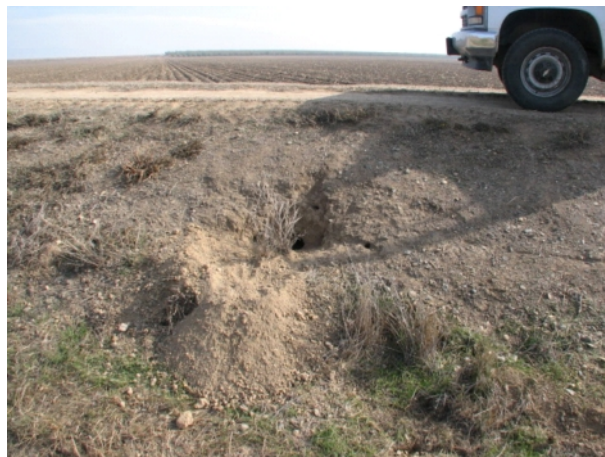
Levee Mile Report Line	21
Start Levee Mile	0.73
End Levee Mile	0.73
Location	Water Side
Category	Earthen Levee
Item	Animal Control

Active animal burrows on levee slope.

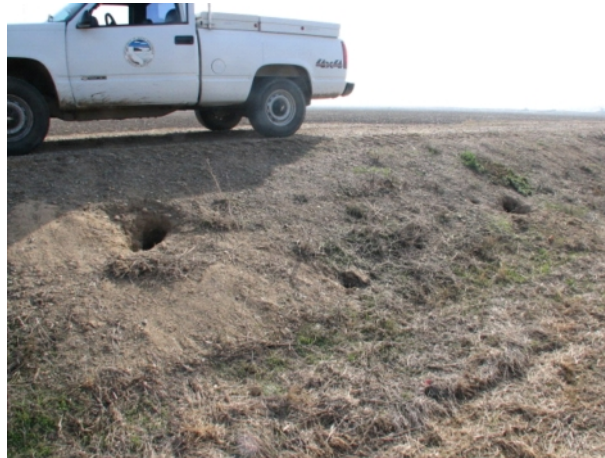
Active animal burrows on levee slope.

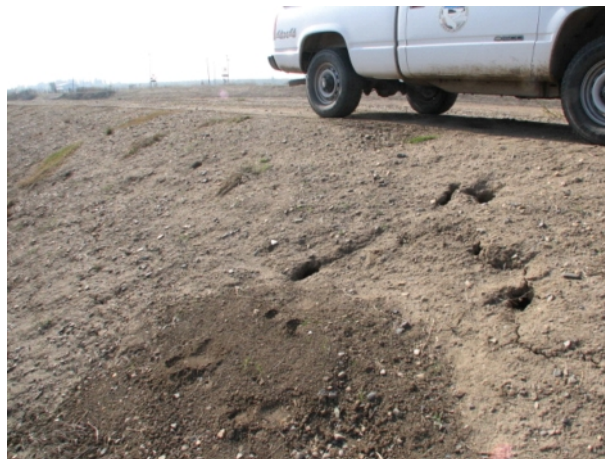
Levee Mile Report Line	30
Start Levee Mile	0.93
End Levee Mile	0.93
Location	Land Side
Category	Earthen Levee
Item	Animal Control

Active animal burrows on levee slope.

30	0.93	0.93	Earthen Levee	Animal Control	LS	M	Exterminate rodents and backfill and compact or grout burrows.	37.264325 ° -120.288038 °	37.264325 ° -120.288038 °	970 Y
31	0.93	0.93	Earthen Levee	Animal Control	CR	M	No rodents visible, but rodent burrows visible; need to backfill and compact or grout borrows.	37.264325 ° -120.288038 °	37.264325 ° -120.288038 °	36
32	0.97	0.97	Earthen Levee	Cracking	WS	W		37.263850 ° -120.288021 °	37.263850 ° -120.288021 °	14 Y

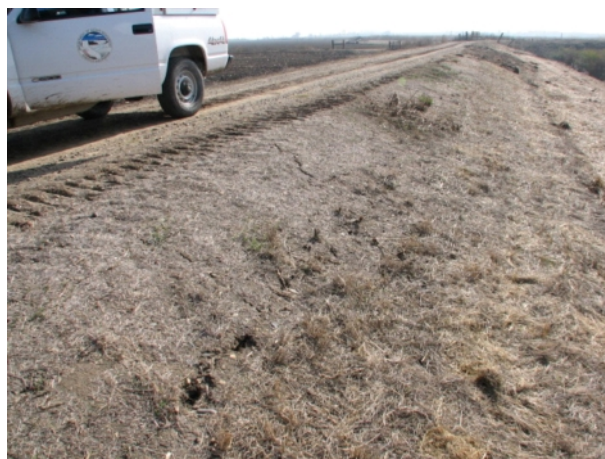
Levee Mile Report Line	32
Start Levee Mile	0.97
End Levee Mile	0.97
Location	Water Side
Category	Earthen Levee
Item	Cracking

Minor surface cracking on waterside levee slope.

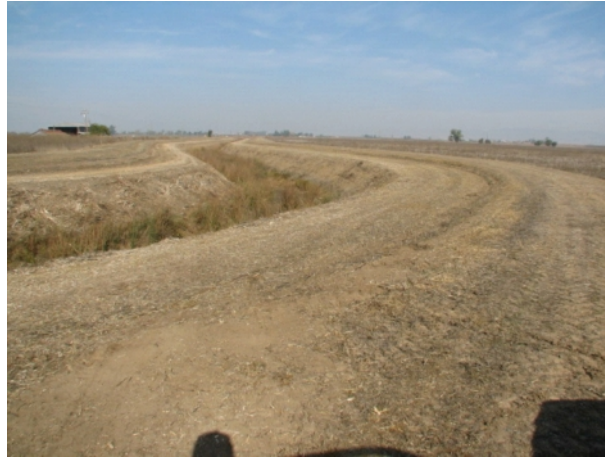
Well maintained vegetation on levee slopes allows access and visibility.
