**Flood Control Project Maintenance
Levee Inspections**

Fall 2011 Levee Maintenance Deficiency Summary Report

Merced Streams Group

Waterway						Bank	Unit Miles	Inspection Start/End	Inspector
Unit No. 01 Black Rascal Diversion						Right	1.64	11/22/2011 11/21/2011	Herman Phillips

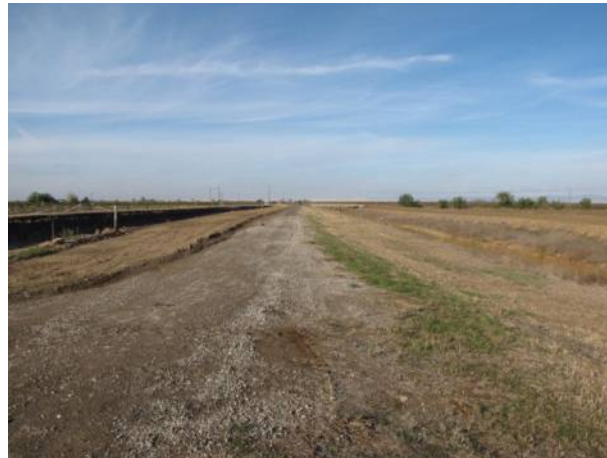
Levee Mile Report Line	1
Start Levee Mile	0.00
End Levee Mile	0.00
Location	Land Side
Category	Earthen Levee
Item	Vegetation

Black Rascal Diversion Unit # 1 looking downstream from levee mile 0.00. Photo taken 11-21-2011.

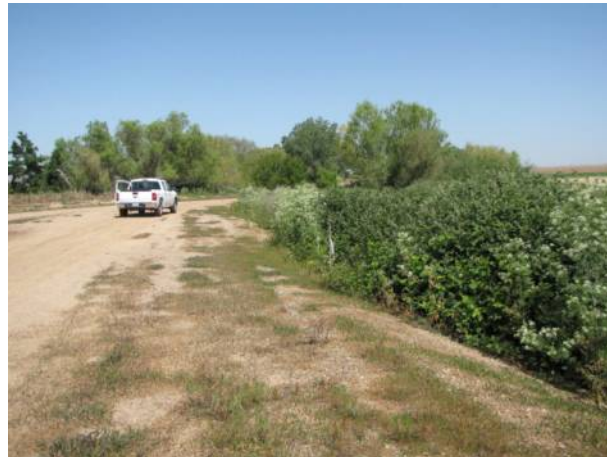
Levee Mile Report Line	3
Start Levee Mile	1.31
End Levee Mile	1.63
Location	Water Side
Category	Earthen Levee
Item	Vegetation

Looking downstream at vegetation on waterward the top 20-feet over grown levee mile 1.31-1.63. Photo taken 5-4-2011.

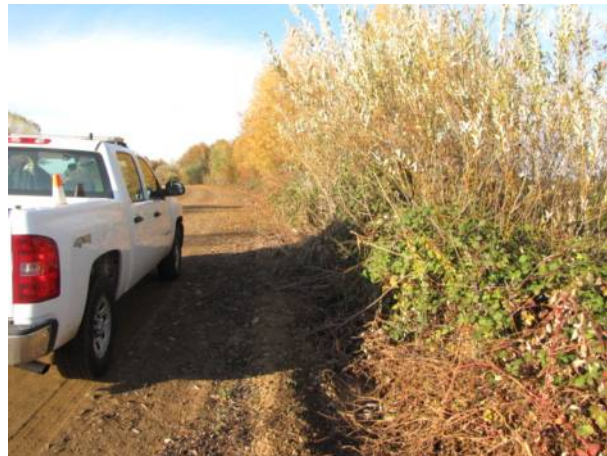
Levee Mile Report Line	3
Start Levee Mile	1.31
End Levee Mile	1.63
Location	Water Side
Category	Earthen Levee
Item	Vegetation

Unsatisfactory wild growth from levee mile 1.31-1.63. Photo taken 11-21-2011.

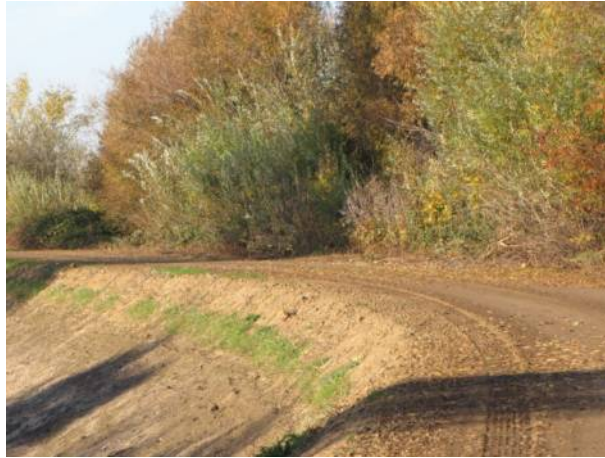
Levee Mile Report Line	3
Start Levee Mile	1.31
End Levee Mile	1.63
Location	Water Side
Category	Earthen Levee
Item	Vegetation
Continue wild growth levee miles 1.32-1.63. Photo taken 11-21-2011.	
phillips_f_20111208_121.jpg

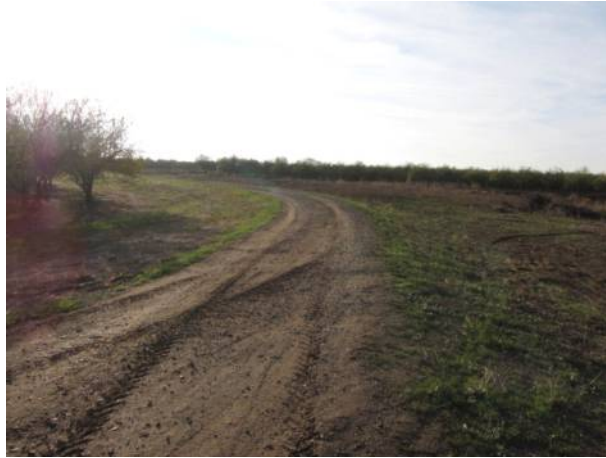
Levee Mile Report Line	1
Start Levee Mile	0.00
End Levee Mile	0.00
Location	Land Side
Category	Earthen Levee
Item	Vegetation

Black Rascal Creek Unit 2 levee mile 0.00 looking downstream. Photo taken 11-21-2011.

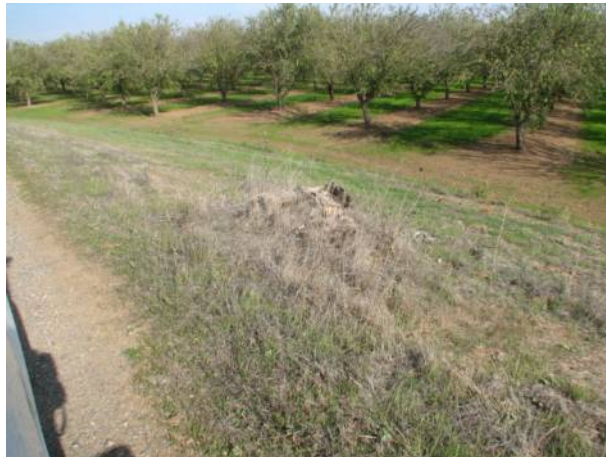
Levee Mile Report Line	3
Start Levee Mile	0.44
End Levee Mile	0.44
Location	Land Side
Category	Earthen Levee
Item	Trim / Thin Trees

Large tree stump on levee slope.

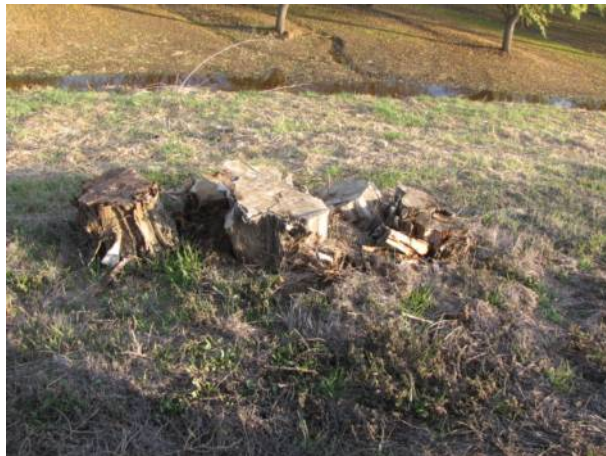
Levee Mile Report Line	3
Start Levee Mile	0.44
End Levee Mile	0.44
Location	Land Side
Category	Earthen Levee
Item	Trim / Thin Trees

Large tree stumps have not been removed. Photo taken 11-21-2011.

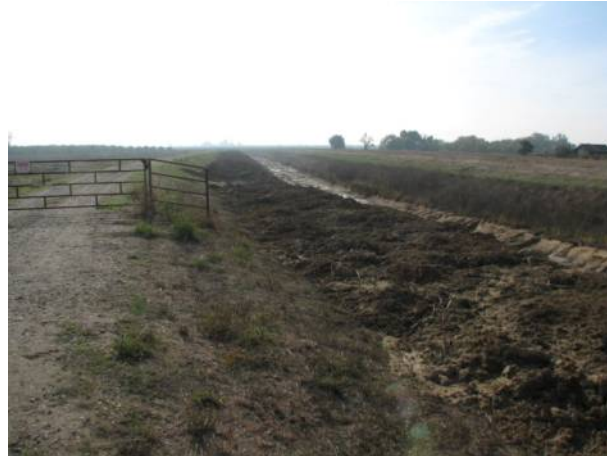
Levee Mile Report Line	4
Start Levee Mile	0.53
End Levee Mile	1.67
Location	Water Side
Category	Channels
Item	Encroachments
Dredge material placed on berm of diversion channel.	
phillips_f_20110929_039.jpg

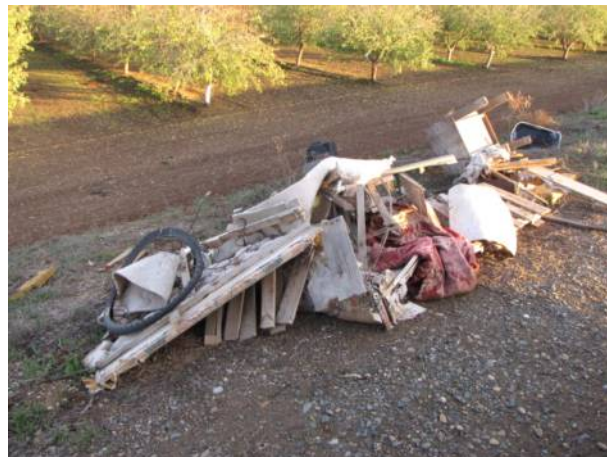
Levee Mile Report Line	13
Start Levee Mile	1.54
End Levee Mile	1.54
Location	Land Side
Category	Earthen Levee
Item	Encroachments
Levee mile 1.54 garbage dumped on landward slope and toe of levee section. Photo taken 11-21-2011.	
phillips_f_20111208_125.jpg

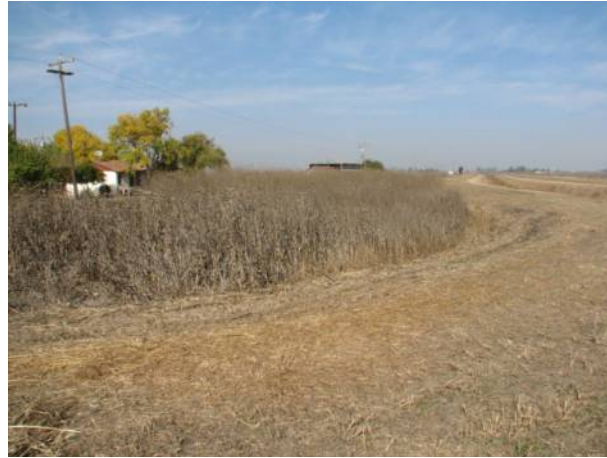
Levee Mile Report Line	1
Start Levee Mile	0.01
End Levee Mile	0.01
Location	Land Side
Category	Earthen Levee
Item	Vegetation
Tall thistle within 10' of landside toe obstructs access and visibility.	
phillips_f_20110929_050.jpg

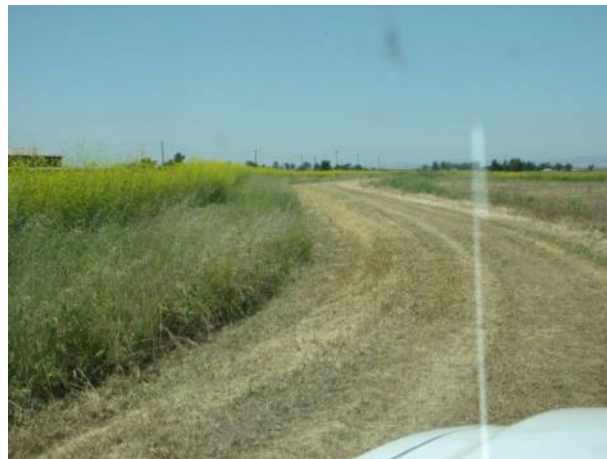
Levee Mile Report Line	1
Start Levee Mile	0.01
End Levee Mile	0.01
Location	Land Side
Category	Earthen Levee
Item	Vegetation
The area hasn't changed much since last inspection. Tall thistle and mustards within 10' of landside toe. 5-4-2011	
phillips_f_20110929_051.jpg

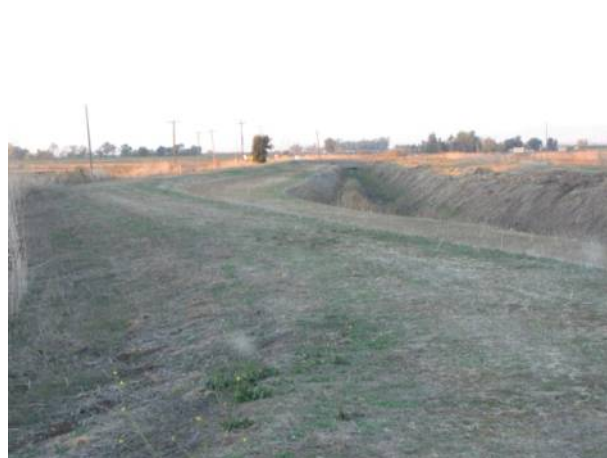
Levee Mile Report Line	1
Start Levee Mile	0.01
End Levee Mile	0.01
Location	Land Side
Category	Earthen Levee
Item	Vegetation
Owens Creek Unit 3 looking downstream from levee mile 0.01. Photo taken 11-21-2011.	
phillips_f_20111208_124.jpg

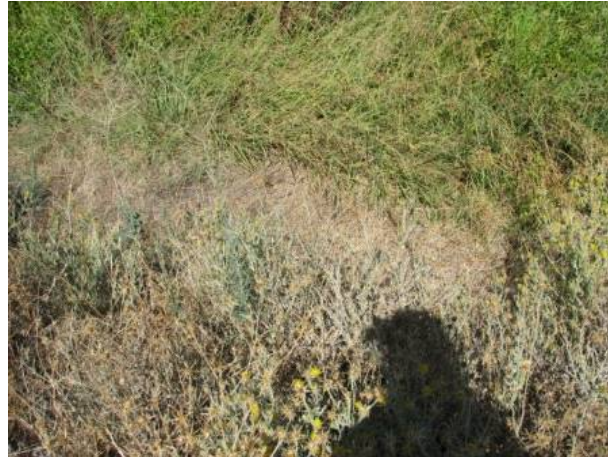
Levee Mile Report Line	8
Start Levee Mile	1.00
End Levee Mile	1.00
Location	Water Side
Category	Supplemental
Item	DWR Erosion Survey

A close look at the site, which is covered by thick star thistles.

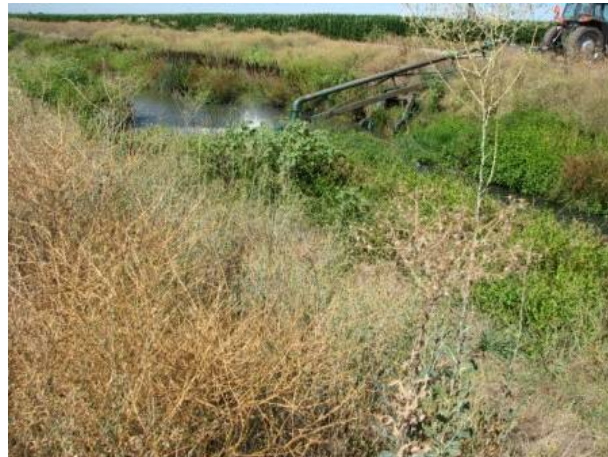
Levee Mile Report Line	8
Start Levee Mile	1.00
End Levee Mile	1.00
Location	Water Side
Category	Supplemental
Item	DWR Erosion Survey

Site covered with dense vegetation.

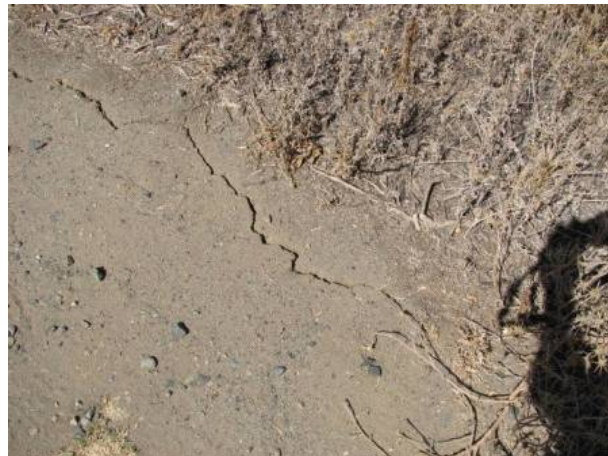
Levee Mile Report Line	8
Start Levee Mile	1.00
End Levee Mile	1.00
Location	Water Side
Category	Supplemental
Item	DWR Erosion Survey

Some cracking on the site.

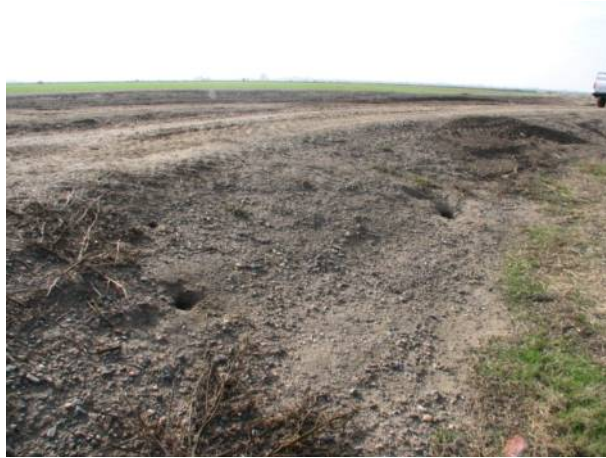
Levee Mile Report Line	14
Start Levee Mile	1.25
End Levee Mile	1.25
Location	Land Side
Category	Earthen Levee
Item	Animal Control

Active animal burrows on levee slope and toe.

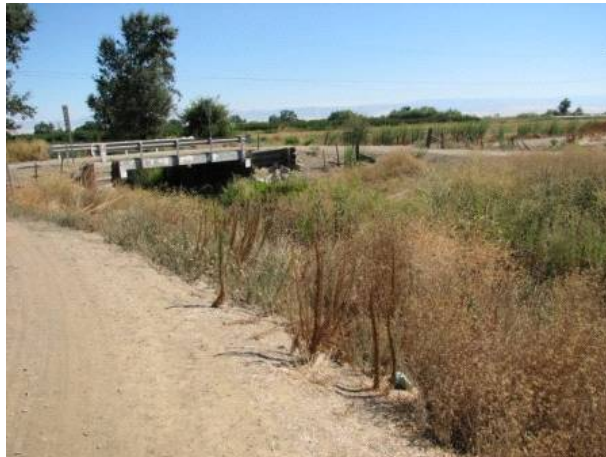
Levee Mile Report Line	15
Start Levee Mile	1.25
End Levee Mile	1.25
Location	Water Side
Category	Supplemental
Item	DWR Erosion Survey

The site is covered with dense thistles.

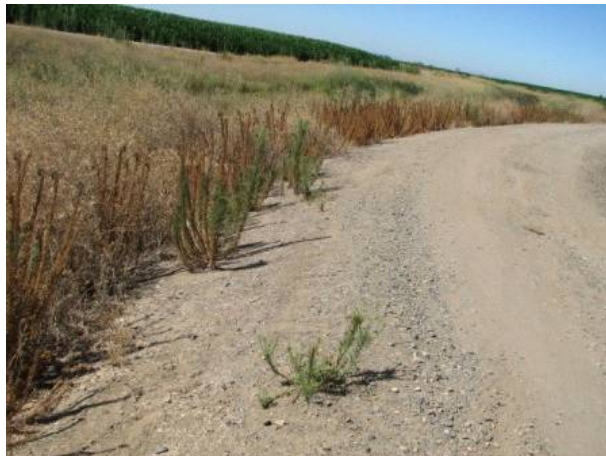
Levee Mile Report Line	15
Start Levee Mile	1.25
End Levee Mile	1.25
Location	Water Side
Category	Supplemental
Item	DWR Erosion Survey

No significant change visible from the levee top

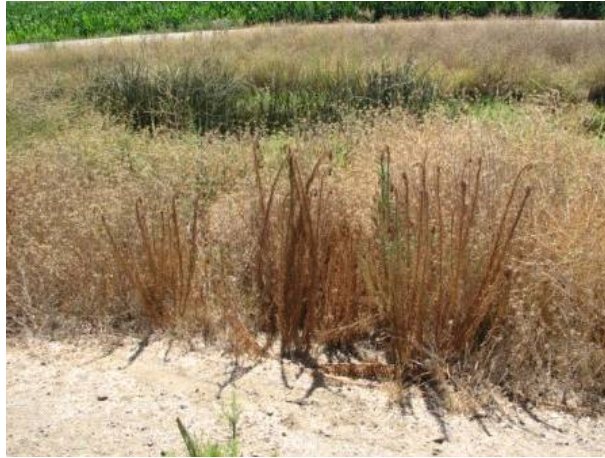
The site is covered with dense thistles.

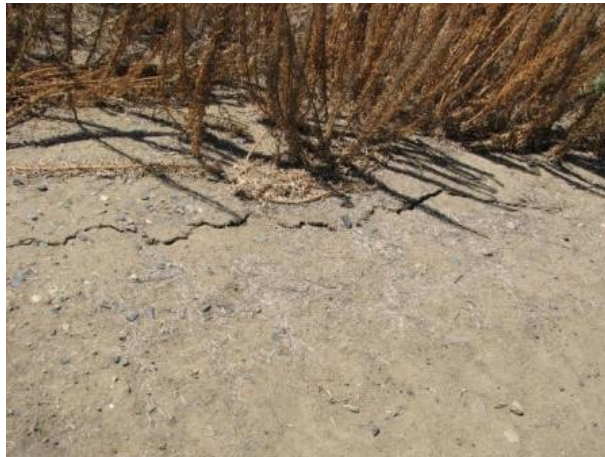
Levee Mile Report Line	15
Start Levee Mile	1.25
End Levee Mile	1.25
Location	Water Side
Category	Supplemental
Item	DWR Erosion Survey

Minor cracking visible at the levee shoulder

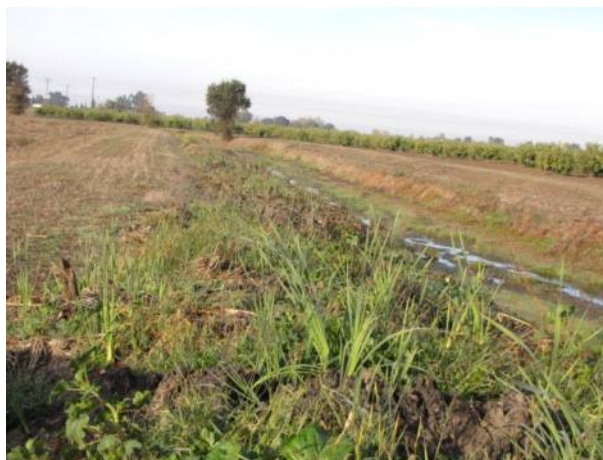
Dredged material on waterward berm.

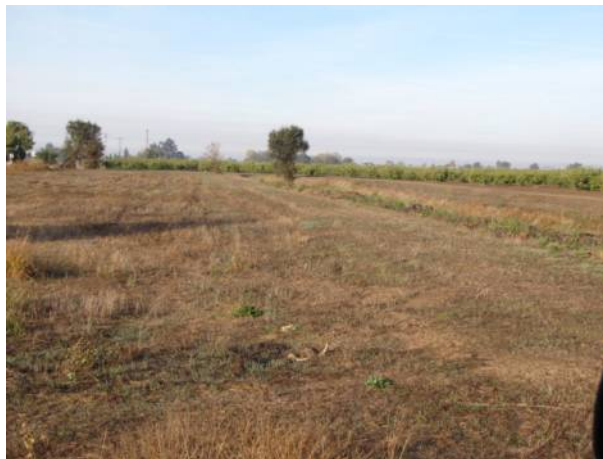
Levee Mile Report Line	2
Start Levee Mile	0.01
End Levee Mile	0.01
Location	Land Side
Category	Earthen Levee
Item	Vegetation

Owens Creek Unit 4 standing at levee mile 0.00 looking downstream. Photo taken 11-21-2011.

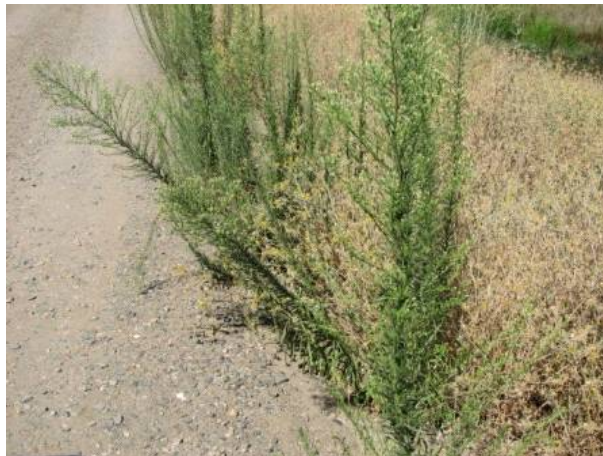
Levee Mile Report Line	6
Start Levee Mile	0.15
End Levee Mile	0.28
Location	Water Side
Category	Supplemental
Item	DWR Erosion Survey

The site is covered with dense star thistles. No significant changes visible

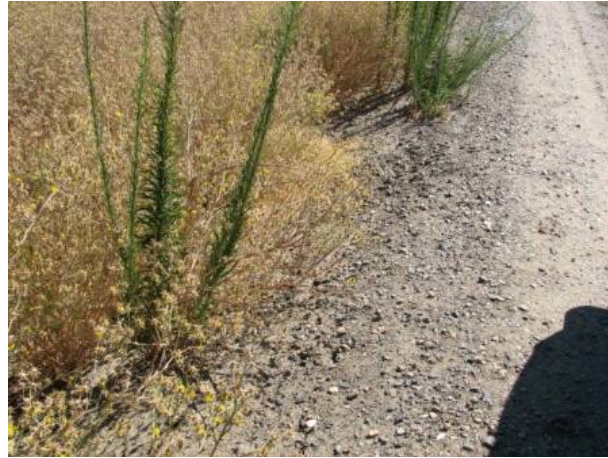
The site is covered with dense star thistles

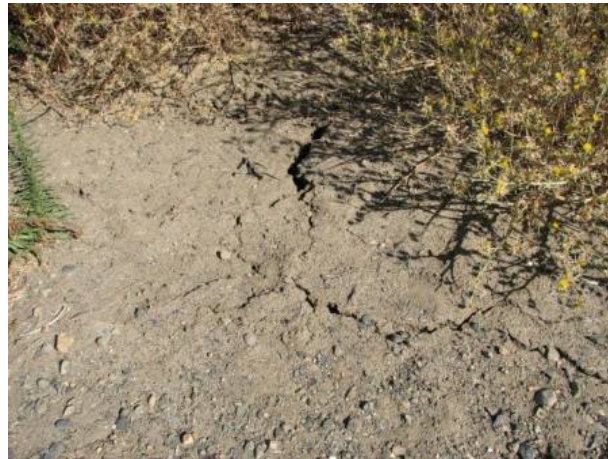
Levee Mile Report Line	6
Start Levee Mile	0.15
End Levee Mile	0.28
Location	Water Side
Category	Supplemental
Item	DWR Erosion Survey

Minor cracking visible on the site

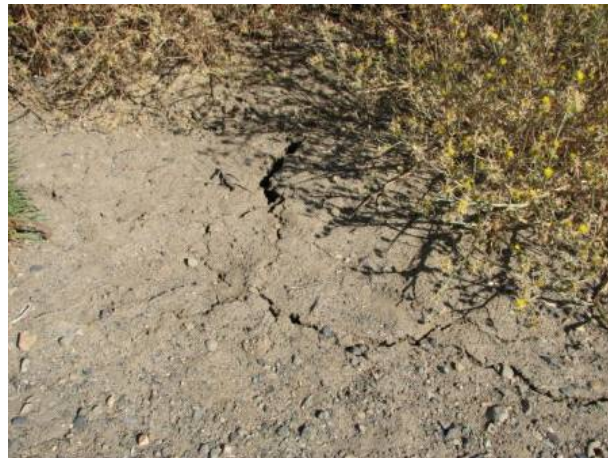
Levee Mile Report Line	6
Start Levee Mile	0.15
End Levee Mile	0.28
Location	Water Side
Category	Supplemental
Item	DWR Erosion Survey

Minor cracking visible on the site

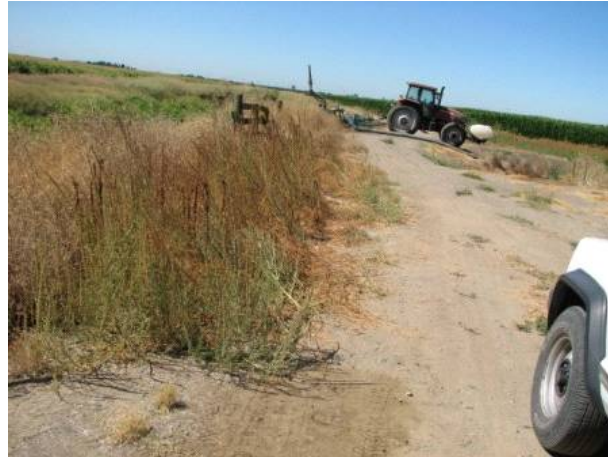
The site is covered with thick vegetation

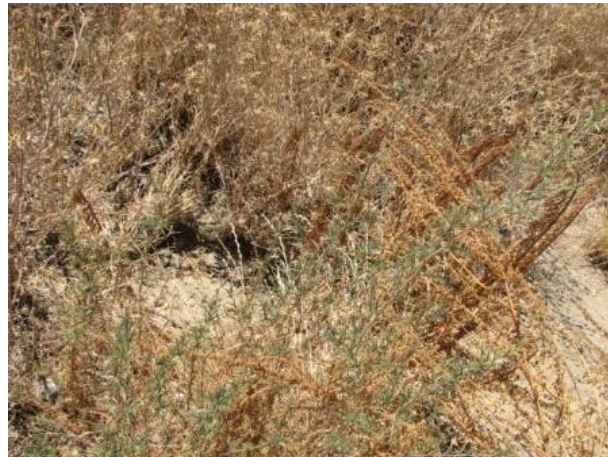
Levee Mile Report Line	10
Start Levee Mile	0.42
End Levee Mile	0.43
Location	Water Side
Category	Supplemental
Item	DWR Erosion Survey

The site is covered with thick vegetation

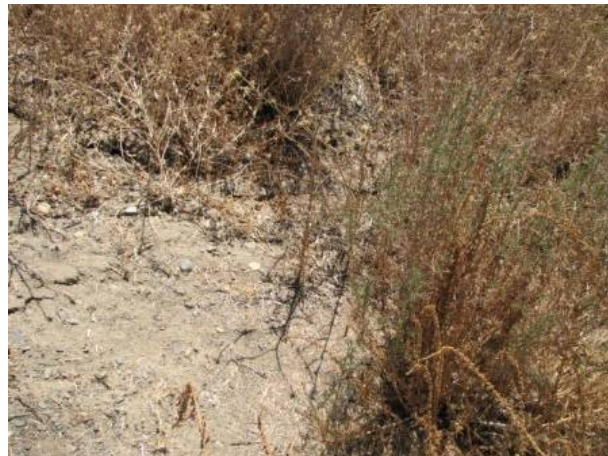
Levee Mile Report Line	10
Start Levee Mile	0.42
End Levee Mile	0.43
Location	Water Side
Category	Supplemental
Item	DWR Erosion Survey

Minor cracking on waterside levee shoulder

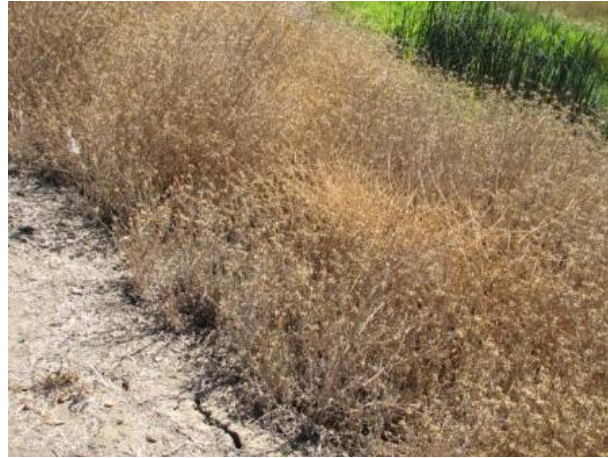
Minor cracking on waterside levee shoulder

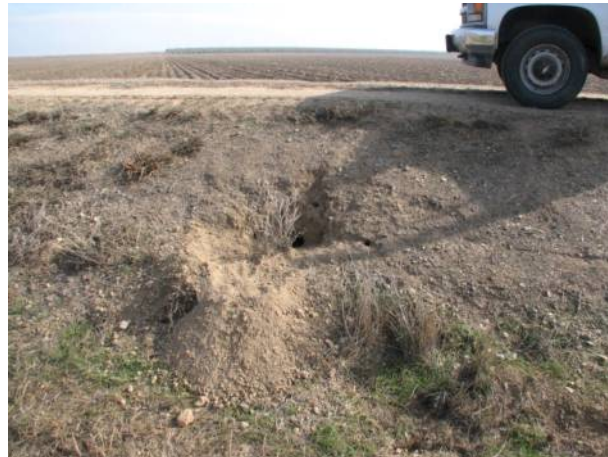
Levee Mile Report Line	21
Start Levee Mile	0.73
End Levee Mile	0.73
Location	Water Side
Category	Earthen Levee
Item	Animal Control

Active animal burrows on levee slope.

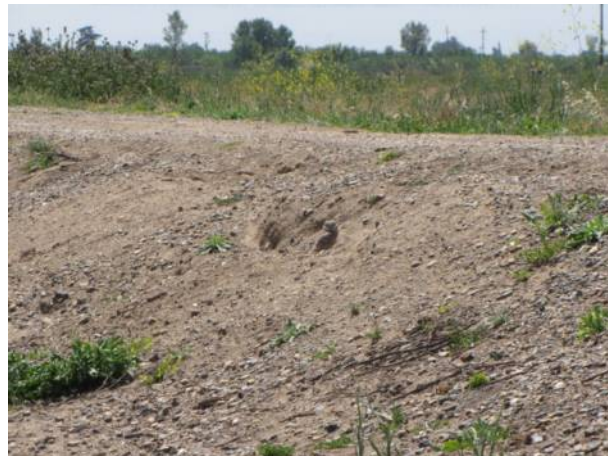
Levee Mile Report Line	21
Start Levee Mile	0.73
End Levee Mile	0.73
Location	Water Side
Category	Earthen Levee
Item	Animal Control

Active animal burrows on levee slopes. 5-4-2011

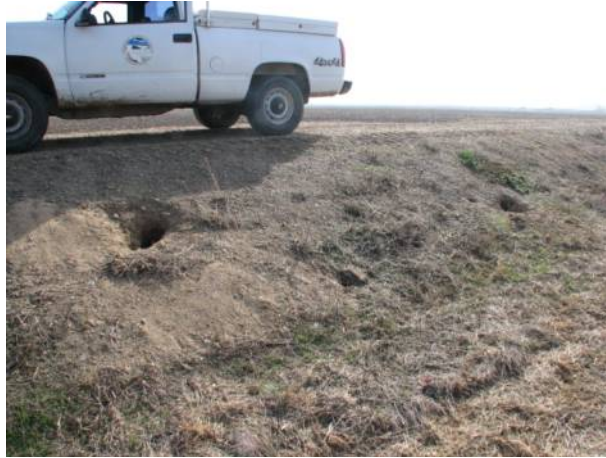
Active animal burrows on levee slope.

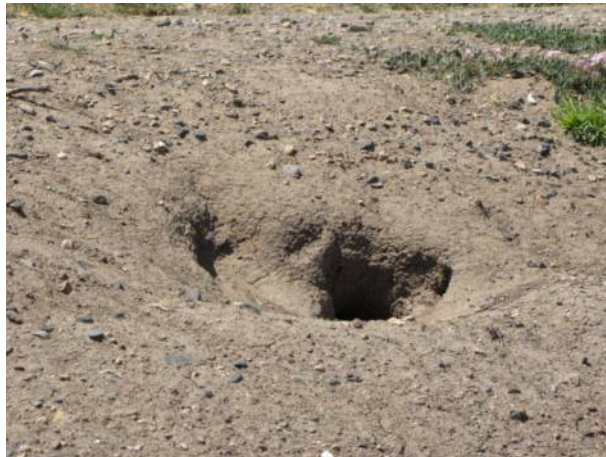
Levee Mile Report Line	22
Start Levee Mile	0.75
End Levee Mile	0.75
Location	Water Side
Category	Earthen Levee
Item	Animal Control

Active animal borrows on levee slope. 5-4-2011

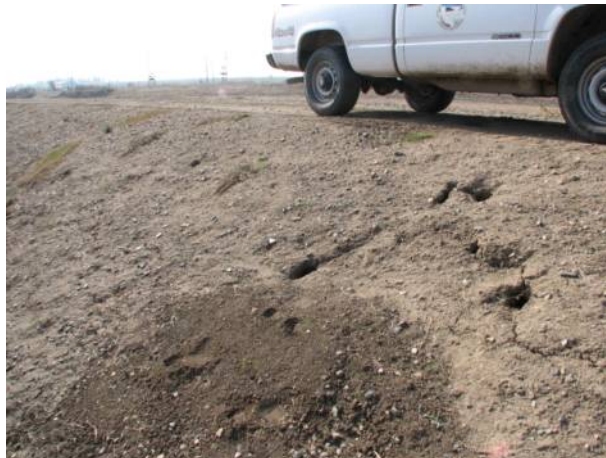
Levee Mile Report Line	29
Start Levee Mile	0.93
End Levee Mile	0.93
Location	Land Side
Category	Earthen Levee
Item	Animal Control

Active animal burrows on levee slope.

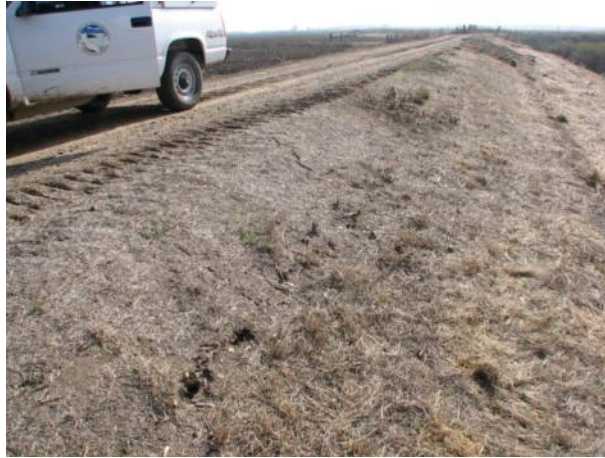
Levee Mile Report Line	30
Start Levee Mile	0.97
End Levee Mile	0.97
Location	Water Side
Category	Earthen Levee
Item	Cracking

Minor surface cracking on waterside levee slope.
