**Flood Control Project Maintenance  
Levee Inspections**

**Fall 2012 Levee Maintenance Deficiency Summary Report**

**Merced Streams Group**

**Levee Inspection Report By Mile - Fall 2012**

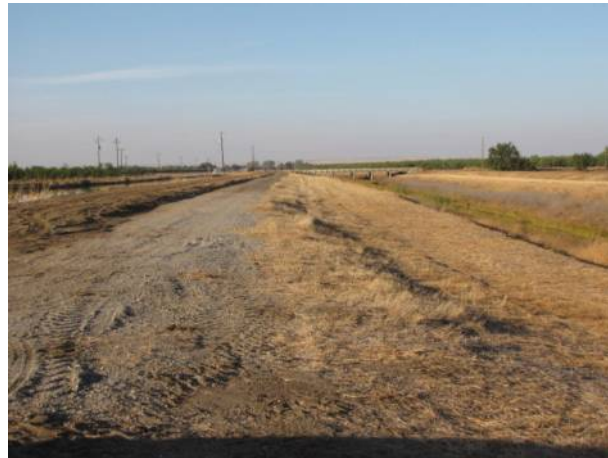
Levee Mile Report Line	4
Start Levee Mile	0.00
End Levee Mile	0.00
Location	Water Side
Category	Earthen Levee
Item	Vegetation

Merced County Unit 1 Black Rascal Creek levee mile 0.00 looking downstream from waterside. Photo taken 10-30-2012.

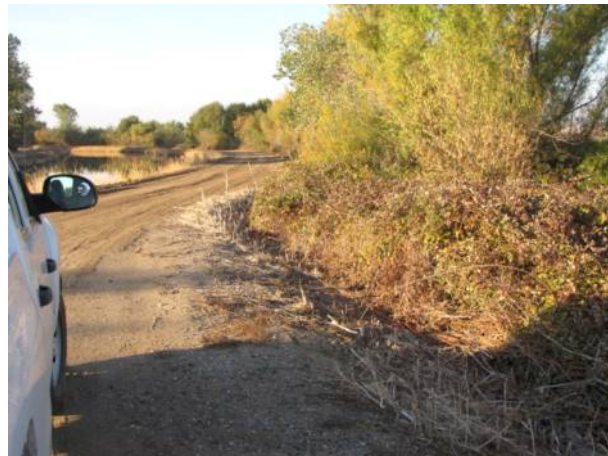
Levee Mile Report Line	7
Start Levee Mile	1.31
End Levee Mile	1.63
Location	Water Side
Category	Earthen Levee
Item	Vegetation

Looking downstream from levee mile 1.31. Photo taken 10-30-2012.

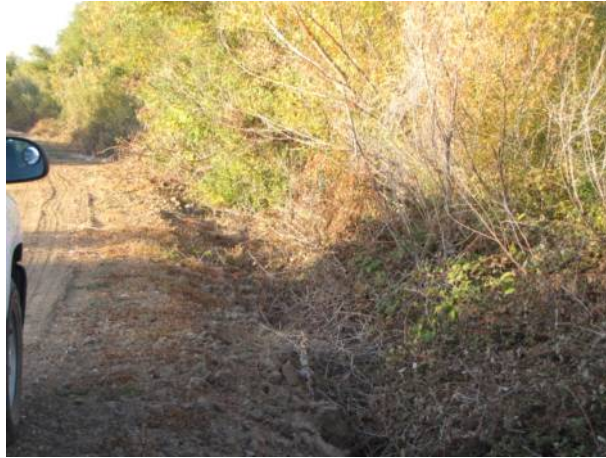
Levee Mile Report Line	9
Start Levee Mile	1.33
End Levee Mile	1.40
Location	Water Side
Category	Earthen Levee
Item	Trim / Thin Trees

Black Rascal Creek looking downstream from levee mile 1.39 water side. Photo taken 10-30-2012.

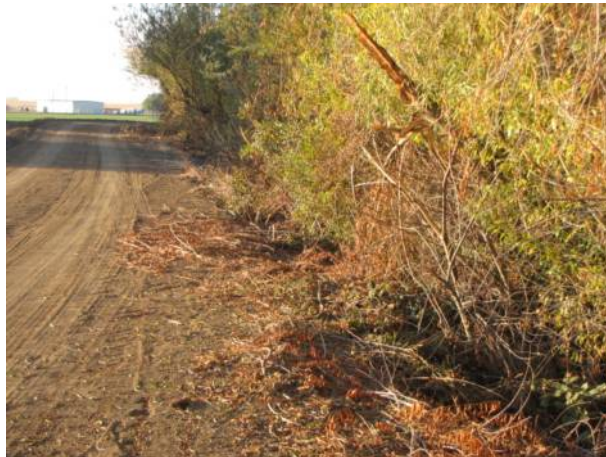
Levee Mile Report Line	10
Start Levee Mile	1.40
End Levee Mile	1.50
Location	Water Side
Category	Earthen Levee
Item	Trim / Thin Trees

DWR ID: DWR_NA0013_01_f_2012_10										
10	1.40	1.50	Earthen Levee	Trim / Thin Trees	WS	U Ma	T2 : Thin trees to allow visibility of the ground and room to flood fight. Inspector Comments: The District needs to remove more of the wild tree growth from the levee section.	37.334120 ° -120.395217 °	37.335325 ° -120.395780 °	11 Y
DWR ID: DWR_NA0013_01_f_2012_11

Looking downstream from levee mile 1.40-1.54 waterward slope. Photo taken 10-30-2012.

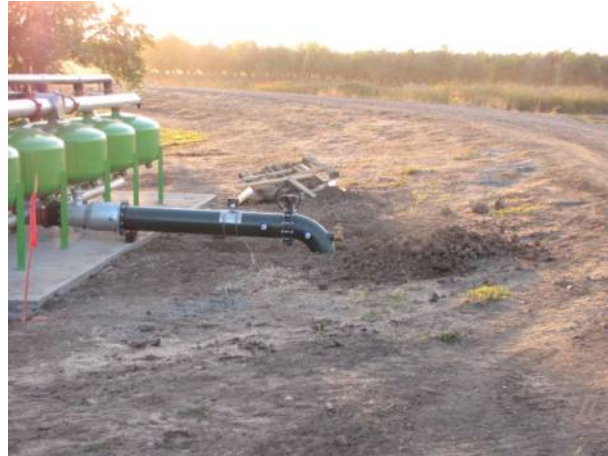
Levee Mile Report Line	1
Start Levee Mile	0.00
End Levee Mile	0.00
Location	Land Side
Category	Earthen Levee
Item	Encroachments
New filtration system installed within the 10-foot of levee toe. Photo taken 10-30-2012.	
phillips_f_20121105_382.jpg

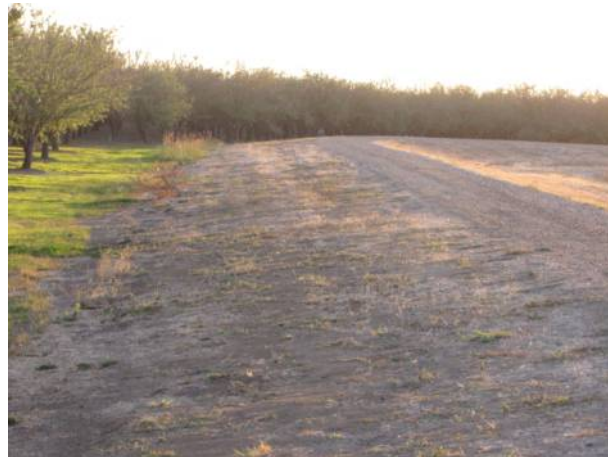
Levee Mile Report Line	4
Start Levee Mile	0.02
End Levee Mile	0.02
Location	Land Side
Category	Earthen Levee
Item	Vegetation
Looking downstream from levee mile 0.02 at the landside slope. Photo taken 10-30-2012.	
phillips_f_20121105_381.jpg

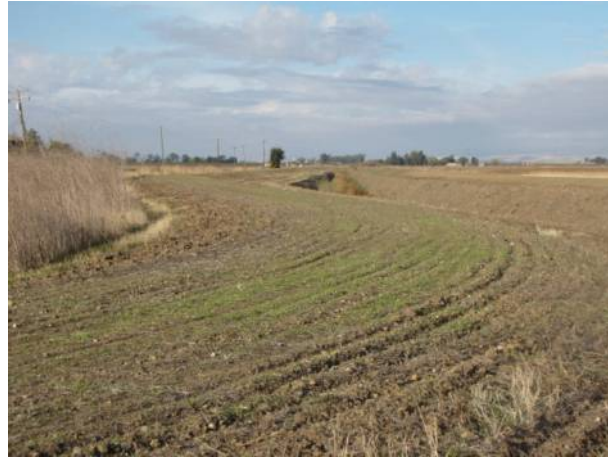
Owens Creek, Merced County, Unit 3 levee mile 0.00 looking downstream. Photo taken 11-21-2012

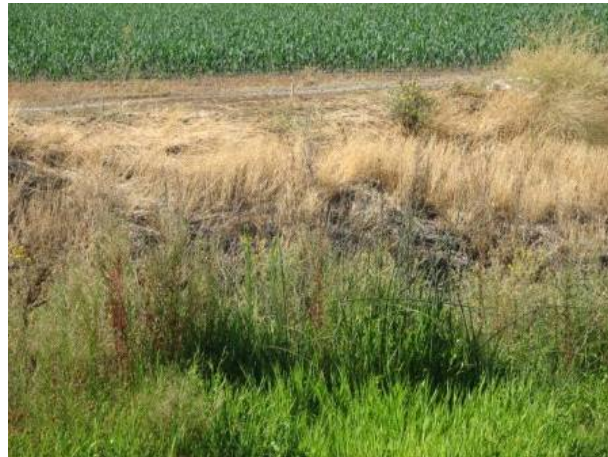
Levee Mile Report Line	7
Start Levee Mile	1.00
End Levee Mile	1.00
Location	Water Side
Category	Supplemental
Item	DWR Erosion Survey

A close look at the site, which is covered by thick vegetation

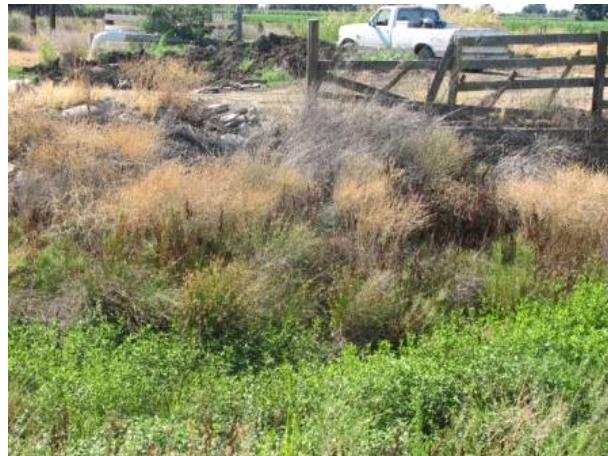
Levee Mile Report Line	7
Start Levee Mile	1.00
End Levee Mile	1.00
Location	Water Side
Category	Supplemental
Item	DWR Erosion Survey

Site covered with dense vegetation.

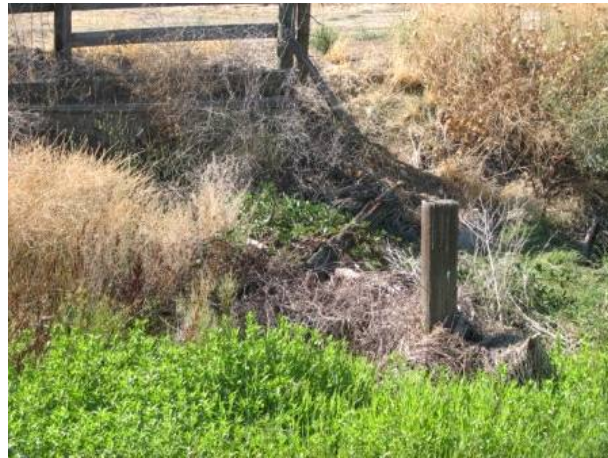
Wooden posts and fence on site

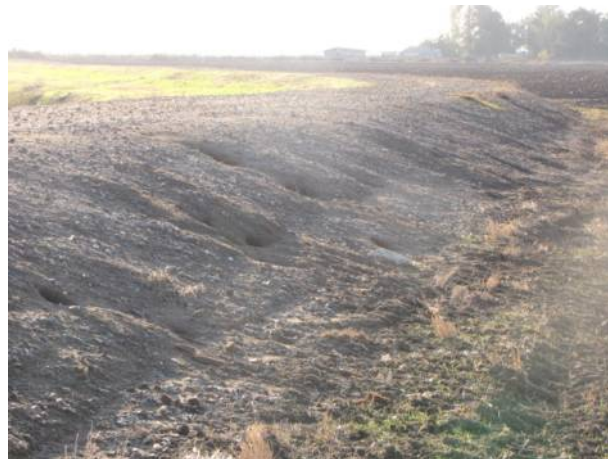
Levee Mile Report Line	8
Start Levee Mile	1.11
End Levee Mile	1.24
Location	Land Side
Category	Earthen Levee
Item	Animal Control

DWR ID:										
8	1.11	1.24	Earthen Levee	Animal Control	LS	U Ma	A1 : Exterminate rodents and backfill and compact or grout burrows. Inspector Comments: This levee section has a history of rodent problems that has been known for more than 10 years.	37.271737 ° -120.282642 °	37.272498 ° -120.280511 °	9 Y
DWR ID: DWR_NA0013_03_f_2012_9										
9	1.20	1.20	Earthen Levee	Animal Control	LS	M Ma	A1 : Exterminate rodents and backfill and compact or grout burrows.	37.272444 ° -120.281282 °	37.272444 ° -120.281282 °	970
DWR ID: DWR_NA0013_03_s_2012_970

Unit 3 Owens Creek, active rodents at levee miles 1.11-1.24 on the landside levee section with no bait stations. Photo taken 11-21-2012.

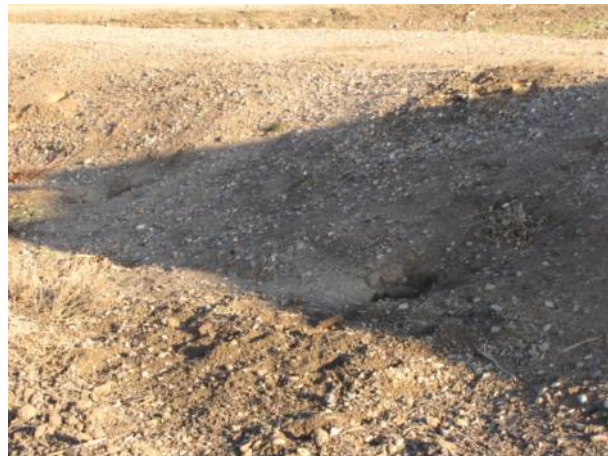
Levee Mile Report Line	8
Start Levee Mile	1.11
End Levee Mile	1.24
Location	Land Side
Category	Earthen Levee
Item	Animal Control

Owens Creek, Unit 3 at levee miles 1.11-1.24. The waterside has more active holes present. 11-21-2012.

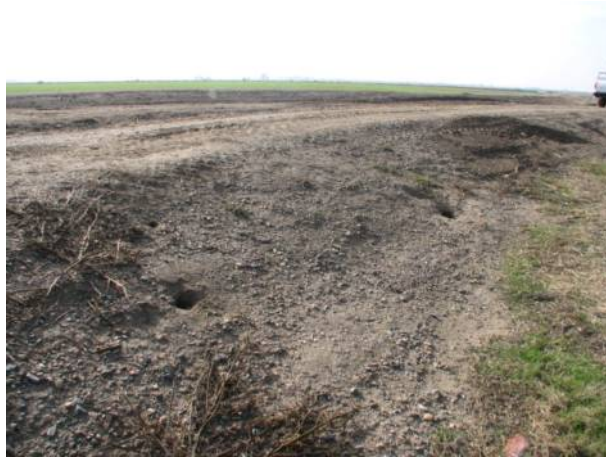
Active animal burrows on levee slope and toe.

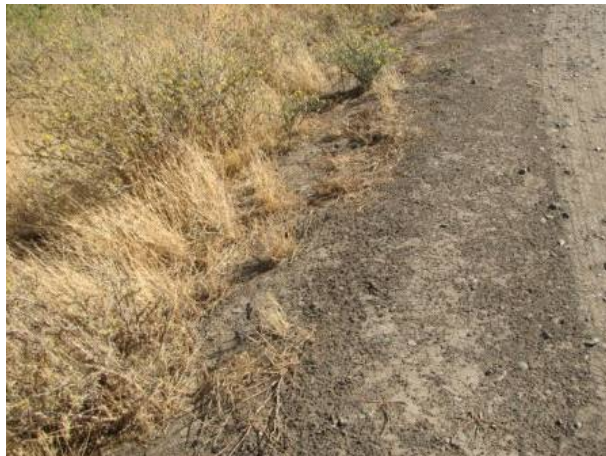
Levee Mile Report Line	14
Start Levee Mile	1.25
End Levee Mile	1.25
Location	Water Side
Category	Supplemental
Item	DWR Erosion Survey

No significant change visible from the levee top

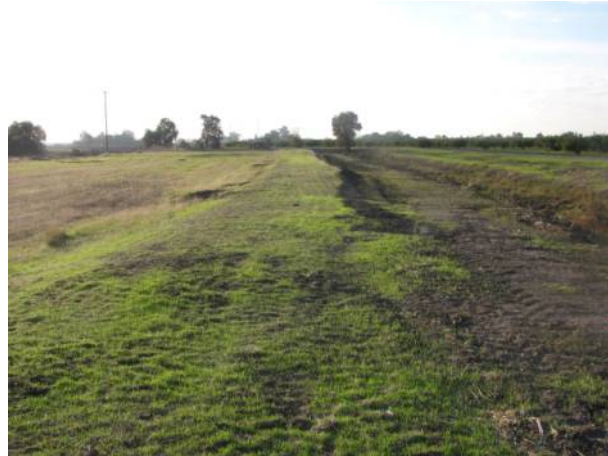
Levee Mile Report Line	1
Start Levee Mile	0.00
End Levee Mile	0.00
Location	Land Side
Category	Earthen Levee
Item	Vegetation
Owens Creek Unit 4 looking downstream from levee mile 0.00. Photo taken 11-21-2012.	
phillips_f_20121203_431.jpg

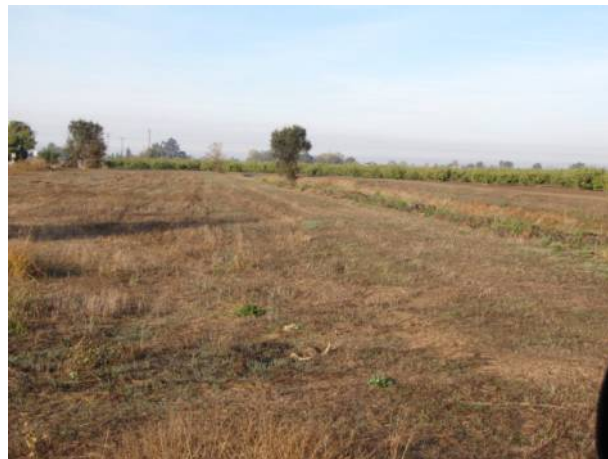
Levee Mile Report Line	2
Start Levee Mile	0.01
End Levee Mile	0.01
Location	Land Side
Category	Earthen Levee
Item	Vegetation
Owens Creek Unit 4 standing at levee mile 0.00 looking downstream. Photo taken 11-21-2011.	
phillips_f_20120911_055.jpg

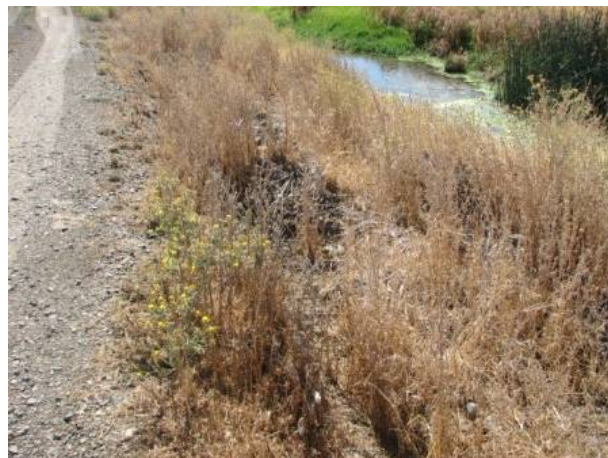
Levee Mile Report Line	7
Start Levee Mile	0.15
End Levee Mile	0.28
Location	Water Side
Category	Supplemental
Item	DWR Erosion Survey
The site is covered with dense star thistles. No significant changes visible	
SJR2012_NA0013U04RM0.21_1.jpg

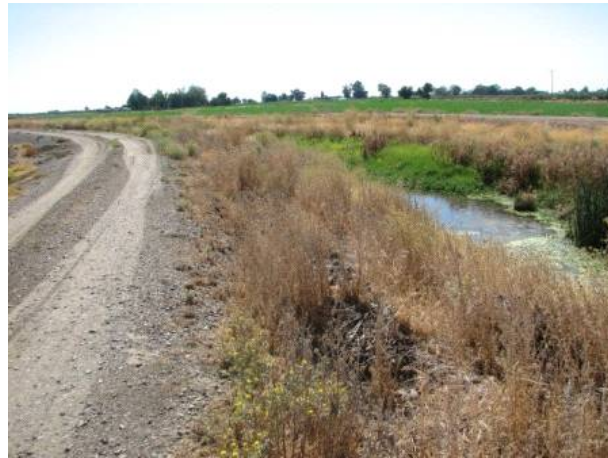
The site is covered with dense star thistles

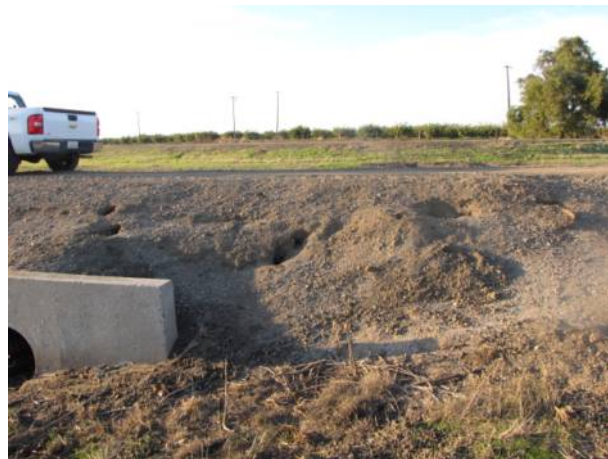
Levee Mile Report Line	9
Start Levee Mile	0.18
End Levee Mile	0.23
Location	Land Side
Category	Earthen Levee
Item	Animal Control

Owens Creek Unit 4 levee section infested with rodents, no bait stations present. Photo taken 11-21-2012.

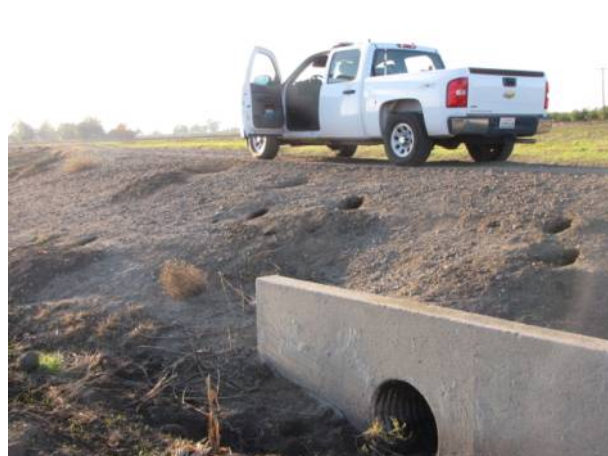
Levee Mile Report Line	9
Start Levee Mile	0.18
End Levee Mile	0.23
Location	Land Side
Category	Earthen Levee
Item	Animal Control

Owens Creek looking downstream to 0.23 at rodent holes. Photo taken 11-21-2012.

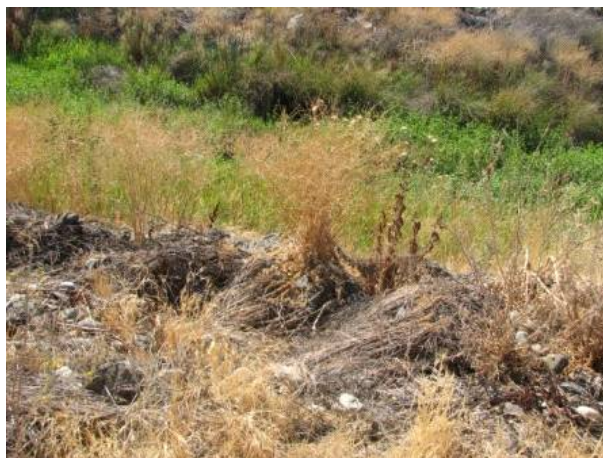
Direct look at the site

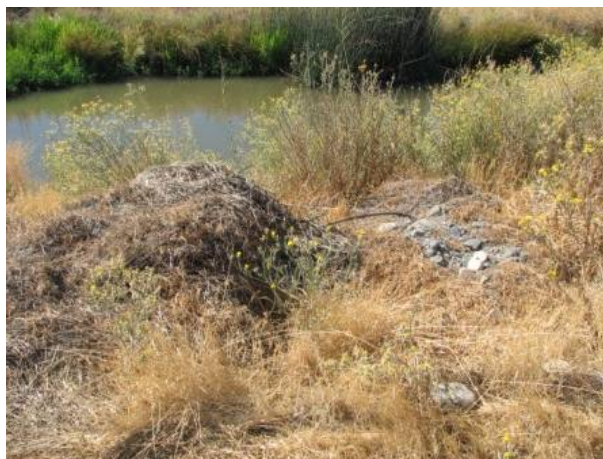
Levee Mile Report Line	13
Start Levee Mile	0.42
End Levee Mile	0.43
Location	Water Side
Category	Supplemental
Item	DWR Erosion Survey

The site is covered with thick vegetation

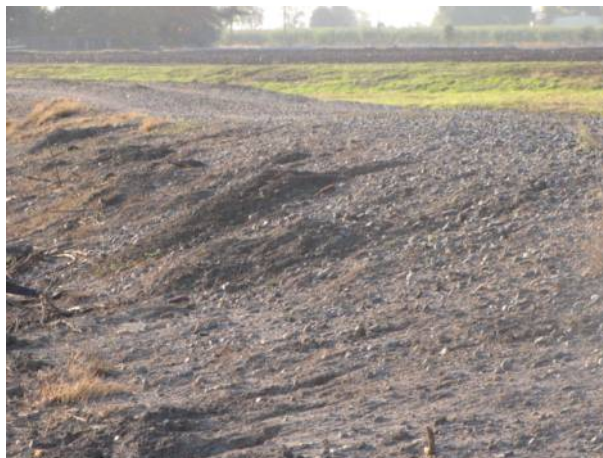
Levee Mile Report Line	16
Start Levee Mile	0.55
End Levee Mile	1.01
Location	Land Side
Category	Earthen Levee
Item	Animal Control

Rodents continue on levee section. No bait stations. 2012 landward and waterward.

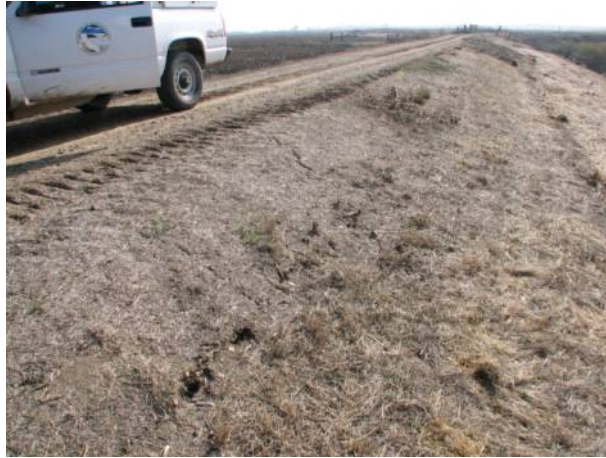
Levee Mile Report Line	19
Start Levee Mile	0.97
End Levee Mile	0.97
Location	Water Side
Category	Earthen Levee
Item	Cracking

Minor surface cracking on waterside levee slope.
