**Flood Control Project Maintenance
Levee Inspections**

Fall 2013 Levee Maintenance Deficiency Summary Report

Merced Streams Group

Levee Inspection Report By Mile - Fall 2013

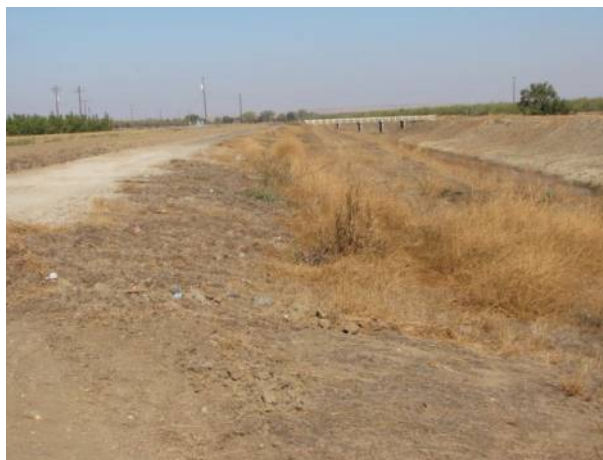
Levee Mile Report Line	4
Start Levee Mile	0.00
End Levee Mile	0.00
Location	Land Side
Category	Earthen Levee
Item	Vegetation

Black Rascal Diversion Unit 1 looking upstream waterside slope. Photo taken 11-05-2013.

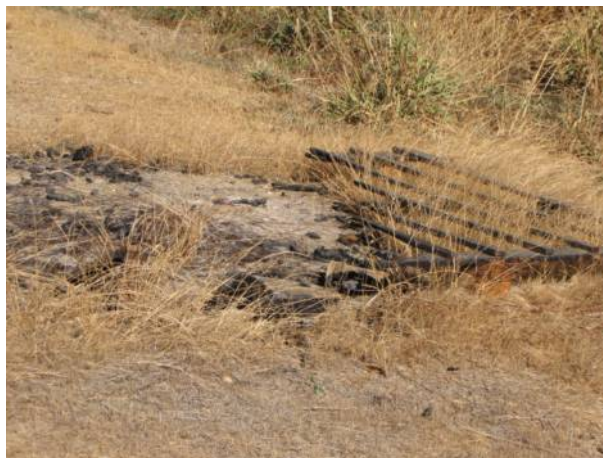
Levee Mile Report Line	6
Start Levee Mile	0.51
End Levee Mile	0.51
Location	Water Side
Category	Earthen Levee
Item	Encroachments

Levee mile 0.51 this encroachment has not been removed. Photo taken 11-05-2013.

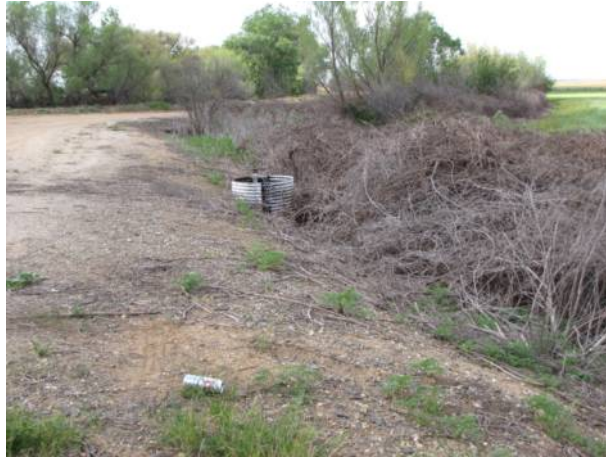
Levee Mile Report Line	10
Start Levee Mile	1.31
End Levee Mile	1.63
Location	Water Side
Category	Earthen Levee
Item	Vegetation

District has sprayed and mowed some of the wild growth along the channel. Photo taken 4-15-2013.

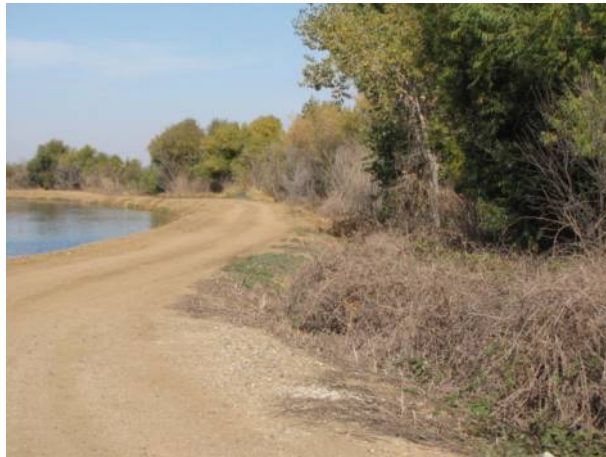
Levee Mile Report Line	10
Start Levee Mile	1.31
End Levee Mile	1.63
Location	Water Side
Category	Earthen Levee
Item	Vegetation

Woody tree growth and berry vines seems to be sprayed remove the dead growth from slope waterside. Photo taken 11-05-2013.

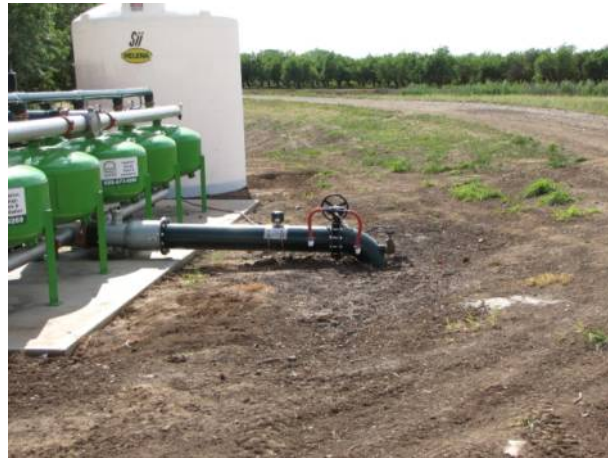
Levee Mile Report Line	1
Start Levee Mile	0.00
End Levee Mile	0.00
Location	Land Side
Category	Earthen Levee
Item	Encroachments
Black Rascal Creek looking downstream from 0.00 landside slope. Photo taken 4-15-2013.	
phillips_f_20130925_773.JPG

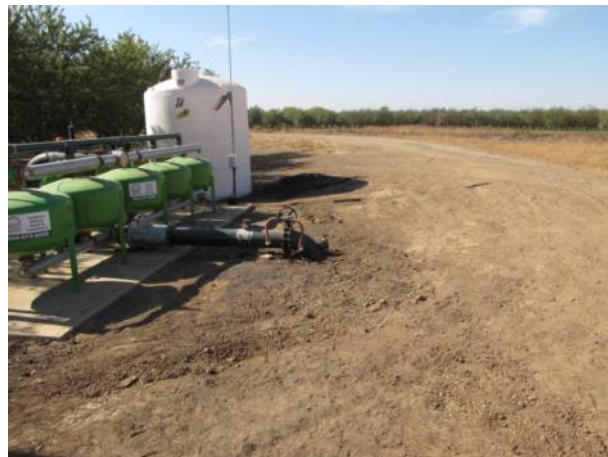
Levee Mile Report Line	1
Start Levee Mile	0.00
End Levee Mile	0.00
Location	Land Side
Category	Earthen Levee
Item	Encroachments
Need permit covering this application located at levee mile 0.00 landside. Photo taken 11-05-2013.	
phillips_f_20131127_716.JPG

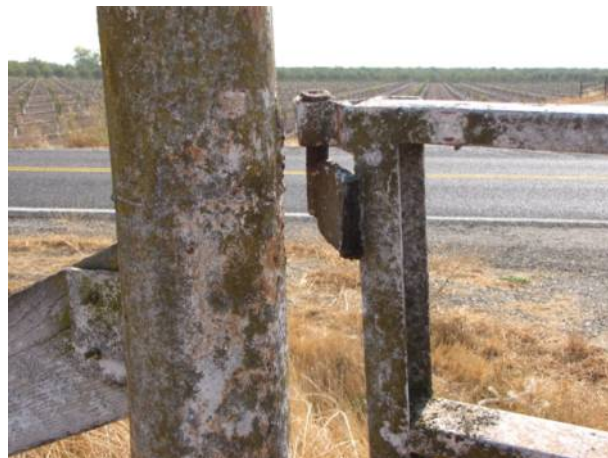
Levee Mile Report Line	6
Start Levee Mile	0.61
End Levee Mile	0.61
Location	Crown
Category	Earthen Levee
Item	Repair Gates
This gate is broken at the hinge, making it difficult to navigate. Photo taken 11-05-2013.	
phillips_f_20131127_717.JPG

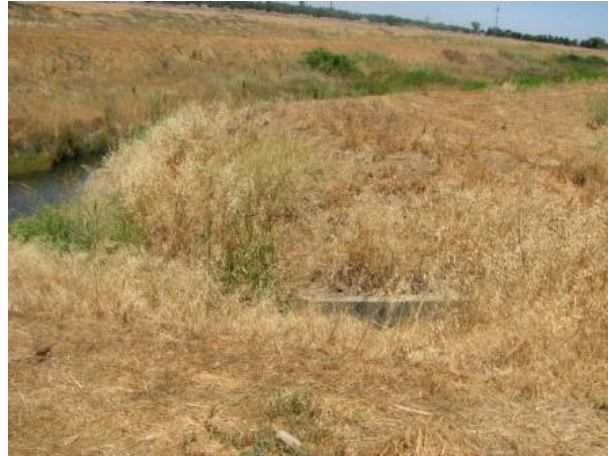
Levee Mile Report Line	13
Start Levee Mile	1.31
End Levee Mile	1.31
Location	Water Side
Category	Supplemental
Item	DWR Erosion Survey

Looking down at the site.

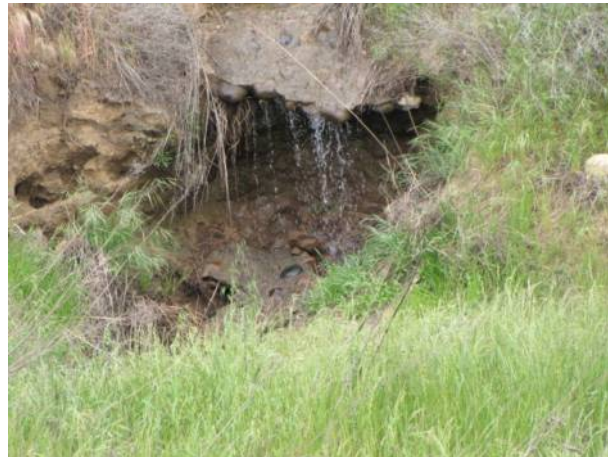
Levee Mile Report Line	14
Start Levee Mile	1.31
End Levee Mile	1.31
Location	Water Side
Category	Earthen Levee
Item	Erosion / Bank Caving

This erosion was noted during my Spring Inspection 4-15-2013.

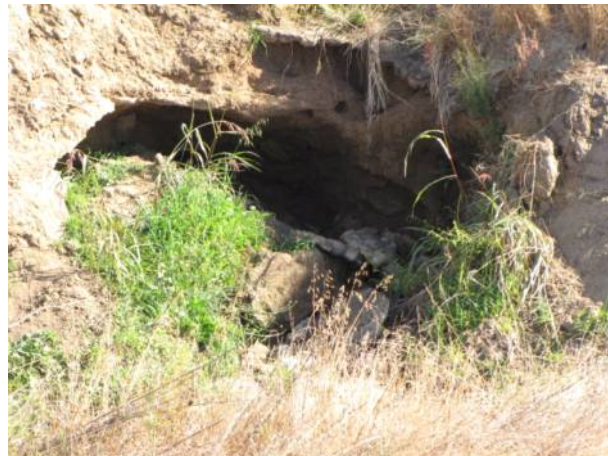
Levee Mile Report Line	14
Start Levee Mile	1.31
End Levee Mile	1.31
Location	Water Side
Category	Earthen Levee
Item	Erosion / Bank Caving

No repairs has been made to this erosion site noted in my last two reports. Photo taken 11-05-2013.

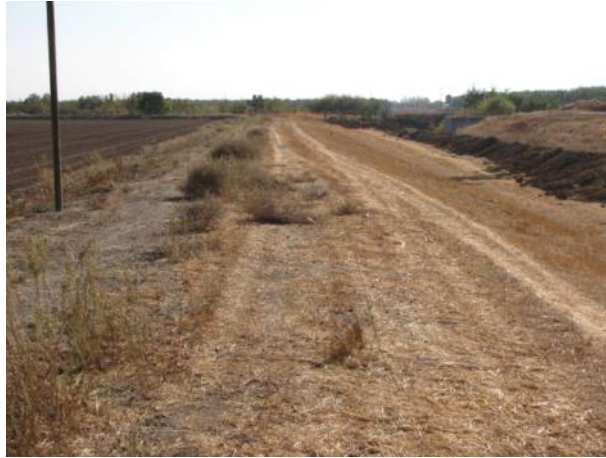
Levee Mile Report Line	19
Start Levee Mile	1.66
End Levee Mile	1.87
Location	Crown
Category	Earthen Levee
Item	Vegetation

Looking downstream at Unit 2 the grasses have been mowed, but some still remains on crown roadway. Photo taken 11-05-2013.

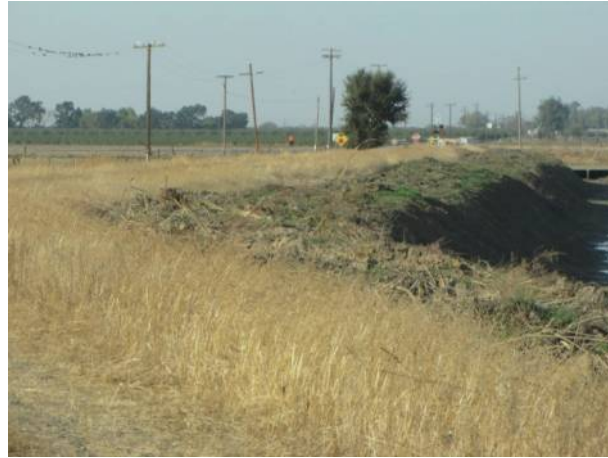
Levee Mile Report Line	1
Start Levee Mile	0.01
End Levee Mile	1.01
Location	Water Side
Category	Earthen Levee
Item	Vegetation
Weeds taller than 2-foot present on waterside slope. Photo taken 11-05-2013.	
phillips_f_20131127_720.JPG

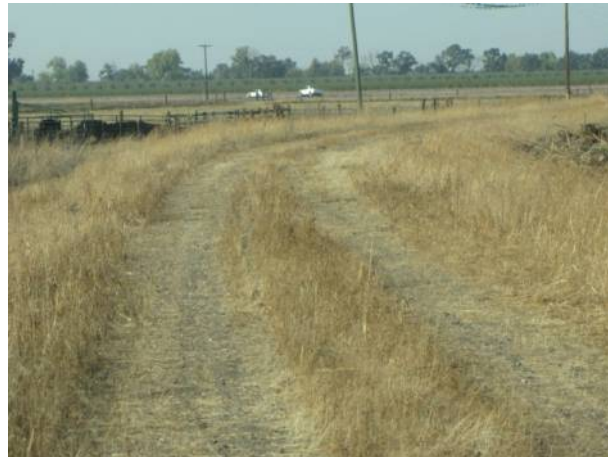
Levee Mile Report Line	2
Start Levee Mile	0.01
End Levee Mile	0.72
Location	Crown
Category	Earthen Levee
Item	Vegetation
Looking upstream at Unit 3 Owens Creek Crown roadway is overgrown. Photo taken 11-05-2013.	
phillips_f_20131127_721.JPG

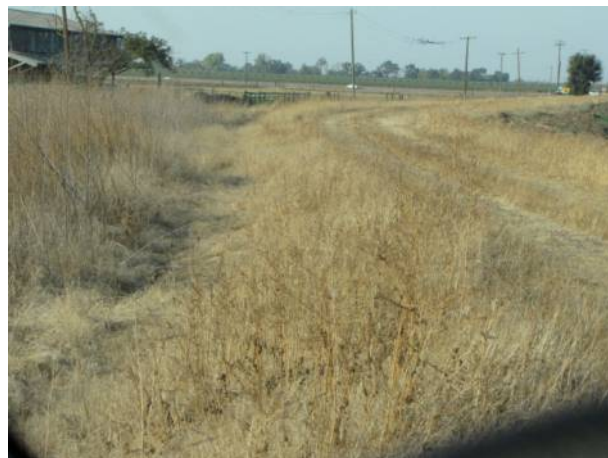
Levee Mile Report Line	3
Start Levee Mile	0.01
End Levee Mile	0.95
Location	Land Side
Category	Earthen Levee
Item	Vegetation
Looking upstream from landside weeds are taller than 2-foot. Photo taken 11-05-2013.	
phillips_f_20131127_722.JPG

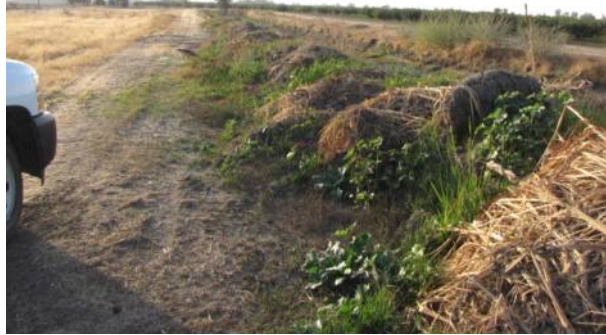
Dredged materials from channel placed on water side toe and shoulder. Photo taken 11-05-2013.

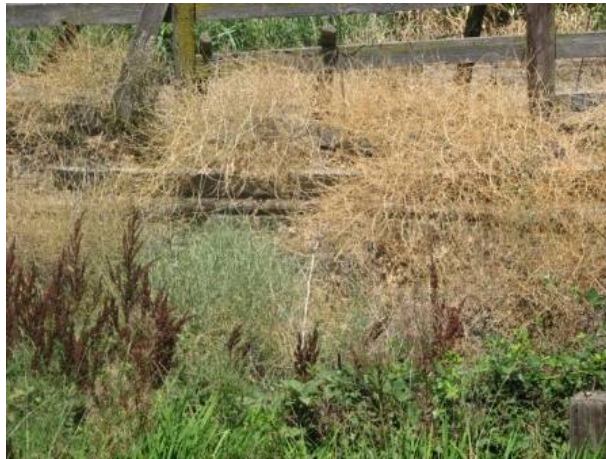
Levee Mile Report Line	12
Start Levee Mile	1.00
End Levee Mile	1.00
Location	Water Side
Category	Supplemental
Item	DWR Erosion Survey

LMR No.	Levee Mile		Category	Item	Location	Rating	Action/Comment	GPS Latitude/Longitude		Issue No.
	Start	End						Start	End	
12	1.00	1.00	Supplemental	DWR Erosion Survey	WS	M Ma	Inspector Comments: 07/16/2013. No significant changes have been observed. 07/31/2012: Site was visited on 07/26/2012. No significant changes observed. Dense vegetation presents at the site. 08/16/2011: No visible change. 100 percent vegetation coverage with star thistles. Minor cracking visible on the waterside slope. 11/30/2010: Site was not inspected this year due to time constraint. There have been no reports from the district that this site was corrected. Continue to monitor during flood events. 2009: Site is recommended as local maintenance issue, per CLRO CES Evaluation 2008 Report; it was previously rated "U". 8/26/2008: Terracetting erosion; frequent livestock traversing the slopes has caused deformation of the waterside levee slope. 9/11/2007: GPS extended from opposite bank using Google Earth. [2013 Site ID:NA0013U03RM1]	37.270800 ° -120.284180 °	37.270800 ° -120.284180 °	1 Y

Remains of the crossing structure at the site.

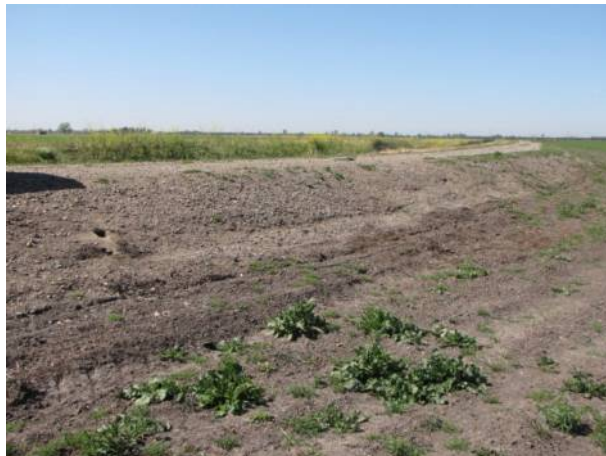
Levee Mile Report Line	13
Start Levee Mile	1.11
End Levee Mile	1.24
Location	Land Side
Category	Earthen Levee
Item	Animal Control

Levee taken over by rodents, levee mile 1.11-1.24. Photo taken 4-18-2013. No bait stations present on landward slope. This site hasn't changed from last inspection. 11-05-2013.

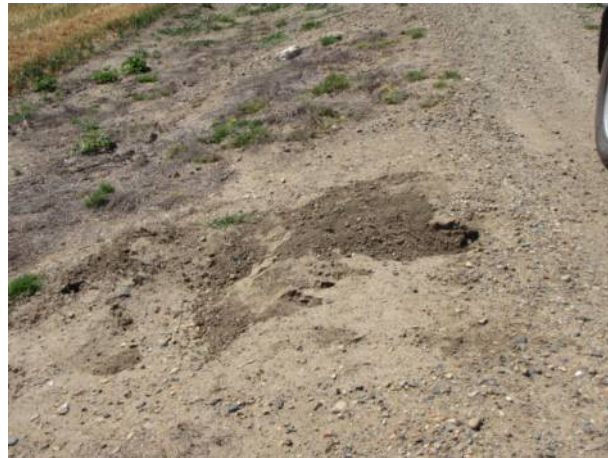
Landside slope taken over by rodents. Photo taken 4-18-2013.

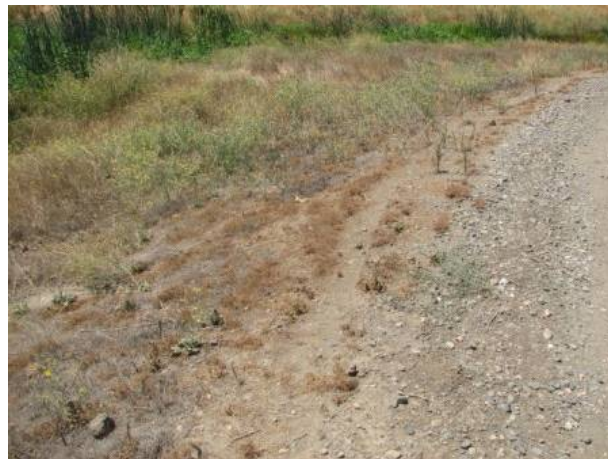
Levee Mile Report Line	21
Start Levee Mile	1.25
End Levee Mile	1.25
Location	Water Side
Category	Supplemental
Item	DWR Erosion Survey

The site is covered with dense thistles.

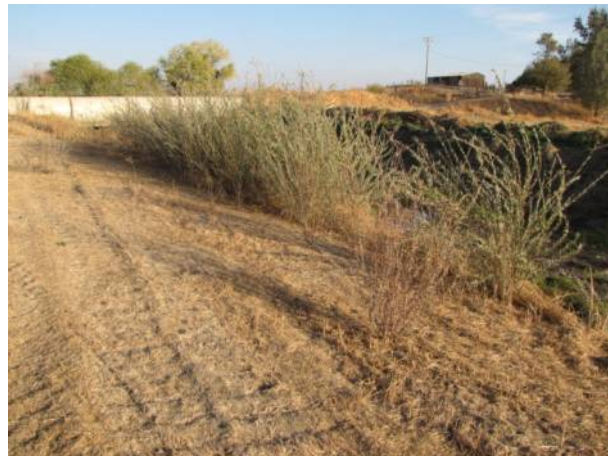
Levee Mile Report Line	22
Start Levee Mile	1.29
End Levee Mile	1.40
Location	Water Side
Category	Earthen Levee
Item	Vegetation

Looking upstream water side at vegetation. Photo taken 11-05-2013.

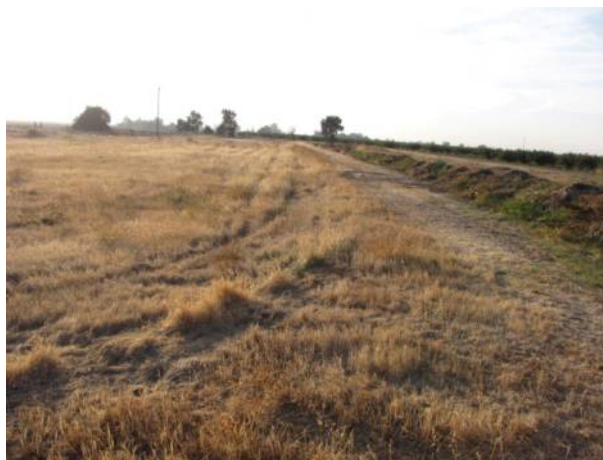
Owen's Creek looking downstream from levee mile 0.01. Photo taken 11-05-2013.

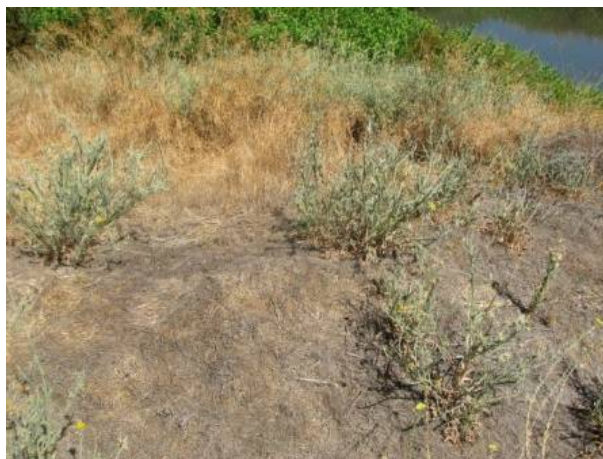
Levee Mile Report Line	5
Start Levee Mile	0.15
End Levee Mile	0.28
Location	Water Side
Category	Supplemental
Item	DWR Erosion Survey

The site is covered with dense star thistles.

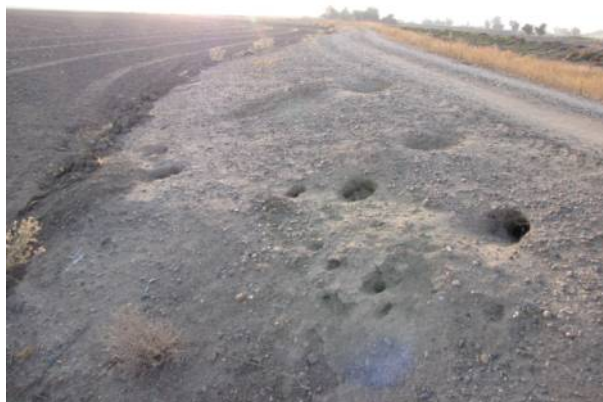
Levee Mile Report Line	8
Start Levee Mile	0.18
End Levee Mile	0.23
Location	Land Side
Category	Earthen Levee
Item	Animal Control

Unit 4 looking downstream rodents are very active along this section of levee, there are no bait stations. Photo taken 11-05-2013.

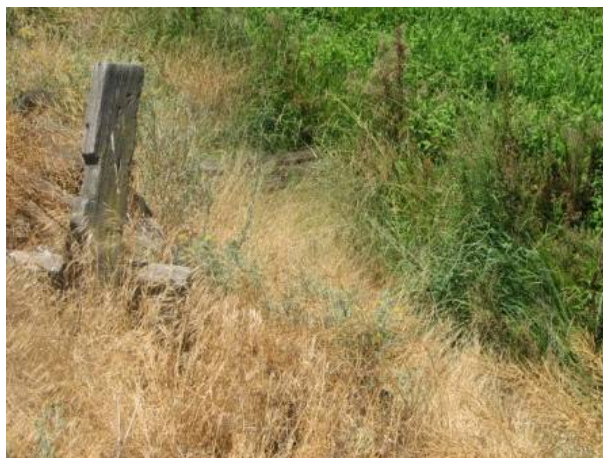
LMR No.	Levee Mile		Category	Item	Location	Rating	Action/Comment	GPS Latitude/Longitude		Issue No.
	Start	End						Start	End	
12	0.42	0.43	Supplemental	DWR Erosion Survey	WS	M	Inspector Comments: 07/16/2013: No significant changes observed. 07/24/2012: No significant changes observed. 08/16/2011: No visible significant changes. 100 percent vegetation coverage with star thistles. Minor cracking visible on the waterside slope. 11/30/2010: Site was not inspected this year due to time constraints. There have been no reports from the district that the site has been corrected. 2009: Site is recommended as local maintenance issue, per CLRO CES Evaluation 2008 Report; terracetting damage from livestock traversing; there is a wooden platform installed on site; landside is on high ground; site was previously rated "M". 9/10/2007: GPS extended from opposite bank using Google Earth; GPS on file is correct. [2013 Site ID:NA0013U04RM0.42]	37.270630 ° -120.283970 °	37.270630 ° -120.283970 °	4 Y

Direct view of the site. Remains of fence post.

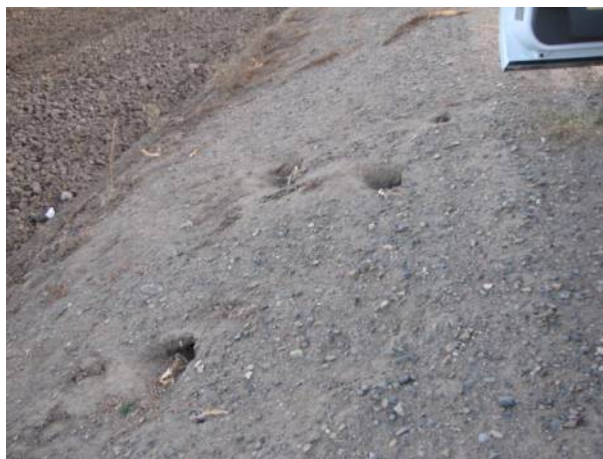
Levee Mile Report Line	15
Start Levee Mile	0.55
End Levee Mile	1.01
Location	Land Side
Category	Earthen Levee
Item	Animal Control

Rodent activity along landside slope. Photo taken 11-05-2013.

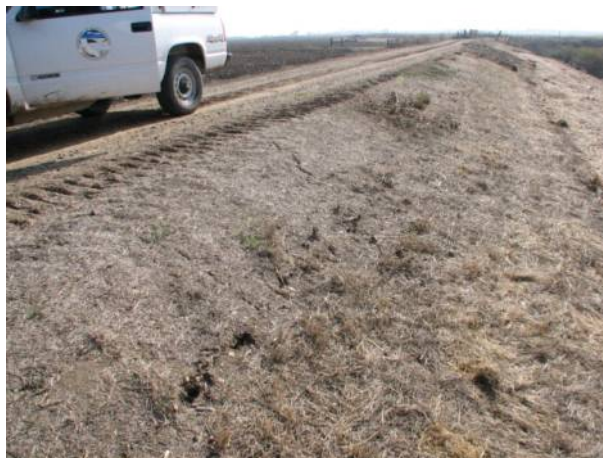
Levee Mile Report Line	18
Start Levee Mile	0.97
End Levee Mile	0.97
Location	Water Side
Category	Earthen Levee
Item	Cracking

Minor surface cracking on waterside levee slope.

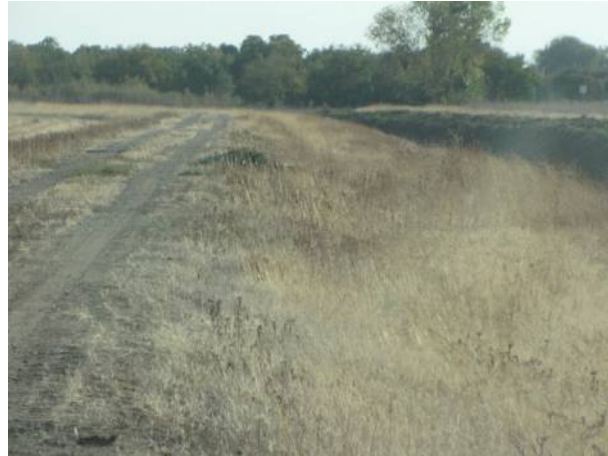
Looking downstream at water side weeds taller than 2-foot. Photo taken 11-05-2013.

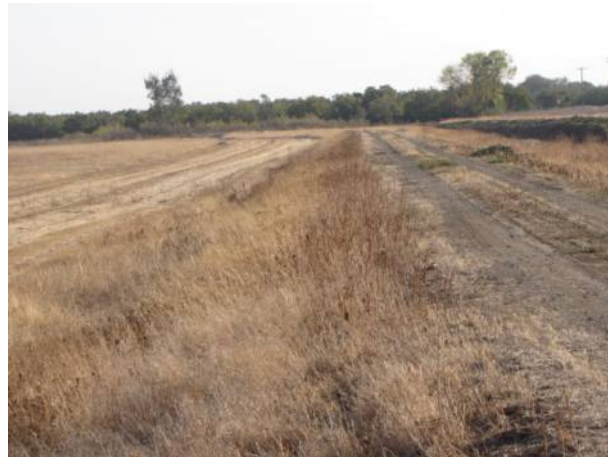
Levee Mile Report Line	21
Start Levee Mile	1.08
End Levee Mile	1.44
Location	Land Side
Category	Earthen Levee
Item	Vegetation

Looking downstream from levee mile 1.08 weeds are taller than 2-foot on landside slope. Photo taken 11-05-2013.

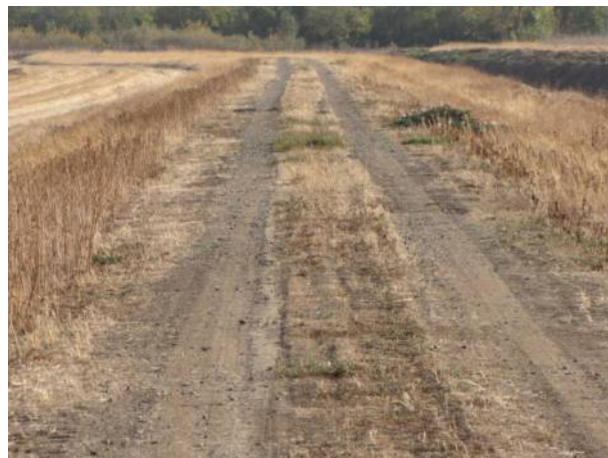
Levee Mile Report Line	22
Start Levee Mile	1.08
End Levee Mile	1.44
Location	Crown
Category	Earthen Levee
Item	Vegetation

Looking downstream from levee mile 1.08 - 1.44 vegetation on crown. Photo taken 11-05-2013.
