**Flood Control Project Maintenance
Levee Inspections**

Fall 2014 Levee Maintenance Deficiency Summary Report

Merced Streams Group

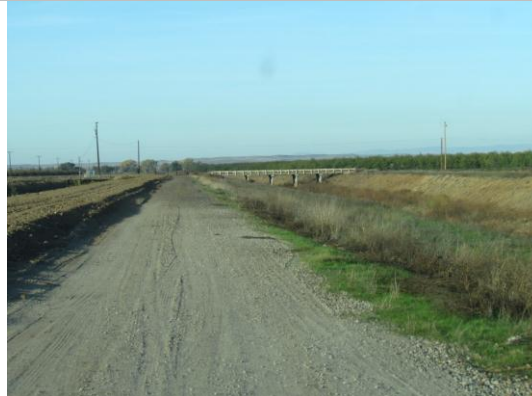
Photo 1 of 1 : FA_2014_NA0013_331_1_20141125_00004.jpg

LM Start	0.10	Rating **	M	Issue No.	1
LM End	0.22	Issue Type +	Ma	Location *	WS
Category	Earthen Levee			GPS Latitude/Longitude	
				Start	End
Item	Vegetation			37.316005 °	37.317802 °
				-120.396363 °	-120.396350 °
DWR ID	DWR_NA0013_01_f_2014_1				
Action/Comments					
Control annual grass and weeds on the levee slopes and easements.

Black Rascal Creek looking downstream from waterside slope, there are weeds present on the slope.

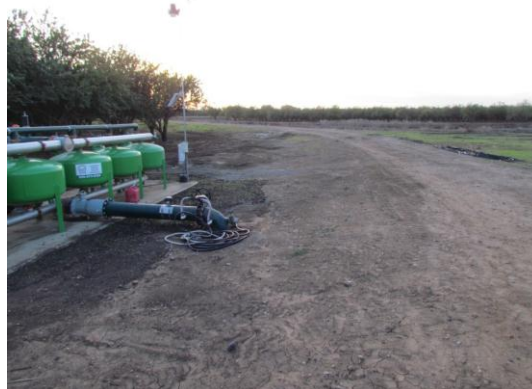
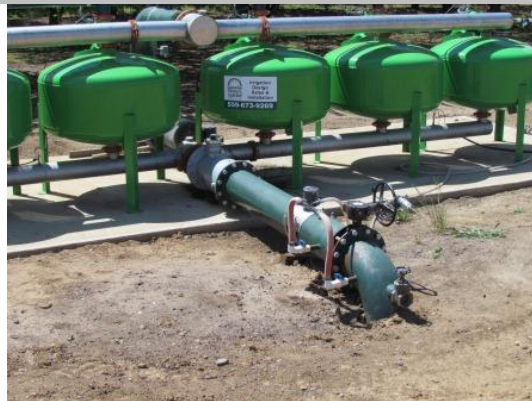
LM Start	0.00	Rating **	U	Issue No.	2
LM End	0.00	Issue Type +	En	Location *	LS
Category	Earthen Levee			GPS Latitude/Longitude	
				Start	End
Item	Encroachments			37.337034 °	37.337034 °
				-120.387422 °	-120.387422 °
DWR ID	DWR_NA0013_02_f_2012_2				
Action/Comments					
Pipe Inspector Comments: There is no CVFPB permit on record for this issue.

Black Rascal Creek Unit 2 looking downstream landside levee mile 0.00.

There is no CVFPB permit on file for this installation. Photo taken 4-23-21014

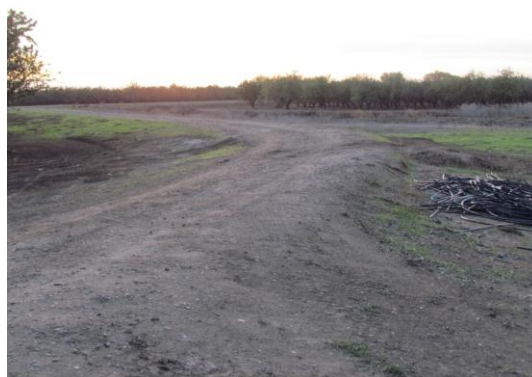
Photo 1 of 1 : FA_2014_NA0013_332_16_20141119_00011.jpg

LM Start	0.03	Rating **	A	Issue No.	16
LM End	1.65	Issue Type +	Ma	Location *	LS
Category	Earthen Levee			GPS Latitude/Longitude	
				Start	End
Item	Vegetation			37.336948 °	37.317937 °
				-120.387918 °	-120.395733 °
DWR ID	DWR_NA0013_02_f_2014_16				
Action/Comments					
Control annual grass and weeds on the levee slopes and easements.

Black Rascal Creek landside levee mile 0.00 looking downstream.

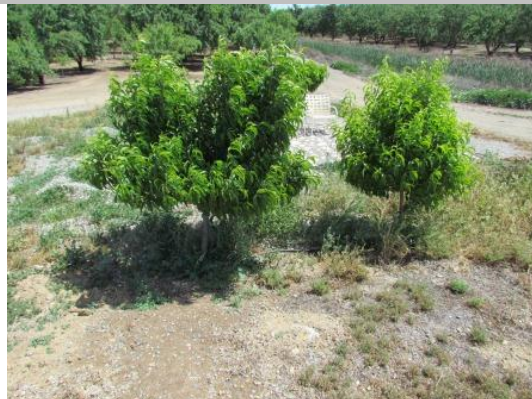
Photo 1 of 3 : FA_2014_NA0013_332_24_20141008_00004.jpg

LM Start	0.90	Rating **	U	Issue No.	24
LM End	0.90	Issue Type +	En	Location *	N/A
Category	Earthen Levee			GPS Latitude/Longitude	
				Start	End
Item	Encroachments			37.328567 °	37.328567 °
				-120.396062 °	-120.396062 °
DWR ID	DWR_NA0013_02_s_2014_24				
Action/Comments					
Tree or limb					
Inspector Comments: Three fruit trees with irrigation system, stock pie of material (2) piles on the land side toe and rock pad placed n land side toe. Discovered during the fall 2014 inspection a structure has been installed on the landward levee slope and berm. No permit for these encroachments.

Unauthorized fruit trees planted on the landward toe. Photo taken 4-23-2014.

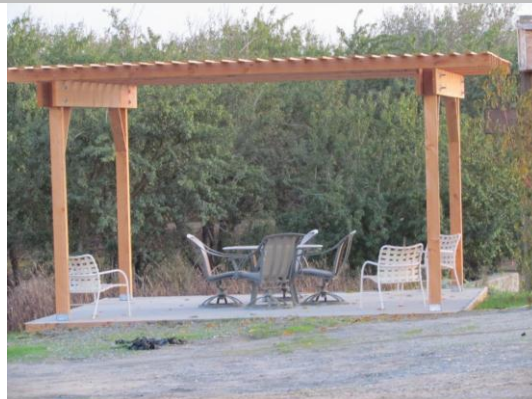
Photo 2 of 3 : FA_2014_NA0013_332_24_20141120_00012.jpg

Unauthorized encroachment placed on the landside shoulder and berm.

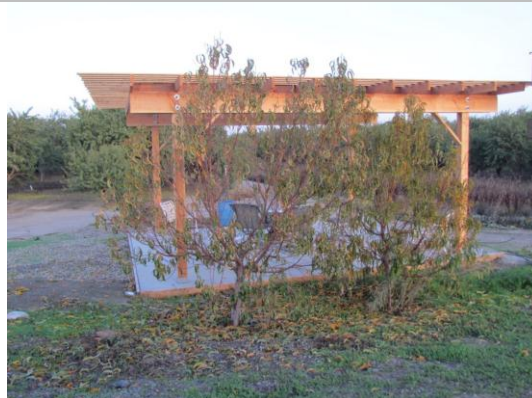
Photo 3 of 3 : FA_2014_NA0013_332_24_20141120_00014.jpg

Another view of unauthorized structure.

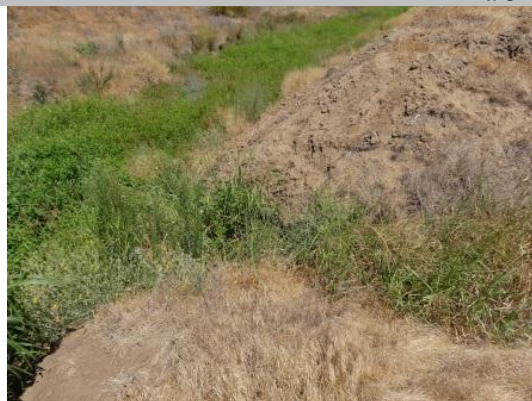
Photo 1 of 1 : SJR2014_NA0013U02RM1.31_1.jpg

LM Start	1.31	Rating **	M	Issue No.	26
LM End	1.31	Issue Type +	Ma	Location *	WS
Category	Supplemental			GPS Latitude/Longitude	
				Start	End
Item	DWR Erosion Survey			37.322615 °	37.322615 °
				-120.395948 °	-120.395948 °
DWR ID					
Action/Comments					
Inspector Comments: 7/31/2014: Soil has been added near the site. More vegetation is visible.					
7/16/2013: The site was reported in the 2013 Spring Levee Inspection Reports. The erosion was caused by the water from the discharge line crossing the levee. Above the erosion a concrete discharge structure is present at the levee toe. The site is covered with dense vegetation.					
[2014 Site ID:NA0013U02RM1.31]

Looking down at the site.

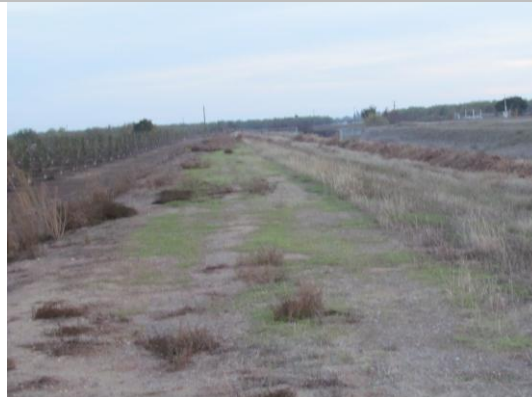
Photo 1 of 1 : FA_2014_NA0013_332_28_20141120_00013.jpg

LM Start	1.67	Rating **	U	Issue No.	28
LM End	1.87	Issue Type +	Ma	Location *	CR
Category	Earthen Levee			GPS Latitude/Longitude	
				Start	End
Item	Vegetation			37.317588 °	37.314669 °
				-120.395738 °	-120.395810 °
DWR ID	DWR_NA0013_02_f_2014_28				
Action/Comments					
Keep the crown roadway free of vegetation. Inspector Comments: The crown roadway is overgrown with unwanted wild weeds.

Looking downstream from levee mile 1.67 to levee mile 1.87.

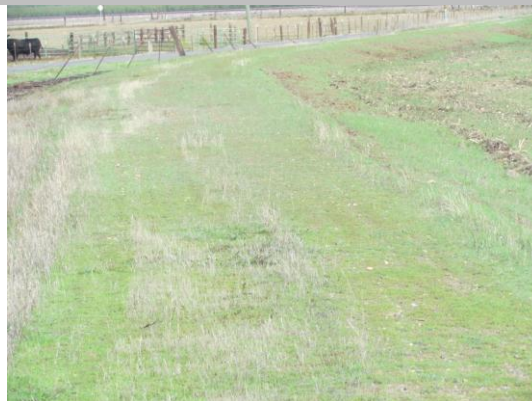
Photo 1 of 1 : FA_2014_NA0013_333_21_20141121_00016.jpg

LM Start	0.01	Rating **	U	Issue No.	21
LM End	0.67	Issue Type +	Ma	Location *	CR
Category	Earthen Levee			GPS Latitude/Longitude	
				Start	End
Item	Vegetation			37.257731 °	37.266833 °
				-120.288546 °	-120.287558 °
DWR ID	DWR_NA0013_03_s_2014_21				
Action/Comments					
Keep the crown roadway free of vegetation.					
Inspector Comments: Crown roadway shall be free of vegetation.

Looking upstream at crown roadway levee mile 0.01.

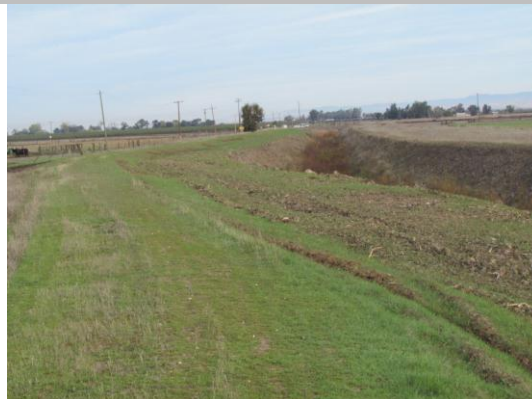
Photo 1 of 1 : FA_2014_NA0013_333_24_20141121_00018.jpg

LM Start	0.02	Rating **	A	Issue No.	24
LM End	1.14	Issue Type +	Ma	Location *	WS
Category	Earthen Levee			GPS Latitude/Longitude	
				Start	End
Item	Vegetation			37.257902 °	37.271980 °
				-120.288348 °	-120.282280 °
DWR ID	DWR_NA0013_03_f_2014_24				
Action/Comments					
Control annual grass and weeds on the levee slopes and easements. Inspector Comments: The growth on the waterside slope at this location is acceptable.

Looking downstream from levee mile 0.02 at the waterward slope no wild growth present.

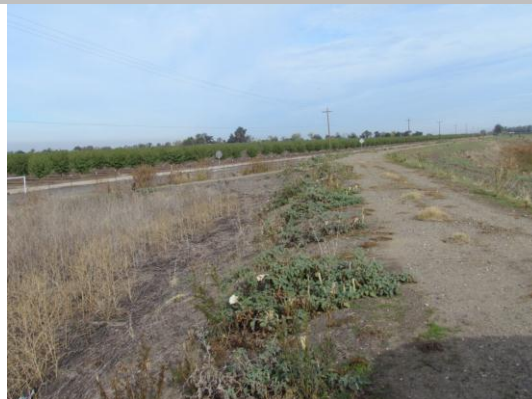
Photo 1 of 1 : FA_2014_NA0013_333_27_20141121_00019.jpg

LM Start	0.49	Rating **	U	Issue No.	27
LM End	0.76	Issue Type +	Ma	Location *	LS
Category	Earthen Levee			GPS Latitude/Longitude	
				Start	End
Item	Vegetation			37.264472 °	37.267925 °
				-120.288464 °	-120.286572 °
DWR ID	DWR_NA0013_03_f_2014_27				
Action/Comments					
Control annual grass and weeds on the levee slopes and easements. Inspector Comments: The broadleaf taking over the landside need to be sprayed.

Looking upstreram landside broadleaf starting to take over slope.

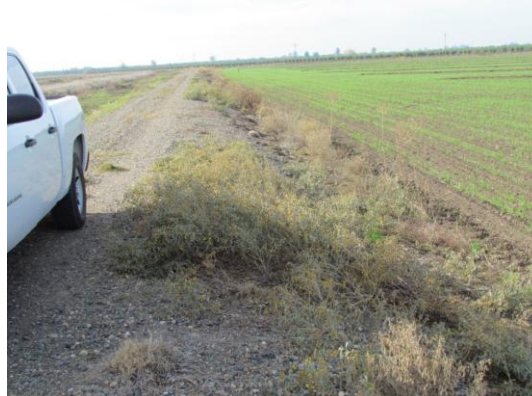
Photo 1 of 1 : FA_2014_NA0013_333_30_20141121_00020.jpg

LM Start	0.82	Rating **	U	Issue No.	30
LM End	0.86	Issue Type +	Ma	Location *	LS
Category	Earthen Levee			GPS Latitude/Longitude	
				Start	End
Item	Vegetation			37.268618 °	37.269137 °
				-120.286025 °	-120.285647 °
DWR ID	DWR_NA0013_03_f_2014_30				
Action/Comments					
Remove the wild growth other than native grasses from the levee slopes.					
Inspector Comments: Remove the wild tall weeds form the landward slope.

Levee mile 0.82 to 0.86 wild tall weeds present on the landside slope.

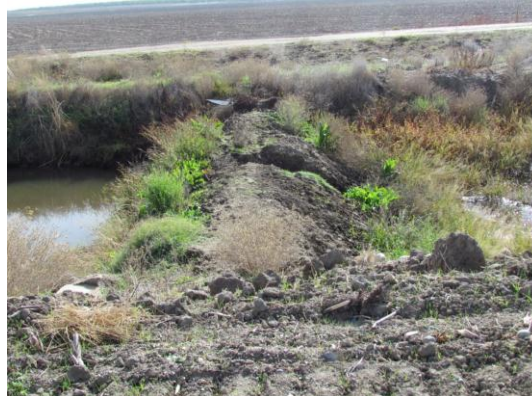
Photo 1 of 1 : FA_2014_NA0013_333_31_20141121_00021.jpg

LM Start	0.99	Rating **	U	Issue No.	31
LM End	0.99	Issue Type +	Ma	Location *	WS
Category	Rivers, Channels & Designated Floodways			GPS Latitude/Longitude	
				Start	End
Item	Encroachments			37.270665 °	37.270665 °
				-120.284330 °	-120.284330 °
DWR ID	DWR_NA0013_03_f_2014_31				
Action/Comments					
Inspector Comments: Remove the earthen dam placed across the channel.

Earthen dam placed across the channel.

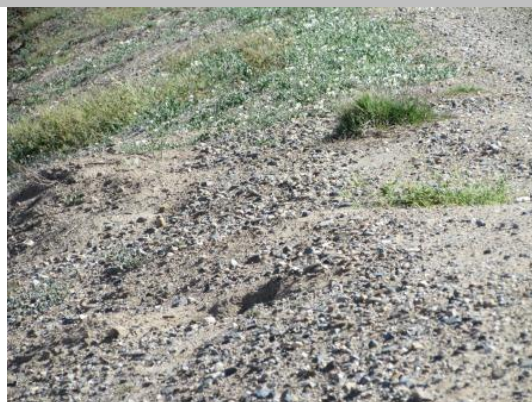
Photo 1 of 1 : FA_2014_NA0013_333_9_20141008_00007.jpg

LM Start	1.11	Rating **	U	Issue No.	9
LM End	1.24	Issue Type +	Ma	Location *	LS
Category	Earthen Levee			GPS Latitude/Longitude	
				Start	End
Item	Animal Control			37.271737 °	37.272498 °
				-120.282642 °	-120.280511 °
DWR ID	DWR_NA0013_03_f_2012_9				
Action/Comments					
Exterminate rodents and backfill and compact or grout burrows. Inspector Comments: This levee section has a history of rodent problems that has been known for many years. There should be bait stations in place in these infested areas.

Levee slope taken over by rodents, levee mile 1.11-1.24. Photo taken 4-23-2014.

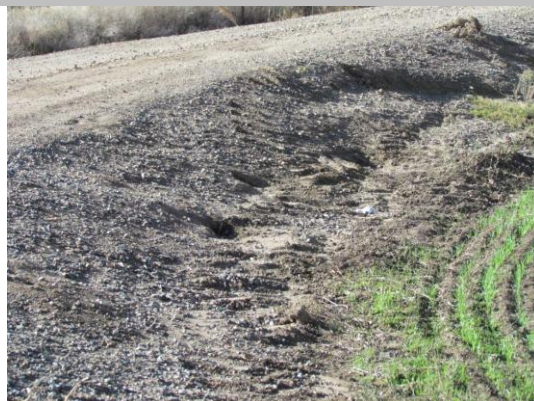
Photo 1 of 1 : FA_2014_NA0013_333_7_20141121_00022.jpg

LM Start	1.25	Rating **	M	Issue No.	7
LM End	1.30	Issue Type +	Ma	Location *	LS
Category	Earthen Levee			GPS Latitude/Longitude	
				Start	End
Item	Animal Control			37.272707 °	37.273379 °
				-120.280334 °	-120.279976 °
DWR ID	DWR_NA0013_03_s_2012_7				
Action/Comments					
Exterminate rodents and backfill and compact or grout burrows. Inspector Comments: The District needs to be more aggressive in their efforts of controlling the ground rodents. There should be some bait stations placed in infected areas.

Looking at the rodent holes at the levee slope. Levee mile 1.25-1.30.

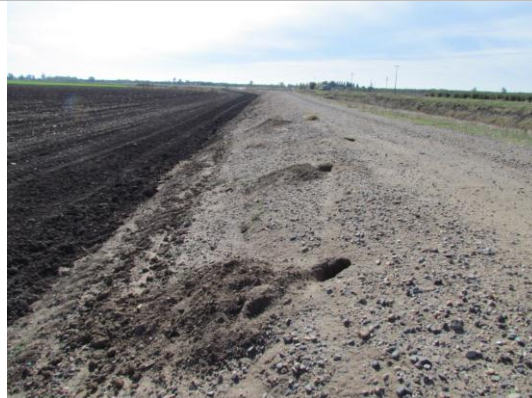
Photo 1 of 1 : FA_2014_NA0013_334_29_20141121_00023.jpg

LM Start	0.87	Rating **	U	Issue No.	29
LM End	0.95	Issue Type +	Ma	Location *	LS
Category	Earthen Levee			GPS Latitude/Longitude	
				Start	End
Item	Animal Control			37.265188 °	37.263963 °
				-120.288058 °	-120.288050 °
DWR ID	DWR_NA0013_04_f_2014_29				
Action/Comments					
Exterminate rodents and backfill and compact or grout burrows. Inspector Comments: District need to place bait stations along infested areas of the levee section where activiity is high.

Looking downstream from levee mile 0.87 down to levee mile 0.95 lots of active rodent holes present on slope.
