**Flood Control Project Maintenance
Levee Inspections**

Fall 2015 Levee Maintenance Deficiency Summary Report

San Joaquin River Basin

Merced Streams Group

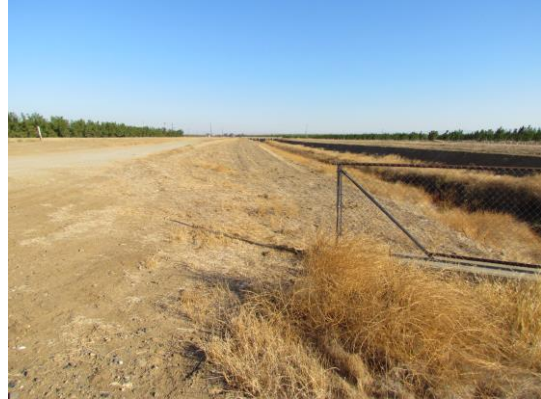
Photo 1 of 1 : FA_2015_NA0013_331_1_20151020_00001.jpg

Black Rascal Creek looking downstream from levee mile 0.00 waterside slope.

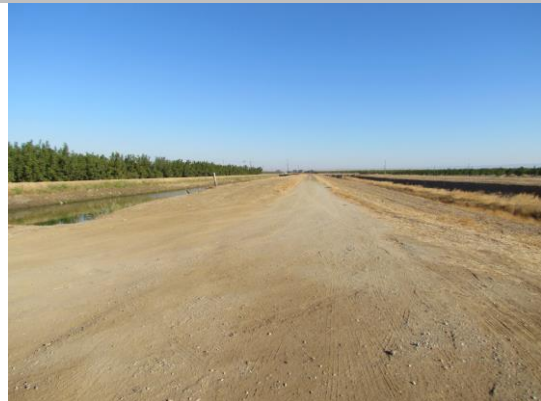
Photo 1 of 1 : FA_2015_NA0013_331_2_20151020_00002.jpg

Black Rascal Creek looking downstream from the landside levee slope.

LM Start	0.33	Rating **	M	Issue No.	3
LM End	1.27	Issue Type +	Ma	Location *	WS
Category	Earthen Levee			GPS Latitude/Longitude	
				Start	End
Item	Vegetation			37.319347 °	37.332520 °
				-120.396585 °	-120.394767 °
DWR ID	DWR_NA0013_01_f_2015_3				
Action/Comments					
Remove the wild growth other than native grasses from the levee slopes.					
Inspector Comments: Vegetation here has been sprayed however the dead brush remains on the slope.

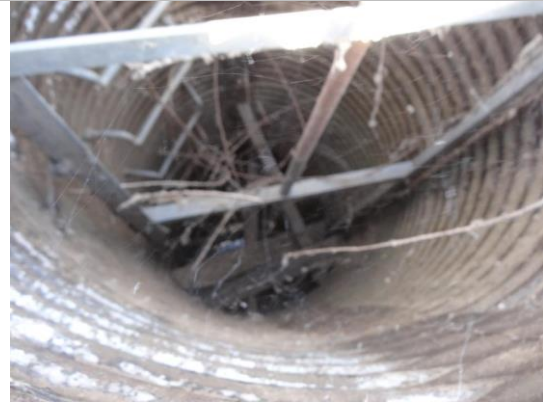
Photo 1 of 3 : UCIP_FA_2015_1606.jpg

LM Start	1.29	Rating **	M	Issue No.	10
LM End	1.29	Issue Type +	En	Location *	CR
Category	Supplemental			GPS Latitude/Longitude	
				Start	End
Item	DWR UCIP Field Study			37.332805 °	37.332805 °
				-120.394906 °	-120.394906 °
DWR ID					
Action/Comments					
Inspector Comments: FS_ID:41672 DS_ID:23079 EP_NO: N/A FS_HLM: 1.305 Repair Type: Non-Urgent Crossing Status: Indicator Found UCIP Comments: Verify Pipe is abandoned or still intact.- may be this crossing was abandoned/removed during recent levee reconstruction.- no signs of pipe and appurtenances on waterside.- only a CM pipe riser with slide gate found on landside. FIELD_STRUCT_DESC: 36-inch corrugated metal pipe through the levee, 10.0 feet below the crown, riser on the landward side, concrete headwall and cobble spillway on the landward toe, screw gate in a 48-inch pipe well on the waterward slope, concrete headwall on the waterward toe (O&M Unit No. 607, 1962) FS Date: 09/17/2013

LS view: inside view of CM pipe riser with slide gate.

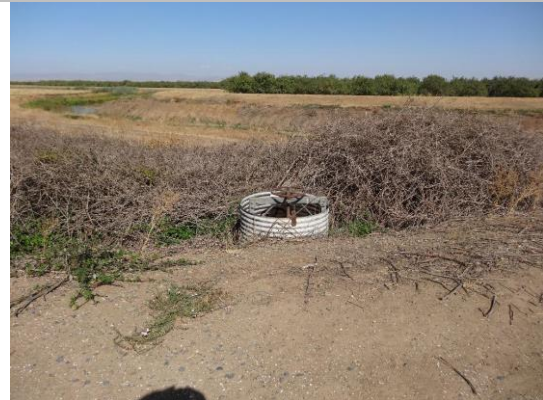
Photo 2 of 3 : UCIP_FA_2015_1607.jpg

LS view: overview of CM pipe riser with slide gate. Dense vegetation on landside.

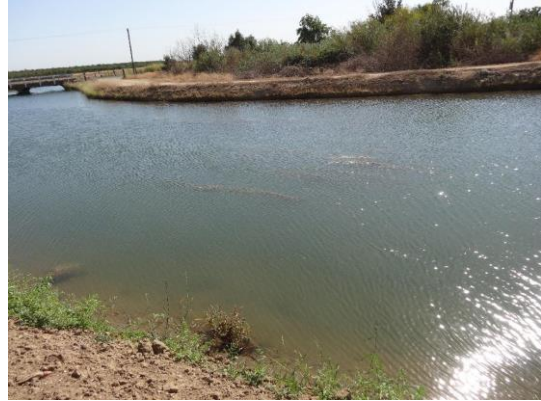
Photo 3 of 3 : UCIP_FA_2015_1608.jpg

LM Start	1.29	Rating **	M	Issue No.	10 (cont)
LM End	1.29	Issue Type +	En	Location *	CR
Category	Supplemental			GPS Latitude/Longitude	
				Start	End
Item	DWR UCIP Field Study			37.332805 °	37.332805 °
				-120.394906 °	-120.394906 °
DWR ID					
Action/Comments					
Inspector Comments: FS_ID:41672					
DS_ID:23079					
EP_NO: N/A					
FS_HLM: 1.305					
Repair Type: Non-Urgent					
Crossing Status: Indicator Found

WS view: no signs of pipe and appurtenances on levee slope and channel bank.

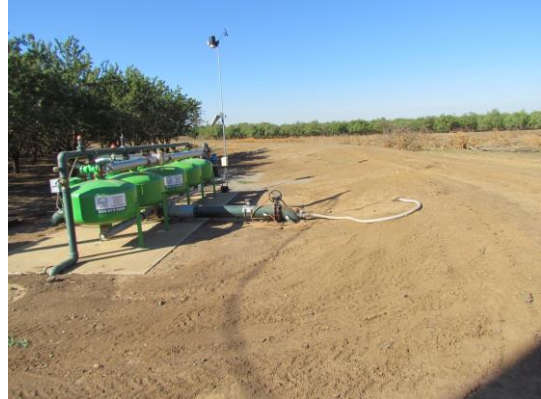
Photo 1 of 2 : FA_2015_NA0013_332_2_20151020_00013.jpg

This filtration has no CVFPB Permit.

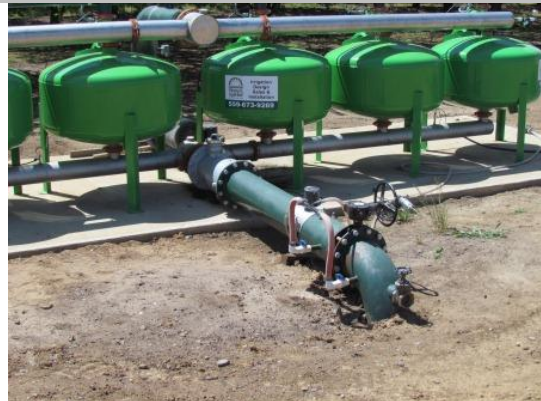
Photo 2 of 2 : FA_2015_NA0013_332_2_20150915_00002.jpg

LM Start	0.00	Rating **	U	Issue No.	2 (cont)
LM End	0.00	Issue Type +	En	Location *	LS

There is no CVFPB permit on file for this installation. Photo taken 4-23-2014

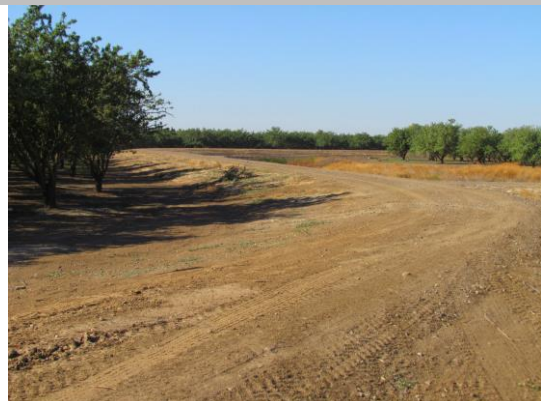
Photo 1 of 1 : FA_2015_NA0013_332_16_20151020_00014.jpg

LM Start	0.01	Rating **	A	Issue No.	16
LM End	0.67	Issue Type +	Ma	Location *	LS
Category	Earthen Levee			GPS Latitude/Longitude	
				Start	End
Item	Vegetation			37.337022 °	37.331307 °
				-120.387448 °	-120.394517 °
DWR ID	DWR_NA0013_02_f_2015_16				
Action/Comments					
Control annual grass and weeds on the levee slopes and easements. Inspector Comments: No unwanted vegetation on the landside levee slope.

Black Rascal Creek looking downstream from levee mile 0.01.

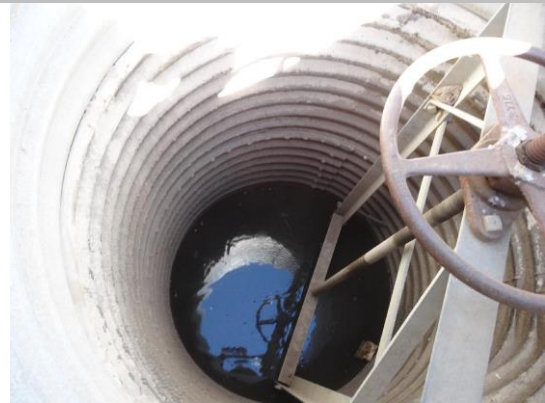
Photo 1 of 3 : UCIP_FA_2015_1568.jpg

LM Start	0.01	Rating **	M	Issue No.	29
LM End	0.01	Issue Type +	En	Location *	WS
Category	Supplemental			GPS Latitude/Longitude	
				Start	End
Item	DWR UCIP Field Study			37.337019 °	37.337019 °
				-120.387539 °	-120.387539 °
DWR ID					
Action/Comments					
Inspector Comments: FS_ID:21263 DS_ID:23052 EP_NO: N/A FS_HLM: 0.01 Repair Type: Non-Urgent Crossing Status: Found UCIP Comments: - needs more investigations on this crossing. - new water filtration plant on LS with pump and concrete vault.- a concrete standpipe and CM pipe riser on WS. FIELD_STRUCT_DESC: 10-inch steel pipe through the levee, 5.0 feet below the crown, riser on the landward side, screw gate in a 36-inch pipe well on the waterward slope (O&M Unit No. 607, 1962) FS Date: 09/17/2013

WS view: inside view of CMP standpipe with slide gate.

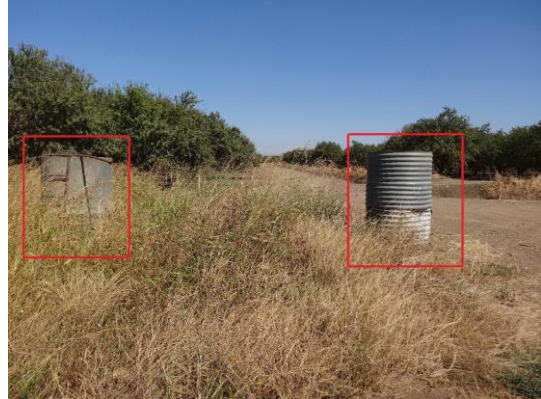
Photo 2 of 3 : UCIP_FA_2015_1569.jpg

Inspector Comments: FS_ID:21263
 DS_ID:23052
 EP_NO: N/A
 FS_HLM: 0.01
 Repair Type: Non-Urgent
 Crossing Status: Found
 UCIP Comments: - needs more investigations on this crossing. - new water filtration plant on LS with pump and concrete vault.- a concrete standpipe and CM pipe riser on WS.
 FIELD_STRUCT_DESC: 10-inch steel pipe through the levee, 5.0 feet below the crown, riser on the landward side, screw gate in a 36-inch pipe well on the waterward slope (O&M Unit No. 607, 1962)
 FS Date: 09/17/2013

WS view: concrete standpipe (left) and CMP standpipe (right).

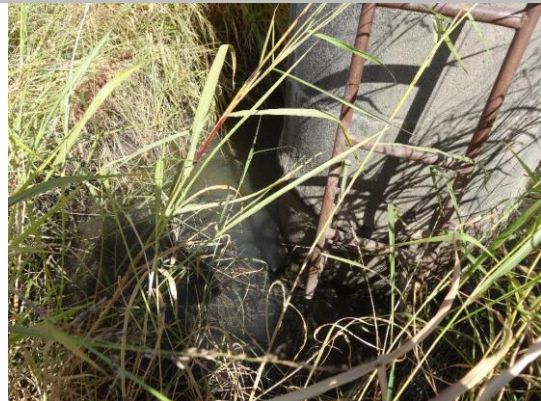
Photo 3 of 3 : UCIP_FA_2015_1578.jpg

WS view: concrete standpipe with water ponding at its base.

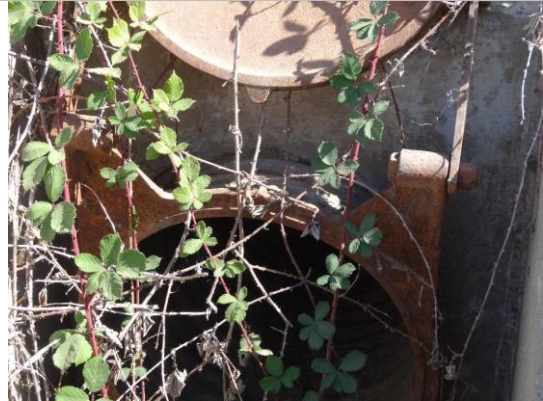
Photo 1 of 2 : UCIP_FA_2015_1702.jpg

LM Start	0.29	Rating **	U	Issue No.	30
LM End	0.29	Issue Type +	En	Location *	LS
Category	Supplemental			GPS Latitude/Longitude	
				Start	End
Item	DWR UCIP Field Study			37.336006 °	37.336006 °
				-120.392011 °	-120.392011 °
DWR ID					
Action/Comments					
Inspector Comments: FS_ID:41261 DS_ID:23053 EP_NO: N/A FS_HLM: 0.296 Repair Type: Urgent Crossing Status: Found UCIP Comments: - needs vegetation cleaning on both sides.- flap gate was not closed during field survey.- inlet needs cleaning. FIELD_STRUCT_DESC: 24-inch corrugated metal drainage pipe through the levee, 8.0 feet below the crown, concrete headwall, flap gate, and concrete grouted cobble spillway on the waterward toe, concrete headwall on the landward toe (O&M Unit No. 607, 1962) FS Date: 09/17/2013

WS view: U typed concrete headwall, CM pipe, and flap gate. Flap gate was not closed. Vegetation needs to be cleared.

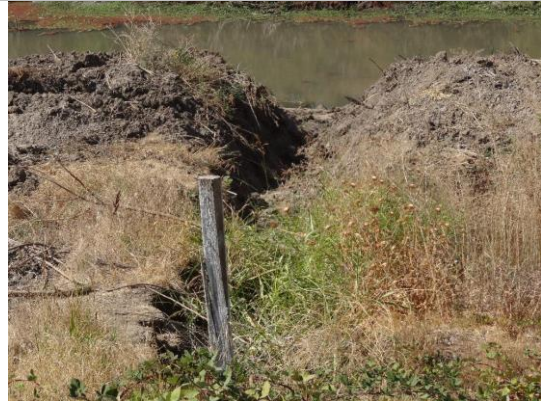
Photo 2 of 2 : UCIP_FA_2015_1703.jpg

LM Start	0.29	Rating **	U	Issue No.	30 (cont)	
LM End	0.29	Issue Type +	En	Location *	LS	
Category	Supplemental			GPS Latitude/Longitude		
				Start	End	
Item	DWR UCIP Field Study			37.336006 °	37.336006 °	
				-120.392011 °	-120.392011 °	
DWR ID						
Action/Comments						
Inspector Comments: FS_ID:41261 DS_ID:23053 EP_NO: N/A FS_HLM: 0.296 Repair Type: Urgent Crossing Status: Found UCIP Comments: - needs vegetation cleaning on both sides.- flap gate was not closed during field survey.- inlet needs cleaning. FIELD_STRUCT_DESC: 24-inch corrugated metal drainage pipe through the levee, 8.0 feet below the crown, concrete headwall, flap gate, and concrete grouted cobble spillway on the waterward toe, concrete headwall on the landward toe (O&M Unit No. 607, 1962) FS Date: 09/17/2013

WS view: cobble spillway and channel on waterside.

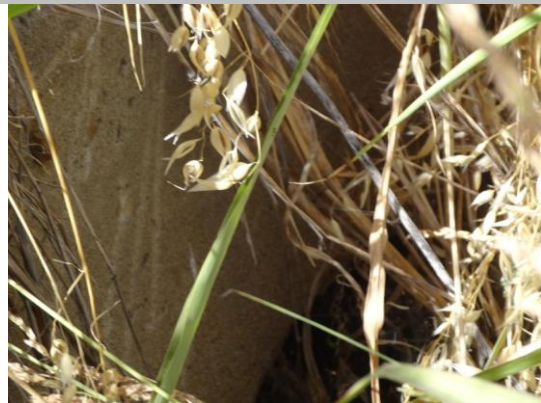
Photo 1 of 3 : UCIP_FA_2015_1775.jpg

LM Start	0.54	Rating **	M	Issue No.	31
LM End	0.54	Issue Type +	En	Location *	LS
Category	Supplemental			GPS Latitude/Longitude	
				Start	End
Item	DWR UCIP Field Study			37.333180 °	37.333180 °
				-120.394069 °	-120.394069 °
DWR ID					
Action/Comments					
Inspector Comments: FS_ID:20946					
DS_ID:23054					
EP_NO: N/A					
FS_HLM: 0.5444					
Repair Type: Non-Urgent					
Crossing Status: Found					
UCIP Comments: - needs vegetation cleaning on both sides.- flap gate was not properly closed during field survey.- inlet needs cleaning.					
FIELD_STRUCT_DESC: 24-inch corrugated metal drainage pipe through the levee, 12.0 feet below the crown, concrete headwall, flap gate, and concrete grouted cobble spillway on the waterward toe, concrete headwall on the landward toe (O&M Unit No. 607, 1962)					
FS Date: 09/17/2013

LS view: concrete headwall and CM pipe. Inlet needs cleaning.

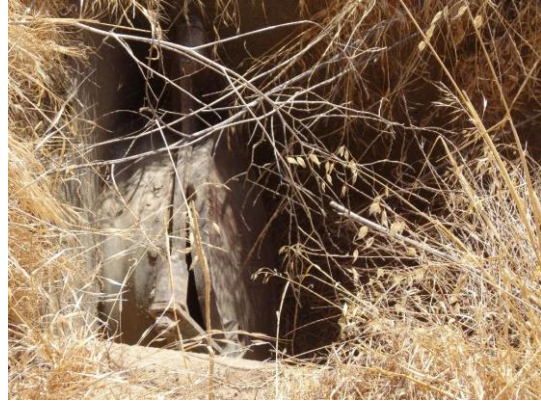
Photo 2 of 3 : UCIP_FA_2015_1776.jpg

Inspector Comments: FS_ID:20946
 DS_ID:23054
 EP_NO: N/A
 FS_HLM: 0.5444
 Repair Type: Non-Urgent
 Crossing Status: Found
 UCIP Comments: - needs vegetation cleaning on both sides.- flap gate was not properly closed during field survey.- inlet needs cleaning.
 FIELD_STRUCT_DESC: 24-inch corrugated metal drainage pipe through the levee, 12.0 feet below the crown, concrete headwall, flap gate, and concrete grouted cobble spillway on the waterward toe, concrete headwall on the landward toe (O&M Unit No. 607, 1962)
 FS Date: 09/17/2013

WS view: U typed concrete headwall, CM pipe, and flap gate. Flap gate was not properly closed.

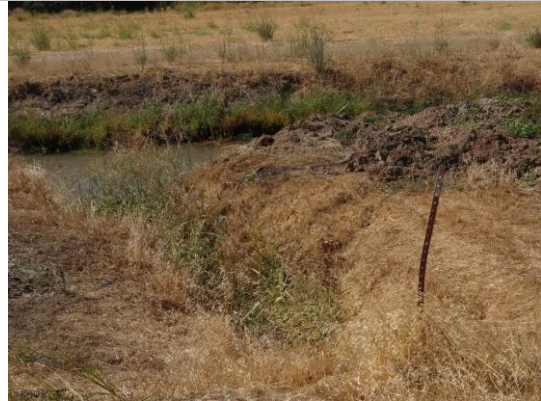
Photo 3 of 3 : UCIP_FA_2015_1777.jpg

WS view: cobble spillway and channel on waterside.

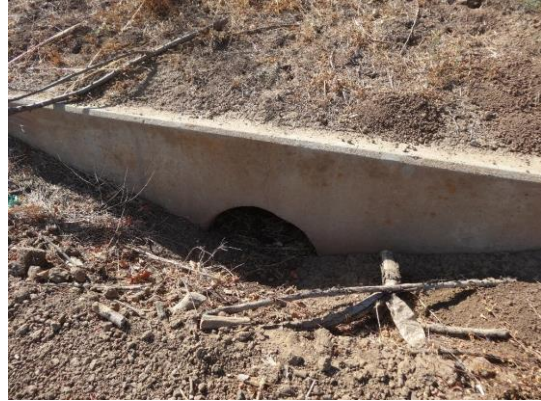
Photo 1 of 3 : UCIP_FA_2015_1952.jpg

LM Start	0.74	Rating **	M	Issue No.	32
LM End	0.74	Issue Type +	En	Location *	LS
Category	Supplemental			GPS Latitude/Longitude	
				Start	End
Item	DWR UCIP Field Study			37.330525 °	37.330525 °
				-120.395132 °	-120.395132 °
DWR ID					
Action/Comments					
Inspector Comments: FS_ID:20992 DS_ID:23055 EP_NO: N/A FS_HLM: 0.747 Repair Type: Non-Urgent Crossing Status: Found

LS view: concrete headwall and CM pipe. Half of inlet pipe buried.

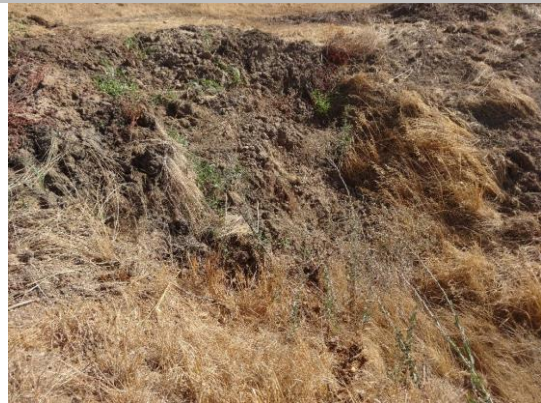
Photo 2 of 3 : UCIP_FA_2015_2056.jpg

WS view: debris and mud deposited from the channel cleaning. It needs to be cleared from spillway and outlet structure.

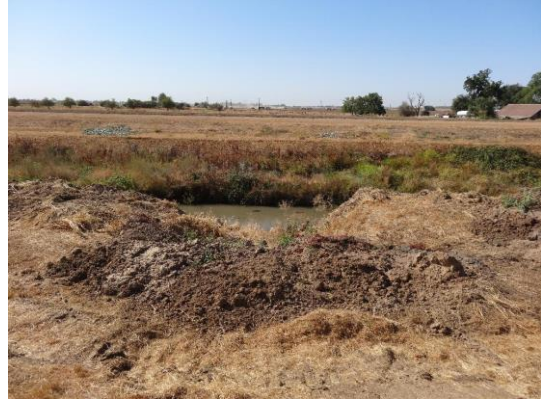
Photo 3 of 3 : UCIP_FA_2015_2057.jpg

LM Start	0.74	Rating **	M	Issue No.	32 (cont)	
LM End	0.74	Issue Type +	En	Location *	LS	
Category	Supplemental			GPS Latitude/Longitude		
				Start	End	
Item	DWR UCIP Field Study			37.330525 °	37.330525	
				-120.395132 °	-120.395132	
DWR ID						
Action/Comments						
Inspector Comments: FS_ID:20992						
DS_ID:23055						
EP_NO: N/A						
FS_HLM: 0.747						
Repair Type: Non-Urgent						
Crossing Status: Found

WS view: concrete headwall and CM pipe buried under debris and mud.

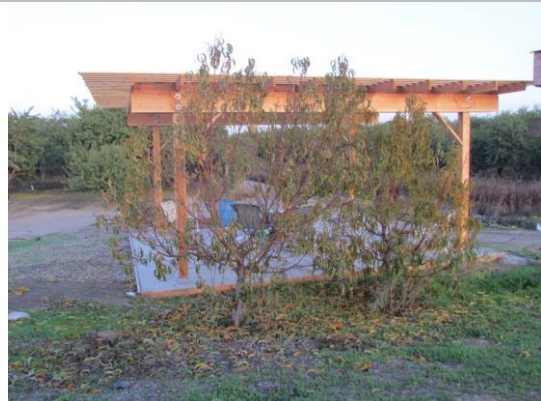
Photo 1 of 2 : FA_2015_NA0013_332_24_20150915_00004.jpg

Another view of unauthorized structure.

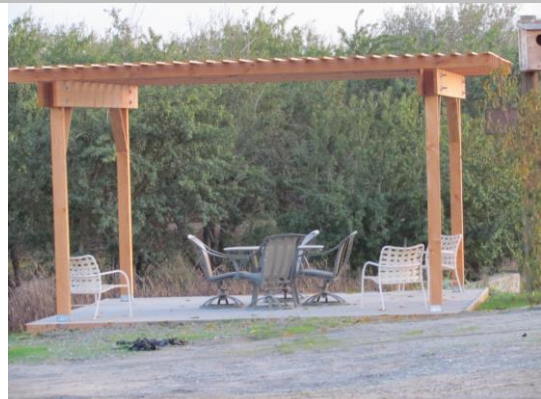
Photo 2 of 2 : FA_2015_NA0013_332_24_20150915_00005.jpg

Unauthorized encroachment placed on the landside shoulder and berm.

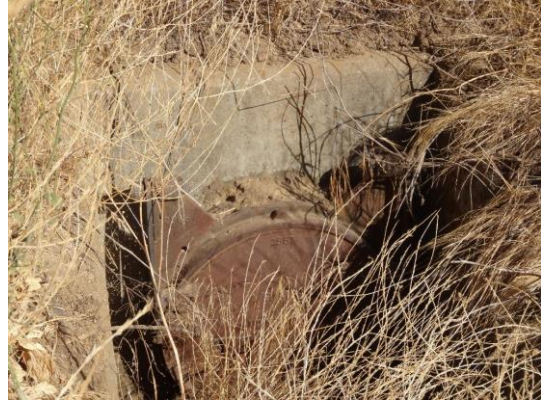
Photo 1 of 2 : UCIP_FA_2015_1950.jpg

LM Start	1.61	Rating **	M	Issue No.	33
LM End	1.61	Issue Type +	En	Location *	LS
Category	Supplemental			GPS Latitude/Longitude	
				Start	End
Item	DWR UCIP Field Study			37.318015 °	37.318015 °
				-120.395738 °	-120.395738 °
DWR ID					
Action/Comments					
Inspector Comments: FS_ID:42993					
DS_ID:23058					
EP_NO: N/A					
FS_HLM: 1.641					
Repair Type: Non-Urgent					
Crossing Status: Found					
UCIP Comments: - needs cleaning of debris on spillway on WS.					
Flapgate blocked by debris on WS. - needs cleaning inside CMP on LS					
FIELD_STRUCT_DESC: 24-inch corrugated metal drainage pipe through the levee, 8.0 feet below the crown, concrete headwall, flap gate, and concrete grouted cobble spillway on the waterward toe, concrete headwall on the landward toe (O&M Unit No. 607, 1962)					
FS Date: 09/17/2013

WS view: U typed concrete headwall, CM pipe and flap gate. Vegetation and debris need to be cleared.

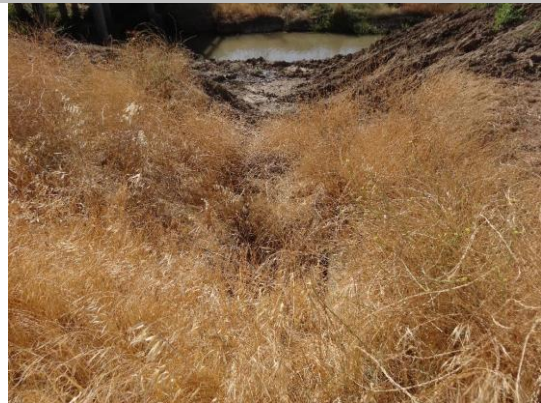
Photo 2 of 2 : UCIP_FA_2015_1951.jpg

WS view: overview of outlet area and channel. Debris and vegetations on spillway.

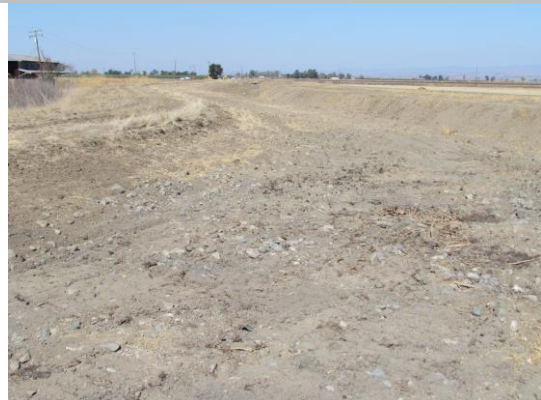
Photo 1 of 1 : FA_2015_NA0013_333_17_20151020_00013.jpg

Owens Creek looking downstream from levee mile 0.00 waterside slope.

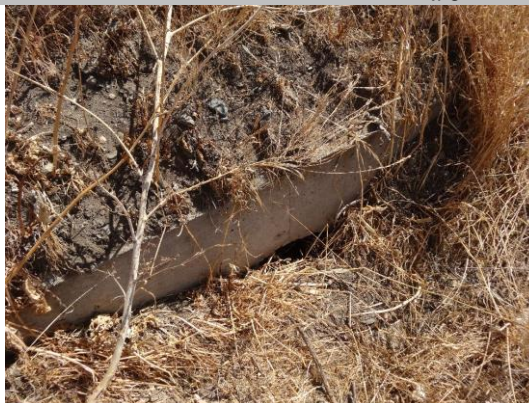
Photo 1 of 3 : UCIP_FA_2015_1513.jpg

LS view: concrete headwall and CM pipe. Inlet needs cleaning and silt removed.

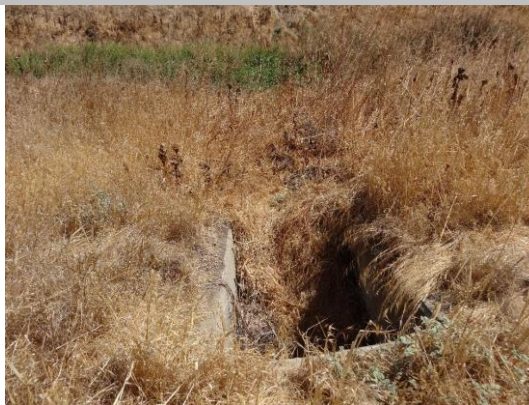
Photo 2 of 3 : UCIP_FA_2015_1514.jpg

WS view: Silt needs to be removed. Vegetations needs to be cleared.

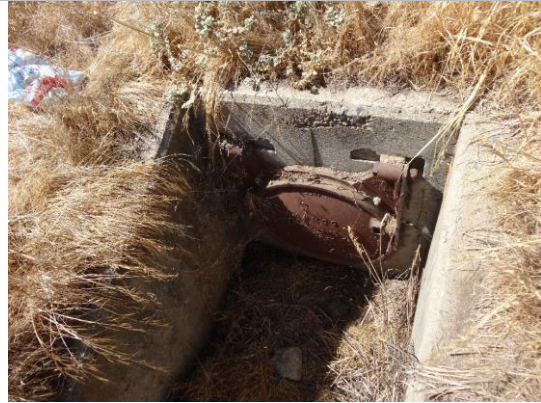
Photo 3 of 3 : UCIP_FA_2015_1515.jpg

WS view: U typed concrete headwall, CM pipe, and flap gate.

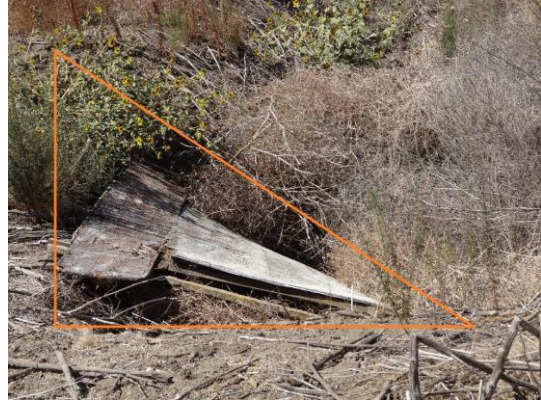
Photo 1 of 3 : UCIP_FA_2015_2071.jpg

LS view: Debris dumped on onlet structure. Needs to be cleared or abandoned properly.

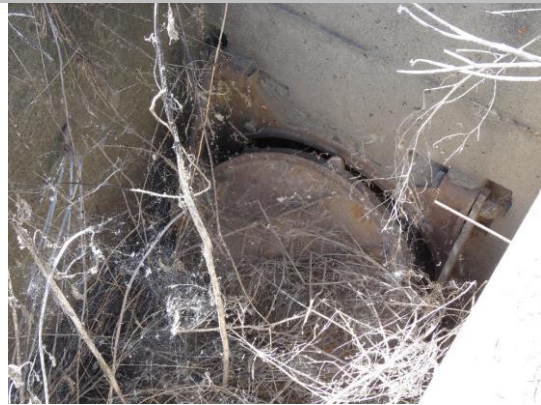
Photo 2 of 3 : UCIP_FA_2015_2072.jpg

WS view: U typed concrete headwall, CM pipe, and flap gate. Damaged flap gate.

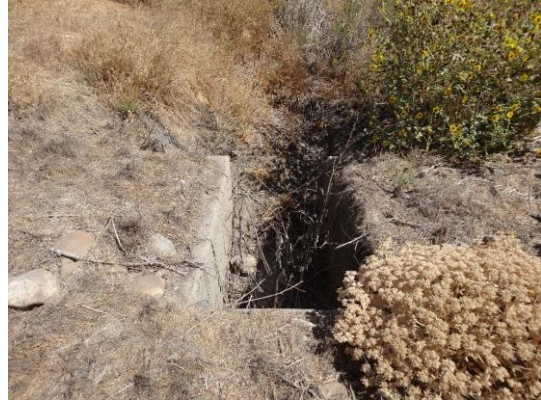
Photo 3 of 3 : UCIP_FA_2015_2073.jpg

WS view: U typed concrete headwall, cobble spillway, and channel on waterside.

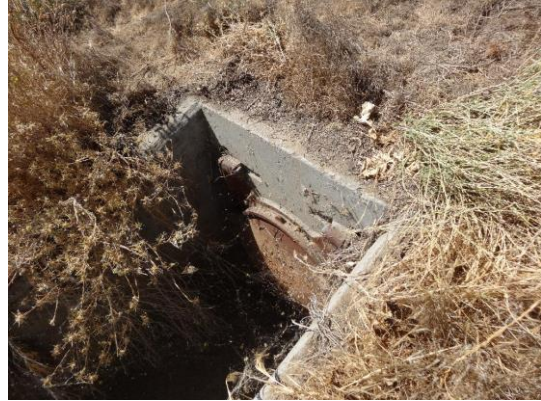
Photo 1 of 2 : UCIP_FA_2015_1516.jpg

WS view: U typed concrete headwall, CM pipe, and flap gate. Vegetation needs to be cleared.

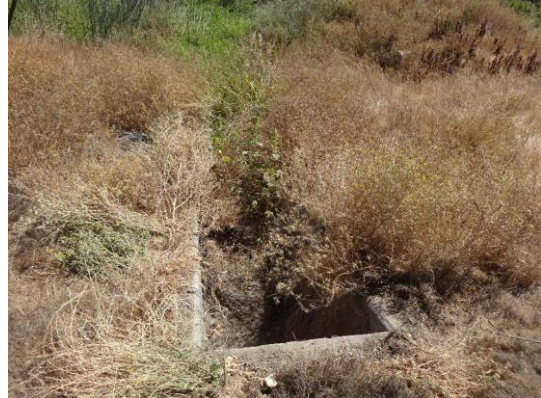
Photo 2 of 2 : UCIP_FA_2015_1517.jpg

WS view: cobble spillway and channel on waterside. Dense vegetation on levee slope.

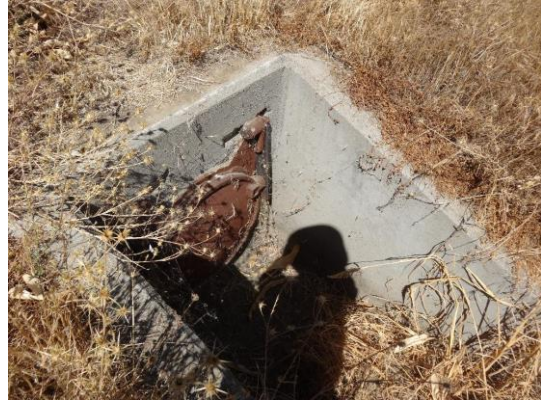
Photo 1 of 2 : UCIP_FA_2015_1518.jpg

WS view: U typed concrete headwall, CM pipe, and flap gate. Vegetation needs to be cleared.

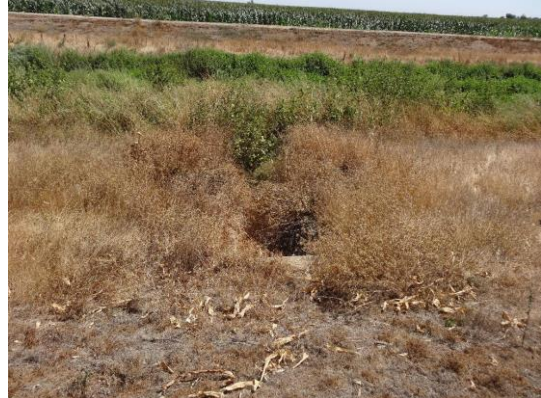
Photo 2 of 2 : UCIP_FA_2015_1519.jpg

WS view: overview of spillway/outlet area on waterside.

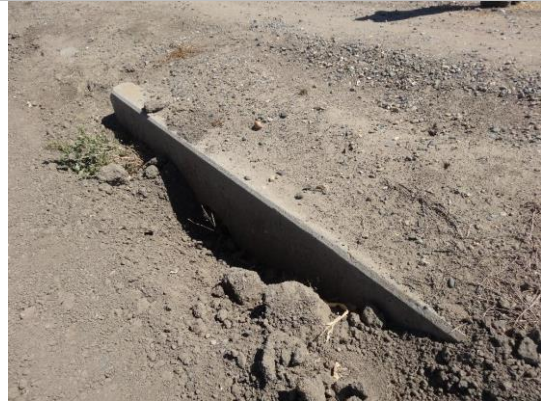
Photo 1 of 3 : UCIP_FA_2015_1520.jpg

LS view: concrete headwall and CM pipe. Inlet needs clearing &

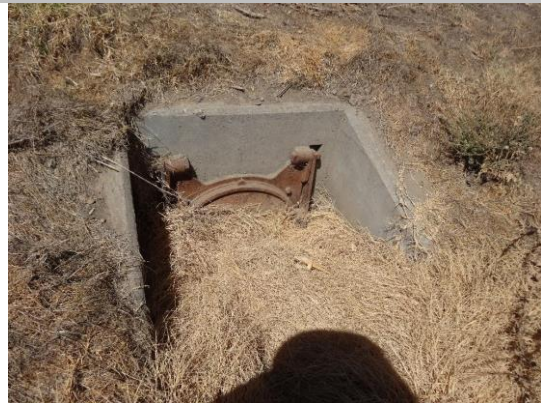
Photo 2 of 3 : UCIP_FA_2015_1521.jpg

WS view: U typed concrete headwall, CM pipe, and flap gate. Vegetation needs to be cleared.

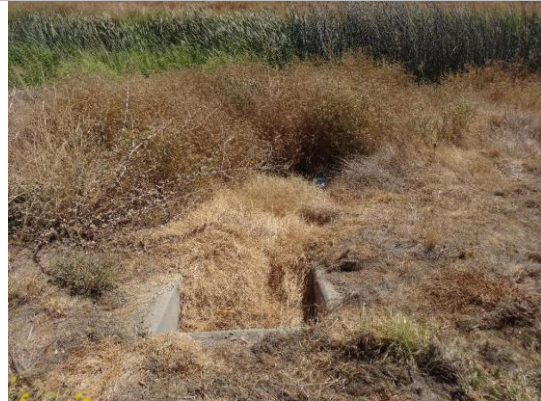
Photo 3 of 3 : UCIP_FA_2015_1522.jpg

WS view: cobble spillway and channel on waterside.

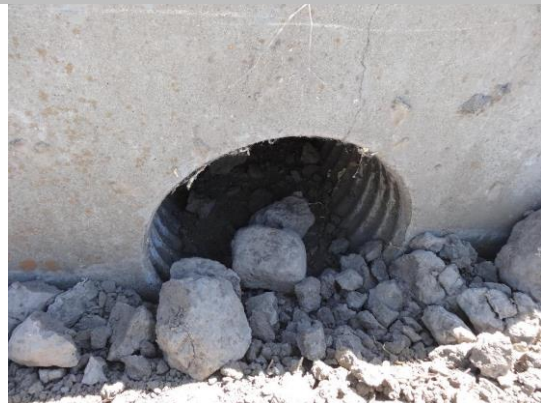
Photo 1 of 3 : UCIP_FA_2015_1641.jpg

LS view: closer view of CM pipe. Inlet needs cleaning & clearing.

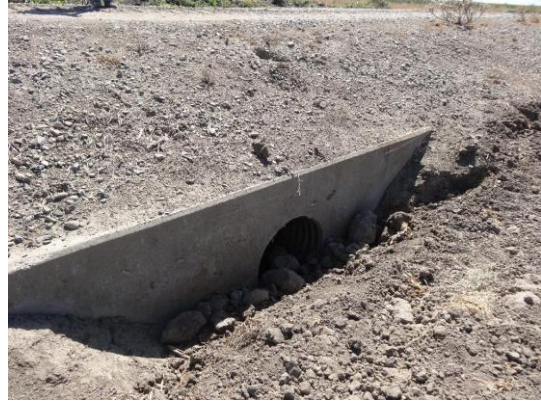
Photo 2 of 3 : UCIP_FA_2015_1643.jpg

LS view: concrete headwall and CM pipe. Inlet needs clearing.

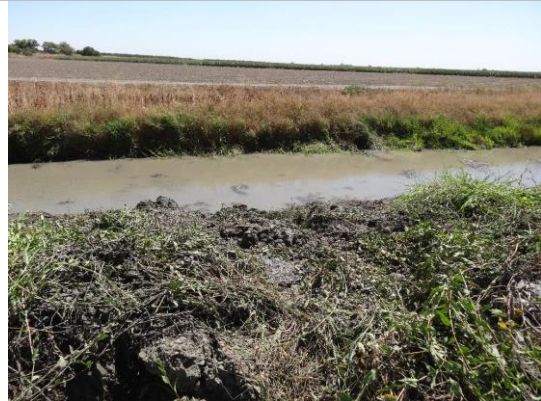
Photo 3 of 3 : UCIP_FA_2015_1644.jpg

WS view: U typed concrete headwall, CM pipe, and flap gate buried under mud/debris.

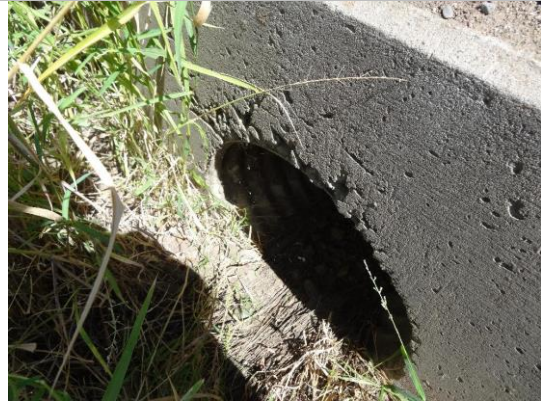
Photo 1 of 3 : UCIP_FA_2015_1510.jpg

LS view: concrete headwall and CM pipe. Inlet needs clearing.

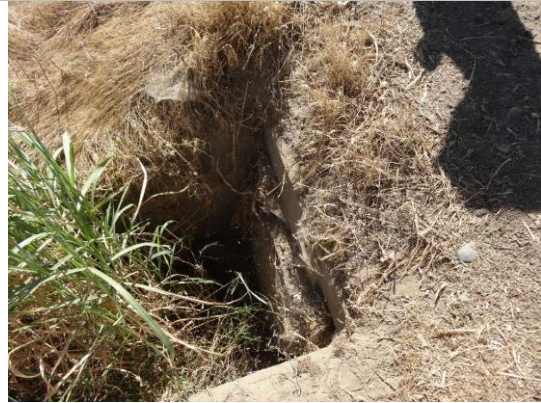
Photo 2 of 3 : UCIP_FA_2015_1511.jpg

WS view: U typed concrete headwall, CM pipe, and flap gate. Vegetation needs to be cleared.

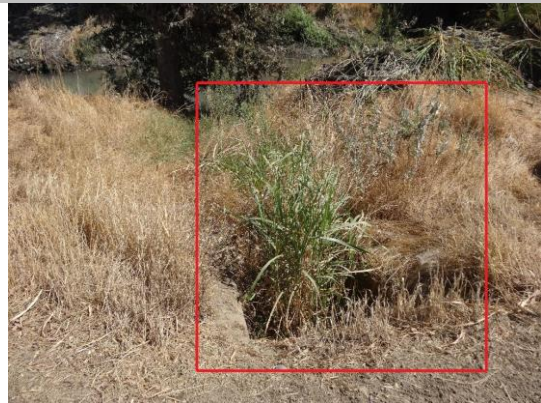
Photo 3 of 3 : UCIP_FA_2015_1512.jpg

WS view: cobble spillway and channel on waterside. Dense vegetation on levee slope and spillway.

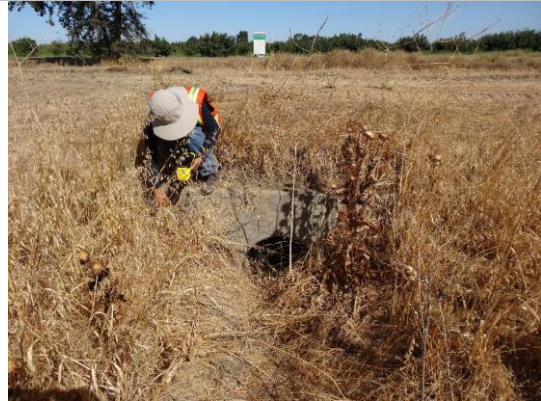
Photo 1 of 3 : UCIP_FA_2015_1565.jpg

LS view: concrete headwall and CM pipe. Inlet silt needs clearing.

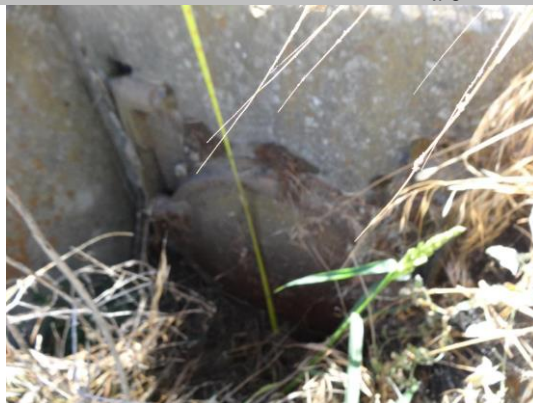
Photo 2 of 3 : UCIP_FA_2015_1566.jpg

WS view: U typed concrete headwall, CM pipe, and flap gate.
 Vegetation and silt need to be cleared.

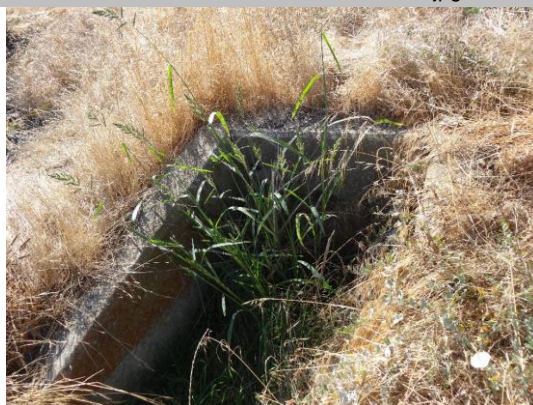
Photo 3 of 3 : UCIP_FA_2015_1567.jpg

WS view: concrete spillway and channel on waterside. Dense vegetation on levee slope and spillway.

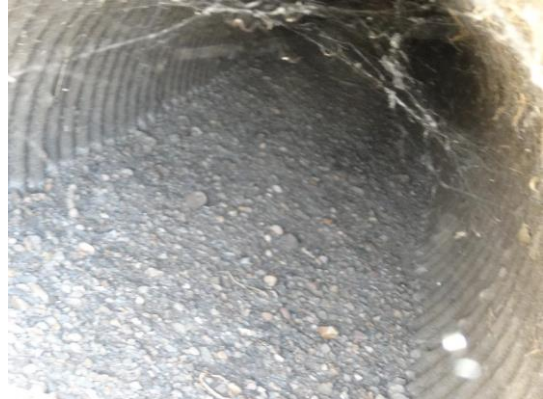
Photo 1 of 3 : UCIP_FA_2015_1178.jpg

LS view: inside view of CM pipe. Inlet pipe needs clearing.

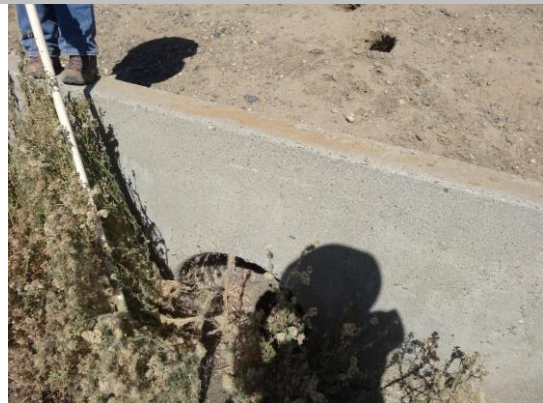
Photo 2 of 3 : UCIP_FA_2015_1179.jpg

LS view: concrete headwall and CM pipe. Inlet needs clearing.

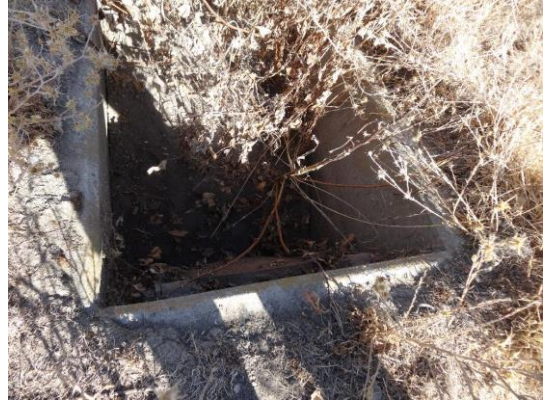
Photo 3 of 3 : UCIP_FA_2015_1564.jpg

WS view: U typed concrete headwall, CM pipe, and flap gate. Vegetation needs to be cleared.

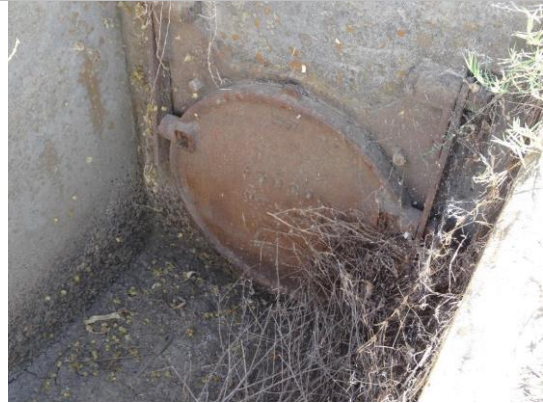
Photo 1 of 3 : UCIP_FA_2015_2047.jpg

WS view: CM pipe and flap gate. Vegetation needs to be cleared.

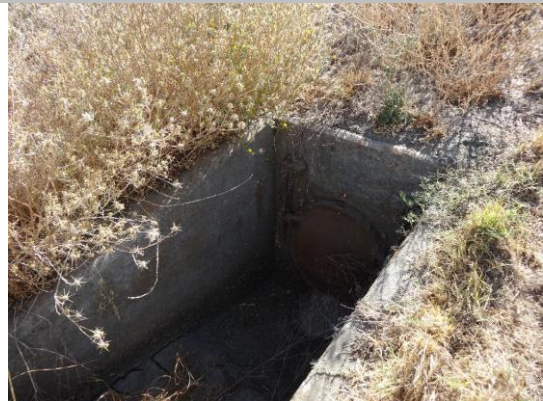
Photo 2 of 3 : UCIP_FA_2015_2048.jpg

WS view: U typed concrete headwall, CM pipe, and flap gate. Vegetation needs to be cleared on spillway.

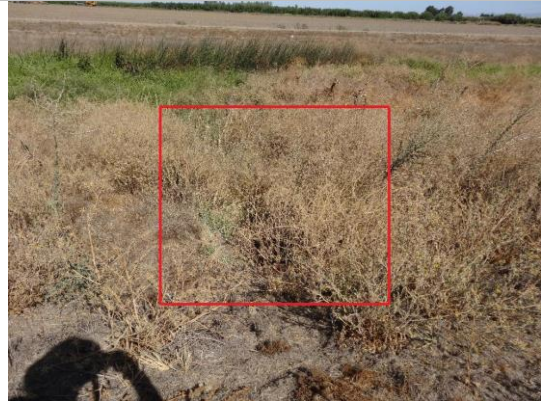
Photo 3 of 3 : UCIP_FA_2015_2049.jpg

WS view: Dense vegetation on levee slope and spillway.

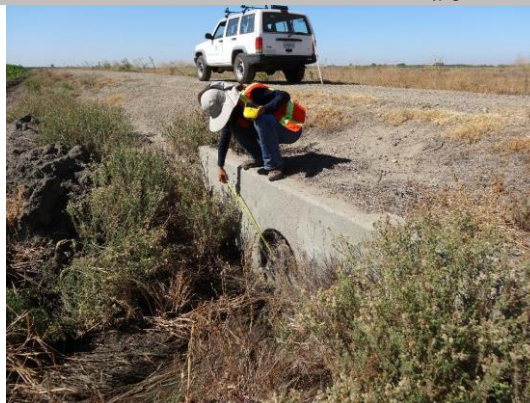
Photo 1 of 3 : UCIP_FA_2015_2050.jpg

LS view: concrete headwall and CM pipe.

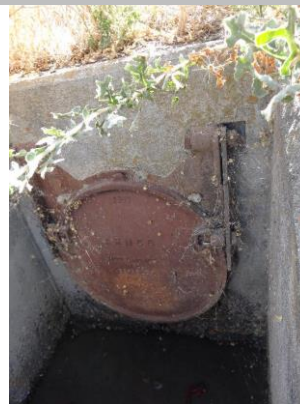
Photo 2 of 3 : UCIP_FA_2015_2051.jpg

WS view: U typed concrete headwall, CM pipe, and flap gate.

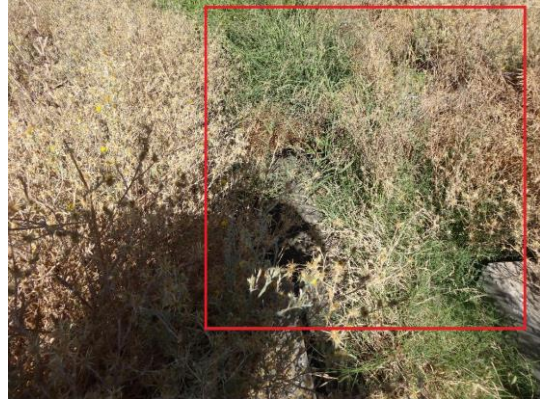
Photo 3 of 3 : UCIP_FA_2015_2052.jpg

WS view: Dense vegetation on levee slope and spillway.

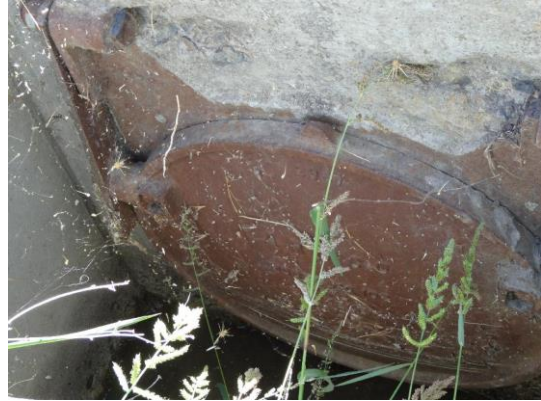
Photo 1 of 3 : UCIP_FA_2015_2053.jpg

WS view: CM pipe and flap gate. Vegetation needs to be cleared.

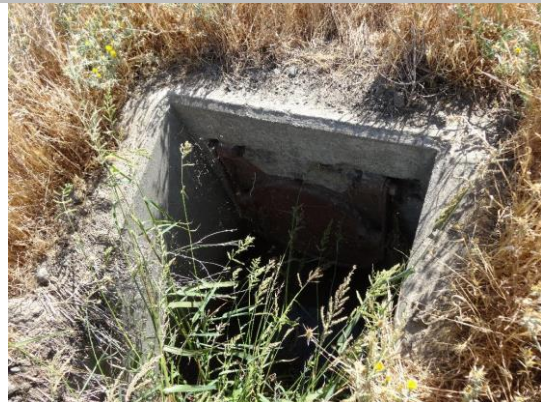
Photo 2 of 3 : UCIP_FA_2015_2054.jpg

WS view: U typed concrete headwall, CM pipe, and flap gate. Vegetation needs to be cleared.

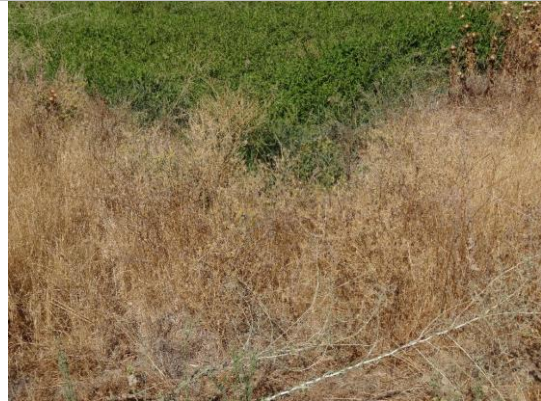
Photo 3 of 3 : UCIP_FA_2015_2055.jpg

WS view: Dense vegetation on levee slope and spillway.

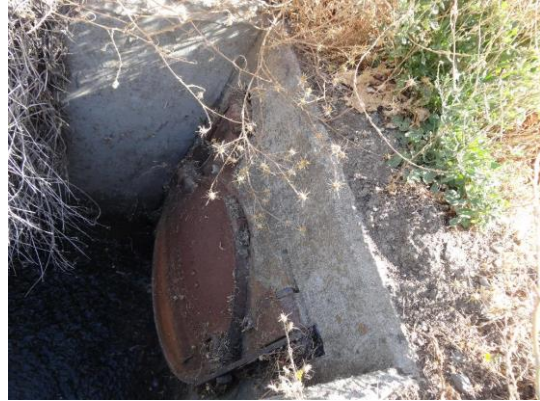
Photo 1 of 2 : UCIP_FA_2015_1693.jpg

WS view: U typed concrete headwall, CM pipe, and flap gate. Vegetation needs to be cleared on spillway.

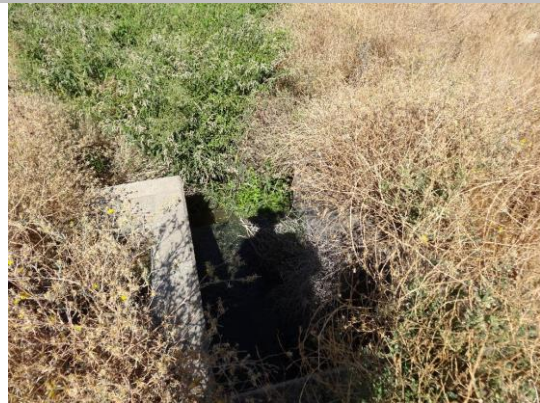
Photo 2 of 2 : UCIP_FA_2015_1694.jpg

WS view: concrete spillway and channel on waterside. Dense vegetation on levee slope and spillway.

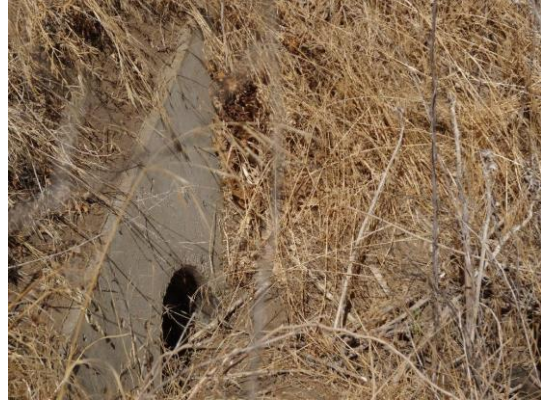
Photo 1 of 3 : UCIP_FA_2015_1815.jpg

LS view: concrete headwall and CM pipe. Inlet silt needs clearing.

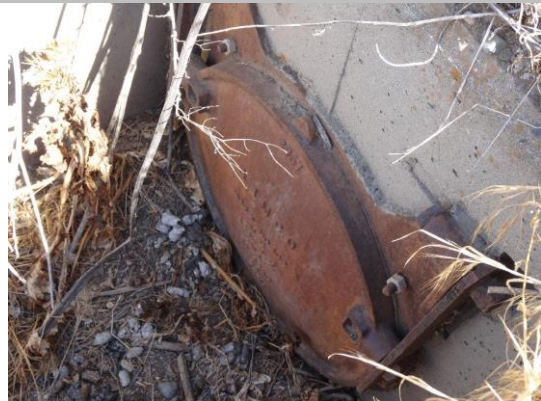
Photo 2 of 3 : UCIP_FA_2015_1816.jpg

WS view: U typed concrete headwall, CM pipe, and flap gate. Spillway needs to be cleared.

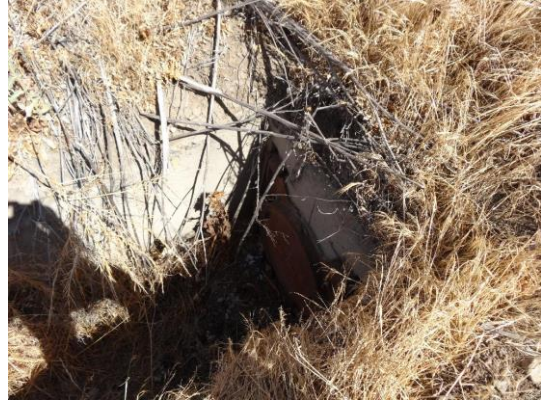
Photo 3 of 3 : UCIP_FA_2015_1817.jpg

WS view: concrete spillway and channel on waterside. Dense vegetation on levee slope and spillway.

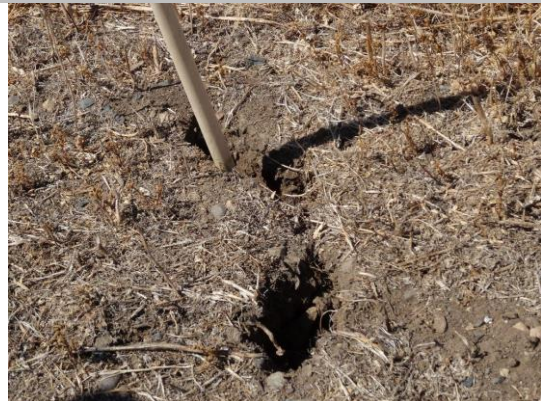
Photo 1 of 3 : UCIP_FA_2015_1175.jpg

WS view: significant levee cracks along the pipe alignment. Needs detailed investigation on the issue.

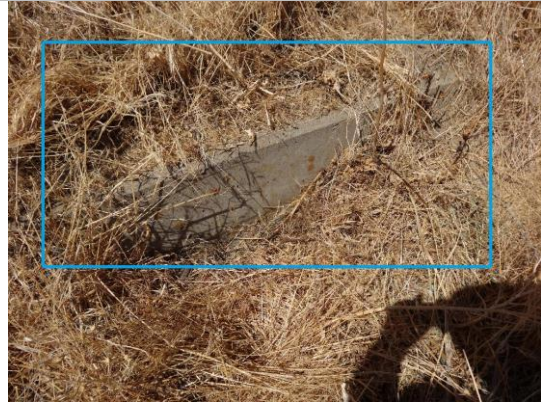
Photo 2 of 3 : UCIP_FA_2015_1176.jpg

LS view: concrete headwall and burried CM pipe. Dirt removal and clearing needed in inlet.

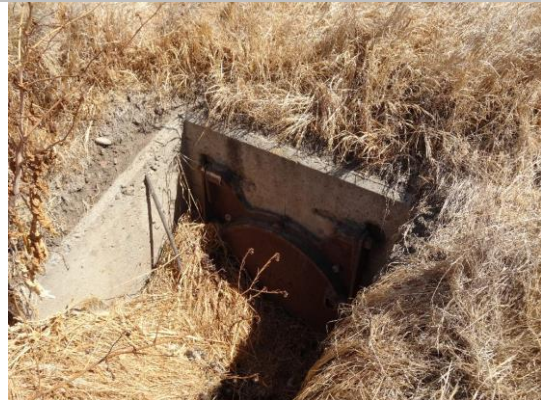
Photo 3 of 3 : UCIP_FA_2015_1177.jpg

WS view: U typed concrete headwall, CM pipe, and flap gate. Dirt and vegetations need to be removed and cleared.
