**Flood Control Project Maintenance
Levee Inspections**

Fall 2016 Levee Maintenance Deficiency Summary Report

Fall 2016 Levee Inspection Results

Merced Streams Group

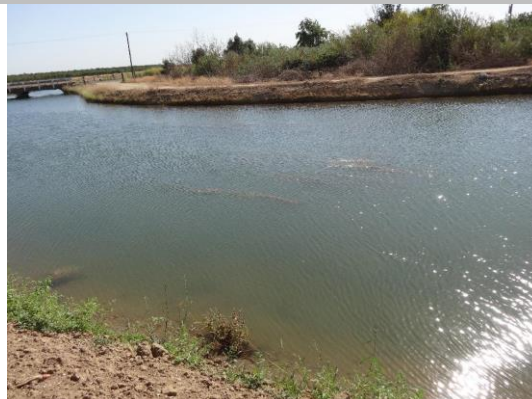
Photo 1 of 2 : UCIP_FA_2016_41672_35211.jpg

FS_ID:41672
DS_ID:23079
EP_NO: N/A
Repair Type: Non-Urgent
Crossing Status: Indicator Found
UCIP Comments: Verify Pipe is abandoned or still intact.- may be this crossing was abandoned/removed during recent levee reconstruction.- no signs of pipe and appurtenances on waterside.- only a CM pipe riser with slide gate found on landside.
FIELD_STRUCT_DESC: 36-inch corrugated metal pipe through the levee, 10.0 feet below the crown, riser on the landward side, concrete headwall and cobble spillway on the landward toe, screw gate in a 48-inch pipe well on the waterward slope, concrete headwall on the waterward toe (O&M Unit No. 607, 1962)
FS Date: 9/17/2013

WS view: no signs of pipe and appurtenances on levee slope and channel bank.

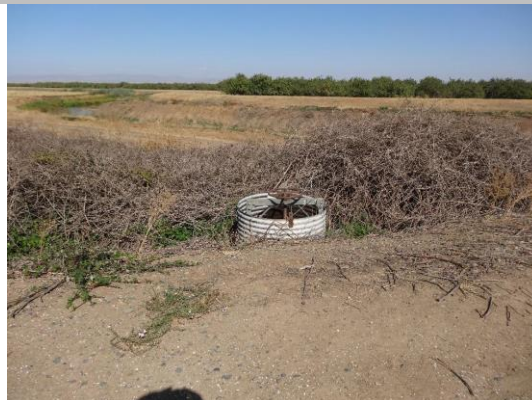
Photo 2 of 2 : UCIP_FA_2016_41672_35210.jpg

LS view: overview of CM pipe riser with slide gate. Dense vegetation on landside.

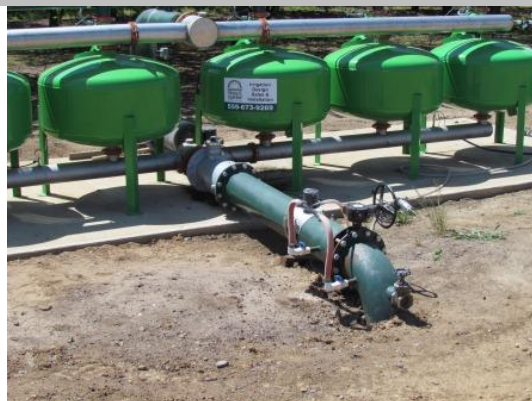
Photo 1 of 2 : FA_2016_NA0013_332_2_20161004_00002.jpg

LM Start	0.00	Rating **	U	Issue No.	2 (cont)
LM End	0.00	Issue Type +	En	Location *	LS

There is no CVFPB permit on file for this installation. Photo taken 4-23-2014

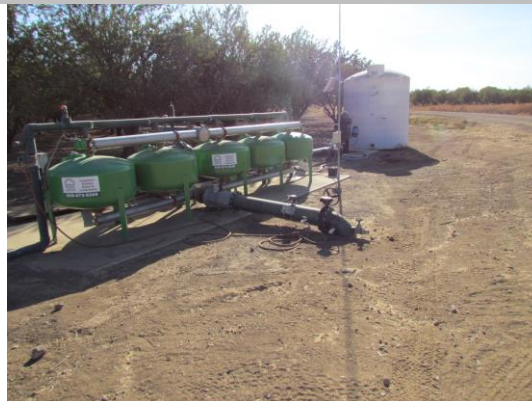
Photo 2 of 2 : FA_2016_NA0013_332_2_20161012_00017.jpg

No Permit for this filtration system and tank on the easement. 2016

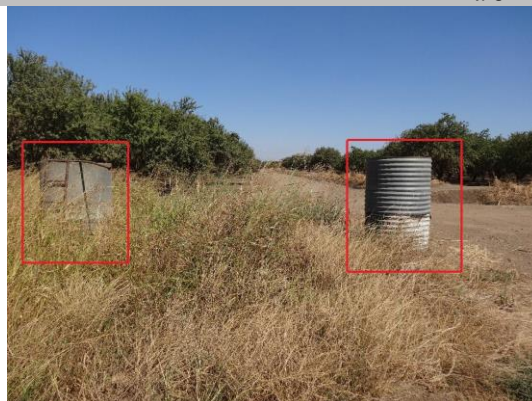
Photo 1 of 2 : UCIP_FA_2016_21263_35761.jpg

LM Start	0.01	Rating **	M	Issue No.	25
LM End	0.01	Issue Type +	En	Location *	WS
Category	Supplemental			GPS Latitude/Longitude	
				Start	End
Item	DWR UCIP Field Study			37.337019 °	37.337019 °
				-120.387539 °	-120.387539 °
DWR ID					
Comment Code					
Inspector Comment					
FS_ID:21263					
DS_ID:23052					
EP_NO: N/A					
Repair Type: Non-Urgent					
Crossing Status: Found					
UCIP Comments: - needs more investigations on this crossing. - new water filtration plant on LS with pump and concrete vault.- a concrete standpipe and CM pipe riser on WS.					
FIELD_STRUCT_DESC: 10-inch steel pipe through the levee, 5.0 feet below the crown, riser on the landward side, screw gate in a 36-inch pipe well on the waterward slope (O&M Unit No. 607, 1962)					
FS Date: 9/17/2013

WS view: concrete standpipe (left) and CMP standpipe (right).

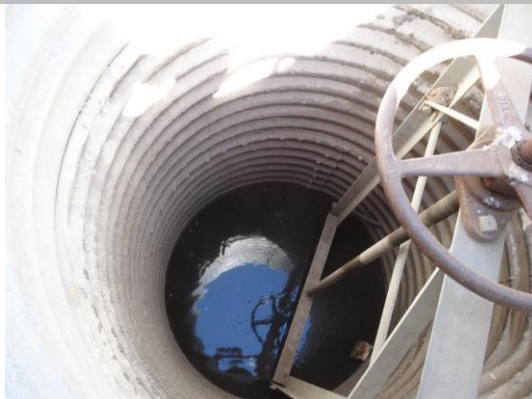
Photo 2 of 2 : UCIP_FA_2016_21263_35760.jpg

WS view: inside view of CMP standpipe with slide gate.

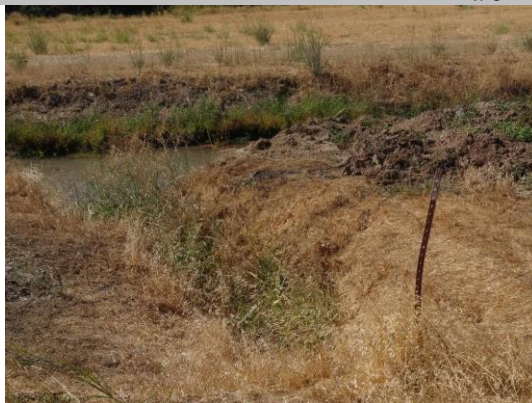
Photo 1 of 2 : UCIP_FA_2016_20946_35266.jpg

LM Start	0.54	Rating **	M	Issue No.	26
LM End	0.54	Issue Type +	En	Location *	WS
Category	Supplemental			GPS Latitude/Longitude	
				Start	End
Item	DWR UCIP Field Study			37.333180 °	37.333180 °
				-120.394069 °	-120.394069 °
DWR ID					
Comment Code					
Inspector Comment					
FS_ID:20946					
DS_ID:23054					
EP_NO: N/A					
Repair Type: Non-Urgent					
Crossing Status: Found					
UCIP Comments: - needs vegetation cleaning on both sides.- flap gate was not properly closed during field survey.- inlet needs cleaning.					
FIELD_STRUCT_DESC: 24-inch corrugated metal drainage pipe through the levee, 12.0 feet below the crown, concrete headwall, flap gate, and concrete grouted cobble spillway on the waterward toe, concrete headwall on the landward toe (O&M Unit No. 607, 1962)					
FS Date: 9/17/2013

WS view: cobble spillway and channel on waterside.

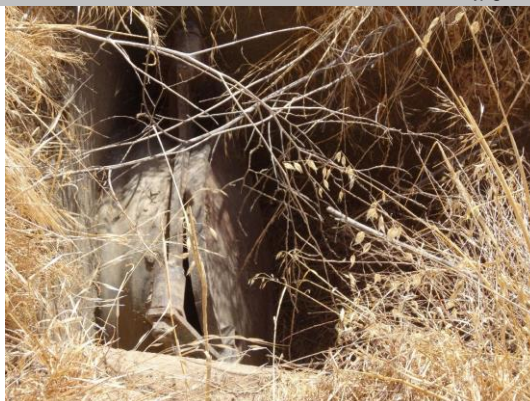
Photo 2 of 2 : UCIP_FA_2016_20946_35265.jpg

WS view: U typed concrete headwall, CM pipe, and flap gate. Flap gate was not properly closed.

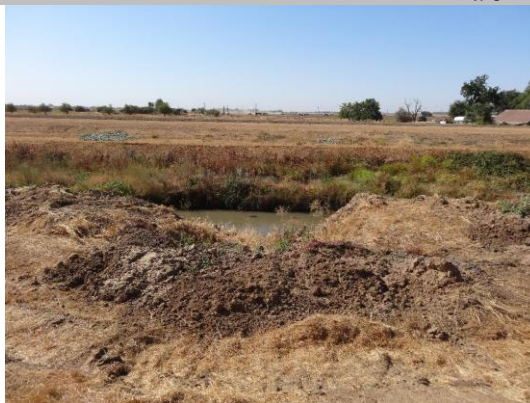
Photo 1 of 2 : UCIP_FA_2016_20992_35370.jpg

LM Start	0.74	Rating **	M	Issue No.	27
LM End	0.74	Issue Type +	En	Location *	WS
Category	Supplemental			GPS Latitude/Longitude	
				Start	End
Item	DWR UCIP Field Study			37.330525 °	37.330525 °
				-120.395132 °	-120.395132 °
DWR ID					
Comment Code					
Inspector Comment					
FS_ID:20992 DS_ID:23055 EP_NO: N/A Repair Type: Non-Urgent Crossing Status: Found UCIP Comments: - mud and debris from recent channel cleaning needs to be removed from spillway and outlet - pipe filled with debris, it needs cleaning.- half of inlet pipe buried. FIELD_STRUCT_DESC: 24-inch corrugated metal drainage pipe through the levee, 8.0 feet below the crown, concrete headwall, flap gate, and concrete grouted cobble spillway on the waterward toe, concrete headwall on the landward toe (O&M Unit No. 607, 1962) FS Date: 9/17/2013

WS view: concrete headwall and CM pipe buried under debris and mud.

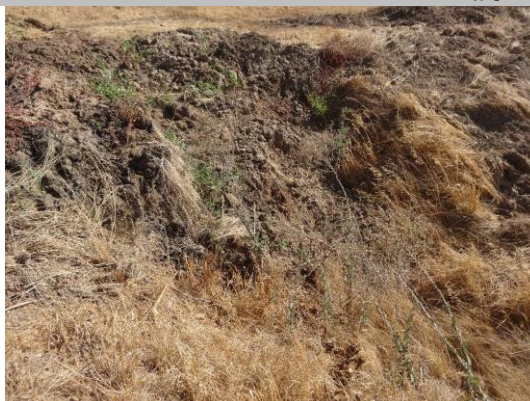
Photo 2 of 2 : UCIP_FA_2016_20992_35369.jpg

WS view: debris and mud deposited from the channel cleaning. It needs to be cleared from spillway and outlet structure.

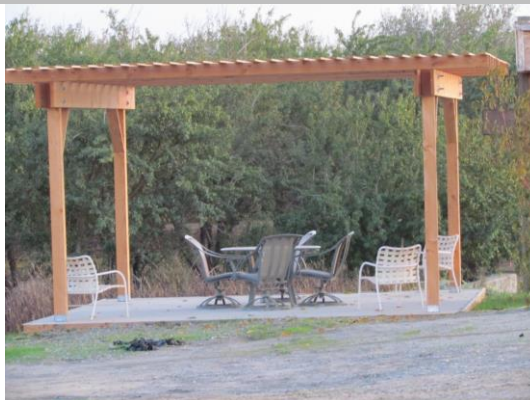
Photo 1 of 3 : FA_2016_NA0013_332_24_20161004_00003.jpg

LM Start	0.88	Rating **	U	Issue No.	24
LM End	0.88	Issue Type +	En	Location *	N/A
Category	Earthen Levee			GPS Latitude/Longitude	
				Start	End
Item	Encroachments			37.328567 °	37.328567 °
				-120.396062 °	-120.396062 °
DWR ID	DWR_NA0013_02_s_2014_24				
Comment Code					
TR : Tree or limb					
Inspector Comment					
Three fruit trees with irrigation system, stock pile of material (2) piles on the land side toe and rock pad placed on land side toe. Discovered during the fall 2014 inspection a structure has been installed on the landward levee slope and berm. No permit for these encroachments.

Unauthorized encroachment placed on the landside shoulder and berm.

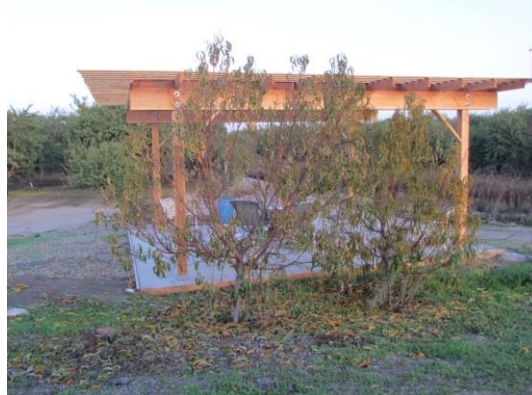
Photo 2 of 3 : FA_2016_NA0013_332_24_20161004_00004.jpg

Another view of unauthorized structure.

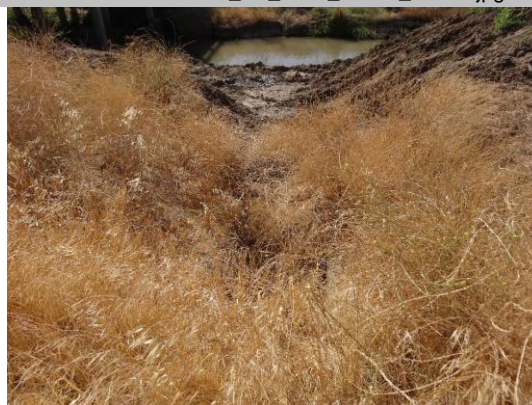
Photo 1 of 2 : UCIP_FA_2016_42993_35310.jpg

LM Start	1.62	Rating **	M	Issue No.	28
LM End	1.62	Issue Type +	En	Location *	WS
Category	Supplemental			GPS Latitude/Longitude	
				Start	End
Item	DWR UCIP Field Study			37.318015 °	37.318015 °
				-120.395738 °	-120.395738 °
DWR ID					
Comment Code					
Inspector Comment					
FS_ID:42993 DS_ID:23058 EP_NO: N/A Repair Type: Non-Urgent Crossing Status: Found UCIP Comments: - needs cleaning of debris on spillway on WS. Flapgate blocked by debris on WS. - needs cleaning inside CMP on LS FIELD_STRUCT_DESC: 24-inch corrugated metal drainage pipe through the levee, 8.0 feet below the crown, concrete headwall, flap gate, and concrete grouted cobble spillway on the waterward toe, concrete headwall on the landward toe (O&M Unit No. 607, 1962) FS Date: 9/17/2013

WS view: overview of outlet area and channel. Debris and vegetations on spillway.

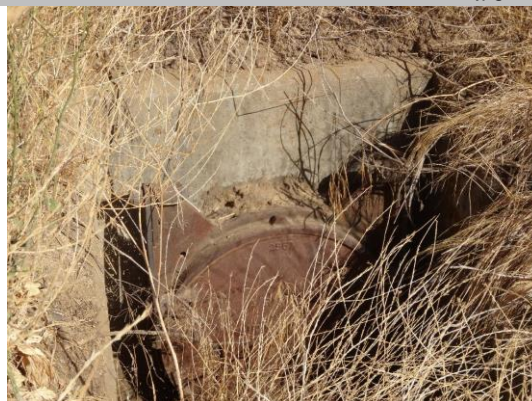
Photo 2 of 2 : UCIP_FA_2016_42993_35309.jpg

WS view: U typed concrete headwall, CM pipe and flap gate. Vegetation and debris need to be cleared.

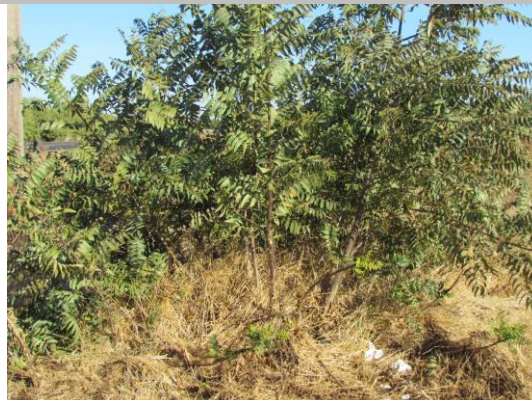
Photo 1 of 1 : FA_2016_NA0013_332_9_20161012_00021.jpg

LM Start	1.63	Rating **	M	Issue No.	9
LM End	1.63	Issue Type +	Ma	Location *	LS
Category	Earthen Levee			GPS Latitude/Longitude	
				Start	End
Item	Encroachments			37.317758 °	37.317758 °
				-120.395750 °	-120.395750 °
DWR ID	DWR_NA0013_02_f_2016_9				
Comment Code					
TR : Tree or limb					
Inspector Comment					
Take out this walnut tree from the landside shoulder.

Unit 2 levee mile 1.63 landside shoulder.

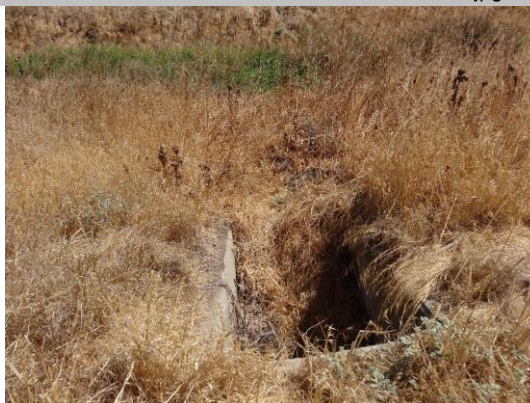
Photo 2 of 2 : UCIP_FA_2016_41815_35532.jpg

LM Start	0.19	Rating **	M	Issue No.	10
LM End	0.19	Issue Type +	En	Location *	CR
Category	Supplemental			GPS Latitude/Longitude	
				Start	End
Item	DWR UCIP Field Study			37.260355 °	37.260355 °
				-120.288517 °	-120.288517 °
DWR ID					
Comment Code					
Inspector Comment					
FS_ID:41815 DS_ID:23060 EP_NO: N/A Repair Type: Non-Urgent Crossing Status: Found UCIP Comments: - more than a half of intet pipe burried on LS. - needs vegetation cleaning on both sides.- inlet needs silt removed and cleaning. FIELD_STRUCT_DESC: 24-inch corrugated metal drainage pipe through the levee, 6.0 feet below the crown, concrete headwall, flap gate, and concrete grouted cobble spillway on the waterward toe, concrete headwall on the landward toe (O&M Unit No. 607, 1962) FS Date: 9/17/2013

WS view: Silt needs to be removed. Vegetations needs to be cleared.

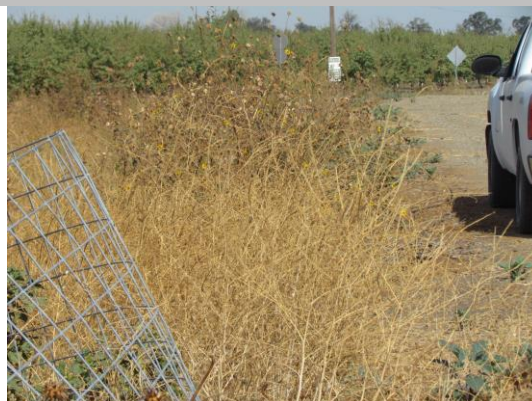
Photo 1 of 1 : FA_2016_NA0013_333_4_20161013_00003.jpg

Unit 3 looking upstream landside slope levee mile 0.40-0.57.

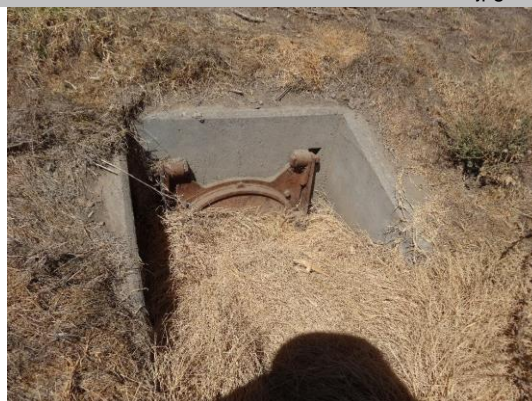
Photo 2 of 2 : UCIP_FA_2016_50152_35543.jpg

Comment Code					
Inspector Comment					
FS_ID:50152 DS_ID:23064 EP_NO: N/A Repair Type: Non-Urgent Crossing Status: Found UCIP Comments: 09/29/2016: WS outlet has been cleared by NA0013. Crossing will be downgraded from Non-Urgent to No Action Needed upon receipt of photo showing cleared LS. (K. Fazel - UCIP)09/2013:- vegetations need to be removed from spillway and outlet at flapgate (blocked). It needs clearing.- more than half of inlet pipe was buried in inlet. It needs cleaning & clearing. (P. Amatya - UCIP) FIELD_STRUCT_DESC: 24-inch corrugated metal drainage pipe through the levee, 5.0 feet below the crown, concrete headwall, flap gate, and concrete grouted cobble spillway on the waterward toe, concrete headwall on the landward toe (O&M Unit No. 607, 1962) FS Date: 9/7/2016

WS view: U typed concrete headwall, CM pipe, and flap gate. Vegetation needs to be cleared.

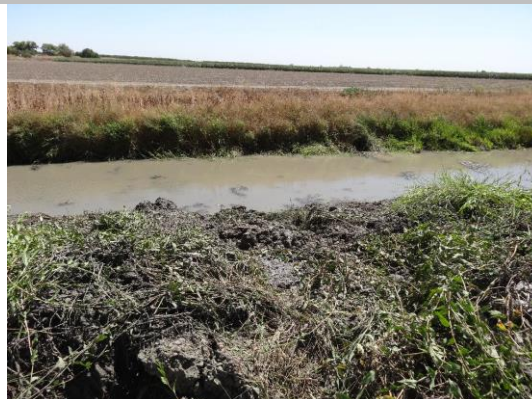
Photo 1 of 2 : UCIP_FA_2016_21063_35502.jpg

LM Start	1.15	Rating **	M	Issue No.	8
LM End	1.15	Issue Type +	En	Location *	LS
Category	Supplemental			GPS Latitude/Longitude	
				Start	End
Item	DWR UCIP Field Study			37.272193 °	37.272193 °
				-120.281805 °	-120.281805 °
DWR ID					
Comment Code					
Inspector Comment					
FS_ID:21063 DS_ID:23065 EP_NO: N/A Repair Type: Non-Urgent Crossing Status: Found UCIP Comments: - mud and debris from recent channel cleaning needs to be removed from spillway and outlet - inlet pipe needs clearing and cleaning on landside. FIELD_STRUCT_DESC: 24-inch corrugated metal drainage pipe through the levee, 6.0 feet below the crown, concrete headwall, flap gate, and concrete grouted cobble spillway on the waterward toe, concrete headwall on the landward toe (O&M Unit No. 607, 1962) FS Date: 9/17/2013

WS view: U typed concrete headwall, CM pipe, and flap gate buried under mud/debris.

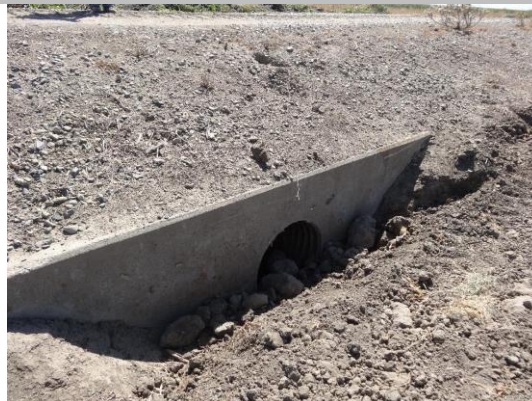
Photo 2 of 2 : UCIP_FA_2016_21063_35501.jpg

LS view: concrete headwall and CM pipe. Inlet needs clearing.

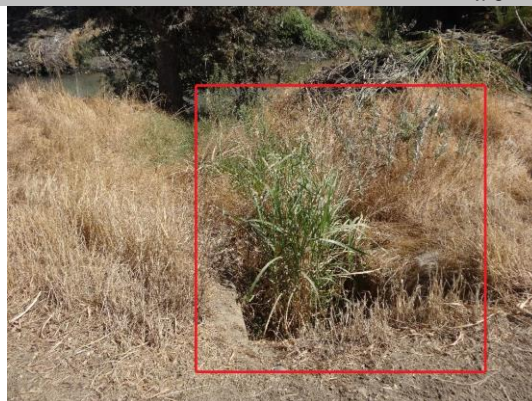
Photo 1 of 2 : UCIP_FA_2016_21064_35506.jpg

LM Start	1.27	Rating **	M	Issue No.	9
LM End	1.27	Issue Type +	En	Location *	LS
Category	Supplemental			GPS Latitude/Longitude	
				Start	End
Item	DWR UCIP Field Study			37.273082 °	37.273082 °
				-120.280288 °	-120.280288 °
DWR ID					
Comment Code					
Inspector Comment					
FS_ID:21064 DS_ID:23066 EP_NO: N/A Repair Type: Non-Urgent Crossing Status: Found UCIP Comments: - needs clearing and cleaning of vegetations on both ends of the pipe.- needs clearing and cleaning of silt deposited inside of the pipe. FIELD_STRUCT_DESC: 24-inch corrugated metal drainage pipe through the levee, 4.0 feet below the crown, concrete headwall, flap gate, and concrete grouted cobble spillway on the waterward toe, concrete headwall on the landward toe (O&M Unit No. 607, 1962 FS Date: 9/17/2013

WS view: cobble spillway and channel on waterside. Dense vegetation on levee slope and spillway.

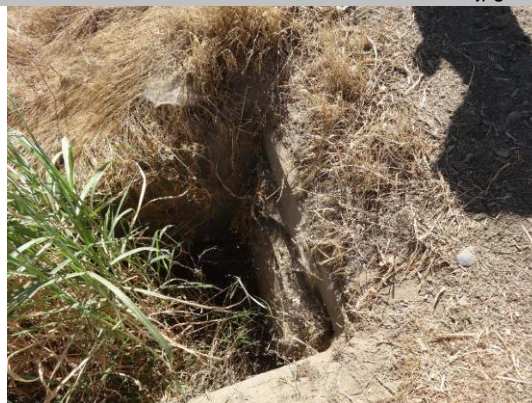
Photo 2 of 2 : UCIP_FA_2016_21064_35505.jpg

WS view: U typed concrete headwall, CM pipe, and flap gate. Vegetation needs to be cleared.

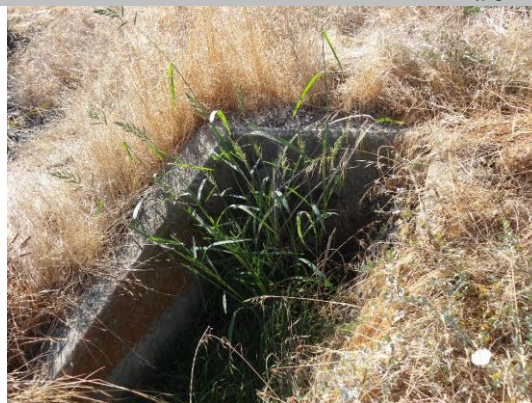
Photo 1 of 2 : UCIP_FA_2016_42991_35751.jpg

LM Start	0.11	Rating **	M	Issue No.	13
LM End	0.11	Issue Type +	En	Location *	WS
Category	Supplemental			GPS Latitude/Longitude	
				Start	End
Item	DWR UCIP Field Study			37.273295 °	37.273295 °
				-120.279673 °	-120.279673 °
DWR ID					
Comment Code					
Inspector Comment					
FS_ID:42991					
DS_ID:23068					
EP_NO: N/A					
Repair Type: Non-Urgent					
Crossing Status: Found					
UCIP Comments: - needs vegetation clearing on both sides. Flapgate blocked by debris on WS. - inlet and outlet need silt clearing and cleaning.					
FIELD_STRUCT_DESC: 24-inch corrugated metal drainage pipe through the levee, 5.0 feet below the crown, concrete headwall, flap gate, and concrete grouted cobble spillway on the waterward toe, concrete headwall on the landward toe (O&M Unit No. 607, 1962)					
FS Date: 9/17/2013

WS view: concrete spillway and channel on waterside. Dense vegetation on levee slope and spillway.

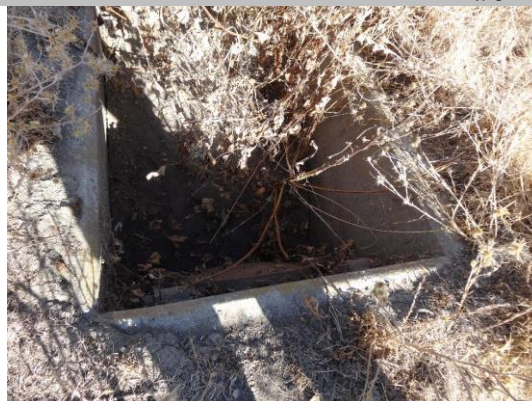
Photo 1 of 2 : UCIP_FA_2016_50146_35748.jpg

FS_ID:50146
DS_ID:23069
EP_NO: N/A
Repair Type: Non-Urgent
Crossing Status: Found
UCIP Comments: 09/29/2016: WS and LS ends have been cleared. Crossing will be downgraded from Non-Urgent to No Action Needed upon receipt of photo showing cleared LS inlet. (K. Fazel - UCIP)09/2013:- needs vegetation clearing on both sides. Flapgate blocked on WS. - inlet pipe needs clearing on landside. (P. Amatya - UCIP)
FIELD_STRUCT_DESC: 24-inch corrugated metal drainage pipe through the levee, 6.0 feet below the crown, concrete headwall, flap gate, and concrete grouted cobble spillway on the waterward toe, concrete headwall on the landward toe (O&M Unit No. 607, 1962)
FS Date: 9/7/2016

WS view: U typed concrete headwall, CM pipe, and flap gate. Vegetation needs to be cleared.

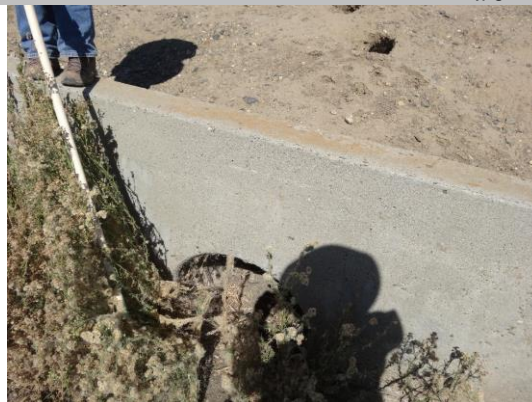
Photo 2 of 2 : UCIP_FA_2016_50146_35747.jpg

LS view: concrete headwall and CM pipe. Inlet needs clearing.

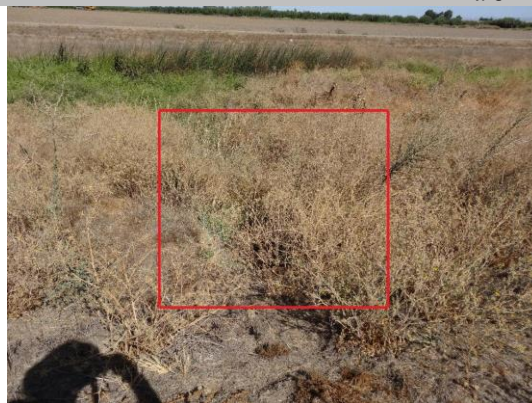
Photo 1 of 2 : UCIP_FA_2016_50154_35608.jpg

Comment Code					
Inspector Comment					
FS_ID:50154					
DS_ID:23070					
EP_NO: N/A					
Repair Type: Non-Urgent					
Crossing Status: Found					
UCIP Comments: 09/29/2016: WS and LS ends have been cleared by Mike Walejko of NA0013. Crossing will be downgraded from Non-Urgent to No Action Needed upon receipt of photo showing cleared LS inlet. (K. Fazel - UCIP)09/2013:- needs vegetation clearing on waterside.- inlet on landside needs clearing. (P. Amatya - UCIP)					
FIELD_STRUCT_DESC: 24-inch corrugated metal drainage pipe through the levee, 6.0 feet below the crown, concrete headwall, flap gate, and concrete grouted cobble spillway on the waterward toe, concrete headwall on the landward toe (O&M Unit No. 607, 1962)					
FS Date: 9/7/2016

WS view: Dense vegetation on levee slope and spillway.

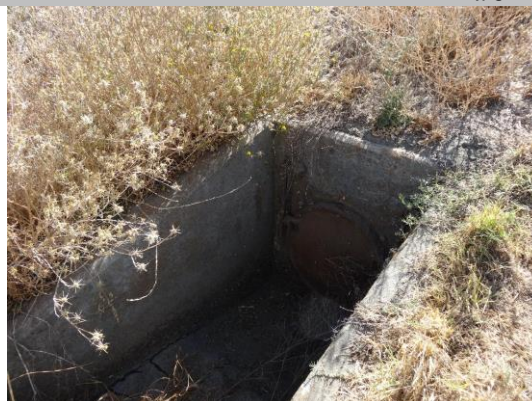
Photo 2 of 2 : UCIP_FA_2016_50154_35607.jpg

WS view: U typed concrete headwall, CM pipe, and flap gate. Vegetation needs to be cleared on spillway.

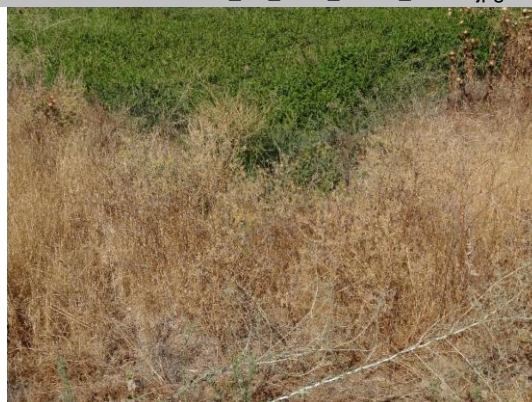
Photo 1 of 2 : UCIP_FA_2016_50155_35642.jpg

LM Start	0.58	Rating **	M	Issue No.	16
LM End	0.58	Issue Type +	En	Location *	LS
Category	Supplemental			GPS Latitude/Longitude	
				Start	End
Item	DWR UCIP Field Study			37.268705 °	37.268705 °
				-120.285546 °	-120.285546 °
DWR ID					
Comment Code					
Inspector Comment					
FS_ID:50155 DS_ID:23072 EP_NO: N/A Repair Type: Non-Urgent Crossing Status: Found UCIP Comments: 09/29/2016: WS cleared by NA0013. Crossing will be downgraded from Non-Urgent to No Action Needed upon receipt of photo showing cleared LS inlet. (K. Fazel - UCIP)09/2013:- needs vegetation clearing on both levee sides. (P. Amatya - UCIP) FIELD_STRUCT_DESC: 24-inch corrugated metal drainage pipe through the levee, 6.0 feet below the crown, concrete headwall, flap gate, and concrete grouted cobble spillway on the waterward toe, concrete headwall on the landward toe (O&M Unit No. 607, 1962) FS Date: 9/7/2016

WS view: Dense vegetation on levee slope and spillway.

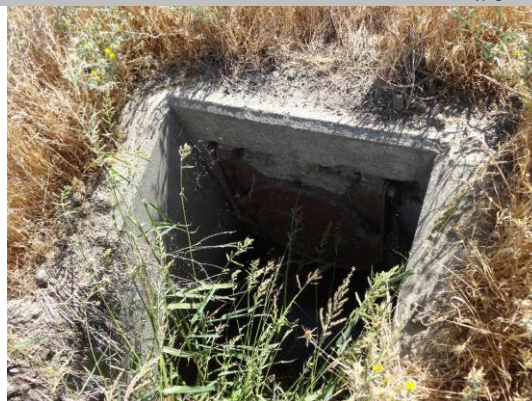
Photo 2 of 2 : UCIP_FA_2016_50155_35641.jpg

WS view: U typed concrete headwall, CM pipe, and flap gate. Vegetation needs to be cleared.

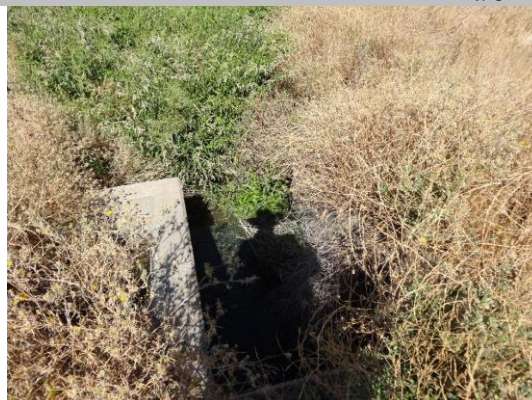
Photo 1 of 2 : UCIP_FA_2016_21126_35652.jpg

WS view: concrete spillway and channel on waterside. Dense vegetation on levee slope and spillway.

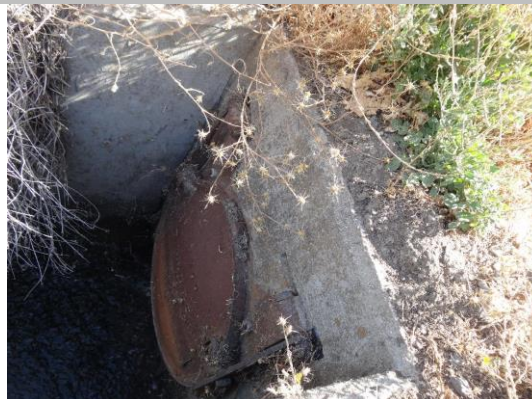
Photo 2 of 2 : UCIP_FA_2016_21126_35651.jpg

WS view: U typed concrete headwall, CM pipe, and flap gate. Vegetation needs to be cleared on spillway.

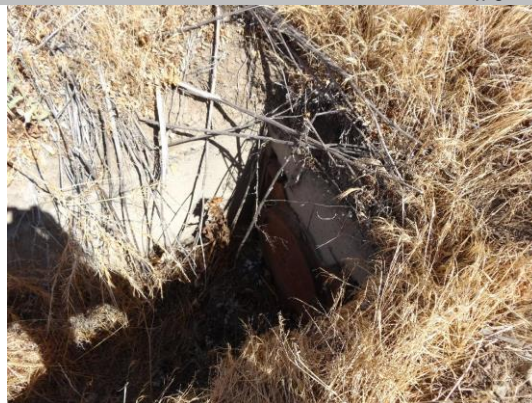
Photo 1 of 2 : UCIP_FA_2016_21210_35709.jpg

WS view: concrete spillway and channel on waterside. Dense vegetation on levee slope and spillway.

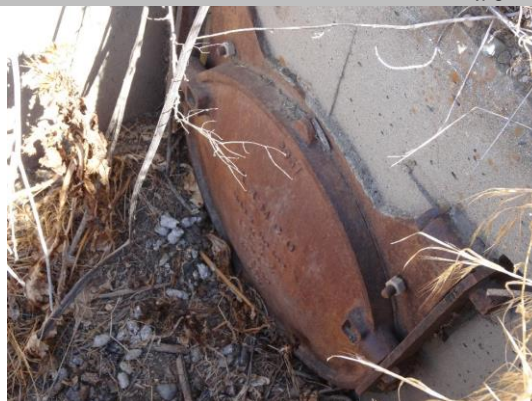
Photo 2 of 2 : UCIP_FA_2016_21210_35708.jpg

WS view: U typed concrete headwall, CM pipe, and flap gate. Spillway needs to be cleared.
