**Flood Control Project Maintenance  
Levee Inspections**

**Fall 2017 Levee Maintenance Deficiency Summary Report**

***San Joaquin River Basin***

**Merced Streams Group**

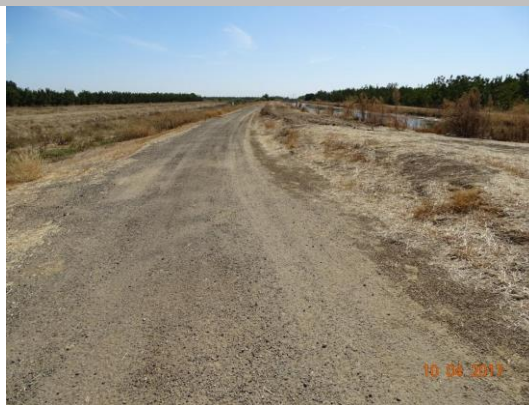
Photo 2 of 2 : FA\_2017\_NA0013\_331\_7\_20171009\_00015.jpg

Crown road is clear of vegetation.

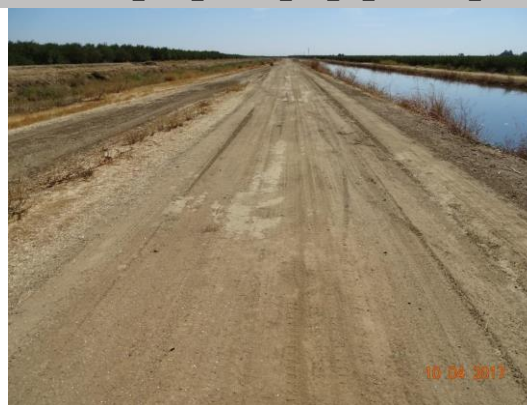
Photo 1 of 1 : FA\_2017\_NA0013\_331\_11\_20171009\_00010.jpg

Crown is clear of weeds.

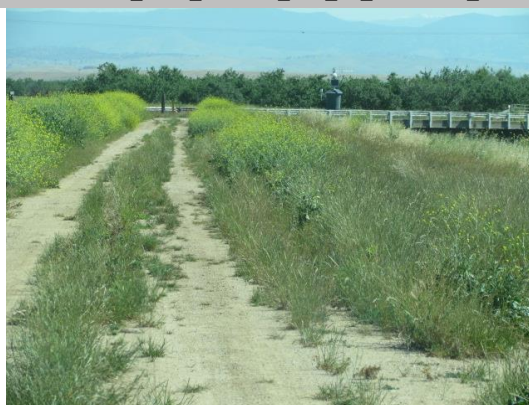
Photo 1 of 2 : FA\_2017\_NA0013\_331\_13\_20171002\_00005.jpg

Looking back upstream from levee mile 1.05-1.61 unwanted weeds present on the crown roadway.

LM Start	<b>1.05</b>	Rating **	A/W	Issue No.	<b>13 (cont)</b>
LM End	<b>1.61</b>	Issue Type +	Ma	Location *	CR

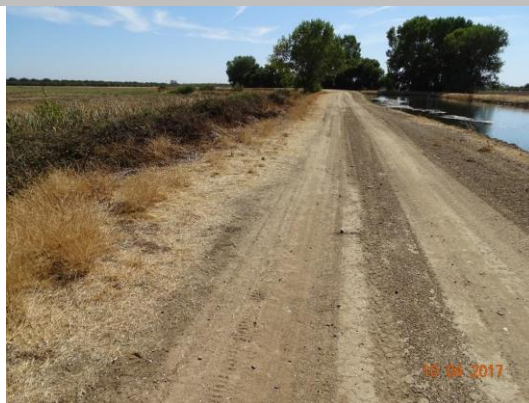
Photo 2 of 2 : FA\_2017\_NA0013\_331\_13\_20171009\_00009.jpg

Crown is cleared of weeds.

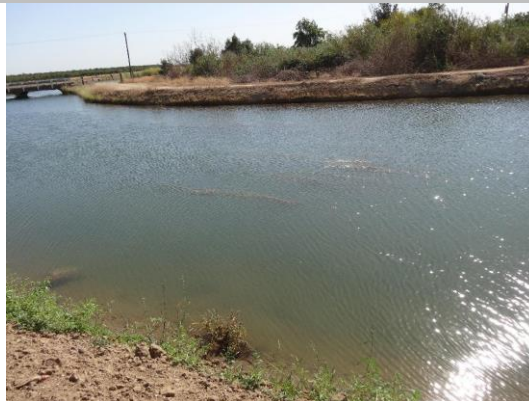
Photo 1 of 3 : UCIP\_FA\_2017\_41672\_35211.jpg

Comment Code					
Inspector Comment					
FS_ID:41672					
DS_ID:23079					
EP_NO: N/A					
Repair Type: Non-Urgent					
Crossing Status: Indicator Found					
UCIP Comments: Verify Pipe is abandoned or still intact.- may be this crossing was abandoned/removed during recent levee reconstruction.- no signs of pipe and appurtenances on waterside.- only a CM pipe riser with slide gate found on landside.					
FIELD_STRUCT_DESC: 36-inch corrugated metal pipe through the levee, 10.0 feet below the crown. Riser on the landward side. Concrete headwall and cobble spillway on the landward toe. Screw gate in a 48-inch pipe well on the waterward slope. Concrete headwall on the waterward toe. [Additional Reference(s): DWR Levee Log, 2005. USACE Sacramento O&M Manual 607, 1962 (HLM 1.305)].					
FS Date: 9/17/2013

WS view: no signs of pipe and appurtenances on levee slope and channel bank.

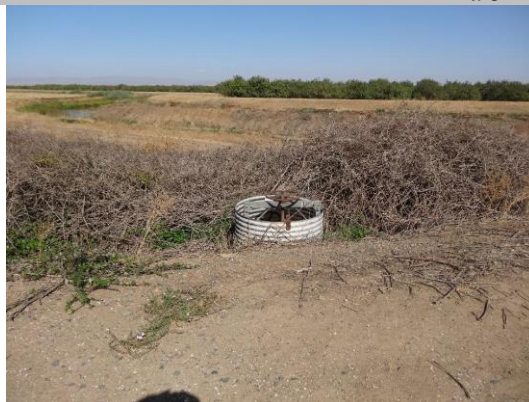
Photo 2 of 3 : UCIP\_FA\_2017\_41672\_35210.jpg

LS view: overview of CM pipe riser with slide gate. Dense vegetation on landside.

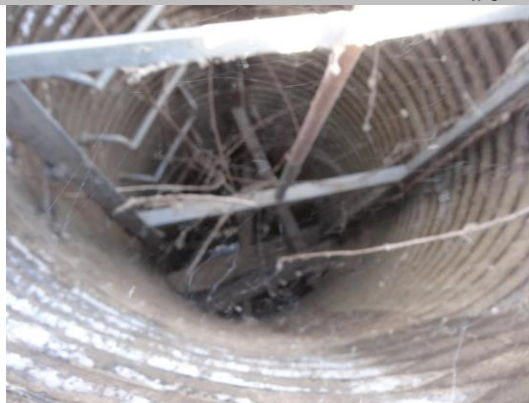
Photo 3 of 3 : UCIP\_FA\_2017\_41672\_35209.jpg

Comment Code						
Inspector Comment						
FS_ID:41672 DS_ID:23079 EP_NO: N/A Repair Type: Non-Urgent Crossing Status: Indicator Found UCIP Comments: Verify Pipe is abandoned or still intact.- may be this crossing was abandoned/removed during recent levee reconstruction.- no signs of pipe and appurtenances on waterside.- only a CM pipe riser with slide gate found on landside. FIELD_STRUCT_DESC: 36-inch corrugated metal pipe through the levee, 10.0 feet below the crown. Riser on the landward side. Concrete headwall and cobble spillway on the landward toe. Screw gate in a 48-inch pipe well on the waterward slope. Concrete headwall on the waterward toe. [Additional Reference(s): DWR Levee Log, 2005. USACE Sacramento O&M Manual 607, 1962 (HLM 1.305)]. FS Date: 9/17/2013

LS view: inside view of CM pipe riser with slide gate.

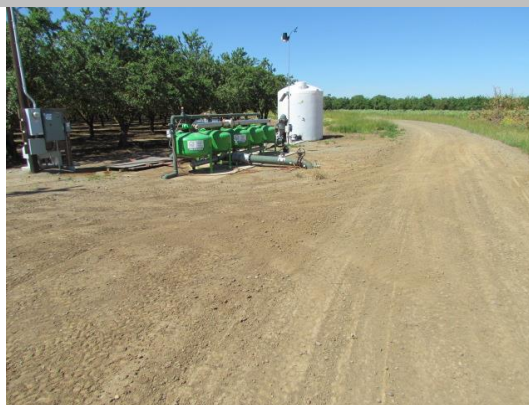
Photo 2 of 3 : FA\_2017\_NA0013\_332\_2\_20171002\_00002.jpg

No Permit for this filtration system and tank on the easement. No change since last inspection.

LM Start	<b>0.00</b>	Rating **	U	Issue No.	<b>2 (cont)</b>
LM End	<b>0.00</b>	Issue Type +	En	Location *	LS

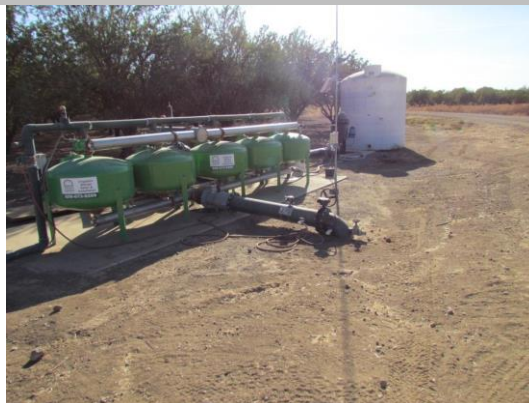
Photo 3 of 3 : FA\_2017\_NA0013\_332\_2\_20171002\_00003.jpg

No Permit for this filtration system and tank on the easement. 2016

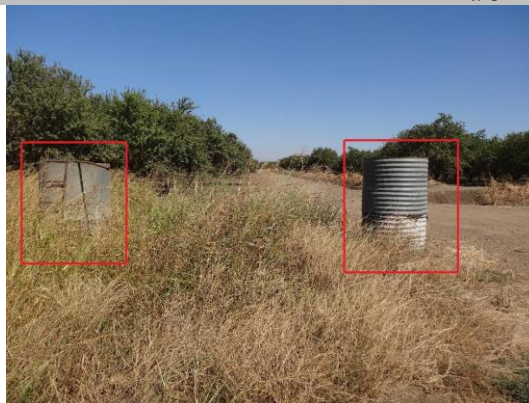
Photo 1 of 3 : UCIP\_FA\_2017\_21263\_35761.jpg

LM Start	0.01	Rating **	M	Issue No.	25	
LM End	0.01	Issue Type +	En	Location *		
Category	Supplemental			GPS Latitude/Longitude		
				Start		End
Item	DWR UCIP Field Study			37.337019 °		37.337019 °
				-120.387539 °		-120.387539 °
DWR ID						
Comment Code						
Inspector Comment						
FS_ID:21263 DS_ID:23052 EP_NO: N/A Repair Type: Non-Urgent Crossing Status: Found UCIP Comments: - needs more investigations on this crossing. - new water filtration plant on LS with pump and concrete vault.- a concrete standpipe and CM pipe riser on WS. FIELD_STRUCT_DESC: 10-inch steel pipe through the levee, 5.0 feet below the crown. Riser on the landward side. Screw gate in a 36-inch pipe well on the waterside (WS) slope. [Additional Reference(s): DWR Levee Log, 2005. USACE Sacramento O&M Manual 607, 1962 (HLM 0.01)]. FS Date: 9/17/2013

WS view: concrete standpipe (left) and CMP standpipe (right).

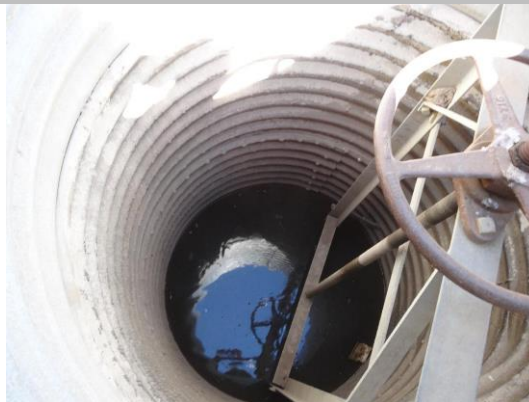
Photo 2 of 3 : UCIP\_FA\_2017\_21263\_35760.jpg

WS view: inside view of CMP standpipe with slide gate.

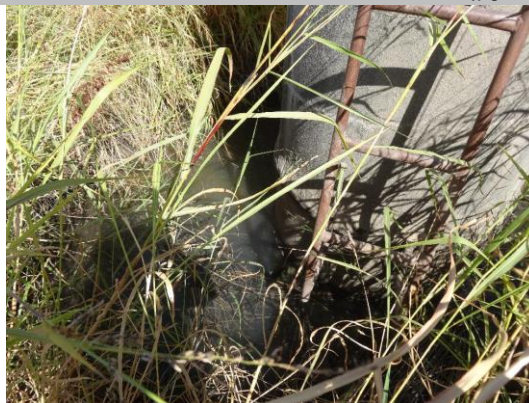
Photo 3 of 3 : UCIP\_FA\_2017\_21263\_35764.jpg

LM Start	0.01	Rating **	M	Issue No.	25 (cont)	
LM End	0.01	Issue Type +	En	Location *		
Category	Supplemental			GPS Latitude/Longitude		
				Start		End
Item	DWR UCIP Field Study			37.337019 °		37.337019 °
				-120.387539 °		-120.387539 °
DWR ID						
Comment Code						
Inspector Comment						
FS_ID:21263 DS_ID:23052 EP_NO: N/A Repair Type: Non-Urgent Crossing Status: Found UCIP Comments: - needs more investigations on this crossing. - new water filtration plant on LS with pump and concrete vault.- a concrete standpipe and CM pipe riser on WS. FIELD_STRUCT_DESC: 10-inch steel pipe through the levee, 5.0 feet below the crown. Riser on the landward side. Screw gate in a 36-inch pipe well on the waterside (WS) slope. [Additional Reference(s): DWR Levee Log, 2005. USACE Sacramento O&M Manual 607, 1962 (HLM 0.01)]. FS Date: 9/17/2013

WS view: concrete standpipe with water ponding at its base.

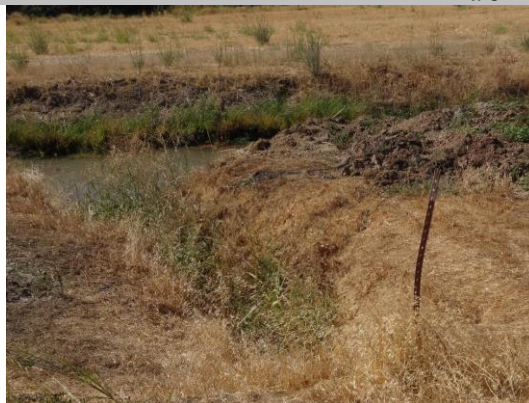
Photo 1 of 3 : UCIP\_FA\_2017\_20946\_35266.jpg

LM Start	0.54	Rating **	M	Issue No.	27
LM End	0.54	Issue Type +	Ma	Location *	
Category	Supplemental			GPS Latitude/Longitude	
				Start	End
Item	DWR UCIP LMA Responsibility			37.333180 °	37.333180 °
				-120.394069 °	-120.394069 °
DWR ID					
Comment Code					
Inspector Comment					
FS_ID:20946 DS_ID:23054 EP_NO: N/A Repair Type: Non-Urgent Crossing Status: Found UCIP Comments: - needs vegetation cleaning on both sides.- flap gate was not properly closed during field survey.- inlet needs cleaning. FIELD_STRUCT_DESC: 24-inch corrugated metal drainage pipe through the levee, 12.0 feet below the crown. Concrete headwall, flap gate, and concrete grouted cobble spillway on the waterward toe. Concrete headwall on the landward toe. [Additional Reference(s): DWR Levee Log, 2005. USACE Sacramento O&M Manual 607, 1962 (HLM 0.5444)]. FS Date: 9/17/2013

WS view: cobble spillway and channel on waterside.

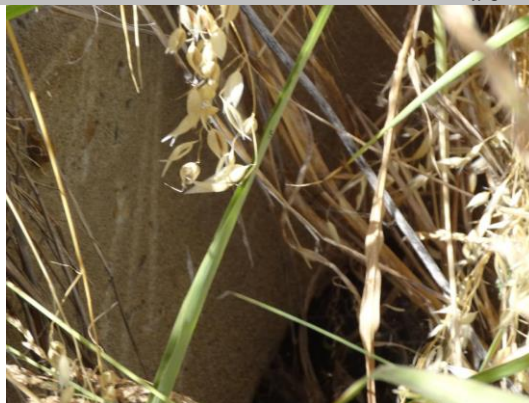
Photo 3 of 3 : UCIP\_FA\_2017\_20946\_35264.jpg

LM Start	0.54	Rating **	M	Issue No.	27 (cont)	
LM End	0.54	Issue Type +	Ma	Location *		
Category	Supplemental			GPS Latitude/Longitude		
				Start		End
Item	DWR UCIP LMA Responsibility			37.333180 °	37.333180 °	
				-120.394069 °	-120.394069 °	
DWR ID						
Comment Code						
Inspector Comment						
FS_ID:20946 DS_ID:23054 EP_NO: N/A Repair Type: Non-Urgent Crossing Status: Found UCIP Comments: - needs vegetation cleaning on both sides.- flap gate was not properly closed during field survey.- inlet needs cleaning. FIELD_STRUCT_DESC: 24-inch corrugated metal drainage pipe through the levee, 12.0 feet below the crown. Concrete headwall, flap gate, and concrete grouted cobble spillway on the waterward toe. Concrete headwall on the landward toe. [Additional Reference(s): DWR Levee Log, 2005. USACE Sacramento O&M Manual 607, 1962 (HLM 0.5444)]. FS Date: 9/17/2013

LS view: concrete headwall and CM pipe. Inlet needs cleaning.

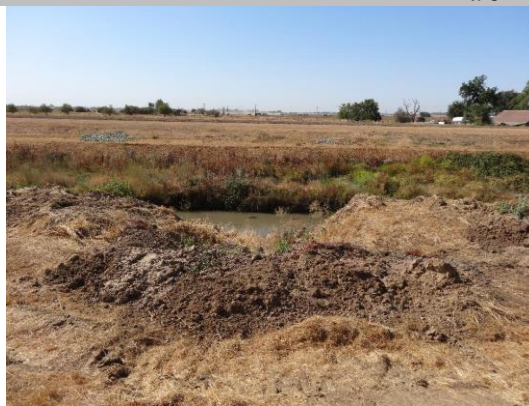
Photo 1 of 3 : UCIP\_FA\_2017\_20992\_35370.jpg

Comment Code						
Inspector Comment						
FS_ID:20992 DS_ID:23055 EP_NO: N/A Repair Type: Non-Urgent Crossing Status: Found UCIP Comments: - mud and debris from recent channel cleaning needs to be removed from spillway and outlet - pipe filled with debris, it needs cleaning.- half of intet pipe burried. FIELD_STRUCT_DESC: 24-inch corrugated metal drainage pipe through the levee, 8.0 feet below the crown. Concrete headwall, flap gate, and concrete grouted cobble spillway on the waterward toe. Concrete headwall on the landward toe. [Additional Reference(s): DWR Levee Log, 2005. USACE Sacramento O&M Manual 607, 1962 (HLM 0.747)]. FS Date: 9/17/2013

WS view: concrete headwall and CM pipe burried under debris and mud.

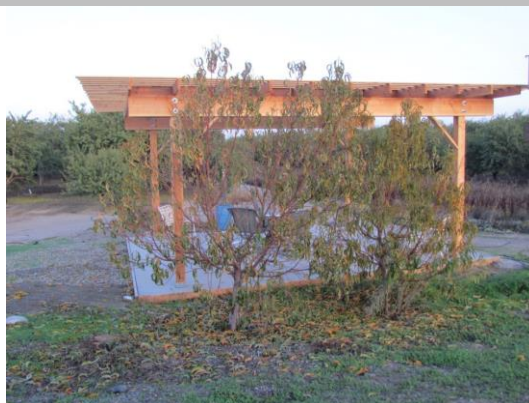
Photo 2 of 4 : FA\_2017\_NA0013\_332\_24\_20171002\_00007.jpg

Another view of unauthorized structure.

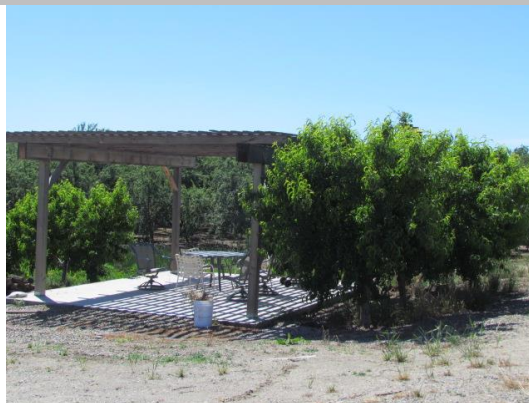
Photo 4 of 4 : FA\_2017\_NA0013\_332\_24\_20171002\_00009.jpg

No change 5-2017.

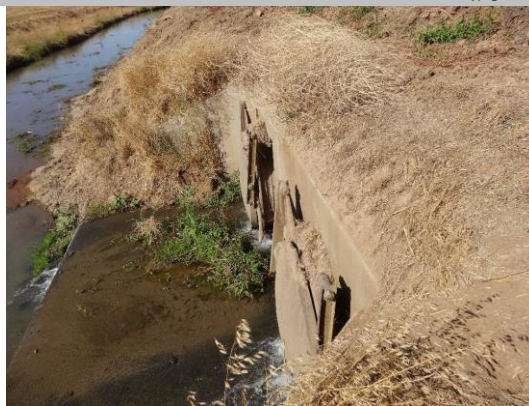
Photo 1 of 3 : UCIP\_FA\_2017\_20965\_35292.jpg

LM Start	0.90	Rating **	A/W	Issue No.	29
LM End	0.90	Issue Type +	Ma	Location *	
Category	Supplemental			GPS Latitude/Longitude	
				Start	End
Item	DWR UCIP LMA Responsibility			37.328283 °	37.328283 °
				-120.396074 °	-120.396074 °
DWR ID					
Comment Code					
Inspector Comment					
FS_ID:20965 DS_ID:23056 EP_NO: N/A Repair Type: No Action Needed Crossing Status: Found UCIP Comments: - working during field inspection.- vegetation on drainage ditch/channel FIELD_STRUCT_DESC: 1 of 2: 60-inch corrugated metal drainage pipe through the levee, 10.0 feet below the crown. Concrete headwall and flap gate on the waterward berm. 5 feet from the levee toe. Concrete headwall on the landward toe. [Additional Reference(s): DWR Levee Log, 2005. USACE Sacramento O&M Manual 607, 1962 (HLM 0.9175)]. FS Date: 9/17/2013

WS view: two 60" CMPs, flap gates, and headwall on channel bank.

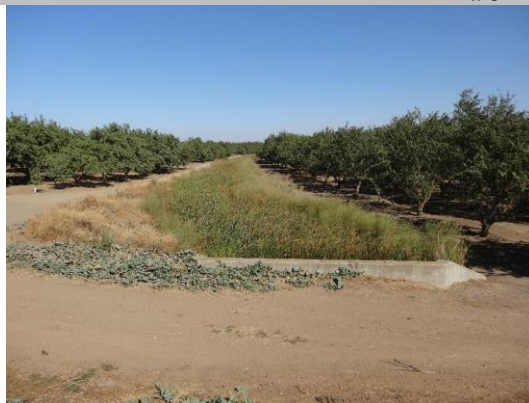
Photo 2 of 3 : UCIP\_FA\_2017\_20965\_35291.jpg

LM Start	0.90	Rating **	A/W	Issue No.	29 (cont)	
LM End	0.90	Issue Type +	Ma	Location *		
Category	Supplemental			GPS Latitude/Longitude		
				Start	End	
Item	DWR UCIP LMA Responsibility			37.328283 °	37.328283 °	
				-120.396074 °	-120.396074 °	
DWR ID						
Comment Code						
Inspector Comment						
FS_ID:20965 DS_ID:23056 EP_NO: N/A Repair Type: No Action Needed Crossing Status: Found UCIP Comments: - working during field inspection.- vegetation on drainage ditch/channel FIELD_STRUCT_DESC: 1 of 2: 60-inch corrugated metal drainage pipe through the levee, 10.0 feet below the crown. Concrete headwall and flap gate on the waterward berm. 5 feet from the levee toe. Concrete headwall on the landward toe. [Additional Reference(s): DWR Levee Log, 2005. USACE Sacramento O&M Manual 607, 1962 (HLM 0.9175)]. FS Date: 9/17/2013

LS view: headwall on levee toe. Green vegetation in drainage channel.

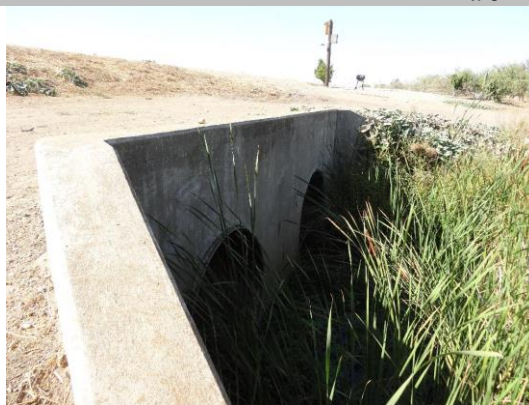
Photo 3 of 3 : UCIP\_FA\_2017\_20965\_35290.jpg

LS view: two CM pipes and U typed headwall on levee toe. Green vegetation in drainage channel.

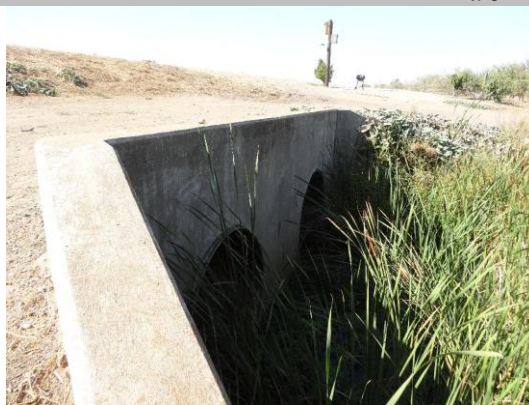
Photo 2 of 3 : UCIP\_FA\_2017\_20983\_35301.jpg

LM Start	0.91	Rating **	A/W	Issue No.	30
LM End	0.91	Issue Type +	Ma	Location *	
Category	Supplemental			GPS Latitude/Longitude	
				Start	End
Item	DWR UCIP LMA Responsibility			37.328267 °	37.328267 °
				-120.396084 °	-120.396084 °
DWR ID					
Comment Code					
Inspector Comment					
FS_ID:20983 DS_ID:23080 EP_NO: N/A Repair Type: No Action Needed Crossing Status: Found UCIP Comments: It was working during field inspection. Dense vegetation in drainage ditch. FIELD_STRUCT_DESC: 2 of 2: 60-inch corrugated metal drainage pipe through the levee, 10.0 feet below the crown. Concrete headwall and flap gate on the waterward berm. 5 feet from the levee toe. Concrete headwall on the landward toe. [Additional Reference(s): DWR Levee Log, 2005. USACE Sacramento O&M Manual 607, 1962 (HLM 0.9186)]. FS Date: 9/17/2013

LS view: U typed concrete headwall, two CMPs in drainage ditch. Dense vegetation in drainage ditch.

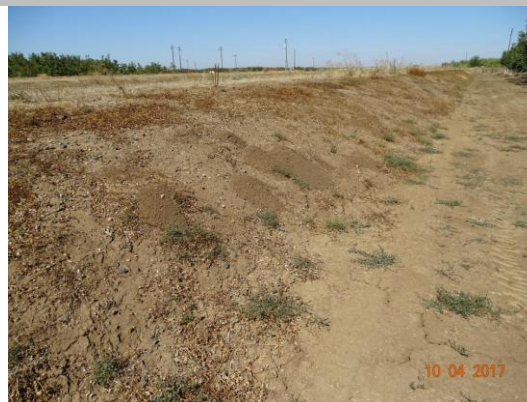
Photo 1 of 1 : FA\_2017\_NA0013\_332\_18\_20171009\_00055.jpg

Rodent activity on LS slope.

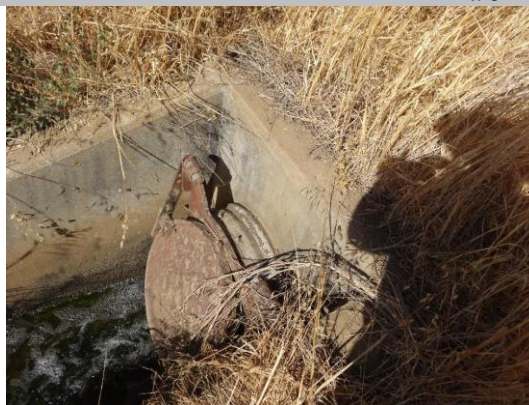
Photo 2 of 3 : UCIP\_FA\_2017\_20984\_35304.jpg

WS view: U typed concrete headwall, CM pipe, and flap gate. It was working during field inspection.

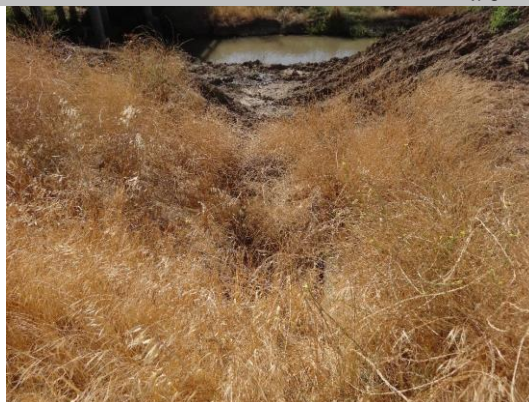
Photo 1 of 3 : UCIP\_FA\_2017\_42993\_35310.jpg

WS view: overview of outlet area and channel. Debris and vegetations on spillway.

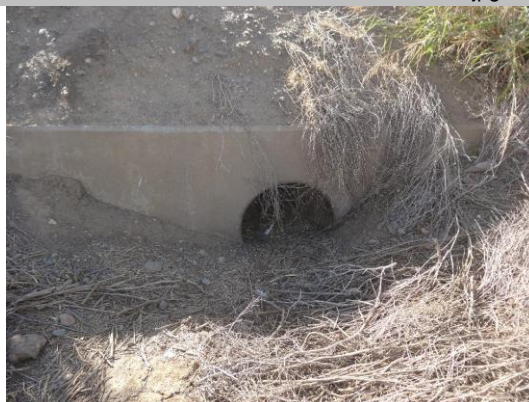
Photo 3 of 3 : UCIP\_FA\_2017\_42993\_35312.jpg

LS view: concrete headwall and CM pipe. Inlet needs cleaning. Part of inlet pipe buried.

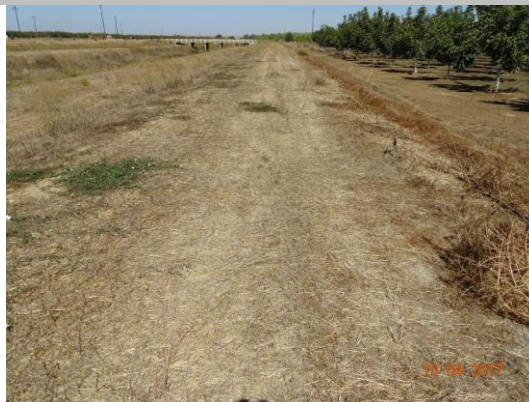
Photo 2 of 2 : FA\_2017\_NA0013\_332\_17\_20171009\_00056.jpg

Crown and slopes have been mowed to allow visibility and access.

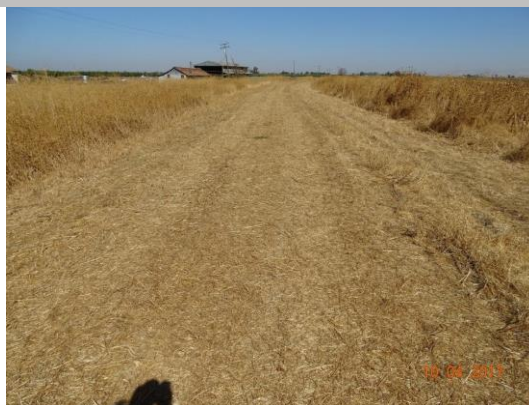
Photo 2 of 2 : FA\_2017\_NA0013\_333\_13\_20171009\_00045.jpg

Tall weeds cut LS and WS.

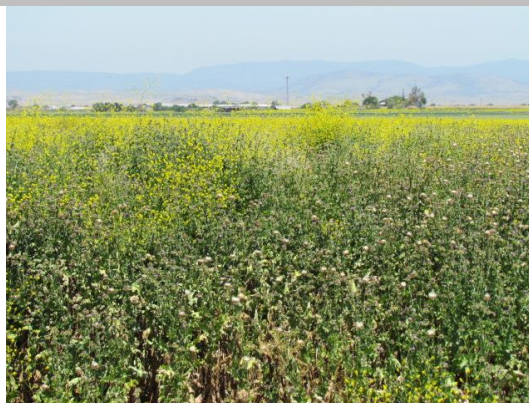
Photo 1 of 2 : FA\_2017\_NA0013\_333\_12\_20171002\_00001.jpg

Owens Creek levee mile 0.00 -1.40, unsatisfactory growth of weeds has completely taken over the levee section.

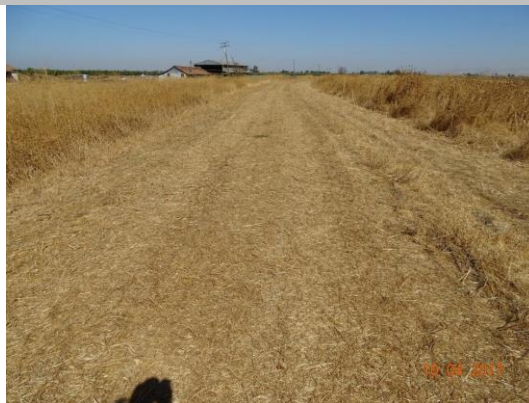
Photo 2 of 2 : FA\_2017\_NA0013\_333\_12\_20171009\_00046.jpg

Tall weeds cut LS and WS.

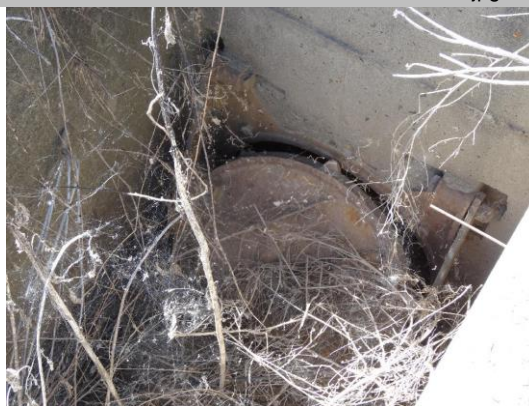
Photo 2 of 3 : UCIP\_FA\_2017\_50144\_35421.jpg

WS view: U typed concrete headwall, CM pipe, and flap gate. Damaged flap gate.

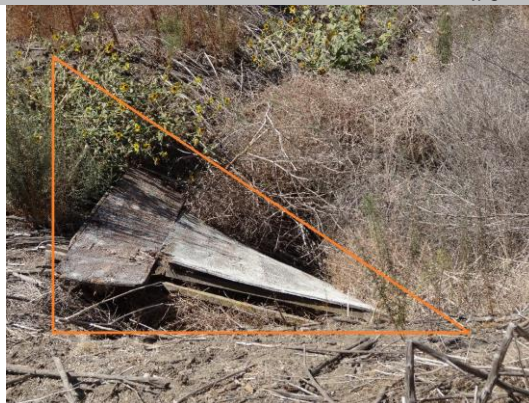
Photo 3 of 3 : UCIP\_FA\_2017\_50144\_35420.jpg

LS view: Debris dumped on inlet structure. Needs to be cleared or abandoned properly.

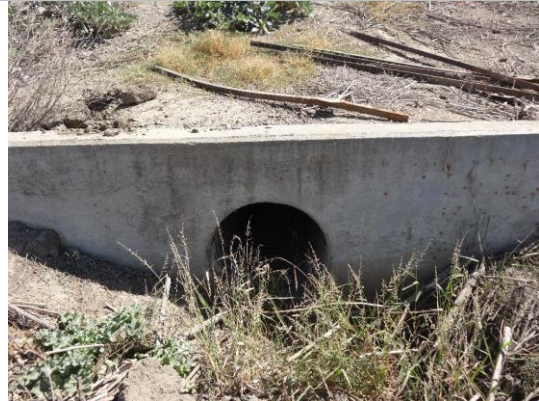
Photo 3 of 3 : UCIP\_FA\_2017\_50149\_35537.jpg

LS view: concrete headwall and CM pipe. Inlet needs clearing.

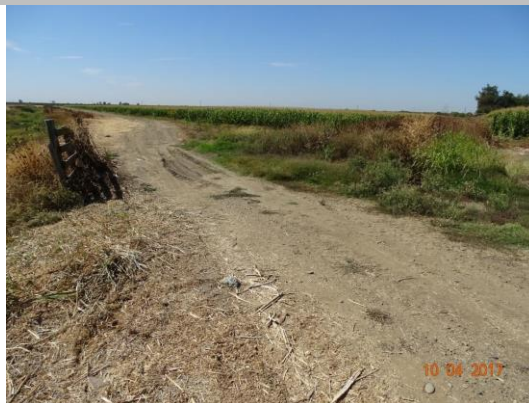
Photo 1 of 1 : FA\_2017\_NA0013\_333\_9\_20171009\_00047.jpg

Repair rutted crossing over storm drain. Restore grade and add gravel.

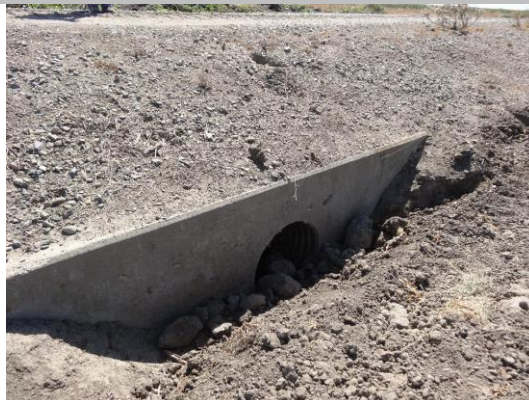
Photo 2 of 3 : UCIP\_FA\_2017\_21063\_35501.jpg

LS view: concrete headwall and CM pipe. Inlet needs clearing.

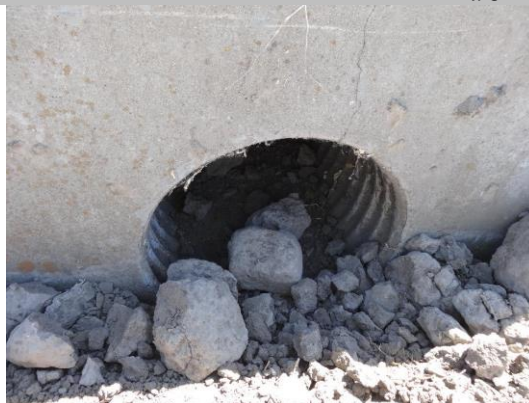
Photo 3 of 3 : UCIP\_FA\_2017\_21063\_35500.jpg

LS view: closer view of CM pipe. Inlet needs cleaning & clearing.

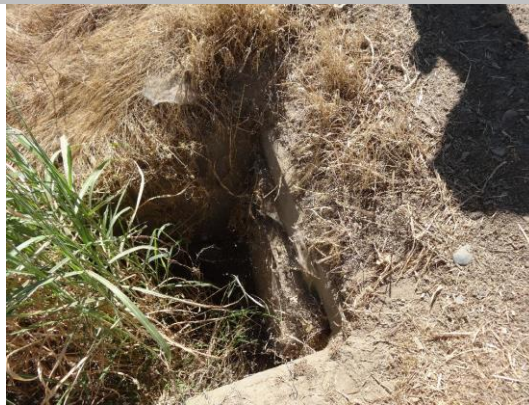
Photo 2 of 3 : UCIP\_FA\_2017\_21064\_35505.jpg

WS view: U typed concrete headwall, CM pipe, and flap gate. Vegetation needs to be cleared.

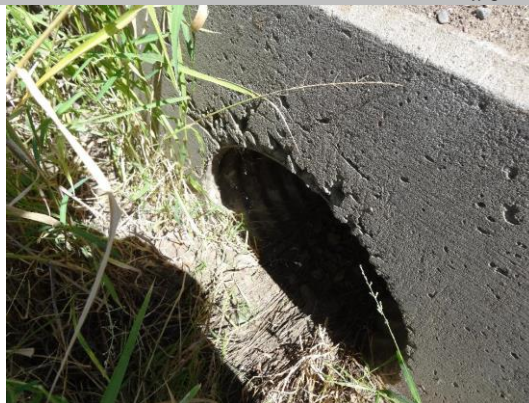
Photo 3 of 3 : UCIP\_FA\_2017\_21064\_35504.jpg

LS view: concrete headwall and CM pipe. Inlet needs clearing.

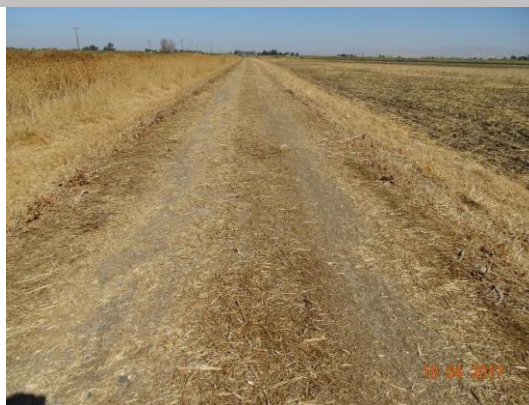
Photo 2 of 2 : FA\_2017\_NA0013\_334\_11\_20171009\_00057.jpg

Tall weeds cut LS and WS.

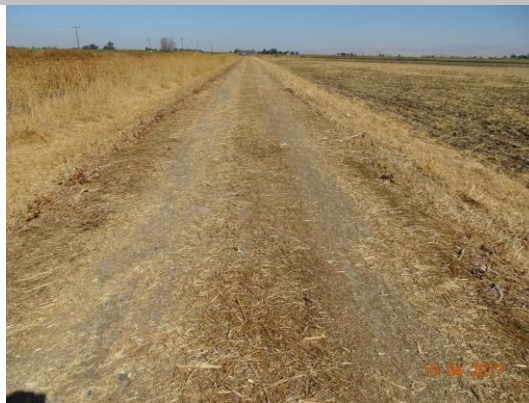
Photo 2 of 2 : FA\_2017\_NA0013\_334\_12\_20171009\_00058.jpg

Tall weeds cut LS and WS.

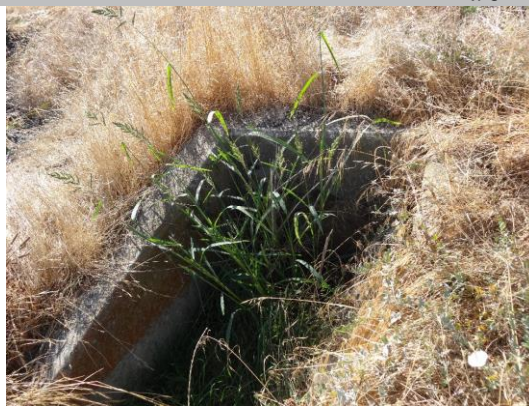
Photo 1 of 3 : UCIP\_FA\_2017\_42991\_35751.jpg

WS view: concrete spillway and channel on waterside. Dense vegetation on levee slope and spillway.

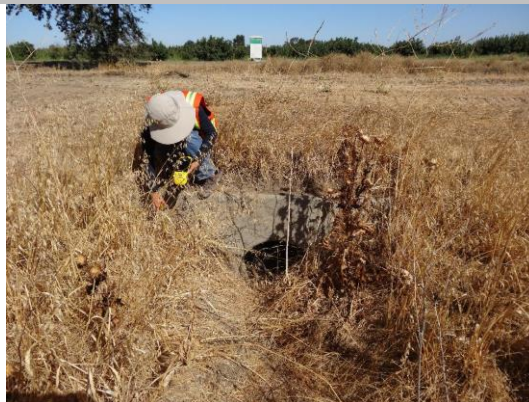
Photo 3 of 3 : UCIP\_FA\_2017\_42991\_35749.jpg

LS view: concrete headwall and CM pipe. Inlet silt needs clearing.

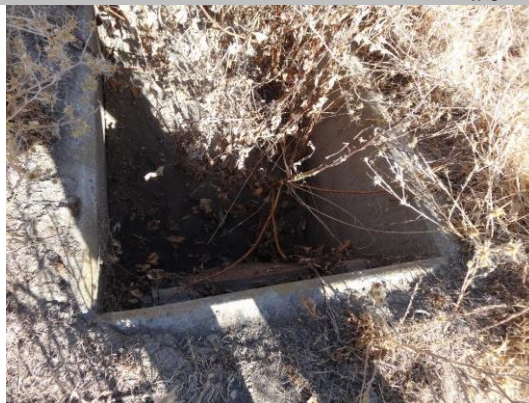
Photo 1 of 3 : UCIP\_FA\_2017\_50146\_35748.jpg

WS view: U typed concrete headwall, CM pipe, and flap gate. Vegetation needs to be cleared.

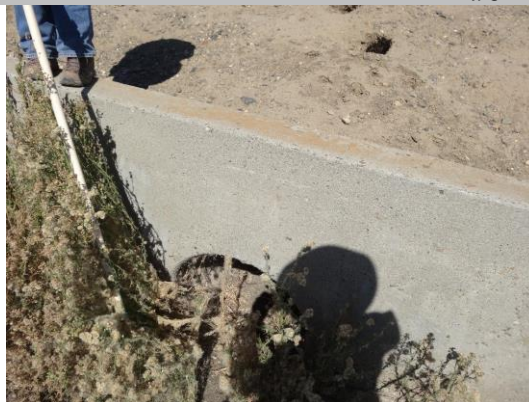
Photo 2 of 3 : UCIP\_FA\_2017\_50146\_35747.jpg

LS view: concrete headwall and CM pipe. Inlet needs clearing.

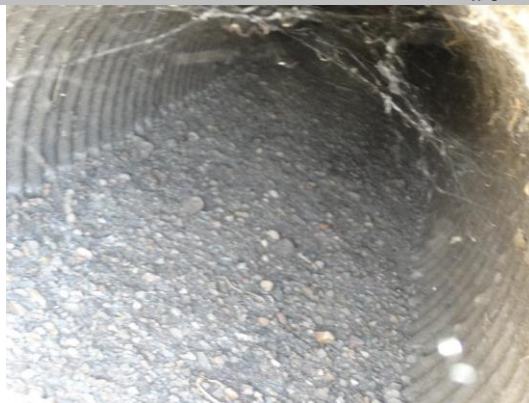
Photo 3 of 3 : UCIP\_FA\_2017\_50146\_35746.jpg

LS view: inside view of CM pipe. Inlet pipe needs clearing.

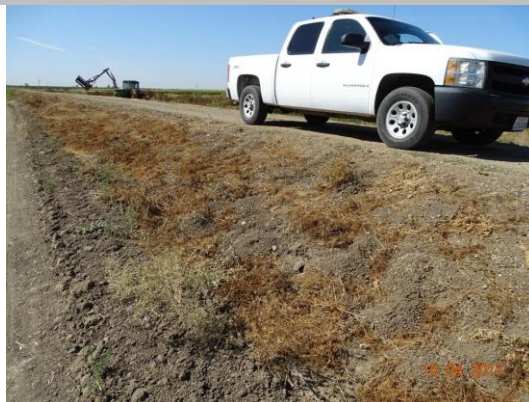
Photo 1 of 1 : FA\_2017\_NA0013\_334\_10\_20171009\_00060.jpg

Numerous rodent holes on LS slope.

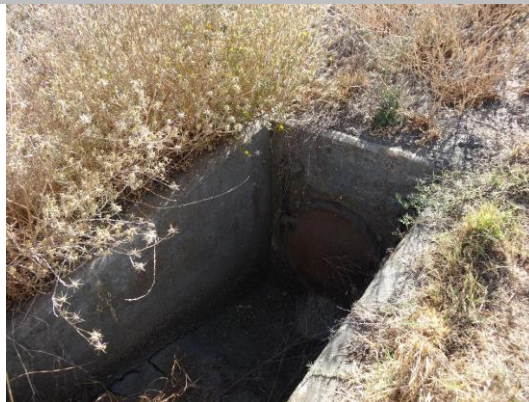
Photo 2 of 3 : UCIP\_FA\_2017\_50154\_35607.jpg

WS view: U typed concrete headwall, CM pipe, and flap gate. Vegetation needs to be cleared on spillway.

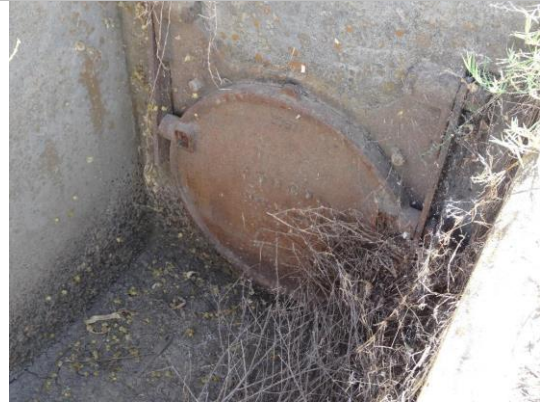
Photo 3 of 3 : UCIP\_FA\_2017\_50154\_35606.jpg

WS view: CM pipe and flap gate. Vegetation needs to be cleared.

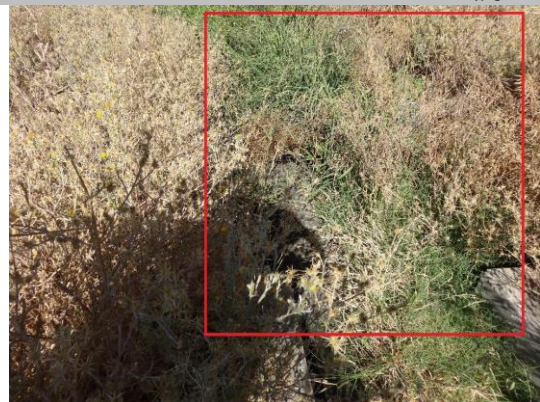
Photo 1 of 3 : UCIP\_FA\_2017\_50148\_35613.jpg

WS view: Dense vegetation on levee slope and spillway.

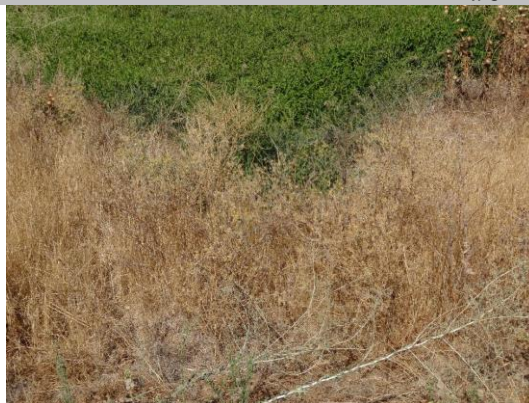
Photo 1 of 3 : UCIP\_FA\_2017\_50155\_35642.jpg

WS view: Dense vegetation on levee slope and spillway.

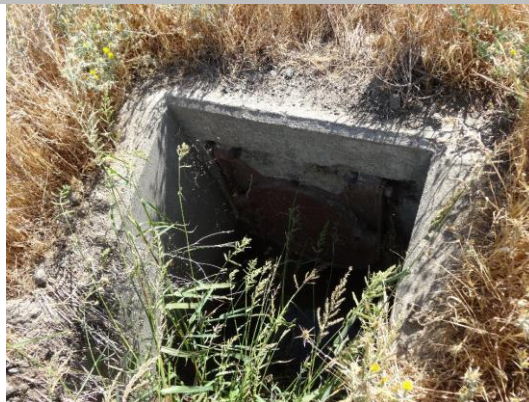
Photo 2 of 3 : UCIP\_FA\_2017\_50155\_35641.jpg

WS view: U typed concrete headwall, CM pipe, and flap gate. Vegetation needs to be cleared.

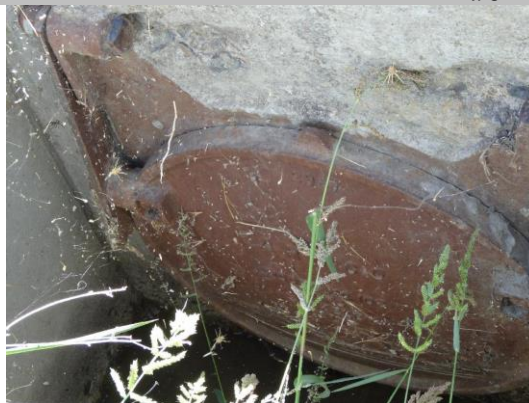
Photo 3 of 3 : UCIP\_FA\_2017\_50155\_35640.jpg

WS view: CM pipe and flap gate. Vegetation needs to be cleared.

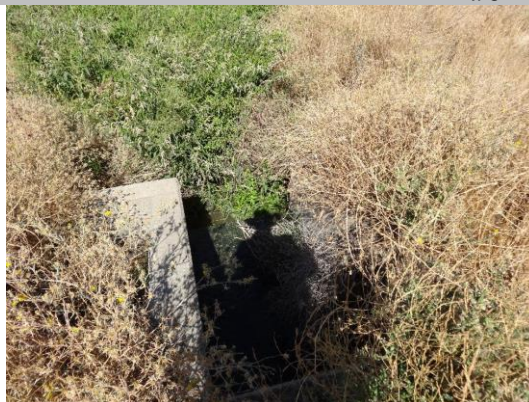
Photo 1 of 3 : UCIP\_FA\_2017\_21126\_35652.jpg

WS view: concrete spillway and channel on waterside. Dense vegetation on levee slope and spillway.

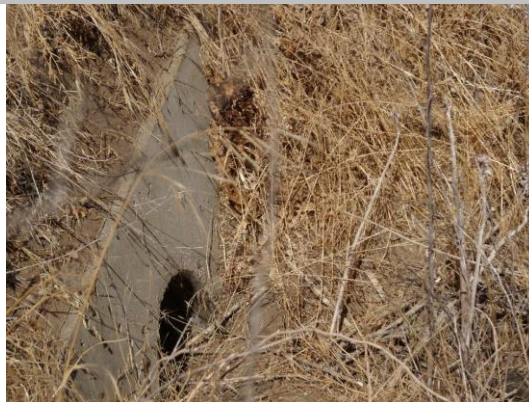
Photo 3 of 3 : UCIP\_FA\_2017\_21210\_35707.jpg

LS view: concrete headwall and CM pipe. Inlet silt needs clearing.

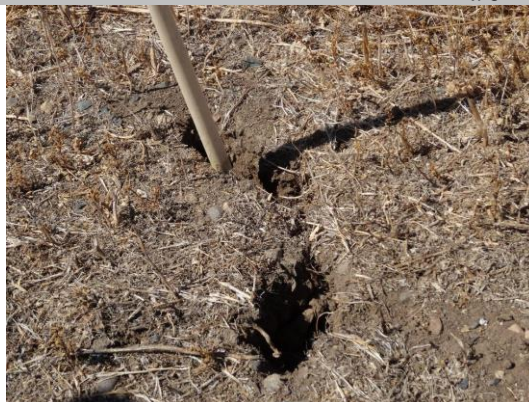
Photo 2 of 3 : UCIP\_FA\_2017\_50153\_35744.jpg

WS view: significant levee cracks along the pipealignment. Needs detailed investigation on the issue.

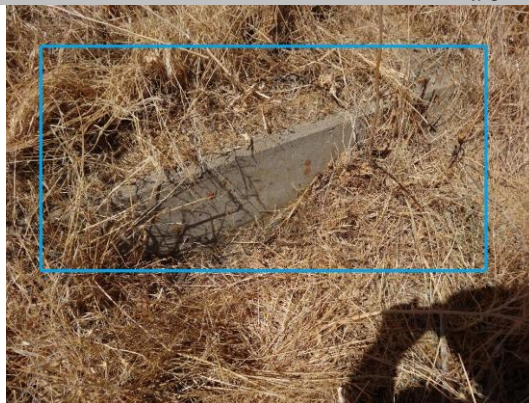
Photo 3 of 3 : UCIP\_FA\_2017\_50153\_35743.jpg

LS view: concrete headwall and buried CM pipe. Dirt removal and clearing needed in inlet.
