**Flood Control Project Maintenance  
Levee Inspections**

**Fall 2018 Levee Maintenance Deficiency Summary Report**

***San Joaquin River Basin***

<b>NA0013</b>	Overall LMA Rating	Total LMA Miles						
<b>Merced Streams Group</b>	<b>U</b>	<b>6.31</b>						
Rated Item	Maintenance Deficiency				Enforcement		Design & System Obsolescence	
	M Miles	U Miles	M + 4U Miles	Threshold %	M Miles	U Miles	M Miles	U Miles
<i>Earthen Levee</i>								
Vegetation	0.62	1.09	4.98	78.96%				
Trim / Thin Trees	0.02		0.02	0.32%				
Encroachments	0.01		0.01	0.16%	0.23	0.02		
Animal Control	1.08		1.08	17.12%				
Slope Stability	0.01		0.01	0.16%				
Erosion / Bank Caving	0.02		0.02	0.32%				
Crown Surface / Depressions / Rutting	1.22		1.22	19.34%				
<i>Supplemental</i>								
DWR UCIP Field Study					0.02			
DWR UCIP LMA Responsibility								
<i>LMA Totals:</i>	2.98	1.09	7.34	116.38%	0.25	0.02	0.00	0.00
<b>Unit No. 01 Black Rascal Diversion RB</b>	Overall Unit Rating	Total Unit Miles						
<b>NA0013</b>	<b>M</b>	<b>1.61</b>						
Rated Item	Maintenance Deficiency				Enforcement		Design & System Obsolescence

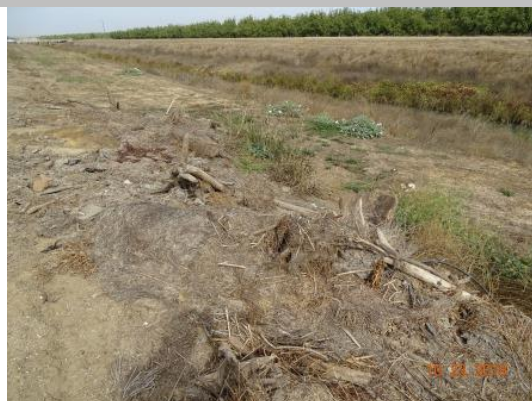
Photo 1 of 1 : FA\_2018\_NA0013\_331\_11\_20181108\_00007.jpg

Debris and garbage along waterside slope. (Fall 2018)

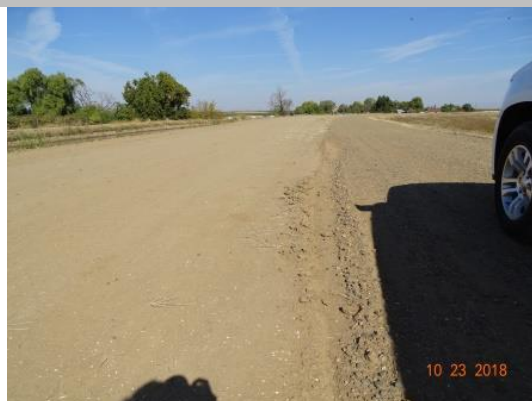
Photo 1 of 2 : FA\_2018\_NA0013\_331\_8\_20181108\_00010.jpg

LM Start	0.27	Rating **	A/W	Issue No.	8
LM End	1.62	Issue Type +	Ma	Location *	CR
Category	Earthen Levee			GPS Latitude/Longitude	
				Start	End
Item	Crown Surface / Depressions / Rutting			37.318525 °	37.337176 °
				-120.396598 °	-120.396531 °
DWR ID	DWR_NA0013_01_s_2018_8				
Comment Code					
C2 : Repair depressions or ruts in the crown or slope.					
Inspector Comment					
vehicle tracks and rutting on crown

View of vehicle tracks on levee crown. (Fall 2018)

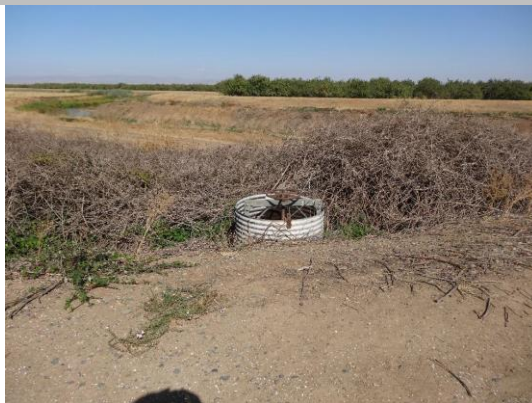
Photo 2 of 3 : UCIP\_FA\_2018\_41672\_35210.jpg

Comment Code						
Inspector Comment						
FS_ID:41672 DS_ID:23079 EP_NO: N/A Repair Type: Non-Urgent Crossing Status: Indicator Found UCIP Comments: 09/17/2013 Verify Pipe is abandoned or still intact.- may be this crossing was abandoned/removed during recent levee reconstruction.- no signs of pipe and appurtenances on waterside.- only a CM pipe riser with slide gate found on landside. (DWR UCIP - P. Amatya) FIELD_STRUCT_DESC: 36-inch corrugated metal irrigation pipe through the levee, 10 feet below the crown. Riser on the landside (LS). Screw gate in a 48-inch pipe well on the waterside (WS) slope. Concrete headwall and cobble spillway at the LS toe. Concrete headwall at the WS toe. [Additional Reference(s): USACE San Joaquin O&M Manual 607, June 1962, (HLM 1.32)]. FS Date: 9/17/2013

LS view: overview of CM pipe riser with slide gate. Dense vegetation on landside.

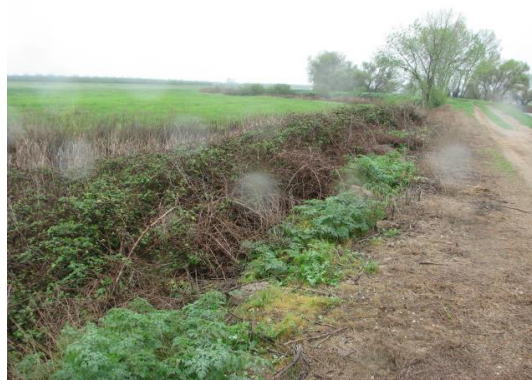
Photo 2 of 2 : FA\_2018\_NA0013\_331\_7\_20180905\_00002.jpg

Looking downstream at wildroses on waterward slope. (Spring 2018)

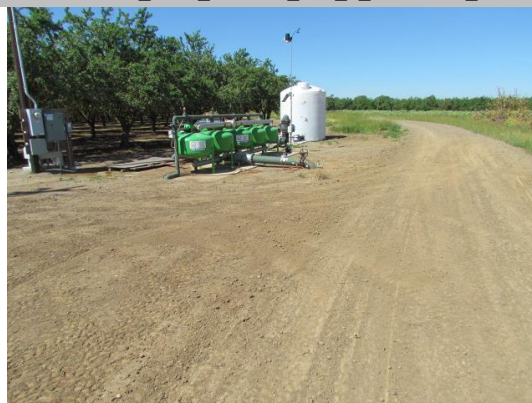
Photo 2 of 3 : FA\_2018\_NA0013\_332\_2\_20180905\_00002.jpg

No Permit for this filtration system and tank on the easement. No change since last inspection.

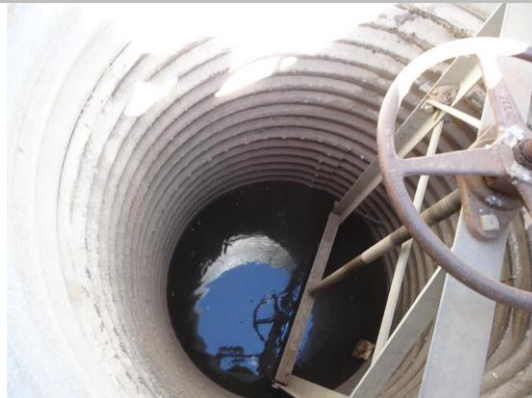
Photo 2 of 3 : UCIP\_FA\_2018\_21263\_35760.jpg

Comment Code						
Inspector Comment						
FS_ID:21263						
DS_ID:23052						
EP_NO: N/A						
Repair Type: Non-Urgent						
Crossing Status: Found						
UCIP Comments: 09/17/2013 - needs more investigations on this crossing. - new water filtration plant on LS with pump and concrete vault.- a concrete standpipe and CM pipe riser on WS. (DWR UCIP - P. Amatya)						
FIELD_STRUCT_DESC: 10-inch steel irrigation pipe through the levee, 5 feet below the crown. Riser on the landside (LS). Screw gate in a 36-inch pipe well on the waterside (WS) slope. [Additional Reference(s): DWR Levee Log, 2005. USACE San Joaquin O&M Manual 607, June 1962, (HLM 0.00)].						
FS Date: 9/17/2013

WS view: inside view of CMP standpipe with slide gate.

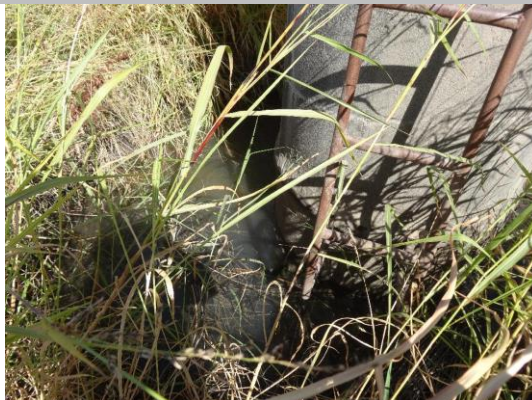
Photo 3 of 3 : UCIP\_FA\_2018\_21263\_35764.jpg

WS view: concrete standpipe with water ponding at its base.

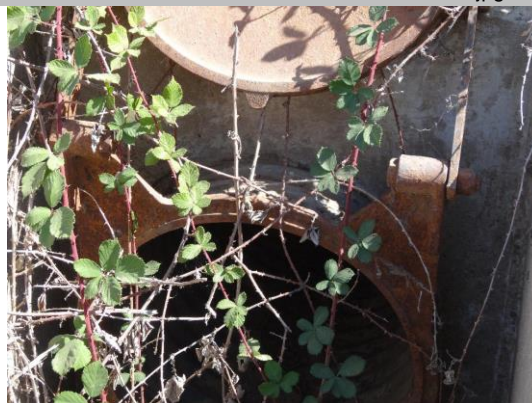
Photo 2 of 3 : UCIP\_FA\_2018\_50156\_35244.jpg

WS view: U typed concrete headwall, CM pipe, and flap gate. Flap gate was not closed. Vegetation needs to be cleared.

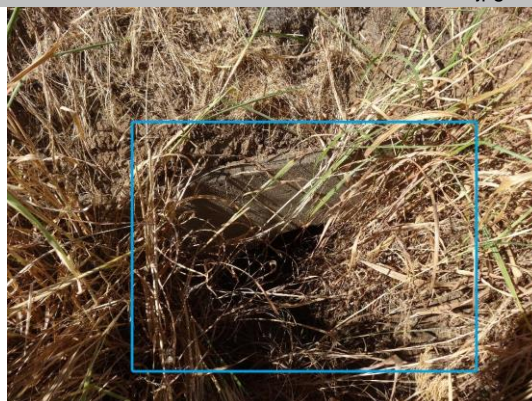
Photo 3 of 3 : UCIP\_FA\_2018\_50156\_35246.jpg

LS view: concrete headwall and CM pipe. Inlet needs cleaning.

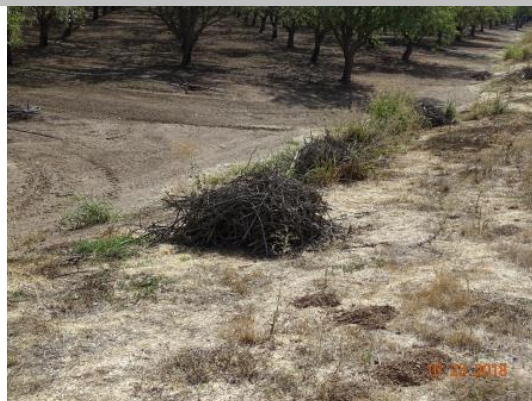
Photo 1 of 1 : FA\_2018\_NA0013\_332\_10\_20181108\_00037.jpg

Pruning piles on landside slope. (Fall 2018)

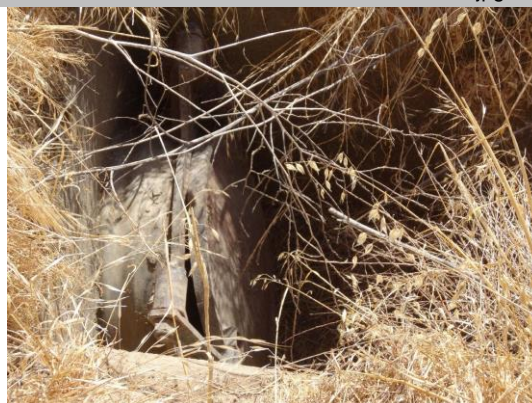
Photo 2 of 3 : UCIP\_FA\_2018\_20946\_35265.jpg

WS view: U typed concrete headwall, CM pipe, and flap gate. Flap gate was not properly closed.

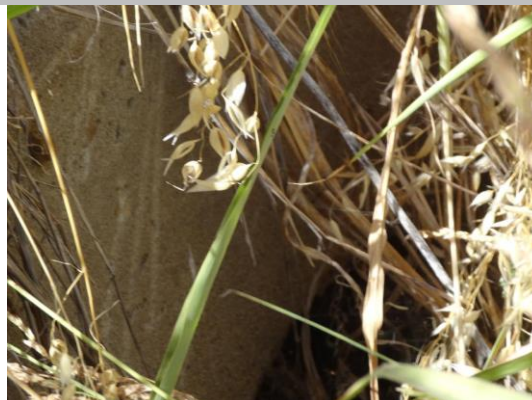
Photo 3 of 3 : UCIP\_FA\_2018\_20946\_35264.jpg

LS view: concrete headwall and CM pipe. Inlet needs cleaning.

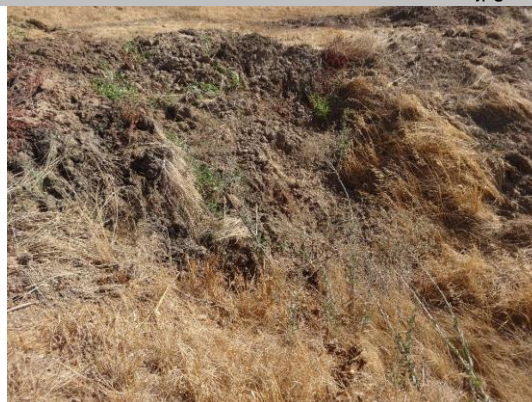
Photo 2 of 3 : UCIP\_FA\_2018\_20992\_35369.jpg

Comment Code						
Inspector Comment						
FS_ID:20992						
DS_ID:23055						
EP_NO: N/A						
Repair Type: Non-Urgent						
Crossing Status: Found						
UCIP Comments: 09/17/2013 - mud and debris from recent channel cleaning needs to be removed from spillway and outlet - pipe filled with debris, it needs cleaning.- half of intet pipe burried. (DWR UCIP - P. Amatya)						
FIELD_STRUCT_DESC: 24-inch corrugated metal gravity drainage pipe through the levee, 8 feet below the crown. Concrete headwall, flap gate, and concrete grouted cobble spillway on the waterside (WS) toe. Concrete headwall on the landside (LS) toe. [Additional Reference(s): DWR Levee Log, 2005. USACE San Joaquin O&M Manual 607, June 1962, (HLM 0.73)].						
FS Date: 9/17/2013

WS view: debris and mud deposited from the channel cleaning. It needs to be cleared from spillway and outlet structure.

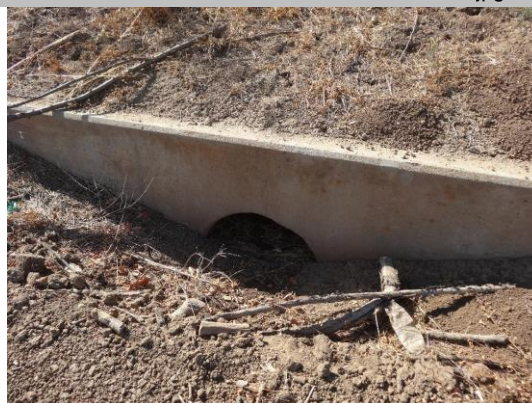
Photo 3 of 3 : UCIP\_FA\_2018\_20992\_35366.jpg

LS view: concrete headwall and CM pipe. Half of intet pipe burried.

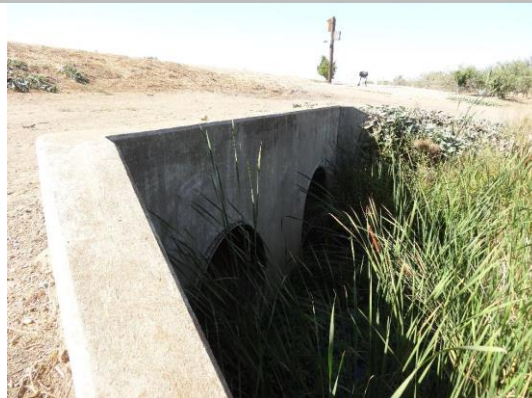
Photo 3 of 3 : UCIP\_FA\_2018\_20965\_35290.jpg

LS view: two CM pipes and U typed headwall on levee toe. Green vegetation in drainage channel.

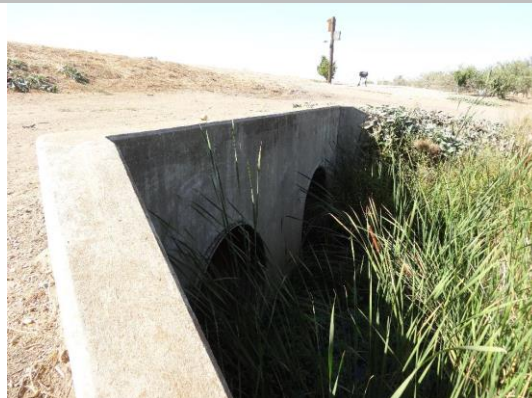
Photo 2 of 3 : UCIP\_FA\_2018\_20983\_35301.jpg

LS view: U typed concrete headwall, two CMPs in drainage ditch. Dense vegetation in drainage ditch.

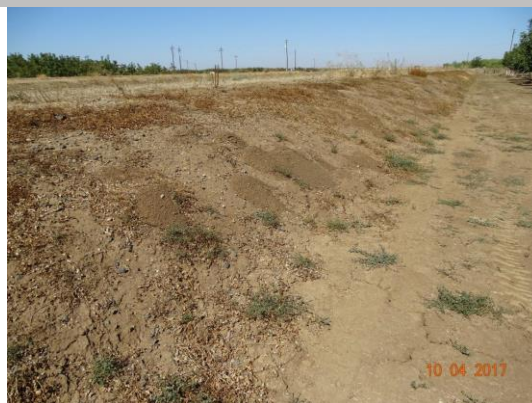
Photo 1 of 1 : FA\_2018\_NA0013\_332\_18\_20180905\_00008.jpg

Rodent activity on LS slope.

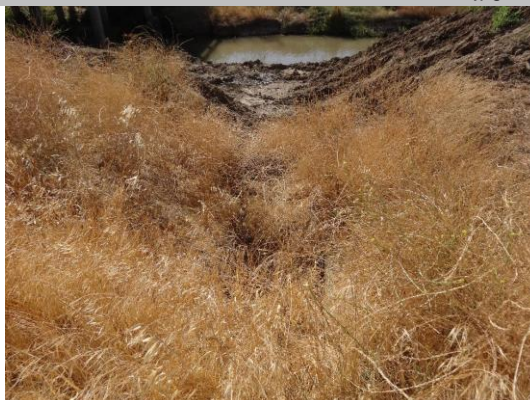
Photo 1 of 3 : UCIP\_FA\_2018\_42993\_35310.jpg

WS view: overview of outlet area and channel. Debris and vegetations on spillway.

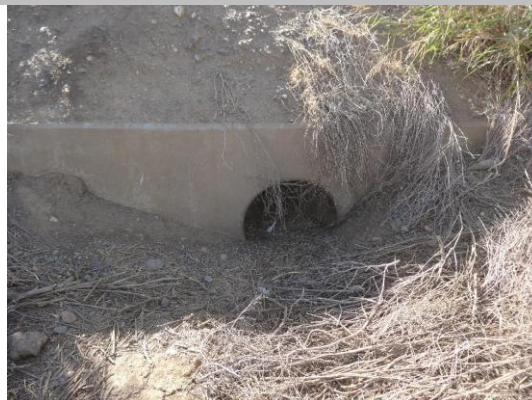
Photo 3 of 3 : UCIP\_FA\_2018\_42993\_35312.jpg

LS view: concrete headwall and CM pipe. Inlet needs cleaning. Part of inlet pipe buried.

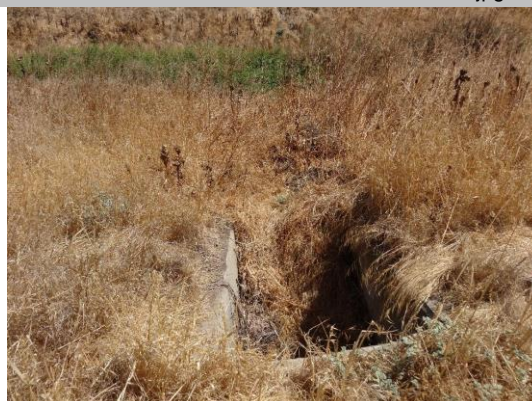
Photo 2 of 3 : UCIP\_FA\_2018\_41815\_35532.jpg

WS view: Silt needs to be removed. Vegetations needs to be cleared.

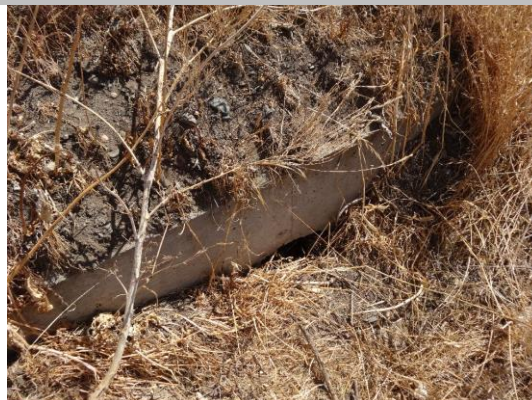
Photo 3 of 3 : UCIP\_FA\_2018\_41815\_35531.jpg

LS view: concrete headwall and CM pipe. Inlet needs cleaning and silt removed.

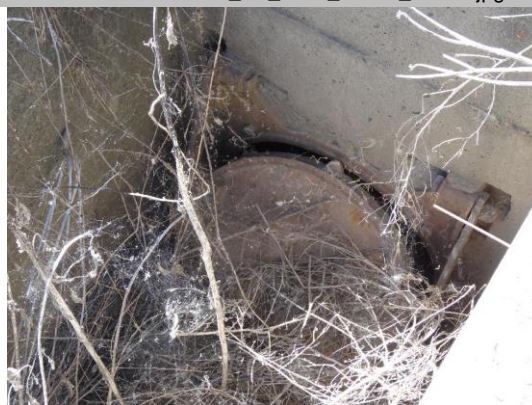
Photo 2 of 3 : UCIP\_FA\_2018\_50144\_35421.jpg

WS view: U typed concrete headwall, CM pipe, and flap gate. Damaged flap gate.

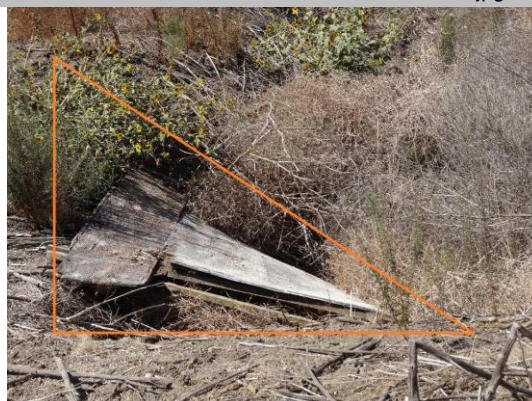
Photo 3 of 3 : UCIP\_FA\_2018\_50144\_35420.jpg

LS view: Debris dumped on inlet structure. Needs to be cleared or abandoned properly.

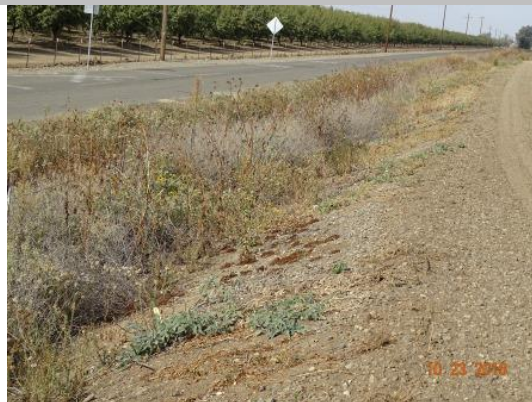
Photo 1 of 1 : FA\_2018\_NA0013\_333\_14\_20181108\_00031.jpg

Dense vegetation at landside toe. (Fall 2018)

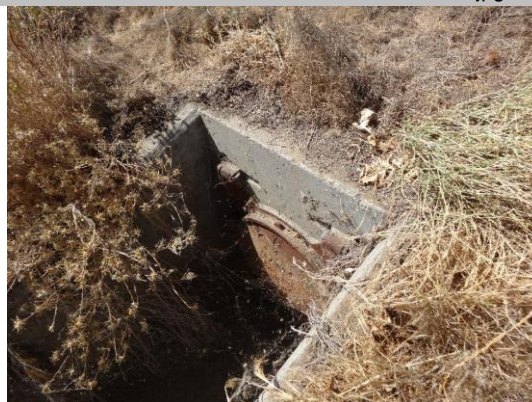
Photo 2 of 3 : UCIP\_FA\_2018\_50149\_35534.jpg

WS view: U typed concrete headwall, CM pipe, and flap gate. Vegetation needs to be cleared.

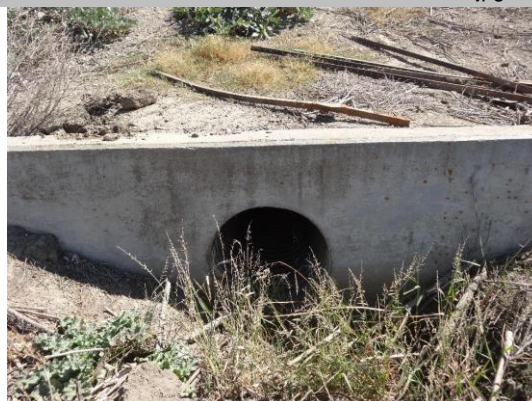
Photo 3 of 3 : UCIP\_FA\_2018\_50149\_35537.jpg

LS view: concrete headwall and CM pipe. Inlet needs clearing.

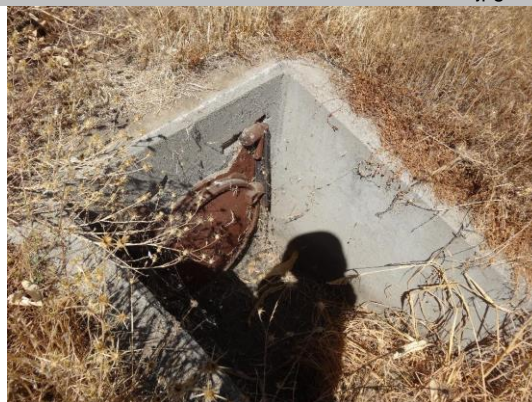
Photo 2 of 3 : UCIP\_FA\_2018\_50151\_35538.jpg

WS view: U typed concrete headwall, CM pipe, and flap gate. Vegetation needs to be cleared.

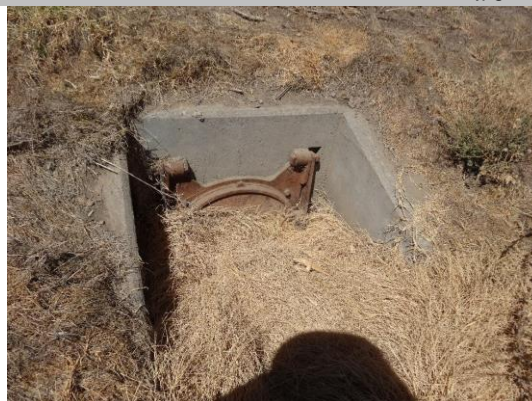
Photo 2 of 3 : UCIP\_FA\_2018\_50152\_35543.jpg

WS view: U typed concrete headwall, CM pipe, and flap gate. Vegetation needs to be cleared.

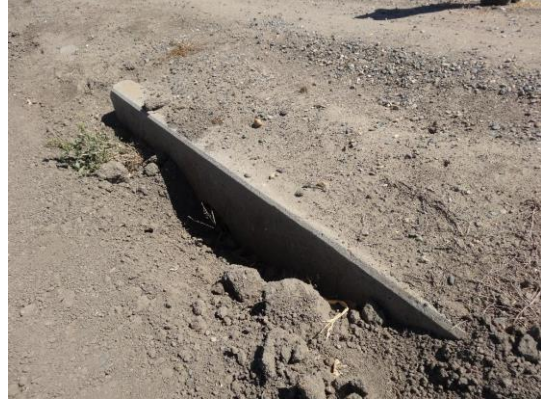
Photo 3 of 3 : UCIP\_FA\_2018\_50152\_35542.jpg

LS view: concrete headwall and CM pipe. Inlet needs clearing & cleaning.

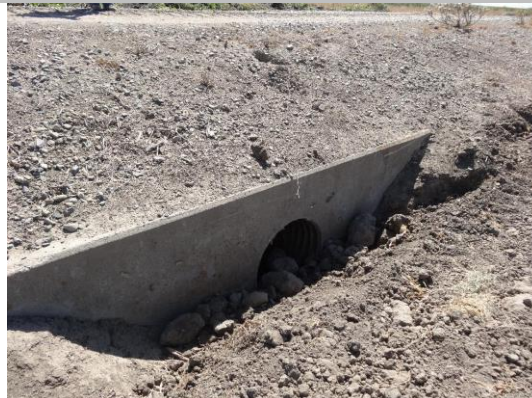
Photo 2 of 3 : UCIP\_FA\_2018\_21063\_35501.jpg

LS view: concrete headwall and CM pipe. Inlet needs clearing.

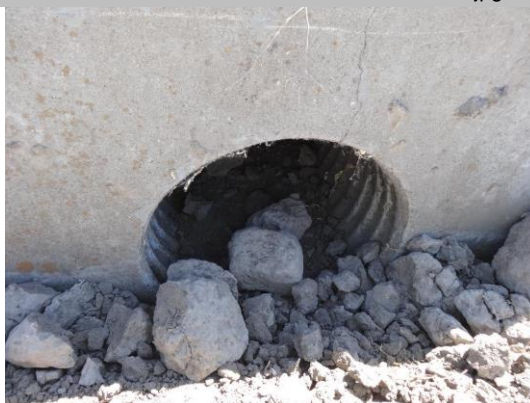
Photo 3 of 3 : UCIP\_FA\_2018\_21063\_35500.jpg

LS view: closer view of CM pipe. Inlet needs cleaning & clearing.

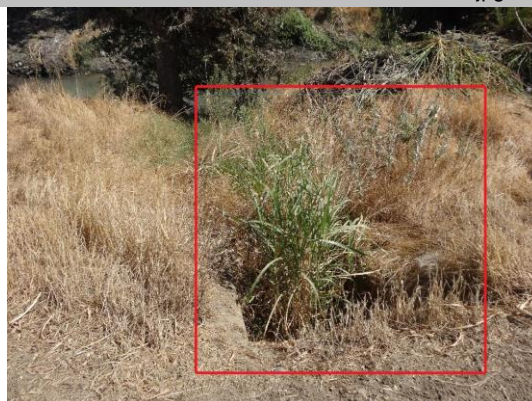
Photo 1 of 3 : UCIP\_FA\_2018\_21064\_35506.jpg

WS view: cobble spillway and channel on waterside. Dense vegetation on levee slope and spillway.

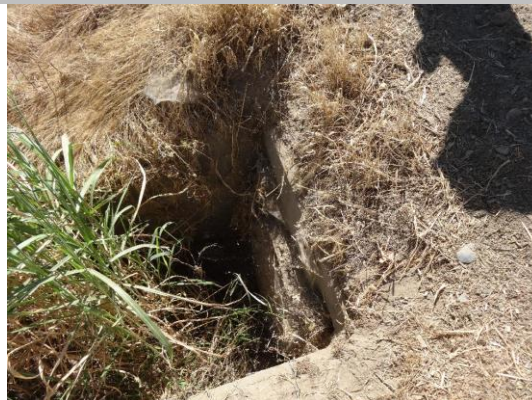
Photo 2 of 3 : UCIP\_FA\_2018\_21064\_35505.jpg

WS view: U typed concrete headwall, CM pipe, and flap gate. Vegetation needs to be cleared.

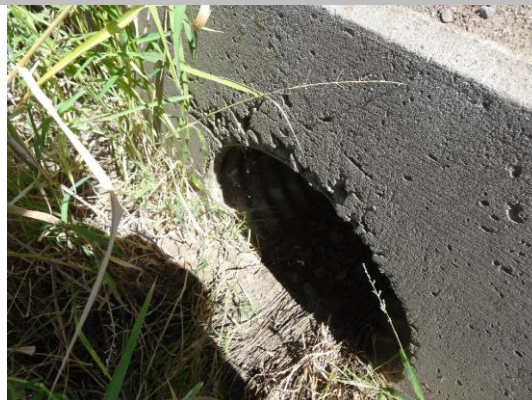
Photo 3 of 3 : UCIP\_FA\_2018\_21064\_35504.jpg

LS view: concrete headwall and CM pipe. Inlet needs clearing.

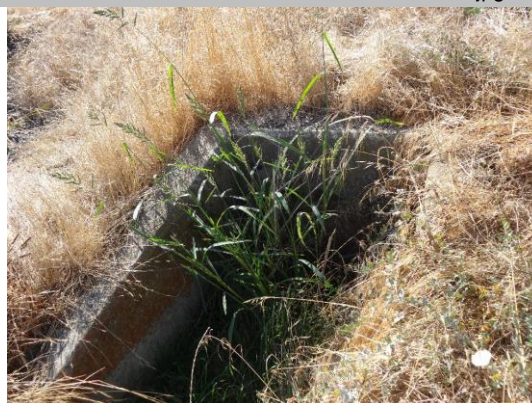
Photo 1 of 3 : UCIP\_FA\_2018\_42991\_35751.jpg

WS view: concrete spillway and channel on waterside. Dense vegetation on levee slope and spillway.

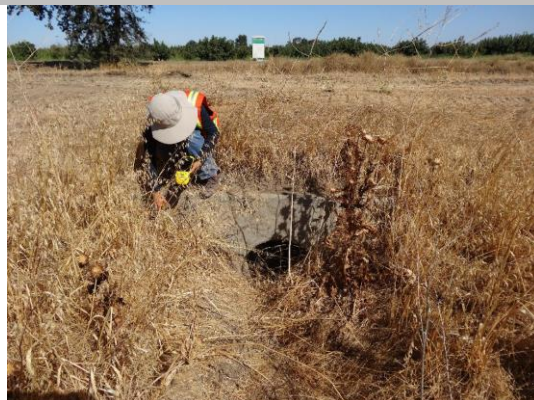
Photo 3 of 3 : UCIP\_FA\_2018\_42991\_35749.jpg

LS view: concrete headwall and CM pipe. Inlet silt needs clearing.

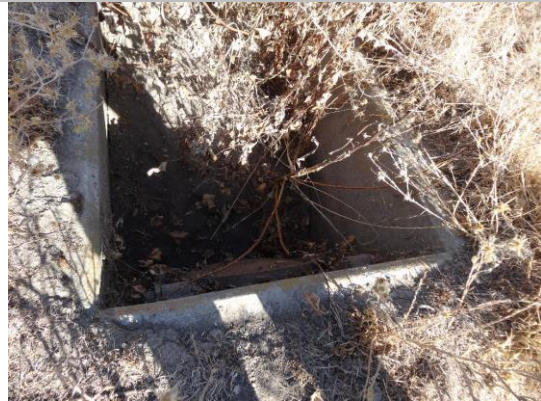
Photo 1 of 3 : UCIP\_FA\_2018\_50146\_35748.jpg

WS view: U typed concrete headwall, CM pipe, and flap gate. Vegetation needs to be cleared.

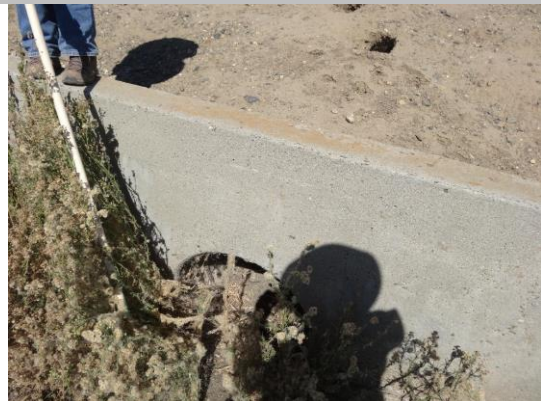
Photo 2 of 3 : UCIP\_FA\_2018\_50146\_35747.jpg

LS view: concrete headwall and CM pipe. Inlet needs clearing.

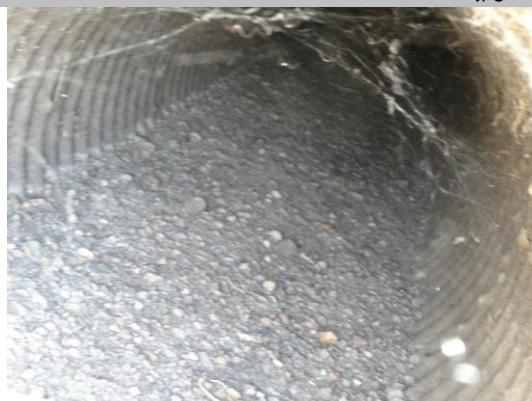
Photo 3 of 3 : UCIP\_FA\_2018\_50146\_35746.jpg

LS view: inside view of CM pipe. Inlet pipe needs clearing.

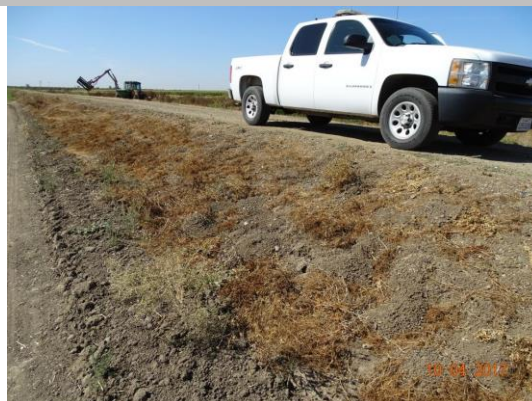
Photo 1 of 1 : FA\_2018\_NA0013\_334\_10\_20180905\_00001.jpg

Numerous rodent holes on LS slope.

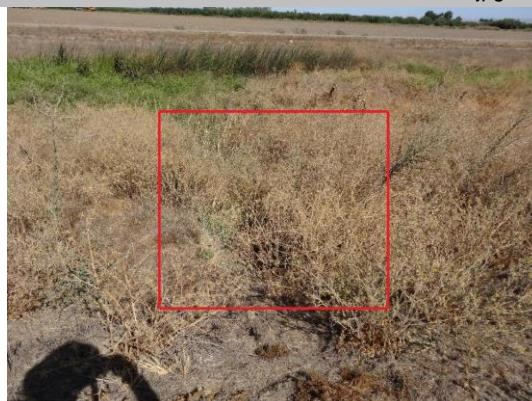
Photo 1 of 3 : UCIP\_FA\_2018\_50154\_35608.jpg

WS view: Dense vegetation on levee slope and spillway.

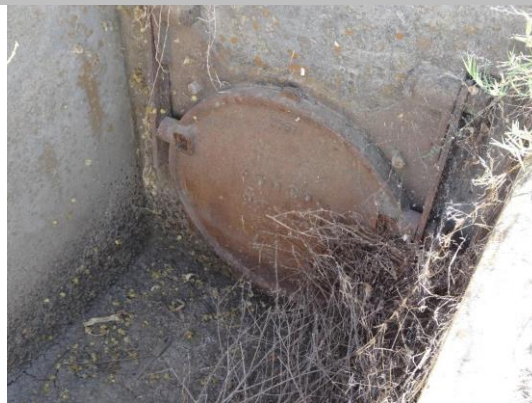
Photo 3 of 3 : UCIP\_FA\_2018\_50154\_35606.jpg

WS view: CM pipe and flap gate. Vegetation needs to be cleared.

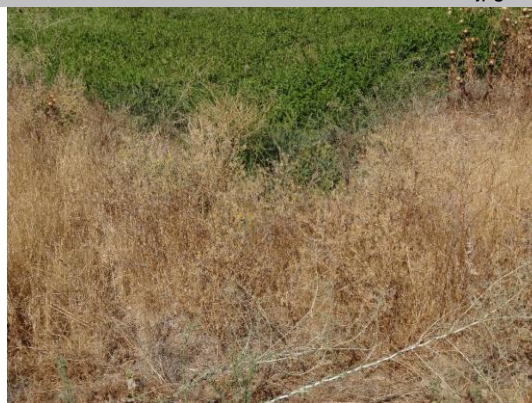
Photo 1 of 3 : UCIP\_FA\_2018\_50155\_35642.jpg

WS view: Dense vegetation on levee slope and spillway.

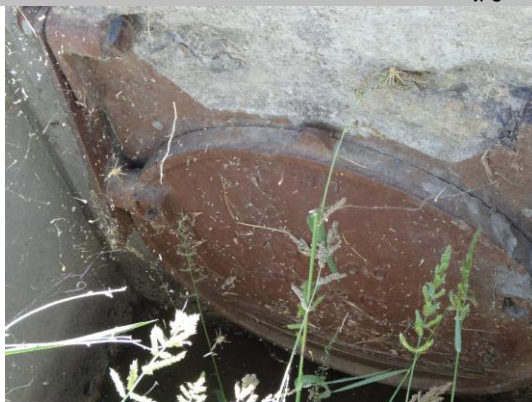
Photo 3 of 3 : UCIP\_FA\_2018\_50155\_35640.jpg

WS view: CM pipe and flap gate. Vegetation needs to be cleared.

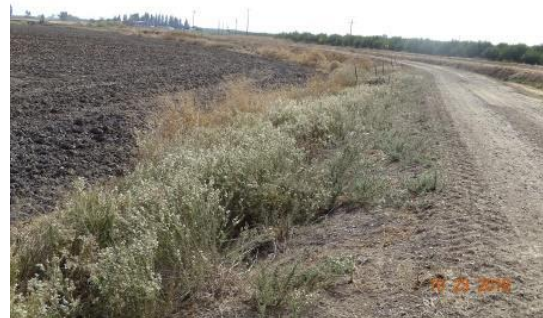
Photo 1 of 1 : FA\_2018\_NA0013\_334\_19\_20181108\_00035.jpg

dense vegetation on landside slope. (Fall 2018)

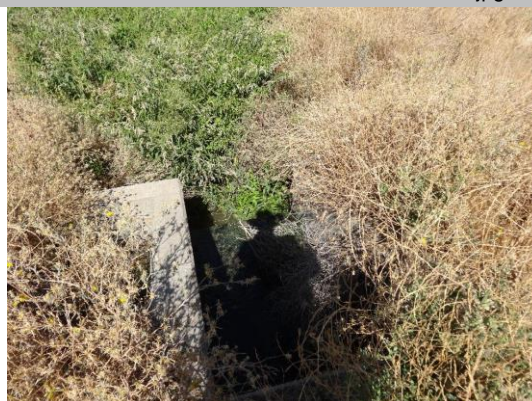
Photo 1 of 3 : UCIP\_FA\_2018\_21126\_35652.jpg

WS view: concrete spillway and channel on waterside. Dense vegetation on levee slope and spillway.

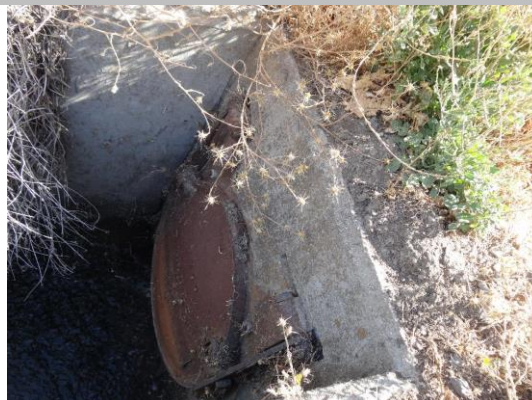
Photo 2 of 3 : UCIP\_FA\_2018\_21126\_35651.jpg

WS view: U typed concrete headwall, CM pipe, and flap gate. Vegetation needs to be cleared on spillway.

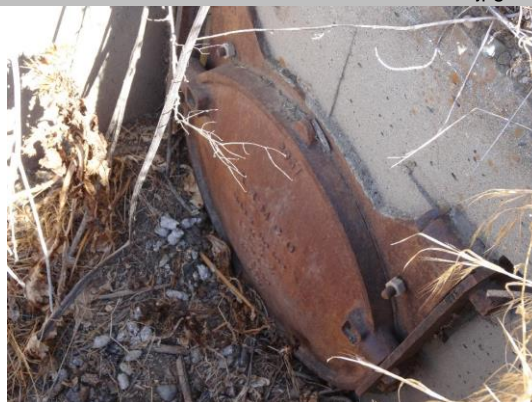
Photo 2 of 3 : UCIP\_FA\_2018\_52888\_35708.jpg

WS view: U typed concrete headwall, CM pipe, and flap gate. Spillway needs to be cleared.

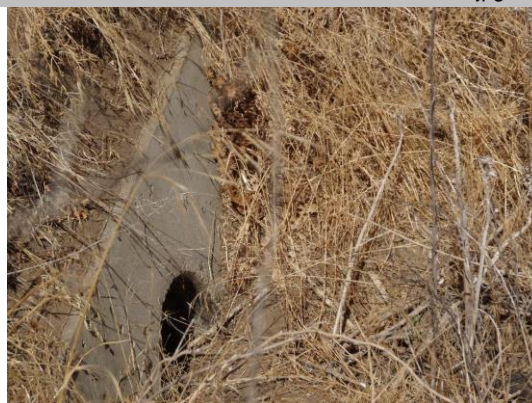
Photo 3 of 3 : UCIP\_FA\_2018\_52888\_35707.jpg

LS view: concrete headwall and CM pipe. Inlet silt needs clearing.

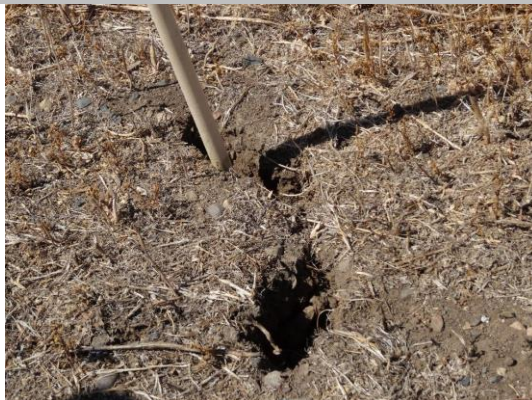
Photo 2 of 3 : UCIP\_FA\_2018\_50153\_35744.jpg

WS view: significant levee cracks along the pipe alignment. Needs detailed investigation on the issue.

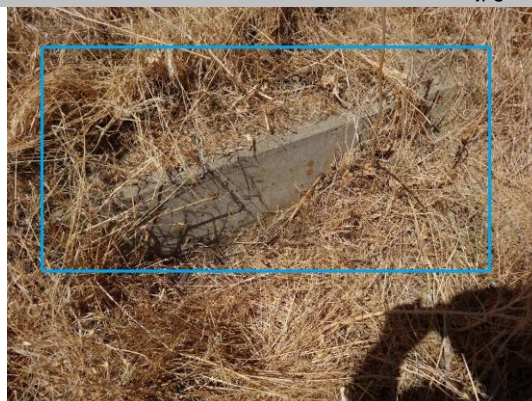
Photo 3 of 3 : UCIP\_FA\_2018\_50153\_35743.jpg

LS view: concrete headwall and buried CM pipe. Dirt removal and clearing needed in inlet.
