**Flood Control Project Maintenance
Levee Inspections**

Fall 2019 Levee Maintenance Deficiency Summary Report

San Joaquin River Basin

**Flood Control Project Maintenance
Levee Inspections****LMA District Cover Sheet****Fall 2019 Levee Inspection Results****Merced Streams Group**

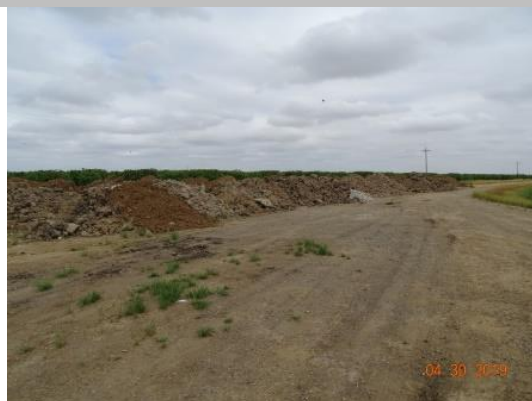
Photo 1 of 1 : FA_2019_NA0013_331_13_20190912_00008.jpg

View of material piled on levee crown. (Spring 2019)

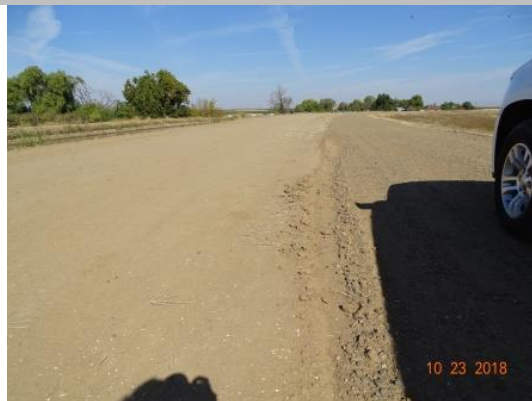
Photo 1 of 2 : FA_2019_NA0013_331_8_20190912_00004.jpg

LM Start	0.27	Rating **	M	Issue No.	8
LM End	1.62	Issue Type +	Ma	Location *	CR
Category	Earthen Levee			GPS Latitude/Longitude	
				Start	End
Item	Crown Surface / Depressions / Rutting			37.318525 °	37.337176 °
				-120.396598 °	-120.396531 °
DWR ID	DWR_NA0013_01_s_2018_8				
Comment Code					
C2 : Repair depressions or ruts in the crown or slope.					
Inspector Comment					
Vehicle tracks and rutting on the crown should be repaired.

View of vehicle tracks on levee crown. (Fall 2018)

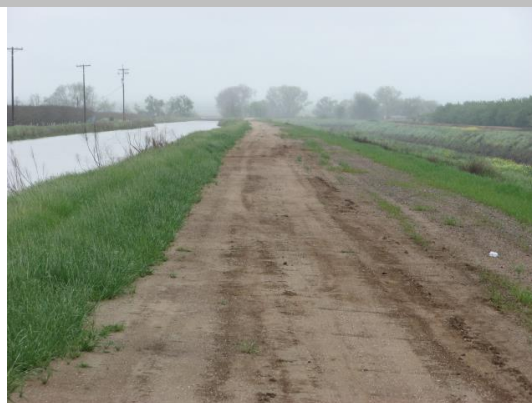
Photo 2 of 2 : FA_2019_NA0013_331_8_20190912_00005.jpg

Looking downstream at typical view of levee crown (Spring 2018)

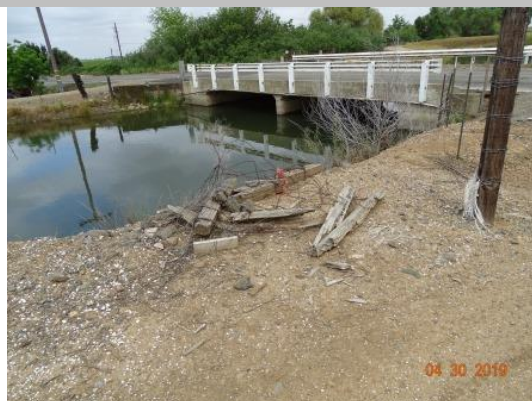
Photo 1 of 1 : FA_2019_NA0013_331_16_20190912_00010.jpg

LM Start	1.23	Rating **	M	Issue No.	16
LM End	1.23	Issue Type +	Ma	Location *	CR
Category	Earthen Levee			GPS Latitude/Longitude	
				Start	End
Item	Repair Gates			37.332005 °	37.332005 °
				-120.394751 °	-120.394751 °
DWR ID	DWR_NA0013_01_s_2019_16				
Comment Code					
Inspector Comment					
Gate has been removed.

View of barbed wire gate discarded on levee. (Spring 2019)

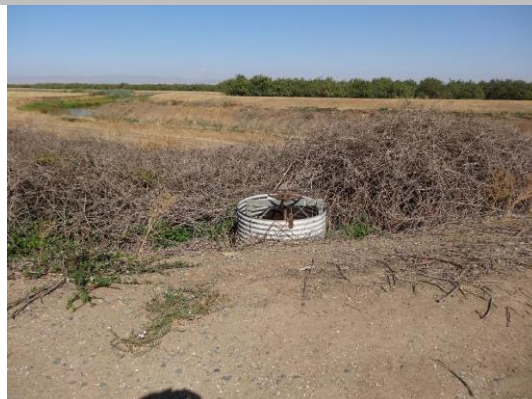
Photo 2 of 3 : UCIP_FA_2019_41672_35210.jpg

Comment Code					
Inspector Comment					
DS_ID:23079 FS_ID:41672 EP_NO: N/A Repair Type: Non-Urgent Crossing Status: Indicator Found UCIP Comments: 09/17/2013 Verify Pipe is abandoned or still intact.- may be this crossing was abandoned/removed during recent levee reconstruction.- no signs of pipe and appurtenances on waterside.- only a CM pipe riser with slide gate found on landside. (DWR UCIP - P. Amatya) FIELD_STRUCT_DESC: 36-inch corrugated metal irrigation pipe through the levee, 10 feet below the crown. Riser on the landside (LS). Screw gate in a 48-inch pipe well on the waterside (WS) slope. Concrete headwall and cobble spillway at the LS toe. Concrete headwall at the WS toe. [Additional Reference(s): USACE San Joaquin O&M Manual 607, June 1962, (HLM 1.32)]. FS Date: 9/17/2013

LS view: overview of CM pipe riser with slide gate. Dense vegetation on landside.

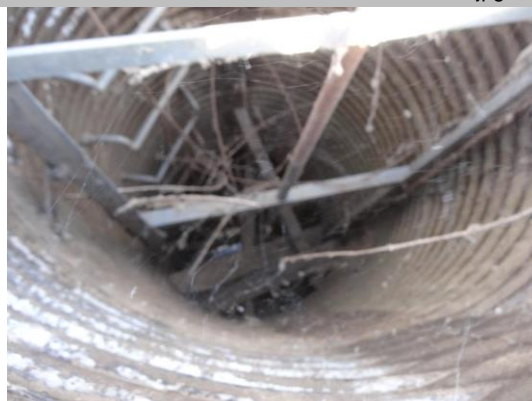
Photo 3 of 3 : UCIP_FA_2019_41672_35209.jpg

LS view: inside view of CM pipe riser with slide gate.

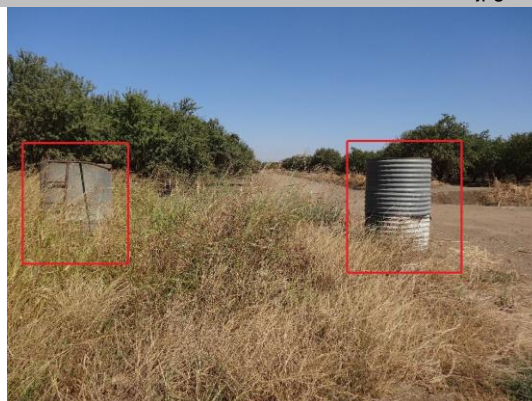
Photo 1 of 3 : UCIP_FA_2019_21263_35761.jpg

Comment Code						
Inspector Comment						
DS_ID:23052						
FS_ID:21263						
EP_NO: N/A						
Repair Type: Non-Urgent						
Crossing Status: Found						
UCIP Comments: 09/17/2013 - needs more investigations on this crossing. - new water filtration plant on LS with pump and concrete vault.- a concrete standpipe and CM pipe riser on WS. (DWR UCIP - P. Amatya)						
FIELD_STRUCT_DESC: 10-inch steel irrigation pipe through the levee, 5 feet below the crown. Riser on the landside (LS). Screw gate in a 36-inch pipe well on the waterside (WS) slope. [Additional Reference(s): DWR Levee Log, 2005. USACE San Joaquin O&M Manual 607, June 1962, (HLM 0.00)].						
FS Date: 9/17/2013

WS view: concrete standpipe (left) and CMP standpipe (right).

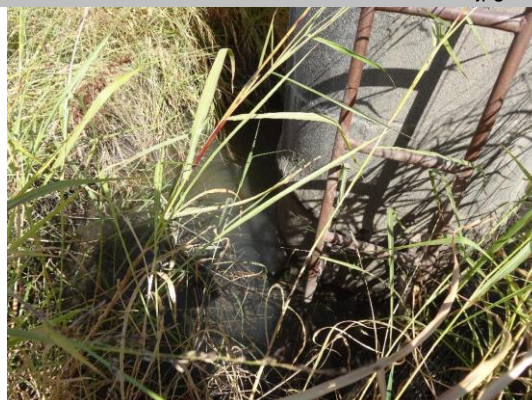
Photo 3 of 3 : UCIP_FA_2019_21263_35764.jpg

WS view: concrete standpipe with water ponding at its base.

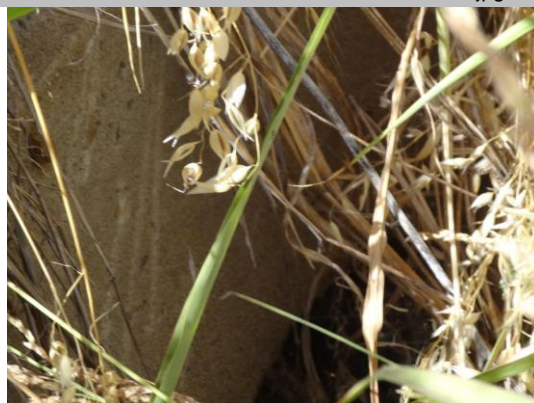
Photo 3 of 3 : UCIP_FA_2019_20946_35264.jpg

LS view: concrete headwall and CM pipe. Inlet needs cleaning.

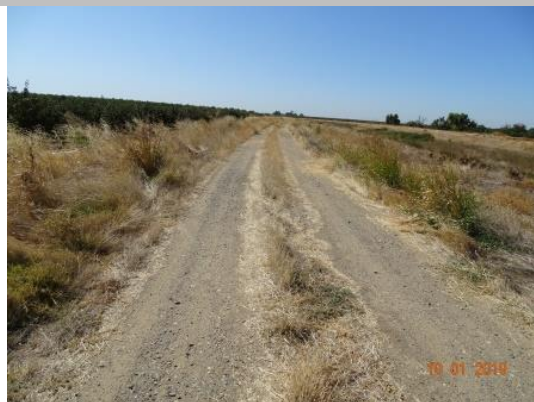
Photo 1 of 1 : FA_2019_NA0013_332_17_20191008_00044.jpg

View of vegetation along levee crown looking downstream. (Fall 2019)

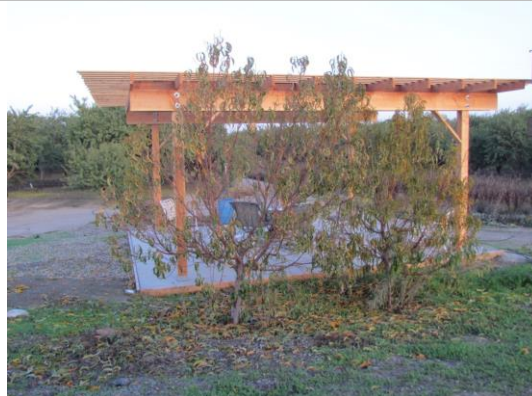
Photo 2 of 4 : FA_2019_NA0013_332_24_20190912_00012.jpg

Another view of unauthorized structure.

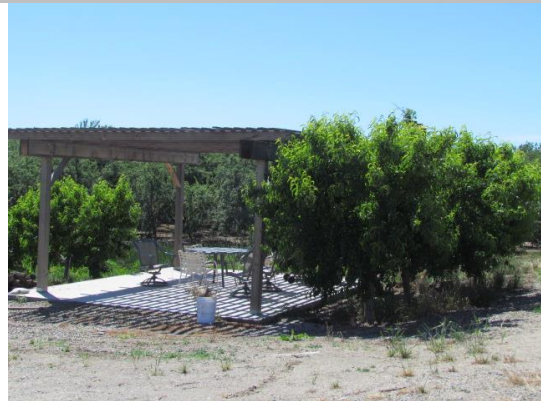
Photo 4 of 4 : FA_2019_NA0013_332_24_20190912_00014.jpg

View of encroachment looking downstream.

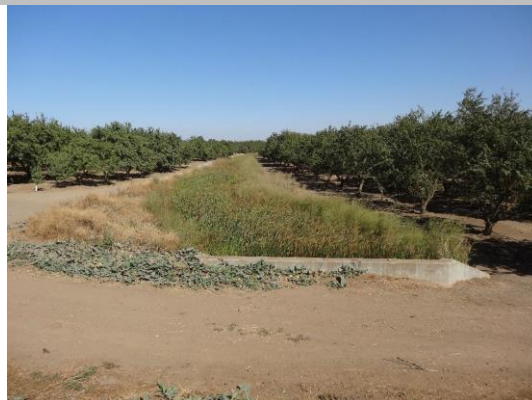
Photo 2 of 3 : UCIP_FA_2019_20965_35291.jpg

LS view: headwall on levee toe. Green vegetation in drainage channel.

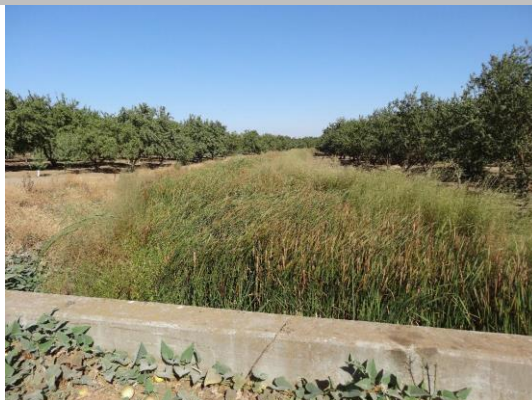
Photo 3 of 3 : UCIP_FA_2019_20983_35300.jpg

LS view: concrete headwall in drainage ditch. Dense vegetation in drainage ditch.

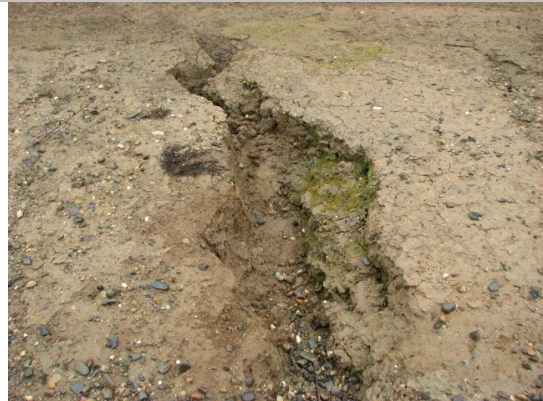
Photo 1 of 3 : FA_2019_NA0013_332_15_20190912_00005.jpg

Looking east at finger erosion on landward slope. (Spring 2018)

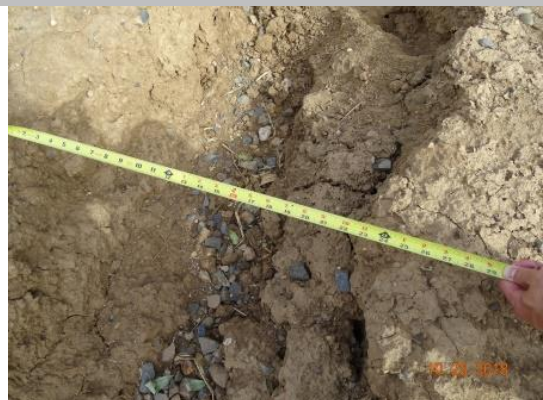
Photo 3 of 3 : FA_2019_NA0013_332_15_20190912_00007.jpg

Measurement across erosion at widest point. (Fall 2018)

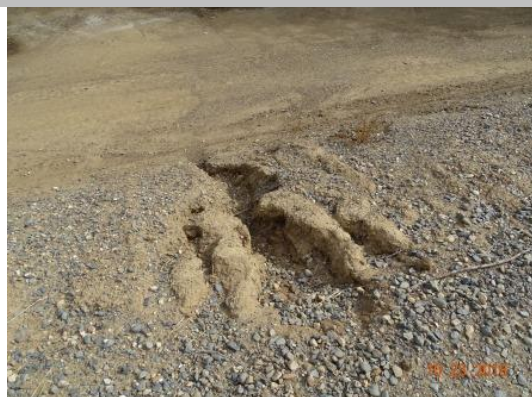
Photo 1 of 2 : FA_2019_NA0013_332_16_20190912_00008.jpg

View of large finger erosion in landside slope. (Fall 2018)

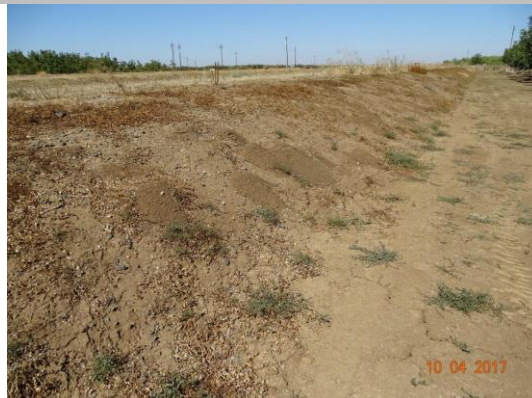
Photo 1 of 1 : FA_2019_NA0013_332_18_20190912_00010.jpg

View of rodent activity on the landside slope.

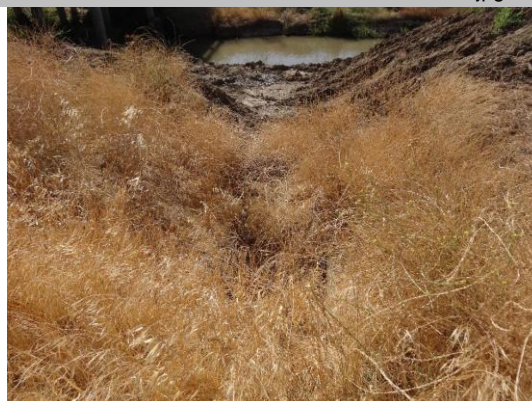
Photo 1 of 3 : UCIP_FA_2019_42993_35310.jpg

WS view: overview of outlet area and channel. Debris and vegetations on spillway.

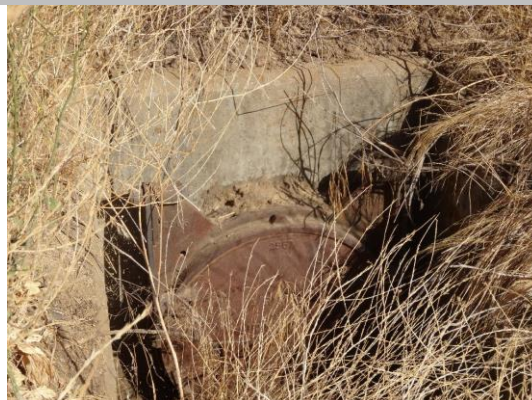
Photo 2 of 3 : UCIP_FA_2019_42993_35309.jpg

WS view: U typed concrete headwall, CM pipe and flap gate. Vegetation and debris need to be cleared.

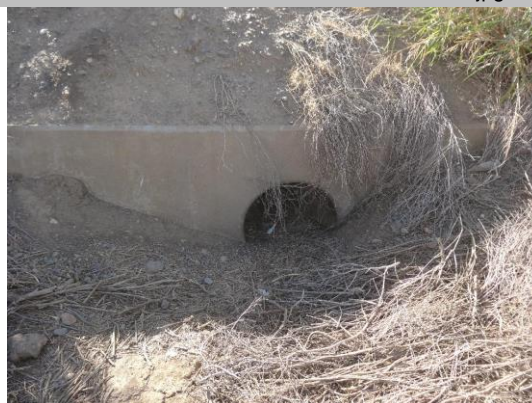
Photo 3 of 3 : UCIP_FA_2019_42993_35312.jpg

LS view: concrete headwall and CM pipe. Inlet needs cleaning. Part of inlet pipe buried.

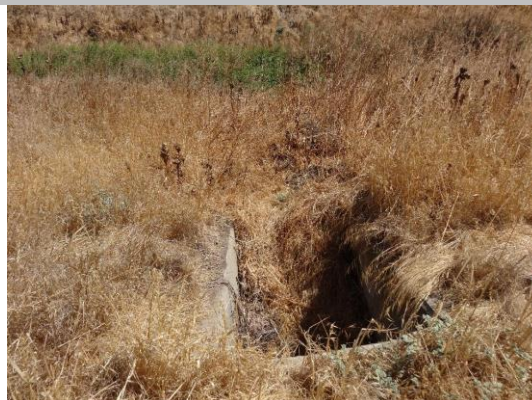
Photo 2 of 3 : UCIP_FA_2019_41815_35532.jpg

WS view: Silt needs to be removed. Vegetations needs to be cleared.

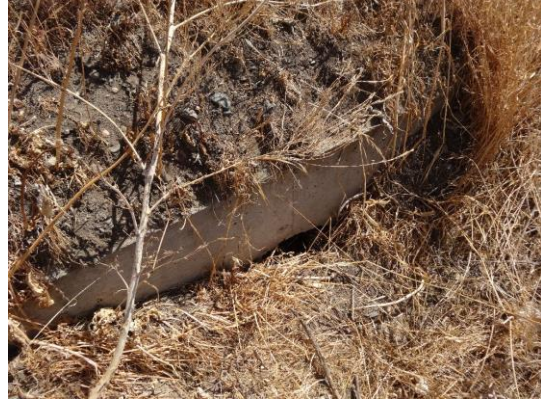
Photo 3 of 3 : UCIP_FA_2019_41815_35531.jpg

LS view: concrete headwall and CM pipe. Inlet needs cleaning and silt removed.

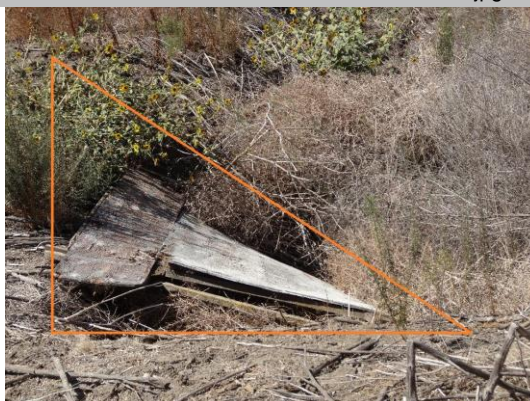
Photo 3 of 3 : UCIP_FA_2019_50144_35420.jpg

LS view: Debris dumped on inlet structure. Needs to be cleared or abandoned properly.

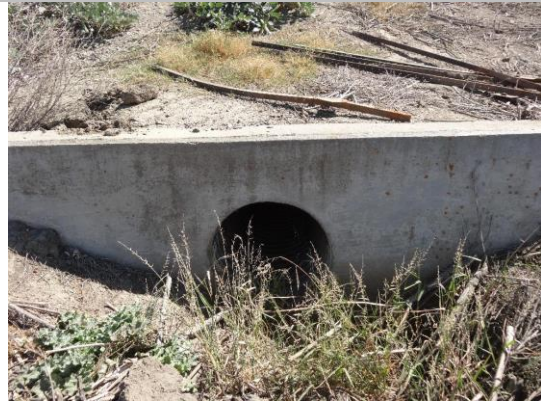
Photo 3 of 3 : UCIP_FA_2019_50149_35537.jpg

LS view: concrete headwall and CM pipe. Inlet needs clearing.

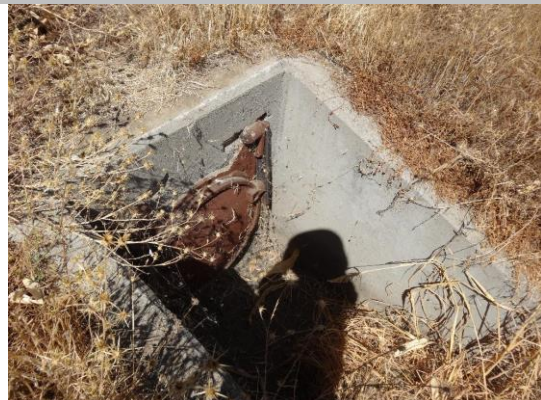
Photo 2 of 3 : UCIP_FA_2019_50151_35538.jpg

WS view: U typed concrete headwall, CM pipe, and flap gate. Vegetation needs to be cleared.

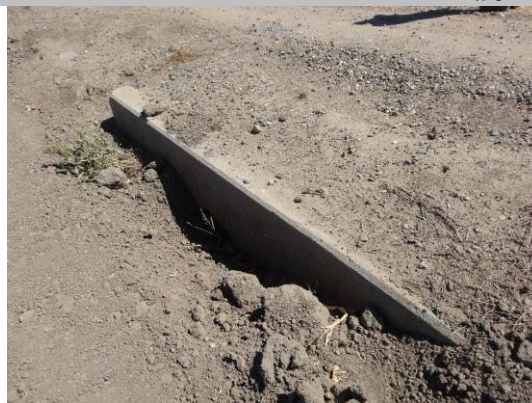
Photo 3 of 3 : UCIP_FA_2019_50152_35542.jpg

LS view: concrete headwall and CM pipe. Inlet needs clearing & cleaning.

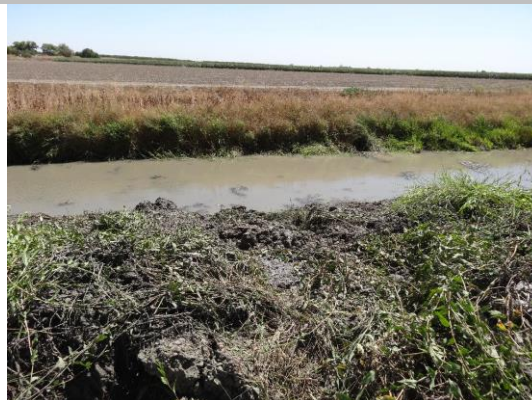
Photo 1 of 3 : UCIP_FA_2019_21063_35502.jpg

WS view: U typed concrete headwall, CM pipe, and flap gate buried under mud/debris.

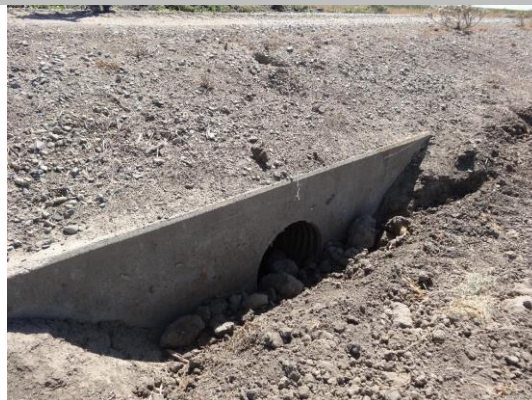
Photo 2 of 3 : UCIP_FA_2019_21063_35501.jpg

LS view: concrete headwall and CM pipe. Inlet needs clearing.

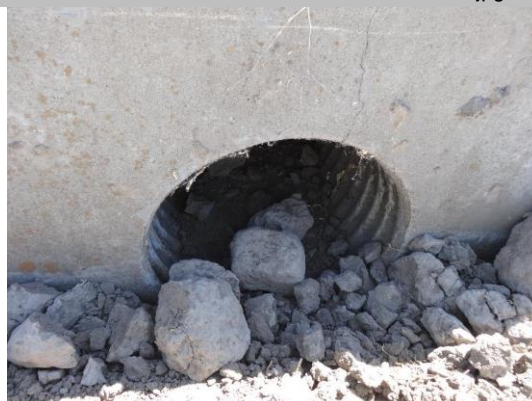
Photo 3 of 3 : UCIP_FA_2019_21063_35500.jpg

LS view: closer view of CM pipe. Inlet needs cleaning & clearing.

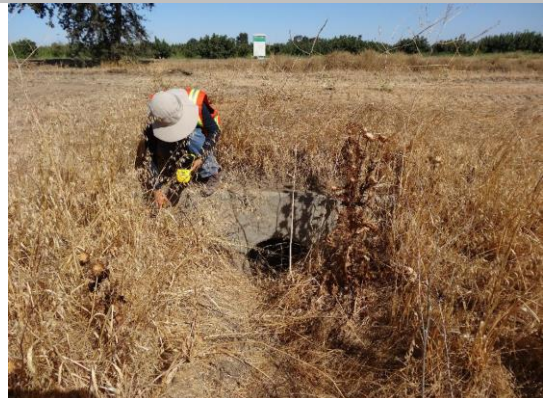
Photo 3 of 3 : UCIP_FA_2019_42991_35749.jpg

LS view: concrete headwall and CM pipe. Inlet silt needs clearing.

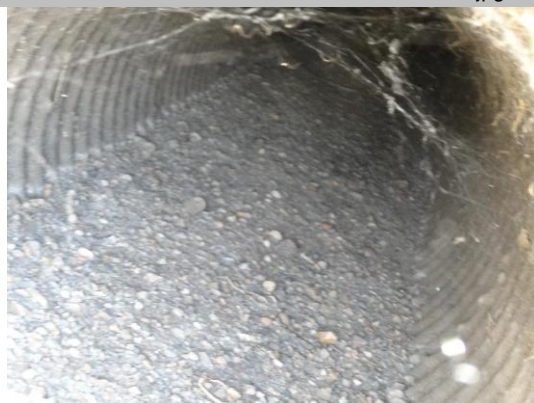
Photo 3 of 3 : UCIP_FA_2019_50146_35746.jpg

LS view: inside view of CM pipe. Inlet pipe needs clearing.

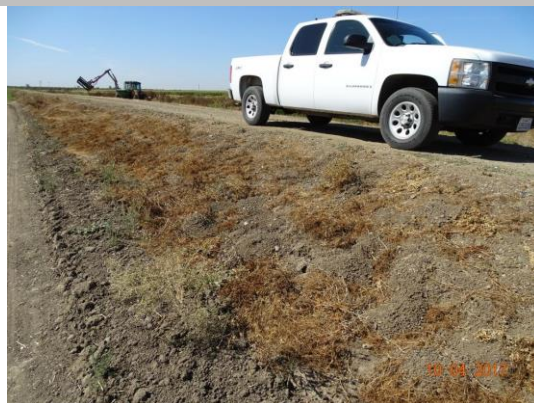
Photo 1 of 1 : FA_2019_NA0013_334_10_20190912_00001.jpg

Numerous rodent holes on LS slope.

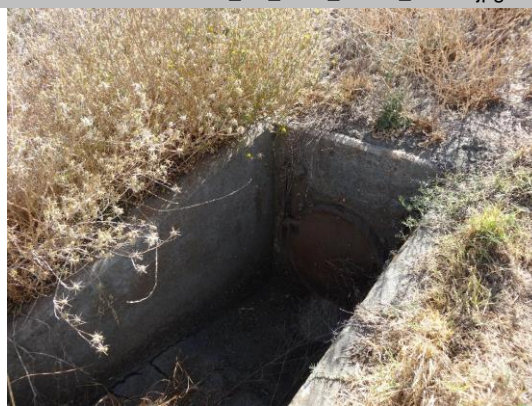
Photo 2 of 3 : UCIP_FA_2019_50154_35607.jpg

WS view: U typed concrete headwall, CM pipe, and flap gate. Vegetation needs to be cleared on spillway.

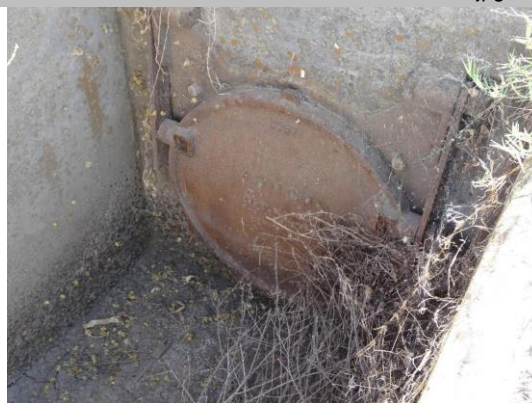
Photo 3 of 3 : UCIP_FA_2019_50154_35606.jpg

WS view: CM pipe and flap gate. Vegetation needs to be cleared.

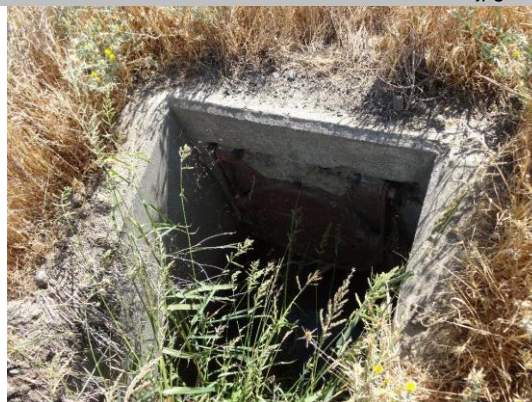
Photo 2 of 3 : UCIP_FA_2019_50155_35641.jpg

WS view: U typed concrete headwall, CM pipe, and flap gate. Vegetation needs to be cleared.

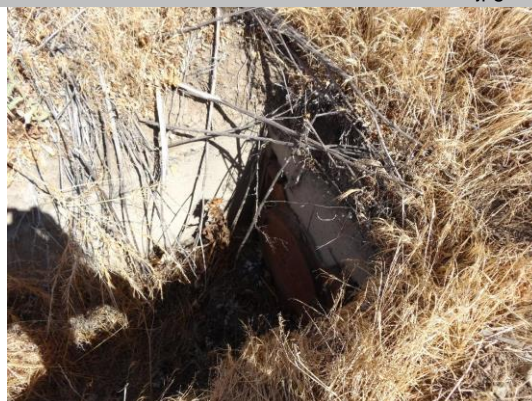
Photo 1 of 3 : UCIP_FA_2019_52888_35709.jpg

WS view: concrete spillway and channel on waterside. Dense vegetation on levee slope and spillway.

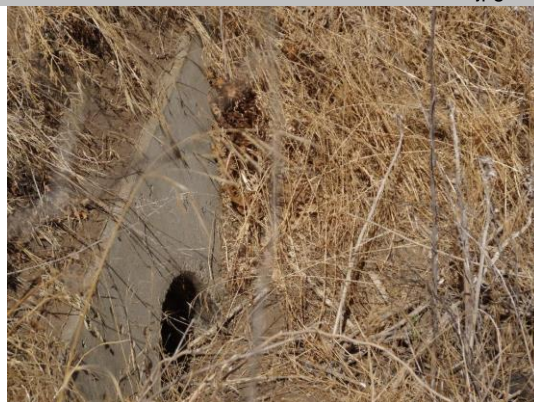
Photo 3 of 3 : UCIP_FA_2019_52888_35707.jpg

LS view: concrete headwall and CM pipe. Inlet silt needs clearing.

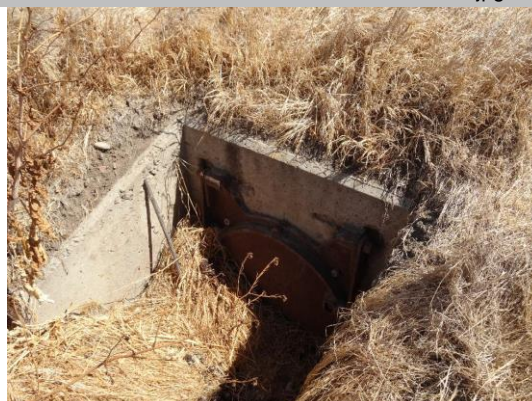
Photo 1 of 3 : UCIP_FA_2019_50153_35745.jpg

WS view: U typed concrete headwall, CM pipe, and flap gate. Dirt and vegetations need to be removed and cleared.

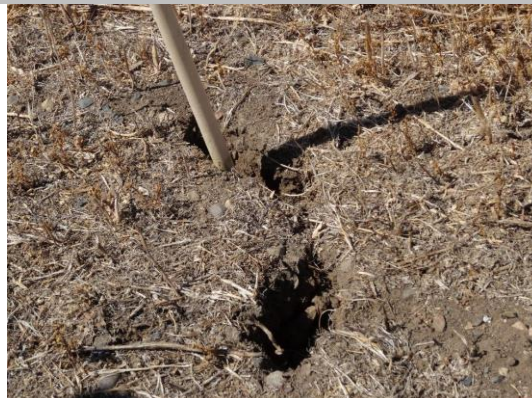
Photo 2 of 3 : UCIP_FA_2019_50153_35744.jpg

WS view: significant levee cracks along the pipealignment. Needs detailed investigation on the issue.

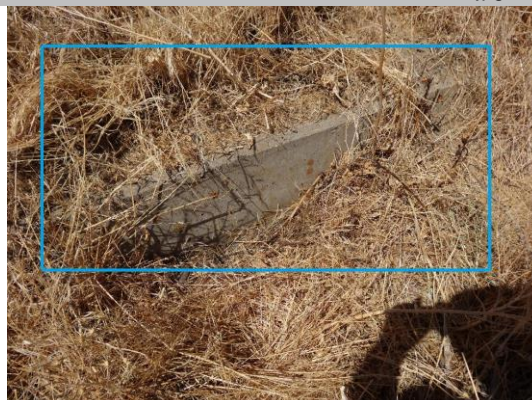
Photo 3 of 3 : UCIP_FA_2019_50153_35743.jpg

LS view: concrete headwall and buried CM pipe. Dirt removal and clearing needed in inlet.
