## Flood Control Project Maintenance Levee Inspections

### Fall 2020 Levee Maintenance Deficiency Summary Report

#### San Joaquin River Basin

**Merced Streams Group**

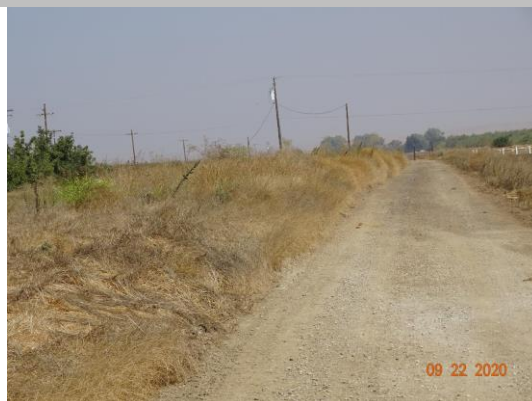
Photo 1 of 1 : FA\_2020\_NA0013\_331\_3\_20200928\_00011.jpg

View of vegetation looking upstream along the landside slope. (Fall 2020)

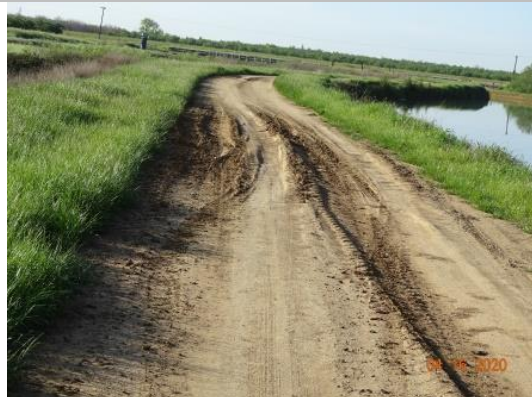
Photo 1 of 1 : FA\_2020\_NA0013\_331\_8\_20200901\_00001.jpg

LM Start	0.44	Rating **	M	Issue No.	8
LM End	0.55	Issue Type +	Ma	Location *	CR
Category	Earthen Levee			GPS Latitude/Longitude	
				Start	End
Item	Crown Surface / Depressions / Rutting			37.320976 °	37.322571 °
				-120.396594 °	-120.396599 °
DWR ID	DWR_NA0013_01_s_2018_8				
Comment Code					
C2 : Repair depressions or ruts in the crown or slope.					
Inspector Comment					
Vehicle tracks and rutting on the crown should be repaired.

View of vehicle tracks on the levee crown. (Spring 2020)

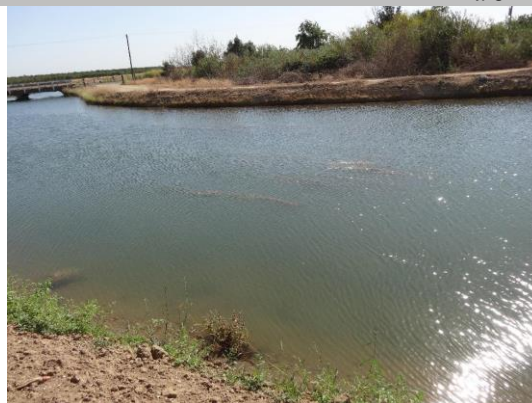
Photo 1 of 3 : UCIP\_FA\_2020\_41672\_35211.jpg

Comment Code					
Inspector Comment					
DS_ID:23079 FS_ID:41672 EP_NO: N/A Repair Type: Non-Urgent EVAL Issue: Crossing Status: Indicator Found UCIP Comments: 09/17/2013 Verify Pipe is abandoned or still intact.- may be this crossing was abandoned/removed during recent levee reconstruction.- no signs of pipe and appurtenances on waterside.- only a CM pipe riser with slide gate found on landside. (DWR UCIP - P. Amatya) FIELD_STRUCT_DESC: 36-inch corrugated metal irrigation pipe through the levee, 10 feet below the crown. Riser on the landside (LS). Screw gate in a 48-inch pipe well on the waterside (WS) slope. Concrete headwall and cobble spillway at the LS toe. Concrete headwall at the WS toe. [Additional Reference(s): USACE San Joaquin O&M Manual 607, June 1962, (HLM 1.32)]. FS Date: 9/17/2013

WS view: no signs of pipe and appurtenances on levee slope and channel bank.

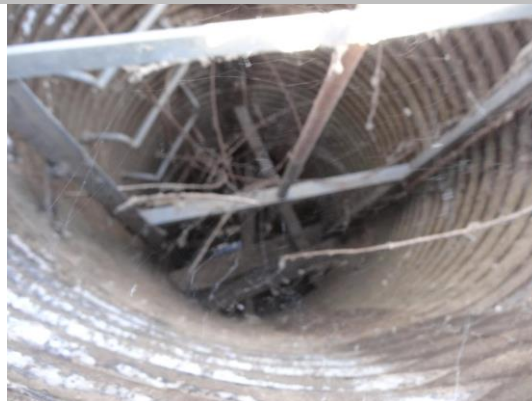
Photo 3 of 3 : UCIP\_FA\_2020\_41672\_35209.jpg

LS view: inside view of CM pipe riser with slide gate.

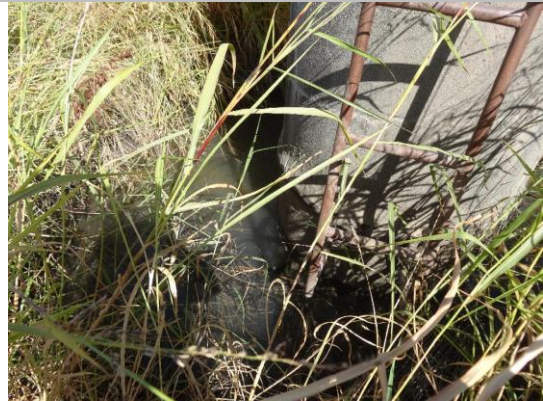
Photo 3 of 3 : UCIP\_FA\_2020\_21263\_35764.jpg

WS view: concrete standpipe with water ponding at its base.

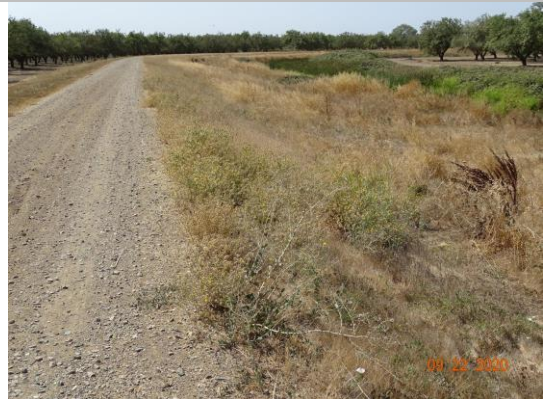
Photo 1 of 1 : FA\_2020\_NA0013\_332\_10\_20200928\_00033.jpg

LM Start	0.06	Rating **	M	Issue No.	10
LM End	0.46	Issue Type +	Ma	Location *	WS
Category	Earthen Levee			GPS Latitude/Longitude	
				Start	End
Item	Vegetation			37.336674 °	37.333729 °
				-120.388235 °	-120.392887 °
DWR ID	DWR_NA0013_02_f _ 2020_10				
Comment Code					
V1 : Control annual grass and weeds on the levee slopes and easements.					
Inspector Comment

Looking downstream along the waterside slope. (Fall 2020)

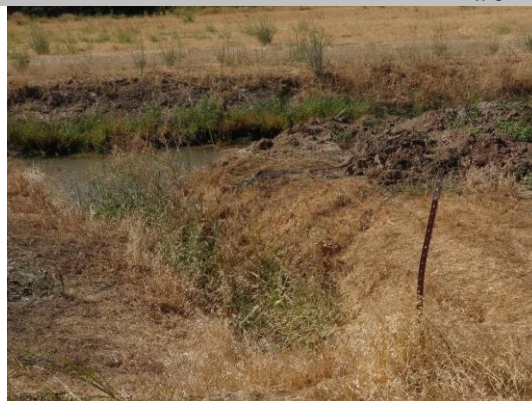
Photo 1 of 3 : UCIP\_FA\_2020\_20946\_35266.jpg

LM Start	0.54	Rating **	M	Issue No.	34
LM End	0.54	Issue Type +	Ma	Location *	
Category	Supplemental			GPS Latitude/Longitude	
				Start	End
Item	DWR UCIP LMA Responsibility			37.333180 °	37.333180 °
				-120.394069 °	-120.394069 °
DWR ID	23054				
Comment Code					
Inspector Comment					
DS_ID:23054 FS_ID:20946 EP_NO: N/A Repair Type: Non-Urgent EVAL Issue: Crossing Status: Found UCIP Comments: 09/17/2013 - needs vegetation cleaning on both sides.- flap gate was not properly closed during field survey.- inlet needs cleaning. (DWR UCIP - P. Amatya) FIELD_STRUCT_DESC: 24-inch corrugated metal gravity drainage pipe through the levee, 12 feet below the crown. Concrete headwall, flap gate, and concrete grouted cobble spillway on the waterside (WS) toe. Concrete headwall on the landside (LS) toe. [Additional Reference(s): DWR Levee Log, 2005]. FS Date: 9/17/2013

WS view: cobble spillway and channel on waterside.

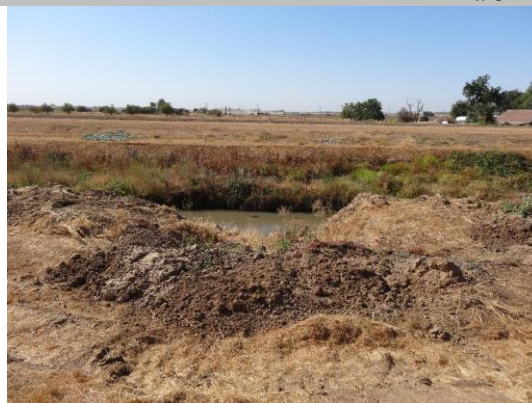
Photo 1 of 3 : UCIP\_FA\_2020\_20992\_35370.jpg

Comment Code						
Inspector Comment						
DS_ID:23055 FS_ID:20992 EP_NO: N/A Repair Type: Non-Urgent EVAL Issue: Crossing Status: Found UCIP Comments: 09/17/2013 - mud and debris from recent channel cleaning needs to be removed from spillway and outlet - pipe filled with debris, it needs cleaning.- half of intet pipe burried. (DWR UCIP - P. Amatya) FIELD_STRUCT_DESC: 24-inch corrugated metal gravity drainage pipe through the levee, 8 feet below the crown. Concrete headwall, flap gate, and concrete grouted cobble spillway on the waterside (WS) toe. Concrete headwall on the landside (LS) toe. [Additional Reference(s): DWR Levee Log, 2005. USACE San Joaquin O&M Manual 607, June 1962, (HLM 0.73)]. FS Date: 9/17/2013

WS view: concrete headwall and CM pipe burried under debris and mud.

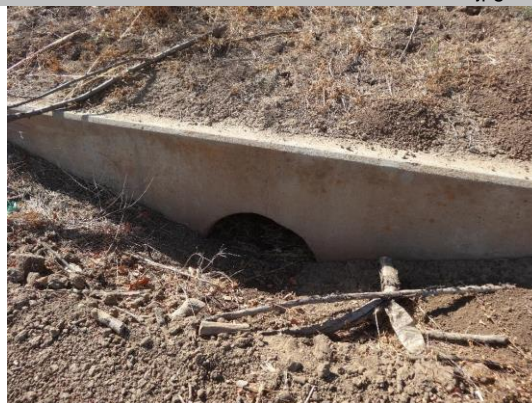
Photo 3 of 3 : UCIP\_FA\_2020\_20992\_35366.jpg

LS view: concrete headwall and CM pipe. Half of inlet pipe buried.

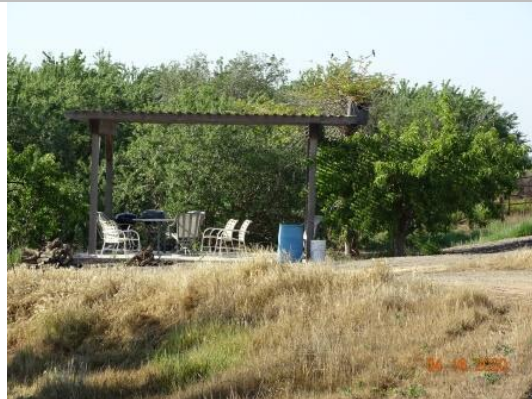
Photo 1 of 1 : FA\_2020\_NA0013\_332\_24\_20200901\_00006.jpg

Unauthorized patio and fruit trees installed on the landside slope.  
(Spring 2020)

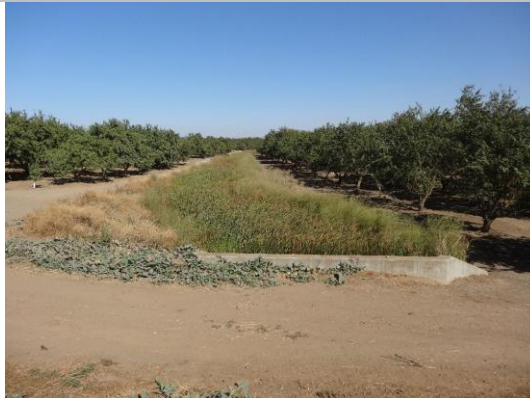
Photo 2 of 3 : UCIP\_FA\_2020\_20965\_35291.jpg

LS view: headwall on levee toe. Green vegetation in drainage channel.

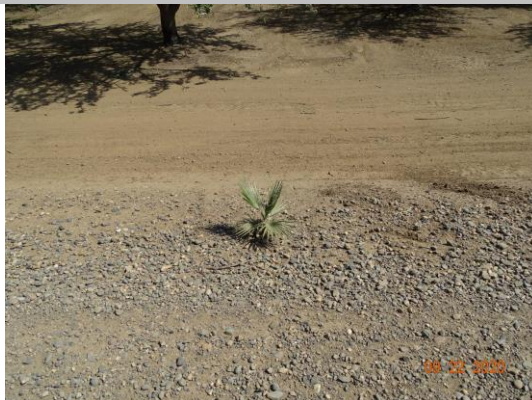
Photo 1 of 1 : FA\_2020\_NA0013\_332\_14\_20200928\_00036.jpg

View of palm tree sapling growing in the landside slope. (Fall 2020)

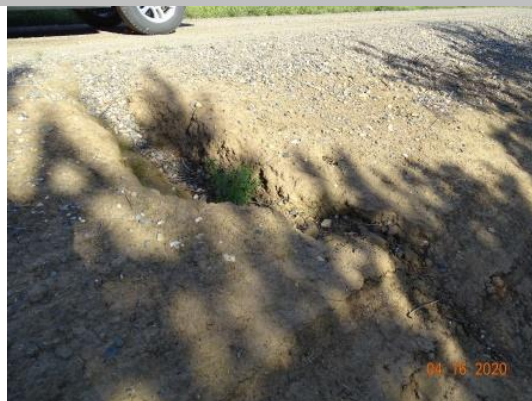
Photo 1 of 1 : FA\_2020\_NA0013\_332\_15\_20200901\_00003.jpg

LM Start	0.97	Rating **	M	Issue No.	15
LM End	0.97	Issue Type +	Ma	Location *	LS
Category	Earthen Levee			GPS Latitude/Longitude	
				Start	End
Item	Erosion / Bank Caving			37.327336 °	37.327336 °
				-120.396085 °	-120.396085 °
DWR ID	DWR_NA0013_02_f_2017_15				
Comment Code					
E2 : Schedule repair of erosion site prior to the next inspection.					
Inspector Comment					
There is large finger erosion on the landward slope. Couple of smaller erosion sites are starting just downstream of the larger erosion.

Looking at finger erosion on the landside slope. (Spring 2020)

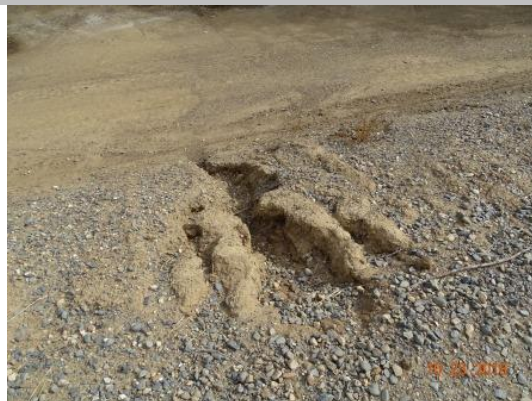
Photo 1 of 1 : FA\_2020\_NA0013\_332\_16\_20200901\_00004.jpg

LM Start	1.10	Rating **	M	Issue No.	16
LM End	1.10	Issue Type +	Ma	Location *	LS
Category	Earthen Levee			GPS Latitude/Longitude	
				Start	End
Item	Erosion / Bank Caving			37.325487 °	37.325487 °
				-120.396052 °	-120.396052 °
DWR ID	DWR_NA0013_02_s_2017_16				
Comment Code					
E2 : Schedule repair of erosion site prior to the next inspection.					
Inspector Comment					
Large finger erosion is located on the landside slope.

View of large finger erosion in landside slope. (Fall 2018)

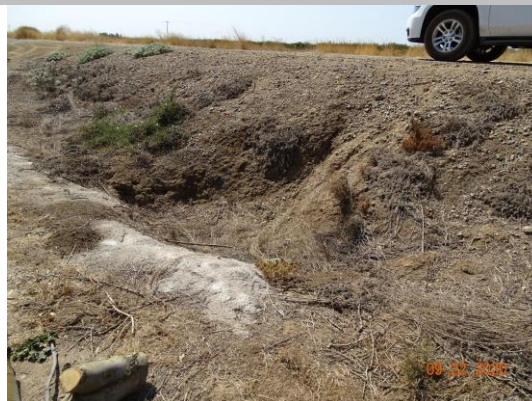
Photo 1 of 1 : FA\_2020\_NA0013\_332\_28\_20200928\_00038.jpg

View of erosion pocket in the landside slope and toe. (Fall 2020)

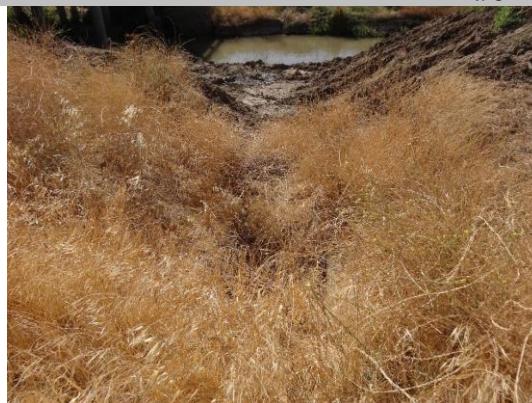
Photo 1 of 3 : UCIP\_FA\_2020\_42993\_35310.jpg

WS view: overview of outlet area and channel. Debris and vegetations on spillway.

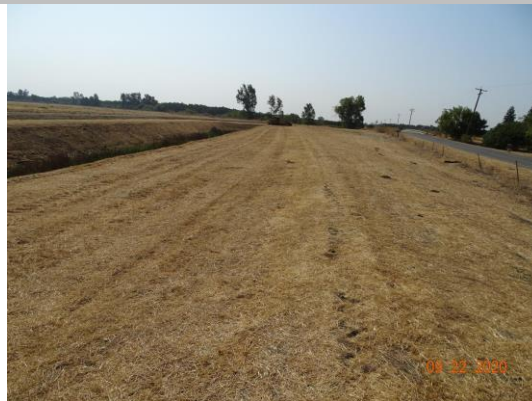
Photo 1 of 1 : FA\_2020\_NA0013\_333\_10\_20200928\_00023.jpg

View of vegetation control on waterside slopes. (Fall 2020)

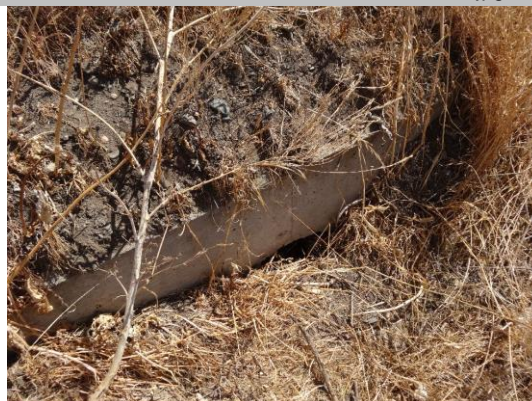
Photo 3 of 3 : UCIP\_FA\_2020\_41815\_35531.jpg

LS view: concrete headwall and CM pipe. Inlet needs cleaning and silt removed.

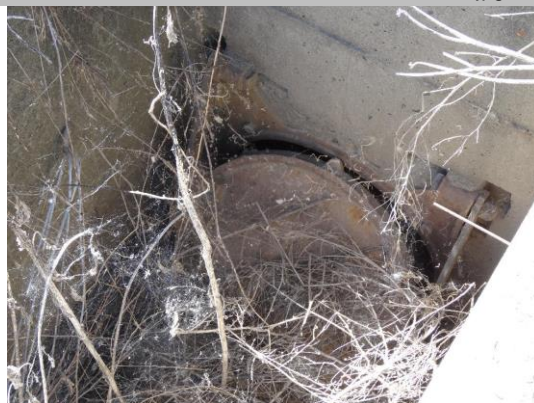
Photo 2 of 3 : UCIP\_FA\_2020\_50144\_35421.jpg

WS view: U typed concrete headwall, CM pipe, and flap gate. Damaged flap gate.

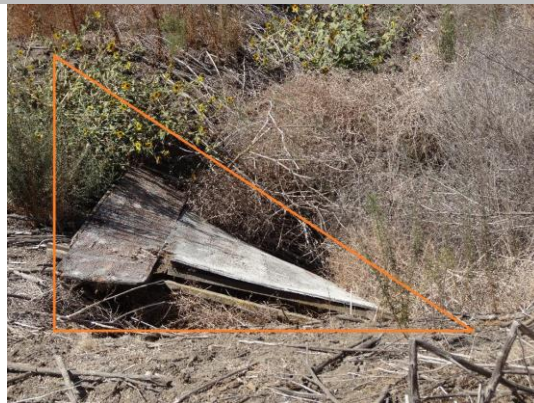
Photo 3 of 3 : UCIP\_FA\_2020\_50144\_35420.jpg

LS view: Debris dumped on inlet structure. Needs to be cleared or abandoned properly.

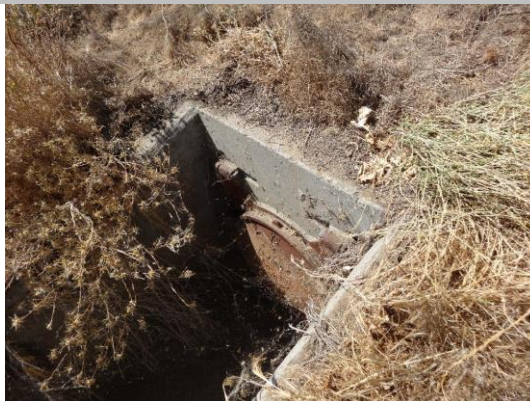
Photo 2 of 3 : UCIP\_FA\_2020\_50149\_35534.jpg

WS view: U typed concrete headwall, CM pipe, and flap gate. Vegetation needs to be cleared.

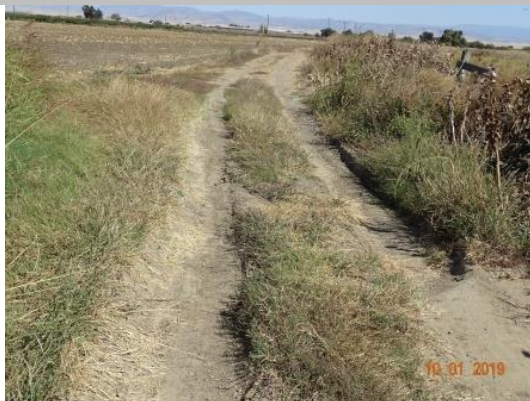
Photo 1 of 1 : FA\_2020\_NA0013\_333\_9\_20200901\_00001.jpg

View of rutted levee crown looking upstream. (Fall 2019)

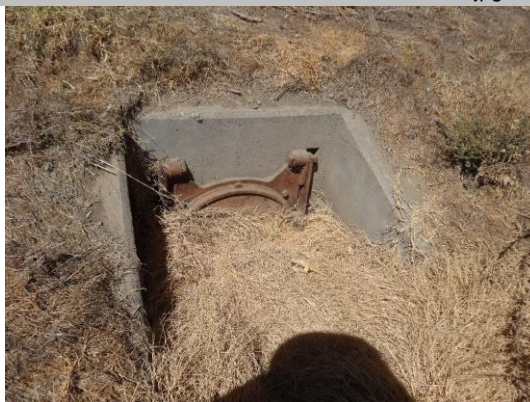
Photo 2 of 3 : UCIP\_FA\_2020\_50152\_35543.jpg

WS view: U typed concrete headwall, CM pipe, and flap gate. Vegetation needs to be cleared.

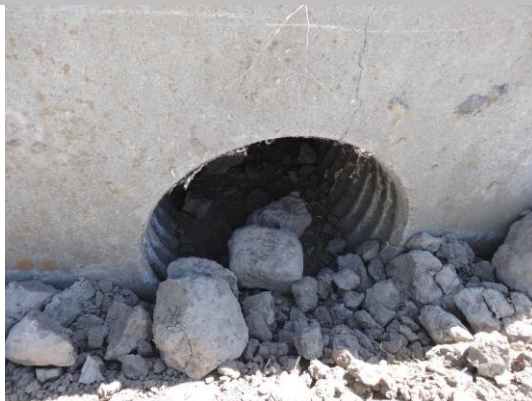
Photo 3 of 3 : UCIP\_FA\_2020\_21063\_35500.jpg

LS view: closer view of CM pipe. Inlet needs cleaning & clearing.

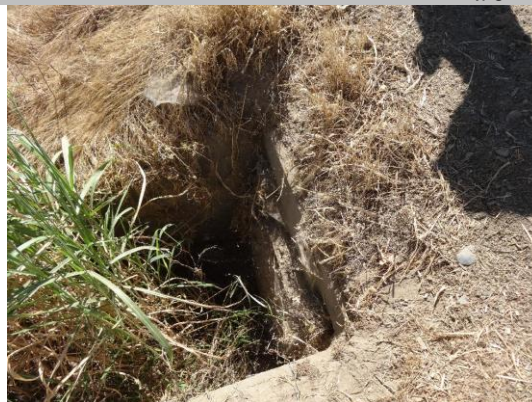
Photo 2 of 3 : UCIP\_FA\_2020\_21064\_35505.jpg

WS view: U typed concrete headwall, CM pipe, and flap gate. Vegetation needs to be cleared.

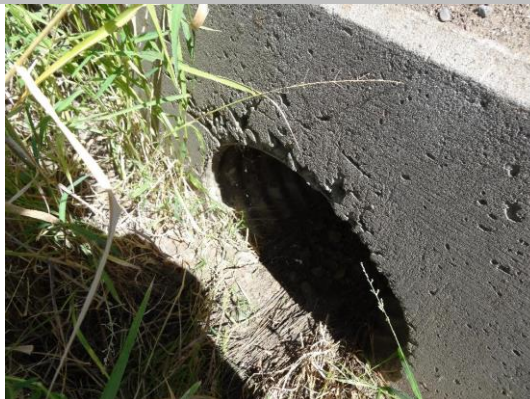
Photo 3 of 3 : UCIP\_FA\_2020\_21064\_35504.jpg

LS view: concrete headwall and CM pipe. Inlet needs clearing.

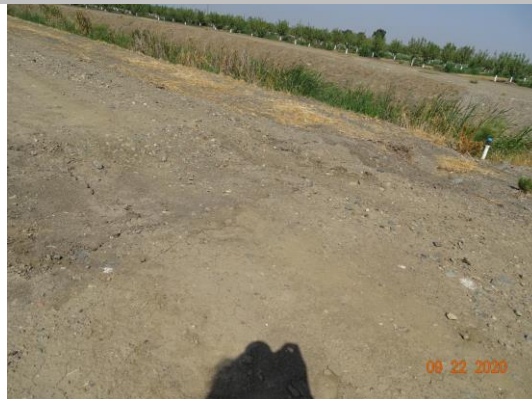
Photo 1 of 1 : FA\_2020\_NA0013\_334\_10\_20200928\_00029.jpg

View of depression across the levee crown and waterside slope. (Fall 2020)

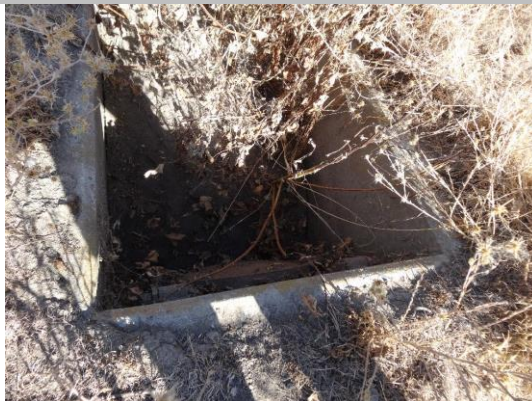
Photo 1 of 3 : UCIP\_FA\_2020\_50146\_35748.jpg

WS view: U typed concrete headwall, CM pipe, and flap gate. Vegetation needs to be cleared.

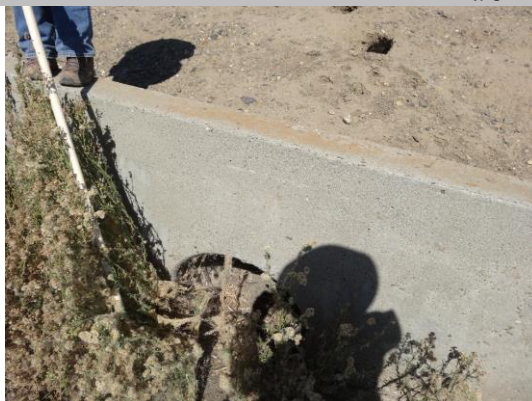
Photo 2 of 3 : UCIP\_FA\_2020\_50146\_35747.jpg

LS view: concrete headwall and CM pipe. Inlet needs clearing.

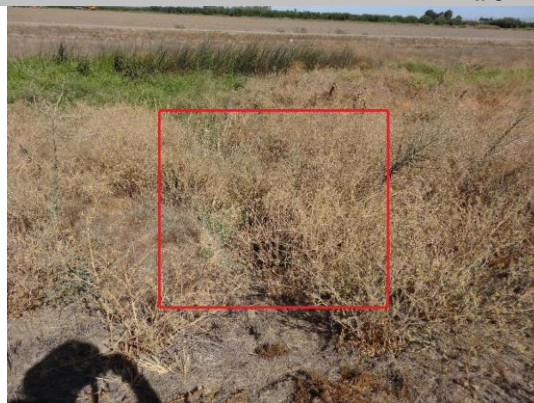
Photo 1 of 3 : UCIP\_FA\_2020\_50154\_35608.jpg

WS view: Dense vegetation on levee slope and spillway.

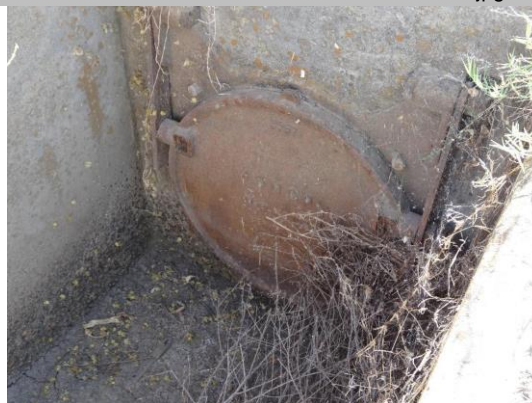
Photo 3 of 3 : UCIP\_FA\_2020\_50154\_35606.jpg

WS view: CM pipe and flap gate. Vegetation needs to be cleared.

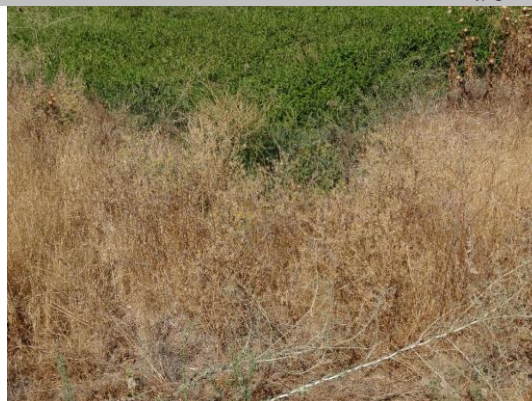
Photo 1 of 3 : UCIP\_FA\_2020\_50155\_35642.jpg

WS view: Dense vegetation on levee slope and spillway.

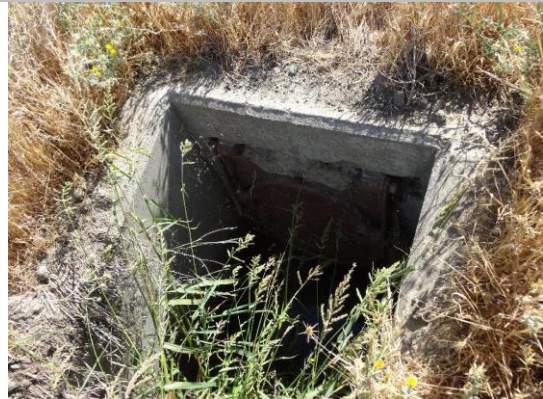
Photo 2 of 3 : UCIP\_FA\_2020\_50155\_35641.jpg

WS view: U typed concrete headwall, CM pipe, and flap gate. Vegetation needs to be cleared.

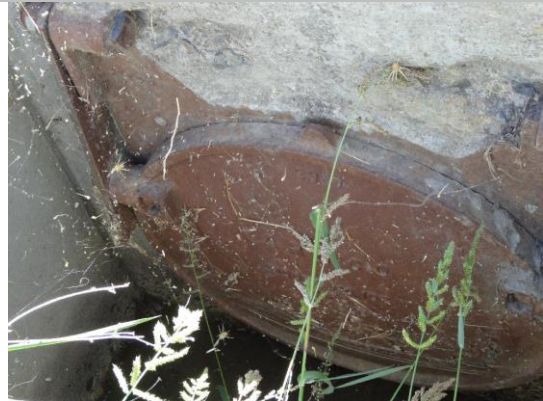
Photo 3 of 3 : UCIP\_FA\_2020\_50155\_35640.jpg

WS view: CM pipe and flap gate. Vegetation needs to be cleared.

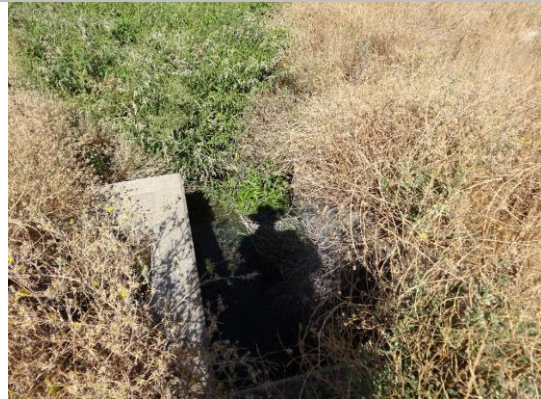
Photo 1 of 3 : UCIP\_FA\_2020\_21126\_35652.jpg

WS view: concrete spillway and channel on waterside. Dense vegetation on levee slope and spillway.

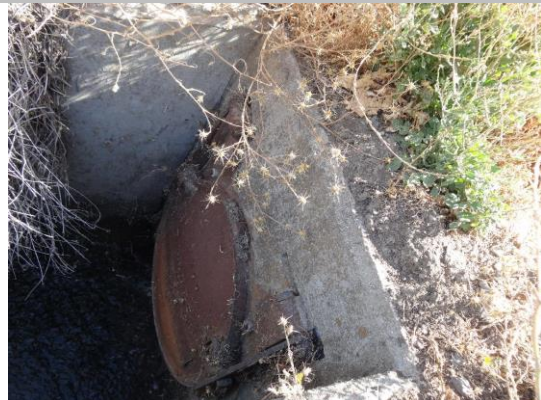
Photo 2 of 3 : UCIP\_FA\_2020\_21126\_35651.jpg

WS view: U typed concrete headwall, CM pipe, and flap gate. Vegetation needs to be cleared on spillway.

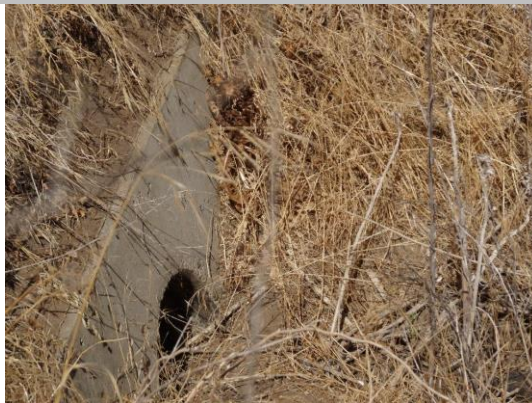
Photo 3 of 3 : UCIP\_FA\_2020\_52888\_35707.jpg

LS view: concrete headwall and CM pipe. Inlet silt needs clearing.

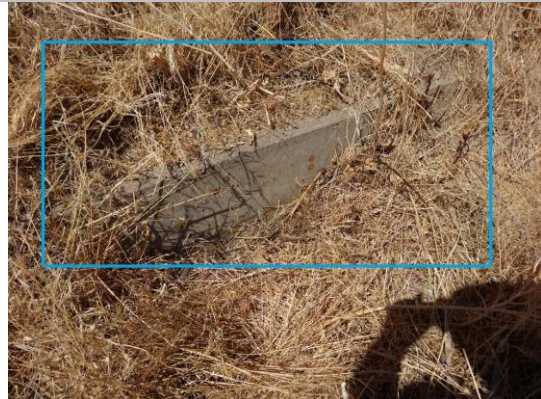
Photo 3 of 3 : UCIP\_FA\_2020\_50153\_35743.jpg

LS view: concrete headwall and buried CM pipe. Dirt removal and clearing needed in inlet.
