Flood Control Project Maintenance Levee Inspections

Fall 2021 Levee Maintenance Deficiency Summary Report

San Joaquin River Basin

Merced Streams Group

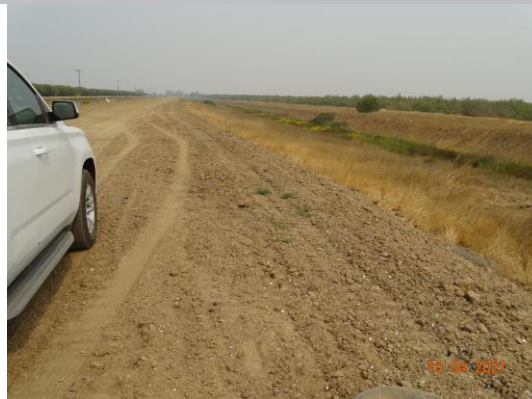
Photo 1 of 1 : FA_2021_NA0013_331_7_20211012_00011.jpg

Dredgings have been leveled but still left within the channel. (Fall 2021)

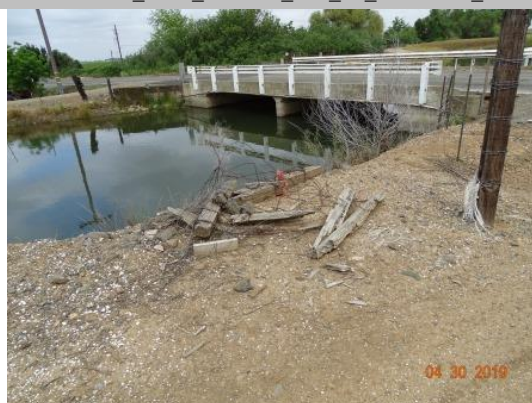
Photo 1 of 1 : FA_2021_NA0013_331_16_20210830_00005.jpg

LM Start	1.23	Rating **	A/W	Issue No.	16
LM End	1.23	Issue Type +	Ma	Location *	CR
Category	Earthen Levee			GPS Latitude/Longitude	
				Start	End
Item	Repair Gates			37.332005 °	37.332005 °
				-120.394751 °	-120.394751 °
DWR ID	DWR_NA0013_01_s_2019_16				
Comment Code					
Inspector Comment					
Gate has been removed.

View of barbed wire gate discarded on levee. (Spring 2019)

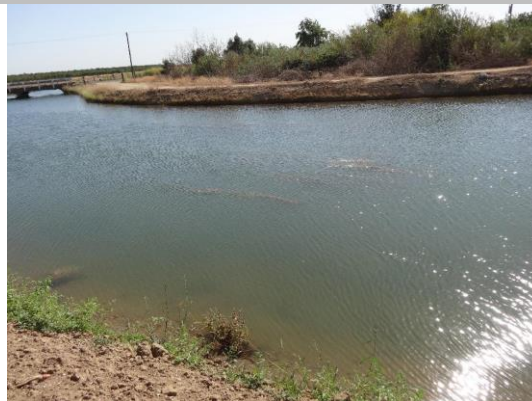
Photo 1 of 3 : UCIP_FA_2021_41672_35211.jpg

Comment Code					
Inspector Comment					
DS_ID:23079 FS_ID:41672 EP_NO: N/A Repair Type: Non-Urgent EVAL Issue: Crossing Status: Indicator Found UCIP Comments: 09/17/2013 Verify Pipe is abandoned or still intact.- may be this crossing was abandoned/removed during recent levee reconstruction.- no signs of pipe and appurtenances on waterside.- only a CM pipe riser with slide gate found on landside. (DWR UCIP - P. Amatya) FIELD_STRUCT_DESC: 36-inch corrugated metal irrigation pipe through the levee, 10 feet below the crown. Riser on the landside (LS). Screw gate in a 48-inch pipe well on the waterside (WS) slope. Concrete headwall and cobble spillway at the LS toe. Concrete headwall at the WS toe. [Additional Reference(s): USACE San Joaquin O&M Manual 607, June 1962, (HLM 1.32)]. FS Date: 9/17/2013

WS view: no signs of pipe and appurtenances on levee slope and channel bank.

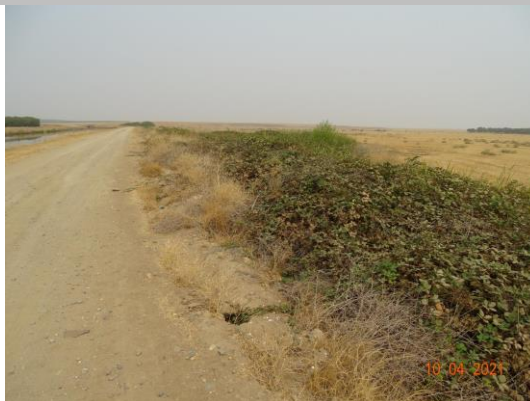
Photo 1 of 1 : FA_2021_NA0013_331_3_20211012_00012.jpg

View of blackberry bushes growing on the the waterside slope. (Fall 2021)

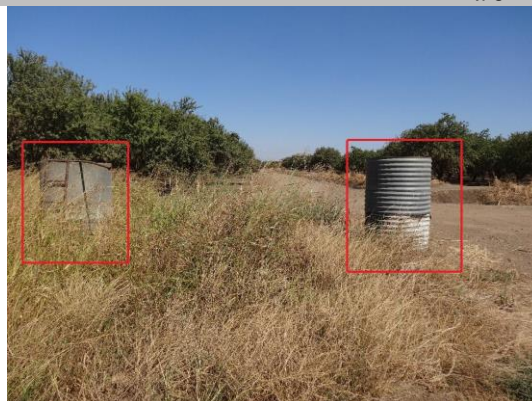
Photo 1 of 3 : UCIP_FA_2021_21263_35761.jpg

LM Start	0.01	Rating **	M	Issue No.	32
LM End	0.01	Issue Type +	En	Location *	
Category	Supplemental			GPS Latitude/Longitude	
				Start	End
Item	DWR UCIP Field Study			37.337019 °	37.337019 °
				-120.387539 °	-120.387539 °
DWR ID	23052				
Comment Code					
Inspector Comment					
DS_ID:23052 FS_ID:21263 EP_NO: N/A Repair Type: Non-Urgent EVAL Issue: Crossing Status: Found UCIP Comments: 09/17/2013 - needs more investigations on this crossing. - new water filtration plant on LS with pump and concrete vault.- a concrete standpipe and CM pipe riser on WS. (DWR UCIP - P. Amatya) FIELD_STRUCT_DESC: 10-inch steel irrigation pipe through the levee, 5 feet below the crown. Riser on the landside (LS). Screw gate in a 36-inch pipe well on the waterside (WS) slope. [Additional Reference(s): DWR Levee Log, 2005. USACE San Joaquin O&M Manual 607, June 1962, (HLM 0.00)]. FS Date: 9/17/2013

WS view: concrete standpipe (left) and CMP standpipe (right).

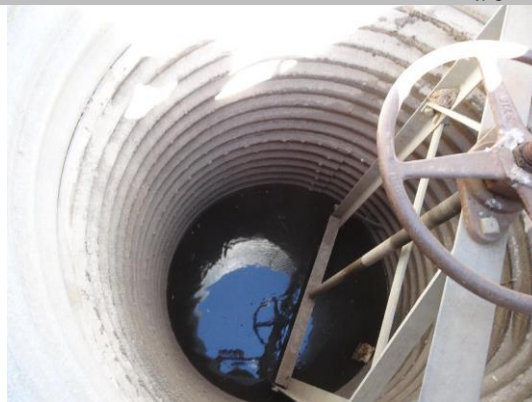
Photo 2 of 3 : UCIP_FA_2021_21263_35760.jpg

WS view: inside view of CMP standpipe with slide gate.

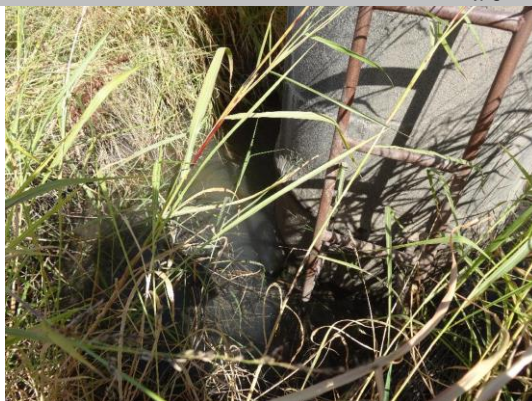
Photo 3 of 3 : UCIP_FA_2021_21263_35764.jpg

WS view: concrete standpipe with water ponding at its base.

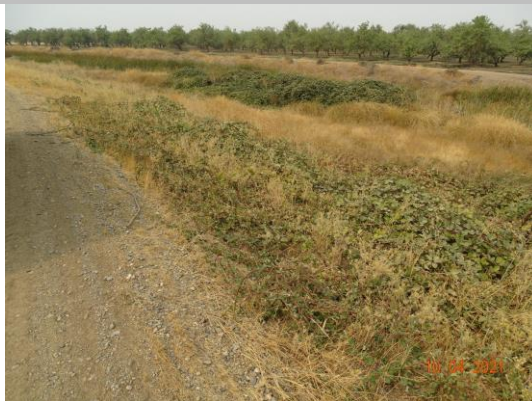
Photo 1 of 1 : FA_2021_NA0013_332_10_20211012_00032.jpg

LM Start	0.22	Rating **	M	Issue No.	10
LM End	0.22	Issue Type +	Ma	Location *	WS
Category	Earthen Levee			GPS Latitude/Longitude	
				Start	End
Item	Vegetation			37.336284 °	37.336284 °
				-120.390694 °	-120.390694 °
DWR ID	DWR_NA0013_02_f_2021_10				
Comment Code					
V2 : Remove the wild growth other than native grasses from the levee slopes.					
Inspector Comment					
Blackberry bushes are beginning to grow on the waterside slope.

Blackberry bushes are beginning to grow up the waterside slope and shoulder. (Fall 2021)

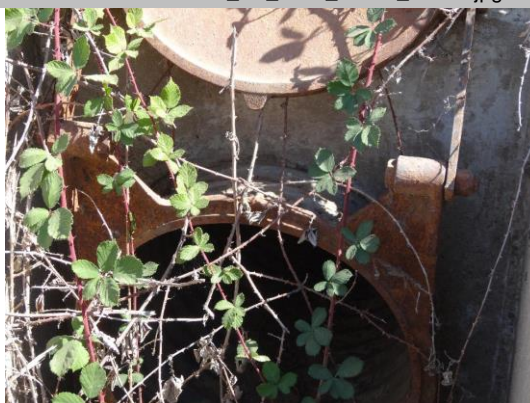
Photo 2 of 3 : UCIP_FA_2021_50156_35244.jpg

WS view: U typed concrete headwall, CM pipe, and flap gate. Flap gate was not closed. Vegetation needs to be cleared.

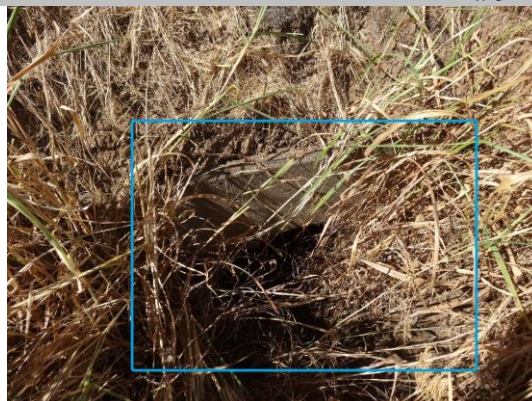
Photo 3 of 3 : UCIP_FA_2021_50156_35246.jpg

LS view: concrete headwall and CM pipe. Inlet needs cleaning.

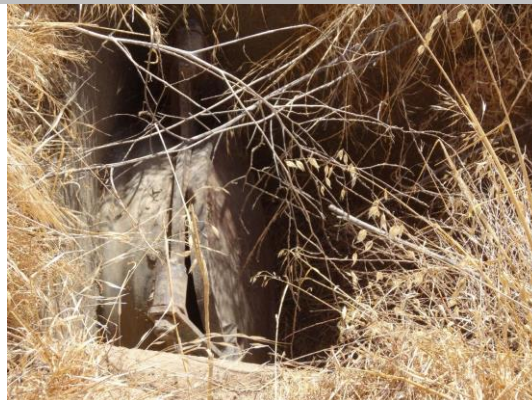
Photo 2 of 3 : UCIP_FA_2021_20946_35265.jpg

WS view: U typed concrete headwall, CM pipe, and flap gate. Flap gate was not properly closed.

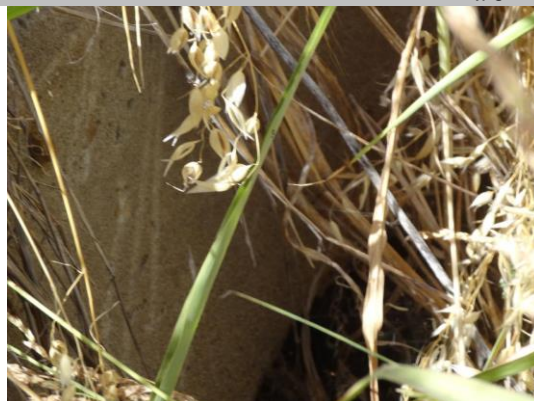
Photo 3 of 3 : UCIP_FA_2021_20946_35264.jpg

LS view: concrete headwall and CM pipe. Inlet needs cleaning.

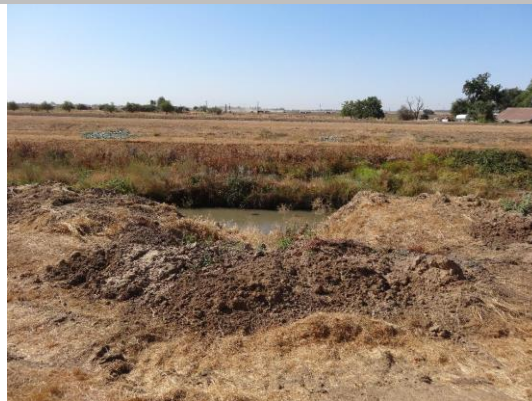
Photo 1 of 3 : UCIP_FA_2021_20992_35370.jpg

Comment Code						
Inspector Comment						
DS_ID:23055 FS_ID:20992 EP_NO: N/A Repair Type: Non-Urgent EVAL Issue: Crossing Status: Found UCIP Comments: 09/17/2013 - mud and debris from recent channel cleaning needs to be removed from spillway and outlet - pipe filled with debris, it needs cleaning.- half of intet pipe burried. (DWR UCIP - P. Amatya) FIELD_STRUCT_DESC: 24-inch corrugated metal gravity drainage pipe through the levee, 8 feet below the crown. Concrete headwall, flap gate, and concrete grouted cobble spillway on the waterside (WS) toe. Concrete headwall on the landside (LS) toe. [Additional Reference(s): DWR Levee Log, 2005. USACE San Joaquin O&M Manual 607, June 1962, (HLM 0.73)]. FS Date: 9/17/2013

WS view: concrete headwall and CM pipe burried under debris and mud.

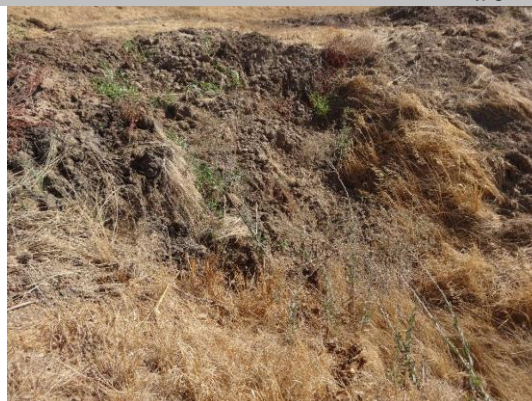
Photo 2 of 3 : UCIP_FA_2021_20992_35369.jpg

WS view: debris and mud deposited from the channel cleaning. It needs to be cleared from spillway and outlet structure.

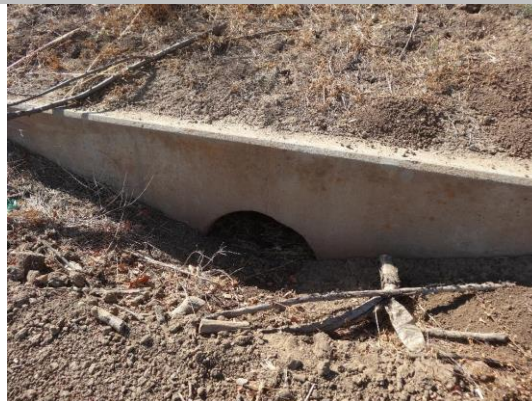
Photo 3 of 3 : UCIP_FA_2021_20992_35366.jpg

LS view: concrete headwall and CM pipe. Half of inlet pipe buried.

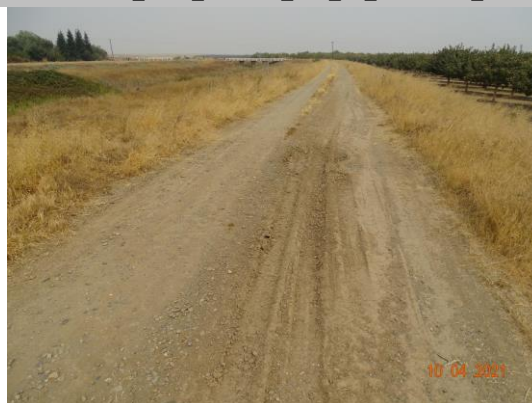
Photo 1 of 1 : FA_2021_NA0013_332_17_20211012_00036.jpg

LM Start	0.74	Rating **	M	Issue No.	17
LM End	0.74	Issue Type +	Ma	Location *	CR
Category	Earthen Levee			GPS Latitude/Longitude	
				Start	End
Item	Crown Surface / Depressions / Rutting			37.330443 °	37.330443 °
				-120.395181 °	-120.395181 °
DWR ID	DWR_NA0013_02_f_2021_17				
Comment Code					
C2 : Repair depressions or ruts in the crown or slope.					
Inspector Comment

Depression in the levee crown from vehicle traffic. (Fall 2021)

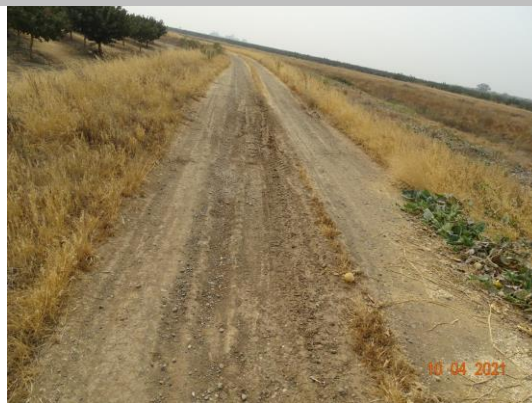
Photo 1 of 1 : FA_2021_NA0013_332_27_20211012_00037.jpg

LM Start	0.78	Rating **	M	Issue No.	27
LM End	0.80	Issue Type +	Ma	Location *	CR
Category	Earthen Levee			GPS Latitude/Longitude	
				Start	End
Item	Crown Surface / Depressions / Rutting			37.329952 °	37.329789 °
				-120.395588 °	-120.395720 °
DWR ID	DWR_NA0013_02_s_2020_27				
Comment Code					
C2 : Repair depressions or ruts in the crown or slope.					
Inspector Comment

View of depressions in the levee crown from vehicle traffic. (Fall 2021)

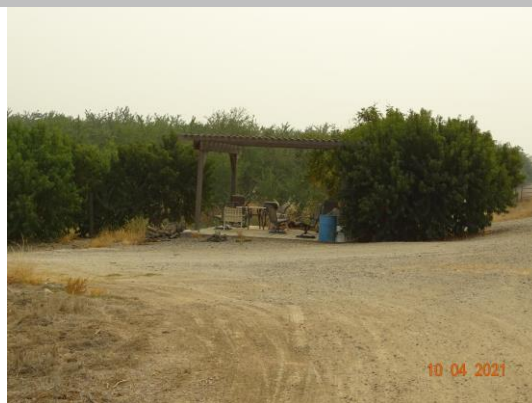
Photo 1 of 1 : FA_2021_NA0013_332_24_20211012_00038.jpg

Unauthorized patio and fruit trees installed on the landside slope. (Fall 2021)

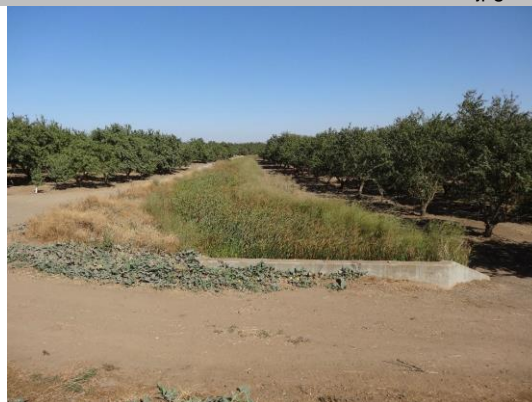
Photo 2 of 3 : UCIP_FA_2021_20965_35291.jpg

LS view: headwall on levee toe. Green vegetation in drainage channel.

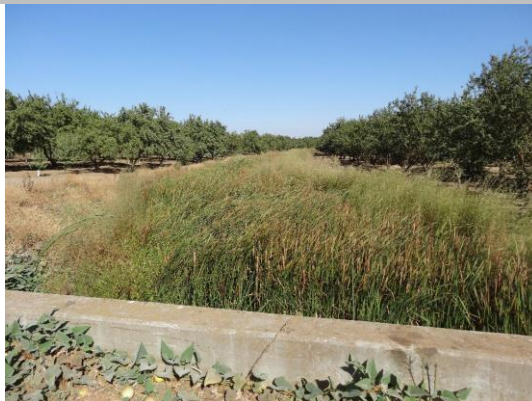
Photo 3 of 3 : UCIP_FA_2021_20983_35300.jpg

LS view: concrete headwall in drainage ditch. Dense vegetation in drainage ditch.

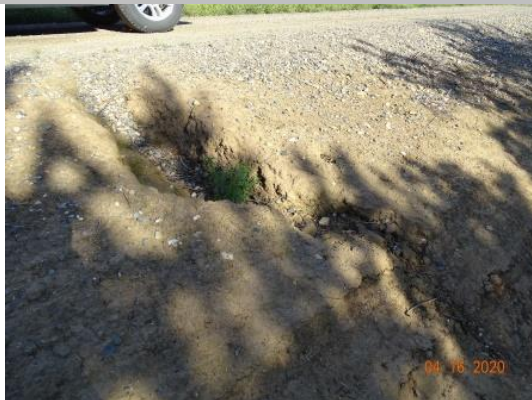
Photo 1 of 1 : FA_2021_NA0013_332_15_20210830_00003.jpg

LM Start	0.97	Rating **	M	Issue No.	15
LM End	0.97	Issue Type +	Ma	Location *	LS
Category	Earthen Levee			GPS Latitude/Longitude	
				Start	End
Item	Erosion / Bank Caving			37.327336 °	37.327336 °
				-120.396085 °	-120.396085 °
DWR ID	DWR_NA0013_02_f_2017_15				
Comment Code					
E2 : Schedule repair of erosion site prior to the next inspection.					
Inspector Comment					
There is large finger erosion on the landward slope. Couple of smaller erosion sites are starting just downstream of the larger erosion.

Looking at finger erosion on the landside slope. (Spring 2020)

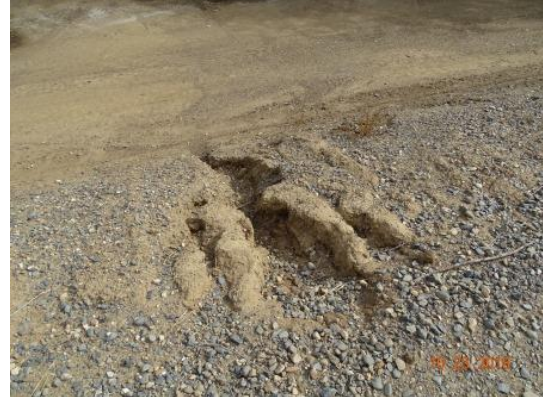
Photo 1 of 1 : FA_2021_NA0013_332_16_20210830_00004.jpg

LM Start	1.10	Rating **	M	Issue No.	16
LM End	1.10	Issue Type +	Ma	Location *	LS
Category	Earthen Levee			GPS Latitude/Longitude	
				Start	End
Item	Erosion / Bank Caving			37.325487 °	37.325487 °
				-120.396052 °	-120.396052 °
DWR ID	DWR_NA0013_02_s_2017_16				
Comment Code					
E2 : Schedule repair of erosion site prior to the next inspection.					
Inspector Comment					
Large finger erosion is located on the landside slope.

View of large finger erosion in landside slope. (Fall 2018)

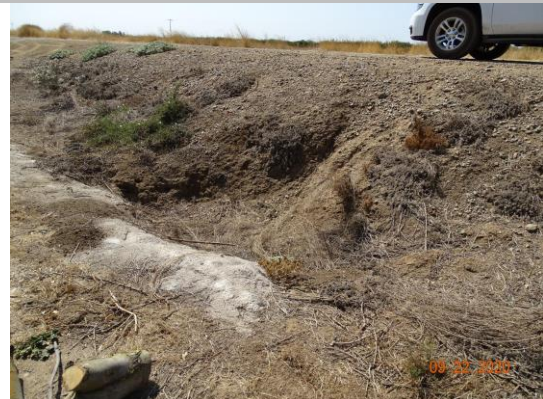
Photo 1 of 1 : FA_2021_NA0013_332_28_20210830_00006.jpg

LM Start	1.29	Rating **	M	Issue No.	28
LM End	1.29	Issue Type +	Ma	Location *	LS
Category	Earthen Levee			GPS Latitude/Longitude	
				Start	End
Item	Erosion / Bank Caving			37.322752 °	37.322752 °
				-120.396030 °	-120.396030 °
DWR ID	DWR_NA0013_02_s_2020_28				
Comment Code					
E2 : Schedule repair of erosion site prior to the next inspection.					
Inspector Comment

View of erosion pocket in the landside slope and toe. (Fall 2020)

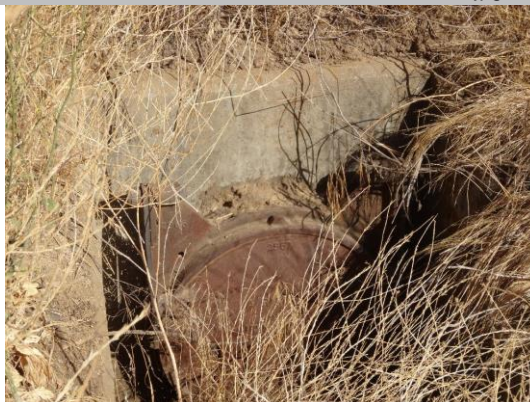
Photo 2 of 3 : UCIP_FA_2021_42993_35309.jpg

WS view: U typed concrete headwall, CM pipe and flap gate. Vegetation and debris need to be cleared.

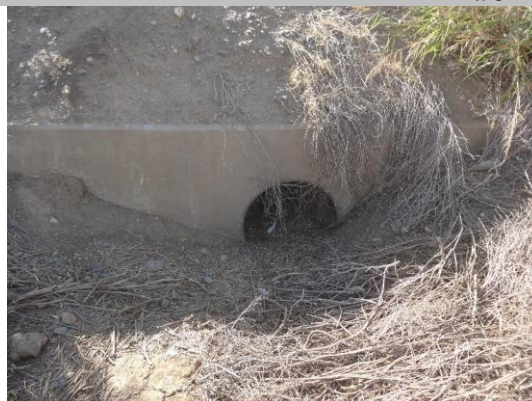
Photo 3 of 3 : UCIP_FA_2021_42993_35312.jpg

LS view: concrete headwall and CM pipe. Inlet needs cleaning. Part of inlet pipe buried.

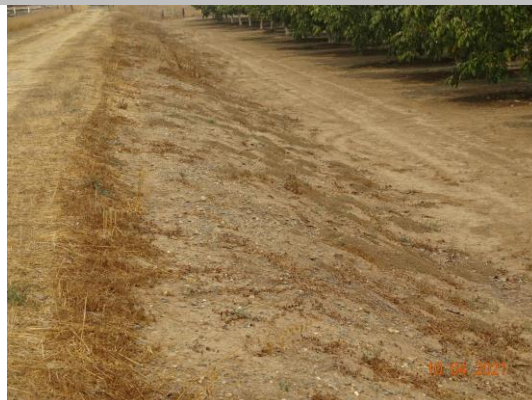
Photo 1 of 1 : FA_2021_NA0013_332_20_20211012_00039.jpg

View of rodent burrows in the landside slope. (Fall 2021)

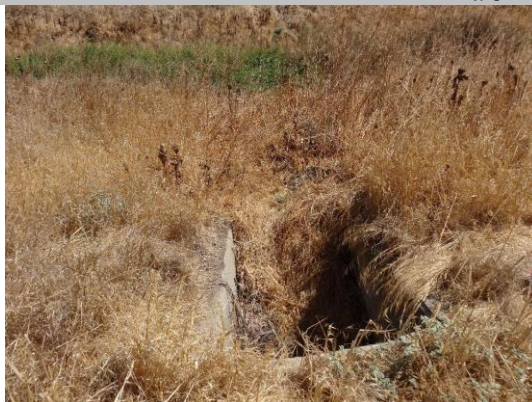
Photo 2 of 3 : UCIP_FA_2021_41815_35532.jpg

WS view: Silt needs to be removed. Vegetations needs to be cleared.

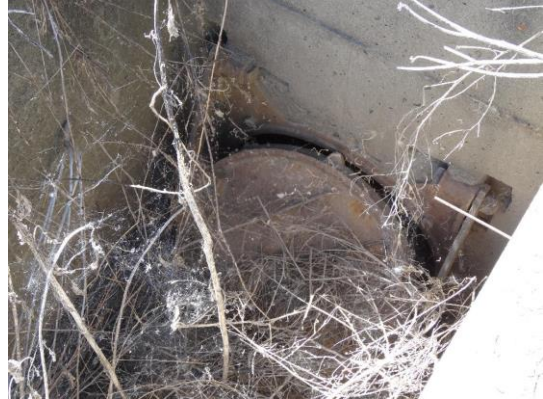
Photo 2 of 3 : UCIP_FA_2021_50144_35421.jpg

WS view: U typed concrete headwall, CM pipe, and flap gate. Damaged flap gate.

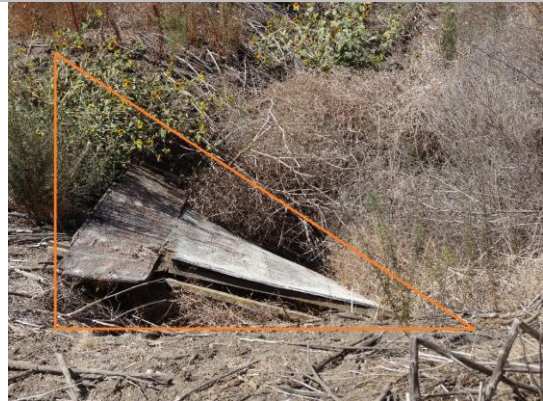
Photo 3 of 3 : UCIP_FA_2021_50144_35420.jpg

LS view: Debris dumped on inlet structure. Needs to be cleared or abandoned properly.

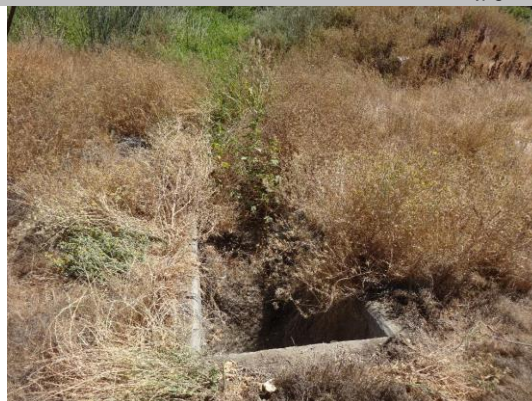
Photo 1 of 3 : UCIP_FA_2021_50149_35535.jpg

WS view: cobble spillway and channel on waterside. Dense vegetation on levee slope.

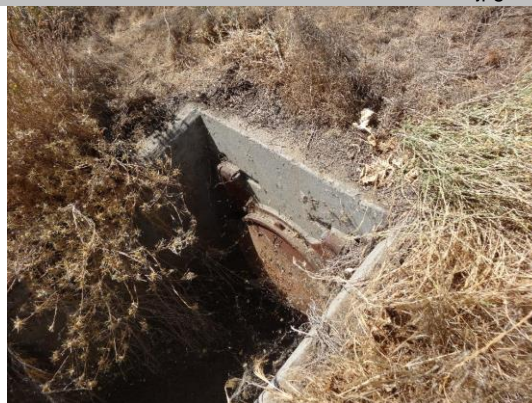
Photo 2 of 3 : UCIP_FA_2021_50149_35534.jpg

WS view: U typed concrete headwall, CM pipe, and flap gate. Vegetation needs to be cleared.

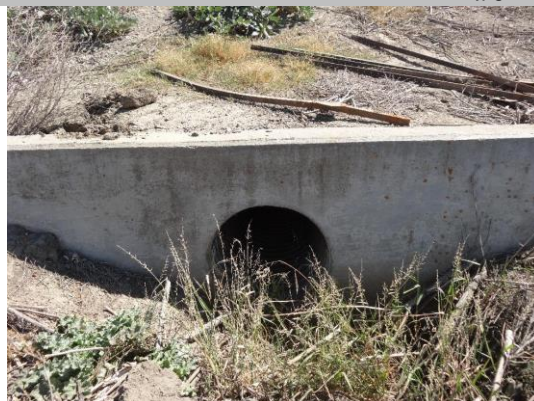
Photo 3 of 3 : UCIP_FA_2021_50149_35537.jpg

LS view: concrete headwall and CM pipe. Inlet needs clearing.

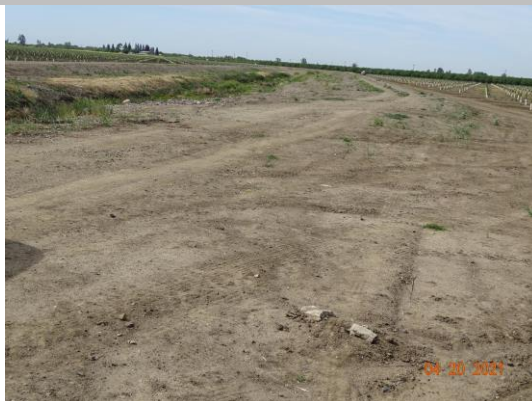
Photo 1 of 1 : FA_2021_NA0013_333_9_20210830_00001.jpg

View of depression on landside slope and levee crown. (Spring 2021)

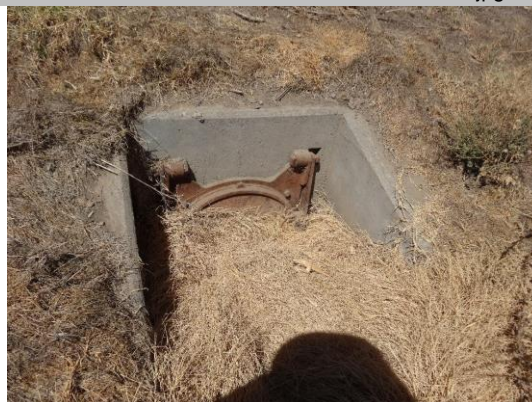
Photo 2 of 3 : UCIP_FA_2021_50152_35543.jpg

WS view: U typed concrete headwall, CM pipe, and flap gate. Vegetation needs to be cleared.

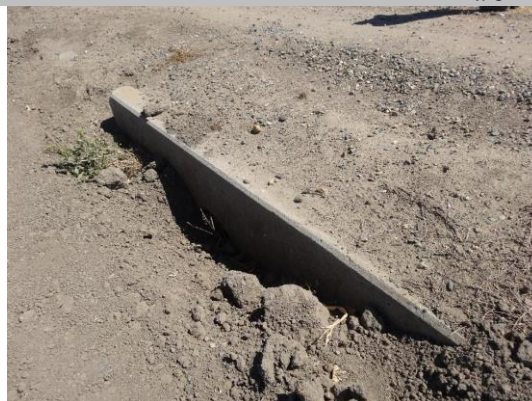
Photo 3 of 3 : UCIP_FA_2021_50152_35542.jpg

LS view: concrete headwall and CM pipe. Inlet needs clearing &

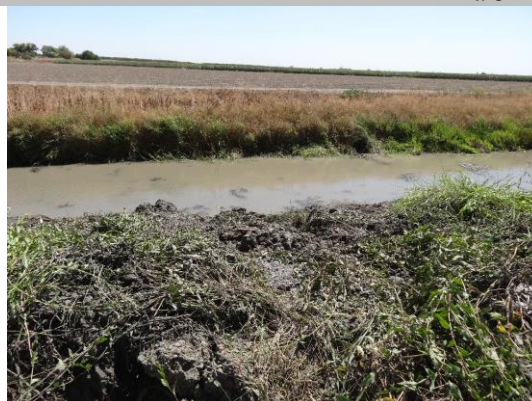
Photo 1 of 3 : UCIP_FA_2021_21063_35502.jpg

WS view: U typed concrete headwall, CM pipe, and flap gate buried under mud/debris.

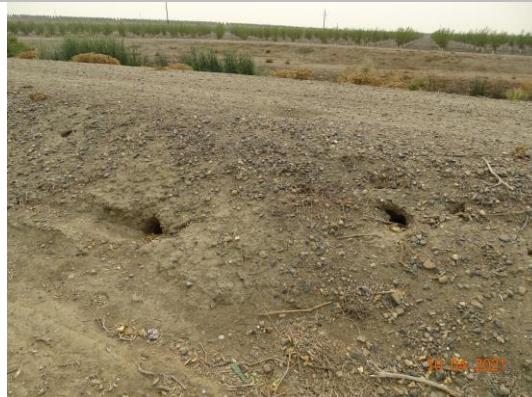
Photo 1 of 1 : FA_2021_NA0013_333_13_20211012_00028.jpg

Rodent holes observed on the landside slope. (Fall 2021)

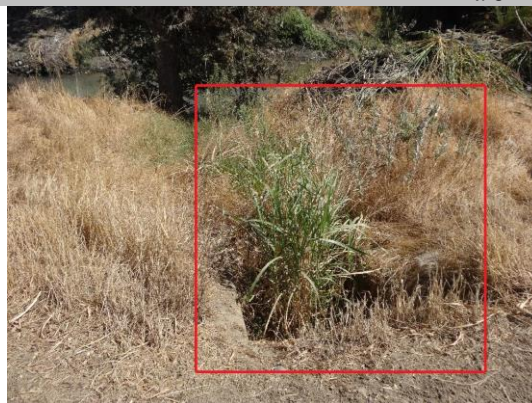
Photo 1 of 3 : UCIP_FA_2021_21064_35506.jpg

WS view: cobble spillway and channel on waterside. Dense vegetation on levee slope and spillway.

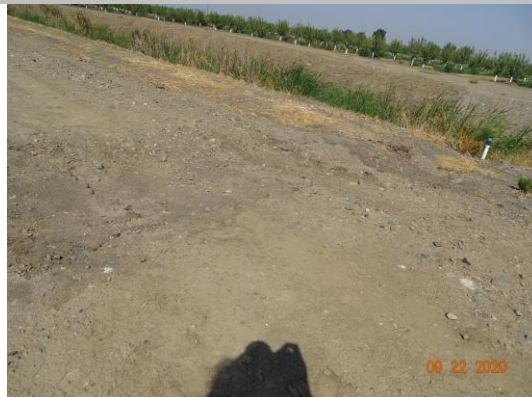
Photo 1 of 1 : FA_2021_NA0013_334_10_20210830_00001.jpg

View of depression across the levee crown and waterside slope. (Fall 2020)

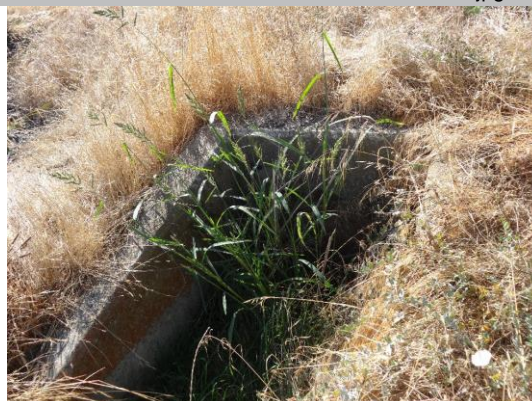
Photo 1 of 3 : UCIP_FA_2021_42991_35751.jpg

WS view: concrete spillway and channel on waterside. Dense vegetation on levee slope and spillway.

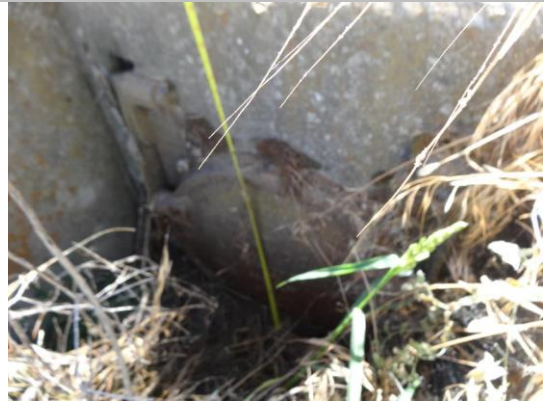
Photo 2 of 3 : UCIP_FA_2021_42991_35750.jpg

WS view: U typed concrete headwall, CM pipe, and flap gate. Vegetation and silt need to be cleared.

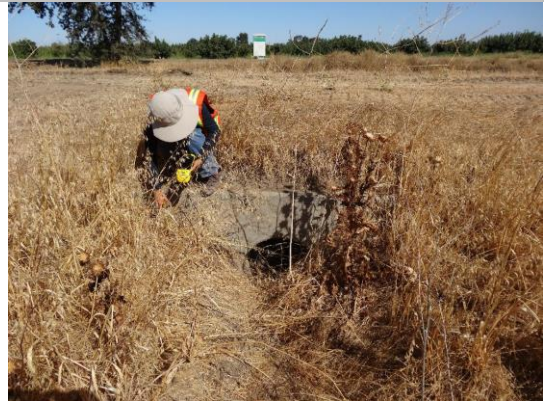
Photo 3 of 3 : UCIP_FA_2021_42991_35749.jpg

LS view: concrete headwall and CM pipe. Inlet silt needs clearing.

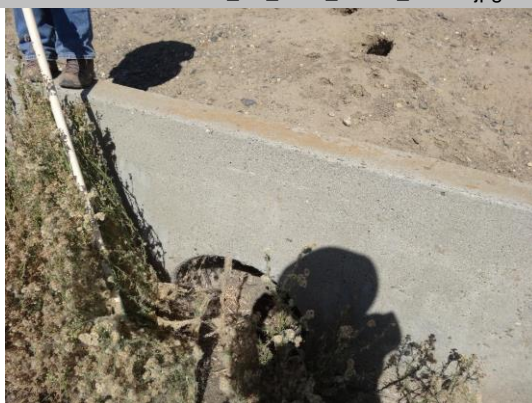
Photo 2 of 3 : UCIP_FA_2021_50146_35747.jpg

LS view: concrete headwall and CM pipe. Inlet needs clearing.

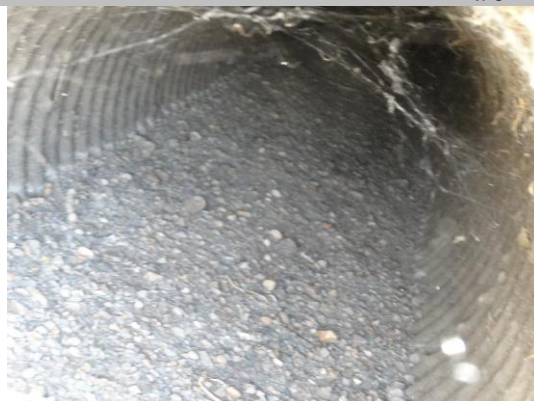
Photo 3 of 3 : UCIP_FA_2021_50146_35746.jpg

LS view: inside view of CM pipe. Inlet pipe needs clearing.

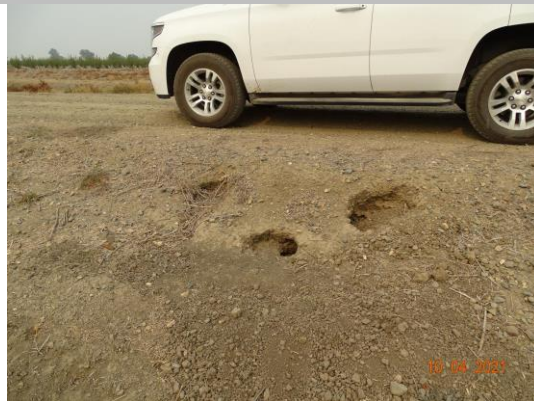
Photo 1 of 1 : FA_2021_NA0013_334_12_20211012_00031.jpg

View of rodent burrows in the landside slope. (Fall 2021)

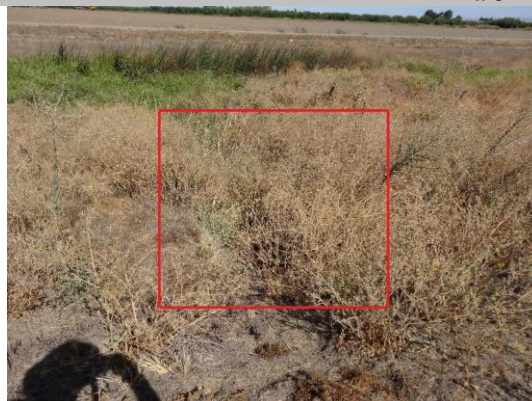
Photo 1 of 3 : UCIP_FA_2021_50154_35608.jpg

WS view: Dense vegetation on levee slope and spillway.

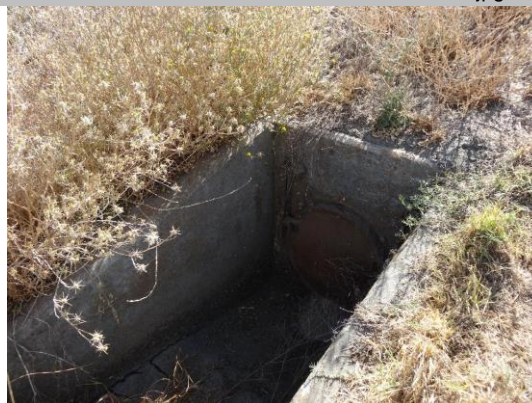
Photo 2 of 3 : UCIP_FA_2021_50154_35607.jpg

WS view: U typed concrete headwall, CM pipe, and flap gate. Vegetation needs to be cleared on spillway.

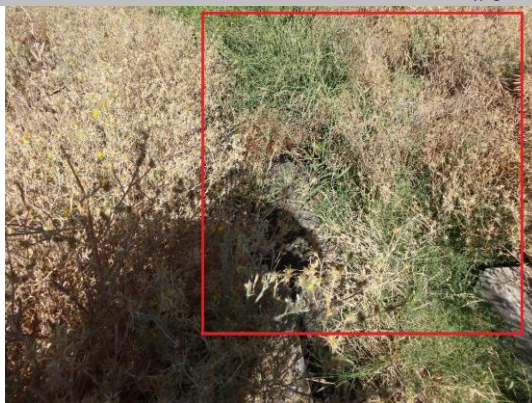
Photo 1 of 3 : UCIP_FA_2021_50148_35613.jpg

WS view: Dense vegetation on levee slope and spillway.

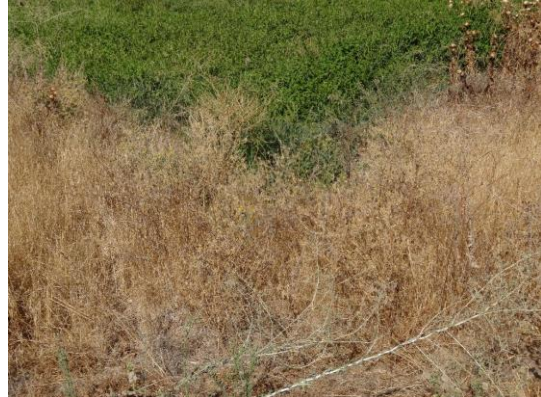
Photo 1 of 3 : UCIP_FA_2021_50155_35642.jpg

WS view: Dense vegetation on levee slope and spillway.

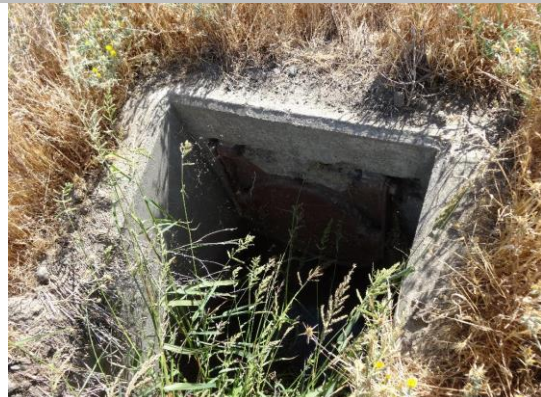
Photo 2 of 3 : UCIP_FA_2021_50155_35641.jpg

WS view: U typed concrete headwall, CM pipe, and flap gate. Vegetation needs to be cleared.

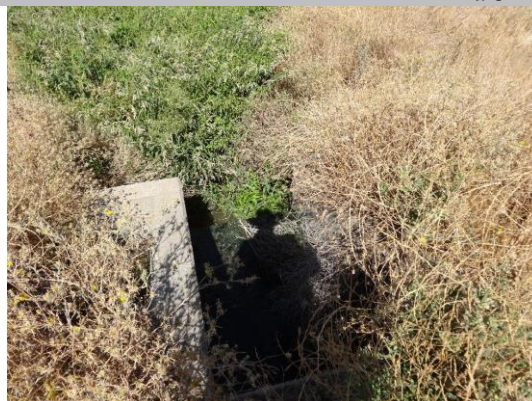
Photo 1 of 3 : UCIP_FA_2021_21126_35652.jpg

WS view: concrete spillway and channel on waterside. Dense vegetation on levee slope and spillway.

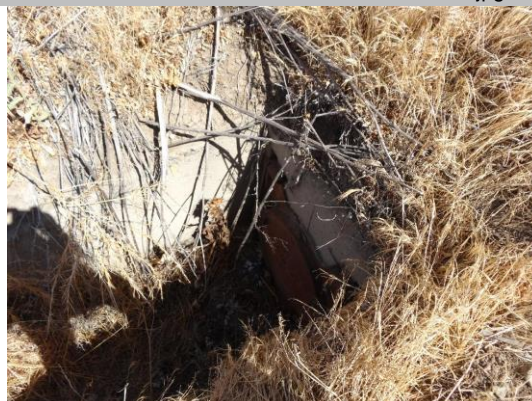
Photo 1 of 3 : UCIP_FA_2021_52888_35709.jpg

WS view: concrete spillway and channel on waterside. Dense vegetation on levee slope and spillway.

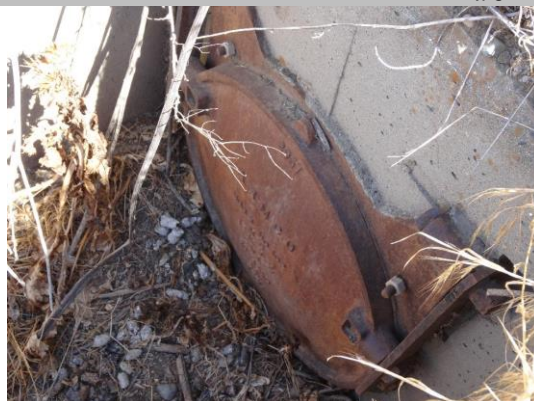
Photo 2 of 3 : UCIP_FA_2021_52888_35708.jpg

WS view: U typed concrete headwall, CM pipe, and flap gate. Spillway needs to be cleared.

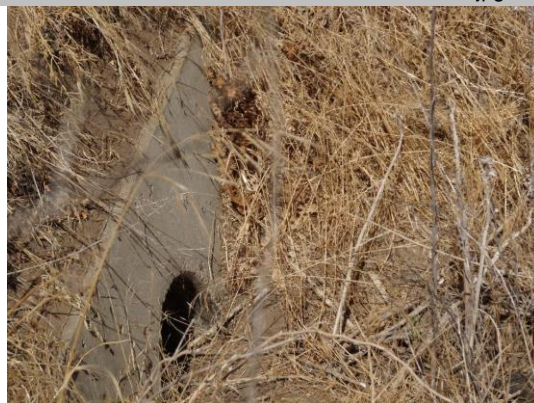
Photo 3 of 3 : UCIP_FA_2021_52888_35707.jpg

LS view: concrete headwall and CM pipe. Inlet silt needs clearing.

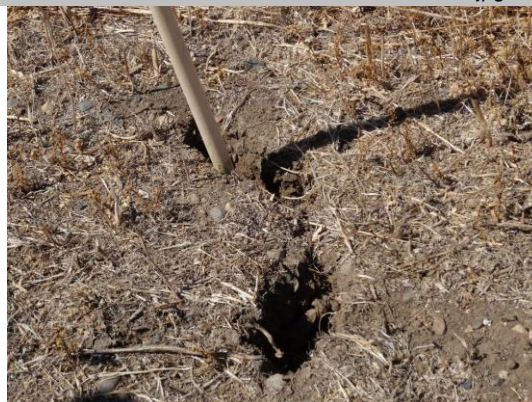
Photo 2 of 3 : UCIP_FA_2021_50153_35744.jpg

WS view: significant levee cracks along the pipe alignment. Needs detailed investigation on the issue.

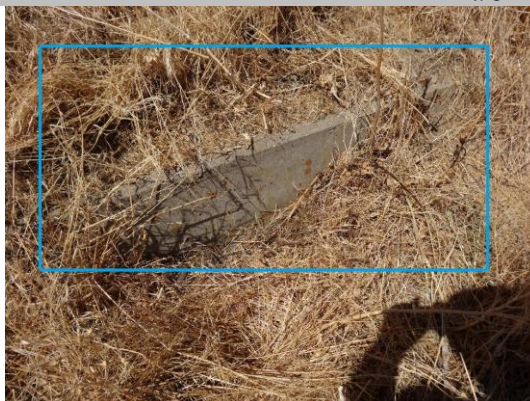
Photo 3 of 3 : UCIP_FA_2021_50153_35743.jpg

LS view: concrete headwall and buried CM pipe. Dirt removal and clearing needed in inlet.
