Flood Control Project Maintenance Levee Inspections

Fall 2022 Levee Maintenance Deficiency Summary Report

San Joaquin River Basin

Merced Streams Group

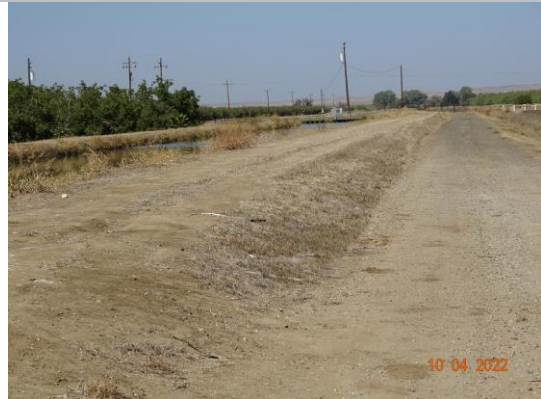
Photo 1 of 1 : FA_2022_NA0013_331_2_20221020_00008.jpg

View of vegetation management on the landside slope. (Fall 2022)

LM Start	0.02	Rating **	C	Issue No.	11
LM End	0.02	Issue Type +	En	Location *	WS
Category	Earthen Levee			GPS Latitude/Longitude	
				Start	End
Item	Encroachments			37.314942 °	37.314942 °
				-120.396394 °	-120.396394 °
DWR ID	DWR_NA0013_01_f_2018_11				
Comment Code					
DE : Debris					
Inspector Comment

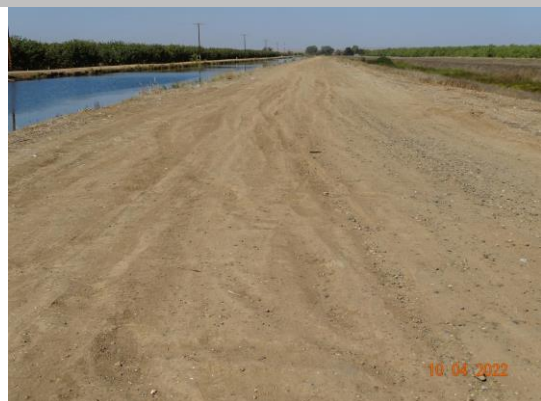
Photo 1 of 1 : FA_2022_NA0013_331_10_20221020_00009.jpg

LM Start	0.27	Rating **	M	Issue No.	10
LM End	0.30	Issue Type +	Ma	Location *	CR
Category	Earthen Levee			GPS Latitude/Longitude	
				Start	End
Item	Crown Surface / Depressions / Rutting			37.318484 °	37.318994 °
				-120.396591 °	-120.396619 °
DWR ID	DWR_NA0013_01_f_2022_10				
Comment Code					
C2 : Repair depressions or ruts in the crown or slope.					
Inspector Comment

Tracks from vehicle traffic on the levee crown should be backfilled. (Fall 2022)

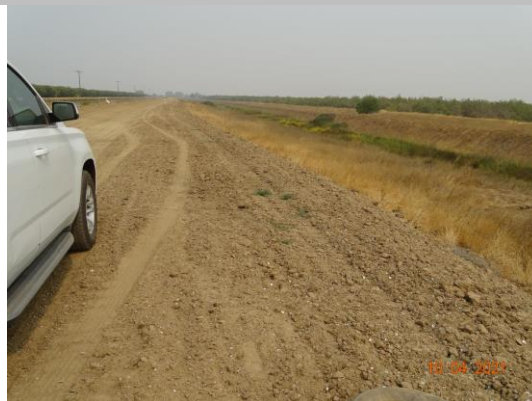
Photo 1 of 1 : FA_2022_NA0013_331_7_20220822_00002.jpg

Dredgings have been leveled but still left within the channel. (Fall 2021)

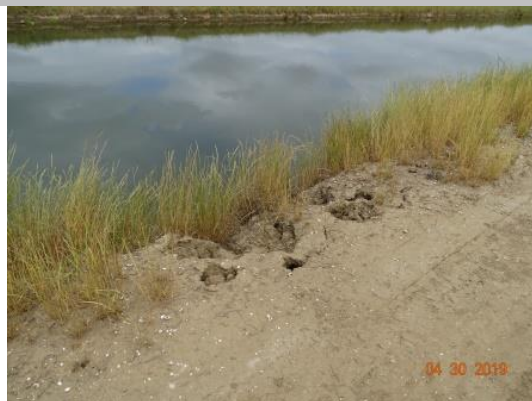
Photo 1 of 1 : FA_2022_NA0013_331_14_20220822_00005.jpg

View of erosion on landside slope. (Spring 2019)

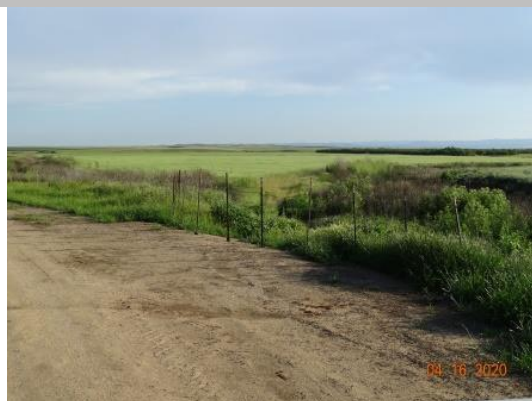
Photo 1 of 1 : FA_2022_NA0013_331_18_20220822_00007.jpg

LM Start	1.23	Rating **	C	Issue No.	16
LM End	1.23	Issue Type +	Ma	Location *	CR
Category	Earthen Levee			GPS Latitude/Longitude	
				Start	End
Item	Access Gates			37.332005 °	37.332005 °
				-120.394751 °	-120.394751 °
DWR ID	DWR_NA0013_01_s_2019_16				
Comment Code					
AG : Access Gates					
Inspector Comment					
Gate has been removed.

View of ramp on waterside slope looking Northeast. (Spring 2020)

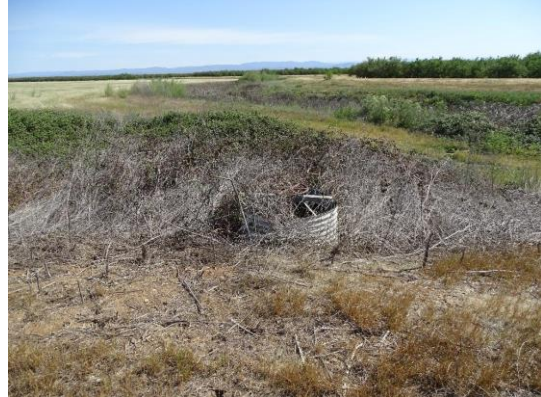
Photo 1 of 2 : UCIP_FA_2022_74566_111342.jpg

Comment Code						
Inspector Comment						
DS_ID:23079 FS_ID:74566 EP_NO: N/A Repair Type: Non-Urgent EVAL Issue: 4b, Safety Issue Crossing Status: Found UCIP Comments: 04/13/2022 Record remains Non-Urgent. Overgrown vegetation limits inspection of levee at this crossing; recommend removing vegetation. Geophysical study indicates possible presence of pipe through levee. Cover on CMP riser is missing causing a safety hazard. Crossing appears abandoned. Owner needs to coordinate with the CVFPB to remove or abandon crossing according to Title 23 requirements. Coordinates have been updated from 37.332805, -120.394906 to 37.332826, -120.394886. (M.Thao - DWR UCIP) 09/17/2013 Verify Pipe is abandoned or still intact.- may be this crossing was abandoned/removed during recent levee reconstruction.- no signs of pipe and appurtenances on waterside.- only a CM pipe riser with slide gate found on landside. (DWR UCIP - P. Amatya) FIELD_STRUCT_DESC: 36-inch corrugated metal irrigation pipe through the levee, 10 feet below the crown. Riser on the landside (LS). Screw gate in a 48-inch pipe well on the waterside (WS) slope. Concrete headwall and cobble spillway at the LS toe. Concrete headwall at the WS toe. [Additional Reference(s): USACE San Joaquin O&M Manual 607, June 1962, (HLM 1.32)]. FS Date: 4/13/2022

WS view: Looking from crown; slide gate in CMP riser. Dense vegetation.

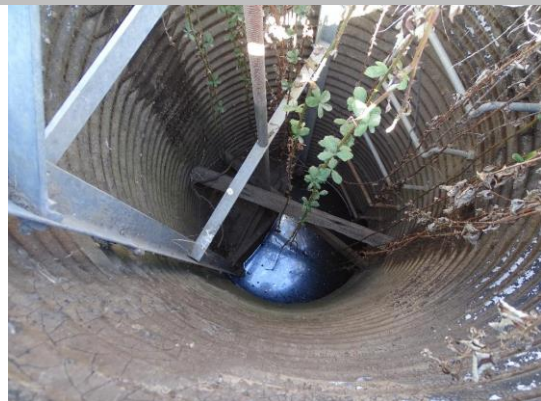
Photo 2 of 2 : UCIP_FA_2022_74566_111343.jpg

WS view: Looking into CMP riser with slide gate; no cover on riser.

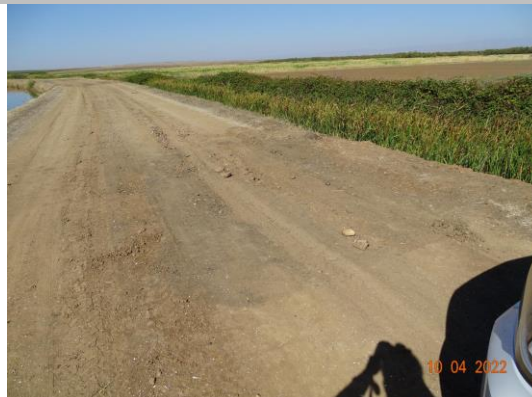
Photo 1 of 1 : FA_2022_NA0013_331_12_20221020_00010.jpg

LM Start	1.34	Rating **	M	Issue No.	12
LM End	1.34	Issue Type +	Ma	Location *	CR
Category	Earthen Levee			GPS Latitude/Longitude	
				Start	End
Item	Crown Surface / Depressions / Rutting			37.333502 °	37.333502 °
				-120.395143 °	-120.395143 °
DWR ID	DWR_NA0013_01_f_2022_12				
Comment Code					
C2 : Repair depressions or ruts in the crown or slope.					
Inspector Comment

Depression in the levee crown should be backfilled. (Fall 2022)

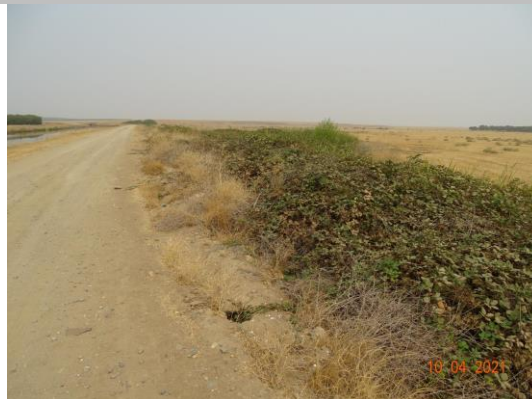
Photo 1 of 1 : FA_2022_NA0013_331_3_20220822_00001.jpg

LM Start	1.57	Rating **	U	Issue No.	3
LM End	1.61	Issue Type +	Ma	Location *	WS
Category	Earthen Levee			GPS Latitude/Longitude	
				Start	End
Item	Vegetation			37.336553 °	37.337109 °
				-120.396529 °	-120.396519 °
DWR ID	DWR_NA0013_01_f _ 2021_3				
Comment Code					
V2 : Remove the wild growth and woody vegetation other than native grasses from the levee slopes.					
Inspector Comment					
Blackberry bushes should be removed from the waterside slope.

View of blackberry bushes growing on the the waterside slope. (Fall 2021)

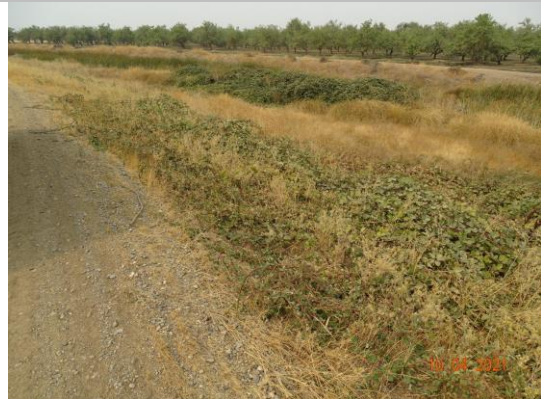
Photo 1 of 1 : FA_2022_NA0013_332_10_20220822_00002.jpg

Blackberry bushes are beginning to grow up the waterside slope and shoulder. (Fall 2021)

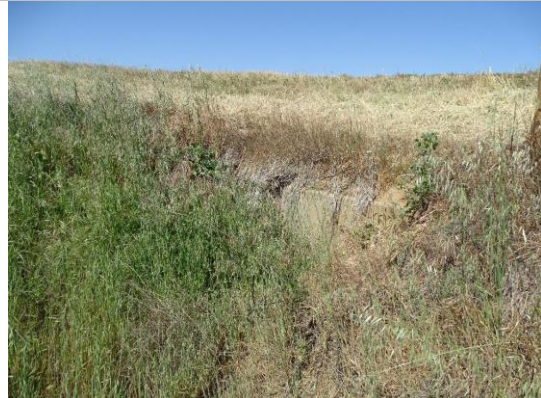
Photo 1 of 2 : UCIP_FA_2022_74570_111356.jpg

Comment Code						
Inspector Comment						
DS_ID:23053 FS_ID:74570 EP_NO: N/A Repair Type: Urgent EVAL Issue: 1, Pipe Integrity Crossing Status: Found UCIP Comments: 04/13/2022 Record updated from No Action Needed to Urgent. DMP internal video inspection has found pipe integrity issues. LOF of crossing is greater than of equal to 5 and less than 6. Crossing will be monitored until funding becomes available to address the issues. Overgrown vegetation limits inspection of levee at this crossing; recommend vegetation removal on LS and WS. (M.Thao - DWR UCIP) 08/23/2016: LS inlet is clear. WS gate has been cleared of vegetation and functions properly. Crossing has been downgraded from Urgent to No Action Needed. (K. Fazel - UCIP)09/17/2013:- needs vegetation cleaning on both sides.- flap gate was not closed during field survey.- inlet needs cleaning. (P. Amatya - UCIP) FIELD_STRUCT_DESC: 24-inch corrugated metal gravity drainage pipe through the levee, 8 feet below the crown. Concrete headwall, flap gate, and concrete grouted cobble apron on the waterside (WS) toe. Concrete headwall on the landside (LS) toe. [Additional Reference(s): DWR Levee Log, 2005 (HLM 0.29). USACE San Joaquin O&M Manual 607, June 1962, (HLM 0.29), listed as 24-inch pipe]. FS Date: 4/13/2022

LS view: Looking toward levee; headwall blocked by vegetation.

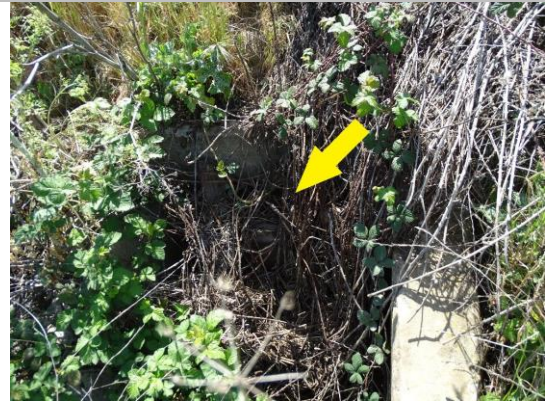
Photo 2 of 2 : UCIP_FA_2022_74570_111354.jpg

WS view: Looking at concrete headwall and flap gate (yellow arrow); dense vegetation blocking flap gate.

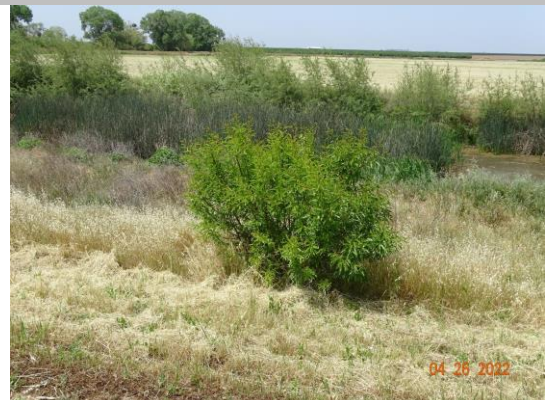
Photo 1 of 1 : FA_2022_NA0013_332_13_20220822_00005.jpg

Tree sapling on the waterside slope. (Spring 2022)

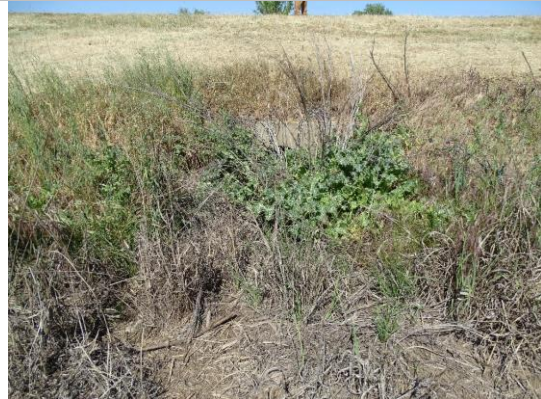
Photo 1 of 1 : UCIP_FA_2022_74654_111367.jpg

Comment Code					
Inspector Comment					
DS_ID:23054 FS_ID:74654 EP_NO: N/A Repair Type: Non-Urgent EVAL Issue: 5, Pipe Damage Crossing Status: Found UCIP Comments: 04/13/2022 Record remains Non-Urgent. DMP internal video inspection has found pipe integrity issues. LOF of crossing is greater than or equal to 4.1 and less than 5. Crossing will be monitored until funding becomes available for rehabilitation. Overgrown vegetation limites inspection of LS headwall and inlet; recommend vegetation removal. Flap gate was properly closed during inspection. (M.Thao - DWR UCIP) 09/17/2013 - needs vegetation cleaning on both sides.- flap gate was not properly closed during field survey.- inlet needs cleaning. (DWR UCIP - P. Amatya) FIELD_STRUCT_DESC: 24-inch corrugated metal gravity drainage pipe through the levee, 12 feet below the crown. Concrete headwall, flap gate, and concrete grouted cobble apron on the waterside (WS) toe. Concrete headwall on the landside (LS) toe. [Additional Reference(s): DWR Levee Log, 2005 (HLM 0.54). USACE San Joaquin O&M Manual 607, June 1962, (HLM 0.54), listed as 24-inch pipe]. FS Date: 4/13/2022

LS view: Headwall and pipe inlet blocked by dense vegetation.

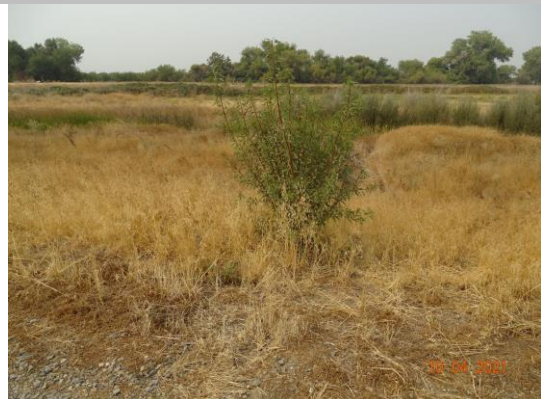
Photo 1 of 1 : FA_2022_NA0013_332_12_20220822_00004.jpg

Sapling growing in the waterside shoulder. (Fall 2021)

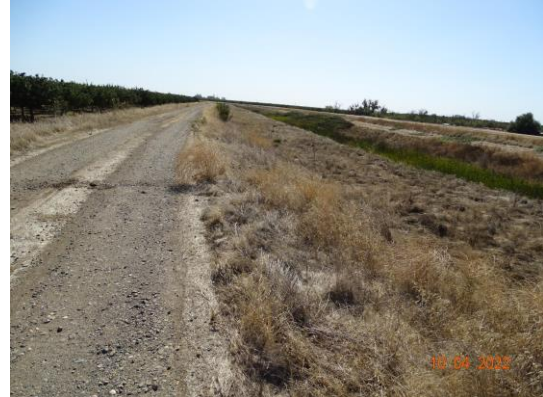
Photo 1 of 1 : FA_2022_NA0013_332_18_20221020_00015.jpg

View of vegetation on the waterside slope. (Fall 2022)

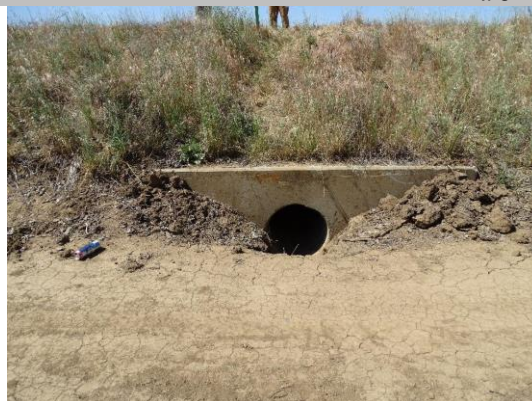
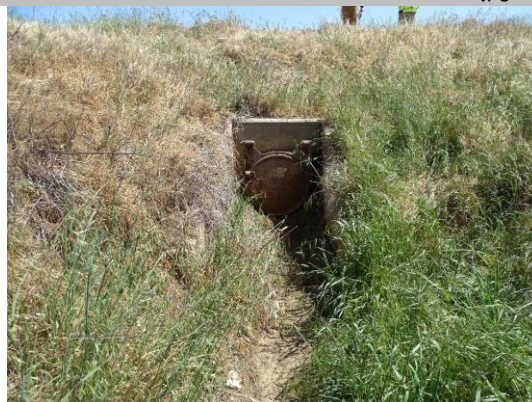
Comment Code						
Inspector Comment						
DS_ID:23055 FS_ID:77422 EP_NO: N/A Repair Type: Non-Urgent EVAL Issue: 5, Pipe Damage Crossing Status: Found UCIP Comments: 04/13/2022 Record remains Non-Urgent. DMP internal video inspection has found pipe integrity issues. LOF of crossing is greater than or equal to 4.1 and less than 5. Crossing will be monitored until funding becomes available for rehabilitation. Pipe and apron has been cleared of mud and debris since the last inspection. (M.Thao - DWR UCIP) 09/17/2013 - mud and debris from recent channel cleaning needs to be removed from spillway and outlet - pipe filled with debris, it needs cleaning.- half of intet pipe burried. (DWR UCIP - P. Amatya) FIELD_STRUCT_DESC: 24-inch corrugated metal gravity drainage pipe through the levee, 8 feet below the crown. Concrete headwall, flap gate, and concrete grouted cobble apron on the waterside (WS) toe. Concrete headwall on the landside (LS) toe. [Additional Reference(s): DWR Levee Log, 2005 (HLM 0.73). USACE San Joaquin O&M Manual 607, June 1962, (HLM 0.73), listed as 24-inch pipe]. FS Date: 4/13/2022

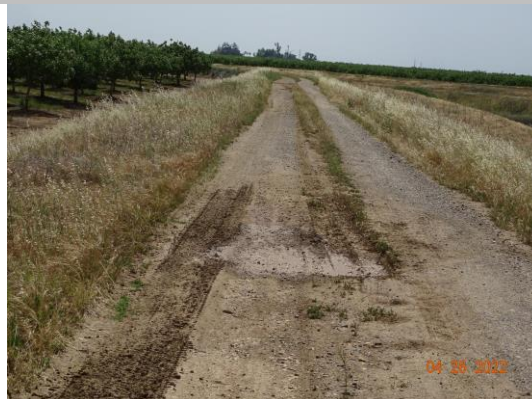
Photo 1 of 1 : FA_2022_NA0013_332_17_20220822_00008.jpg

LM Start	0.74	Rating **	M	Issue No.	17
LM End	0.74	Issue Type +	Ma	Location *	CR
Category	Earthen Levee			GPS Latitude/Longitude	
				Start	End
Item	Crown Surface / Depressions / Rutting			37.330443 °	37.330443 °
				-120.395181 °	-120.395181 °
DWR ID	DWR_NA0013_02_f_2021_17				
Comment Code					
C2 : Repair depressions or ruts in the crown or slope.					
Inspector Comment

Depressions in the levee crown from vehicle traffic. (Spring 2022)

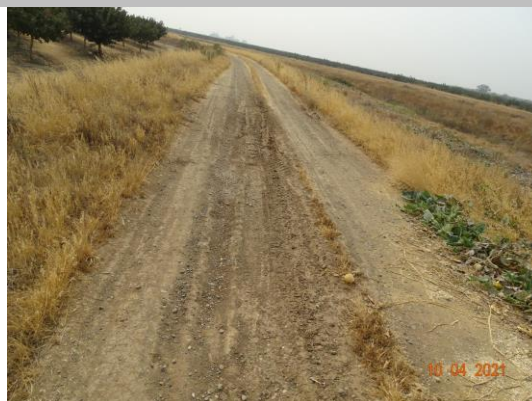
Photo 1 of 1 : FA_2022_NA0013_332_27_20220822_00012.jpg

LM Start	0.78	Rating **	M	Issue No.	27
LM End	0.80	Issue Type +	Ma	Location *	CR
Category	Earthen Levee			GPS Latitude/Longitude	
				Start	End
Item	Crown Surface / Depressions / Rutting			37.329952 °	37.329789 °
				-120.395588 °	-120.395720 °
DWR ID	DWR_NA0013_02_s_2020_27				
Comment Code					
C2 : Repair depressions or ruts in the crown or slope.					
Inspector Comment

View of depressions in the levee crown from vehicle traffic. (Fall 2021)

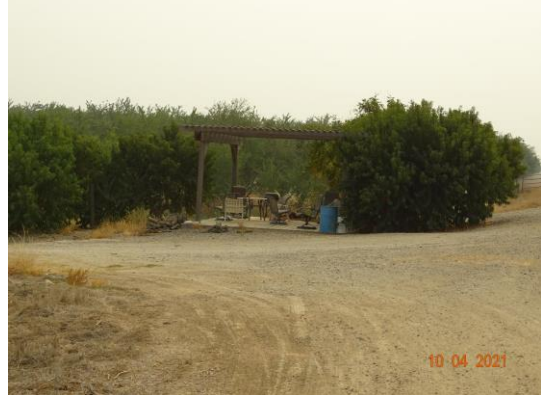
Photo 1 of 1 : FA_2022_NA0013_332_24_20220822_00011.jpg

Unauthorized patio and fruit trees installed on the landside slope.
(Fall 2021)

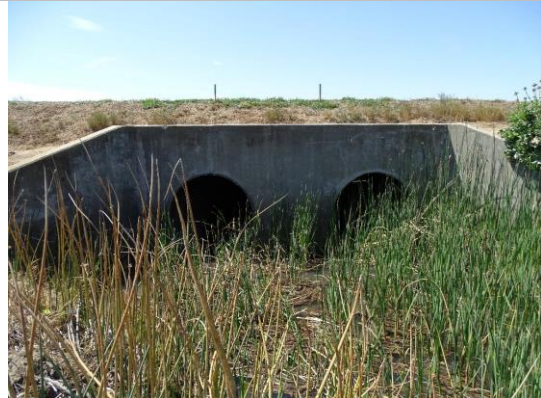
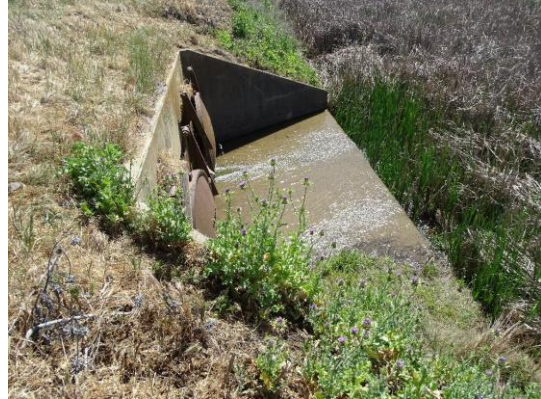
Comment Code					
Inspector Comment					
DS_ID:23056 FS_ID:74581 EP_NO: N/A Repair Type: Urgent EVAL Issue: 1, Pipe Integrity Crossing Status: Found UCIP Comments: 04/13/2022 Record remains Urgent. DMP internal video inspection has found pipe integrity issues. LOF of crossing is greater than or equal to 5 and less than 6. Crossing will be monitored until funding becomes available to address the issues. (M.Thao - DWR UCIP) 04/13/2022 Record remains Urgent. DMP internal video inspection has found pipe integrity issues. LOF of crossing is equal to 5 and less than 6. Crossing will be monitored until funding becomes available to address the issues. (M.Thao - DWR UCIP) 09/17/2013 - working during field inspection.- vegetation on drainage ditch/channel (DWR UCIP - P. Amatya) FIELD_STRUCT_DESC: 1 of 2: 60-inch corrugated metal culvert through the levee, 10 feet below the crown. Concrete headwall and flap gate on the waterside (WS) berm, 5 feet from the levee toe. Concrete headwall on the landside (LS) toe. [Additional Reference(s): DWR Levee Log, 2005 (HLM 0.91). USACE San Joaquin O&M Manual 607, June 1962, (HLM 0.91), listed as 60-inch pipe]. FS Date: 4/13/2022

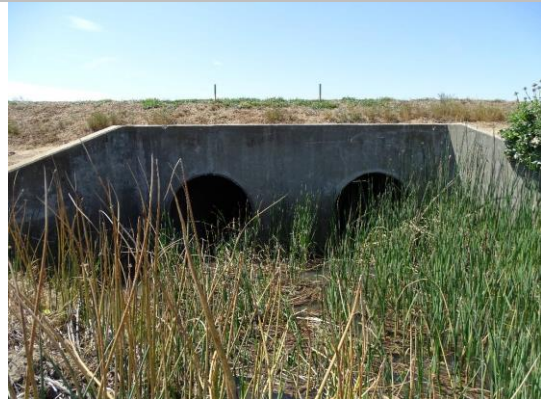
Photo 1 of 2 : UCIP_FA_2022_74584_111404.jpg

DS_ID:23080
 FS_ID:74584
 EP_NO: N/A
 Repair Type: Urgent
 EVAL Issue: 1, Pipe Integrity
 Crossing Status: Found
 UCIP Comments: 04/13/2022 Record remains Urgent. DMP internal video inspection has found pipe integrity issues. LOF of crossing is greater or equal to 5 and and less than 6. Crossing will be monitored until funding becomes available to address the issues. (M.Thao - DWR UCIP)
 09/17/2013 It was working during field inspection. Dense vegetation in drainage ditch (DWR UCIP - P. Amatya).
 FIELD_STRUCT_DESC: 2 of 2: 60-inch corrugated metal culvert through the levee, 10 feet below the crown. Concrete headwall and flap gate on the waterside (WS) berm, 5 feet from the levee toe. Concrete headwall on the landside (LS) toe. [Additional Reference(s): DWR Levee Log, 2005 (HLM 0.91). USACE San Joaquin O&M Manual 607, June 1962, (HLM 0.91), listed as 60-inch pipe].
 FS Date: 4/13/2022

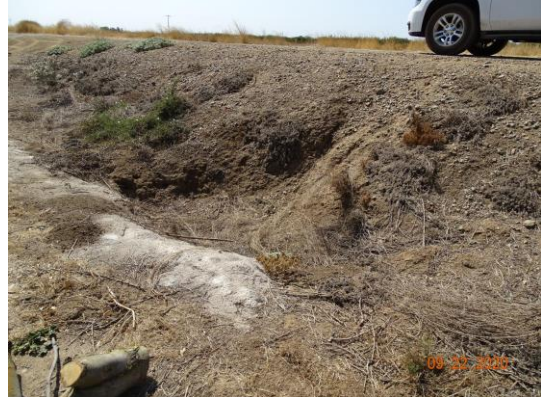
Photo 1 of 1 : FA_2022_NA0013_332_28_20220822_00013.jpg

LM Start	1.29	Rating **	M	Issue No.	28
LM End	1.29	Issue Type +	Ma	Location *	LS
Category	Earthen Levee			GPS Latitude/Longitude	
				Start	End
Item	Erosion / Bank Caving			37.322752 °	37.322752 °
				-120.396030 °	-120.396030 °
DWR ID	DWR_NA0013_02_s_2020_28				
Comment Code					
E2 : Schedule repair of erosion site prior to the next inspection.					
Inspector Comment

View of erosion pocket in the landside slope and toe. (Fall 2020)

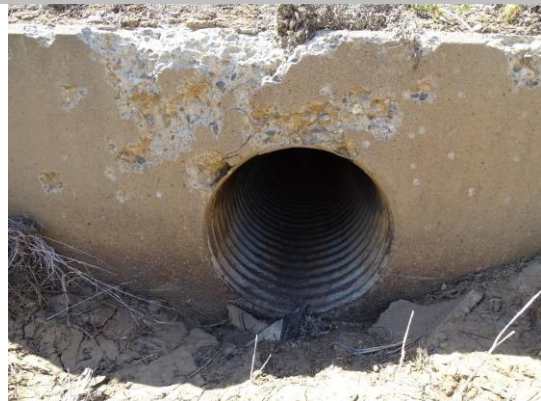
Photo 1 of 3 : UCIP_FA_2022_74587_111414.jpg

Comment Code						
Inspector Comment						
DS_ID:23057 FS_ID:74587 EP_NO: N/A Repair Type: Non-Urgent EVAL Issue: 5, Pipe Damage Crossing Status: Found UCIP Comments: 04/13/2022 Record updated from No Action Needed to Non-Urgent. DMP internal video inspection has found pipe integrity issues. LOF of crossing is greater than or equal to 4.1 and less than 5. Crossing will be monitored until funding becomes available for rehabilitation. Some damage has occurred to the LS concrete headwall since the last inspection. (M.Thao - DWR UCIP) 09/17/2013 - working during field inspection. (DWR UCIP - P. Amatya) FIELD_STRUCT_DESC: 24-inch corrugated metal gravity drainage pipe through the levee, 10 feet below the crown. Concrete headwall, flap gate, and concrete grouted cobble apron on the waterside (WS) toe. Concrete headwall on the landside (LS) toe. [Additional Reference(s): DWR Levee Log, 2005 (HLM 1.32). USACE San Joaquin O&M Manual 607, June 1962, (HLM 1.32), listed as 24-inch pipe]. FS Date: 4/13/2022

LS view: Inlet at toe; concrete headwall damaged since last inspection.

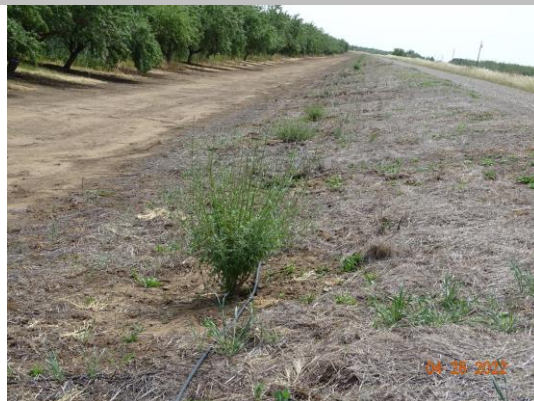
Photo 1 of 1 : FA_2022_NA0013_332_21_20220822_00010.jpg

View of shrubs intermittently planted on the landside slope. (Spring 2022)

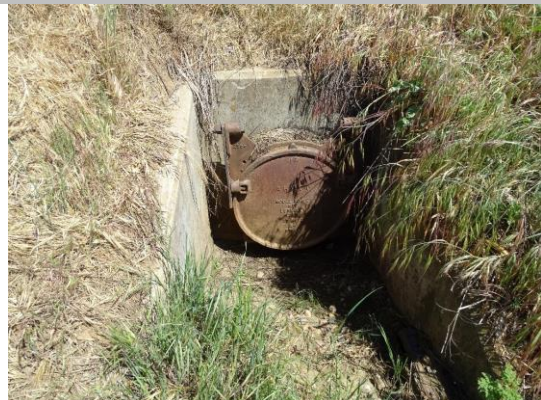
Photo 2 of 2 : UCIP_FA_2022_77425_111434.jpg

Comment Code						
Inspector Comment						
DS_ID:23058 FS_ID:77425 EP_NO: N/A Repair Type: Non-Urgent EVAL Issue: 5, Pipe Damage Crossing Status: Found UCIP Comments: 04/13/2022 Record remains Non-Urgent. DMP internal video inspection has found pipe integrity issues. LOF of crossing is greater than or equal to 4.1 and less than 5. Crossing will be monitored until funding becomes available for rehabilitation. Debris has deposited at the end of WS apron not allowing water to drainage properly; recommend removing debris. Pipe inlet on LS has been cleared since the last inspection. (M.Thao - DWR UCIP) 09/17/2013 - needs cleaning of debris on spillway on WS. Flapgate blocked by debris on WS. - needs cleaning inside CMP on LS. (DWR UCIP - P. Amatya) FIELD_STRUCT_DESC: 24-inch corrugated metal gravity drainage pipe through the levee, 8 feet below the crown. Concrete headwall, flap gate, and concrete grouted cobble apron on the waterside (WS) toe. Concrete headwall on the landside (LS) toe. [Additional Reference(s): DWR Levee Log, 2005 (HLM 1.64). USACE San Joaquin O&M Manual 607, June 1962, (HLM 1.64), listed as 24-inch pipe]. FS Date: 4/13/2022

WS view: Concrete headwall, apron, and flap gate on toe; debris deposited at end of apron (bottom) not allowing water to drain properly.

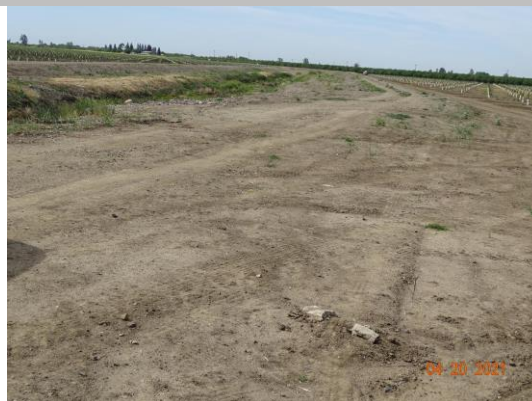
Photo 1 of 1 : FA_2022_NA0013_333_9_20220822_00001.jpg

View of depression on landside slope and levee crown. (Spring 2021)

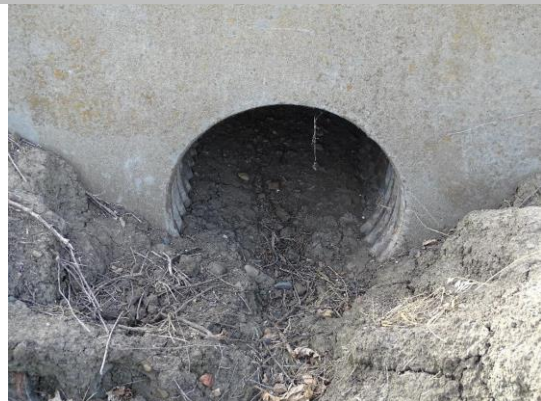
Photo 1 of 1 : UCIP_FA_2022_74609_111479.jpg

LS view: Close-up view of pipe inlet; pipe partially filled with sediment.

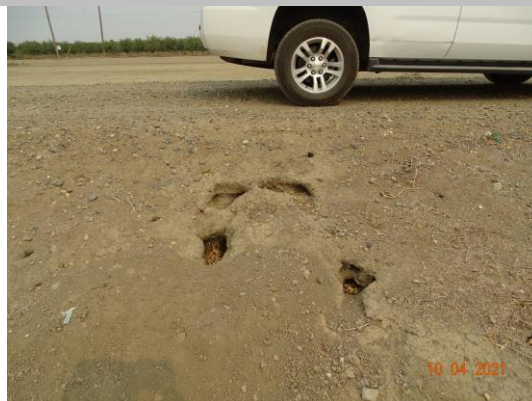
Photo 1 of 1 : FA_2022_NA0013_333_12_20220822_00002.jpg

View of rodent activity on the waterside slope. (Fall 2021)

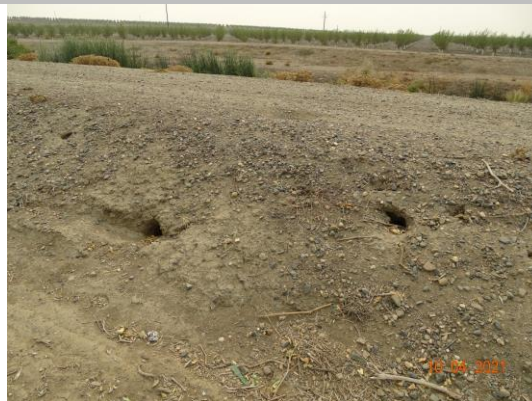
Photo 1 of 1 : FA_2022_NA0013_333_13_20220822_00003.jpg

Rodent holes observed on the landside slope. (Fall 2021)

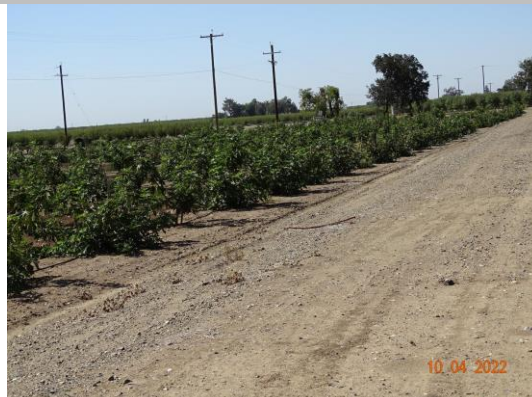
Photo 1 of 1 : FA_2022_NA0013_334_16_20221020_00005.jpg

Crops planted within the easement of the landside toe. (Fall 2022)

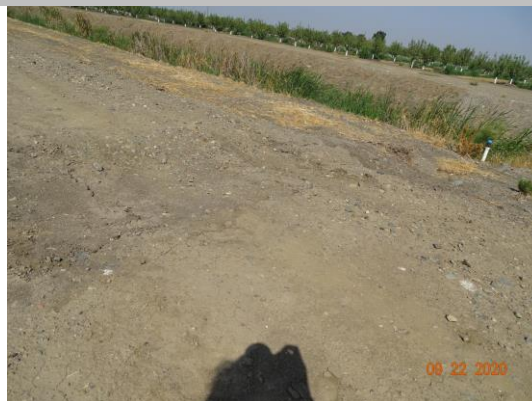
Photo 1 of 1 : FA_2022_NA0013_334_10_20220822_00001.jpg

View of depression across the levee crown and waterside slope. (Fall 2020)

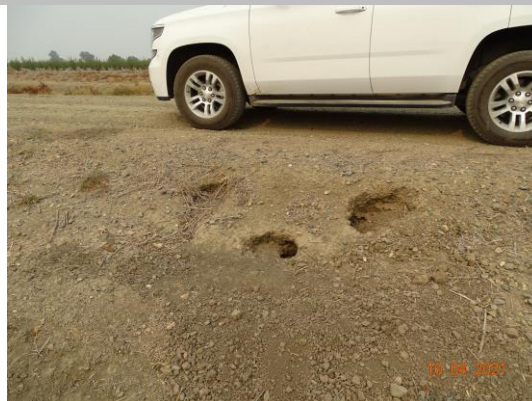
Photo 1 of 1 : FA_2022_NA0013_334_12_20220822_00002.jpg

View of rodent burrows in the landside slope. (Fall 2021)

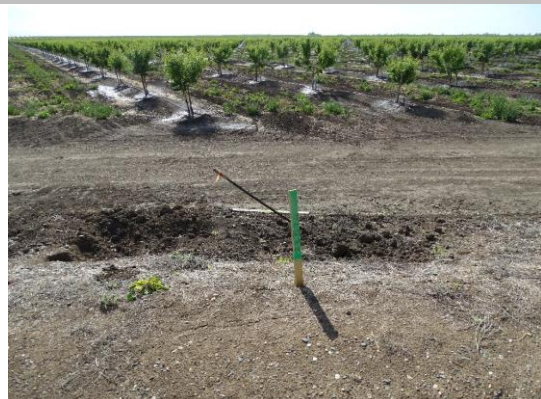
Photo 2 of 3 : UCIP_FA_2022_74659_111556.jpg

LS view: Looking from crown; headwall and pipe inlet on toe not found.

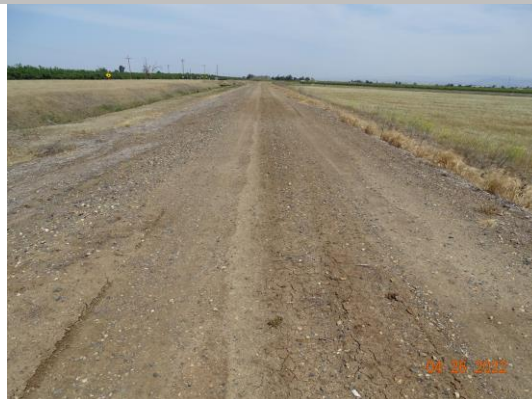
Photo 1 of 1 : FA_2022_NA0013_334_14_20220822_00004.jpg

Depressions beginning to form in the levee crown from vehicle traffic.
(Spring 2022)
