**Flood Control Project Maintenance
Levee Inspections
Fall 2023 Levee Maintenance Deficiency Summary Report**

San Joaquin River Basin

| NA0013 | Overall LMA Rating | Total LMA Miles | | | | | | |

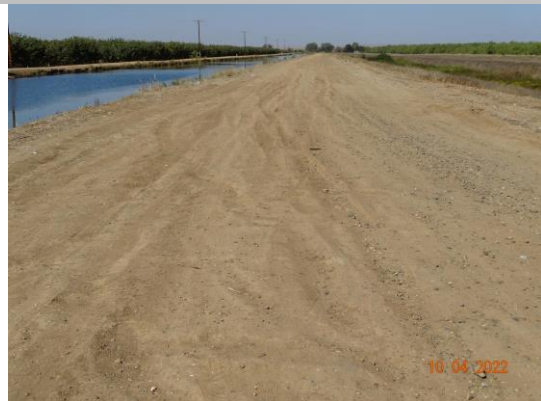
Photo 1 of 1 : FA_2023_NA0013_331_10_20230821_00003.jpg

Tracks from vehicle traffic on the levee crown should be backfilled. (Fall 2022)

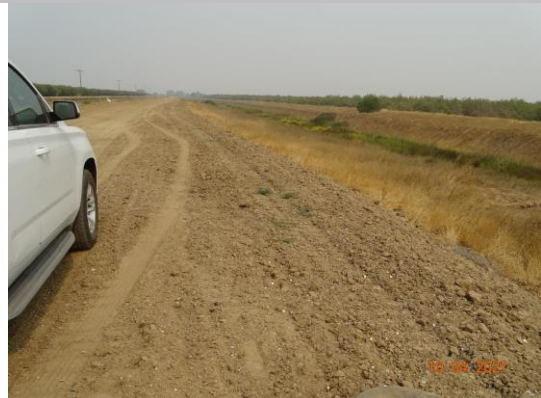
Photo 1 of 1 : FA_2023_NA0013_331_7_20230821_00002.jpg

Dredgings have been leveled but still left within the channel. (Fall 2021)

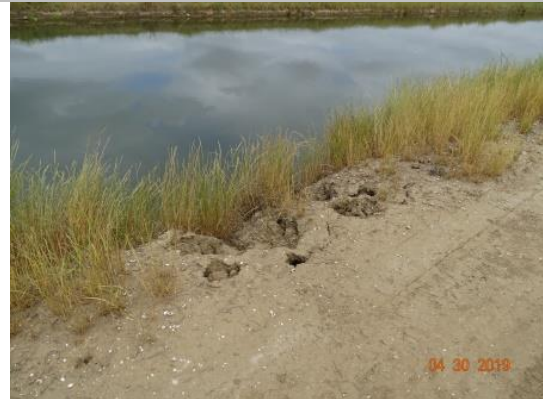
Photo 1 of 1 : FA_2023_NA0013_331_14_20230821_00005.jpg

View of erosion on landside slope. (Spring 2019)

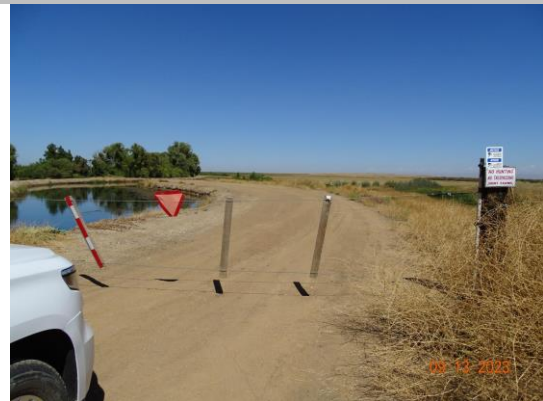
Photo 1 of 1 : FA_2023_NA0013_331_13_20230925_00007.jpg

View of new gate placed across levee crown. LMA does not currently have a key. (Fall 2023)

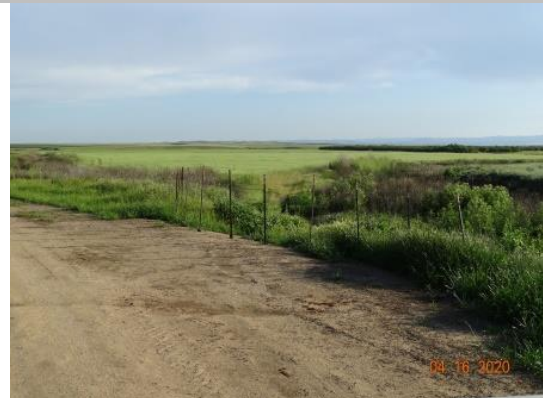
Photo 1 of 1 : FA_2023_NA0013_331_18_20230821_00006.jpg

View of ramp on waterside slope looking Northeast. (Spring 2020)

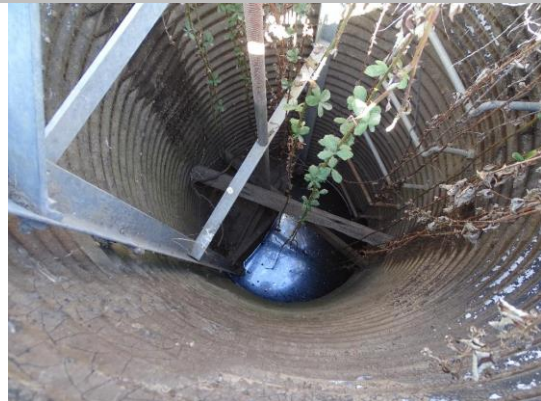
Photo 2 of 2 : UCIP_FA_2023_74566_111343.jpg

WS view: Looking into CMP riser with slide gate; no cover on riser.

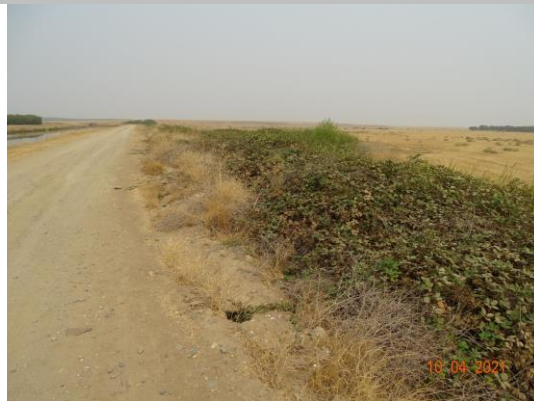
Photo 1 of 1 : FA_2023_NA0013_331_3_20230821_00001.jpg

View of blackberry bushes growing on the the waterside slope. (Fall 2021)

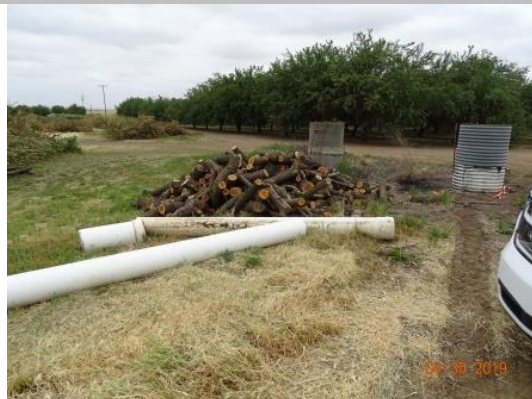
Photo 1 of 1 : FA_2023_NA0013_332_11_20230821_00003.jpg

View of wood pile and pipes on waterside slope. (Spring 2019)

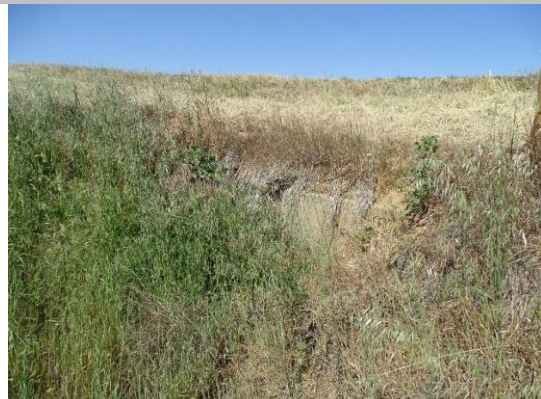
Photo 1 of 2 : UCIP_FA_2023_77950_111356.jpg

| DS_ID:23053 FS_ID:77950 EP_NO: N/A Repair Type: Urgent EVAL Issue: 1, Pipe Integrity Crossing Status: Found UCIP Comments: 04/13/2022 Record updated from No Action Needed to Urgent. DMP internal video inspection has found pipe integrity issues. LOF of crossing is greater than of equal to 5 and less than 6. Crossing will be monitored until funding becomes available to address the issues. Overgrown vegetation limits inspection of levee at this crossing; recommend vegetation removal on LS and WS. (M.Thao - DWR UCIP) 08/23/2016: LS inlet is clear. WS gate has been cleared of vegetation and functions properly. Crossing has been downgraded from Urgent to No Action Needed. (K. Fazel - UCIP)09/17/2013:- needs vegetation cleaning on both sides.- flap gate was not closed during field survey.- inlet needs cleaning. (P. Amatya - UCIP) FIELD_STRUCT_DESC: 24-inch corrugated metal gravity drainage pipe through the levee, 8 feet below the crown. Concrete headwall, flap gate, and concrete grouted cobble apron on the waterside (WS) toe. Concrete headwall on the landside (LS) toe. [Additional Reference(s): DWR Levee Log, 2005 (HLM 0.29). USACE San Joaquin O&M Manual 607, June 1962, Revised March 1984, (HLM 0.29), listed as 24-inch pipe]. FS Date: 4/13/2022 | | | | | | |

LS view: Looking toward levee; headwall blocked by vegetation.

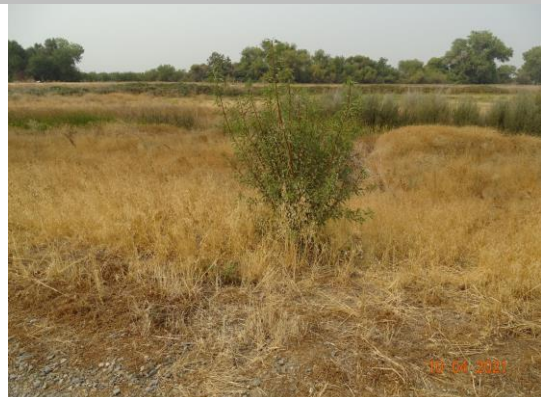
Photo 1 of 1 : FA_2023_NA0013_332_12_20230821_00004.jpg

Sapling growing in the waterside shoulder. (Fall 2021)

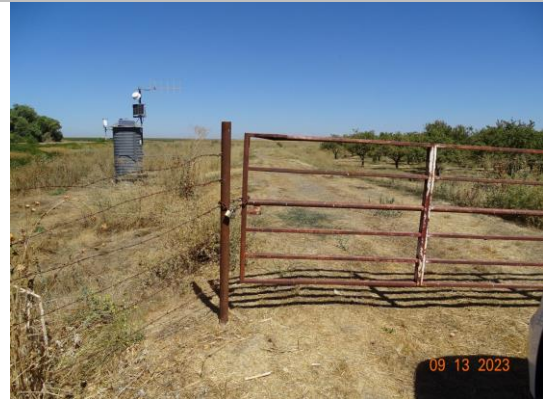
Photo 1 of 1 : FA_2023_NA0013_332_18_20230925_00015.jpg

View of gate with LMA left out of the daisy chain. (Fall 2023)

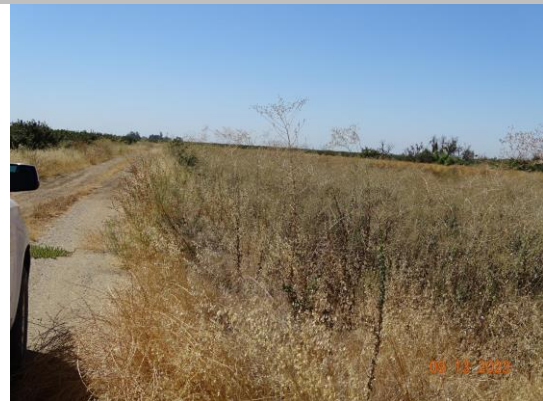
Photo 1 of 1 : FA_2023_NA0013_332_23_20230925_00017.jpg

View of vegetation on the waterside slope looking downstream. (Fall 2023)

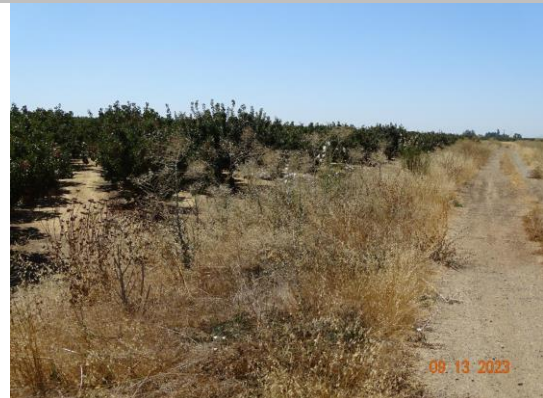
Photo 1 of 1 : FA_2023_NA0013_332_19_20230925_00016.jpg

View of vegetation on the landside slope. (Fall 2023)

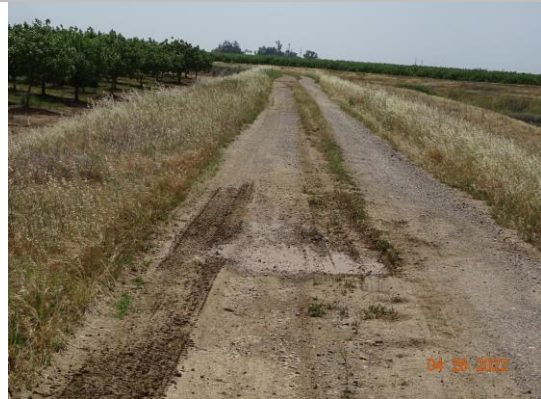
Photo 1 of 1 : FA_2023_NA0013_332_17_20230821_00008.jpg

Depressions in the levee crown from vehicle traffic. (Spring 2022)

| C2 : Repair depressions or ruts in the crown or slope. | | | | | |

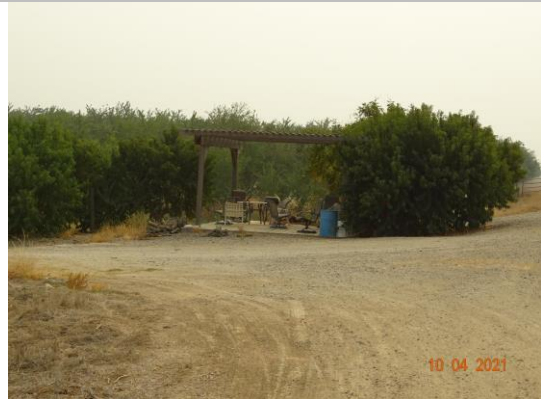
Photo 1 of 1 : FA_2023_NA0013_332_24_20230821_00011.jpg

Unauthorized patio and fruit trees installed on the landside slope. (Fall 2021)

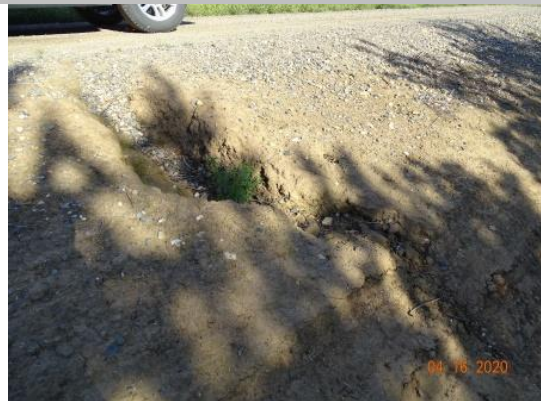
Photo 1 of 1 : FA_2023_NA0013_332_15_20230821_00006.jpg

Looking at finger erosion on the landside slope. (Spring 2020)

| E5 : Schedule repair of rills prior to the next inspection. | | | | | |

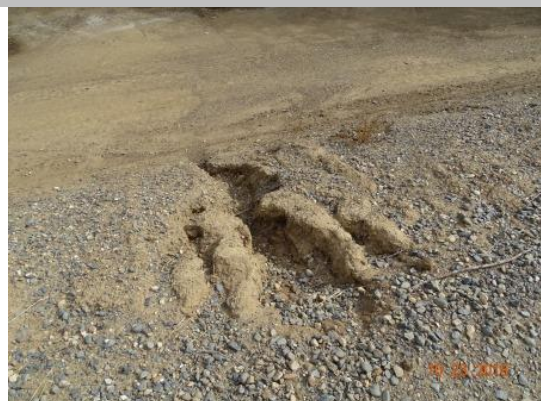
Photo 1 of 1 : FA_2023_NA0013_332_16_20230821_00007.jpg

View of large finger erosion in landside slope. (Fall 2018)

| E5 : Schedule repair of rills prior to the next inspection. | | | | | |

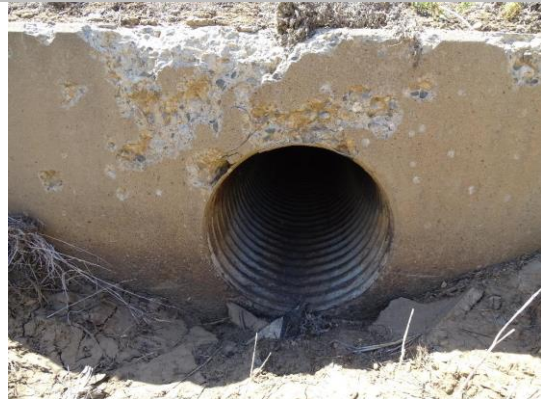
Photo 1 of 3 : UCIP_FA_2023_77958_111414.jpg

LS view: Inlet at toe; concrete headwall damaged since last inspection.

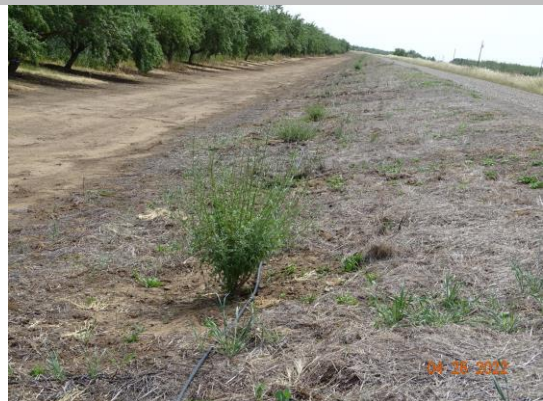
Photo 1 of 1 : FA_2023_NA0013_332_21_20230821_00010.jpg

View of shrubs intermittently planted on the landside slope. (Spring 2022)

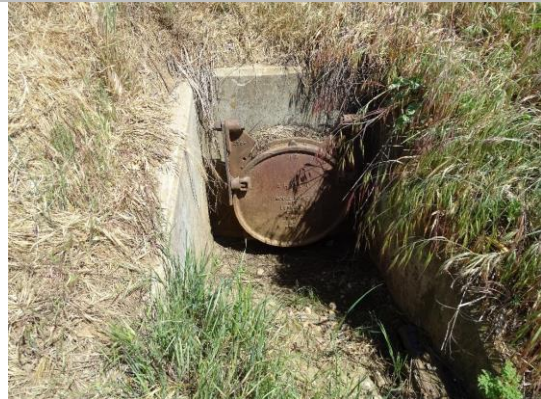
Photo 2 of 2 : UCIP_FA_2023_77959_111434.jpg

WS view: Concrete headwall, apron, and flap gate on toe; debris deposited at end of apron (bottom) not allowing water to drain properly.

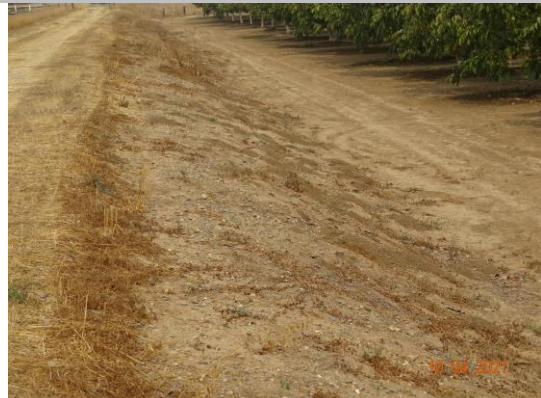
Photo 1 of 1 : FA_2023_NA0013_332_20_20230821_00009.jpg

| Several mole holes observed in this section. Continue to monitor in case issue worsens. | | | | | |

View of rodent burrows in the landside slope. (Fall 2021)

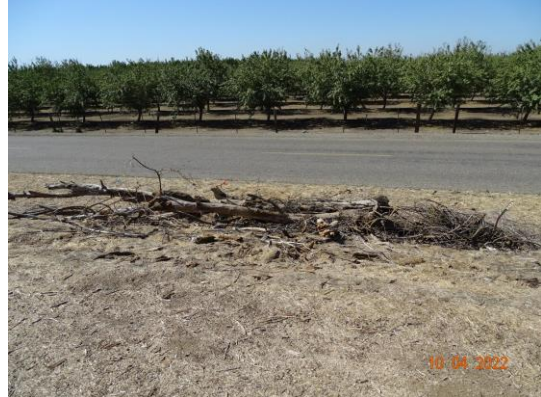
Photo 1 of 1 : FA_2023_NA0013_333_11_20230821_00002.jpg

Fallen tree on the landside toe should be removed. (Fall 2022)

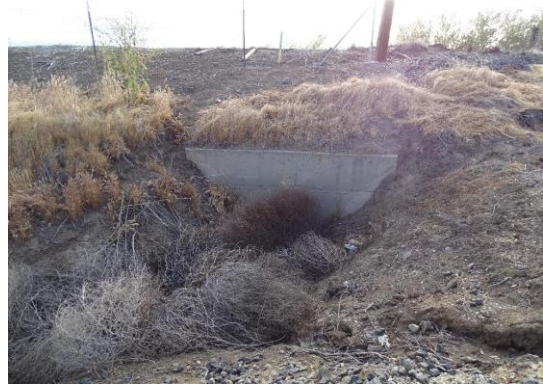
Photo 1 of 2 : UCIP_FA_2023_74601_111459.jpg

LS view: Concrete headwall; vegetation blocking pipe inlet.

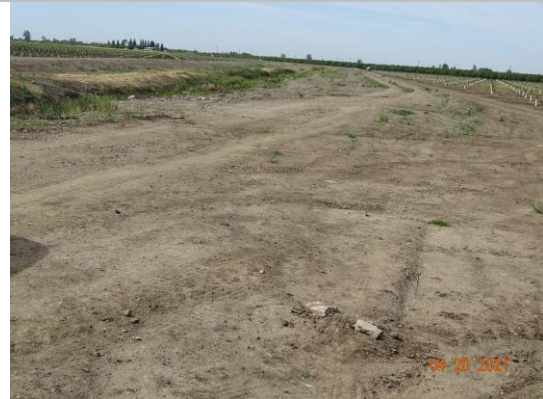
Photo 1 of 1 : FA_2023_NA0013_333_9_20230821_00001.jpg

View of depression on landside slope and levee crown. (Spring 2021)

| C2 : Repair depressions or ruts in the crown or slope. | | | | | |

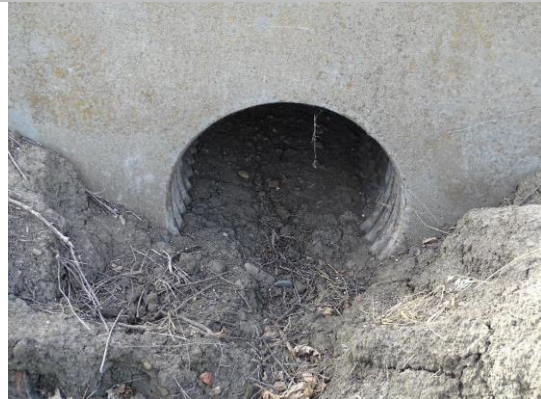
Photo 1 of 1 : UCIP_FA_2023_74609_111479.jpg

LS view: Close-up view of pipe inlet; pipe partially filled with sediment.

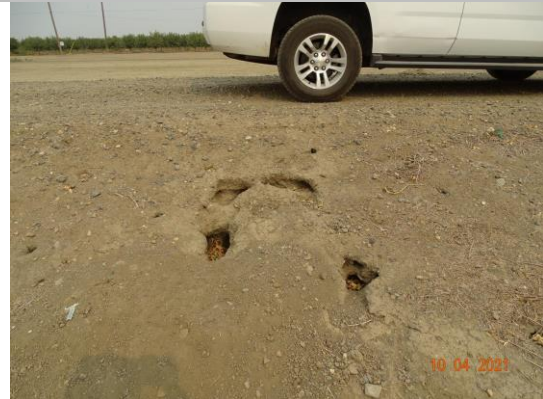
Photo 1 of 1 : FA_2023_NA0013_333_12_20230821_00003.jpg

View of rodent activity on the waterside slope. (Fall 2021)

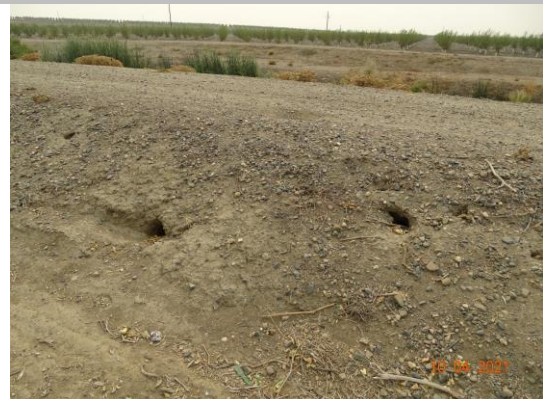
Photo 1 of 1 : FA_2023_NA0013_333_13_20230821_00004.jpg

Rodent holes observed on the landside slope. (Fall 2021)

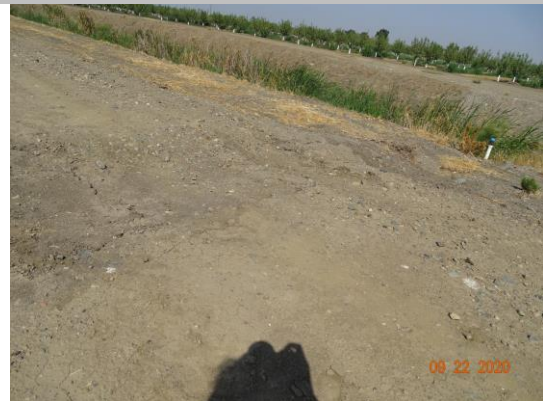
Photo 1 of 1 : FA_2023_NA0013_334_10_20230821_00001.jpg

View of depression across the levee crown and waterside slope. (Fall 2020)

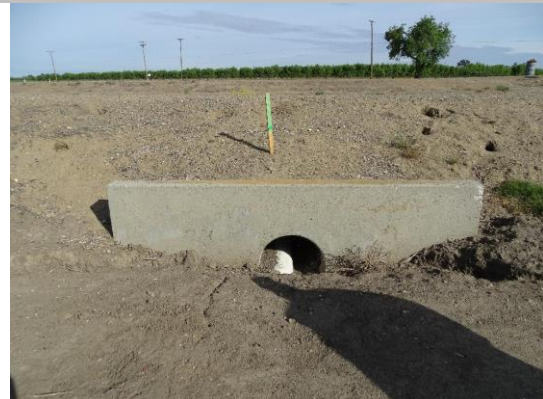
Photo 3 of 3 : UCIP_FA_2023_74658_111525.jpg

LS view: Concrete headwall and pipe inlet; PVC pipe was inserted into the draining pipe inlet.

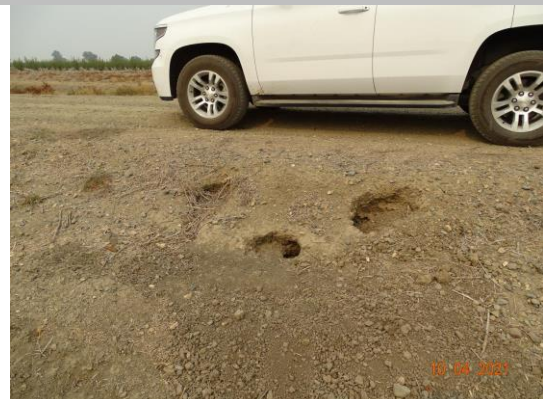
Photo 1 of 1 : FA_2023_NA0013_334_12_20230821_00002.jpg

View of rodent burrows in the landside slope. (Fall 2021)

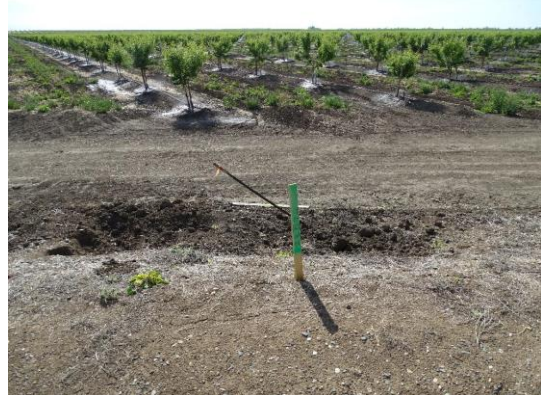
Photo 2 of 3 : UCIP_FA_2023_74659_111556.jpg

LS view: Looking from crown; headwall and pipe inlet on toe not found.

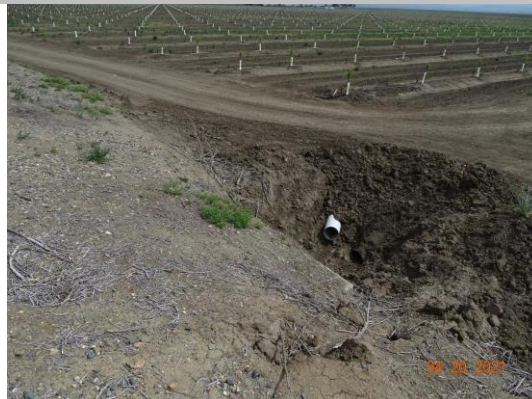
Photo 1 of 1 : FA_2023_NA0013_334_13_20230821_00003.jpg

Drainage pipes feeding to existing pipe crossing. (Spring 2021)

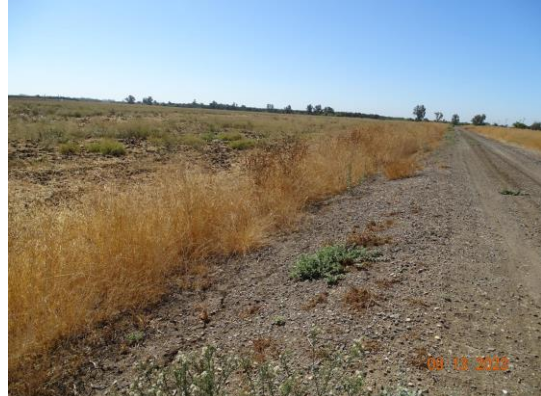
Photo 1 of 1 : FA_2023_NA0013_334_15_20230925_00006.jpg

View of vegetation growing on the landside toe. (Fall 2023)
