Flood Control Project Maintenance Levee Inspections

Fall 2024 Levee Maintenance Deficiency Summary Report

San Joaquin River Basin

Merced Streams Group

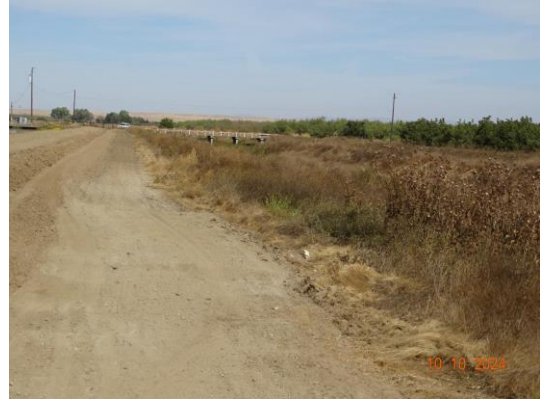
Photo 1 of 1 : FA_2024_NA0013_331_2_20241011_00010.jpg

View of the waterside slope looking upstream. (Fall 2024)

LM Start	0.27	Rating **	C	Issue No.	10
LM End	0.30	Issue Type +	Ma	Location *	CR
Category	Earthen Levee			GPS Latitude/Longitude	
				Start	End
Item	Crown Surface / Depressions / Rutting			37.318484 °	37.318994 °
				-120.396591 °	-120.396619 °
DWR ID	DWR_NA0013_01_f_2022_10				
Comment Code					
C2 : Repair depressions or ruts in the crown or slope.					
Inspector Comment

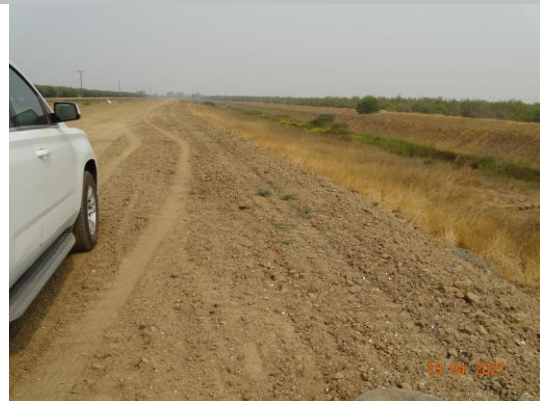
Photo 1 of 1 : FA_2024_NA0013_331_7_20240828_00002.jpg

Dredgings have been leveled but still left within the channel. (Fall 2021)

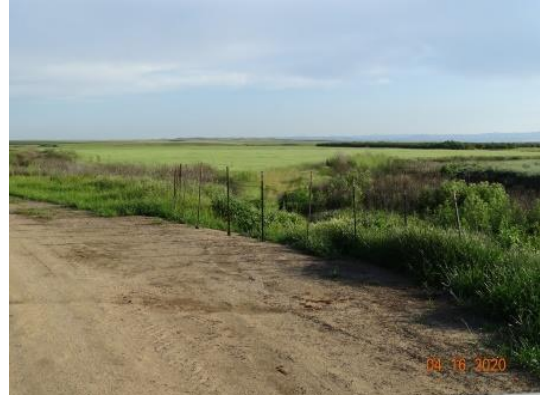
Photo 1 of 1 : FA_2024_NA0013_331_18_20240828_00007.jpg

View of ramp on waterside slope looking Northeast. (Spring 2020)

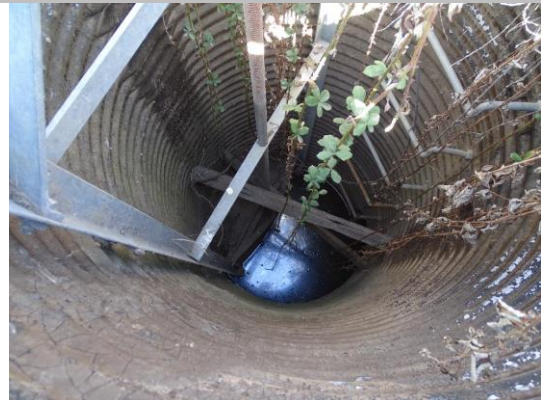
Photo 2 of 2 : UCIP_FA_2024_74566_111343.jpg

DS_ID:23079
FS_ID:74566
EP_NO: N/A
Repair Type: Non-Urgent
EVAL Issue: 4b, Safety Issue
Crossing Status: Found
UCIP Comments: 04/13/2022 Record remains Non-Urgent. Overgrown vegetation limits inspection of levee at this crossing; recommend removing vegetation. Geophysical study indicates possible presence of pipe through levee. Cover on CMP riser is missing causing a safety hazard. Crossing appears abandoned. Owner needs to coordinate with the CVFPB to remove or abandon crossing according to Title 23 requirements. Coordinates have been updated from 37.332805, -120.394906 to 37.332826, -120.394886. (M.Thao - DWR UCIP) 09/17/2013 Verify Pipe is abandoned or still intact may be this crossing was abandoned/removed during recent levee reconstruction. no signs of pipe and appurtenances on waterside only a CM pipe riser with slide gate found on landside. (DWR UCIP - P. Amatya)
FIELD_STRUCT_DESC: 36-inch corrugated metal irrigation pipe through the levee, 10 feet below the crown. Riser on the landside (LS). Screw gate in a 48-inch pipe well on the waterside (WS) slope. Concrete headwall and cobble apron at the LS toe. Concrete headwall at the WS toe. [Additional Reference(s): USACE San Joaquin O&M Manual 607, June 1962, (HLM 1.32), listed as 36-inch pipe].

WS view: Looking into CMP riser with slide gate; no cover on riser.

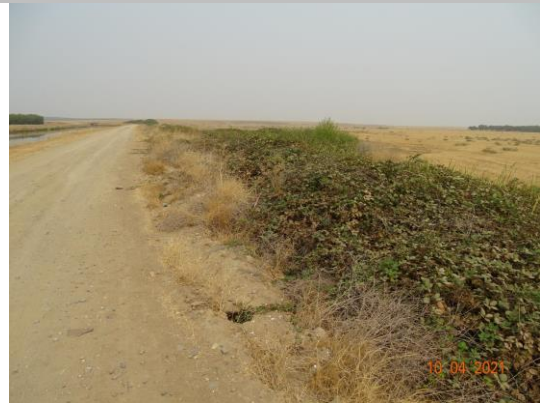
Photo 1 of 1 : FA_2024_NA0013_331_3_20240828_00001.jpg

View of blackberry bushes growing on the the waterside slope. (Fall 2021)

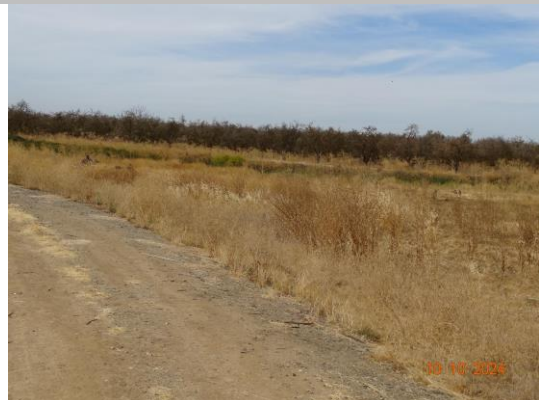
Photo 1 of 1 : FA_2024_NA0013_332_9_20241011_00032.jpg

View of vegetation growing on the waterside slope. (Fall 2024)

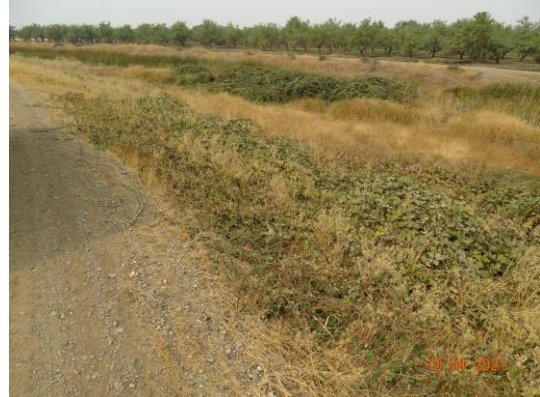
Photo 1 of 1 : FA_2024_NA0013_332_10_20240828_00002.jpg

Blackberry bushes are growing up the waterside slope and shoulder.
(Fall 2021)

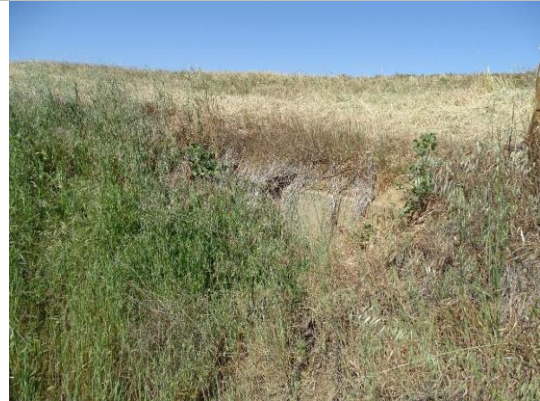
Photo 1 of 2 : UCIP_FA_2024_77950_111356.jpg

Comment Code						
Inspector Comment						
DS_ID:23053 FS_ID:77950 EP_NO: N/A Repair Type: Urgent EVAL Issue: 1, Pipe Integrity Crossing Status: Found UCIP Comments: 04/13/2022 Record updated from No Action Needed to Urgent. DMP internal video inspection has found pipe integrity issues. LOF of crossing is greater than of equal to 5 and less than 6. Crossing will be monitored until funding becomes available to address the issues. Overgrown vegetation limits inspection of levee at this crossing; recommend vegetation removal on LS and WS. (M.Thao - DWR UCIP) 08/23/2016: LS inlet is clear. WS gate has been cleared of vegetation and functions properly. Crossing has been downgraded from Urgent to No Action Needed. (K. Fazel - UCIP) 09/17/2013needs vegetation cleaning on both sidesflap gate was not closed during field surveyinlet needs cleaning. (P. Amatya - UCIP) FIELD_STRUCT_DESC: 24-inch corrugated metal gravity drainage pipe through the levee, 8 feet below the crown. Concrete headwall, flap gate, and concrete grouted cobble apron on the waterside (WS) toe. Concrete headwall on the landside (LS) toe. [Additional Reference(s): DWR Levee Log, 2005 (HLM 0.29). USACE San Joaquin O&M Manual 607, June 1962, Revised March 1984, (HLM 0.29), listed as 24-inch pipe]. FS Date: 4/13/2022

LS view: Looking toward levee; headwall blocked by vegetation.

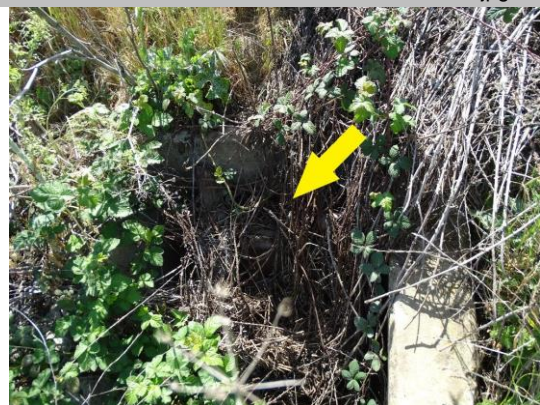
Photo 2 of 2 : UCIP_FA_2024_77950_111354.jpg

WS view: Looking at concrete headwall and flap gate (yellow arrow); dense vegetation blocking flap gate.

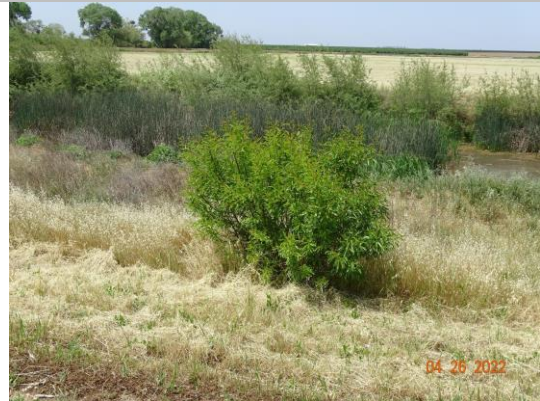
Photo 1 of 1 : FA_2024_NA0013_332_13_20240828_00005.jpg

Tree sapling on the waterside slope. (Spring 2022)

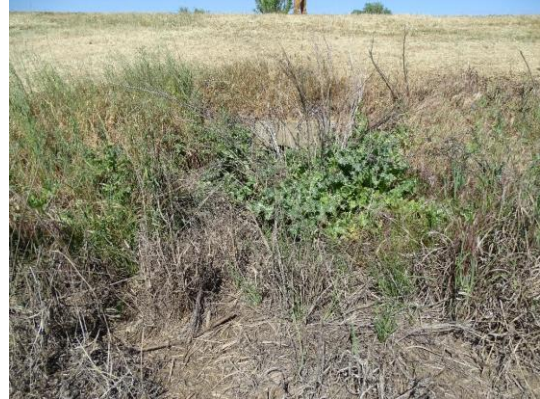
Photo 1 of 1 : UCIP_FA_2024_77954_111367.jpg

Comment Code						
Inspector Comment						
DS_ID:23054 FS_ID:77954 EP_NO: N/A Repair Type: Non-Urgent EVAL Issue: 5, Pipe Damage Crossing Status: Found UCIP Comments: 04/13/2022 Record remains Non-Urgent. DMP internal video inspection has found pipe integrity issues. LOF of crossing is greater than or equal to 4.1 and less than 5. Crossing will be monitored until funding becomes available for rehabilitation. Overgrown vegetation limit inspection of LS headwall and inlet; recommend vegetation removal. Flap gate was properly closed during inspection. (M.Thao - DWR UCIP) 09/17/2013 - needs vegetation cleaning on both sides; flap gate was not properly closed during field survey; inlet needs cleaning. (DWR UCIP - P. Amatya) FIELD_STRUCT_DESC: 24-inch corrugated metal gravity drainage pipe through the levee, 12 feet below the crown. Concrete headwall, flap gate, and concrete grouted cobble apron on the waterside (WS) toe. Concrete headwall on the landside (LS) toe. [Additional Reference(s): DWR Levee Log, 2005 (HLM 0.54). USACE San Joaquin O&M Manual 607, June 1962, Revised March 1984, (HLM 0.54), listed as 24-inch pipe]. FS Date: 4/13/2022

LS view: Headwall and pipe inlet blocked by dense vegetation.

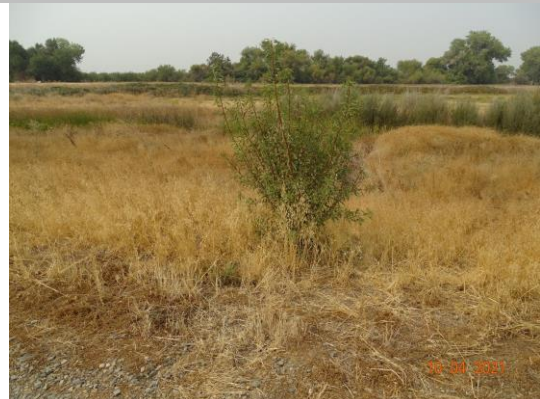
Photo 1 of 1 : FA_2024_NA0013_332_12_20240828_00004.jpg

LM Start	0.54	Rating **	M	Issue No.	12
LM End	0.54	Issue Type +	Ma	Location *	WS
Category	Earthen Levee			GPS Latitude/Longitude	
				Start	End
Item	Trim / Thin Trees			37.333152°	37.333152°
				-120.394099°	-120.394099°
DWR ID	DWR_NA0013_02_f_2021_12				
Comment Code					
T1 : Trim and thin trees to at least five feet above ground level to allow visibility of the ground and room to flood fight.					
Inspector Comment					
Sapling should be removed before it can establish.

Sapling growing in the waterside shoulder. (Fall 2021)

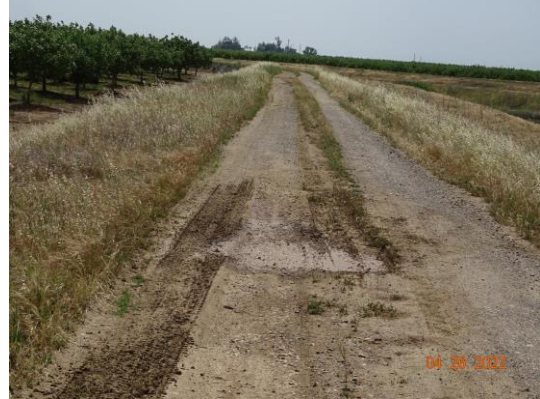
Photo 1 of 1 : FA_2024_NA0013_332_17_20240828_00008.jpg

LM Start	0.74	Rating **	M	Issue No.	17
LM End	0.74	Issue Type +	Ma	Location *	CR
Category	Earthen Levee			GPS Latitude/Longitude	
				Start	End
Item	Crown Surface / Depressions / Rutting			37.330443 °	37.330443 °
				-120.395181 °	-120.395181 °
DWR ID	DWR_NA0013_02_f _ 2021_17				
Comment Code					
C2 : Repair depressions or ruts in the crown or slope.					
Inspector Comment

Depressions in the levee crown from vehicle traffic. (Spring 2022)

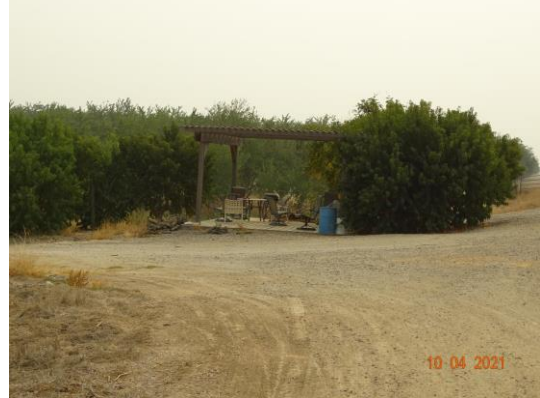
Photo 1 of 1 : FA_2024_NA0013_332_24_20240828_00013.jpg

Unauthorized patio and fruit trees installed on the landside slope.
(Fall 2021)

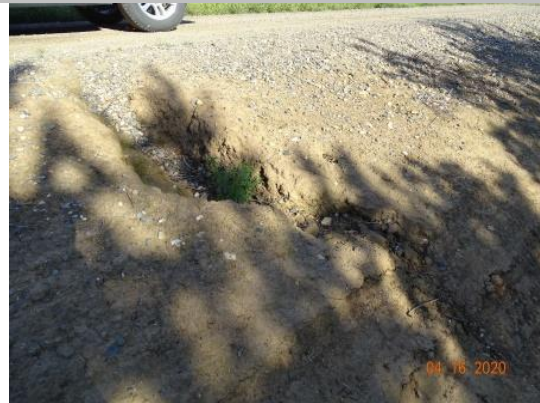
Photo 1 of 1 : FA_2024_NA0013_332_15_20240828_00006.jpg

LM Start	0.97	Rating **	A/W	Issue No.	15
LM End	0.97	Issue Type +	Ma	Location *	LS
Category	Earthen Levee			GPS Latitude/Longitude	
				Start	End
Item	Erosion / Rills			37.327336 °	37.327336 °
				-120.396085 °	-120.396085 °
DWR ID	DWR_NA0013_02_f_2017_15				
Comment Code					
E5 : Schedule repair of rills prior to the next inspection.					
Inspector Comment					
There is large finger erosion on the landward slope. Couple of smaller erosion sites are starting just downstream of the larger erosion.

Looking at finger erosion on the landside slope. (Spring 2020)

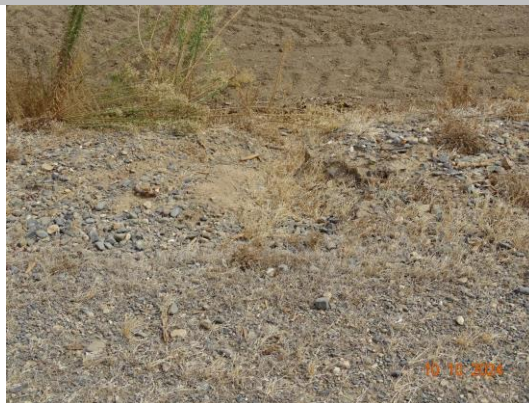
Photo 1 of 1 : FA_2024_NA0013_332_16_20241014_00034.jpg

LM Start	1.10	Rating **	A/W	Issue No.	16
LM End	1.10	Issue Type +	Ma	Location *	LS
Category	Earthen Levee			GPS Latitude/Longitude	
				Start	End
Item	Erosion / Rills			37.325487 °	37.325487 °
				-120.396052 °	-120.396052 °
DWR ID	DWR_NA0013_02_s _ 2017_16				
Comment Code					
E5 : Schedule repair of rills prior to the next inspection.					
Inspector Comment					
Finger erosion is located on the landside slope. Monitor for worsening conditions.

View of depression in the landside slope. (Fall 2024)

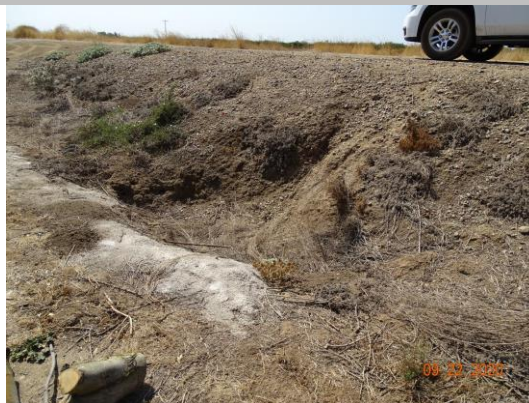
Photo 1 of 1 : FA_2024_NA0013_332_28_20240828_00015.jpg

LM Start	1.29	Rating **	M	Issue No.	28
LM End	1.29	Issue Type +	Ma	Location *	LS
Category	Earthen Levee			GPS Latitude/Longitude	
				Start	End
Item	Erosion / Bank Caving			37.322752 °	37.322752 °
				-120.396030 °	-120.396030 °
DWR ID	DWR_NA0013_02_s _ 2024_28				
Comment Code					
E2 : Schedule repair of erosion site prior to the next inspection.					
Inspector Comment

View of erosion pocket in the landside slope and toe. (Fall 2020)

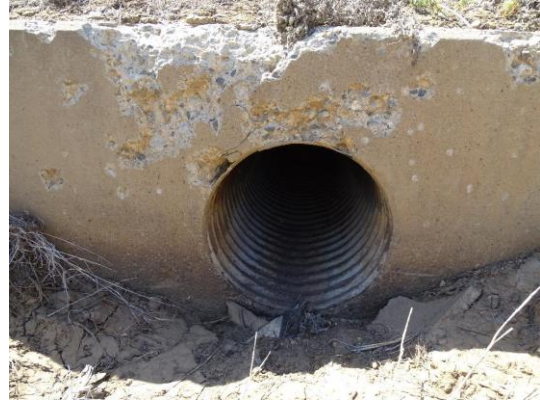
Photo 1 of 3 : UCIP_FA_2024_77958_111414.jpg

LS view: Inlet at toe; concrete headwall damaged since last inspection.

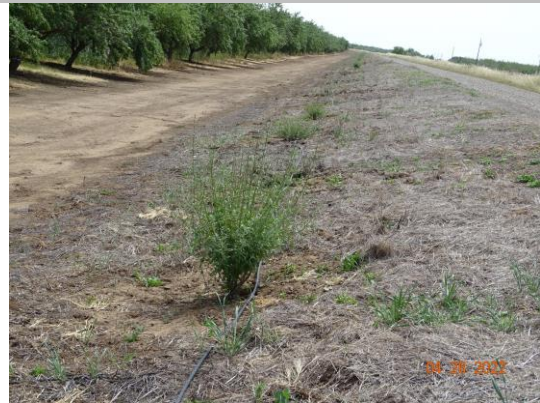
Photo 1 of 1 : FA_2024_NA0013_332_21_20240828_00011.jpg

View of shrubs intermittently planted on the landside slope. (Spring 2022)

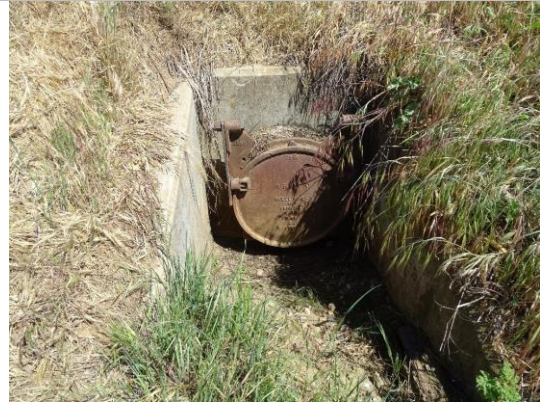
Photo 2 of 2 : UCIP_FA_2024_77959_111434.jpg

WS view: Concrete headwall, apron, and flap gate on toe; debris deposited at end of apron (bottom) not allowing water to drain properly.

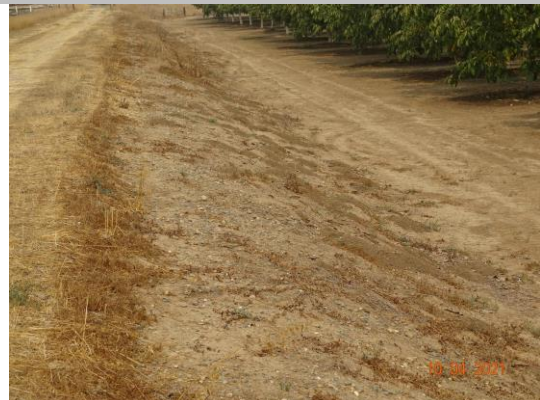
Photo 1 of 1 : FA_2024_NA0013_332_20_20240828_00010.jpg

View of old rodent burrows in the landside slope. (Fall 2021)

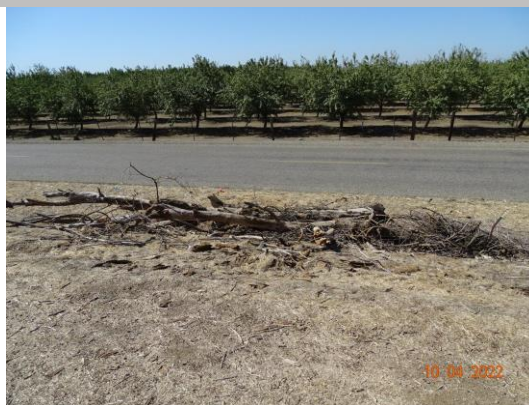
Photo 1 of 1 : FA_2024_NA0013_333_11_20240828_00003.jpg

Fallen tree on the landside toe should be removed. (Fall 2022)

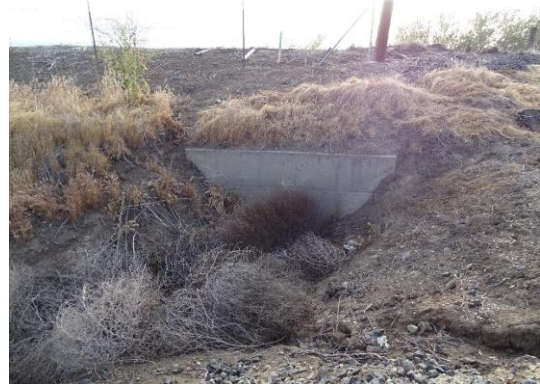
Photo 1 of 2 : UCIP_FA_2024_74601_111459.jpg

LS view: Concrete headwall; vegetation blocking pipe inlet.

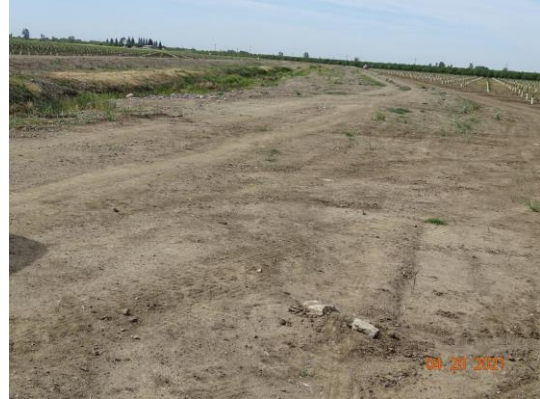
Photo 1 of 1 : FA_2024_NA0013_333_9_20240828_00001.jpg

View of depression on landside slope and levee crown. (Spring 2021)

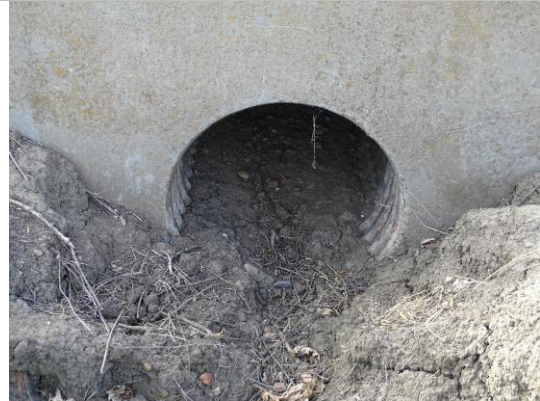
Photo 1 of 1 : UCIP_FA_2024_74609_111479.jpg

LS view: Close-up view of pipe inlet; pipe partially filled with sediment.

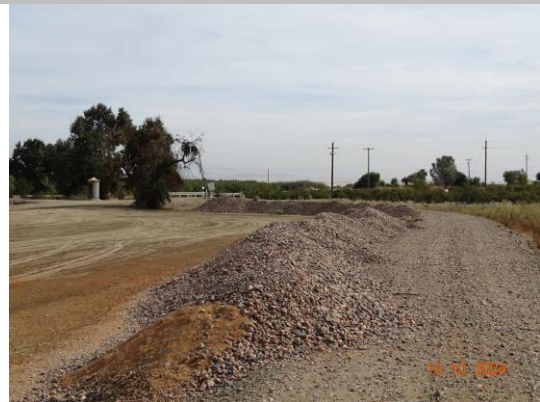
Photo 1 of 1 : FA_2024_NA0013_333_16_20241011_00026.jpg

View of material stored on the landside slope and toe. (Fall 2024)

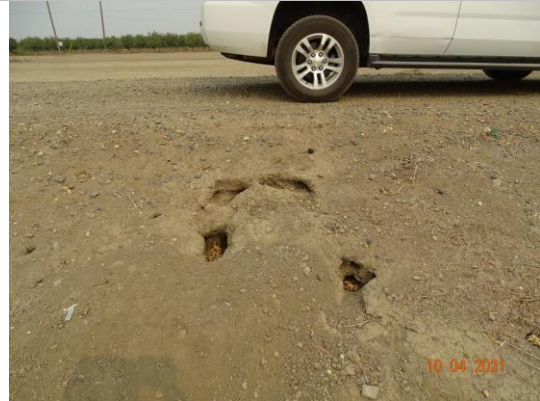
Photo 1 of 1 : FA_2024_NA0013_333_12_20240828_00004.jpg

View of rodent activity on the waterside slope. (Fall 2021)

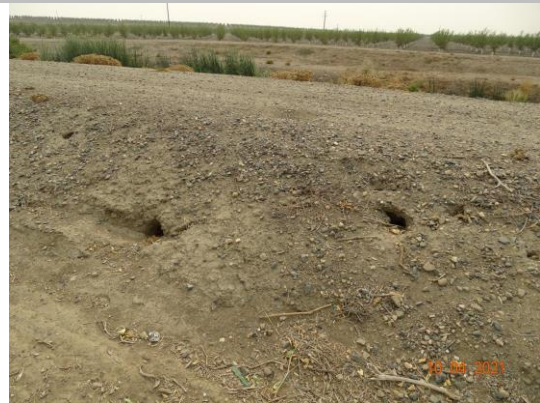
Photo 1 of 1 : FA_2024_NA0013_333_13_20240828_00005.jpg

Rodent holes observed on the landside slope. (Fall 2021)

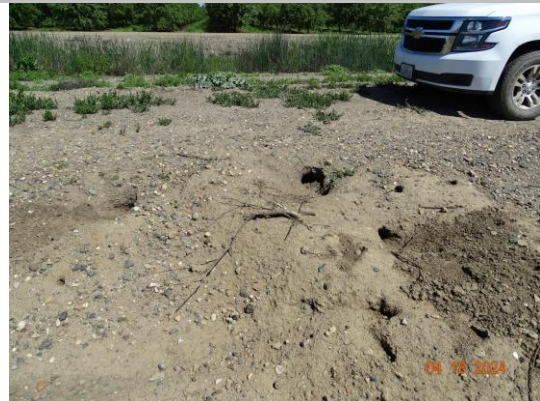
Photo 1 of 1 : FA_2024_NA0013_334_15_20240828_00005.jpg

View of multiple rodent burrows in the landside slope. (Spring 2024)

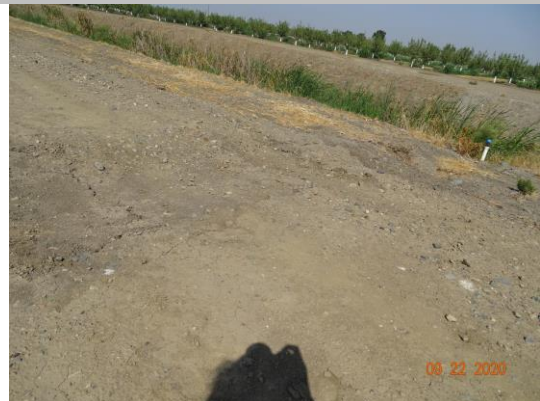
Photo 1 of 1 : FA_2024_NA0013_334_10_20240828_00001.jpg

View of depression across the levee crown and waterside slope. (Fall 2020)

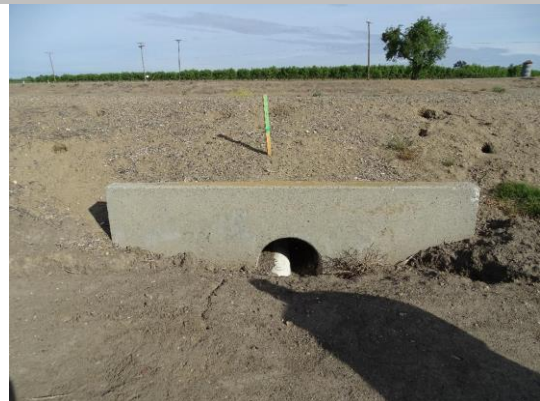
Photo 3 of 3 : UCIP_FA_2024_74658_111525.jpg

LS view: Concrete headwall and pipe inlet; PVC pipe was inserted into the draining pipe inlet.

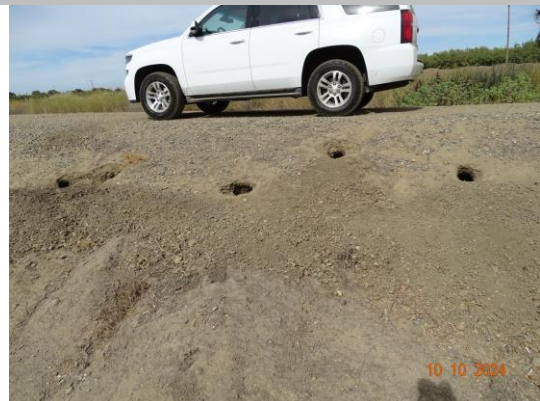
Photo 1 of 1 : FA_2024_NA0013_334_18_20241011_00029.jpg

View of multiple rodent burrows on the landside slope. (Fall 2024)

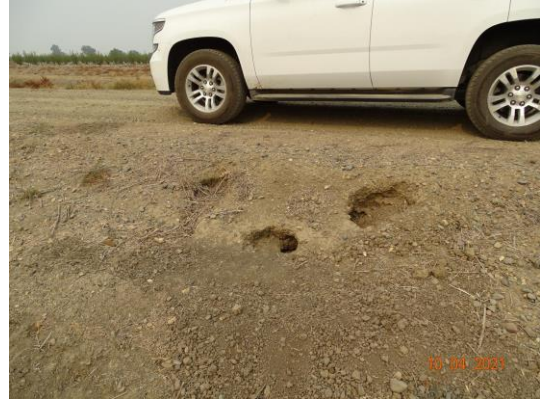
Photo 1 of 1 : FA_2024_NA0013_334_12_20240828_00002.jpg

View of rodent burrows in the landside slope. (Fall 2021)

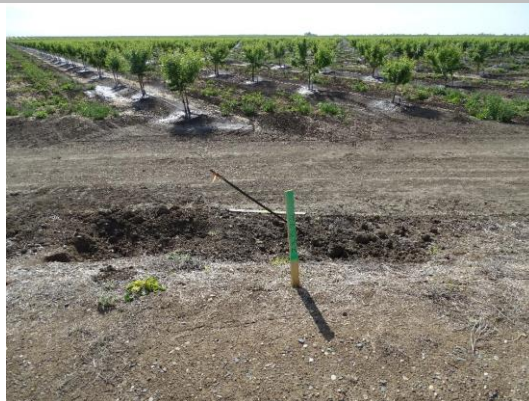
Photo 2 of 3 : UCIP_FA_2024_74659_111556.jpg

LS view: Looking from crown; headwall and pipe inlet on toe not found.

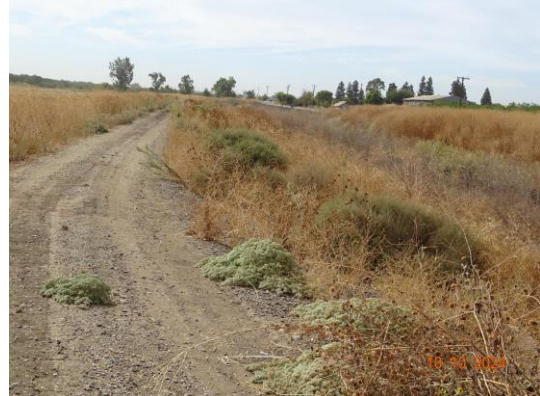
Photo 1 of 1 : FA_2024_NA0013_334_11_20241011_00031.jpg

View of vegetation growing along the waterside slope. (Fall 2024)

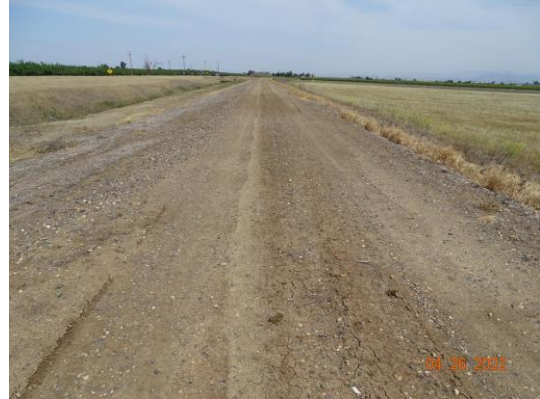
Photo 1 of 1 : FA_2024_NA0013_334_14_20240828_00004.jpg

Depressions beginning to form in the levee crown from vehicle traffic.
(Spring 2022)
