**Flood Control Project Maintenance
Levee Inspections
LMA District Cover Sheet
Spring 2010 Levee Inspection Results**

Merced Streams Group

Levee Inspection Report By Mile - Spring 2010

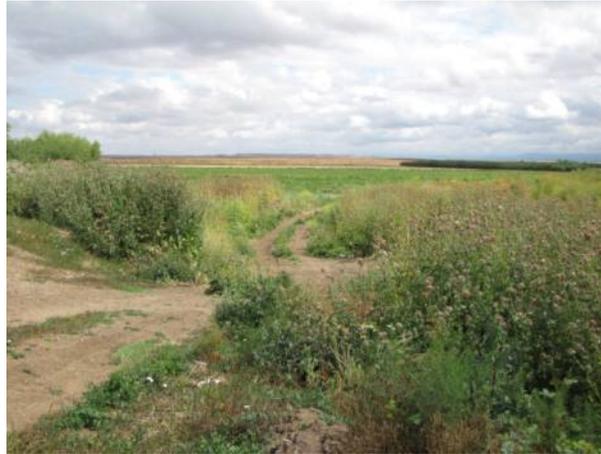
| <p>phillips_s_20100601_064.jpg</p> | |

| <p>This photo was added to show the split unit 1 Black Rascal Slough with Fairfield Canal continues downstream to L/M 1.64</p> | |

| LMIR No | Levee Mile | | Category | Item | Location * | Rating ** | Action/Comment | GPS Latitude/Longitude | | Issue No. Photo |
|---|---|---|---|---|---|---|---|---|---|---|
| 1 | 1.31 | 1.64 | Earthen Levee | Vegetation | WS | M | Control annual grass and weeds on the levee slopes and easements. | 37.332740 ° -120.395045 ° | 37.341433 ° -120.398815 ° | 1 Y |

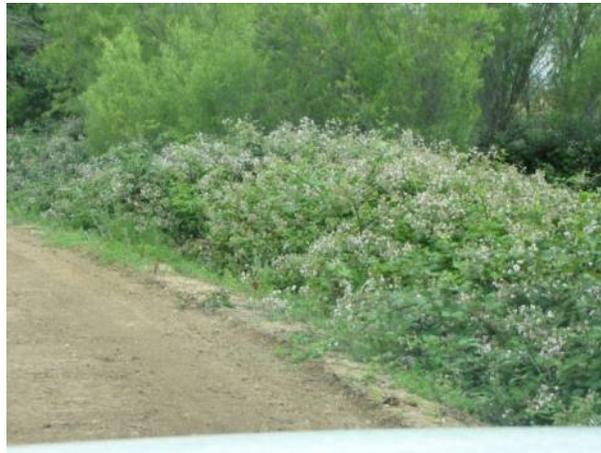
| <p>phillips_s_20100601_065.jpg</p> | |

| <p>Levee mile 1.38 berries on shoulder.waterside.</p> | |

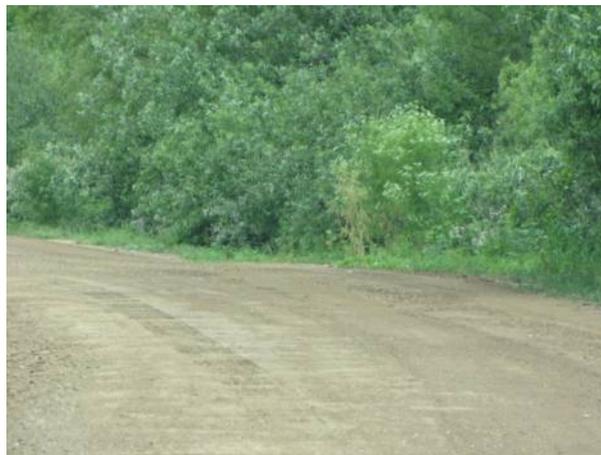
| <p>phillips_s_20100601_066.jpg</p> | |

| <p>Tree growth and wild growth water ward District states that this is not Black Rascal but instead Murphy's canal.</p> | |

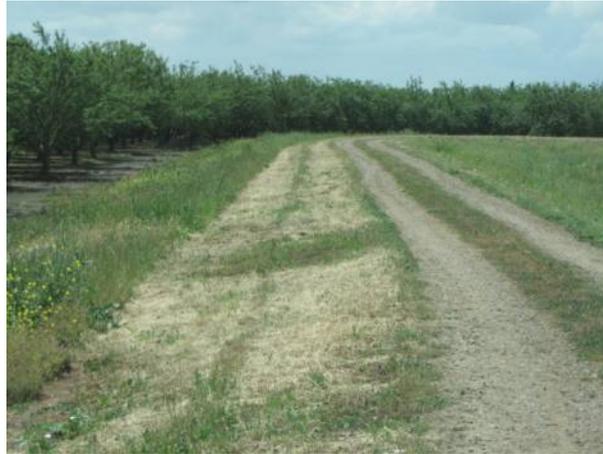
phillips_s_20100601_062.jpg

View looking downstream of unit 2 L/M 0.00 standing on land side. There is growth on crown road way you can see where District made a couple of passes. These grasses aren't tall, you can still view the levee.

| LMIR No | Levee Mile | | Category | Item | Location * | Rating ** | Action/Comment | GPS Latitude/Longitude | | Issue No. Photo |
|---|---|---|---|---|---|---|---|---|---|---|
| 5 | 0.96 | 1.12 | Earthen Levee | Vegetation | LS | M | Control annual grass and weeds on the levee slopes and easements. | 37.327655 ° -120.396175 ° | 37.325408 ° -120.393197 ° | 3 Y |

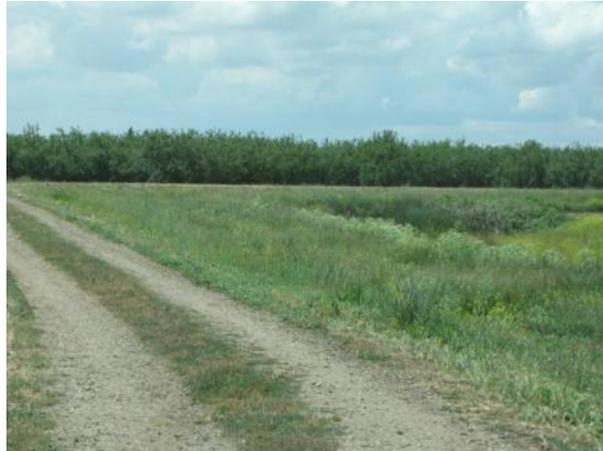
phillips_s_20100601_063.jpg

Looking at water side of levee the weeds are not blocking the view of levee. Looking downstream from L/M 0.00.

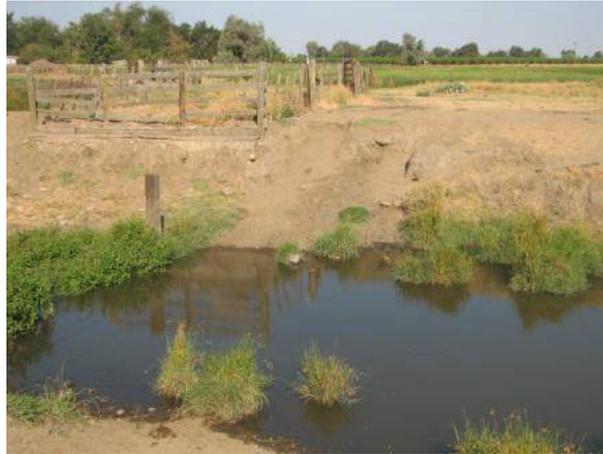
| SJR2009_LM1.0a.JPG | |

| LMIR No | Levee Mile | | Category | Item | Location * | Rating ** | Action/Comment | GPS Latitude/Longitude | | Issue No. Photo |
|---|---|---|---|---|---|---|---|---|---|---|
| 7 | 1.00 | 1.00 | Supplemental | DWR Erosion Survey | WS | U | Inspector Comments: 2009: Site recommended as local maintenance issue, per CLRO CES Evaluation 2008 Report; previously rated "U" [2009 SiteID:NA0013U3RM1] | 37.270800 ° -120.284180 ° | 37.270800 ° -120.284180 ° | 1 Y |

| 2009: Site recommended as local maintenance issue, per CLRO CES Evaluation 2008 Report; previously rated "U" [2009 SiteID:NA0013U3RM1] | |

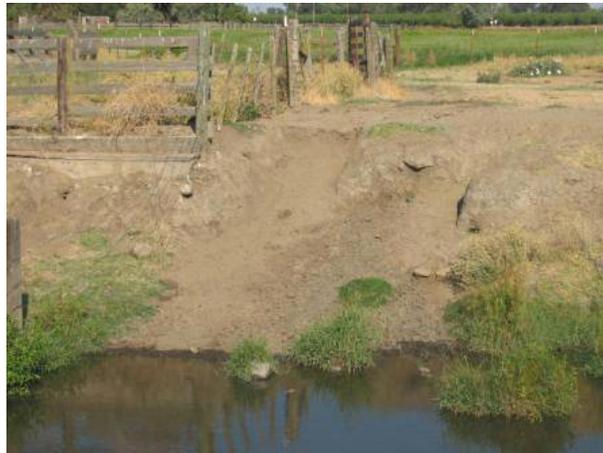
| SJR2009_LM1.0b.JPG | |

| 2009: Site recommended as local maintenance issue, per CLRO CES Evaluation 2008 Report; previously rated "U" [2009 SiteID:NA0013U3RM1] | |

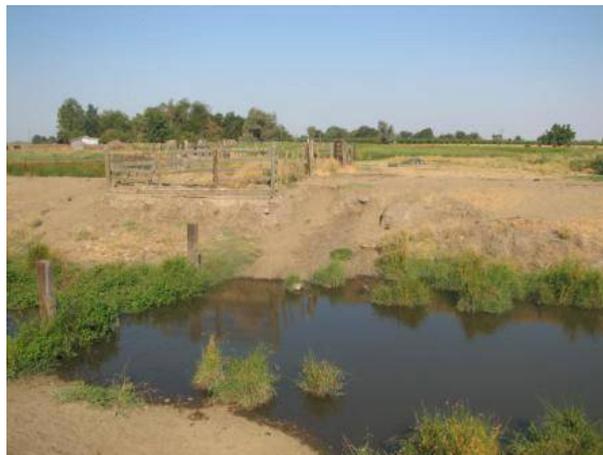
| SJR2009_LM1.0c.JPG | |

| 2009: Site recommended as local maintenance issue, per CLRO CES Evaluation 2008 Report; previously rated "U" [2009 SiteID:NA0013U3RM1] | |

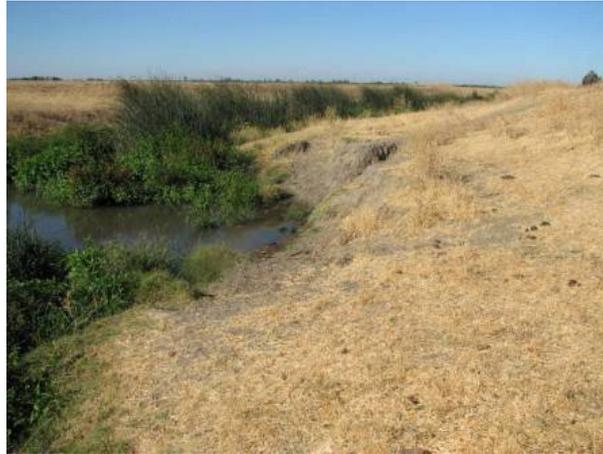
| LMIR No | Levee Mile | | Category | Item | Location * | Rating ** | Action/Comment | GPS Latitude/Longitude | | Issue No. Photo |
|---|---|---|---|---|---|---|---|---|---|---|
| 12 | 1.25 | 1.25 | Supplemental | DWR Erosion Survey | WS | M | Inspector Comments: 2009: Scouring possible created by velocity and effects resulting from channel confinement of the bridge upstream; site recommended as local maintenance issue, per CLRO CES Evaluation 2008 Report; previously rated "M" [2009 SiteID:NA0013U3RM1.25] | 37.272630 ° -120.280390 ° | 37.272630 ° -120.280390 ° | 2 Y |

| <p>2009: bank erosion scour that is immediately downstream of Mission Ave. bridge; noticeable terracetting damage from livestock traversing the slope; site is recommended as local maintenance issue, per CLRO CES Evaluation 2008 Report; previously rated "M" [2009 SiteID:NA0013U3RM1.25]</p> <p>SJR2009_S17 LM1.25 082508b.JPG</p> | |

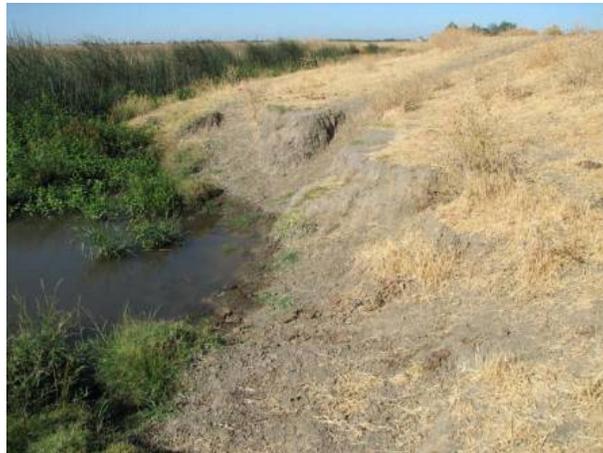
| <p>2009: bank erosion scour that is immediately downstream of Mission Ave. bridge; noticeable terracetting damage from livestock traversing the slope; site is recommended as local maintenance issue, per CLRO CES Evaluation 2008 Report; previously rated "M" [2009 SiteID:NA0013U3RM1.25]</p> <p>SJR2009_S17 LM1.25 082508e.JPG</p> | |

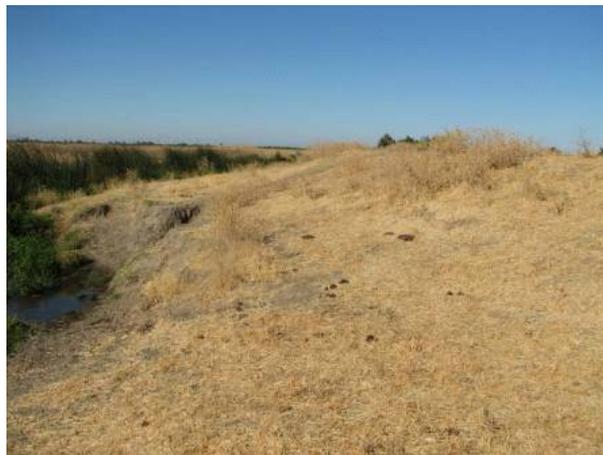
| <p>2009: bank erosion scour that is immediately downstream of Mission Ave. bridge; noticeable terracetting damage from livestock traversing the slope; site is recommended as local maintenance issue, per CLRO CES Evaluation 2008 Report; previously rated "M" [2009 SiteID:NA0013U3RM1.25]</p> <p>SJR2009_S17 LM1.25 082508c.JPG</p> | |

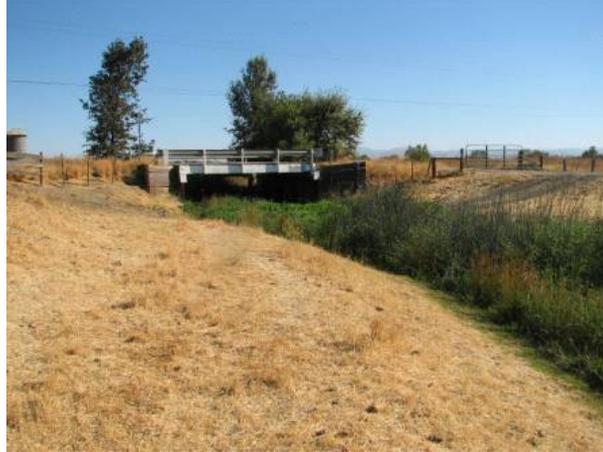
| <p>2009: bank erosion scour that is immediately downstream of Mission Ave. bridge; noticeable terracetting damage from livestock traversing the slope; site is recommended as local maintenance issue, per CLRO CES Evaluation 2008 Report; previously rated "M" [2009 SiteID:NA0013U3RM1.25]</p> <p>SJR2009_S17 LM1.25 082508a.JPG</p> | |

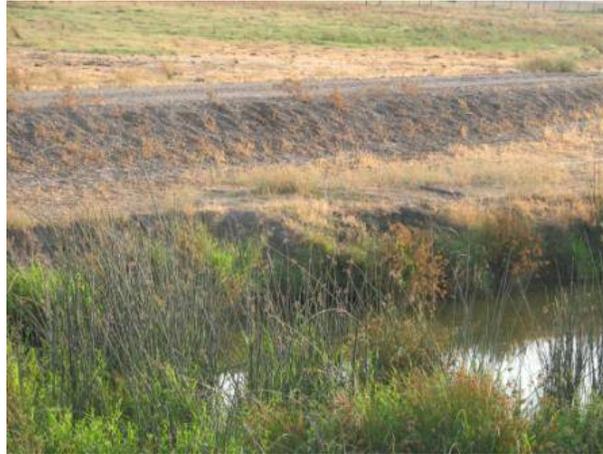
| SJR2009_LM0.21a.JPG | |

| LMIR No | Levee Mile | | Category | Item | Location * | Rating ** | Action/Comment | GPS Latitude/Longitude | | Issue No. Photo |
|---|---|---|---|---|---|---|---|---|---|---|
| 3 | 0.15 | 0.28 | Supplemental | DWR Erosion Survey | WS | M | Inspector Comments: 2009: Site recommended as local maintenance issue, per CLRO CES Evaluation 2008 Report; previously rated "U" [2009 SiteID:NA0013U4RM0.21] | 37.272283 ° -120.280869 ° | 37.272283 ° -120.280869 ° | 3 Y |

| 2009: Site recommended as local maintenance issue, per CLRO CES Evaluation 2008 Report; previously rated "U" [2009 SiteID:NA0013U4RM0.21] | |

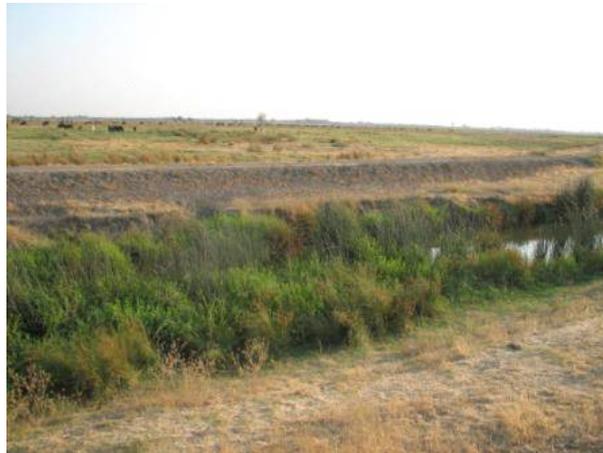
| SJR2009_LM0.21b.JPG | |

| 2009: Site recommended as local maintenance issue, per CLRO CES Evaluation 2008 Report; previously rated "U" [2009 SiteID:NA0013U4RM0.21] | |

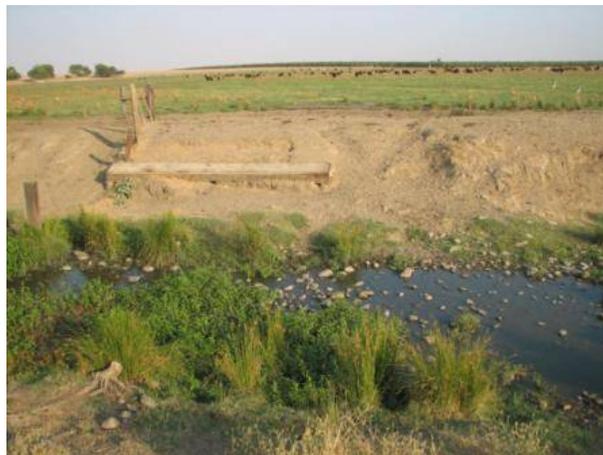
| SJR2009_LM0.42a.JPG | |

| LMIR No | Levee Mile | | Category | Item | Location * | Rating ** | Action/Comment | GPS Latitude/Longitude | | Issue No. Photo |
|---|---|---|---|---|---|---|---|---|---|---|
| 4 | 0.42 | 0.43 | Supplemental | DWR Erosion Survey | WS | U | Inspector Comments: 2009: Site recommended as local maintenance issue, per CLRO CES Evaluation 2008 Report; terracetting damage from livestock traversing; there is a wooden platform installed on site; landside ground is same heights as levee crown; previously rated "M" [2009 | 37.270630 ° -120.283970 ° | 37.270630 ° -120.283970 ° | 4 Y |

| 2009: Site recommended as local maintenance issue, per CLRO CES Evaluation 2008 Report; terracing damage from livestock traversing; there is a wooden platform installed on site; landside ground is same heights as levee crown; previously rated "M" [2009 SiteID:NA0013U4RM0.42] | |

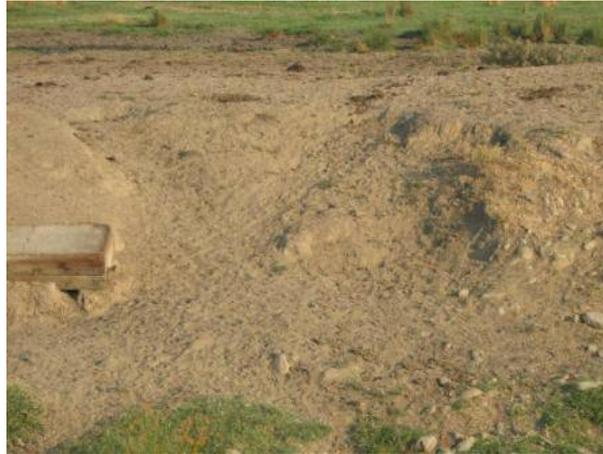
| <p>SJR2009_LM0.42b.JPG</p> | |

| <p>2009: Site recommended as local maintenance issue, per CLRO CES Evaluation 2008 Report; terracetting damage from livestock traversing; there is a wooden platform installed on site; landside ground is same heights as levee crown; previously rated "M" [2009 SiteID:NA0013U4RM0.42]</p> | |

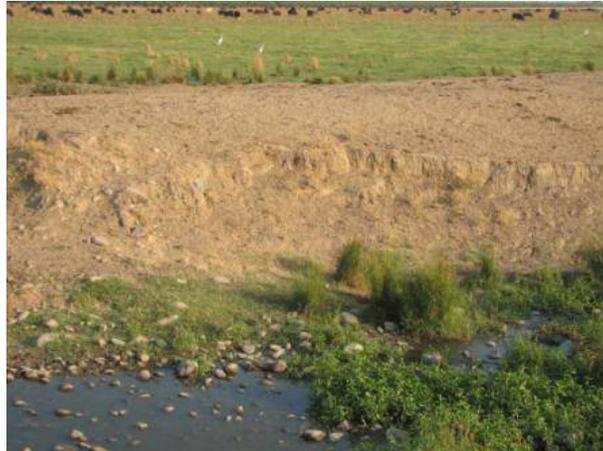
| <p>SJR2009_LM0.42c.JPG</p> | |

| <p>2009: Site recommended as local maintenance issue, per CLRO CES Evaluation 2008 Report; terracetting damage from livestock traversing; there is a wooden platform installed on site; landside ground is same heights as levee crown; previously rated "M" [2009 SiteID:NA0013U4RM0.42]</p> | |

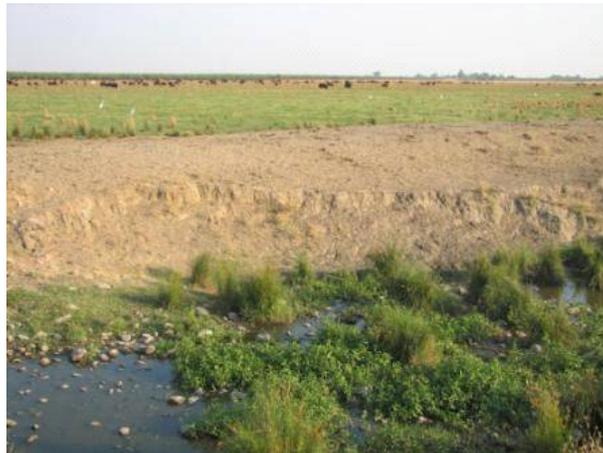
| <p>SJR2009_LM0.42d.JPG</p> | |

| <p>2009: Site recommended as local maintenance issue, per CLRO CES Evaluation 2008 Report; terracetting damage from livestock traversing; there is a wooden platform installed on site; landside ground is same heights as levee crown; previously rated "M" [2009 SiteID:NA0013U4RM0.42]</p> | |
