**Flood Control Project Maintenance
Levee Inspections**
LMA District Cover Sheet
Spring 2012 Levee Inspection Results
Merced Streams Group

**Flood Control Project Maintenance
Levee Inspections
Unit Cover Sheet
Spring 2012 Levee Inspection Results
Merced Streams Group**

Levee Inspection Report By Mile - Spring 2012

Merced Streams Group

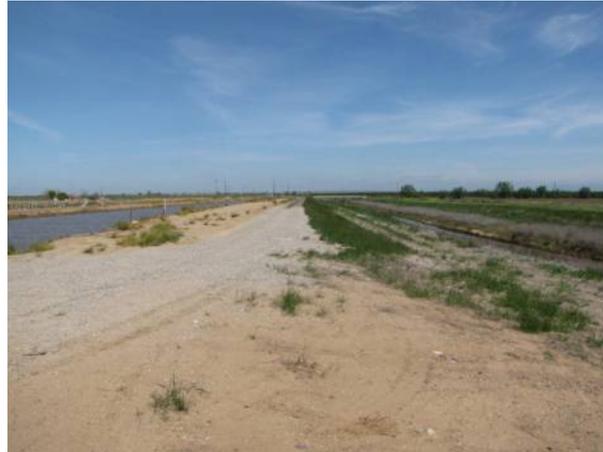
Levee Mile Report Line	4
Start Levee Mile	0.00
End Levee Mile	0.00
Location	Water Side
Category	Earthen Levee
Item	Vegetation
Black Rascal Creek looking upstream waterside levee mile 0.00. Photo taken 4-19-2012.	
phillips_s_20120515_037.jpg

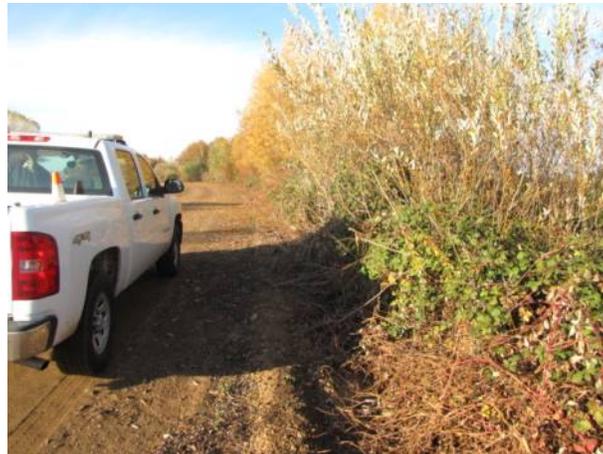
Levee Mile Report Line	8
Start Levee Mile	1.31
End Levee Mile	1.63
Location	Water Side
Category	Earthen Levee
Item	Vegetation
Unsatisfactory wild growth from levee mile 1.31-1.63. Photo taken 11-21-2011.	
phillips_s_20120306_036.jpg

DWR ID: DWR_NA0013_01_s_2012_6										
7	1.07	1.52	Earthen Levee	Vegetation	WS	M Ma	V2 : Remove the wild growth other than native grasses from the levee slopes.	37.329741 ° -120.396368 °	37.335623 ° -120.396136 °	4
DWR ID: DWR_NA0013_01_s_2012_4										
8	1.31	1.63	Earthen Levee	Vegetation	WS	U Ma	V2 : Remove the wild growth other than native grasses from the levee slopes.	37.332825 ° -120.394887 °	37.337056 ° -120.396531 °	1 Y
DWR ID: DWR_NA0013_01_s_2012_1

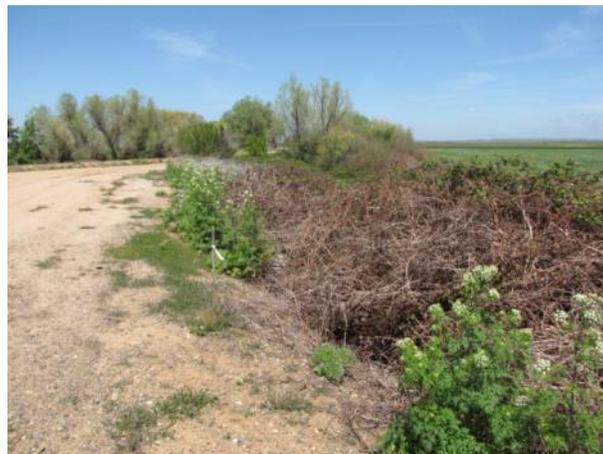
Levee Mile Report Line	8
Start Levee Mile	1.31
End Levee Mile	1.63
Location	Water Side
Category	Earthen Levee
Item	Vegetation
looking downstream from levee mile 1.31. Photo taken 4-19-2012.	
phillips_s_20120515_038.jpg

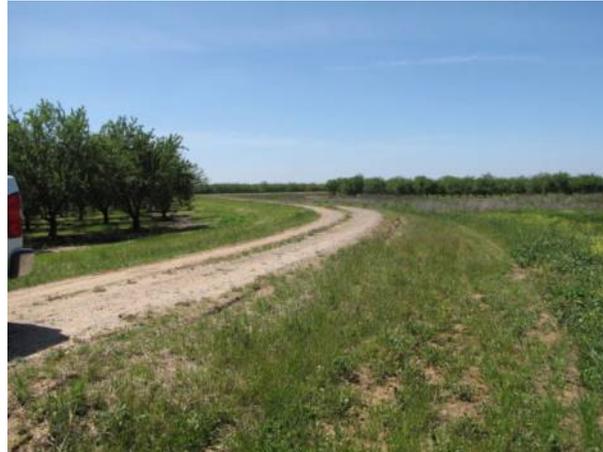
Levee Mile Report Line	1
Start Levee Mile	0.00
End Levee Mile	0.00
Location	Land Side
Category	Earthen Levee
Item	Vegetation
Black Rascal Creek Unit 2 levee mile 0.00 looking downstream waterside slope. Photo taken 4-19-2012	
phillips_s_20120515_042.jpg

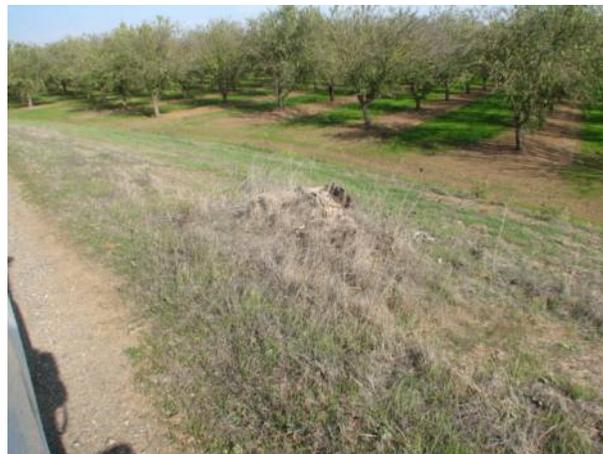
Levee Mile Report Line	4
Start Levee Mile	0.44
End Levee Mile	0.44
Location	Land Side
Category	Earthen Levee
Item	Trim / Thin Trees
Large tree stump on levee slope.	
phillips_s_20120306_040.jpg

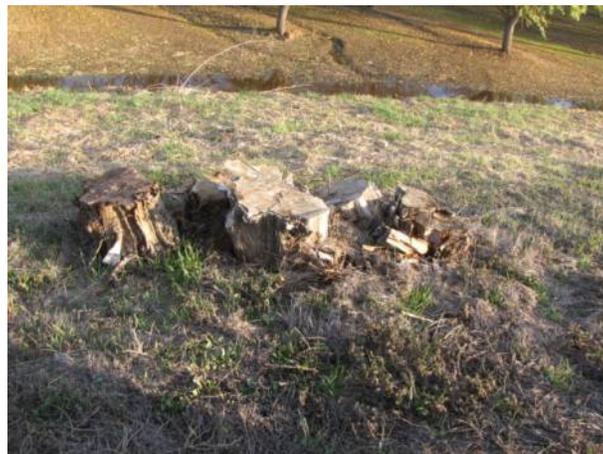
Levee Mile Report Line	4
Start Levee Mile	0.44
End Levee Mile	0.44
Location	Land Side
Category	Earthen Levee
Item	Trim / Thin Trees
Large tree stumps have not been removed. Photo taken 11-21-2011.	
phillips_s_20120306_041.jpg

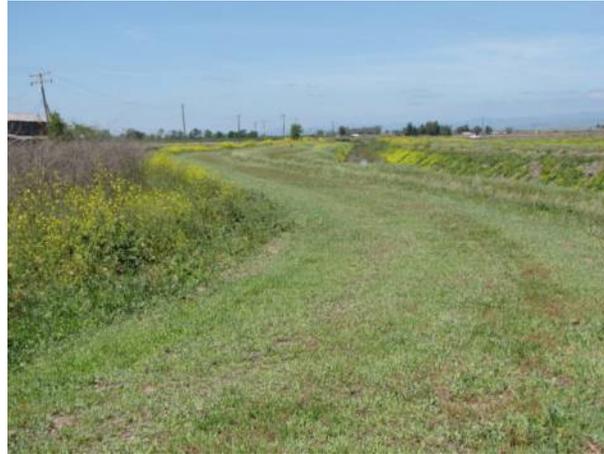
Levee Mile Report Line	4
Start Levee Mile	0.03
End Levee Mile	0.03
Location	Land Side
Category	Earthen Levee
Item	Vegetation

Levee mile 0.00 Owens Creek looking upstream from unit 3. Photo taken 4-19-2012.

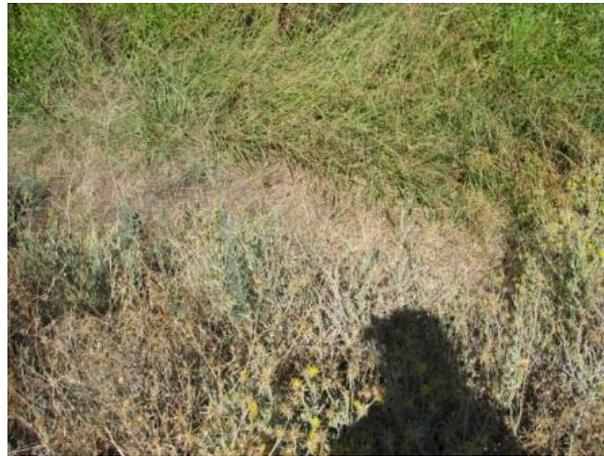
Levee Mile Report Line	12
Start Levee Mile	1.00
End Levee Mile	1.00
Location	Water Side
Category	Supplemental
Item	DWR Erosion Survey

A close look at the site, which is covered by thick star thistles.

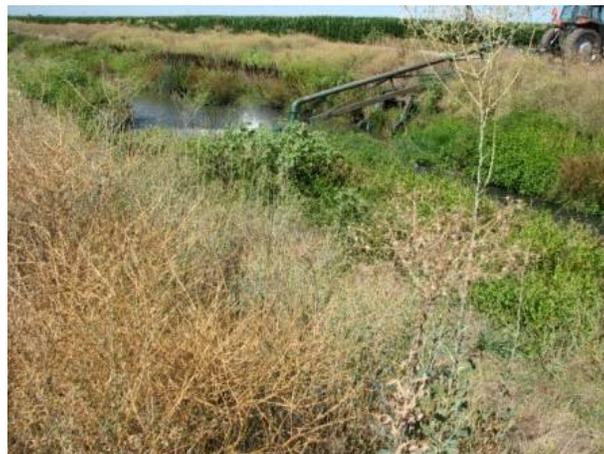
Levee Mile Report Line	12
Start Levee Mile	1.00
End Levee Mile	1.00
Location	Water Side
Category	Supplemental
Item	DWR Erosion Survey

Site covered with dense vegetation.

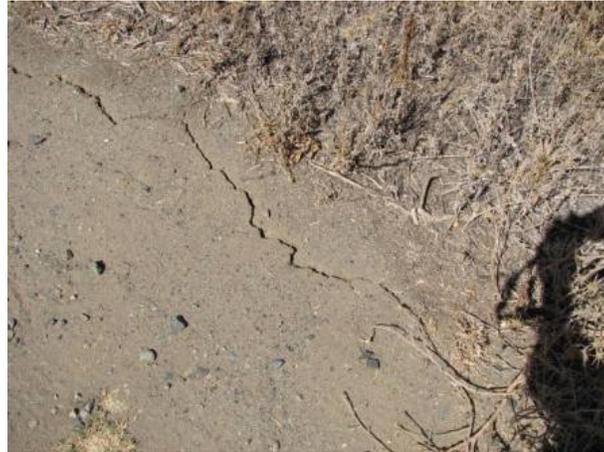
Levee Mile Report Line	12
Start Levee Mile	1.00
End Levee Mile	1.00
Location	Water Side
Category	Supplemental
Item	DWR Erosion Survey

Some cracking on the site.

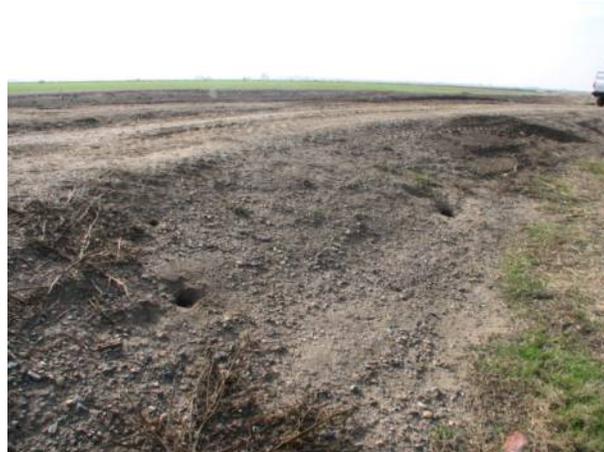
Levee Mile Report Line	18
Start Levee Mile	1.25
End Levee Mile	1.25
Location	Land Side
Category	Earthen Levee
Item	Animal Control

Active animal burrows on levee slope and toe.

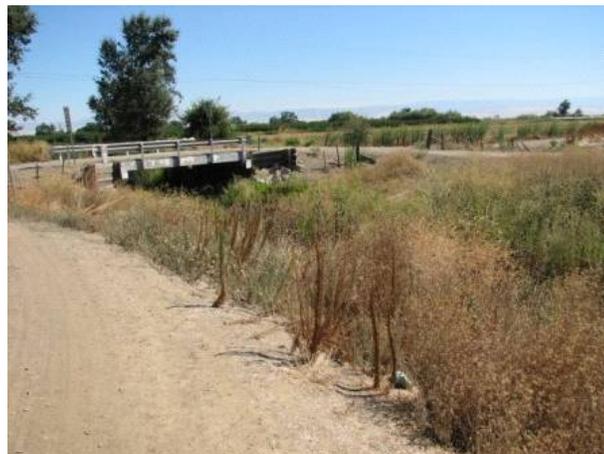
Levee Mile Report Line	19
Start Levee Mile	1.25
End Levee Mile	1.25
Location	Water Side
Category	Supplemental
Item	DWR Erosion Survey

The site is covered with dense thistles.

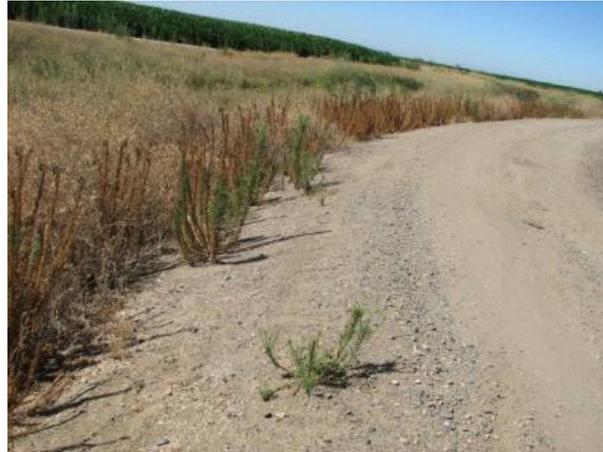
Levee Mile Report Line	19
Start Levee Mile	1.25
End Levee Mile	1.25
Location	Water Side
Category	Supplemental
Item	DWR Erosion Survey
No significant change visible from the levee top	
phillips_s_20120306_046.jpg

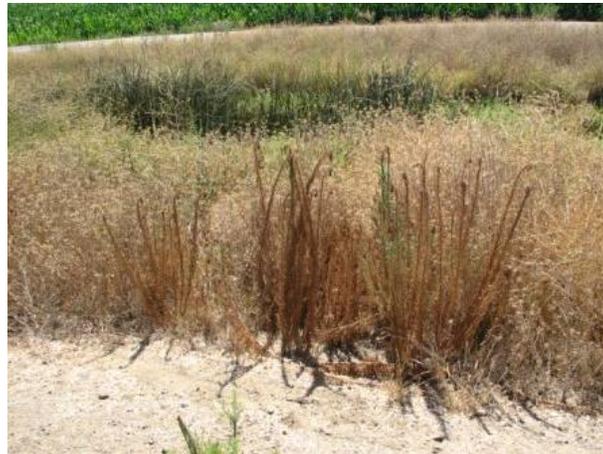
Levee Mile Report Line	19
Start Levee Mile	1.25
End Levee Mile	1.25
Location	Water Side
Category	Supplemental
Item	DWR Erosion Survey
The site is covered with dense thistles.	
phillips_s_20120306_047.jpg

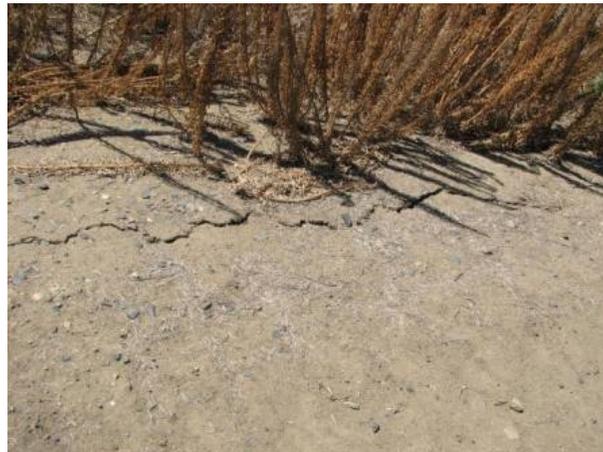
Levee Mile Report Line	19
Start Levee Mile	1.25
End Levee Mile	1.25
Location	Water Side
Category	Supplemental
Item	DWR Erosion Survey
Minor cracking visible at the levee shoulder.	
phillips_s_20120306_048.jpg

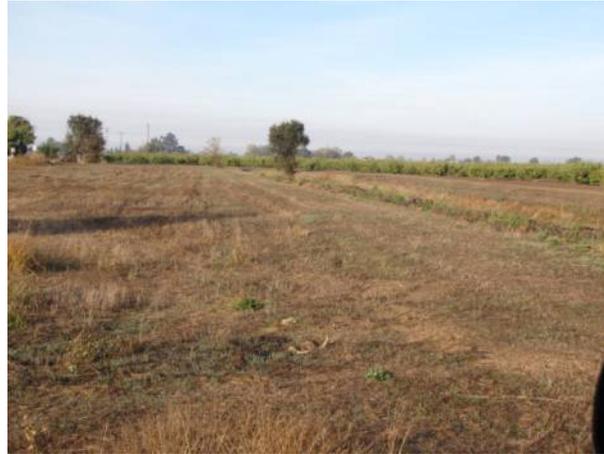
Levee Mile Report Line	2
Start Levee Mile	0.01
End Levee Mile	0.01
Location	Land Side
Category	Earthen Levee
Item	Vegetation
Owens Creek Unit 4 standing at levee mile 0.00 looking downstream. Photo taken 11-21-2011.	
phillips_s_20120306_058.jpg

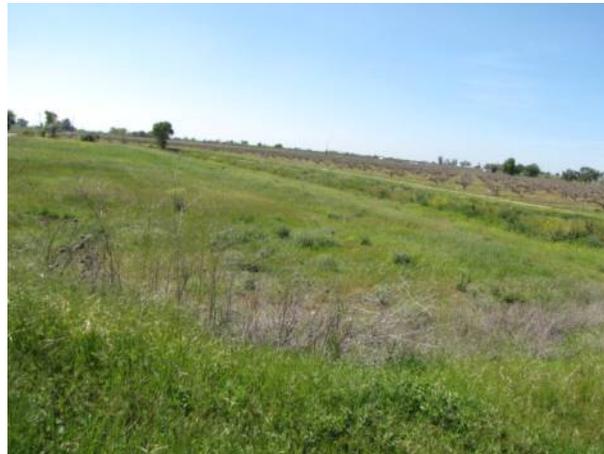
Levee Mile Report Line	6
Start Levee Mile	0.14
End Levee Mile	0.14
Location	Land Side
Category	Interior Drainage & Piping Systems
Item	Vegetation & Obstructions
Looking downstream from levee mile 0.14 Photo taken 4-19-2012.	
phillips_s_20120515_060.jpg

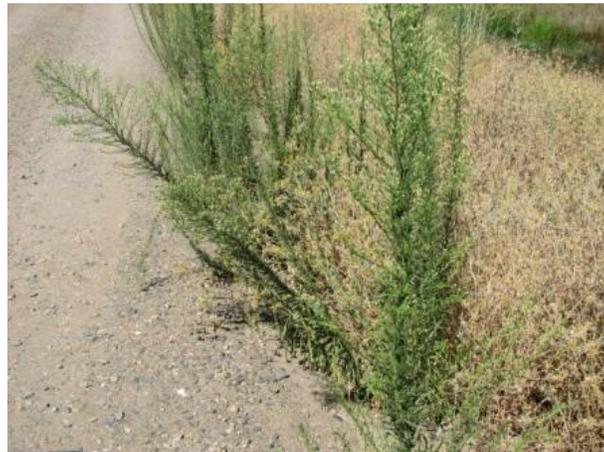
Levee Mile Report Line	7
Start Levee Mile	0.15
End Levee Mile	0.28
Location	Water Side
Category	Supplemental
Item	DWR Erosion Survey
The site is covered with dense star thistles. No significant changes visible.	
phillips_s_20120306_050.jpg

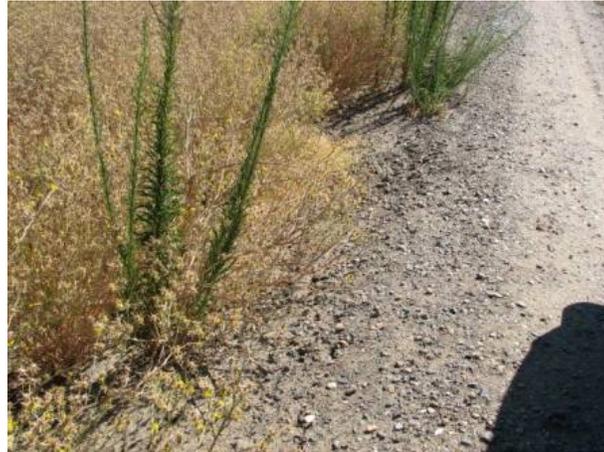
The site is covered with dense star thistles.

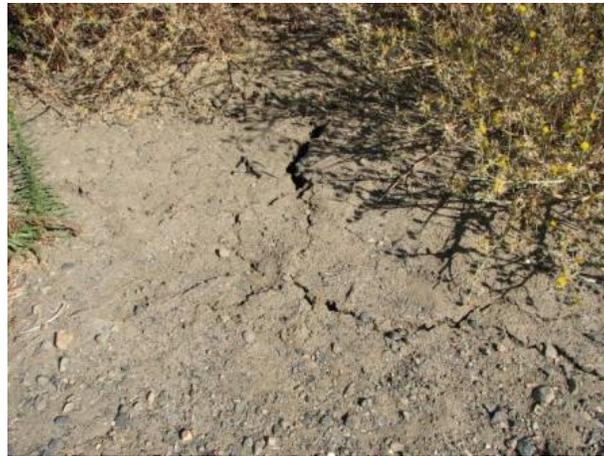
Levee Mile Report Line	7
Start Levee Mile	0.15
End Levee Mile	0.28
Location	Water Side
Category	Supplemental
Item	DWR Erosion Survey

Minor cracking visible on the site.

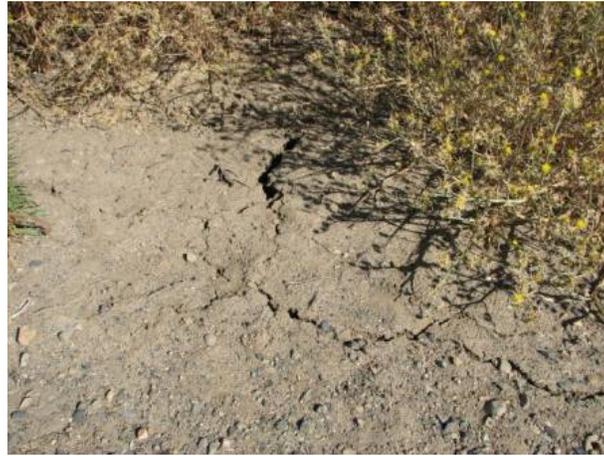
Levee Mile Report Line	7
Start Levee Mile	0.15
End Levee Mile	0.28
Location	Water Side
Category	Supplemental
Item	DWR Erosion Survey

Minor cracking visible on the site.

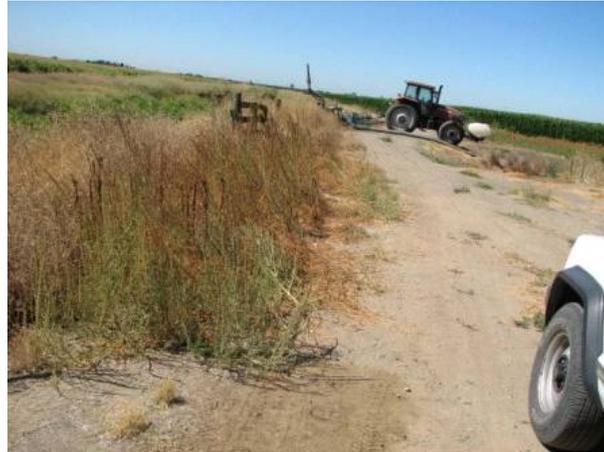
The site is covered with thick vegetation

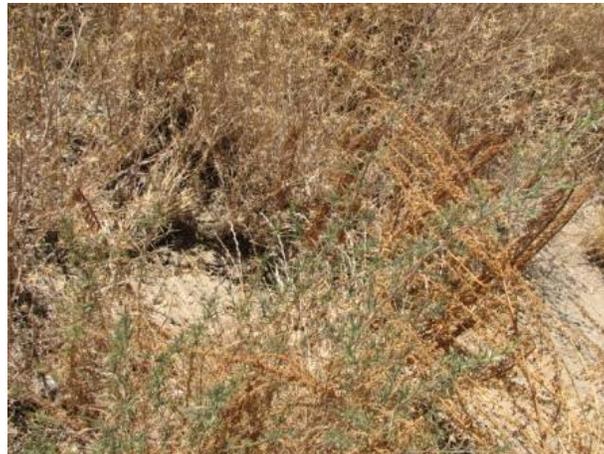
Levee Mile Report Line	12
Start Levee Mile	0.42
End Levee Mile	0.43
Location	Water Side
Category	Supplemental
Item	DWR Erosion Survey

The site is covered with thick vegetation

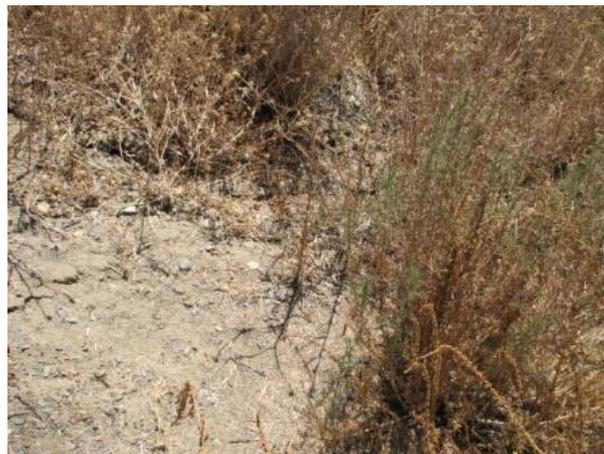
Levee Mile Report Line	12
Start Levee Mile	0.42
End Levee Mile	0.43
Location	Water Side
Category	Supplemental
Item	DWR Erosion Survey

Minor cracking on waterside levee shoulder

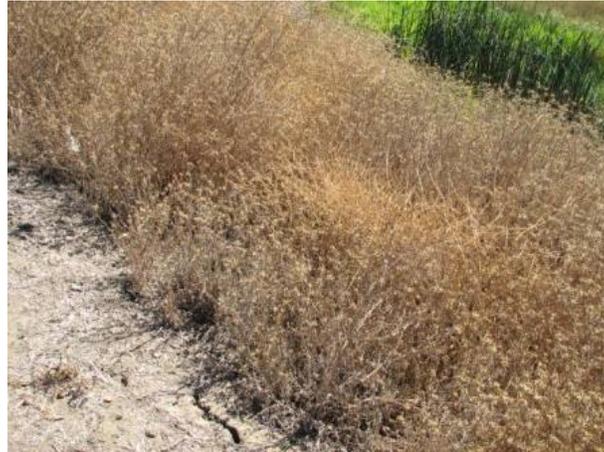
Minor cracking on waterside levee shoulder

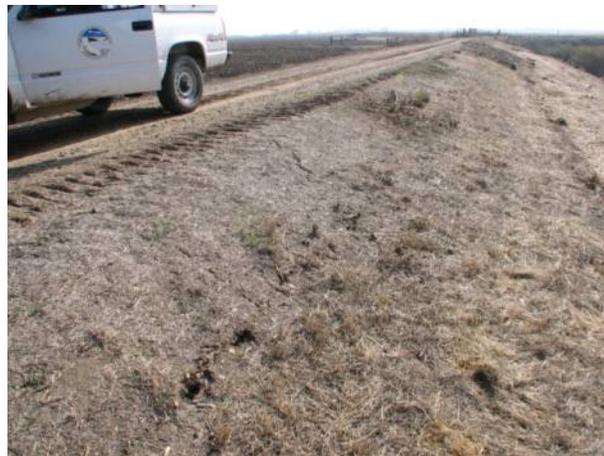
Levee Mile Report Line	22
Start Levee Mile	0.97
End Levee Mile	0.97
Location	Water Side
Category	Earthen Levee
Item	Cracking

Minor surface cracking on waterside levee slope.
