**Flood Control Project Maintenance
Levee Inspections**
LMA District Cover Sheet
Spring 2013 Levee Inspection Results

Merced Streams Group

Spring 2013 Levee Inspection Results

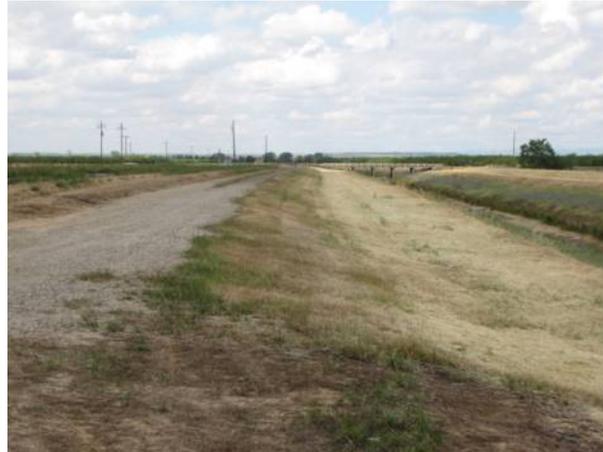
Levee Mile Report Line	4
Start Levee Mile	0.00
End Levee Mile	0.00
Location	Land Side
Category	
Item	Vegetation
<p>Black Rascal Creek looking downstream from levee mile 0.00 waterside slope. Photo taken 4-15-2013.</p> <p>phillips_s_20130508_406.JPG</p>

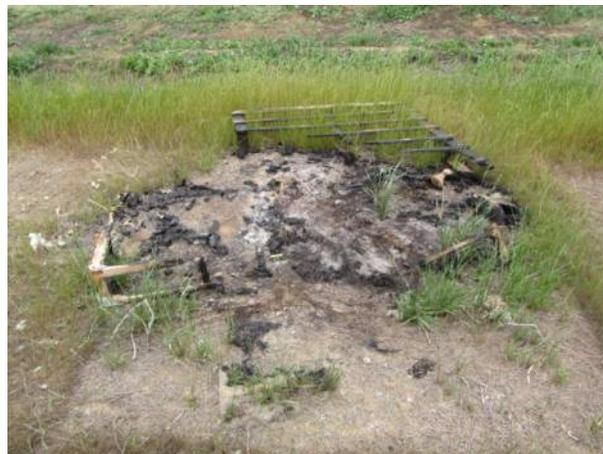
DWR ID: DWR_NA0013_01_s_2013_3										
7	0.51	0.51		Encroachments	WS	U En	GA : Garbage Inspector Comments: Box springs laying on both slopes should be removed from levee section. During my inspection 4-15-2013 found that the boxspring listed 2012 inspection, The boxspring was burned, the debris need to be removed.	37.321864 ° -120.396600 °	37.321864 ° -120.396604 °	5 Y
DWR ID: DWR_NA0013_01_f_2012_5										
8	0.75	1.16		Vegetation	CR	M Ma	V1 : Control annual grass and weeds on the levee slopes and easements.	37.325287 ° -120.396639 °	37.330899 ° -120.395532 °	4
DWR ID: DWR_NA0013_01_s_2013_4										
9	0.94	0.95		Crown Surface / Depressions / Rutting	CR	M Ma	C1 : Add appropriate material and re-grade the levee to bring the crown above the design elevation.	37.328007 ° -120.396650 °	37.328123 ° -120.396648 °	12
DWR ID: DWR_NA0013_01_s_2013_12										
10	1.31	1.63		Vegetation	WS	M Ma	V2 : Remove the wild growth other than native grasses from the levee slopes.	37.332825 ° -120.394887 °	37.337056 ° -120.396531 °	1 Y

Levee Mile Report Line	7
Start Levee Mile	0.51
End Levee Mile	0.51
Location	Water Side
Category	
Item	Encroachments
<p>Levee mile 0.51, this mattress was listed as unsatisfactory encroachment, it appears to have been burned in place not removing from levee section. Photo taken 4-15-2013.</p> <p>phillips_s_20130508_405.JPG</p>

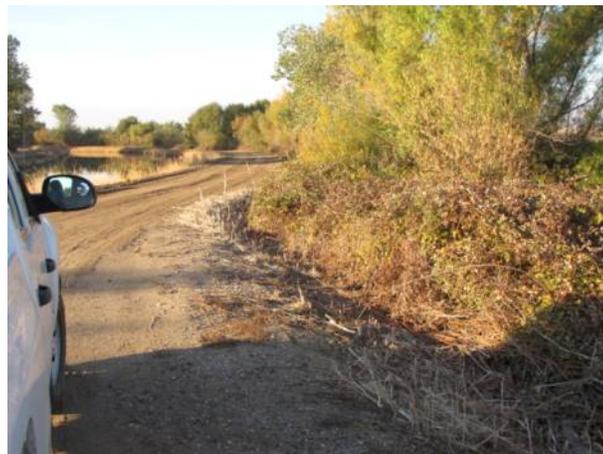
Levee Mile Report Line	10
Start Levee Mile	1.31
End Levee Mile	1.63
Location	Water Side
Category	
Item	Vegetation
<p>Looking downstream from levee mile 1.31. Photo taken 10-30-2012.</p> <p>phillips_s_20130325_276.jpg</p>

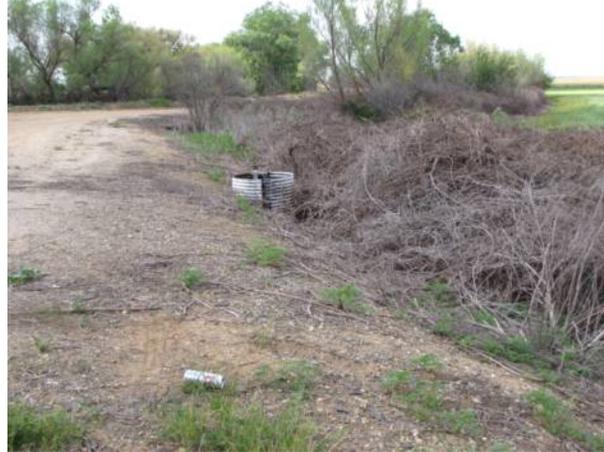
Levee Mile Report Line	10
Start Levee Mile	1.31
End Levee Mile	1.63
Location	Water Side
Category	
Item	Vegetation

District has sprayed and mowed some of the wild growth along the channel. Photo taken 4-15-2013.

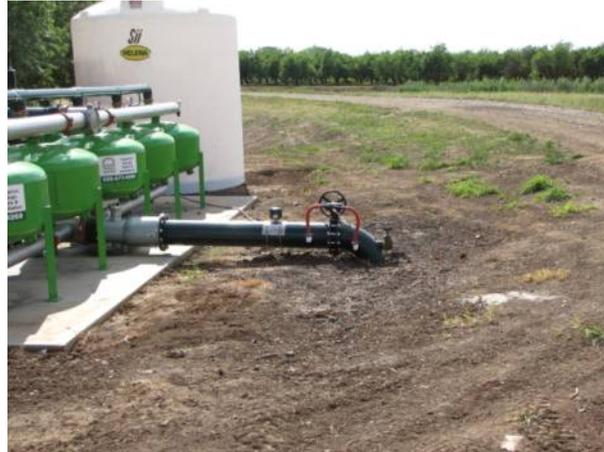
Levee Mile Report Line	1
Start Levee Mile	0.00
End Levee Mile	0.00
Location	Land Side
Category	
Item	Encroachments
Black Rascal Creek looking downstream from 0.00 landside slope. Photo taken 4-15-2013.	
phillips_s_20130509_407.JPG

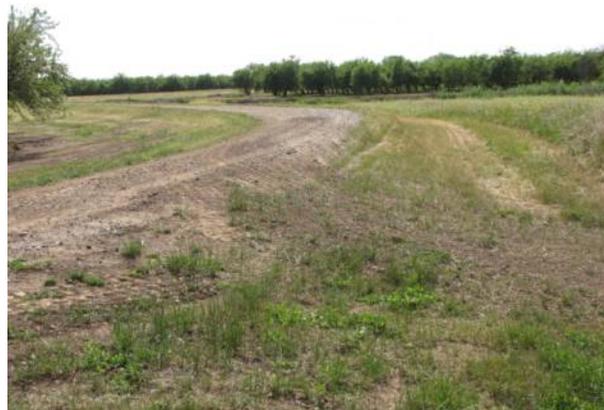
Levee Mile Report Line	2
Start Levee Mile	0.00
End Levee Mile	0.00
Location	Water Side
Category	
Item	Vegetation
Black Rascal Creek looking downstream from levee mile 0.00. Photo taken 4-15-2013.	
phillips_s_20130509_408.JPG

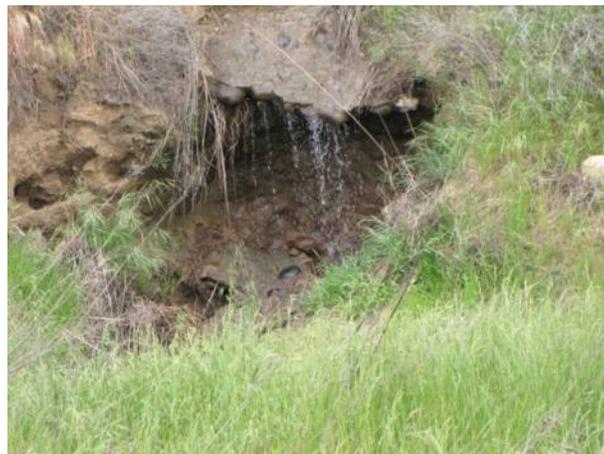
Levee Mile Report Line	9
Start Levee Mile	1.31
End Levee Mile	1.31
Location	Water Side
Category	
Item	Erosion / Bank Caving
This erosion was noted during my Spring Inspection 4-15-2013.	
phillips_s_20130509_409.JPG

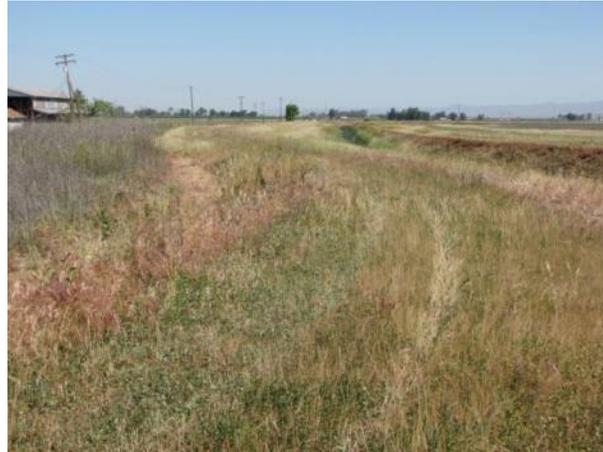
Levee Mile Report Line	1
Start Levee Mile	0.02
End Levee Mile	0.35
Location	Water Side
Category	
Item	Vegetation
Owens Creek Unit 3 looking downstream from 0.00, levee section is overgrown. Photo taken 4-18-2013.	
phillips_s_20130509_410.JPG

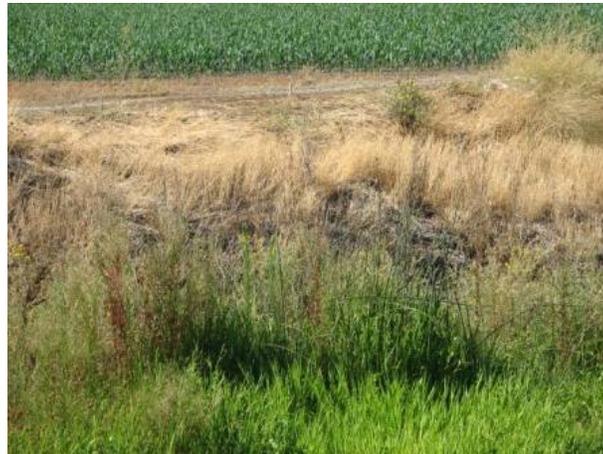
Levee Mile Report Line	6
Start Levee Mile	1.00
End Levee Mile	1.00
Location	Water Side
Category	Supplemental
Item	DWR Erosion Survey
A close look at the site, which is covered by thick vegetation	
phillips_s_20130228_042.jpg

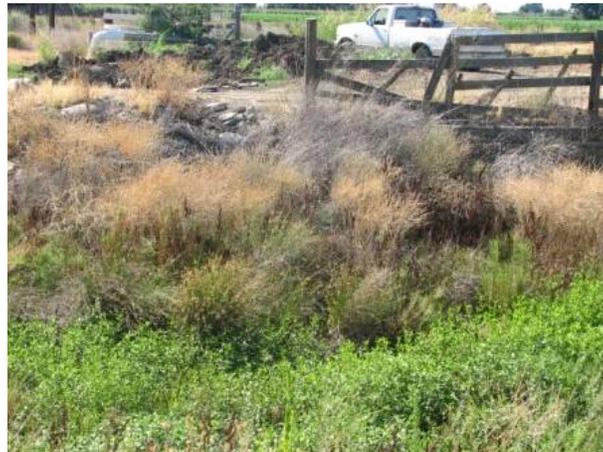
Levee Mile Report Line	6
Start Levee Mile	1.00
End Levee Mile	1.00
Location	Water Side
Category	Supplemental
Item	DWR Erosion Survey
Site covered with dense vegetation.	
phillips_s_20130228_043.jpg

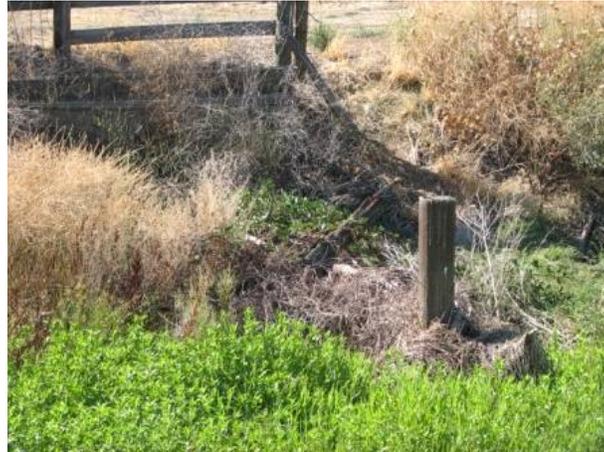
Levee Mile Report Line	6
Start Levee Mile	1.00
End Levee Mile	1.00
Location	Water Side
Category	Supplemental
Item	DWR Erosion Survey
Wooden posts and fense on site	
phillips_s_20130228_044.jpg

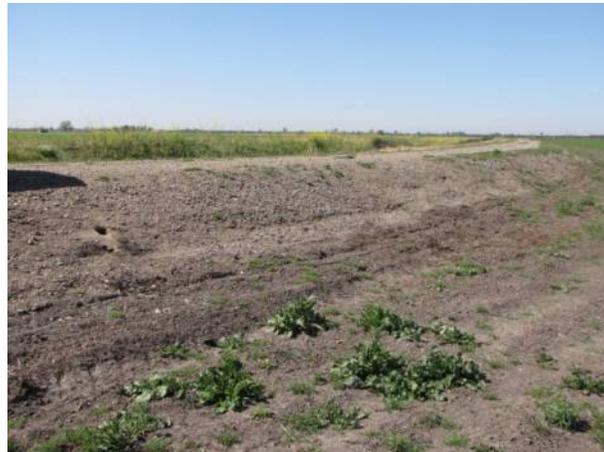
DWR ID: DWR_NA0013_03_s_2013_1										
7	1.11	1.24		Animal Control	LS Ma	U	A1 : Exterminate rodents and backfill and compact or grout burrows. Inspector Comments: This levee section has a history of rodent problems that has been known for more than 10 years.	37.271737 ° -120.282642 °	37.272498 ° -120.280511 °	9 Y
DWR ID: DWR_NA0013_03_f_2012_9										
8	1.20	1.20		Animal Control	LS Ma	M	A1 : Exterminate rodents and backfill and compact or grout burrows.	37.272444 ° -120.281282 °	37.272444 ° -120.281282 °	970 Y
DWR ID: DWR_NA0013_03_s_2012_970										
9	1.21	1.27		Animal Control	WS Ma	M	A1 : Exterminate rodents and backfill and compact or grout burrows.	37.272510 ° -120.281043 °	37.272860 ° -120.280287 °	15 Y
DWR ID: DWR_NA0013_03_s_2013_15

Levee Mile Report Line	7
Start Levee Mile	1.11
End Levee Mile	1.24
Location	Land Side
Category	
Item	Animal Control
Levee taken over by rodents, levee mile 1.11-1.24. Photo taken 4-18-2013.	
phillips_s_20130509_411.JPG

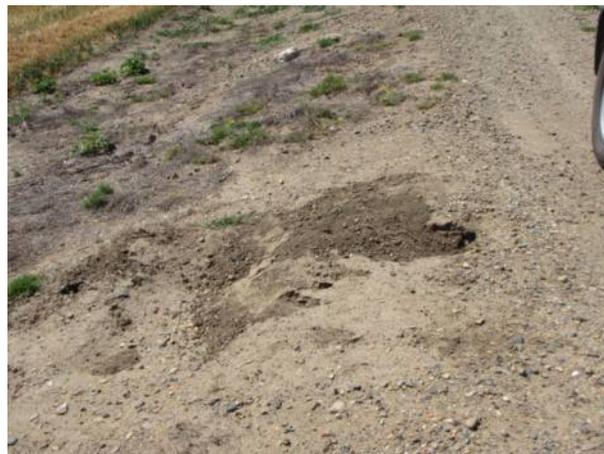
Levee Mile Report Line	14
Start Levee Mile	1.25
End Levee Mile	1.30
Location	Land Side
Category	
Item	Animal Control
Landside slope taken over by rodents. Photo taken 4-18-2013.	
phillips_s_20130509_412.JPG

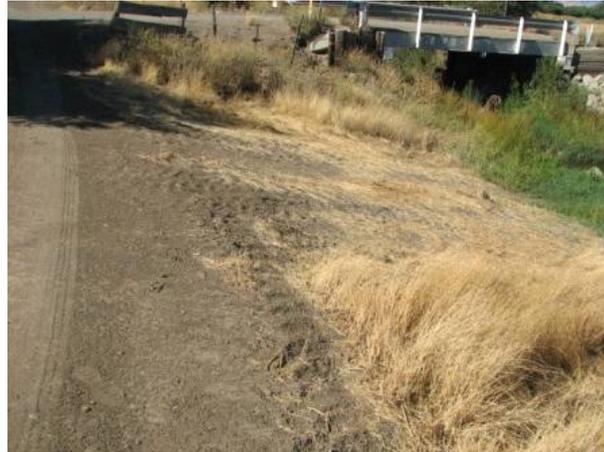
Levee Mile Report Line	15
Start Levee Mile	1.25
End Levee Mile	1.25
Location	Water Side
Category	Supplemental
Item	DWR Erosion Survey

The site is covered with dense thistles.

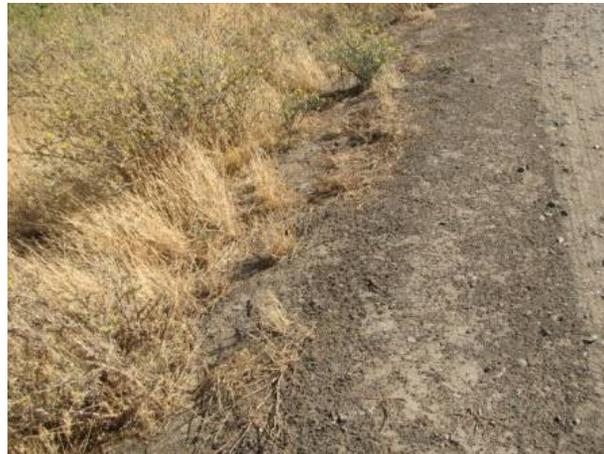
Levee Mile Report Line	15
Start Levee Mile	1.25
End Levee Mile	1.25
Location	Water Side
Category	Supplemental
Item	DWR Erosion Survey

No significant change visible from the levee top

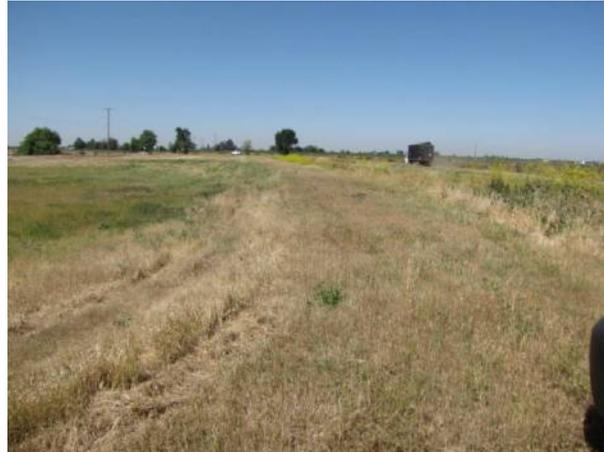
Levee Mile Report Line	4
Start Levee Mile	0.01
End Levee Mile	0.11
Location	Land Side
Category	
Item	Vegetation
Owen Creek Unit 4 looking downstream from 0.00. Photo taken 4-18-2013.	
phillips_s_20130509_413.JPG

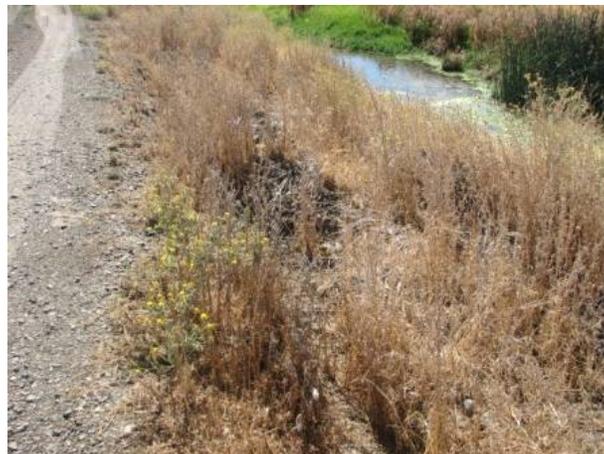
Levee Mile Report Line	7
Start Levee Mile	0.15
End Levee Mile	0.28
Location	Water Side
Category	Supplemental
Item	DWR Erosion Survey
The site is covered with dense star thistles. No significant changes visible.	
phillips_s_20130228_050.jpg

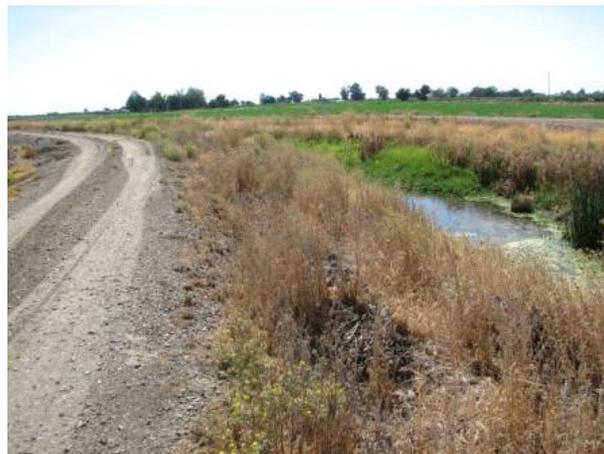
Levee Mile Report Line	7
Start Levee Mile	0.15
End Levee Mile	0.28
Location	Water Side
Category	Supplemental
Item	DWR Erosion Survey
The site is covered with dense star thistles.	
phillips_s_20130228_051.jpg

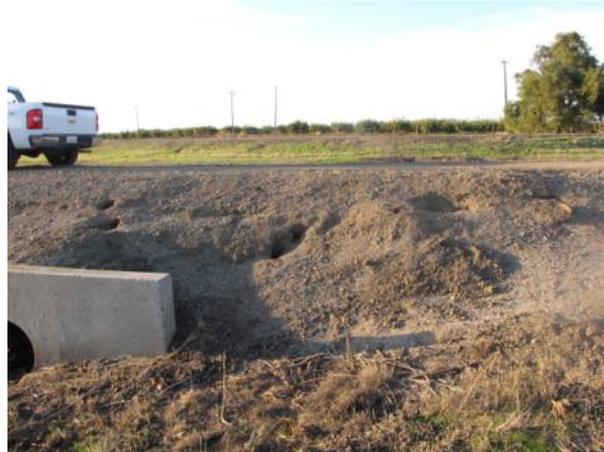
Levee Mile Report Line	10
Start Levee Mile	0.18
End Levee Mile	0.23
Location	Land Side
Category	
Item	Animal Control
Owens Creek Unit 4 levee section infested with rodents, no bait stations present. Photo taken 11-21-2012.	
phillips_s_20130228_055.jpg

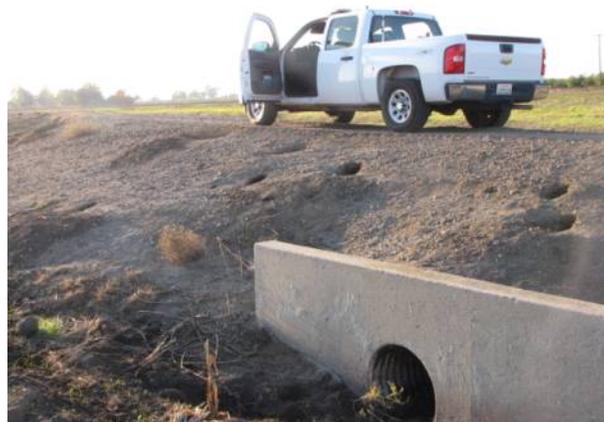
Levee Mile Report Line	10
Start Levee Mile	0.18
End Levee Mile	0.23
Location	Land Side
Category	
Item	Animal Control
Owens Creek looking downstream to 0.23 at rodent holes. Photo taken 11-21-2012.	
phillips_s_20130228_056.jpg

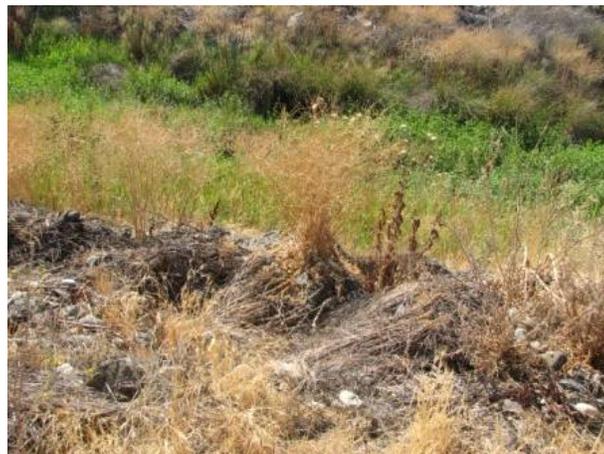
Levee Mile Report Line	14
Start Levee Mile	0.42
End Levee Mile	0.43
Location	Water Side
Category	Supplemental
Item	DWR Erosion Survey
Direct look at the site	
phillips_s_20130228_052.jpg

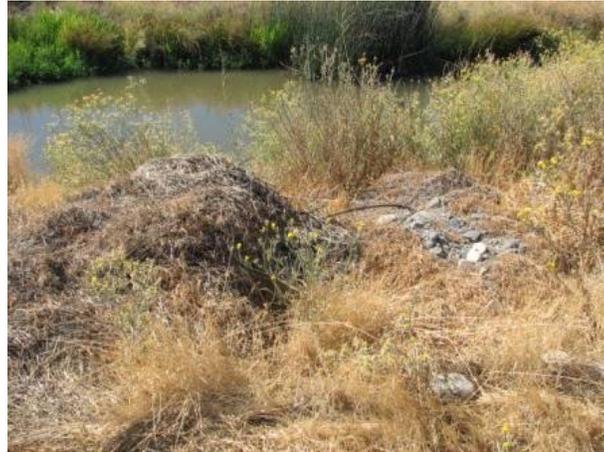
The site is covered with thick vegetation

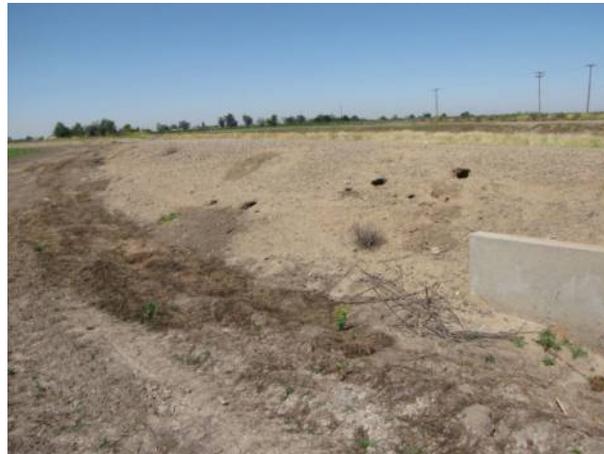
Levee Mile Report Line	18
Start Levee Mile	0.55
End Levee Mile	1.01
Location	Land Side
Category	
Item	Animal Control

Rodent running in and out of these holes shown in this picture. Photo taken 4-18-2013.

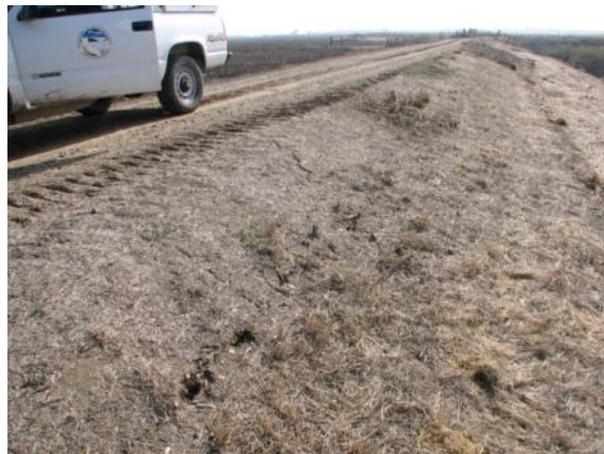
Levee Mile Report Line	21
Start Levee Mile	0.97
End Levee Mile	0.97
Location	Water Side
Category	
Item	Cracking

Minor surface cracking on waterside levee slope.
