**Flood Control Project Maintenance
Levee Inspections**
LMA District Cover Sheet
Spring 2015 Levee Inspection Results
Merced Streams Group

Spring 2015 Levee Inspection Results

Merced Streams Group

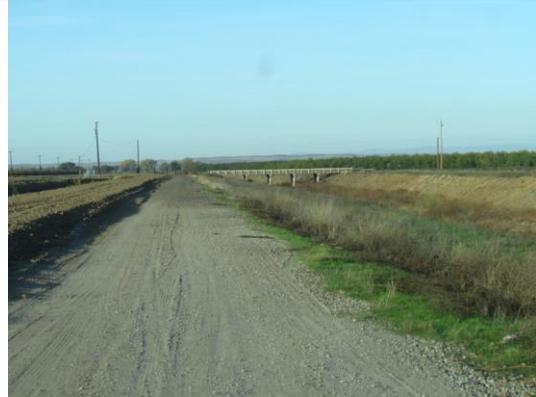
Photo 1 of 1 : SP_2015_NA0013_331_1_20150312_00001.jpg

LM Start	0.09	Rating **	A	Issue No.	1
LM End	0.22	Issue Type +	Ma	Location *	WS
Category	Earthen Levee		GPS Latitude/Longitude		
			Start	End	
Item	Vegetation		37.316005 °	37.317802 °	
			-120.396363 °	-120.396350 °	
DWR ID	DWR_NA0013_01_f_2014_1				
Action/Comments					
Control annual grass and weeds on the levee slopes and easements.

Black Rascal Creek looking downstream from waterside slope, there are weeds present on the slope.

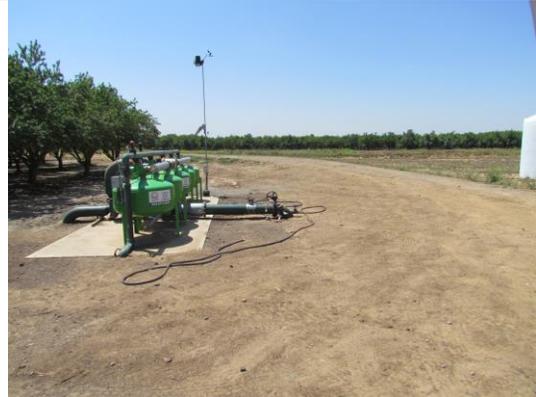
Photo 1 of 1 : SP_2015_NA0013_332_2_20150508_00170.jpg

LM Start	0.00	Rating **	U	Issue No.	2
LM End	0.00	Issue Type +	En	Location *	LS
Category	Earthen Levee		GPS Latitude/Longitude		
			Start	End	
Item	Encroachments		37.337034 °	37.337034 °	
			-120.387422 °	-120.387422 °	
DWR ID	DWR_NA0013_02_f_2012_2				
Action/Comments					
Pipe Inspector Comments: There is no CVFPB permit on record for this issue. I meet with the owner of this issue 5-4-2015 informed him that he need to acquire a CVFPB Permit. I introduced him to Mr. Mike Walejko of Merced County Irrigation District. This issue will remain to be unsatisfactory until a permit has been issued.

Unauthorized encroachment within the 10-foot landside easement.

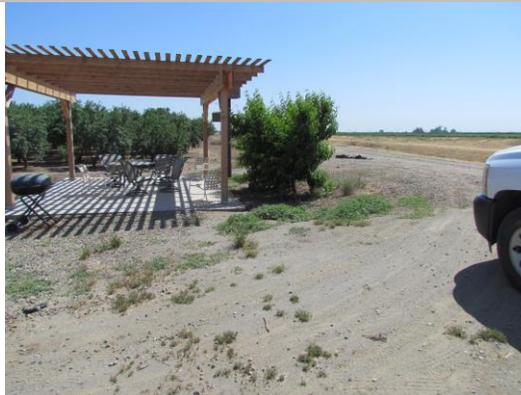
Photo 1 of 2 : SP_2015_NA0013_332_14_20150508_00171.jpg

LM Start	0.89	Rating **	U	Issue No.	14
LM End	0.89	Issue Type +	En	Location *	LS
Category	Earthen Levee		GPS Latitude/Longitude		
			Start	End	
Item	Encroachments		37.328695 °	37.328695 °	
			-120.396050 °	-120.396050 °	
DWR ID	DWR_NA0013_02_s_2015_14				
Action/Comments					
Building Inspector Comments: Unauthorized structure placed on the landside shoulder and fruit trees planted with Permit. The maintaining agency is aware of this issue.

Unauthorized structure placed within the landside shoulder and fruit trees planted.

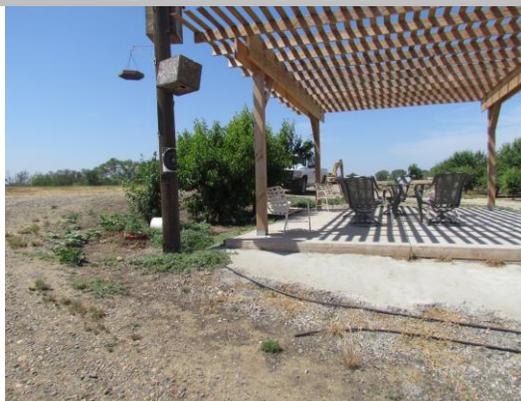
Photo 2 of 2 : SP_2015_NA0013_332_14_20150508_00172.jpg

View from the upstream side.

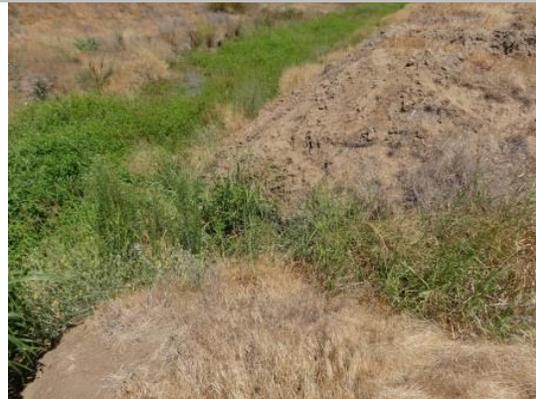
Photo 1 of 1 : SP_2015_NA0013_332_26_20150312_00006.jpg

LM Start	1.29	Rating **	M	Issue No.	26
LM End	1.29	Issue Type +	Ma	Location *	WS
Category	Supplemental			GPS Latitude/Longitude	
				Start	End
Item	DWR Erosion Survey			37.322615 °	37.322615 °
				-120.395948 °	-120.395948 °
DWR ID	DWR_NA0013_02_s_2015_26				
Action/Comments					
Inspector Comments: 7/31/2014: Soil has been added near the site. More vegetation is visible. 7/16/2013: The site was reported in the 2013 Spring Levee Inspection Reports. The erosion was caused by the water from the discharge line crossing the levee. Above the erosion a concrete discharge structure is present at the levee toe. The site is covered with dense vegetation. [2014 Site ID:NA0013U02RM1.31]

Looking down at the site.

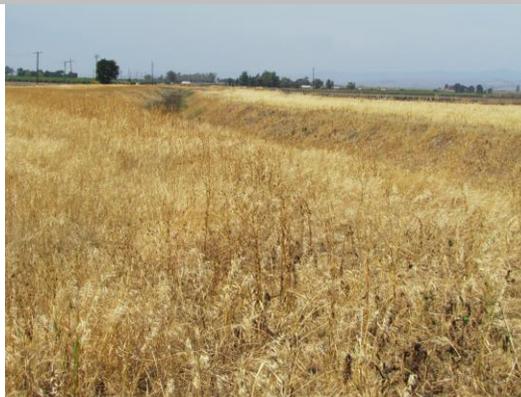
Photo 1 of 1 : SP_2015_NA0013_333_97_20150508_00102.jpg

LM Start	0.00	Rating **	U	Issue No.	97
LM End	1.41	Issue Type +	Ma	Location *	WS
Category	Earthen Levee		GPS Latitude/Longitude		
			Start	End	
Item	Vegetation		37.257731 °	37.273315 °	
			-120.288550 °	-120.277750 °	
DWR ID	DWR_NA0013_03_s_2015_97				
Action/Comments					
Control annual grass and weeds on the levee slopes and easements. Inspector Comments: Remove the tall weeds from the waterside levee slope.

Unsatisfactory wild tall weeds on the landside levee slope.

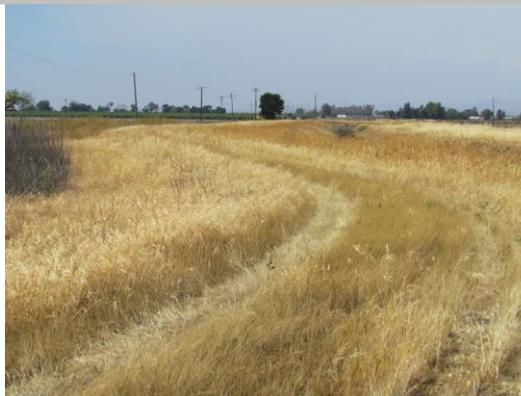
Photo 1 of 1 : SP_2015_NA0013_333_21_20150508_00100.jpg

LM Start	0.00	Rating **	U	Issue No.	21
LM End	0.65	Issue Type +	Ma	Location *	CR
Category	Earthen Levee		GPS Latitude/Longitude		
			Start	End	
Item	Vegetation		37.257731 °	37.266833 °	
			-120.288546 °	-120.287558 °	
DWR ID	DWR_NA0013_03_s_2014_21				
Action/Comments					
Keep the crown roadway free of vegetation. Inspector Comments: Crown roadway shall be free of vegetation.

Looking downstream from levee mile 0.00 the crown road way is overgrown with weeds asis both slopes.

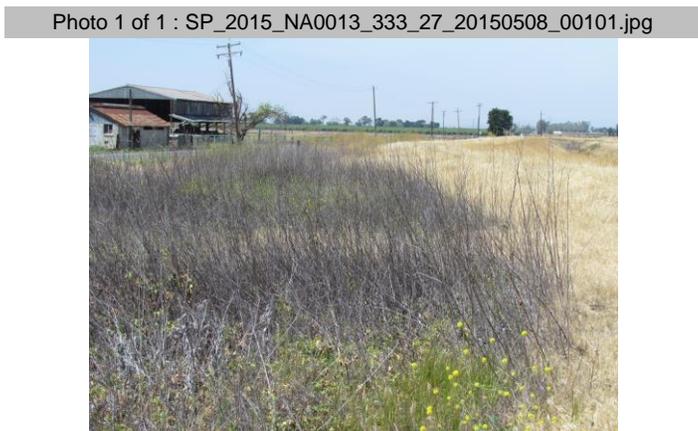
LM Start	0.48	Rating **	U	Issue No.	27
LM End	0.75	Issue Type +	Ma	Location *	LS
Category	Earthen Levee		GPS Latitude/Longitude		
			Start	End	
Item	Vegetation		37.264472 °	37.267925 °	
			-120.288464 °	-120.286572 °	
DWR ID	DWR_NA0013_03_f_2014_27				
Action/Comments					
Control annual grass and weeds on the levee slopes and easements. Inspector Comments: Remove the tall dead weeds from the levee section landside.

Looking upstream landside unsatisfactory tall weeds on slope and berm.

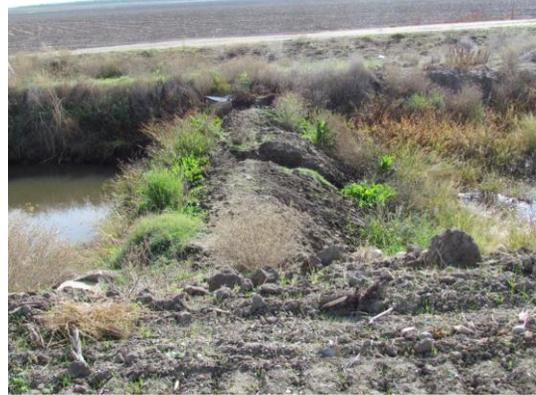
Photo 1 of 1 : SP_2015_NA0013_333_31_20150312_00006.jpg

LM Start	0.97	Rating **	U	Issue No.	31
LM End	0.97	Issue Type +	Ma	Location *	WS
Category	Rivers, Channels & Designated Floodways			GPS Latitude/Longitude	
				Start	End
Item	Encroachments			37.270665 °	37.270665 °
				-120.284330 °	-120.284330 °
DWR ID	DWR_NA0013_03_f_2014_31				
Action/Comments					
Inspector Comments: Remove the earthen dam placed across the channel. May 2015: THIS EARTHEN DAM WAS NOT REMOVED.

Earthen dam placed across the channel. No new photo taken 2015.

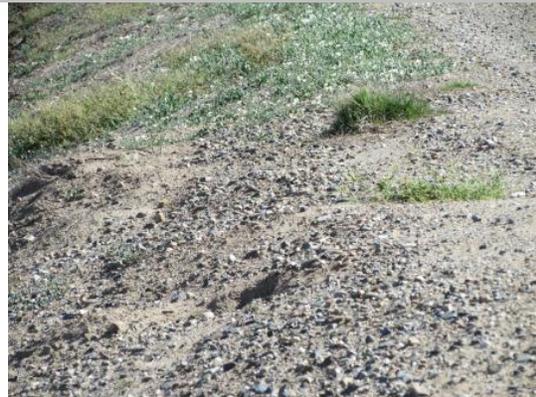
Photo 1 of 1 : SP_2015_NA0013_333_9_20150312_00002.jpg

LM Start	1.09	Rating **	U	Issue No.	9
LM End	1.22	Issue Type +	Ma	Location *	LS
Category	Earthen Levee			GPS Latitude/Longitude	
				Start	End
Item	Animal Control			37.271737 °	37.272498 °
				-120.282642 °	-120.280511 °
DWR ID	DWR_NA0013_03_f_2012_9				
Action/Comments					
Exterminate rodents and backfill and compact or grout burrows. Inspector Comments: This levee section has a history of rodent problems that has been known for many years. There should be bait stations in place in these infested areas.

Levee slope taken over by rodents Photo taken 4-23-2014. No new photo 2015.

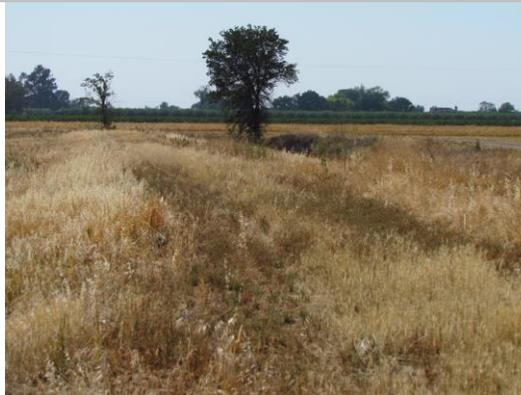
Photo 1 of 1 : SP_2015_NA0013_334_84_20150508_00088.jpg

LM Start	0.00	Rating **	U	Issue No.	84
LM End	0.15	Issue Type +	Ma	Location *	CR
Category	Earthen Levee		GPS Latitude/Longitude		
			Start	End	
Item	Vegetation		37.273315 °	37.272862 °	
			-120.277750 °	-120.280005 °	
DWR ID	DWR_NA0013_04_s_2015_84				
Action/Comments					
Keep the crown roadway free of vegetation. Inspector Comments: Remove the wild growth from levee section.

Unsatisfactory growth on crown roadway and both slopes.

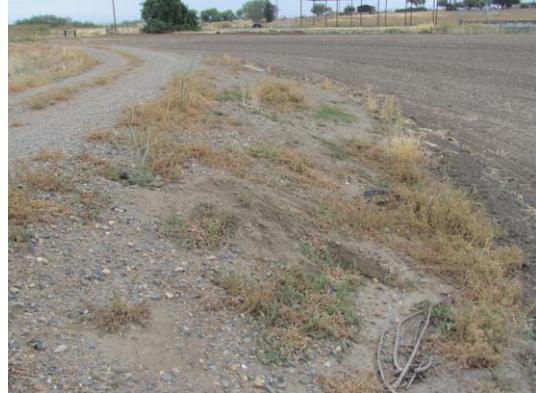
Photo 1 of 1 : SP_2015_NA0013_334_87_20150508_00089.jpg

LM Start	0.17	Rating **	U	Issue No.	87
LM End	0.20	Issue Type +	Ma	Location *	LS
Category	Earthen Levee			GPS Latitude/Longitude	
				Start	End
Item	Animal Control			37.272507 °	37.272335 °
				-120.280172 °	-120.280617 °
DWR ID	DWR_NA0013_04_s_2015_87				
Action/Comments					
Exterminate rodents and backfill and compact or grout burrows.

Active rodents on landside slope.

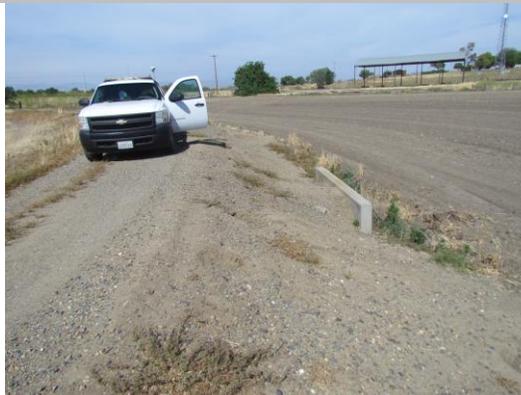
Photo 1 of 1 : SP_2015_NA0013_334_8_20150508_00087.jpg

LM Start	0.18	Rating **	U	Issue No.	8
LM End	0.19	Issue Type +	Ma	Location *	LS
Category	Earthen Levee		GPS Latitude/Longitude		
			Start	End	
Item	Animal Control		37.272429 °	37.272380 °	
			-120.280250 °	-120.280360 °	
DWR ID	DWR_NA0013_04_f_2012_8				
Action/Comments					
Exterminate rodents and backfill and compact or grout burrows. Inspector Comments: There should be bait stations placed along the infested areas.

Unsatisfactory rodent activity continues to be present and active.

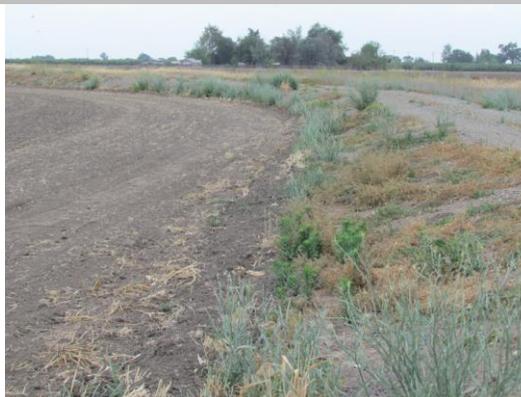
Photo 1 of 1 : SP_2015_NA0013_334_89_20150508_00098.jpg

LM Start	0.20	Rating **	U	Issue No.	89
LM End	0.59	Issue Type +	Ma	Location *	LS
Category	Earthen Levee		GPS Latitude/Longitude		
			Start	End	
Item	Vegetation		37.272342 °	37.268648 °	
			-120.280480 °	-120.285563 °	
DWR ID	DWR_NA0013_04_s_2015_89				
Action/Comments					
Remove the wild growth other than native grasses from the levee slopes.

Tall weeds present on the landside levee slope and toe.

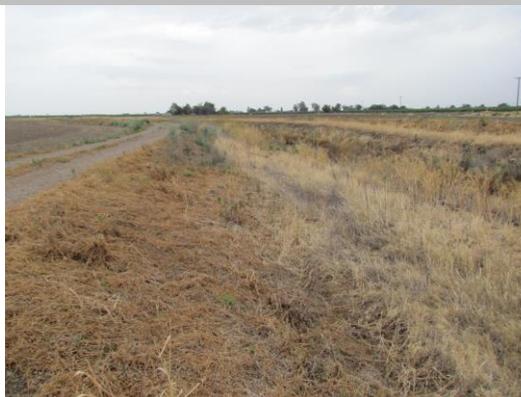
Photo 1 of 1 : SP_2015_NA0013_334_88_20150508_00099.jpg

LM Start	0.20	Rating **	U	Issue No.	88
LM End	1.03	Issue Type +	Ma	Location *	WS
Category	Earthen Levee		GPS Latitude/Longitude		
			Start	End	
Item	Vegetation		37.272342 °	37.262847 °	
			-120.280480 °	-120.287878 °	
DWR ID	DWR_NA0013_04_s_2015_88				
Action/Comments					
Remove the wild growth other than native grasses from the levee slopes.

Tall weeds present on the waterside levee slope and toe from levee mile 0.20-1.03.

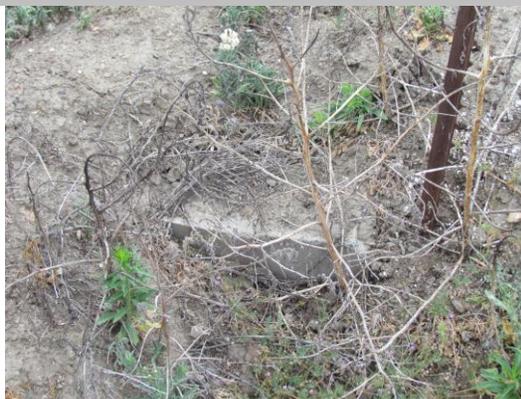
Photo 1 of 2 : SP_2015_NA0013_334_1_20150508_00090.jpg

LM Start	0.45	Rating **	U	Issue No.	1
LM End	0.45	Issue Type +	Ma	Location *	LS
Category	Earthen Levee		GPS Latitude/Longitude		
			Start	End	
Item	Encroachments		37.270328 °	37.270328 °	
			-120.284227 °	-120.284227 °	
DWR ID					
Action/Comments					
Pipe Inspector Comments: The inlet should not be blocked off.

Culvert inlet completely covered up on the landside.

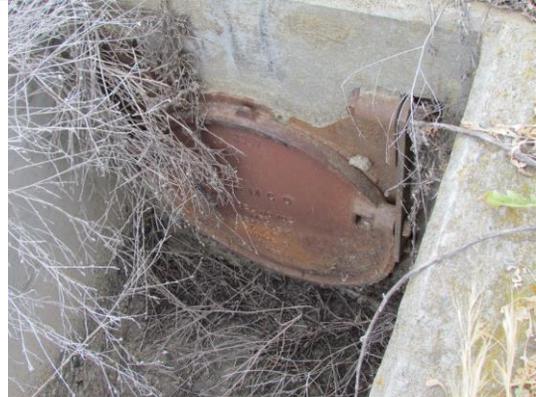
Photo 2 of 2 : SP_2015_NA0013_334_1_20150508_00091.jpg

LM Start	0.45	Rating **	U	Issue No.	1 (cont)
LM End	0.45	Issue Type +	Ma	Location *	LS
Category	Earthen Levee			GPS Latitude/Longitude	
				Start	End
Item	Encroachments			37.270328 °	37.270328 °
				-120.284227 °	-120.284227 °
DWR ID					
Action/Comments					
Pipe Inspector Comments: The inlet should not be blocked off.

View of the outlet.

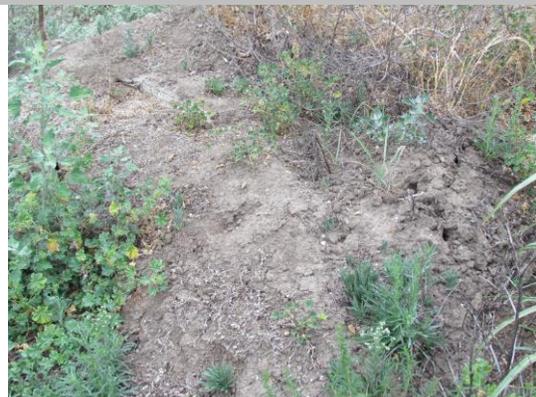
Photo 1 of 1 : SP_2015_NA0013_334_2_20150508_00092.jpg

Culvert has been blocked off with dirt on the inlet side.

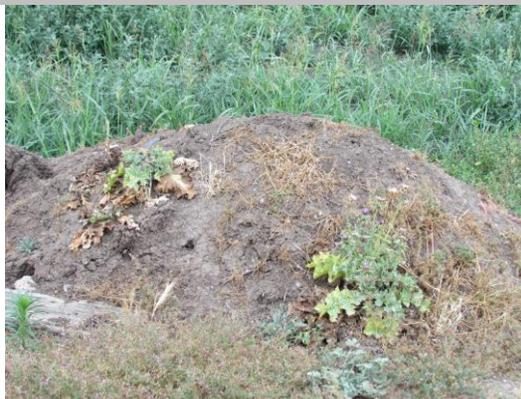
Photo 1 of 2 : SP_2015_NA0013_334_27_20150508_00093.jpg

The inlet of the culvert has been blocked.

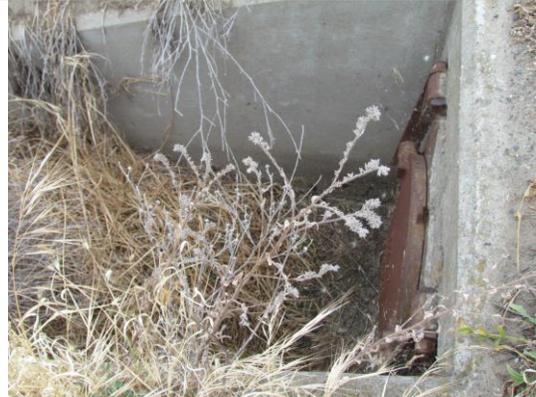
Photo 2 of 2 : SP_2015_NA0013_334_27_20150508_00094.jpg

View on the outlet.

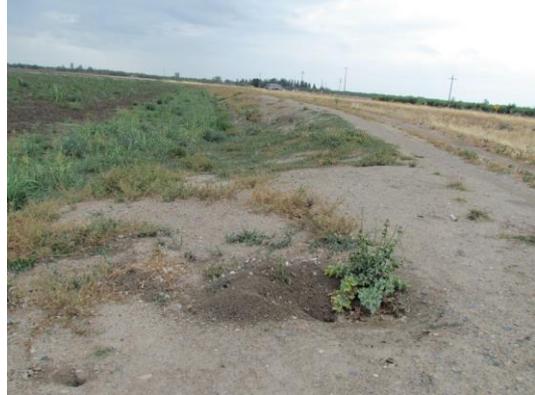
Photo 1 of 1 : SP_2015_NA0013_334_29_20150508_00095.jpg

Looking downstream from levee mile 0.87 active rodent holes on landside slope.

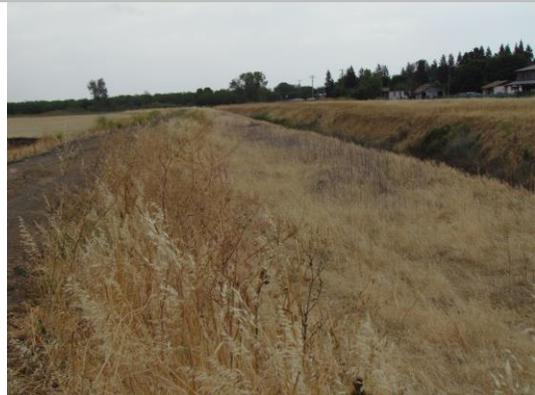
Photo 1 of 1 : SP_2015_NA0013_334_6_20150508_00096.jpg

Unsatisfactory wild growth of weeds on the waterside levee slope.

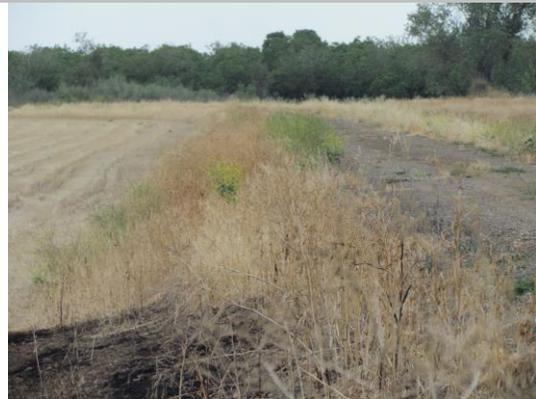
Photo 1 of 1 : SP_2015_NA0013_334_10_20150508_00097.jpg

Unsatisfactory growth of weeds on the landside levee slope.
