**Flood Control Project Maintenance  
Levee Inspections**  
**LMA District Cover Sheet**  
**Spring 2016 Levee Inspection Results**  
**Merced Streams Group**

**Spring 2016 Levee Inspection Results**

**Merced Streams Group**

Waterway		Bank	Unit Miles	
Unit No. 01 Black Rascal Diversion		Right	1.61	
	Spring (March - May)	Summer (June - August)	(September - November) Fall	Winter (December - February)
Unit Maintenance Rating (Fall Only)				
Date of Inspection	4/12/2016 - 4/12/2016			
DWR Inspector	Herman Phillips			
Accompanied By

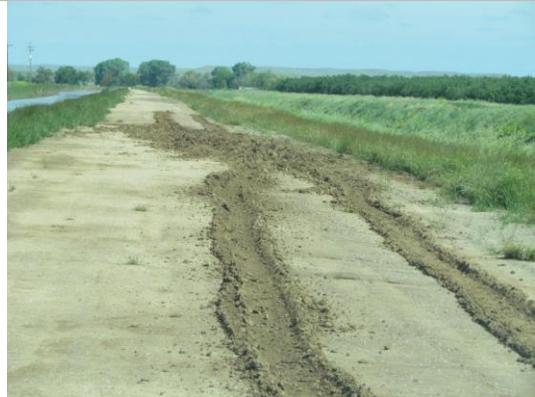
Photo 1 of 1 : SP\_2016\_NA0013\_331\_12\_20160506\_00008.jpg

LM Start	<b>0.27</b>	Rating **	M	Issue No.	<b>12</b>
LM End	<b>0.37</b>	Issue Type +	Ma	Location *	CR
Category	Earthen Levee		GPS Latitude/Longitude		
			Start	End	
Item	Crown Surface / Depressions / Rutting		37.318523 °	37.319920 °	
			-120.396642 °	-120.396582 °	
DWR ID	DWR_NA0013_01_s_2016_12				
Comment Code					
C2 : Repair depressions or ruts in the crown or slope.					
Inspector Comment					
Repair the crown damaged by vehicle.

Looking upstream from levee mile 0.27- 0.37 crown roadway damage by vehicle.

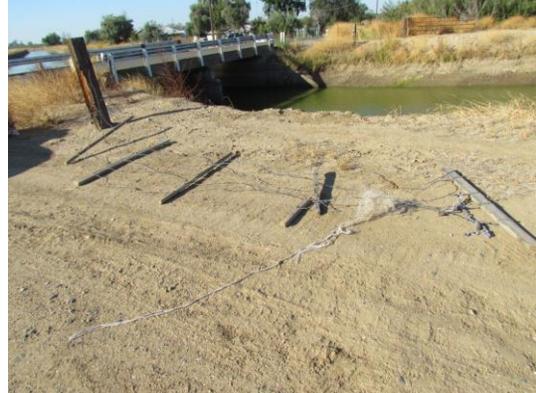
Photo 1 of 1 : SP\_2016\_NA0013\_331\_4\_20160223\_00001.jpg

LM Start	<b>1.24</b>	Rating **	M	Issue No.	<b>4</b>
LM End	<b>1.24</b>	Issue Type +	Ma	Location *	CR
Category	Earthen Levee			GPS Latitude/Longitude	
				Start	End
Item	Repair Gates			37.332165 °	37.332165 °
				-120.394698 °	-120.394698 °
DWR ID	DWR_NA0013_01_f_2014_4				
Comment Code					
Inspector Comment					
This wire gate across the crown roadway needs to be replaced.

This wire gate needs replacing, it poses a safety hazard.

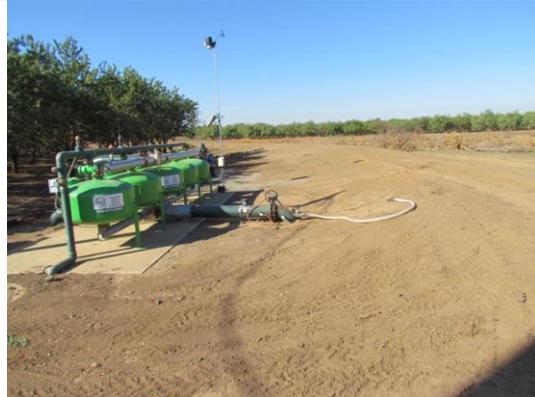
Photo 1 of 2 : SP\_2016\_NA0013\_332\_2\_20160223\_00001.jpg

This filtration has no CVFPB Permit.

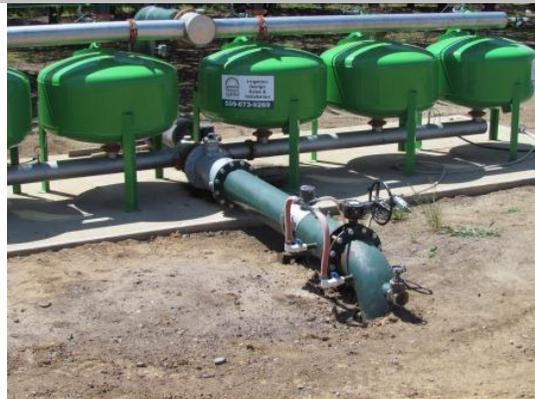
Photo 2 of 2 : SP\_2016\_NA0013\_332\_2\_20160223\_00002.jpg

There is no CVFPB permit on file for this installation. Photo taken 4-23-2014

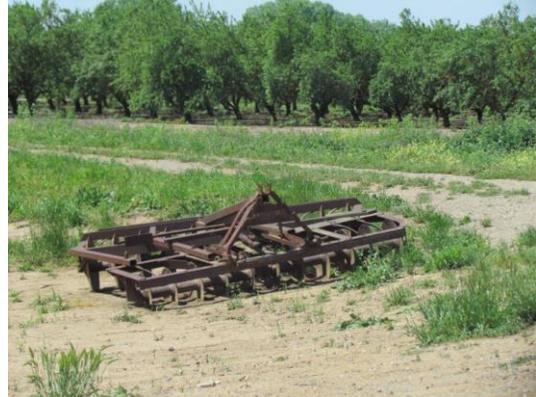
Photo 1 of 1 : SP\_2016\_NA0013\_332\_11\_20160506\_00022.jpg

Looking downstream from levee mile 0.02 farm equipment placed on the landward toe.

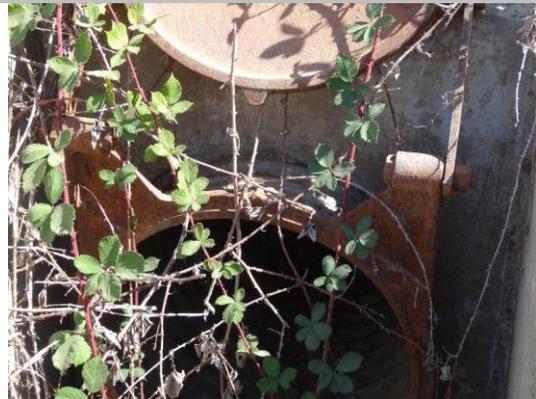
Photo 2 of 2 : UCIP\_SP\_2016\_41261\_35244.jpg

WS view: U typed concrete headwall, CM pipe, and flap gate. Flap gate was not closed. Vegetation needs to be cleared.

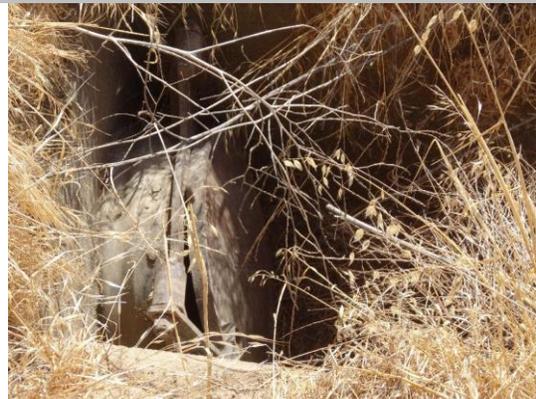
Photo 2 of 2 : UCIP\_SP\_2016\_20946\_35265.jpg

WS view: U typed concrete headwall, CM pipe, and flap gate. Flap gate was not properly closed.

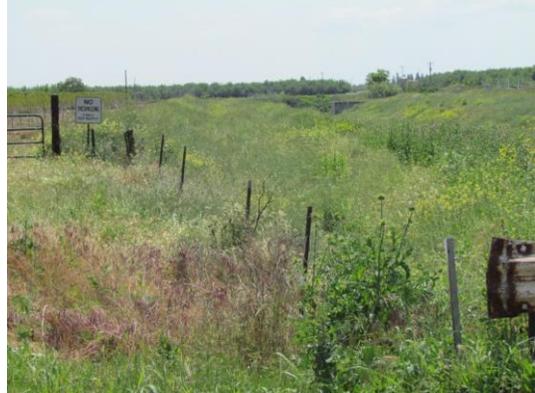
Photo 1 of 1 : SP\_2016\_NA0013\_332\_12\_20160506\_00025.jpg

Looking downstream from levee mile 0.61-1.85 weeds taller than 2.0 foot on the waterside slope.

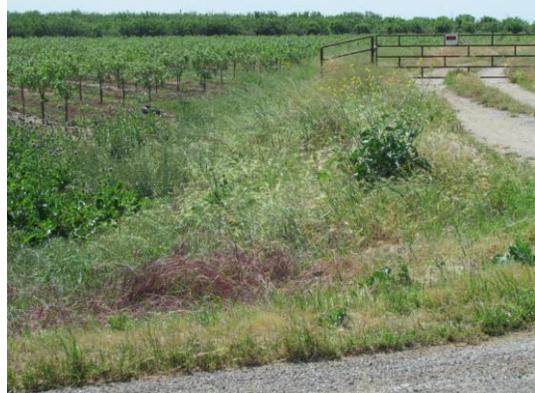
Photo 1 of 1 : SP\_2016\_NA0013\_332\_13\_20160506\_00026.jpg

Looking downstream from the landward shoulder unwanted tall weeds present on the slope.

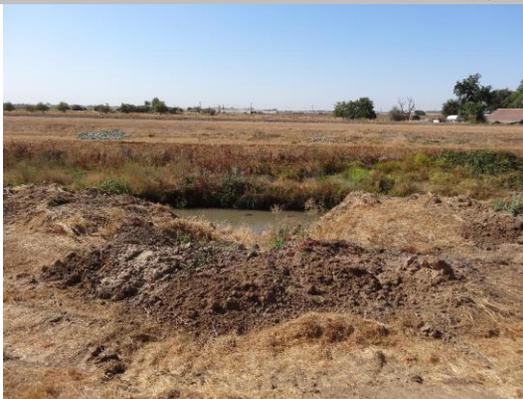
Photo 1 of 2 : UCIP\_SP\_2016\_20992\_35370.jpg

WS view: concrete headwall and CM pipe burried under debris and mud.

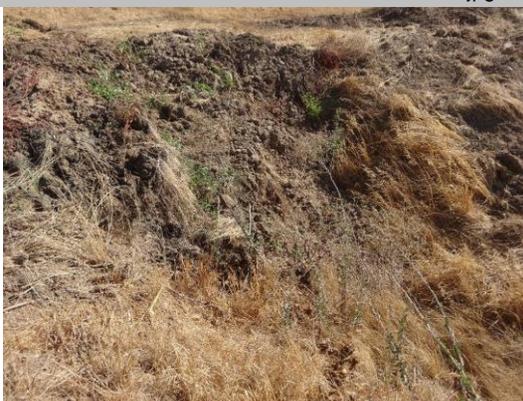
Photo 2 of 2 : UCIP\_SP\_2016\_20992\_35369.jpg

WS view: debris and mud deposited from the channel cleaning. It needs to be cleared from spillway and outlet structure.

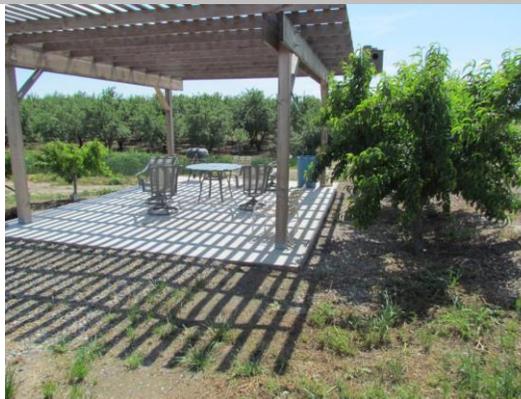
Photo 2 of 2 : SP\_2016\_NA0013\_332\_24\_20160506\_00023.jpg

Unauthorized encroachment reported last inspection at levee mile 0.88 looking downstream.

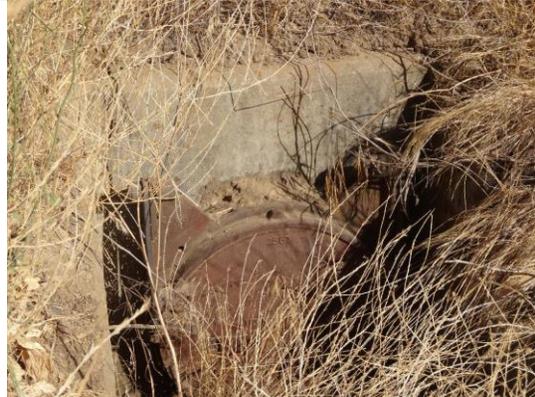
Photo 2 of 2 : UCIP\_SP\_2016\_42993\_35309.jpg

WS view: U typed concrete headwall, CM pipe and flap gate. Vegetation and debris need to be cleared.

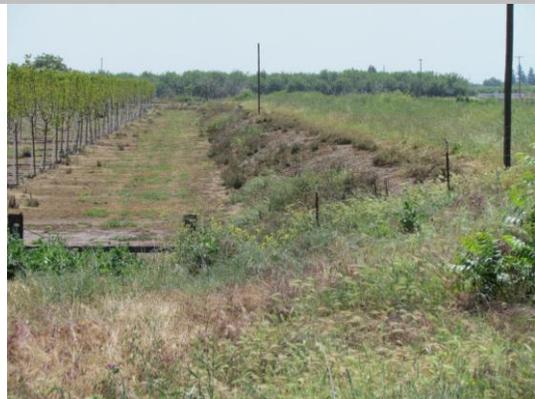
Photo 1 of 1 : SP\_2016\_NA0013\_332\_21\_20160506\_00027.jpg

Looking downstream from levee miles 1.63-1.85 landside slope covered with tall weeds.

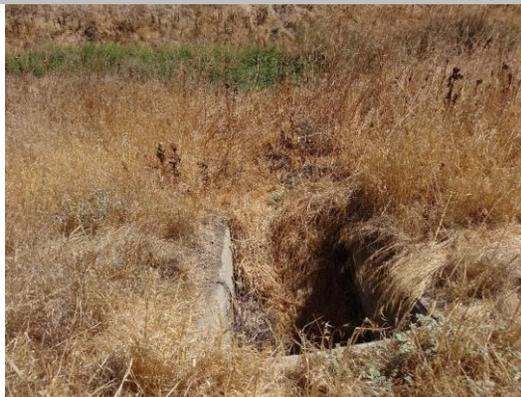
Photo 2 of 2 : UCIP\_SP\_2016\_41815\_35532.jpg

WS view: Silt needs to be removed. Vegetations needs to be cleared.

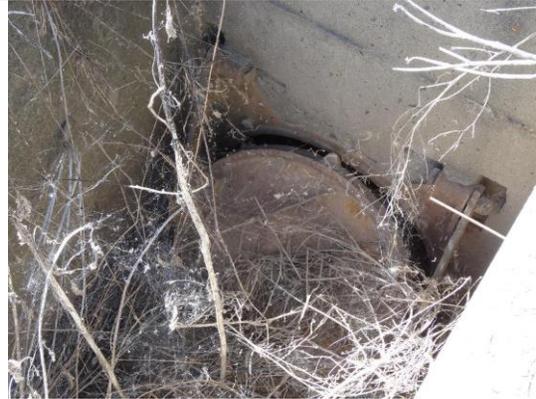
Photo 2 of 2 : UCIP\_SP\_2016\_42989\_35421.jpg

WS view: U typed concrete headwall, CM pipe, and flap gate. Damaged flap gate.

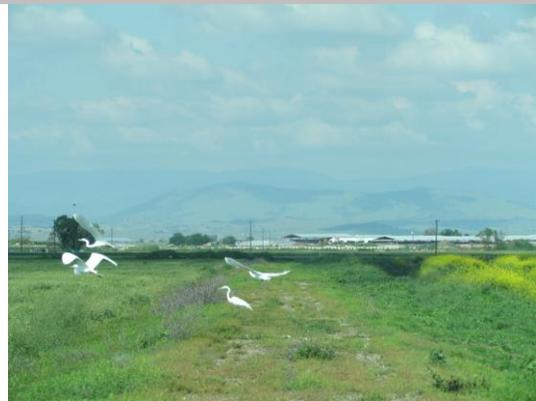
Photo 1 of 1 : SP\_2016\_NA0013\_333\_12\_20160506\_00026.jpg

looking upstream from levee mile 0.42 Crown road covered with vegetation.

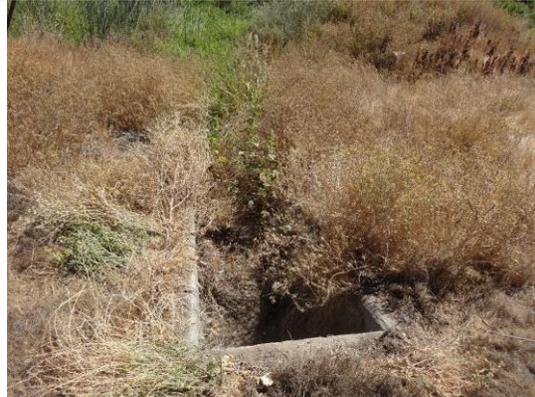
Photo 1 of 2 : UCIP\_SP\_2016\_21068\_35535.jpg

WS view: cobble spillway and channel on waterside. Dense vegetation on levee slope.

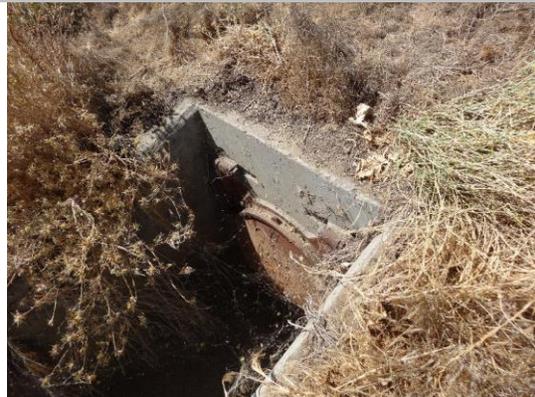
Photo 2 of 2 : UCIP\_SP\_2016\_21068\_35534.jpg

WS view: U typed concrete headwall, CM pipe, and flap gate. Vegetation needs to be cleared.

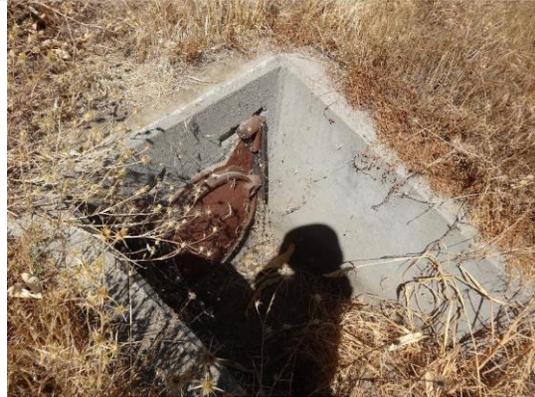
Photo 2 of 2 : UCIP\_SP\_2016\_21069\_35538.jpg

WS view: U typed concrete headwall, CM pipe, and flap gate. Vegetation needs to be cleared.

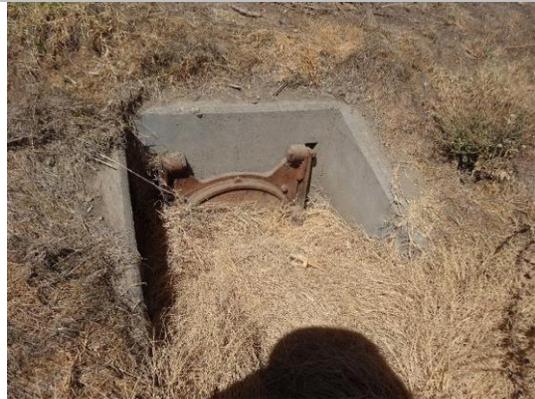
Photo 2 of 2 : UCIP\_SP\_2016\_42992\_35543.jpg

WS view: U typed concrete headwall, CM pipe, and flap gate. Vegetation needs to be cleared.

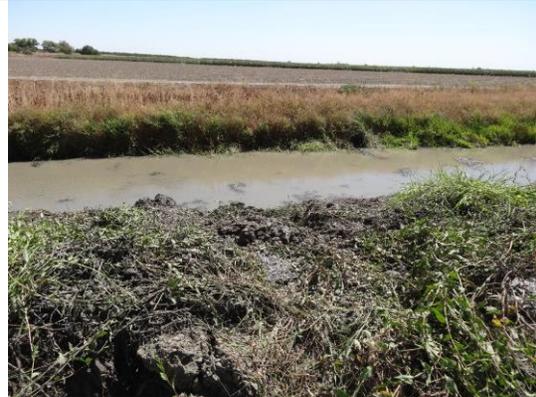
Photo 1 of 2 : UCIP\_SP\_2016\_21063\_35502.jpg

WS view: U typed concrete headwall, CM pipe, and flap gate buried under mud/debris.

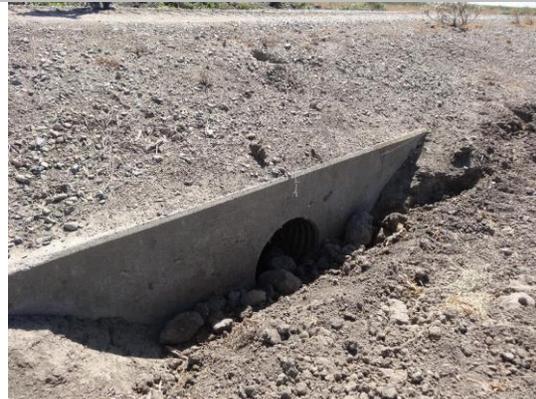
Photo 2 of 2 : UCIP\_SP\_2016\_21063\_35501.jpg

LS view: concrete headwall and CM pipe. Inlet needs clearing.

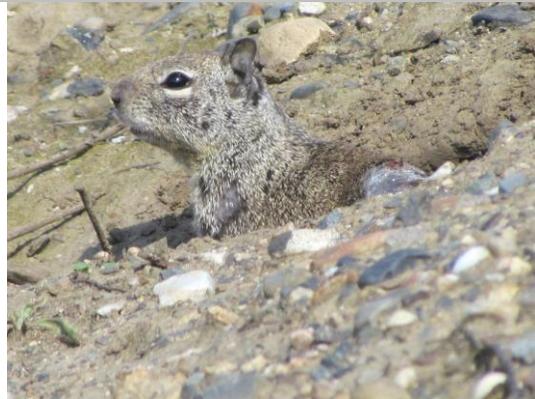
Photo 1 of 1 : SP\_2016\_NA0013\_333\_20\_20160506\_00029.jpg

Looking upstream from levee mile 1.22 active rodents seen in area.

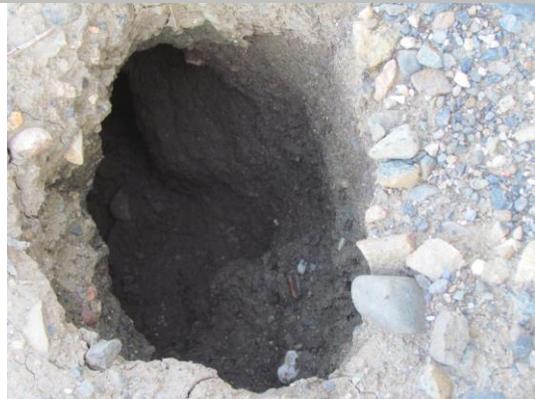
Photo 1 of 1 : SP\_2016\_NA0013\_333\_21\_20160506\_00030.jpg

Rodent holes in crown roadway.

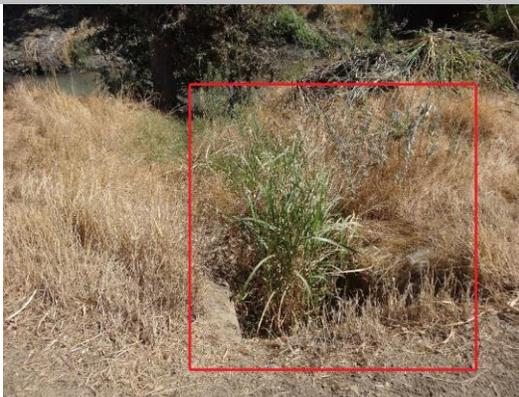
Photo 1 of 2 : UCIP\_SP\_2016\_21064\_35506.jpg

WS view: cobble spillway and channel on waterside. Dense vegetation on levee slope and spillway.

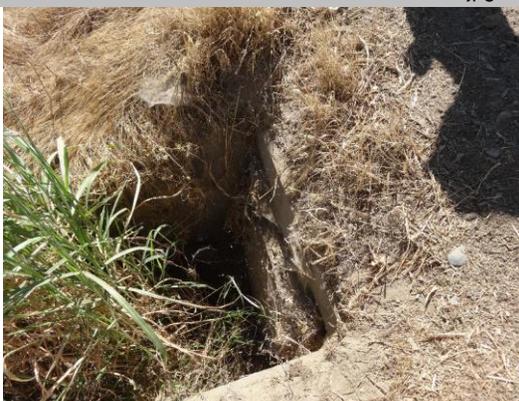
Photo 2 of 2 : UCIP\_SP\_2016\_21064\_35505.jpg

WS view: U typed concrete headwall, CM pipe, and flap gate. Vegetation needs to be cleared.

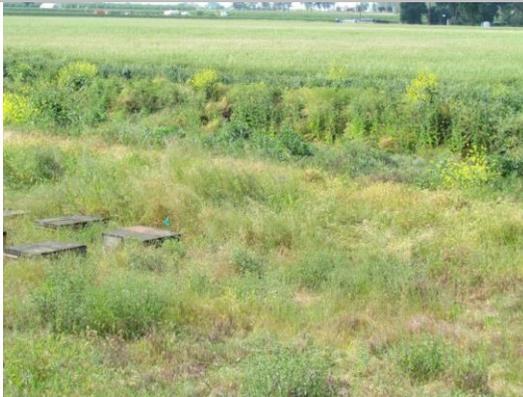
Photo 1 of 1 : SP\_2016\_NA0013\_334\_9\_20160510\_00025.jpg

NA0013 Unit 4 Levee mile 0.02 -0.14 landside and crown roadway covered with unwanted tall weeds. This section is more of a patrol road and not considered a levee. The actual levee begins once you cross Mission.

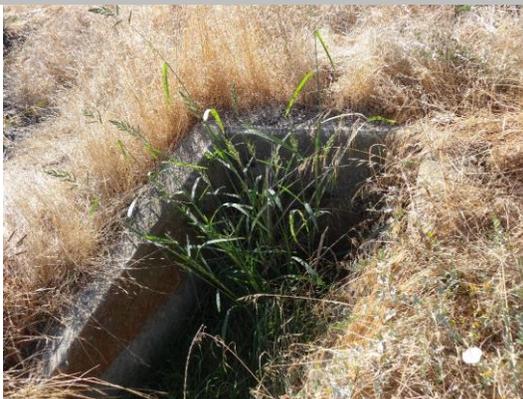
Photo 1 of 2 : UCIP\_SP\_2016\_42991\_35751.jpg

WS view: concrete spillway and channel on waterside. Dense vegetation on levee slope and spillway.

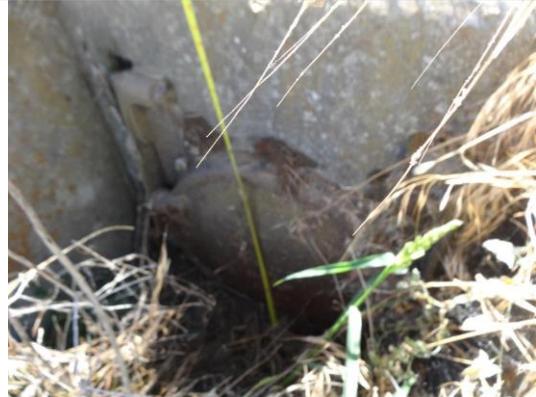
Photo 2 of 2 : UCIP\_SP\_2016\_42991\_35750.jpg

WS view: U typed concrete headwall, CM pipe, and flap gate. Vegetation and silt need to be cleared.

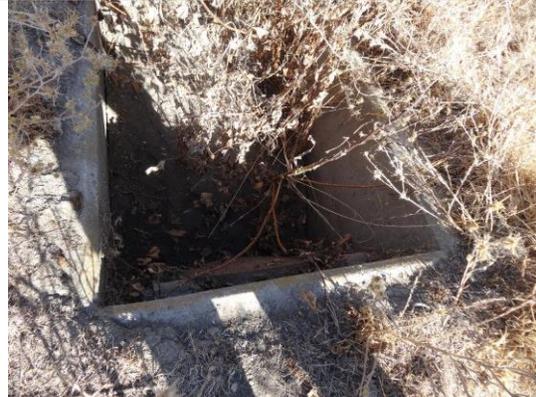
Photo 1 of 2 : UCIP\_SP\_2016\_42990\_35748.jpg

WS view: U typed concrete headwall, CM pipe, and flap gate. Vegetation needs to be cleared.

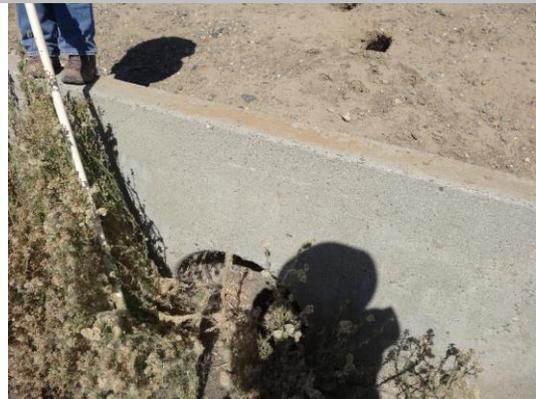
Photo 2 of 2 : UCIP\_SP\_2016\_42990\_35747.jpg

LS view: concrete headwall and CM pipe. Inlet needs clearing.

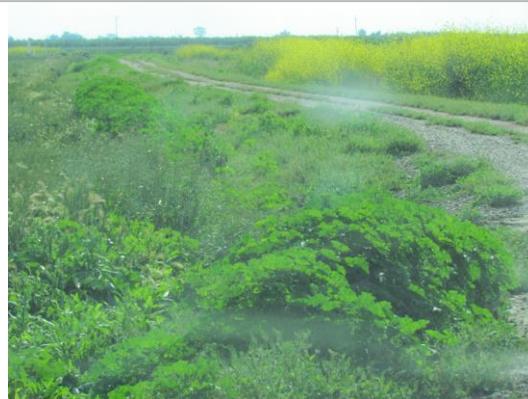
Photo 1 of 1 : SP\_2016\_NA0013\_334\_14\_20160510\_00026.jpg

NA0013 Unit 4 looking downstream landside slope over grown with tall unwanted weeds.

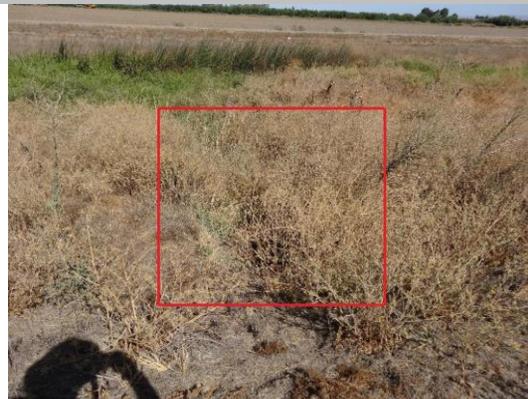
Photo 1 of 2 : UCIP\_SP\_2016\_21105\_35608.jpg

WS view: Dense vegetation on levee slope and spillway.

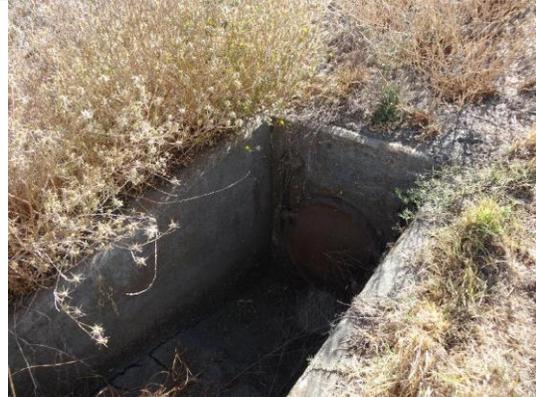
Photo 2 of 2 : UCIP\_SP\_2016\_21105\_35607.jpg

WS view: U typed concrete headwall, CM pipe, and flap gate. Vegetation needs to be cleared on spillway.

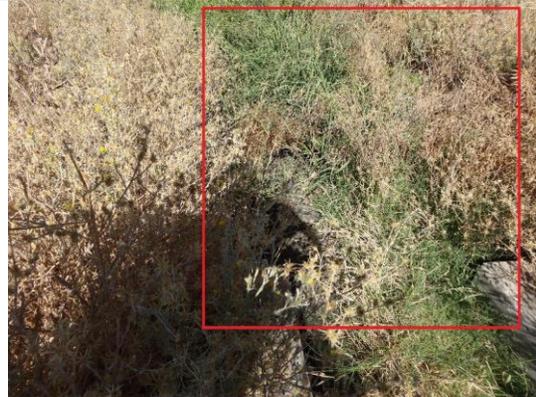
Photo 1 of 2 : UCIP\_SP\_2016\_21106\_35613.jpg

WS view: Dense vegetation on levee slope and spillway.

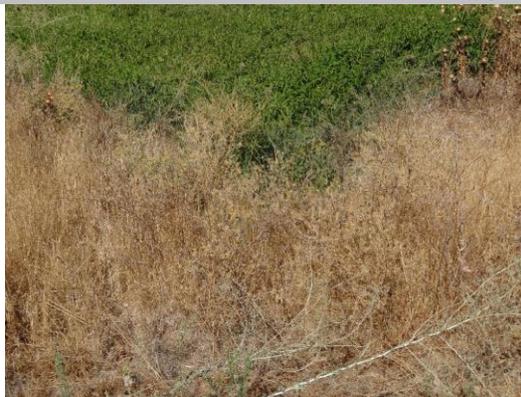
Photo 1 of 2 : UCIP\_SP\_2016\_21124\_35642.jpg

WS view: Dense vegetation on levee slope and spillway.

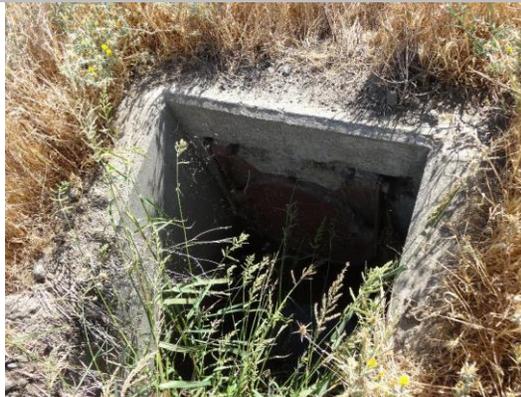
Photo 2 of 2 : UCIP\_SP\_2016\_21124\_35641.jpg

WS view: U typed concrete headwall, CM pipe, and flap gate. Vegetation needs to be cleared.

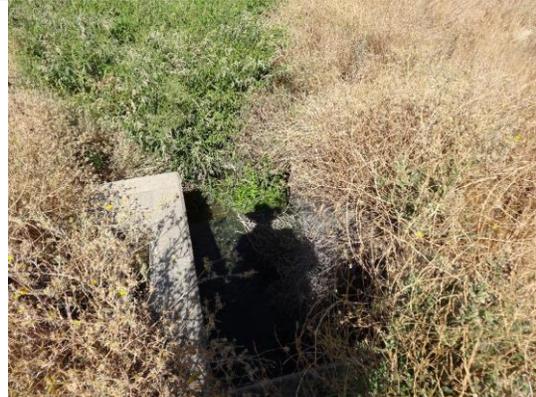
Photo 1 of 2 : UCIP\_SP\_2016\_21126\_35652.jpg

WS view: concrete spillway and channel on waterside. Dense vegetation on levee slope and spillway.

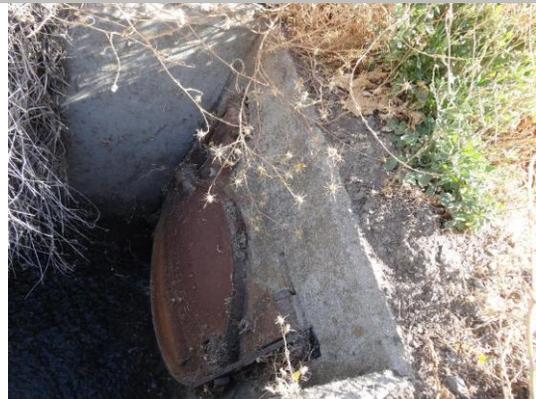
Photo 2 of 2 : UCIP\_SP\_2016\_21126\_35651.jpg

WS view: U typed concrete headwall, CM pipe, and flap gate. Vegetation needs to be cleared on spillway.

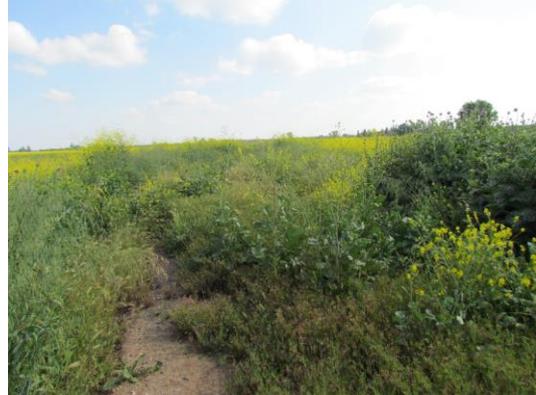
Photo 1 of 1 : SP\_2016\_NA0013\_334\_18\_20160510\_00028.jpg

NA0013 Unit 4 looking downstream at the crown roadway weeds taller than 4.0 foot covering the entire levee section, crown and both slopes.

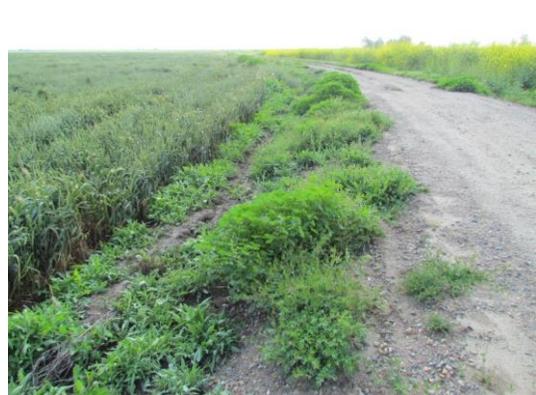
Photo 1 of 1 : SP\_2016\_NA0013\_334\_16\_20160510\_00027.jpg

NA0013 Unit 4 levee miles 1.06- 1.42 tall unwanted weeds covering the shoulder and landside slope.

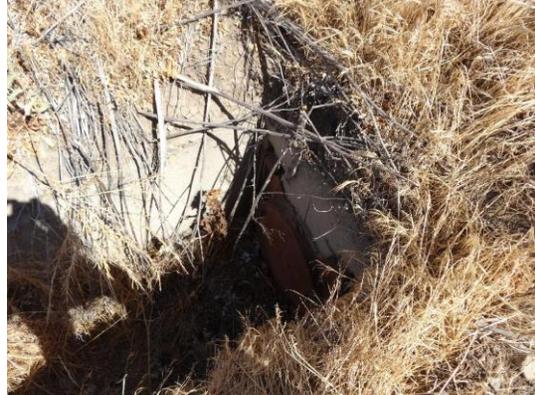
Photo 1 of 2 : UCIP\_SP\_2016\_21210\_35709.jpg

WS view: concrete spillway and channel on waterside. Dense vegetation on levee slope and spillway.

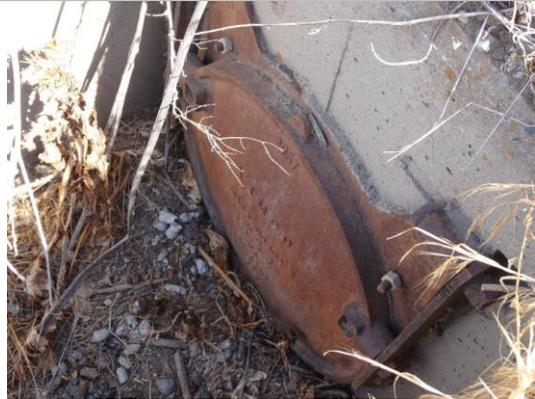
Photo 2 of 2 : UCIP\_SP\_2016\_21210\_35708.jpg

WS view: U typed concrete headwall, CM pipe, and flap gate. Spillway needs to be cleared.

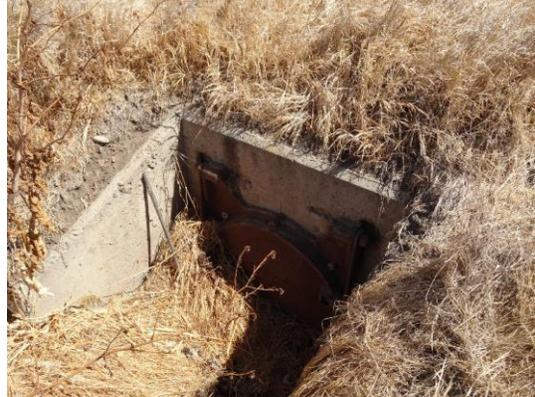
Photo 1 of 2 : UCIP\_SP\_2016\_42859\_35745.jpg

WS view: U typed concrete headwall, CM pipe, and flap gate. Dirt and vegetations need to be removed and cleared.

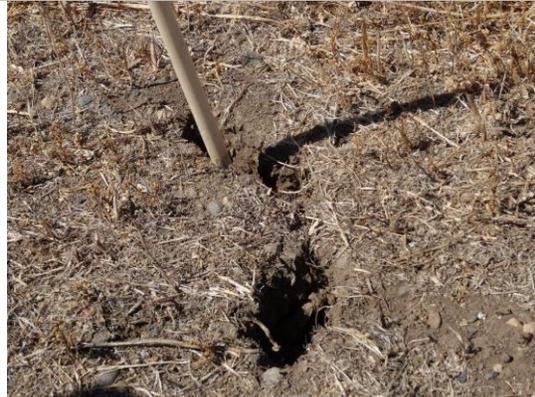
Photo 2 of 2 : UCIP\_SP\_2016\_42859\_35744.jpg

WS view: significant levee cracks along the pipealignment. Needs detailed investigation on the issue.
